**Flood Control Project Maintenance
Levee Inspections**

Maintenance Issue Types Only, Levee Inspection Report By Mile - Fall 2023

Reclamation District No. 1601 Twitchell

Waterway	Bank	Unit Miles	Inspection Start/End	Inspector
Unit No. 01 Threemile Slough	Left	2.43	10/25/2023 10/25/2023	Zach Jojola

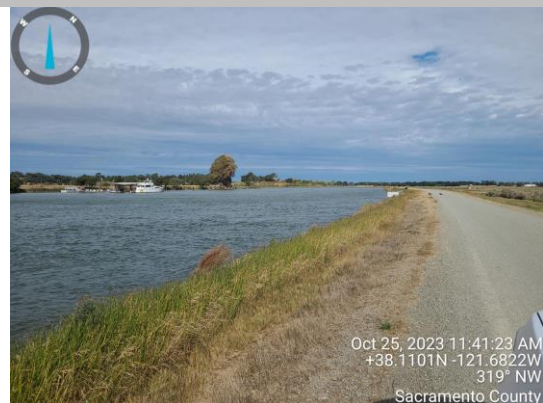
Photo 1 of 1 : FA_2023_RD1601_237_5_20231025_00013.jpg

LM Start	0.71	Rating **	M	Issue No.	5
LM End	0.85	Issue Type +	Ma	Location *	WS
Category	Earthen Levee			GPS Latitude/Longitude	
				Start	End
Item	Vegetation			38.112253°	38.110173°
				-121.682078°	-121.682167°
DWR ID	DWR_RD1601_01_f_2023_5				
Comment Code					
V2 : Remove the wild growth and woody vegetation other than native grasses from the levee slopes.					
Inspector Comment					
Horsetail on the waterside slope. There is riprap throughout the whole slope.

View of vegetation on the waterside slope. Fall 2023.

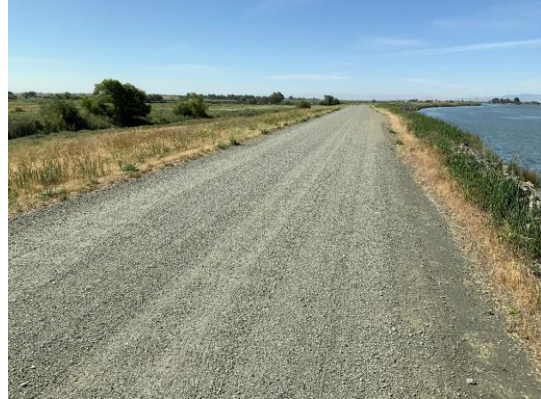
Photo 1 of 3 : UCIP_FA_2023_76138_113885.jpg

Comment Code					
Inspector Comment					
DS_ID:20957 FS_ID:76138 EP_NO: N/A Repair Type: Non-Urgent EVAL Issue: Crossing Status: Not Found UCIP Comments: 05/25/2022 The record is Non-Urgent. Pipe not found by visual inspection. DWR DMP geophysical study did not confirm presence of pipe through levee. Record will remain in UCIP's inspection records until future Levee Improvement Project can confirm no crossing was found through the levee. The UCIP inspection was completed with GEI staff, C. Riddell. (A. Lau - GEI) 05/14/2013 No signs indicating crossing present--rip rap present on waterward slope. (Olivia Magana – DWR) FIELD_STRUCT_DESC: 24-inch corrugated metal drainage pipe through the levee at an unknown depth. [Additional Reference(s): USACE O&M DWG No. 50-4-2958]. FS Date: 5/25/2022 8:57:02 PM

Levee crown at crossing location on record.

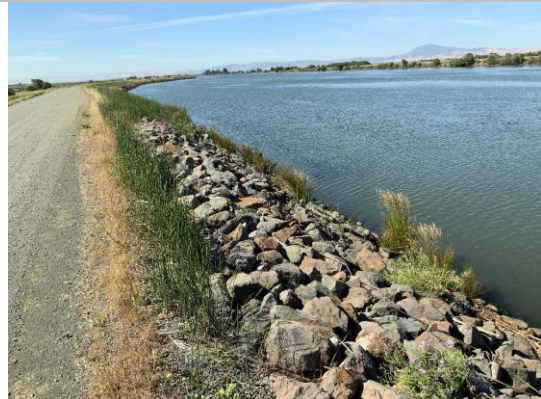
Photo 2 of 3 : UCIP_FA_2023_76138_113886.jpg

WS view: Slope from crown at crossing location on record; no visible pipe crossing.

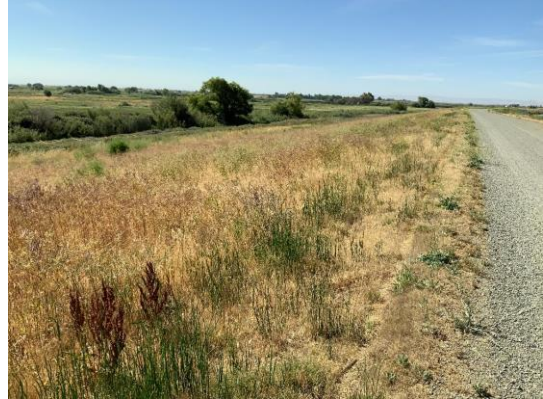
Photo 3 of 3 : UCIP_FA_2023_76138_113887.jpg

LS view: Toe from crown at crossing location on record; no visible pipe crossing.
