**Flood Control Project Maintenance  
Levee Inspections****Maintenance Issue Types Only, Levee Inspection Report By Mile - Fall 2024****Reclamation District No. 1601 Twitchell**

| Waterway | Bank | Unit Miles | Inspection Start/End | Inspector |
|---|---|---|---|---|
| Unit No. 01 Threemile Slough | Left | 2.43 | 10/10/2024<br>10/10/2024 | Gregg<br>McMillon |

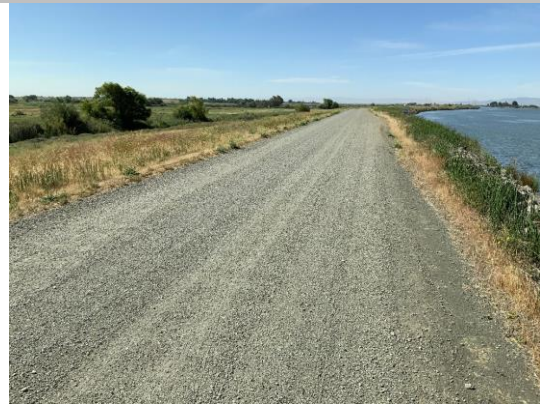
Photo 1 of 3 : UCIP\_FA\_2024\_76138\_113885.jpg

| DS_ID:20957<br>FS_ID:76138<br>EP_NO: N/A<br>Repair Type: Non-Urgent<br>EVAL Issue:<br>Crossing Status: Not Found<br>UCIP Comments: 05/25/2022 The record is Non-Urgent. Pipe not found by visual inspection. DWR DMP geophysical study did not confirm presence of pipe through levee. Record will remain in UCIP's inspection records until future Levee Improvement Project can confirm no crossing was found through the levee. The UCIP inspection was completed with GEI staff, C. Riddell. (A. Lau - GEI) 05/14/2013 No signs indicating crossing present--rip rap present on waterward slope. (Olivia Magana ? DWR)<br>FIELD_STRUCT_DESC: 18-inch corrugated metal drainage pipe through the levee at an unknown depth. [Additional Reference(s): DWR Levee Log, 2023 (HLM 0.79). USACE As-Built Drawing No. 50-04-2671, 25 January 1951, Sheet 12, STA 26+75].<br>FS Date: 5/25/2022 8:57:02 PM | | | | | |

Levee crown at crossing location on record.

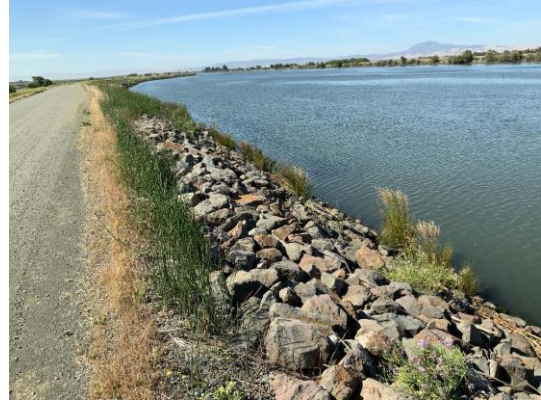
Photo 2 of 3 : UCIP\_FA\_2024\_76138\_113886.jpg

WS view: Slope from crown at crossing location on record; no visible pipe crossing.

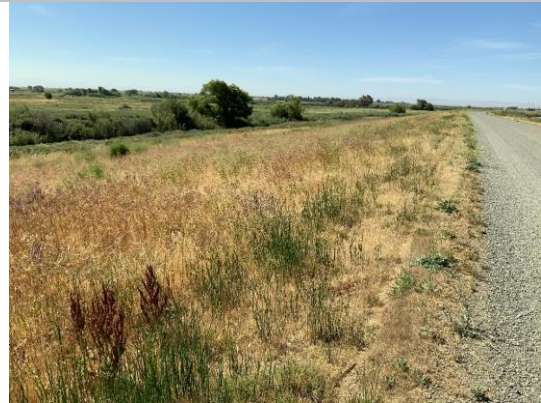
Photo 3 of 3 : UCIP\_FA\_2024\_76138\_113887.jpg

LS view: Toe from crown at crossing location on record; no visible pipe crossing.

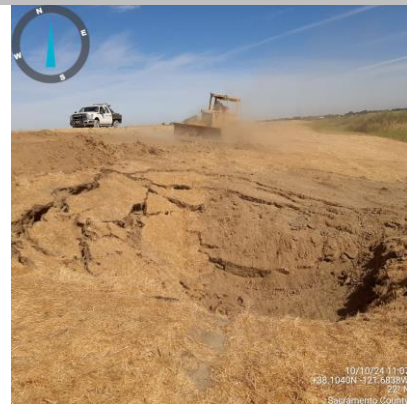
Photo 1 of 1 : FA\_2024\_RD1601\_237\_16\_20241011\_00015.jpg

| Item | Erosion / Bank Caving | | | 38.103970° | 38.103970° |
| Large approximately 30'x30' sink hole has appeared. LMA to work with their district engineer for emergency repairs to fill the sink hole. | | | | | |

View of approximately 30'x30' sink hole that has formed on the landside slope. (Fall 2024)

| E2 : Schedule repair of erosion site prior to the next inspection. | | | | | |

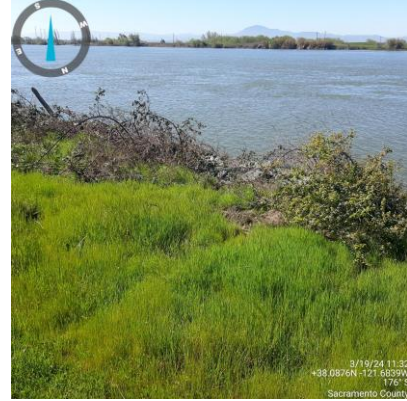
Photo 1 of 1 : FA\_2024\_RD1601\_237\_15\_20241001\_00002.jpg

| Item | Vegetation | | | 38.087580° | 38.087580° |

View of wild vegetation on the WS slope. (Spring 2024)

| V2 : Remove the wild growth and woody vegetation other than native grasses from the levee slopes. | | | | | |
| Blackberry bushes to be removed. | | | | | |
