**Flood Control Project Maintenance  
Levee Inspections**

**Fall 2010 Levee Maintenance Deficiency Summary Report**

**Reclamation District No. 1602 Del Puerto**

Waterway	Bank	Unit Miles
Unit No. 01 San Joaquin River	Left	6.29

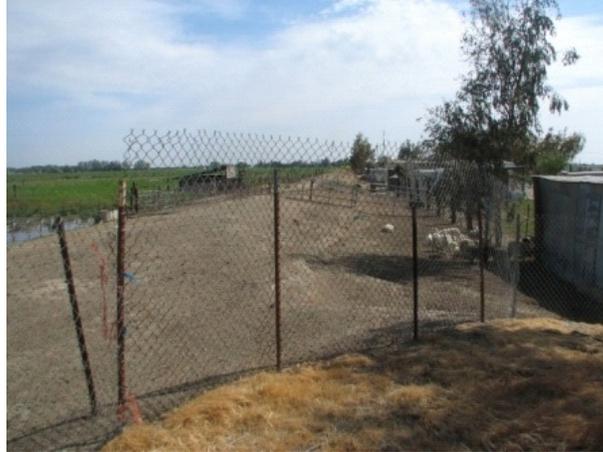
Levee Mile Report Line	1
Start Levee Mile	0.00
End Levee Mile	0.11
Location	Crown
Category	Earthen Levee
Item	Encroachments
Looking at animal pens on crown of levee from LM 0.00 to 0.11	
dpesaven_f_20100928_395.jpg

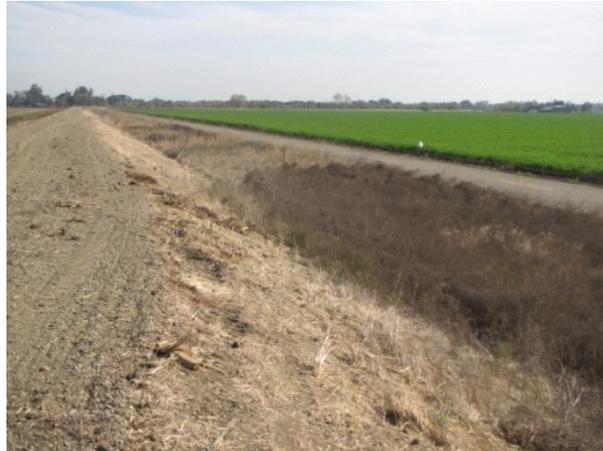
Levee Mile Report Line	3
Start Levee Mile	0.14
End Levee Mile	0.56
Location	Land Side
Category	Earthen Levee
Item	Vegetation
View of vegetation blocking visibility and access along the landward toe looking upstream.	
dpesaven_f_20101029_500.jpg

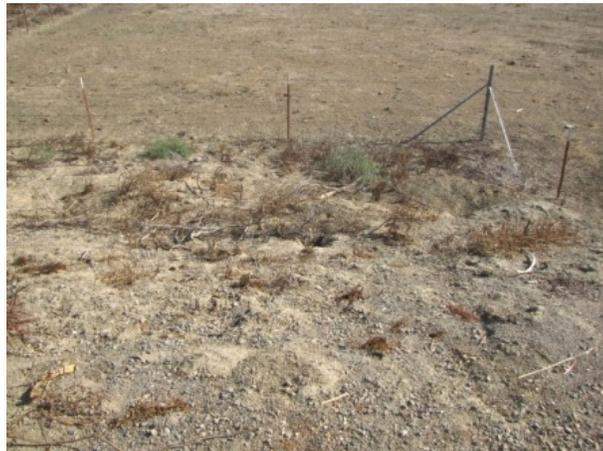
Levee Mile Report Line	4
Start Levee Mile	0.56
End Levee Mile	0.56
Location	Water Side
Category	Earthen Levee
Item	Animal Control
View of rodent holes on the waterward slope looking waterward.	
dpesaven_f_20101029_501.jpg

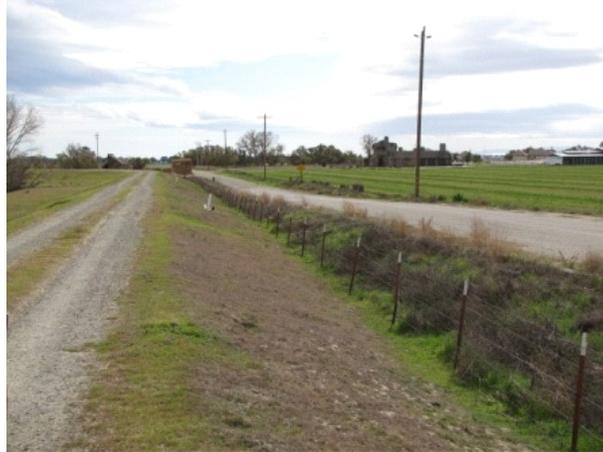
Levee Mile Report Line	6
Start Levee Mile	0.60
End Levee Mile	0.72
Location	Water Side
Category	Earthen Levee
Item	Encroachments

View of barbed wire fence at landward toe looking upstream.

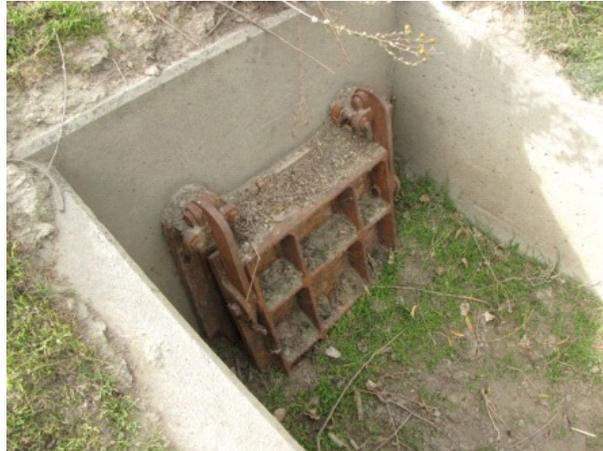
Levee Mile Report Line	11
Start Levee Mile	0.78
End Levee Mile	0.78
Location	Water Side
Category	Interior Drainage & Piping Systems
Item	Flap Gates

View of a flap gate with sediment preventing it from closing.

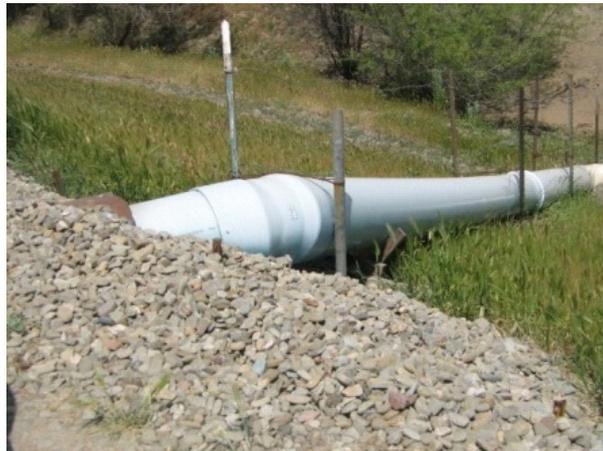
Levee Mile Report Line	15
Start Levee Mile	1.02
End Levee Mile	1.02
Location	Water Side
Category	Interior Drainage & Piping Systems
Item	Encroachments

PVC sleeve through steel pipe on waterward slope at LM 1.02

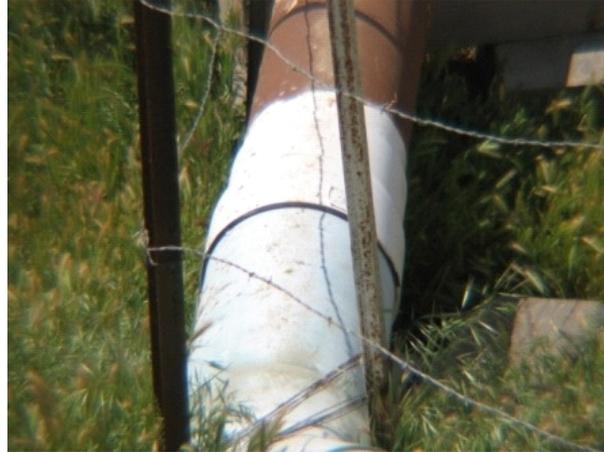
Levee Mile Report Line	15
Start Levee Mile	1.02
End Levee Mile	1.02
Location	Water Side
Category	Interior Drainage & Piping Systems
Item	Encroachments

PVC pipe connected to steel pipe on landward toe at LM 1.02

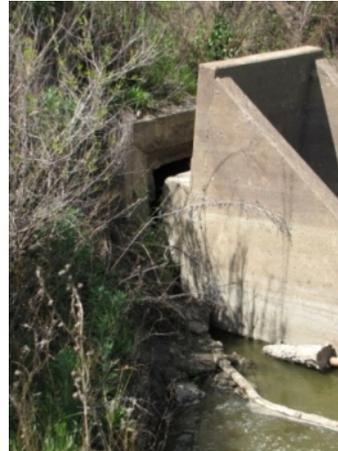
Levee Mile Report Line	16
Start Levee Mile	1.04
End Levee Mile	1.04
Location	Water Side
Category	Interior Drainage & Piping Systems
Item	Concrete Tilting / Settlement

Separation of outfall structure from the outlet pipe at LM 1.04.

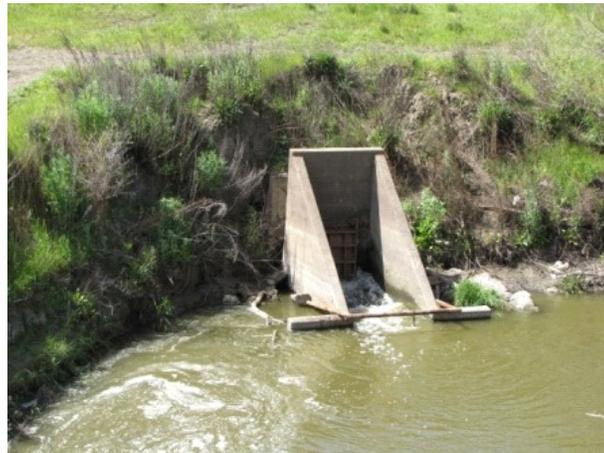
Levee Mile Report Line	16
Start Levee Mile	1.04
End Levee Mile	1.04
Location	Water Side
Category	Interior Drainage & Piping Systems
Item	Concrete Tilting / Settlement

Additional view of outfall structure at LM 1.04.

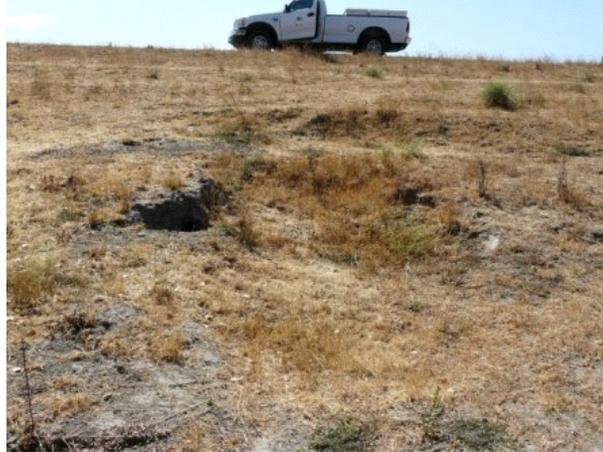
Levee Mile Report Line	17
Start Levee Mile	1.07
End Levee Mile	1.07
Location	Water Side
Category	Earthen Levee
Item	Slope Stability
small amount of slumping at water toe	
dpesaven_f_20100928_405.JPG

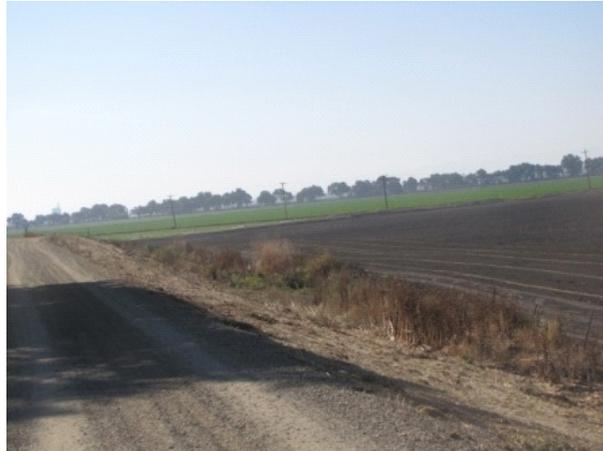
Levee Mile Report Line	21
Start Levee Mile	1.32
End Levee Mile	1.32
Location	Water Side
Category	Earthen Levee
Item	Animal Control
View of vegetation along the landward slope and toe blocking visibility and access looking upstream.	
dpesaven_f_20101029_502.jpg

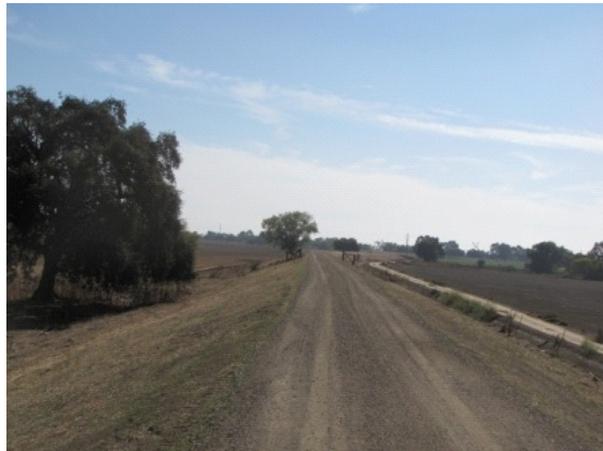
Levee Mile Report Line	39
Start Levee Mile	2.76
End Levee Mile	2.76
Location	Land Side
Category	Earthen Levee
Item	Vegetation
View of now typical condition of the majority of the district's levee. Vegetation is well maintained and slopes appear to be adequately maintained.	
dpesaven_f_20101029_503.jpg

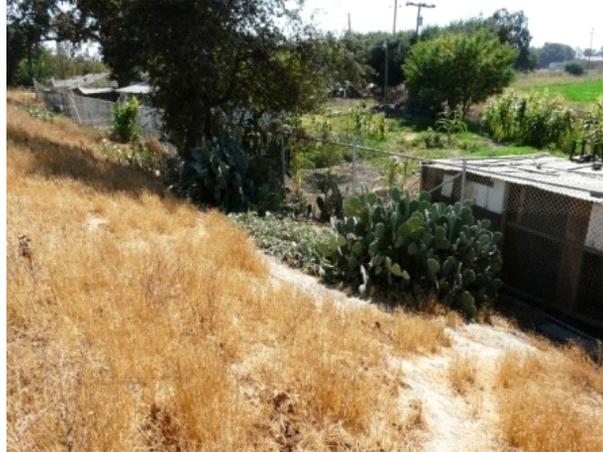
Levee Mile Report Line	52
Start Levee Mile	3.85
End Levee Mile	3.85
Location	Land Side
Category	Earthen Levee
Item	Encroachments
Remove landscaping from within 10' of landside toe	
dpesaven_f_20100928_406.JPG

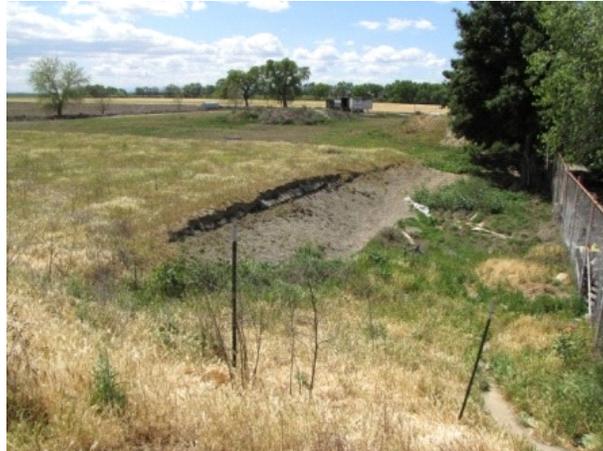
Levee Mile Report Line	53
Start Levee Mile	3.96
End Levee Mile	3.96
Location	Land Side
Category	Earthen Levee
Item	Slope Stability
Repair damage to USACE constructed seepage berm by pedestrian and cycle traffic at LM 3.96.	
dpesaven_f_20100928_409.jpg

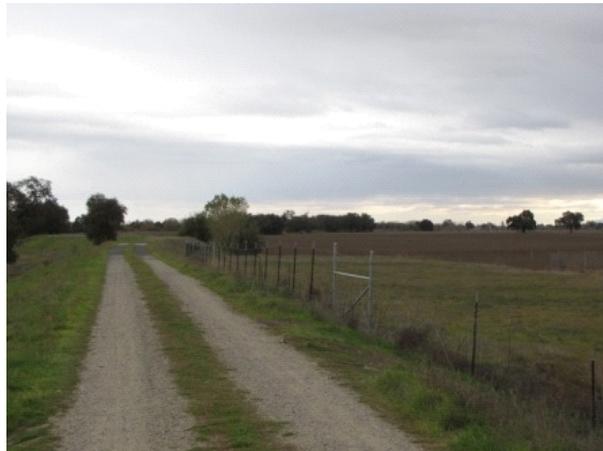
Levee Mile Report Line	54
Start Levee Mile	3.97
End Levee Mile	4.07
Location	Land Side
Category	Earthen Levee
Item	Encroachments
View of a barbed wire fence on the landward slope looking upstream.	
dpesaven_f_20100928_410.jpg

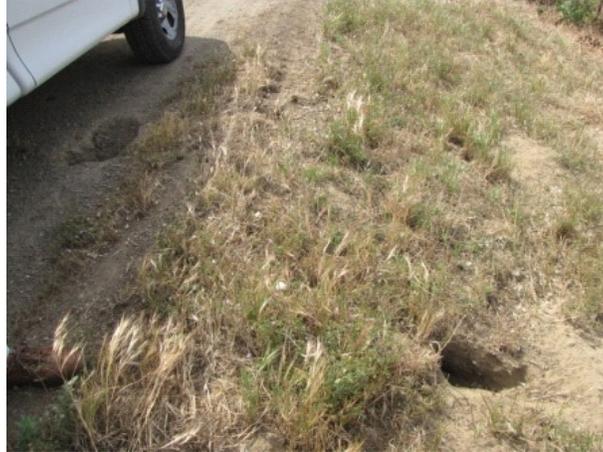
Levee Mile Report Line	66
Start Levee Mile	4.72
End Levee Mile	4.72
Location	Land Side
Category	Earthen Levee
Item	Animal Control
View of rodent holes on the landward slope looking upstream.	
dpesaven_f_20100928_402.jpg

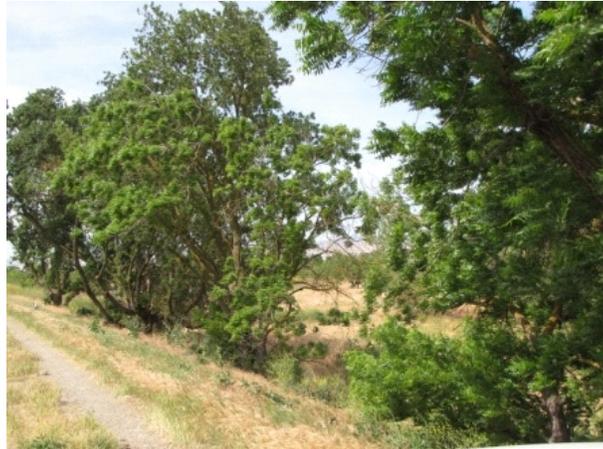
Levee Mile Report Line	69
Start Levee Mile	4.92
End Levee Mile	4.92
Location	Land Side
Category	Earthen Levee
Item	Trim / Thin Trees
View of trees blocking visibility on the landward slope looking upstream.	
dpesaven_f_20100928_403.jpg

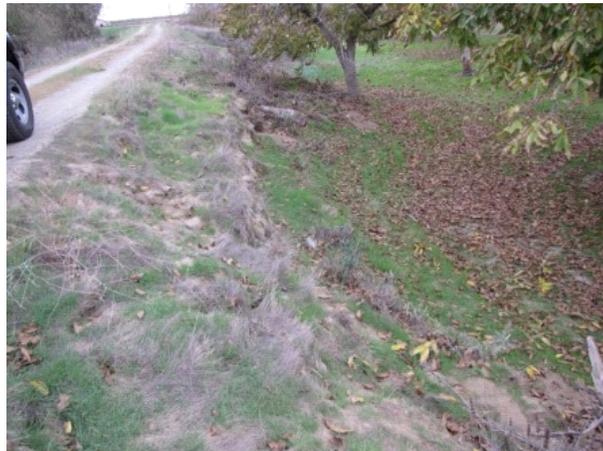
Levee Mile Report Line	83
Start Levee Mile	5.34
End Levee Mile	5.34
Location	Land Side
Category	Earthen Levee
Item	Slope Stability
View of significant damage and erosion to the landward slope looking upstream.	
dpesaven_f_20100928_417.jpg

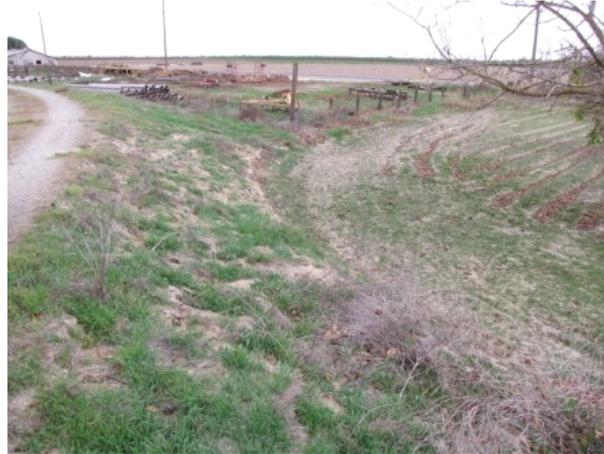
Levee Mile Report Line	87
Start Levee Mile	5.40
End Levee Mile	5.40
Location	Land Side
Category	Earthen Levee
Item	Slope Stability

View of tilling into the landward slope of the levee looking upstream. This slope has also been significantly damaged by rodent activity.
