**Flood Control Project Maintenance
Levee Inspections**

Fall 2008 Levee Maintenance Deficiency Summary Report

Reclamation District No. 1602

Waterway		Bank	Unit Miles
Unit No. 01 San Joaquin River		Left	6.30

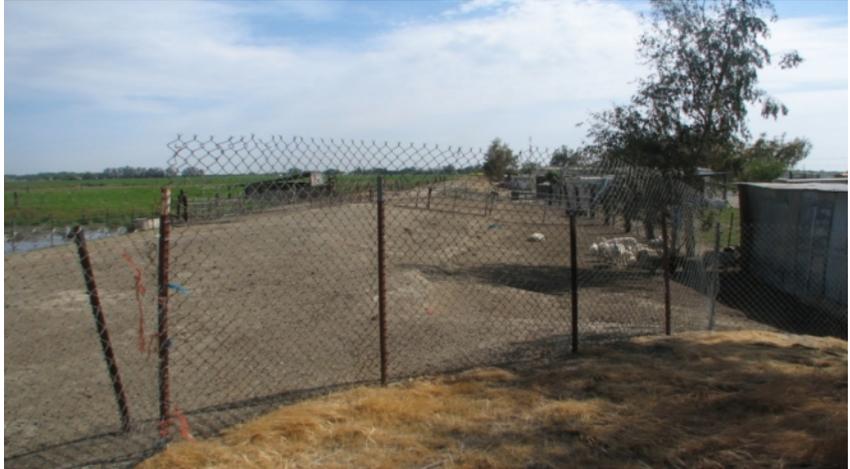
Levee Mile Report Line	1
Start Levee Mile	0.00
End Levee Mile	0.11
Location	
Category	Earthen Levee
Item	Encroachments
Looking at animal pens on crown of levee from LM 0.00 to 0.11

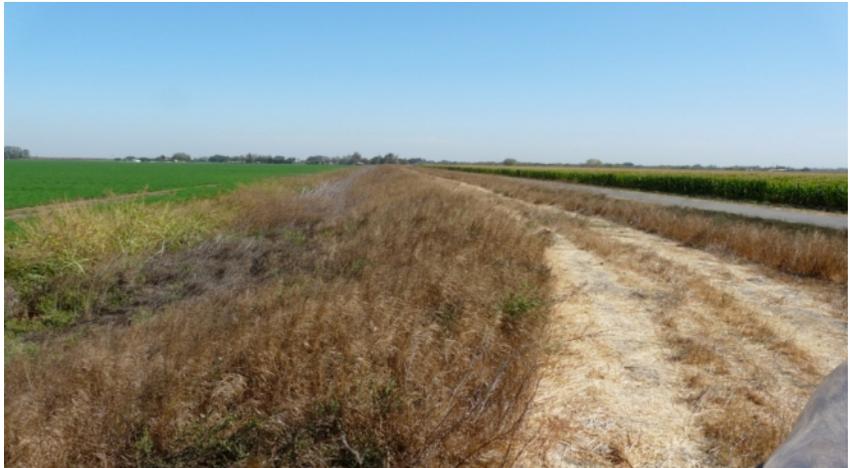
Levee Mile Report Line	2
Start Levee Mile	0.11
End Levee Mile	0.58
Location	
Category	Earthen Levee
Item	Vegetation
Levee overgrown-mow weeds/wild growth on crown, waterside & landside

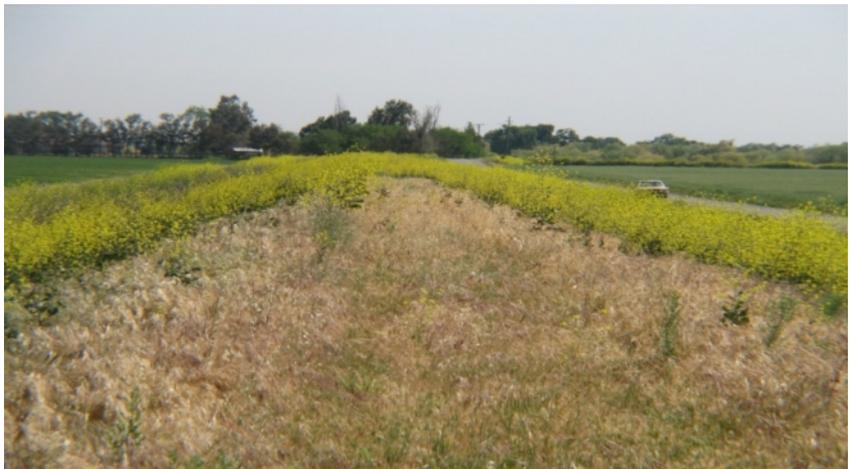
Levee Mile Report Line	4
Start Levee Mile	0.11
End Levee Mile	0.58
Location	
Category	Earthen Levee
Item	Crown Surface / Depressions / Rutting
Vegetation overgrown of levee crown from LM 0.11 to 0.58

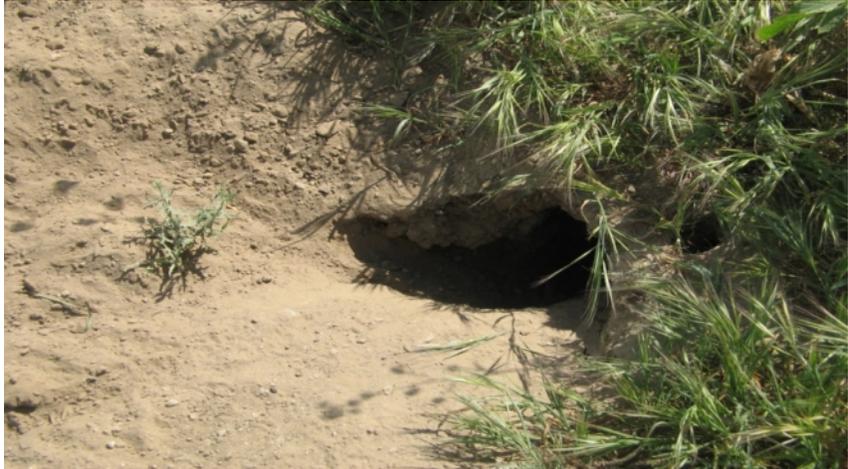
Levee Mile Report Line	5
Start Levee Mile	0.11
End Levee Mile	1.12
Location	
Category	Earthen Levee
Item	Animal Control
Typical picture of animal borrows on landward slope from LM 0.11 to 0.58

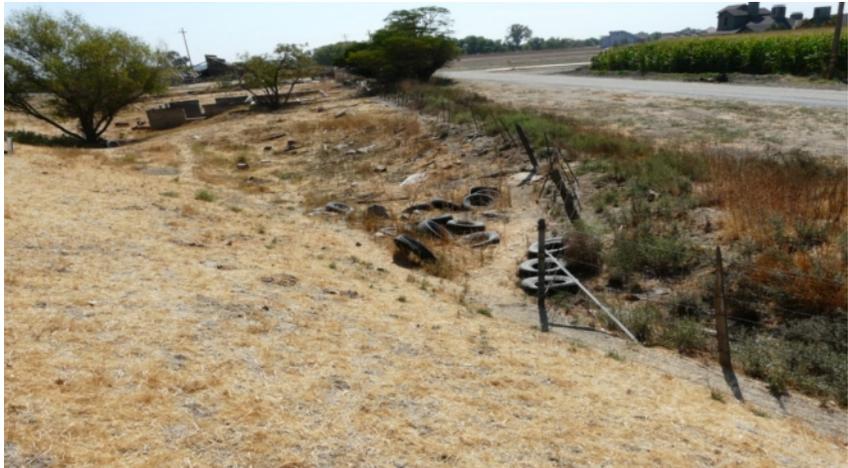
Levee Mile Report Line	8
Start Levee Mile	0.73
End Levee Mile	0.73
Location	
Category	Earthen Levee
Item	Encroachments
Remove debris within 10 feet of landside toe

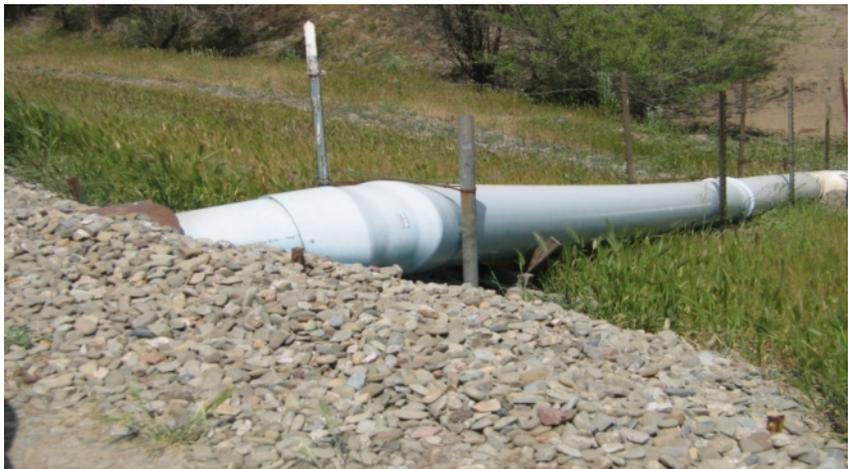
Levee Mile Report Line	11
Start Levee Mile	1.02
End Levee Mile	1.02
Location	
Category	Interior Drainage & Piping Systems
Item	Encroachments
PVC sleeve through steel pipe on waterward slope at LM 1.02

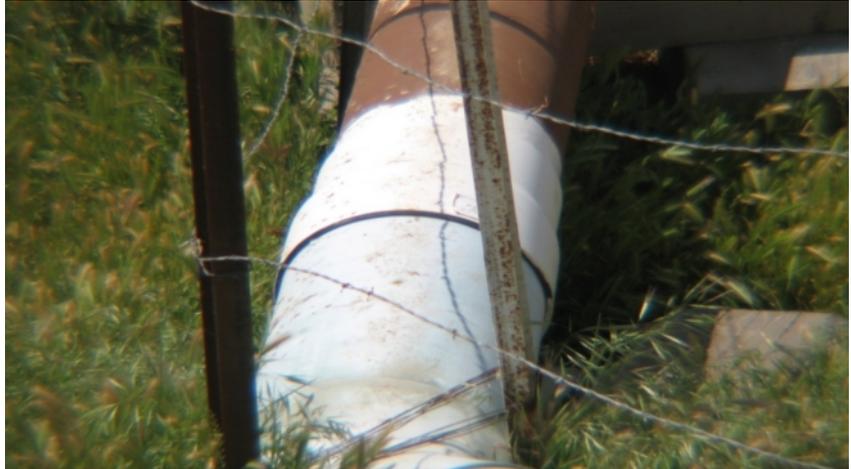
Levee Mile Report Line	11
Start Levee Mile	1.02
End Levee Mile	1.02
Location	
Category	Interior Drainage & Piping Systems
Item	Encroachments
PVC pipe connected to steel pipe on landward toe at LM 1.02

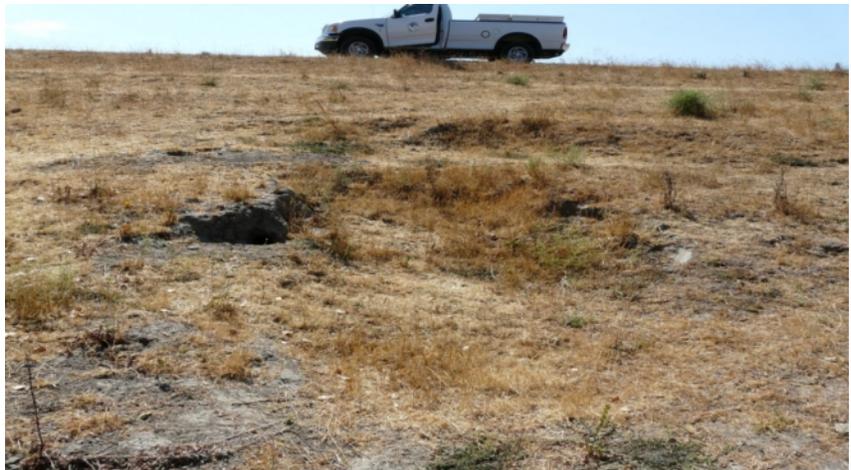
Levee Mile Report Line	12
Start Levee Mile	1.07
End Levee Mile	1.07
Location	
Category	Earthen Levee
Item	Slope Stability
small amount of slumping at water toe

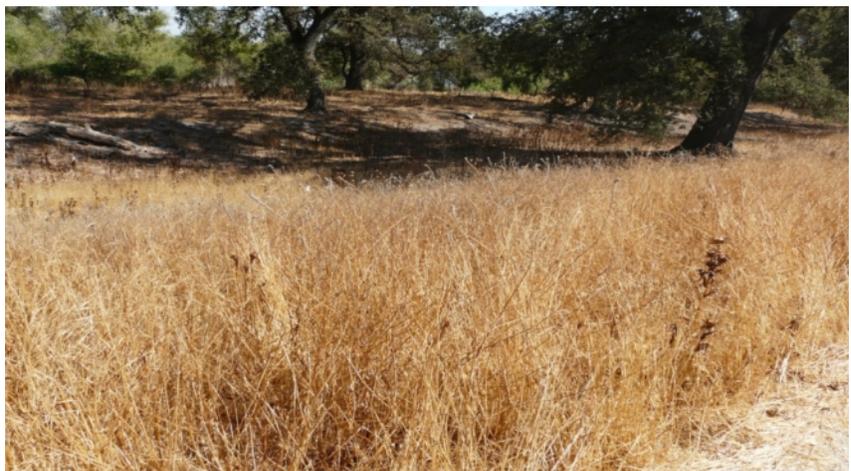
Levee Mile Report Line	17
Start Levee Mile	3.70
End Levee Mile	4.24
Location	
Category	Earthen Levee
Item	Vegetation
Trim weeds/wild growth within 20' of waterside sholder

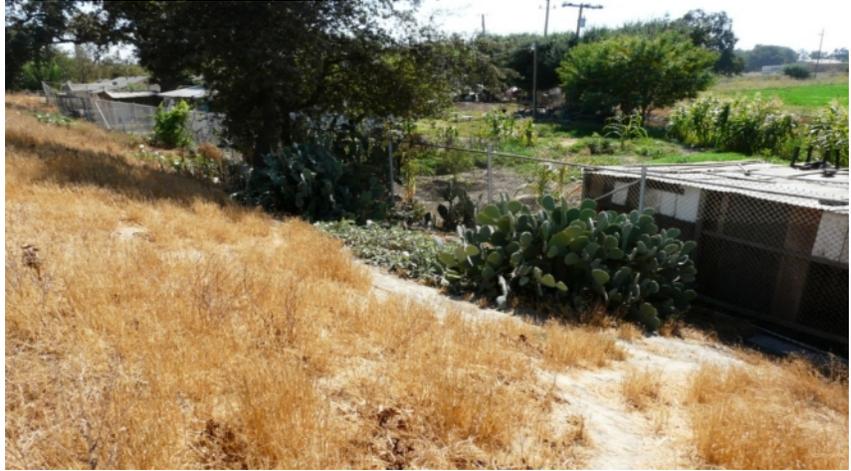
Levee Mile Report Line	19
Start Levee Mile	3.85
End Levee Mile	3.85
Location	
Category	Earthen Levee
Item	Encroachments
Remove landscaping from within 10' of landside toe

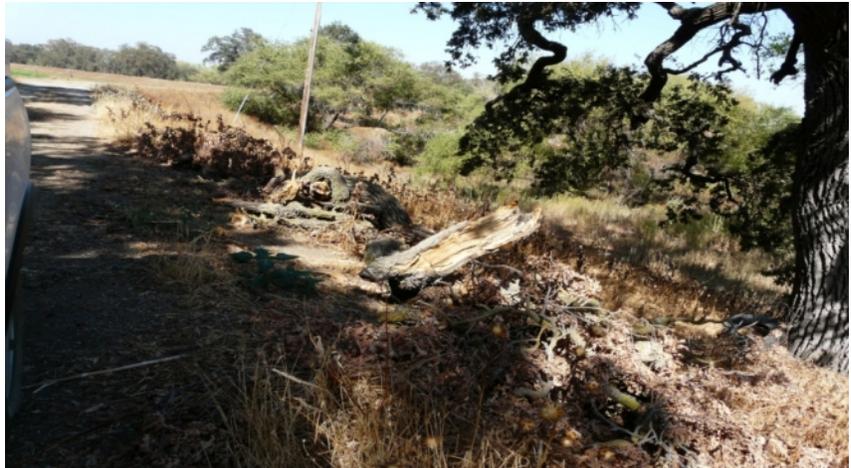
Levee Mile Report Line	21
Start Levee Mile	4.52
End Levee Mile	4.52
Location	
Category	Earthen Levee
Item	Encroachments
Dispose of prunings on waterside slope
