**Flood Control Project Maintenance
Levee Inspections**

Fall 2009 Levee Maintenance Deficiency Summary Report

San Joaquin River Basin

Reclamation District No. 1602 Del Puerto

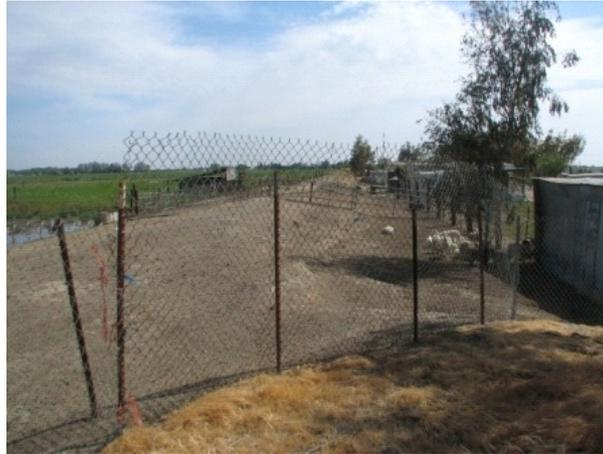
Levee Mile Report Line	1
Start Levee Mile	0.00
End Levee Mile	0.11
Location	Crown
Category	Earthen Levee
Item	Encroachments
Looking at animal pens on crown of levee from LM 0.00 to 0.11	
dpesaven_20091028_279.jpg

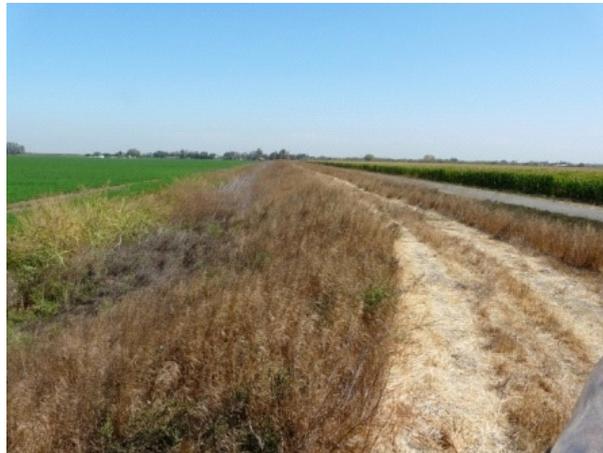
Levee Mile Report Line	2
Start Levee Mile	0.11
End Levee Mile	0.58
Location	Water Side
Category	Earthen Levee
Item	Vegetation
Levee overgrown-mow weeds/wild growth on crown, waterside & landside	
dpesaven_20091028_281.JPG

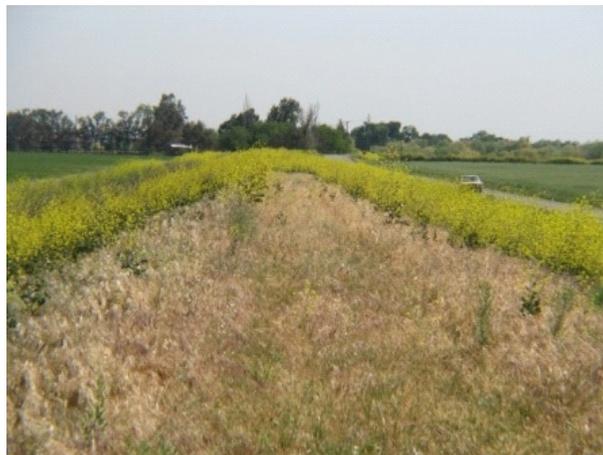
Levee Mile Report Line	4
Start Levee Mile	0.11
End Levee Mile	0.58
Location	Crown
Category	Earthen Levee
Item	Crown Surface / Depressions / Rutting
Vegetation overgrown of levee crown from LM 0.11 to 0.58	
dpesaven_20091028_280.jpg

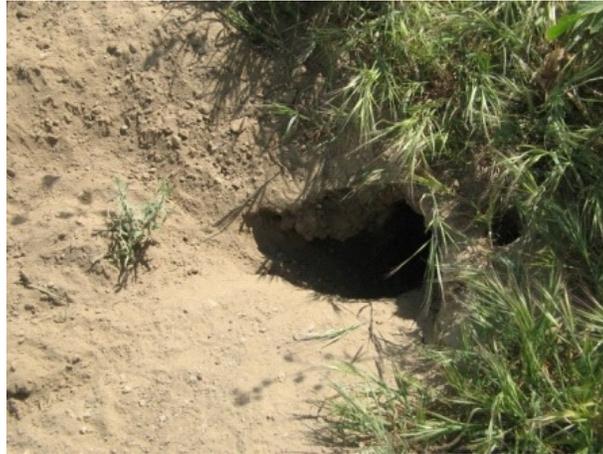
Levee Mile Report Line	5
Start Levee Mile	0.11
End Levee Mile	1.12
Location	Water Side
Category	Earthen Levee
Item	Animal Control
Typical picture of animal borrows on landward slope from LM 0.11 to 0.58	
dpesaven_20091028_282.jpg

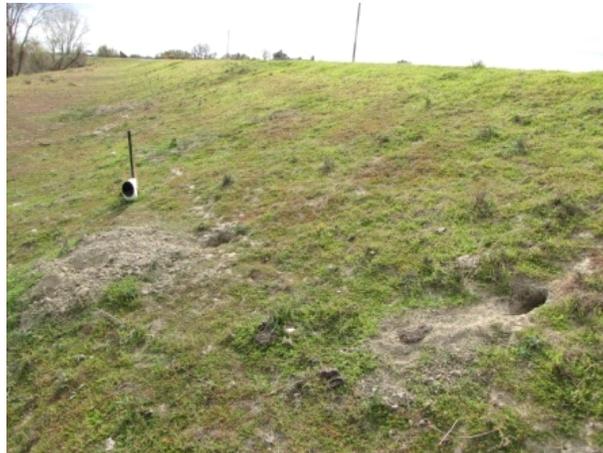
Levee Mile Report Line	7
Start Levee Mile	0.60
End Levee Mile	1.28
Location	Water Side
Category	Earthen Levee
Item	Animal Control
View of rodent holes in the waterward slope looking upstream.	
dpesaven_20091120_495.jpg

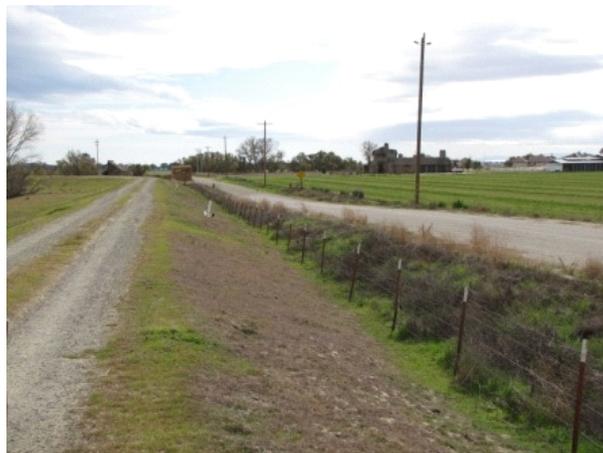
Levee Mile Report Line	8
Start Levee Mile	0.60
End Levee Mile	0.72
Location	Water Side
Category	Earthen Levee
Item	Encroachments
View of barbed wire fence at landward toe looking upstream.	
dpesaven_20091120_496.jpg

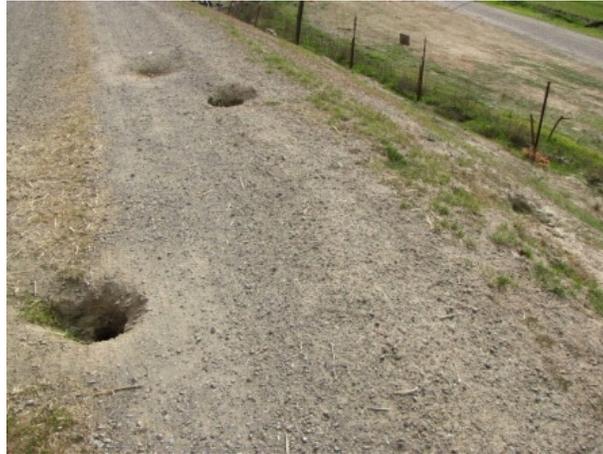
Levee Mile Report Line	9
Start Levee Mile	0.71
End Levee Mile	0.71
Location	Crown
Category	Earthen Levee
Item	Animal Control
View of rodent holes in the crown that go through to the landward side.	
dpesaven_20091120_497.jpg

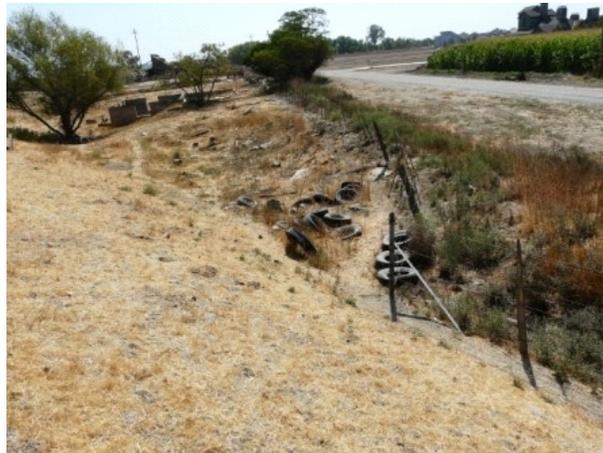
Levee Mile Report Line	10
Start Levee Mile	0.73
End Levee Mile	0.73
Location	Water Side
Category	Earthen Levee
Item	Encroachments
Remove debris within 10 feet of landside toe	
dpesaven_20091028_285.JPG

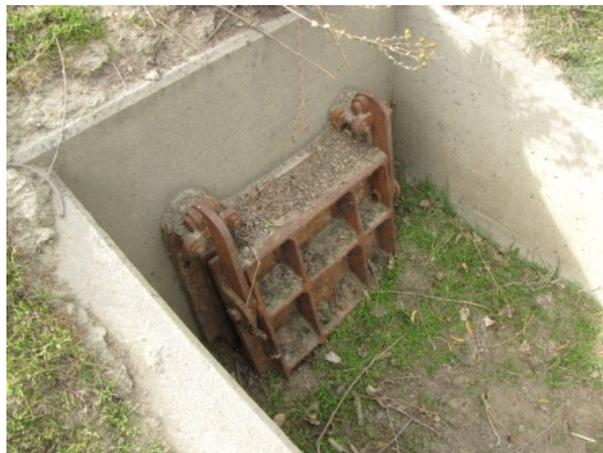
Levee Mile Report Line	11
Start Levee Mile	0.78
End Levee Mile	0.78
Location	Water Side
Category	Interior Drainage & Piping Systems
Item	Flap Gates
View of a flap gate with sediment preventing it from closing.	
dpesaven_20091120_498.jpg

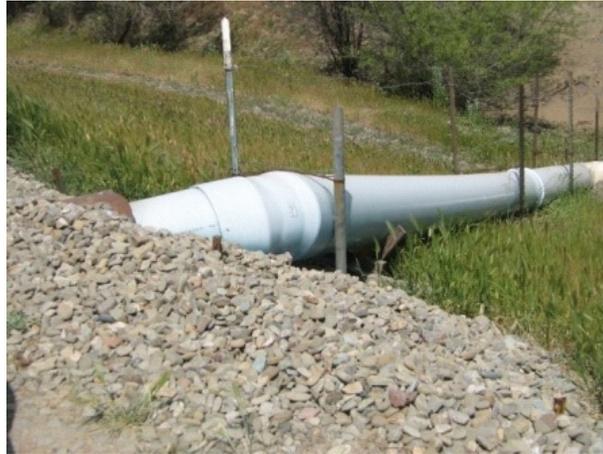
Levee Mile Report Line	14
Start Levee Mile	1.02
End Levee Mile	1.02
Location	Water Side
Category	Interior Drainage & Piping Systems
Item	Encroachments
PVC sleeve through steel pipe on waterward slope at LM 1.02	
dpesaven_20091028_283.jpg

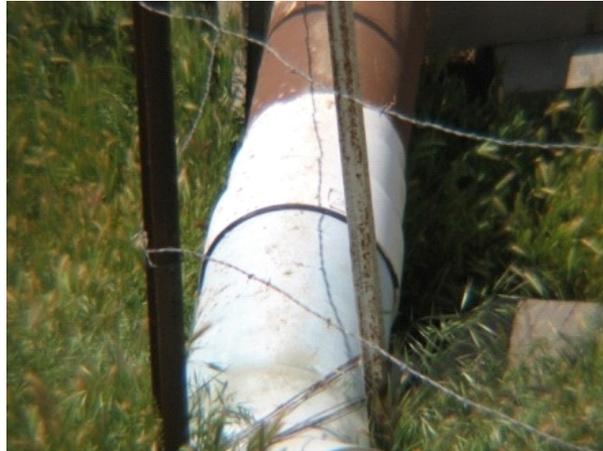
Levee Mile Report Line	14
Start Levee Mile	1.02
End Levee Mile	1.02
Location	Water Side
Category	Interior Drainage & Piping Systems
Item	Encroachments
PVC pipe connected to steel pipe on landward toe at LM 1.02	
dpesaven_20091028_284.jpg

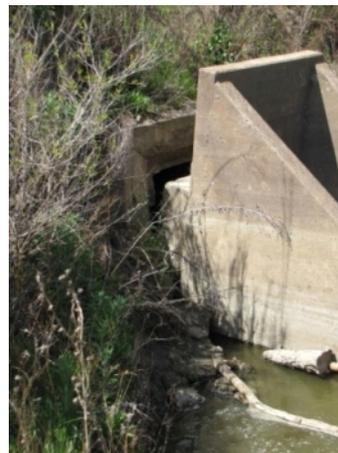
Levee Mile Report Line	15
Start Levee Mile	1.04
End Levee Mile	1.04
Location	Water Side
Category	Interior Drainage & Piping Systems
Item	Concrete Tilting / Settlement
Separation of outfall structure from the outlet pipe at LM 1.04.	
dpesaven_20091028_289.jpg

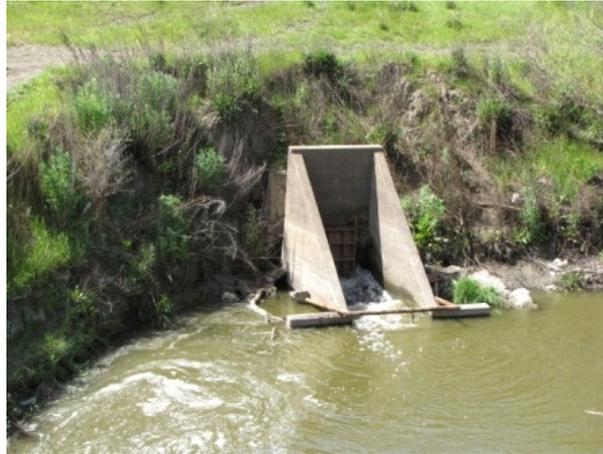
Levee Mile Report Line	15
Start Levee Mile	1.04
End Levee Mile	1.04
Location	Water Side
Category	Interior Drainage & Piping Systems
Item	Concrete Tilting / Settlement
Additional view of outfall structure at LM 1.04.	
dpesaven_20091028_290.jpg

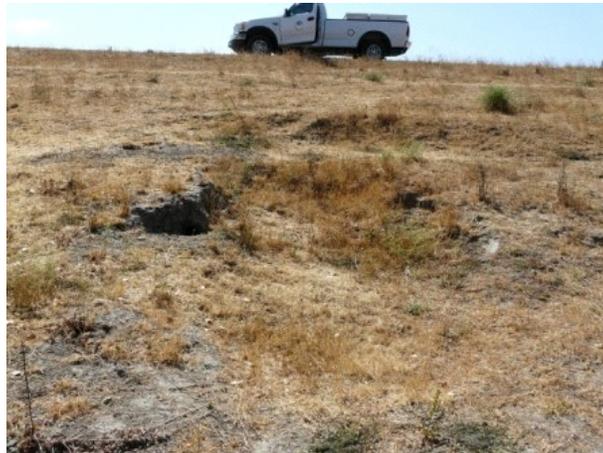
Levee Mile Report Line	16
Start Levee Mile	1.07
End Levee Mile	1.07
Location	Water Side
Category	Earthen Levee
Item	Slope Stability
small amount of slumping at water toe	
dpesaven_20091028_286.JPG

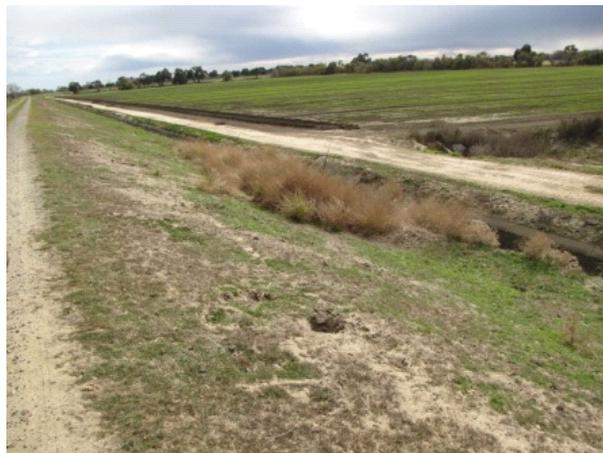
Levee Mile Report Line	29
Start Levee Mile	2.61
End Levee Mile	2.61
Location	Land Side
Category	Earthen Levee
Item	Vegetation
View of vegetation blocking visibility on the landward slope looking upstream.	
dpesaven_20091120_499.jpg

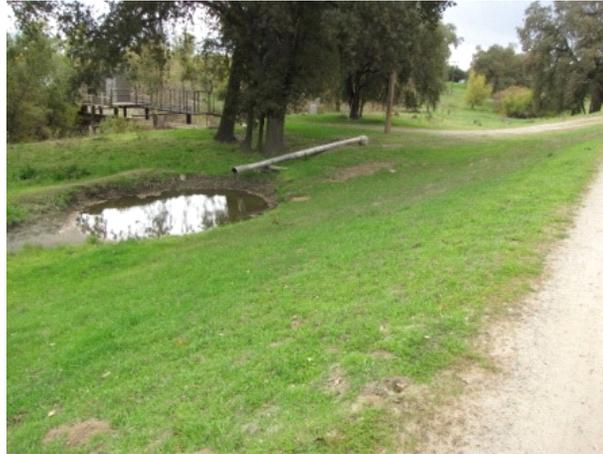
Levee Mile Report Line	32
Start Levee Mile	3.55
End Levee Mile	3.55
Location	Water Side
Category	Earthen Levee
Item	Erosion / Bank Caving
View of an irrigation pond on the waterward side of the levee that is encroaching into the slope looking upstream.	
dpesaven_20091120_500.jpg

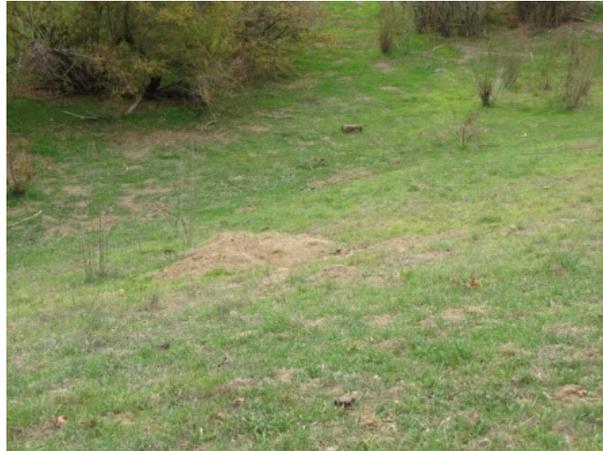
Levee Mile Report Line	33
Start Levee Mile	3.61
End Levee Mile	3.61
Location	Water Side
Category	Earthen Levee
Item	Animal Control
View of a large rodent hole in the waterward slope.	
dpesaven_20091120_501.jpg

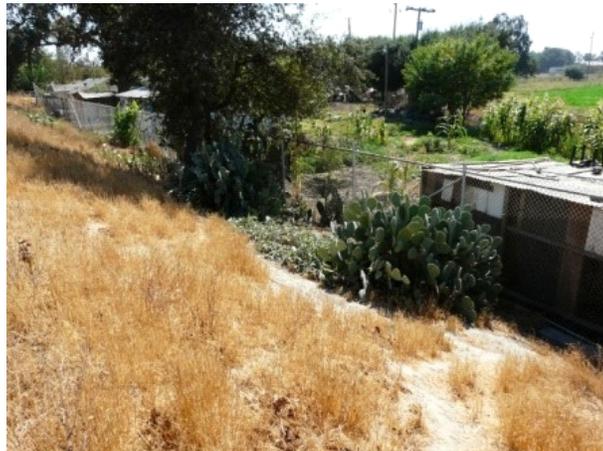
Levee Mile Report Line	35
Start Levee Mile	3.85
End Levee Mile	3.85
Location	Land Side
Category	Earthen Levee
Item	Encroachments
Remove landscaping from within 10' of landside toe	
dpesaven_20091028_287.JPG

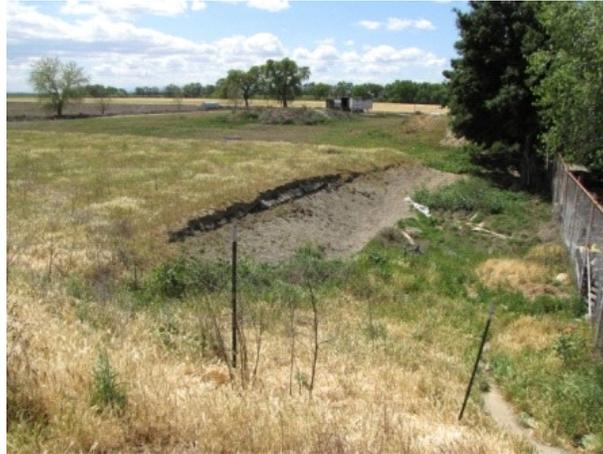
Levee Mile Report Line	37
Start Levee Mile	3.96
End Levee Mile	3.96
Location	Land Side
Category	Earthen Levee
Item	Slope Stability
Repair damage to Corp constructed seepage berm by pedestrian and cycle traffic at LM 3.96.	
dpesaven_20091028_291.jpg

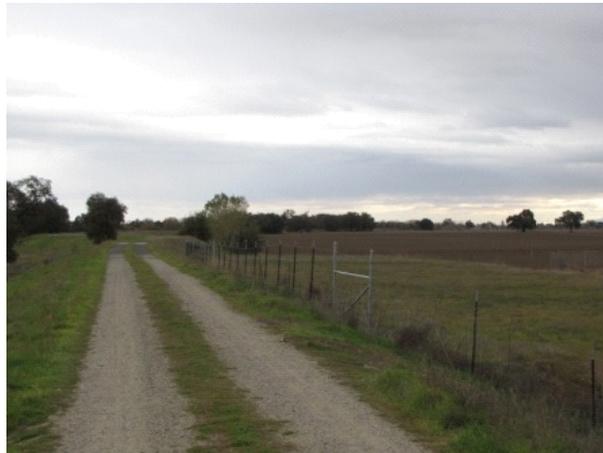
Levee Mile Report Line	38
Start Levee Mile	3.97
End Levee Mile	4.07
Location	Land Side
Category	Earthen Levee
Item	Encroachments
View of a barbed wire fence on the landward slope looking upstream.	
dpesaven_20091120_502.jpg

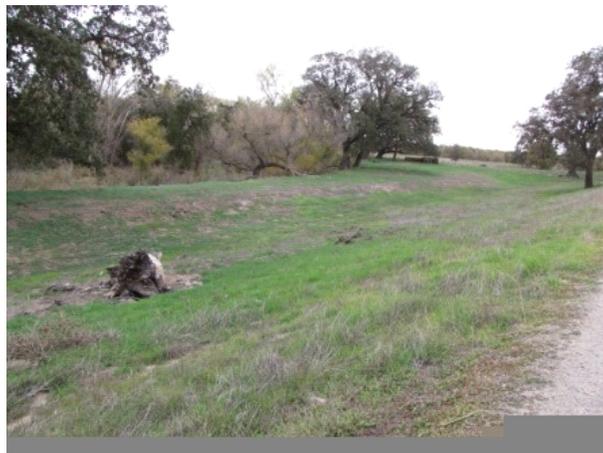
Levee Mile Report Line	44
Start Levee Mile	4.33
End Levee Mile	4.33
Location	Water Side
Category	Earthen Levee
Item	Encroachments
View of a stump and remaining cavity in the waterward slope looking upstream.	
dpesaven_20091120_503.jpg

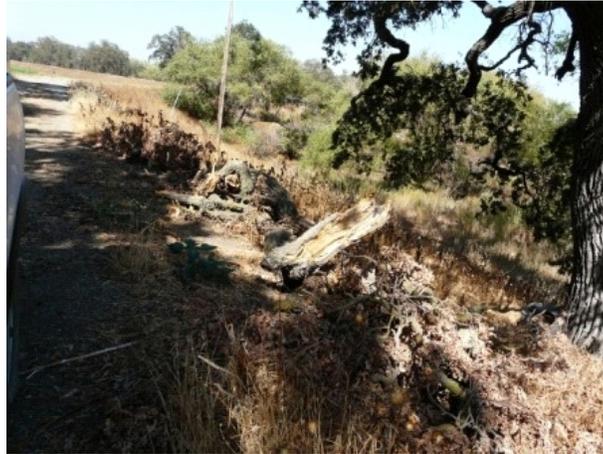
Levee Mile Report Line	47
Start Levee Mile	4.52
End Levee Mile	4.52
Location	Land Side
Category	Earthen Levee
Item	Encroachments
View of prunings on waterward slope looking downstream.	
dpesaven_20091028_288.JPG

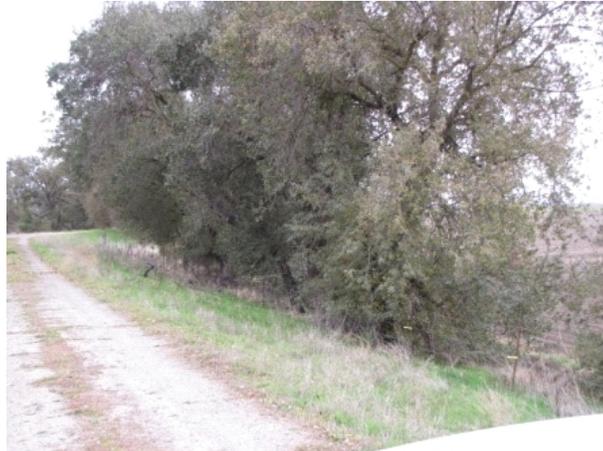
Levee Mile Report Line	48
Start Levee Mile	4.56
End Levee Mile	4.58
Location	Land Side
Category	Earthen Levee
Item	Vegetation
View of excessive vegetation along the landward slope blocking visibility and access looking upstream.	
dpesaven_20091120_504.jpg

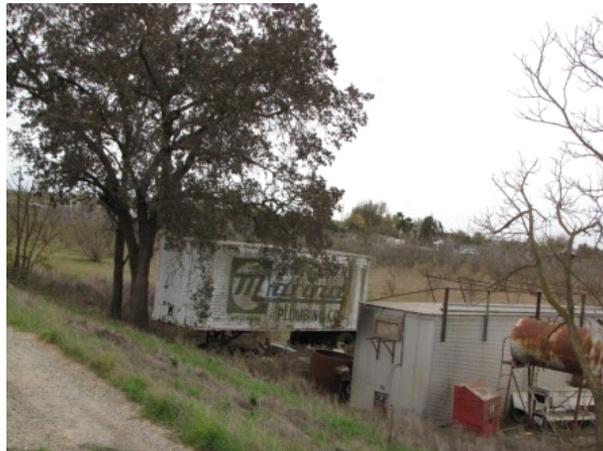
Levee Mile Report Line	55
Start Levee Mile	5.02
End Levee Mile	5.02
Location	Land Side
Category	Earthen Levee
Item	Encroachments
View of equipment at the landward toe blocking visibility and access.	
dpesaven_20091120_505.jpg

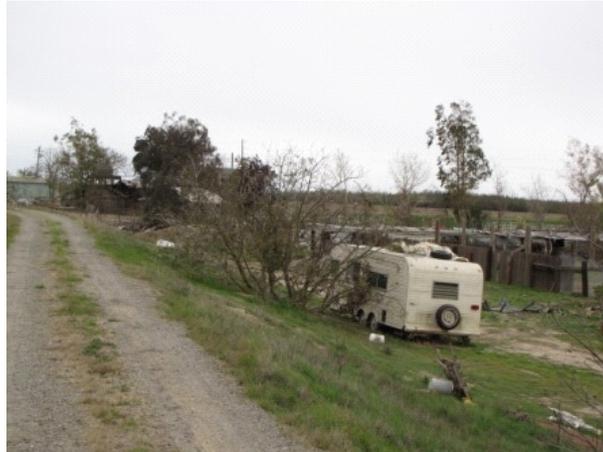
Levee Mile Report Line	58
Start Levee Mile	5.15
End Levee Mile	5.15
Location	Land Side
Category	Earthen Levee
Item	Encroachments
View of a trailer at the landward toe blocking visibility and access looking upstream.	
dpesaven_20091120_506.jpg

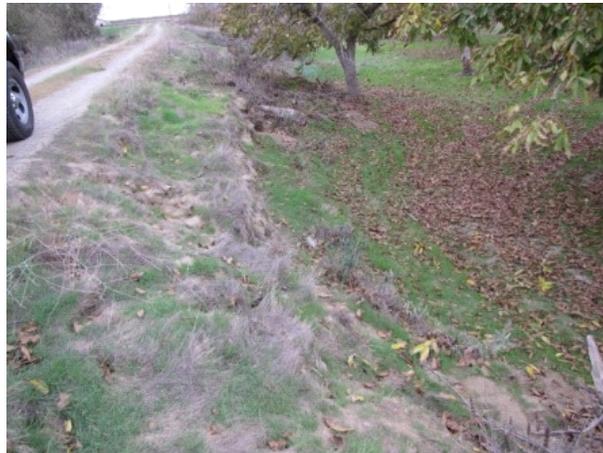
Levee Mile Report Line	64
Start Levee Mile	5.34
End Levee Mile	5.34
Location	Land Side
Category	Earthen Levee
Item	Slope Stability
View of significant damage and erosion to the landward slope looking upstream.	
dpesaven_20091120_507.jpg

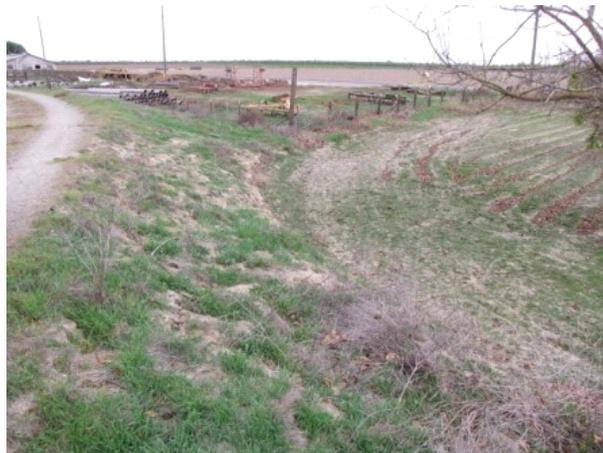
Levee Mile Report Line	69
Start Levee Mile	5.40
End Levee Mile	5.40
Location	Land Side
Category	Earthen Levee
Item	Slope Stability
View of tilling into the landward slope of the levee looking upstream. This slope has also been significantly damaged by rodent activity.	
dpesaven_20091120_508.jpg
