**Flood Control Project Maintenance
Levee Inspections**

Fall 2011 Levee Maintenance Deficiency Summary Report

San Joaquin River Basin

Reclamation District No. 1602 Del Puerto

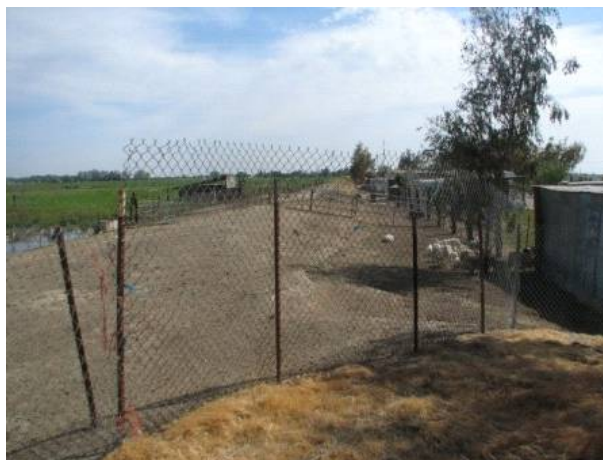
Levee Mile Report Line	2
Start Levee Mile	0.15
End Levee Mile	0.27
Location	Water Side
Category	Earthen Levee
Item	Vegetation

View of the vegetation on the waterside of the levee. The picture was taken from the crown looking upstream.

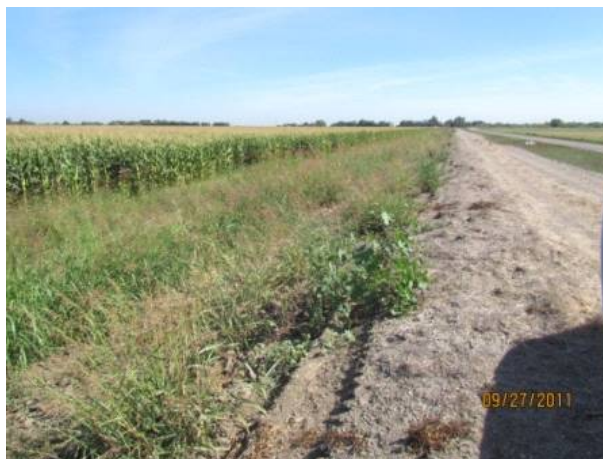
Levee Mile Report Line	3
Start Levee Mile	0.17
End Levee Mile	0.17
Location	Water Side
Category	Earthen Levee
Item	Animal Control

Rodent hole was found on the waterside of the slope. The picture was taken from the crown looking toward waterside of the slope.

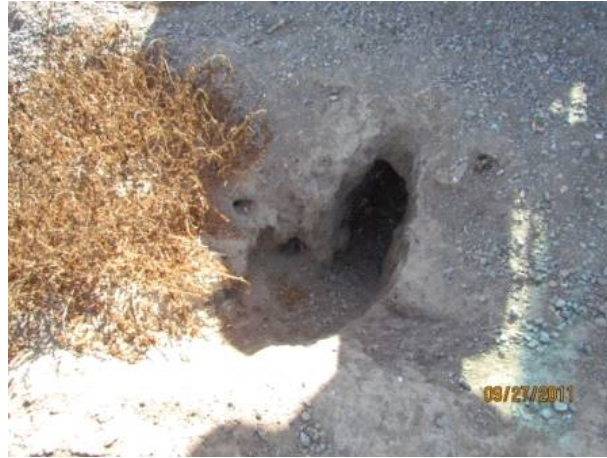
Levee Mile Report Line	5
Start Levee Mile	0.37
End Levee Mile	0.37
Location	Water Side
Category	Earthen Levee
Item	Animal Control

Rodent holes were found on the waterside of the slope. The picture was taken from the toe looking towards the crown of the levee.

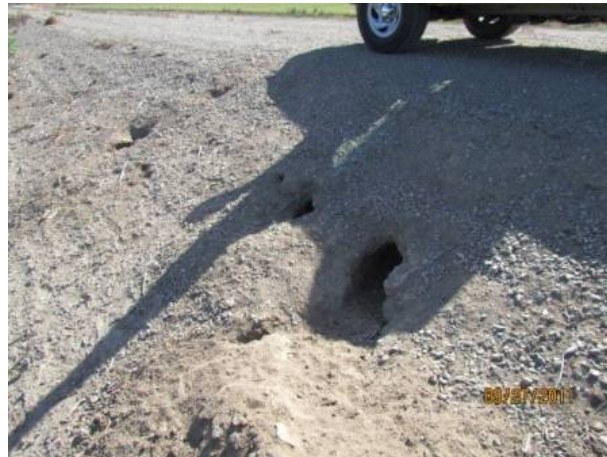
Levee Mile Report Line	6
Start Levee Mile	0.45
End Levee Mile	0.45
Location	Water Side
Category	Earthen Levee
Item	Animal Control

A rodent hole was found on the waterside of the slope. The picture was taken from the toe of the levee looking towards the crown.

6	0.45	0.45	Earthen Levee	Animal Control	WS	M	No rodents visible, but rodent burrows visible; need to backfill and compact or grout burrows.	37.479507 ° -121.076767 °	37.479507 ° -121.076767 °	28 Y
7	0.56	0.56	Earthen Levee	Animal Control	WS	M	Exterminate rodents and backfill and compact or grout burrows.	37.480210 ° -121.074953 °	37.480210 ° -121.074953 °	5 Y
8	0.59	0.59	Earthen Levee	Animal Control	WS	M	Exterminate rodents and backfill and compact or grout burrows.	37.480117 ° -121.074687 °	37.480117 ° -121.074687 °	3 Y
9	0.60	0.60	Earthen Levee	Animal Control	WS	M	Exterminate rodents and backfill and compact or grout burrows.	37.479968 ° -121.074583 °	37.479968 ° -121.074583 °	4 Y
10	0.60	0.72	Earthen Levee	Encroachments	WS	PO	Fences Inspector Comments: Barbed wire fence along the landward toe.	37.479967 ° -121.074582 °	37.478514 ° -121.073435 °	70 Y
11	0.67	0.67	Earthen Levee	Animal Control	WS	M	Exterminate rodents and backfill and compact or grout burrows.	37.479030 ° -121.073909 °	37.479030 ° -121.073909 °	29 Y

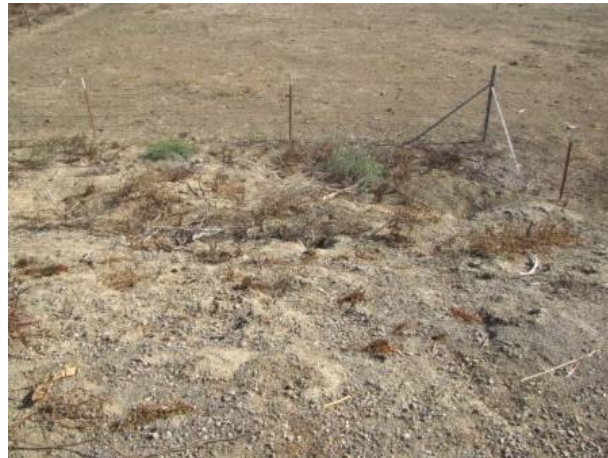
Levee Mile Report Line	8
Start Levee Mile	0.59
End Levee Mile	0.59
Location	Water Side
Category	Earthen Levee
Item	Animal Control

Rodent holes were found on the waterside of the levee. The picture was taken from the toe of waterside of the levee looking upstream.

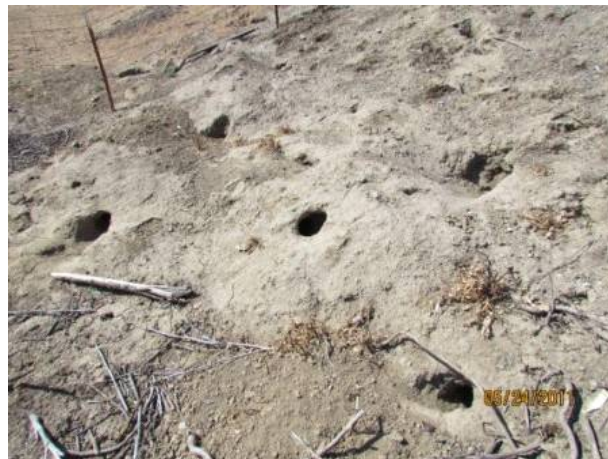
Levee Mile Report Line	8
Start Levee Mile	0.59
End Levee Mile	0.59
Location	Water Side
Category	Earthen Levee
Item	Animal Control

Pictures of the rodent holes on the waterside of the slope looking towards the crown. The picture was taken during Fall 2011 inspection.

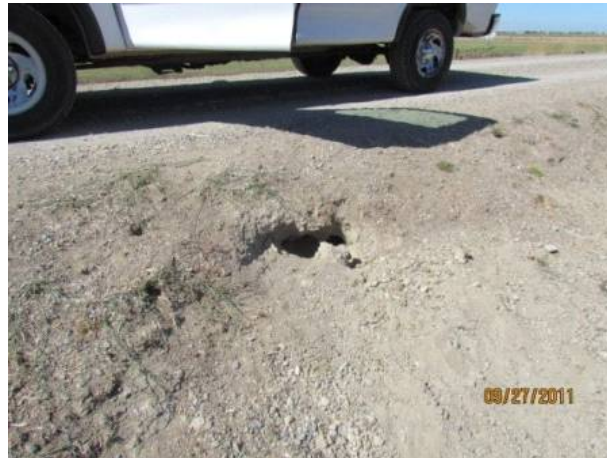
Levee Mile Report Line	13
Start Levee Mile	0.69
End Levee Mile	0.69
Location	Land Side
Category	Earthen Levee
Item	Animal Control
Animal burrow was found on the landside of the levee. The picture was taken from the toe of the levee looking upstream.	
pkazi_f_20111103_104.jpg

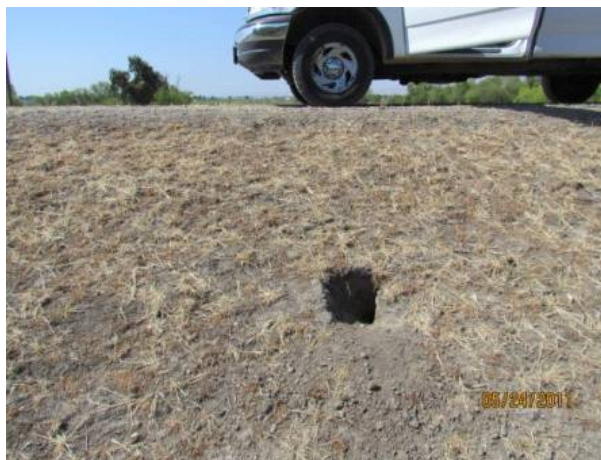
Levee Mile Report Line	23
Start Levee Mile	1.13
End Levee Mile	1.13
Location	Land Side
Category	Earthen Levee
Item	Animal Control

Animal burrow was found on the landside of the levee. The picture was taken from the toe of the levee looking upstream.

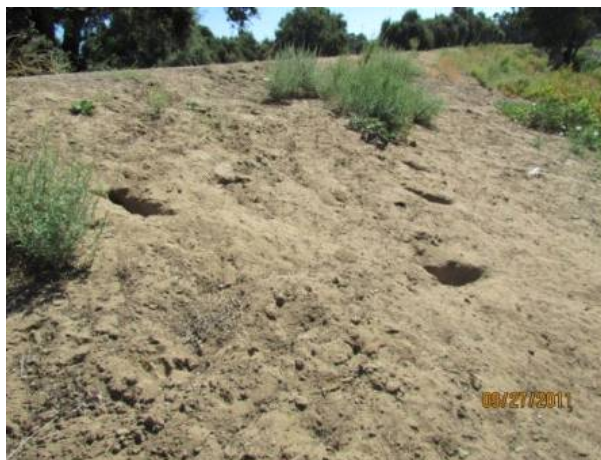
Levee Mile Report Line	32
Start Levee Mile	1.94
End Levee Mile	1.94
Location	Water Side
Category	Earthen Levee
Item	Animal Control

Rodent holes were found on the waterside of the levee. The picture was taken from crown of the levee looking upstream.

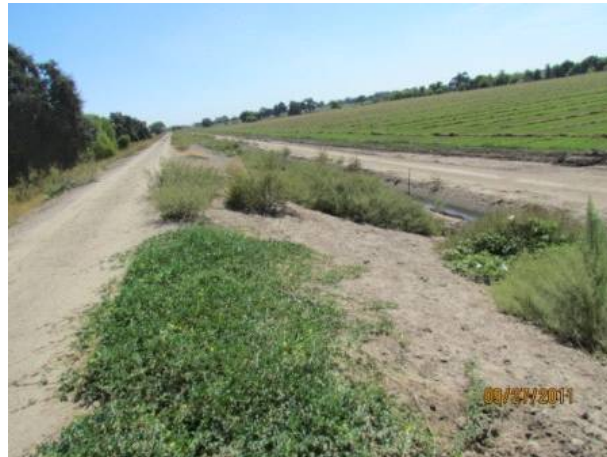
Levee Mile Report Line	41
Start Levee Mile	2.83
End Levee Mile	3.58
Location	Water Side
Category	Earthen Levee
Item	Vegetation

Wild growth was found on the waterside of the levee. The picture was taken from the crown looking upstream.

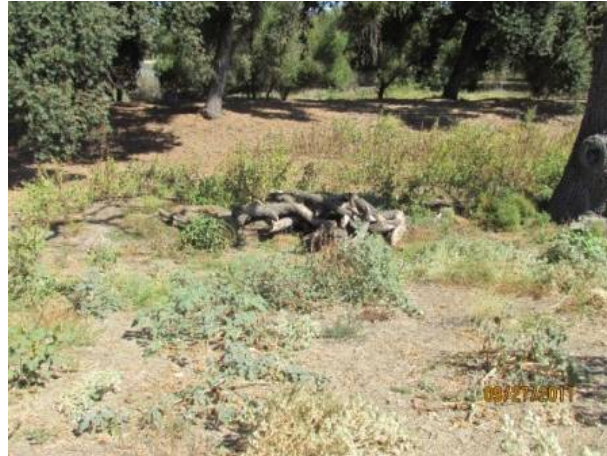
Levee Mile Report Line	48
Start Levee Mile	3.83
End Levee Mile	3.83
Location	Land Side
Category	Earthen Levee
Item	Encroachments

Garbage was found on the landside of the levee. The picture was taken from the crown looking upstream.

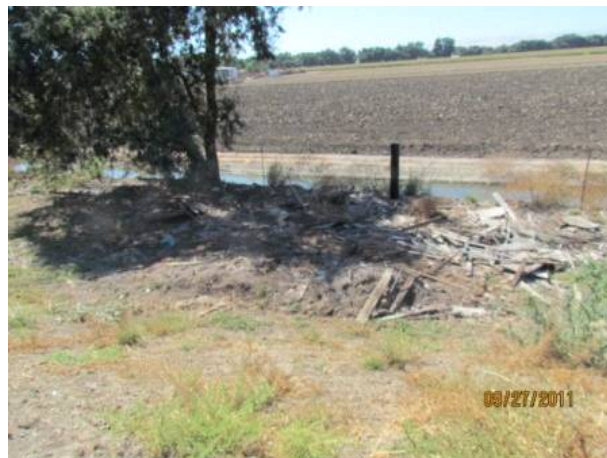
Levee Mile Report Line	49
Start Levee Mile	3.85
End Levee Mile	3.85
Location	Land Side
Category	Earthen Levee
Item	Encroachments
Remove landscaping from within 10' of landside toe	
pkazi_f_20110923_057.JPG

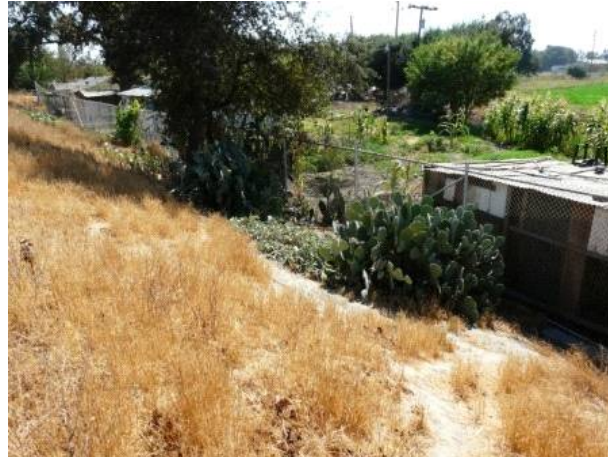
Levee Mile Report Line	50
Start Levee Mile	3.96
End Levee Mile	3.96
Location	Land Side
Category	Earthen Levee
Item	Slope Stability
Repair damage to USACE constructed seepage berm by pedestrian and cycle traffic at LM 3.96.	
pkazi_f_20110923_064.jpg

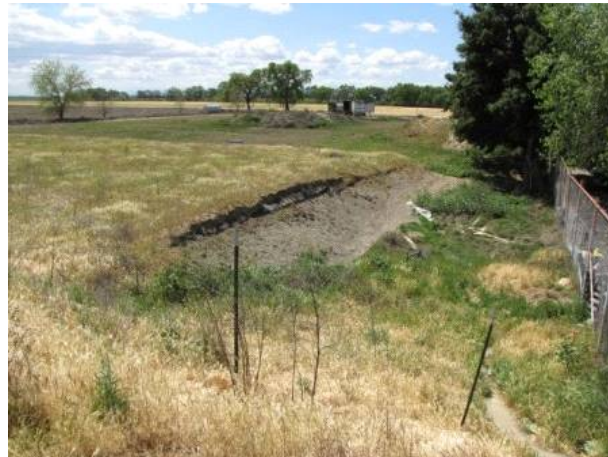
Levee Mile Report Line	51
Start Levee Mile	3.97
End Levee Mile	4.07
Location	Land Side
Category	Earthen Levee
Item	Encroachments
View of a barbed wire fence on the landward slope looking upstream.	
pkazi_f_20110923_065.jpg

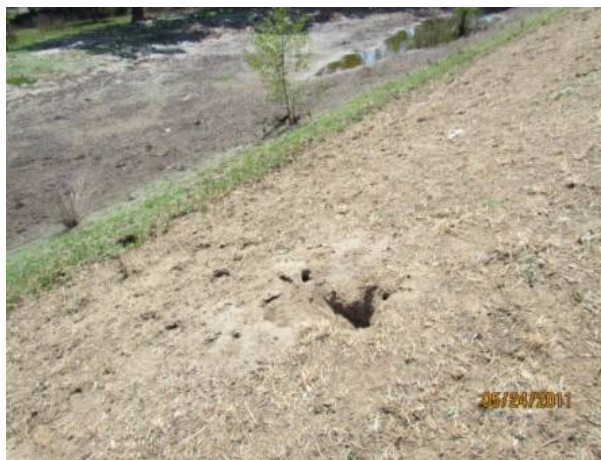
Levee Mile Report Line	52
Start Levee Mile	3.99
End Levee Mile	3.99
Location	Water Side
Category	Earthen Levee
Item	Animal Control

Animal burrow was found on the waterside of the levee. The picture was taken from the toe of the levee looking upstream.

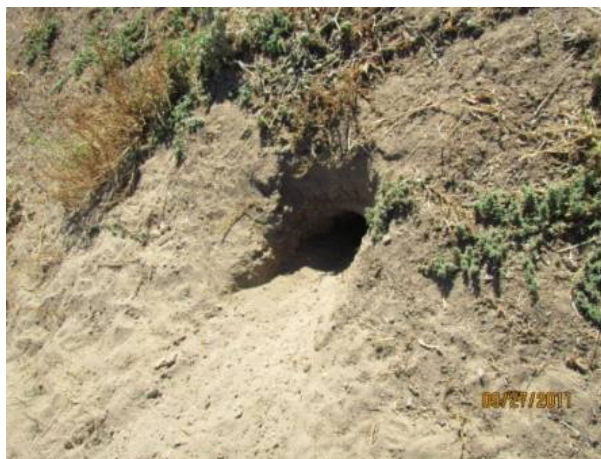
Levee Mile Report Line	53
Start Levee Mile	4.04
End Levee Mile	4.04
Location	Water Side
Category	Earthen Levee
Item	Animal Control

Rodent hole was found the waterside of the levee. The picture was taken from the crown looking upstream.

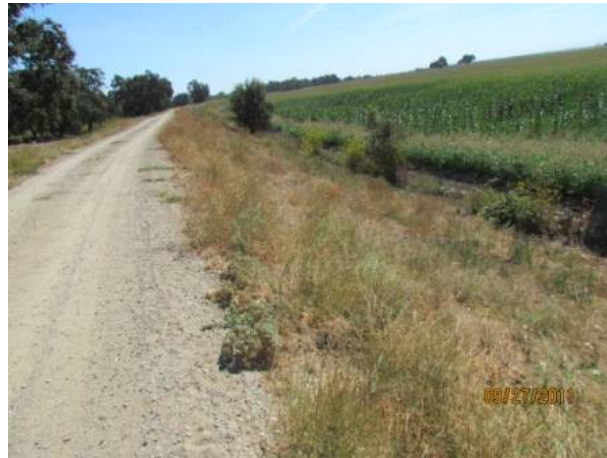
Levee Mile Report Line	55
Start Levee Mile	4.15
End Levee Mile	4.15
Location	Water Side
Category	Earthen Levee
Item	Animal Control

Rodent hole was found on the waterside of the levee. The picture was taken from the crown looking upstream.

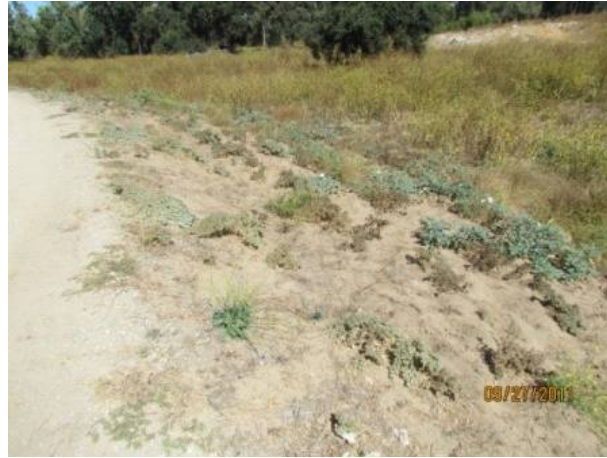
Levee Mile Report Line	63
Start Levee Mile	4.70
End Levee Mile	4.92
Location	Land Side
Category	Earthen Levee
Item	Vegetation

Wild growth was found on the landside of the levee looking upstream.

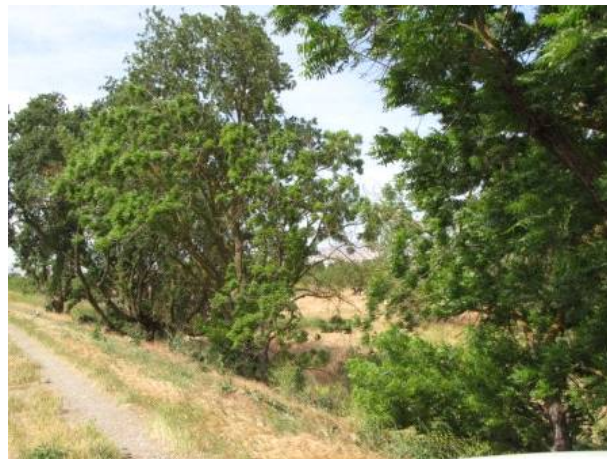
Levee Mile Report Line	67
Start Levee Mile	4.98
End Levee Mile	5.14
Location	Land Side
Category	Earthen Levee
Item	Vegetation

Wild growth was found on the landside of the levee looking upstream.

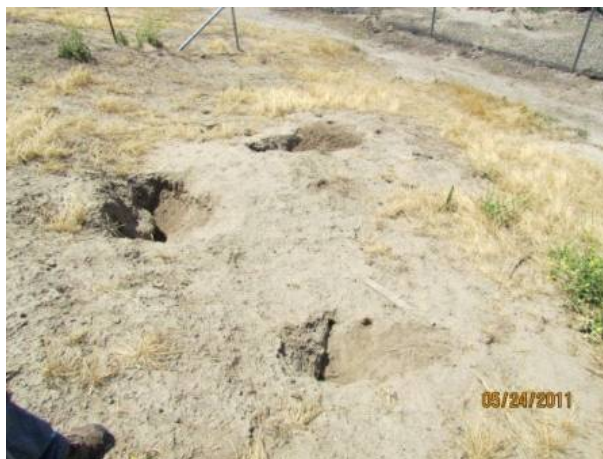
Levee Mile Report Line	74
Start Levee Mile	5.34
End Levee Mile	5.34
Location	Land Side
Category	Earthen Levee
Item	Slope Stability

View of significant damage and erosion to the landward slope looking upstream.

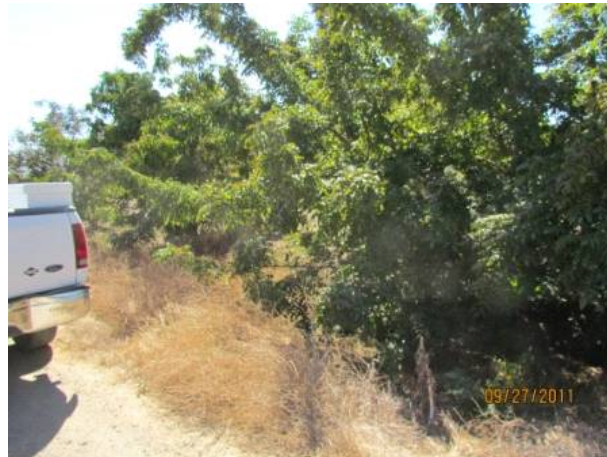
Levee Mile Report Line	78
Start Levee Mile	5.40
End Levee Mile	5.40
Location	Land Side
Category	Earthen Levee
Item	Slope Stability

View of tilling into the landward slope of the levee looking upstream. This slope has also been significantly damaged by rodent activity.
