**Flood Control Project Maintenance
Levee Inspections**

Fall 2012 Levee Maintenance Deficiency Summary Report

Reclamation District No. 1602 Del Puerto

Waterway			Bank	Unit Miles
Unit No. 01 San Joaquin River			Left	6.29
	Spring (March - May)	Summer (June - August)	(September - November) Fall	Winter (December - February)
Unit Maintenance Rating (Fall Only)			U	
Date of Inspection	05/16/2012 - 05/16/2012		11/27/2012 - 11/27/2012	
DWR Inspector	Pavel Kazi		Pavel Kazi	
Accompanied By	Tony Martinez RD1602		Tony Martinez RD1602

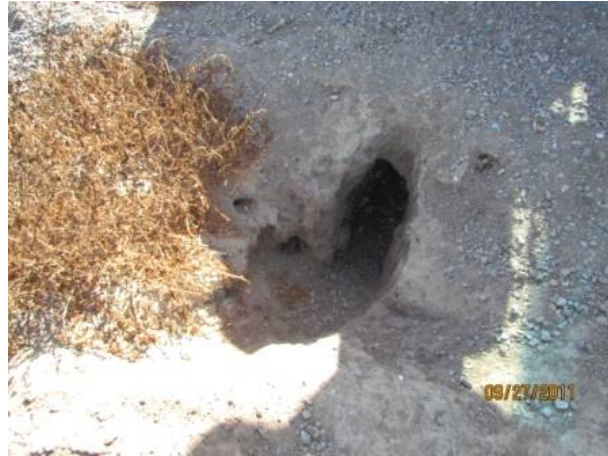
pkazi_f_20120913_842.jpg

A rodent hole was found on the waterside of the slope. The picture was taken from the toe looking toward the crown.

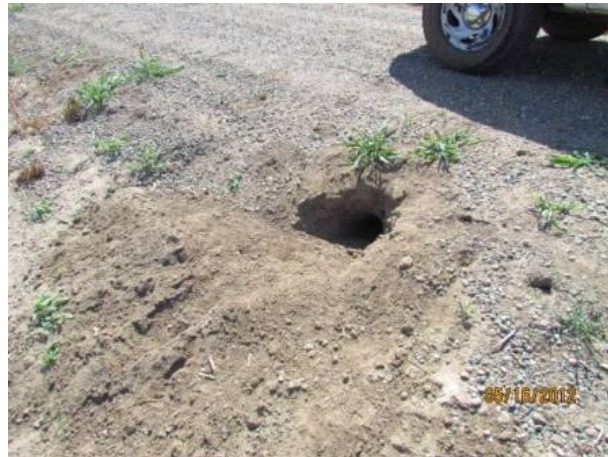
pkazi_f_20120913_843.jpg

A rodent hole was found on the waterside of the slope taken from the toe looking toward the crown. This picture was taken during the spring 2012 inspection.

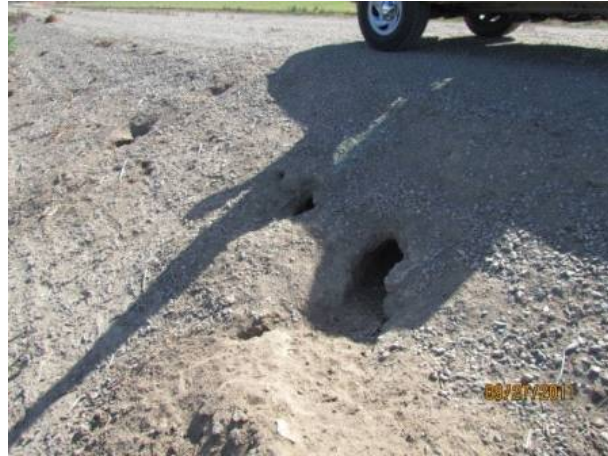
pkazi_f_20120913_844.jpg

Rodent holes were found on the waterside of the slope. The picture was taken from the toe looking towards the crown of the levee.

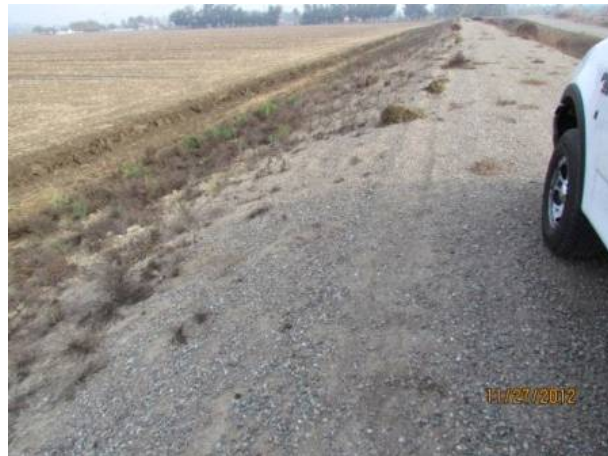
pkazi_f_20121128_164.jpg

Rodent hole was repaired by the LMA on the waterside slope of the levee looking upstream.

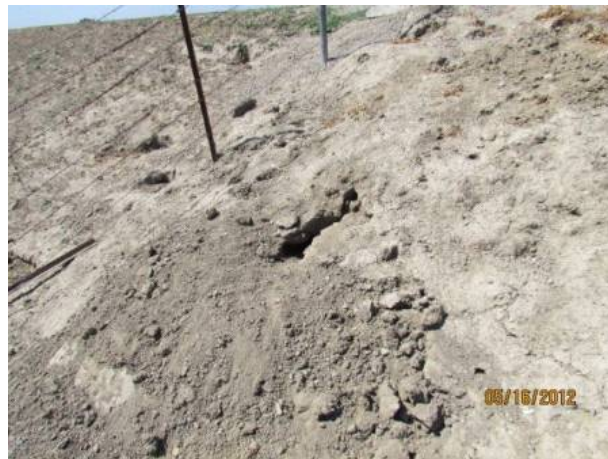
pkazi_f_20120913_826.jpg

Animal holes were found on the waterside of the levee looking upstream. This picture was taken during the spring 2012 inspection.

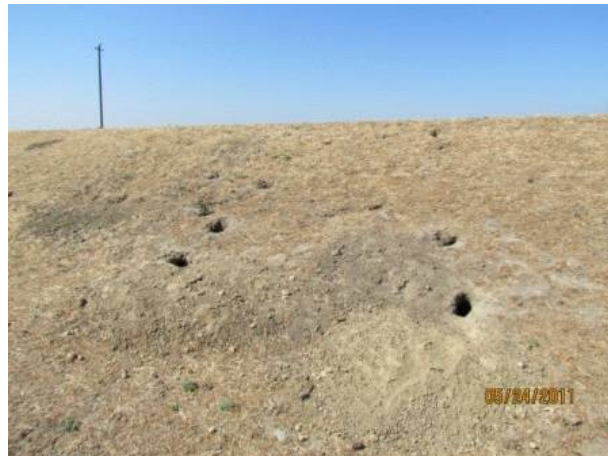
pkazi_f_20120913_824.jpg

Rodent holes were found on the waterside of the levee. The picture was taken from the toe of the waterside of the levee looking upstream.

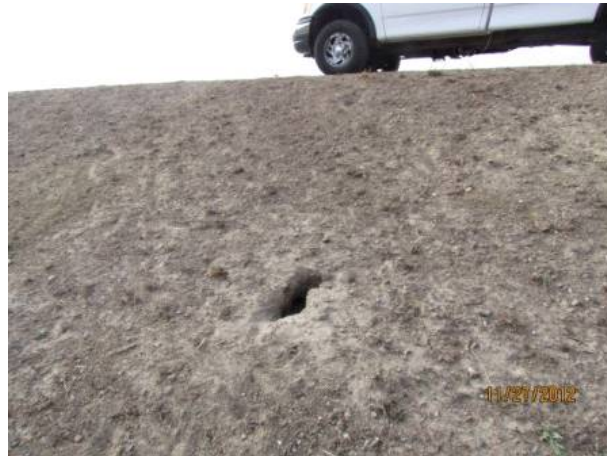
pkazi_f_20121128_165.jpg

A rodent hole was found on the waterside slope looking from the toe of the levee.

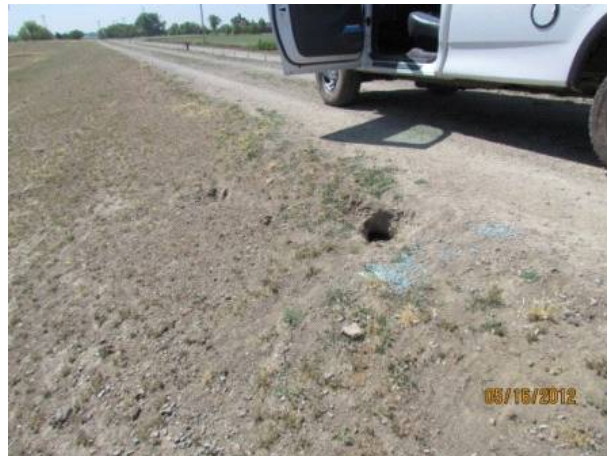
pkazi_f_20120913_855.jpg

A rodent hole was found on the waterside shoulder of the levee looking upstream.

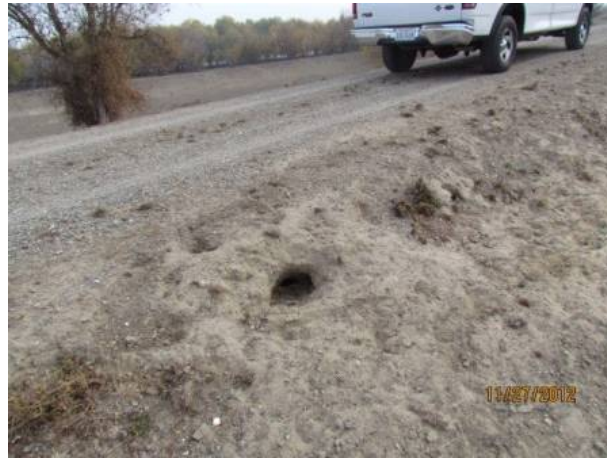
pkazi_f_20121128_166.jpg

A rodent hole was found on the landside shoulder of the levee looking upstream.

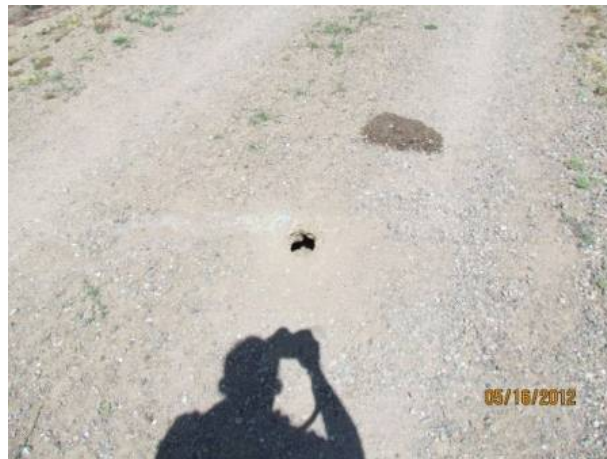
pkazi_f_20120913_856.jpg

A rodent hole was found crown of the levee looking downstream.

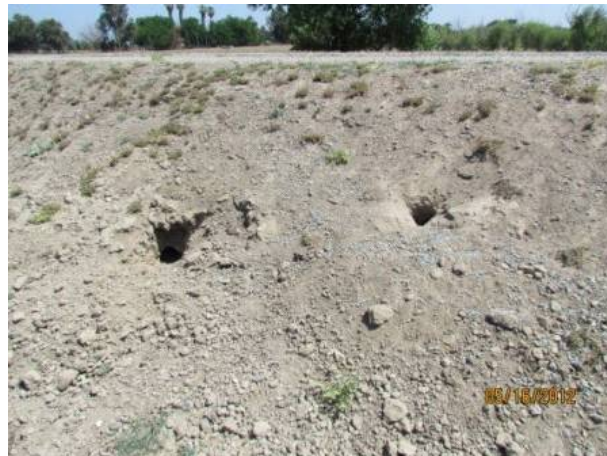
pkazi_f_20120913_861.jpg

Rodent holes were found on the landside of the levee. The picture was taken from the toe of the levee looking towards the crown.

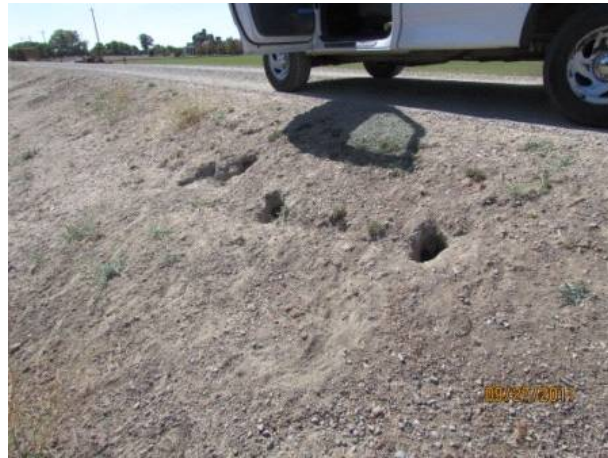
pkazi_f_20120913_851.jpg

The rodent holes were found on the waterside of the levee. The picture was taken from toe looking towards the crown.

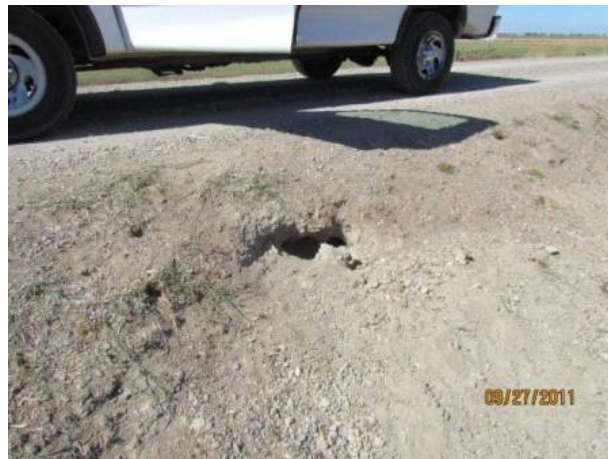
pkazi_f_20120913_852.jpg

Animal burrow was found on the waterside shoulder of the levee. The picture was taken from the toe looking towards the crown.

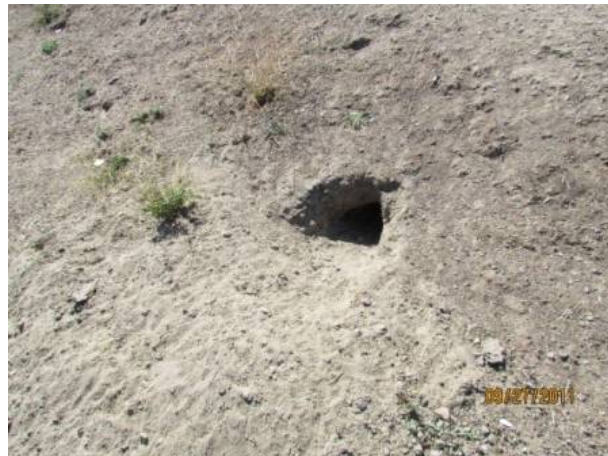
pkazi_f_20120913_853.jpg

Animal burrow was found on the landside of the levee. The picture was taken from the toe of the levee looking upstream.

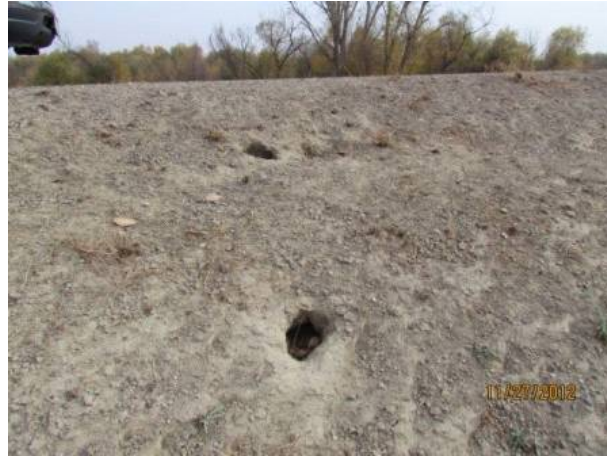
Levee Mile Report Line	25
Start Levee Mile	0.69
End Levee Mile	0.69
Location	Land Side
Category	Earthen Levee
Item	Animal Control
Rodent holes were found on the landside of the levee looking upstream.	
pkazi_f_20121128_167.jpg

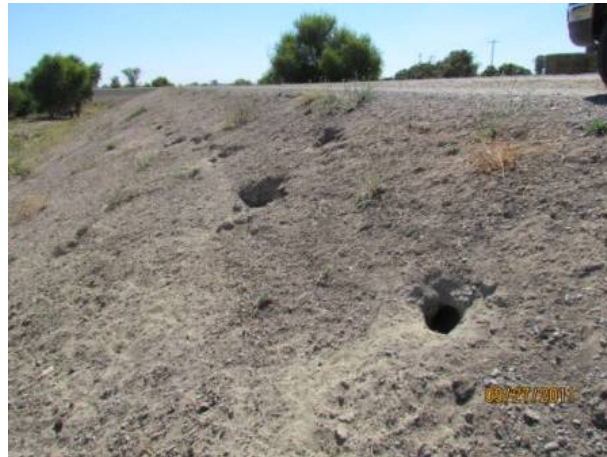
Levee Mile Report Line	26
Start Levee Mile	0.71
End Levee Mile	0.71
Location	Water Side
Category	Earthen Levee
Item	Animal Control
Rodent holes were found on the waterside of the levee. The picture was taken from toe of the levee looking upstream.	
pkazi_f_20120913_854.jpg

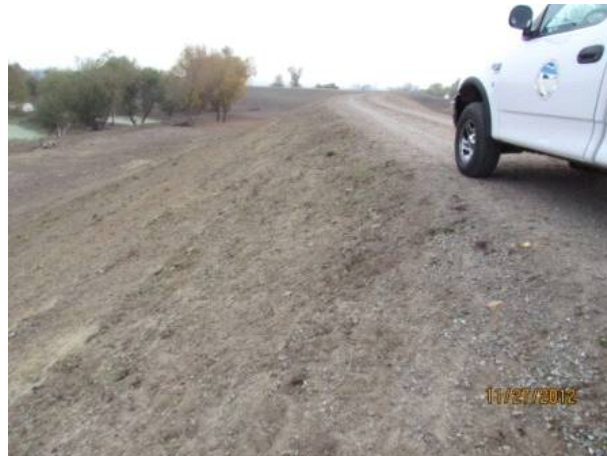
Levee Mile Report Line	28
Start Levee Mile	0.74
End Levee Mile	0.74
Location	Water Side
Category	Earthen Levee
Item	Animal Control
Rodent holes were repaired by the LMA on the waterside slope of the levee looking upstream.	
pkazi_f_20121129_168.jpg

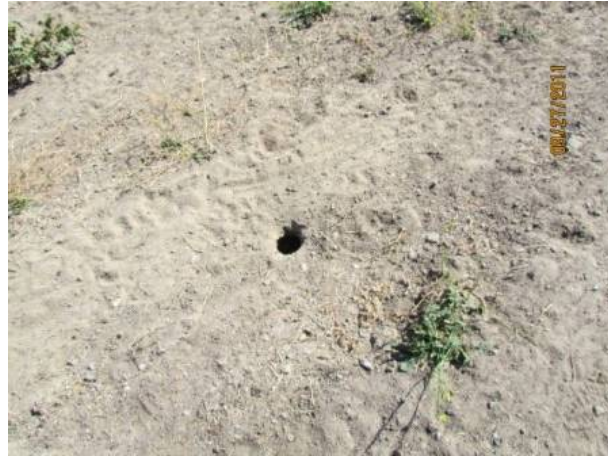
pkazi_f_20120913_827.jpg

Animal burrow was found on the waterside of the levee. The picture was taken from the toe of the levee looking downstream.

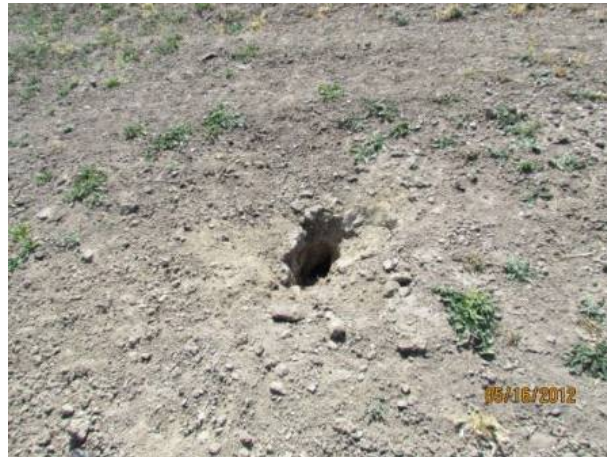
pkazi_f_20120913_875.jpg

A rodent hole was found on the waterside of the levee looking upstream.

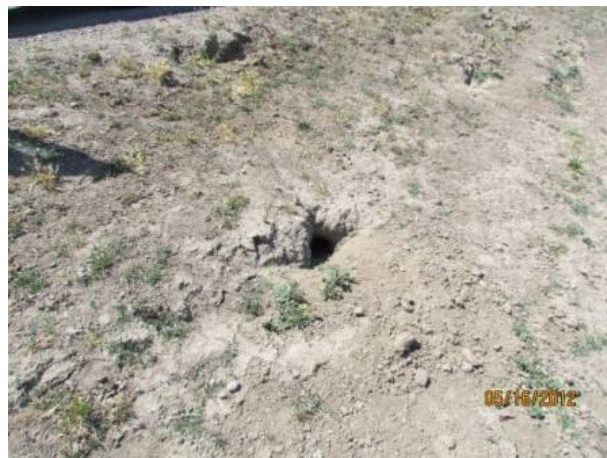
pkazi_f_20120913_888.jpg

A rodent hole was found on the waterside of the levee looking downstream.

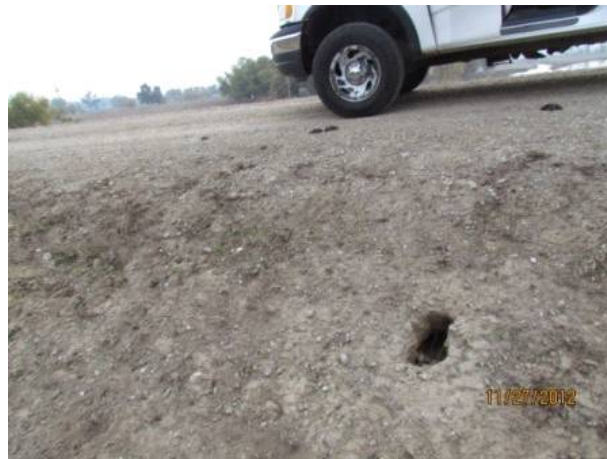
pkazi_f_20121129_171.jpg

A rodent hole was found on the waterside slope of the levee looking upstream.

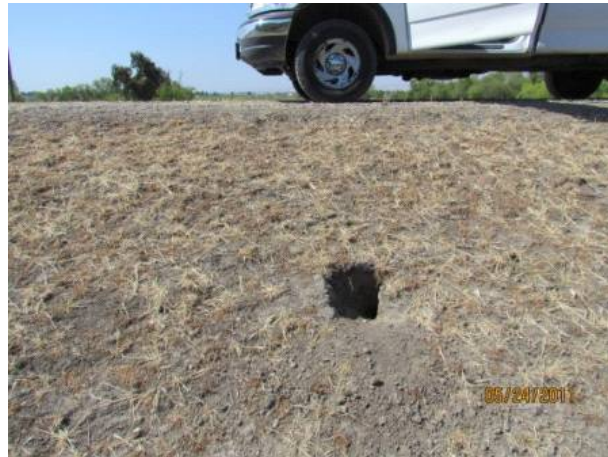
pkazi_f_20120913_829.jpg

Rodent hole was found on the waterside of the levee. The picture was taken from waterside looking upstream.

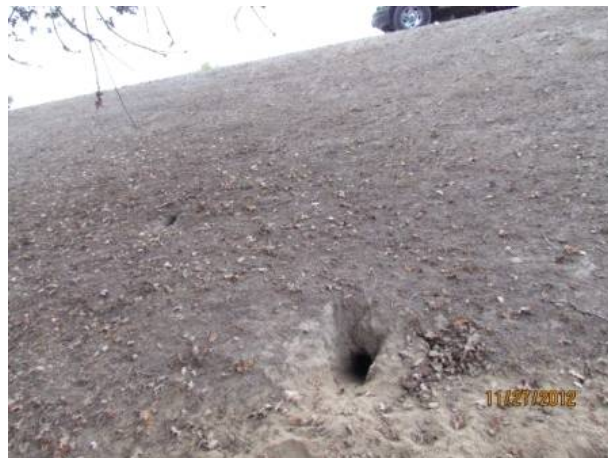
pkazi_f_20121129_172.jpg

A rodent hole was found on the waterside toe of the levee looking upstream.

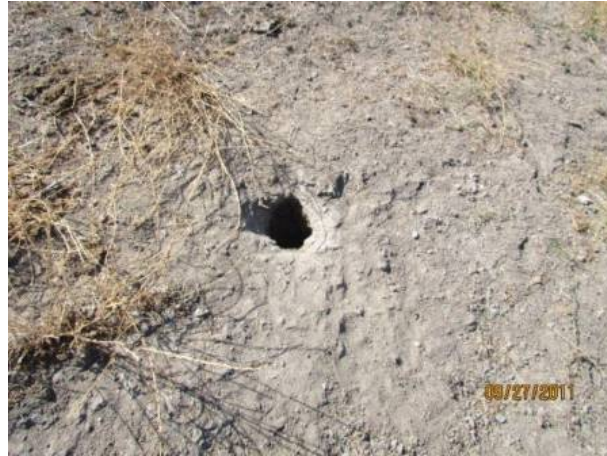
pkazi_f_20120913_828.jpg

Animal burrow was found on the landside of the levee. The picture was taken from the toe of the levee looking upstream.

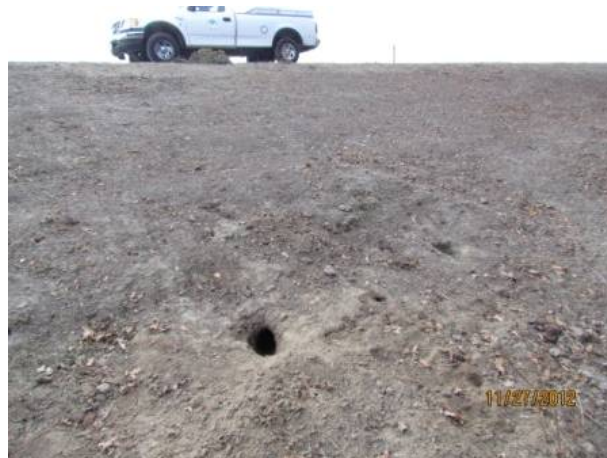
pkazi_f_20121129_174.jpg

A rodent hole was found on the waterside toe of the levee looking downstream.

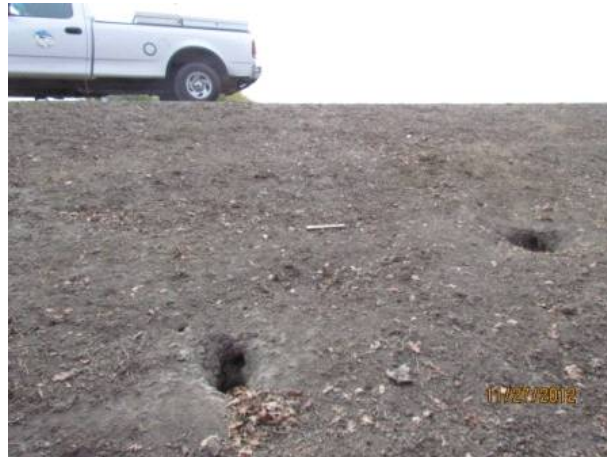
pkazi_f_20121129_175.jpg

Rodent holes were found on the waterside toe of the levee looking downstream.

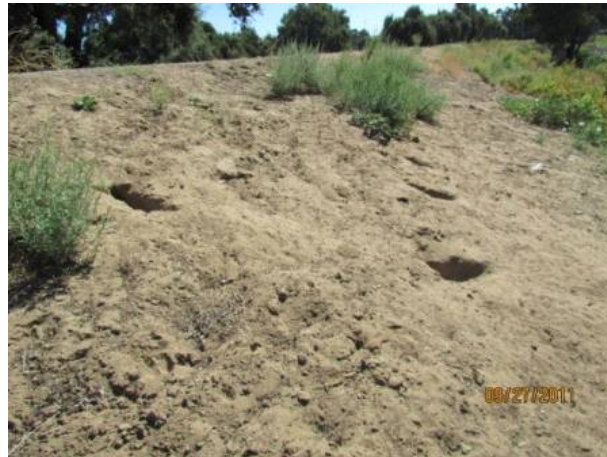
pkazi_f_20120913_864.jpg

Animal burrows were found on the landside of the levee. The picture was taken from the toe of the levee looking upstream.

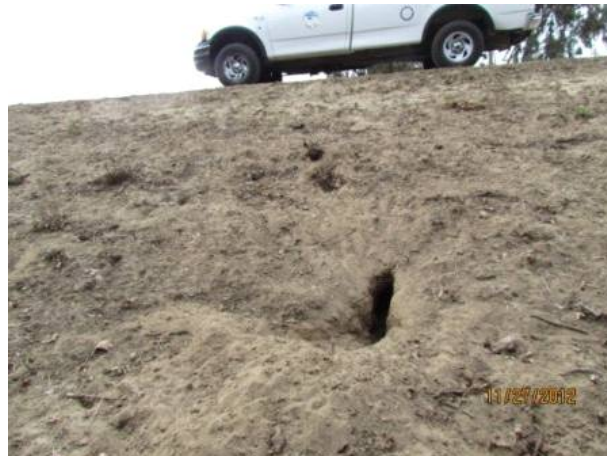
pkazi_f_20121129_177.jpg

Rodent holes were found on the waterside toe of the levee looking upstream.

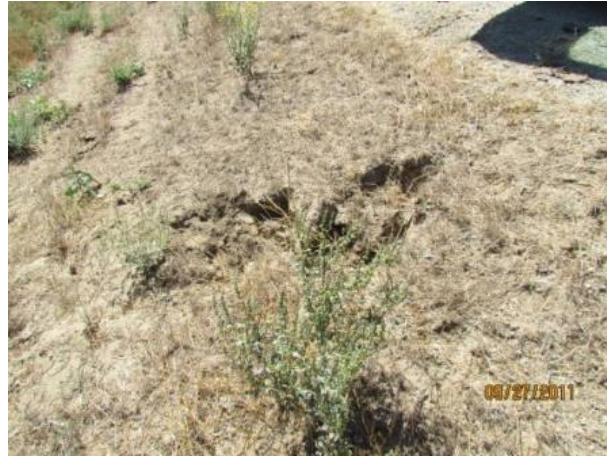
pkazi_f_20120913_849.jpg

Rodent holes were found on the waterside of the levee. The picture was taken from crown of the levee looking upstream.

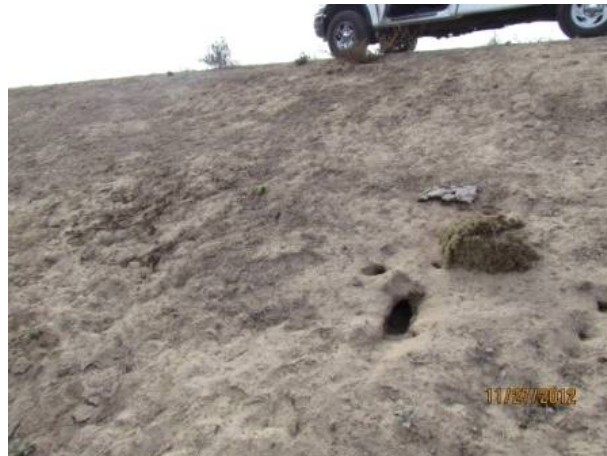
pkazi_f_20121129_178.jpg

Rodent holes were found on the waterside toe of the levee looking upstream.

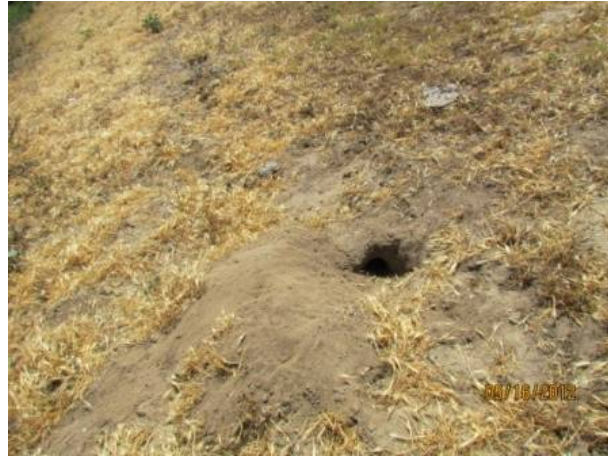
Levee Mile Report Line	57
Start Levee Mile	2.09
End Levee Mile	2.09
Location	Water Side
Category	Earthen Levee
Item	Animal Control
A rodent hole was found on the waterside of the levee looking upstream.	
pkazi_f_20120913_891.jpg

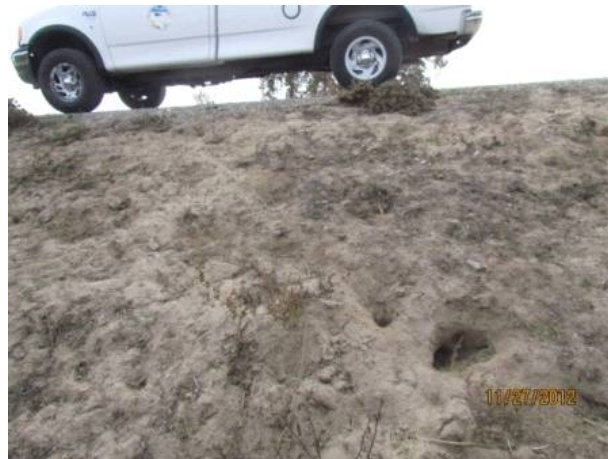
Levee Mile Report Line	59
Start Levee Mile	2.18
End Levee Mile	2.18
Location	Water Side
Category	Earthen Levee
Item	Animal Control
Rodent holes were found on the waterside toe of the levee looking upstream.	
pkazi_f_20121129_179.jpg

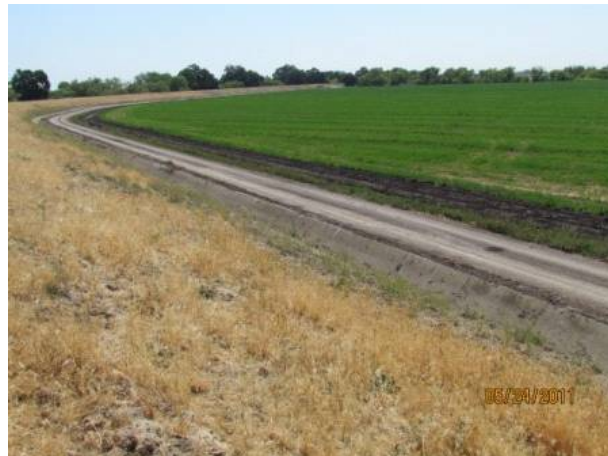
Levee Mile Report Line	60
Start Levee Mile	2.24
End Levee Mile	3.45
Location	Land Side
Category	Earthen Levee
Item	Encroachments
Concrete drain was built at the toe of the levee. The picture was taken from the crown looking upstream.	
pkazi_f_20120913_876.jpg

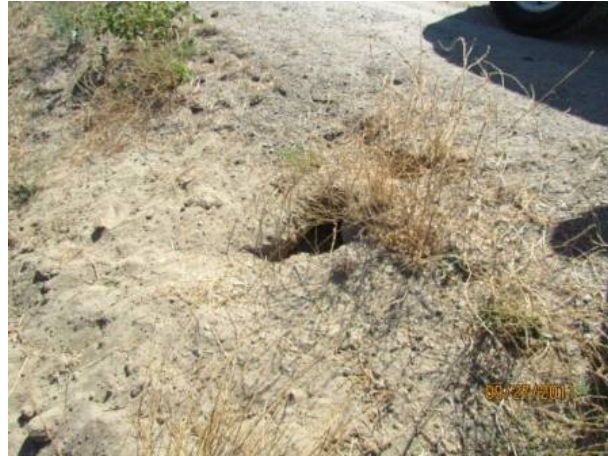
pkazi_f_20120913_866.jpg

Animal burrow was found on the waterside of the levee. The picture was taken from the toe of the levee looking upstream.

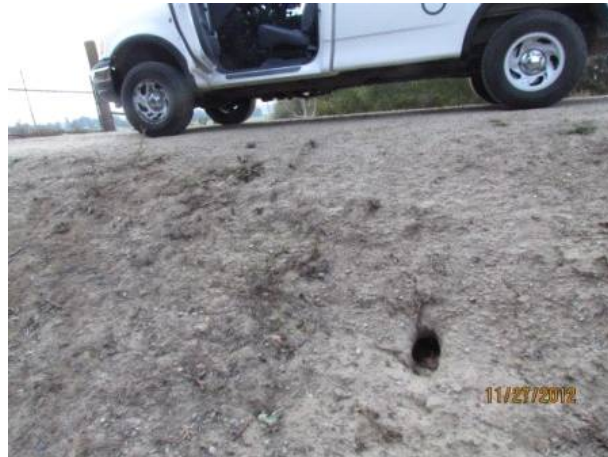
pkazi_f_20121129_180.jpg

A rodent hole was found on the waterside slope of the levee looking upstream.

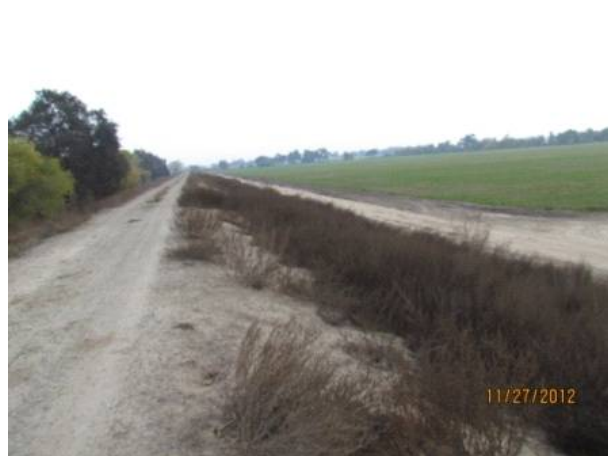
pkazi_f_20121129_181.jpg

Vegetation was found on the landside slope of the levee looking upstream.

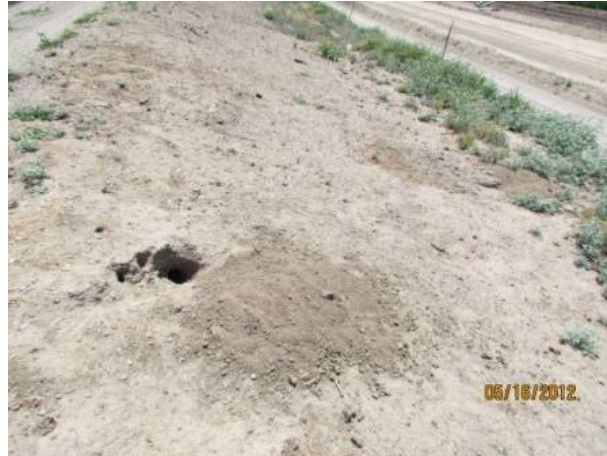
Levee Mile Report Line	66
Start Levee Mile	2.65
End Levee Mile	2.65
Location	Land Side
Category	Earthen Levee
Item	Animal Control
Animal holes were found on the landside of the levee looking upstream.	
pkazi_f_20120913_892.jpg

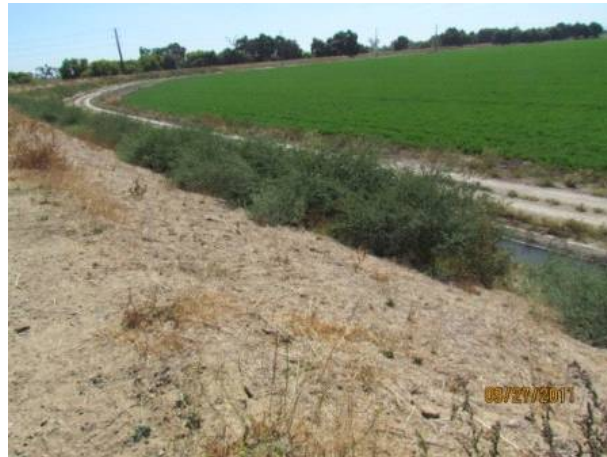
Levee Mile Report Line	70
Start Levee Mile	3.13
End Levee Mile	3.32
Location	Land Side
Category	Earthen Levee
Item	Vegetation
Wild growth was found on the toe of the landside of the levee. The picture was taken from crown looking upstream.	
pkazi_f_20120913_868.jpg

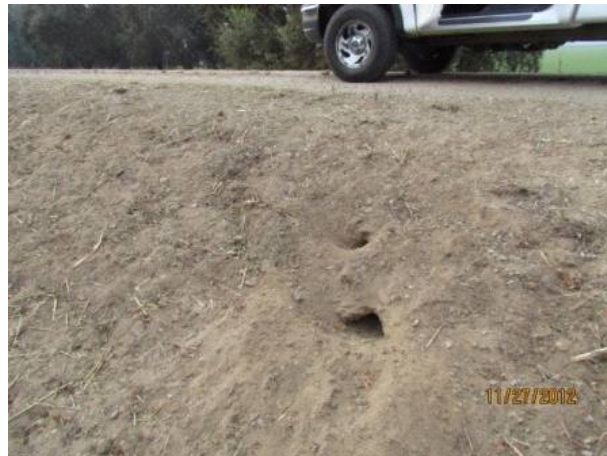
Levee Mile Report Line	72
Start Levee Mile	3.47
End Levee Mile	3.47
Location	Water Side
Category	Earthen Levee
Item	Animal Control
Rodent holes were found on the waterside slope of the levee looking upstream.	
pkazi_f_20121129_182.jpg

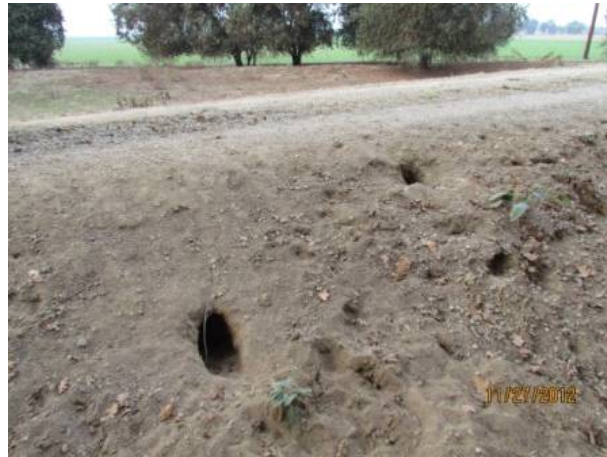
Rodent holes were found on the waterside slope of the levee looking downstream.

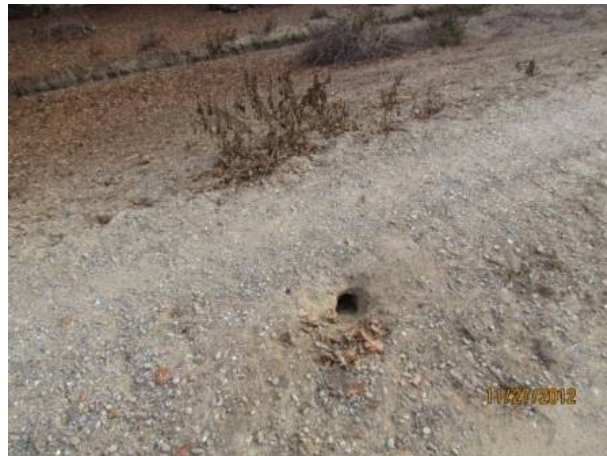
A rodent hole was found on the waterside shoulder of the levee looking upstream.

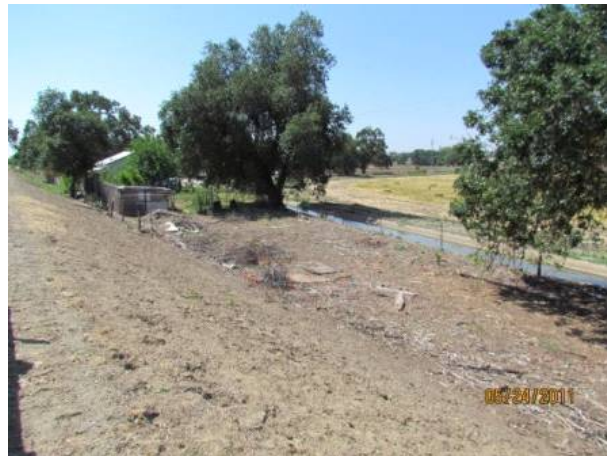
Garbage was found on the landside of the levee. The picture was taken from the crown looking upstream.

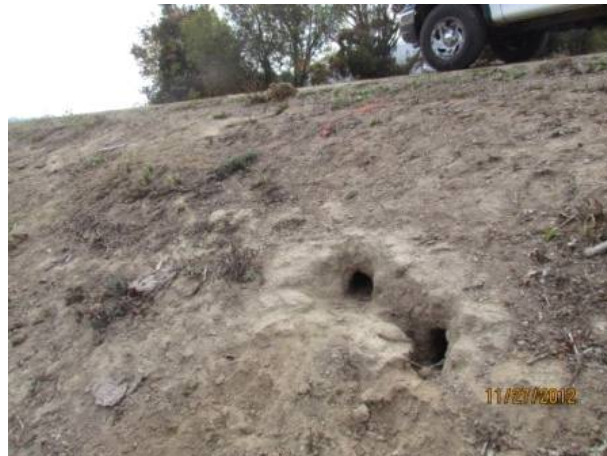
Rodent holes were found on the waterside toe of the levee looking upstream.

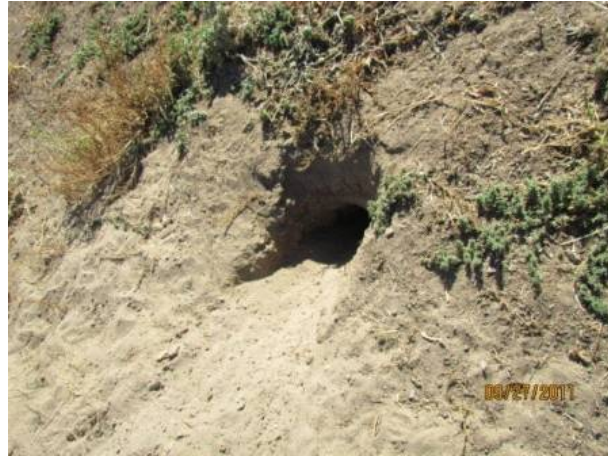
Levee Mile Report Line	83
Start Levee Mile	3.99
End Levee Mile	3.99
Location	Water Side
Category	Earthen Levee
Item	Animal Control
Animal burrow was found on the waterside of the levee. The picture was taken from the toe of the levee looking upstream.	
pkazi_f_20120913_838.jpg

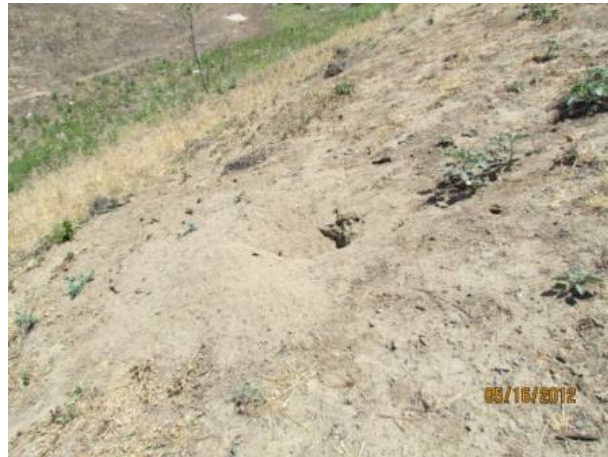
Levee Mile Report Line	84
Start Levee Mile	4.00
End Levee Mile	4.00
Location	Water Side
Category	Earthen Levee
Item	Animal Control
A rodent hole was found on the waterside of the levee looking upstream.	
pkazi_f_20120913_894.jpg

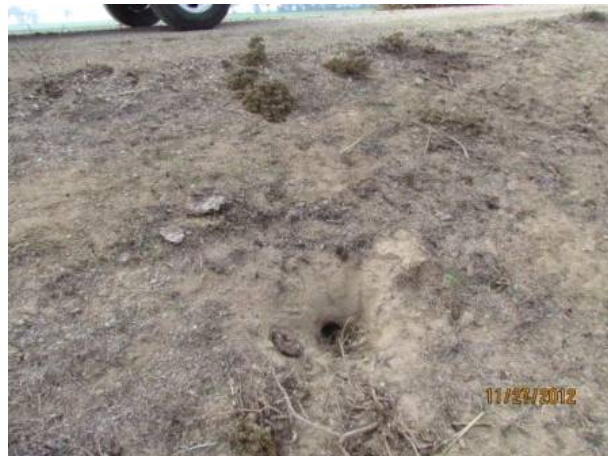
Levee Mile Report Line	85
Start Levee Mile	4.11
End Levee Mile	4.11
Location	Water Side
Category	Earthen Levee
Item	Animal Control
A rodent hole was found on the waterside toe of the levee looking downstream.	
pkazi_f_20121129_188.jpg
