**Flood Control Project Maintenance  
Levee Inspections**

**Fall 2013 Levee Maintenance Deficiency Summary Report**

**Reclamation District No. 1602 Del Puerto**

Waterway		Bank	Unit Miles
Unit No. 01 San Joaquin River		Left	6.29

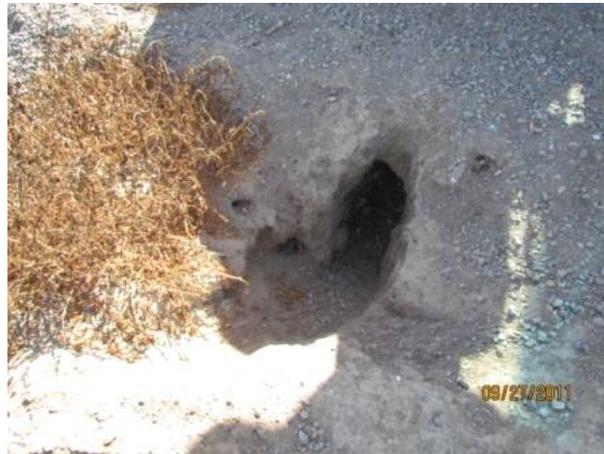
Levee Mile Report Line	5
Start Levee Mile	0.32
End Levee Mile	0.32
Location	Water Side
Category	Earthen Levee
Item	Animal Control
A rodent hole was found on the waterside of the slope taken from the toe looking toward the crown. This picture was taken during the spring 2012 inspection.	
pkazi_f_20131001_842.jpg

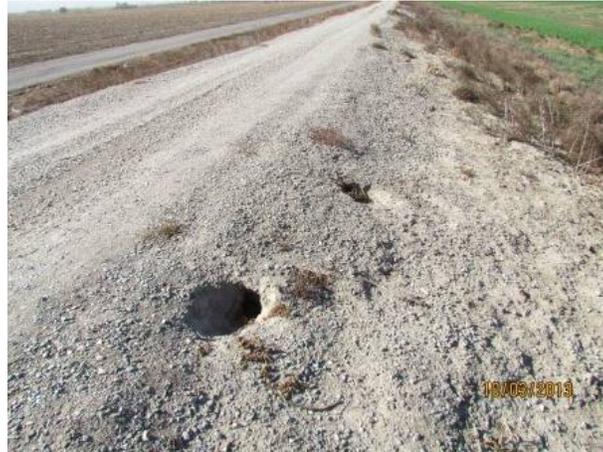
Levee Mile Report Line	7
Start Levee Mile	0.47
End Levee Mile	0.47
Location	Water Side
Category	Earthen Levee
Item	Animal Control
<p>Rodent holes were found on the waterside of the levee looking upstream.</p>	
<p>pkazi_f_20131020_962.JPG</p>

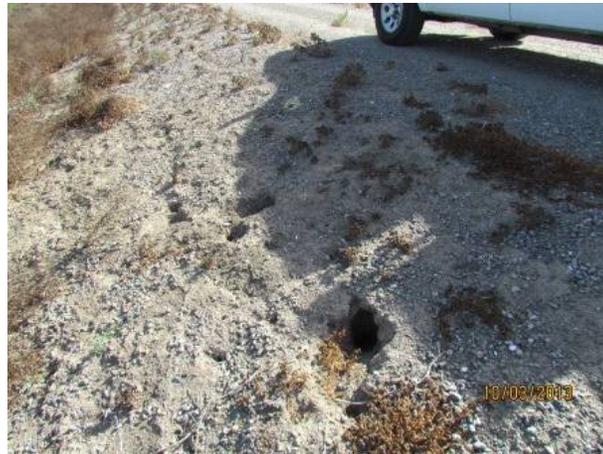
Levee Mile Report Line	9
Start Levee Mile	0.60
End Levee Mile	0.60
Location	Water Side
Category	Earthen Levee
Item	Animal Control
<p>Rodent holes were found on the waterside of the levee. The picture was taken from the toe of the waterside of the levee looking upstream.</p>	
<p>pkazi_f_20131001_820.jpg</p>

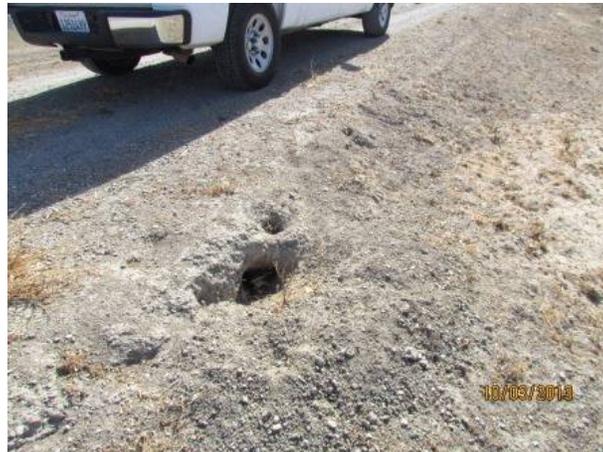
Levee Mile Report Line	13
Start Levee Mile	0.66
End Levee Mile	0.66
Location	Land Side
Category	Earthen Levee
Item	Animal Control

Rodent holes were found on the landside of the levee. The picture was taken from the toe of the levee looking towards the crown.

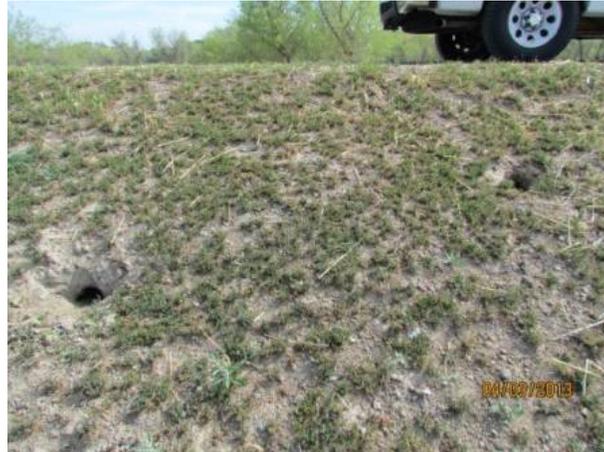
Levee Mile Report Line	13
Start Levee Mile	0.66
End Levee Mile	0.66
Location	Land Side
Category	Earthen Levee
Item	Animal Control
<p>Large rodent holes were found on the landside shoulder of the levee looking upstream.</p>	
<p>pkazi_f_20131020_964.JPG</p>

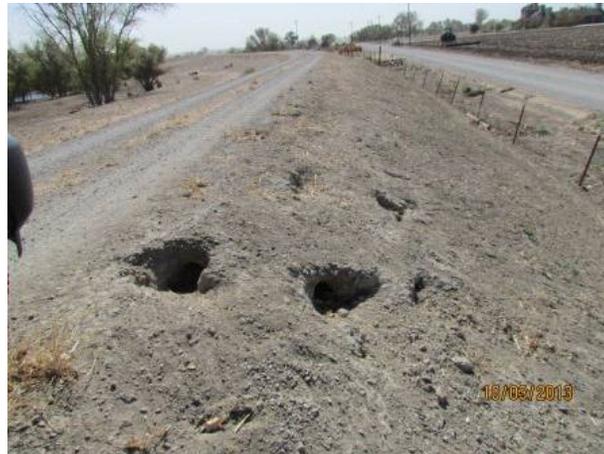
Levee Mile Report Line	15
Start Levee Mile	0.69
End Levee Mile	0.69
Location	Water Side
Category	Earthen Levee
Item	Animal Control
<p>An animal hole was found on the waterside shoulder of the levee looking upstream.</p>	
<p>pkazi_f_20131020_965.JPG</p>

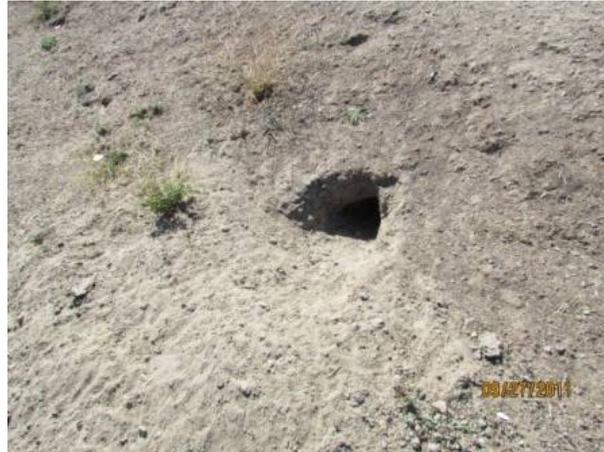
Levee Mile Report Line	16
Start Levee Mile	0.69
End Levee Mile	0.69
Location	Land Side
Category	Earthen Levee
Item	Animal Control
Rodent holes were found on the landside of the levee looking upstream.	
pkazi_f_20131001_857.jpg

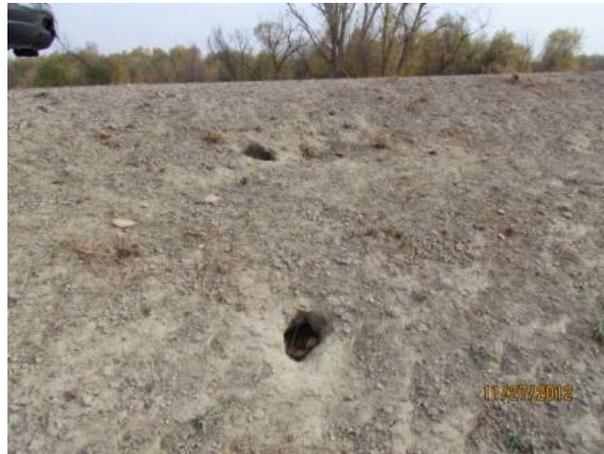
Levee Mile Report Line	17
Start Levee Mile	0.71
End Levee Mile	0.71
Location	Water Side
Category	Earthen Levee
Item	Animal Control
Rodent holes were found on the waterside of the levee. The picture was taken from toe of the levee looking upstream.	
pkazi_f_20131001_858.jpg

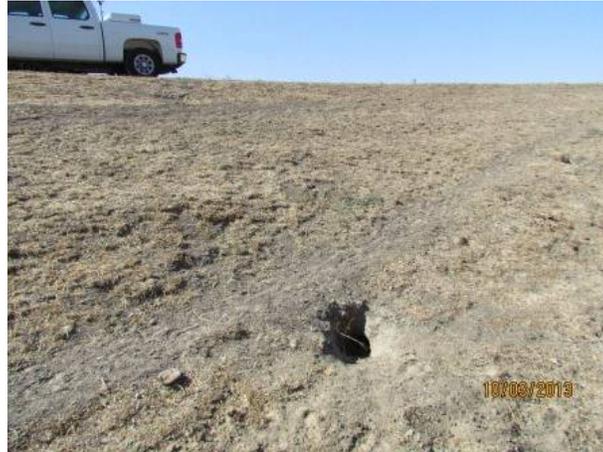
Levee Mile Report Line	28
Start Levee Mile	1.07
End Levee Mile	1.07
Location	Water Side
Category	Earthen Levee
Item	Slope Stability
<p>Small amount of slumping at water toe.</p>	
<p>pkazi_f_20131001_860.JPG</p>

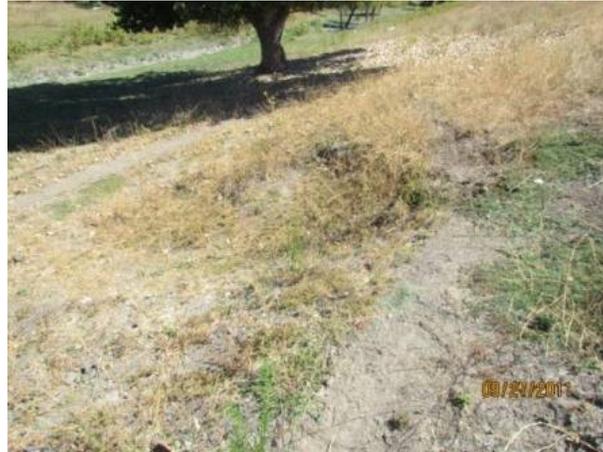
Levee Mile Report Line	30
Start Levee Mile	1.10
End Levee Mile	1.10
Location	Water Side
Category	Earthen Levee
Item	Animal Control

Rodent hole was found on the waterside of the levee. The picture was taken from waterside looking upstream.

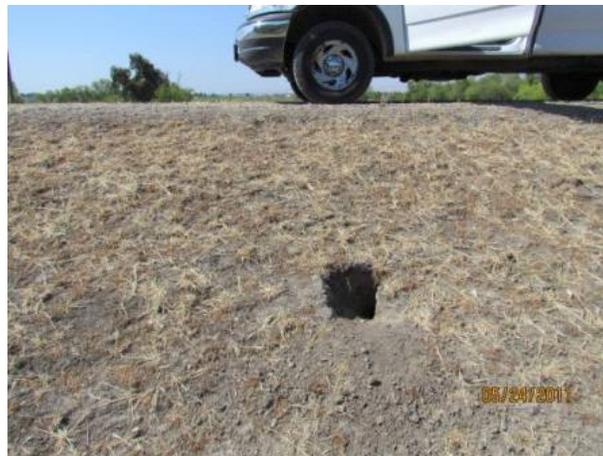
Levee Mile Report Line	31
Start Levee Mile	1.11
End Levee Mile	1.11
Location	Water Side
Category	Earthen Levee
Item	Animal Control

A rodent hole was found on the waterside toe of the levee looking downstream.

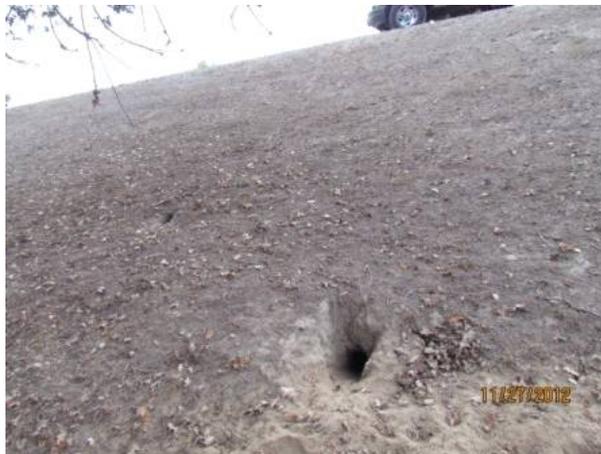
Levee Mile Report Line	33
Start Levee Mile	1.13
End Levee Mile	1.13
Location	Land Side
Category	Earthen Levee
Item	Animal Control
Animal burrow was found on the landside of the levee. The picture was taken from the toe of the levee looking upstream.	
pkazi_f_20131001_825.jpg

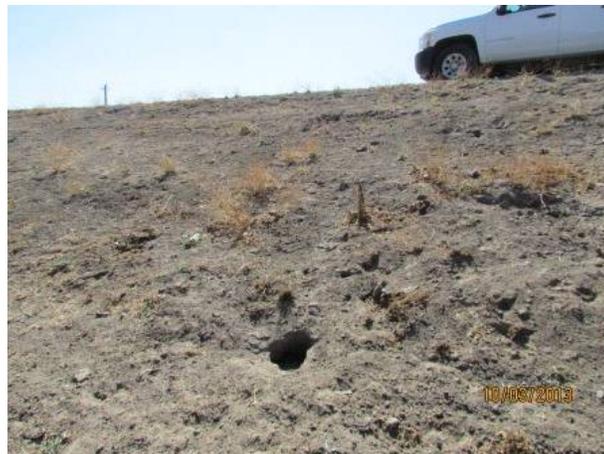
Levee Mile Report Line	35
Start Levee Mile	1.16
End Levee Mile	1.16
Location	Water Side
Category	Earthen Levee
Item	Animal Control
<p>A rodent hole was found on the waterside shoulder of the levee looking downstream.</p>	
<p>pkazi_f_20131001_831.JPG</p>

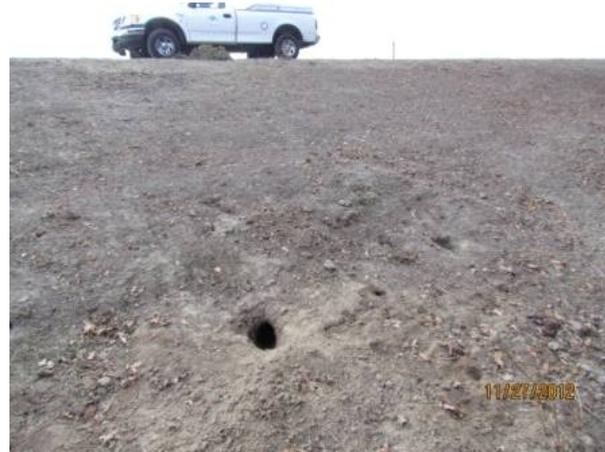
Levee Mile Report Line	37
Start Levee Mile	1.19
End Levee Mile	1.19
Location	Water Side
Category	Earthen Levee
Item	Animal Control

A rodent hole was found on the waterside toe of the levee looking downstream.

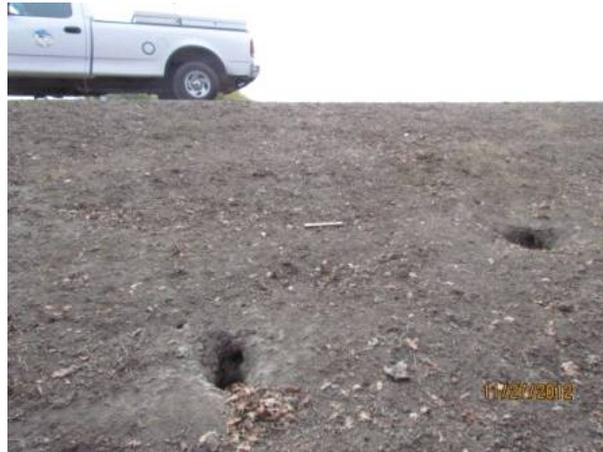
Levee Mile Report Line	40
Start Levee Mile	1.27
End Levee Mile	1.27
Location	Water Side
Category	Earthen Levee
Item	Animal Control
A rodent hole was found on the waterside shoulder of the levee looking downstream.	
pkazi_f_20131020_971.JPG

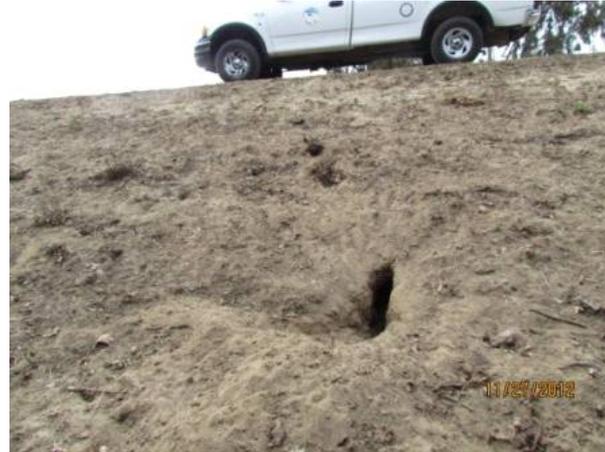
Levee Mile Report Line	44
Start Levee Mile	1.69
End Levee Mile	1.69
Location	Water Side
Category	Earthen Levee
Item	Animal Control
A rodent hole was found on the waterside toe of the levee looking downstream.	
pkazi_f_20131001_838.JPG

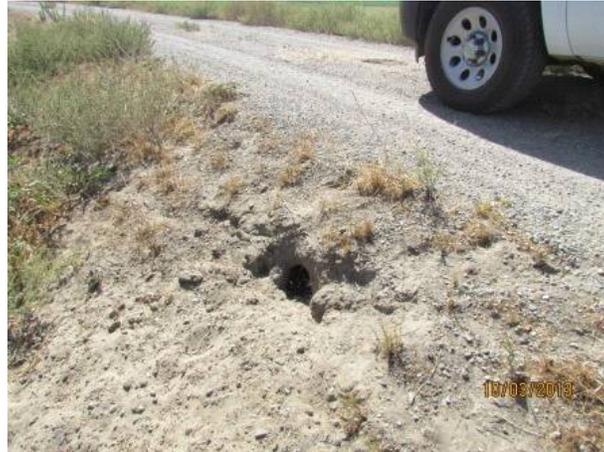
Levee Mile Report Line	53
Start Levee Mile	2.18
End Levee Mile	2.18
Location	Water Side
Category	Earthen Levee
Item	Animal Control
Rodent holes were found on the waterside toe of the levee looking upstream.	
pkazi_f_20131001_901.jpg

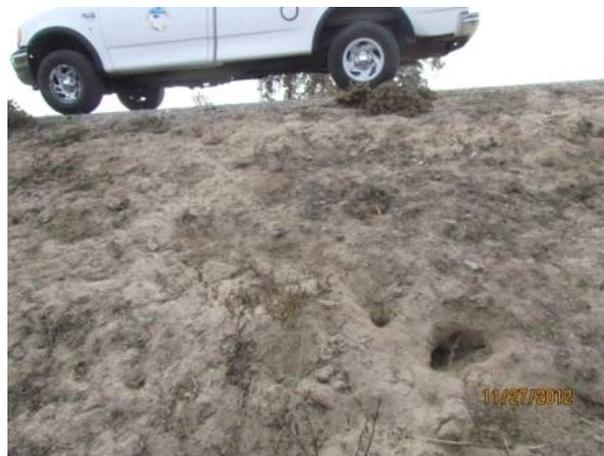
Levee Mile Report Line	54
Start Levee Mile	2.20
End Levee Mile	2.20
Location	Crown
Category	Earthen Levee
Item	Animal Control
A rodent hole was found on the crown of the levee looking downstream.	
pkazi_f_20131020_974.JPG

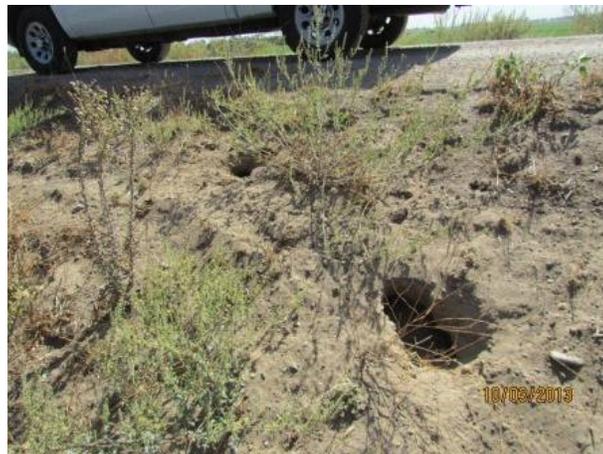
Levee Mile Report Line	58
Start Levee Mile	2.59
End Levee Mile	2.59
Location	Crown
Category	Earthen Levee
Item	Animal Control
A rodent hole was found on the crown of the levee looking downstream.	
pkazi_f_20131001_840.JPG

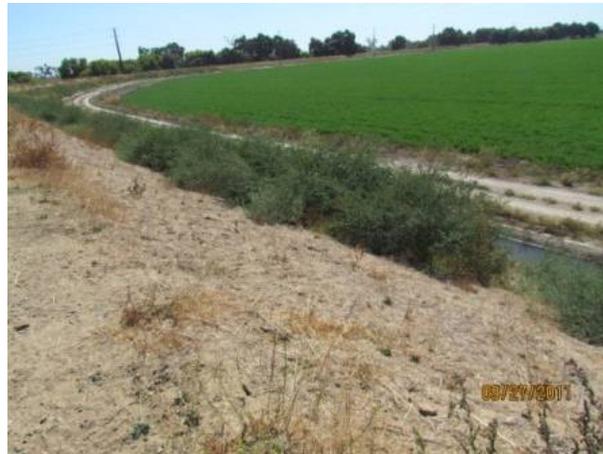
Levee Mile Report Line	66
Start Levee Mile	3.32
End Levee Mile	3.49
Location	Land Side
Category	Earthen Levee
Item	Encroachments
A concrete lined ditch was found on the landside toe of the levee looking upstream.	
pkazi_f_20131020_977.JPG

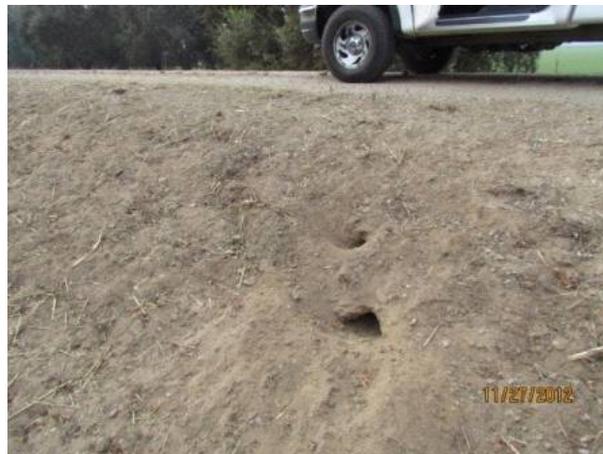
Levee Mile Report Line	69
Start Levee Mile	3.47
End Levee Mile	3.47
Location	Water Side
Category	Earthen Levee
Item	Animal Control
<p>Updated picture of rodent hole on the waterside shoulder of the levee looking downstream.</p>	
<p>pkazi_f_20131020_978.JPG</p>

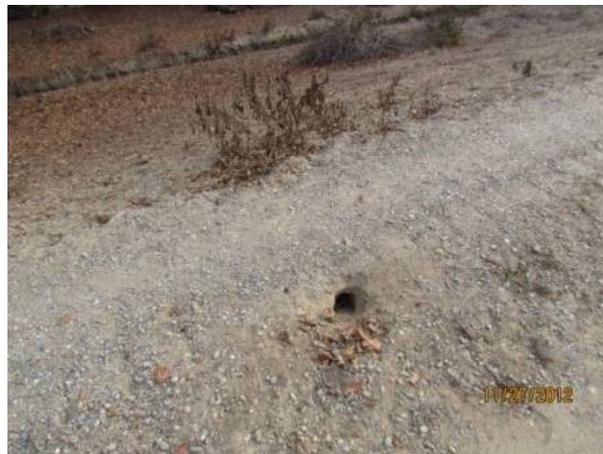
Levee Mile Report Line	71
Start Levee Mile	3.53
End Levee Mile	3.53
Location	Water Side
Category	Earthen Levee
Item	Animal Control
Updated picture of rodent hole on the waterside shoulder of the levee looking upstream.	
pkazi_f_20131020_979.JPG

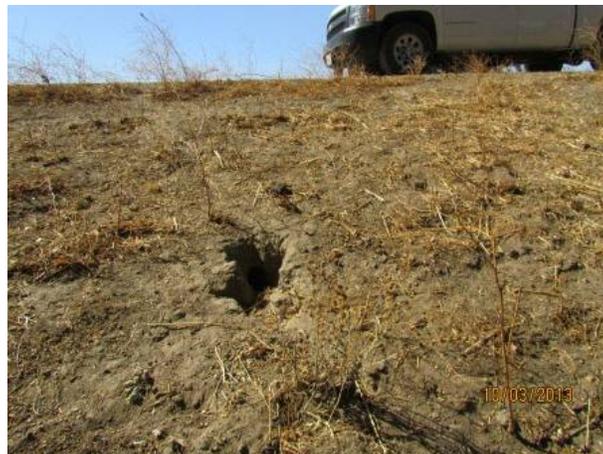
Levee Mile Report Line	74
Start Levee Mile	3.80
End Levee Mile	3.80
Location	Water Side
Category	Earthen Levee
Item	Animal Control
<p>A rodent hole was found on the waterside shoulder of the levee looking downstream.</p>	
<p>pkazi_f_20131001_898.jpg</p>
