**Flood Control Project Maintenance
Levee Inspections**

**Fall 2014 Levee Maintenance Deficiency Summary Report
Overall LMA & Unit Ratings, including DWR Erosion Survey**

Reclamation District No. 1602 Del Puerto

Waterway		Bank	Unit Miles	
Unit No. 01 San Joaquin River		Left	6.24	
	Spring (March - May)	Summer (June - August)	(September - November) Fall	Winter (December - February)
Unit Maintenance Rating (Fall Only)			U	
Date of Inspection	04/24/2014 - 04/24/2014		10/24/2014 - 10/24/2014	
DWR Inspector	Pavel Kazi		Pavel Kazi	
Accompanied By	Tony Martinez RD1602

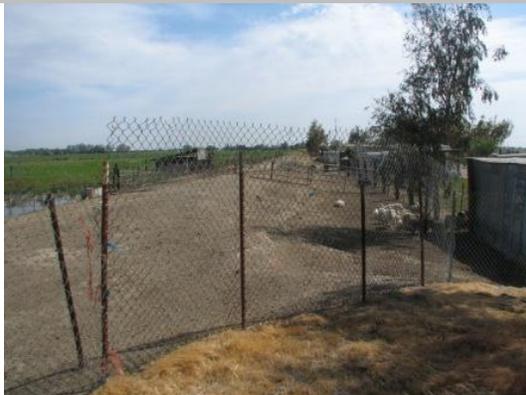
Photo 1 of 1 : FA_2014_RD1602_110_1_20141021_00001.jpg

Looking at animal pens on crown of levee from LM 0.00 to 0.11.

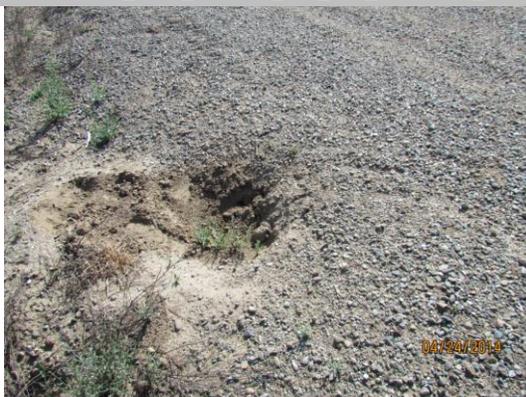
Photo 1 of 1 : FA_2014_RD1602_110_172_20141021_00087.jpg

LM Start	0.32	Rating **	A	Issue No.	172
LM End	0.32	Issue Type +	Ma	Location *	WS
Category	Earthen Levee		GPS Latitude/Longitude		
			Start	End	
Item	Animal Control		37.478581 °	37.478581 °	
			-121.078811 °	-121.078811 °	
DWR ID	DWR_RD1602_01_s_2014_172				
Action/Comments					
No rodents visible, but rodent burrows visible; need to backfill and compact or grout burrows. Inspector Comments: LMA repaired the rodent hole.

The rodent hole was filled with material on the waterside shoulder of the levee looking downstream.

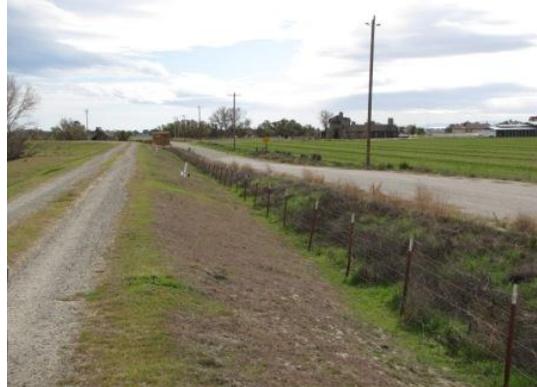
Photo 1 of 1 : FA_2014_RD1602_110_70_20141021_00054.jpg

View of barbed wire fence at landward toe looking upstream.

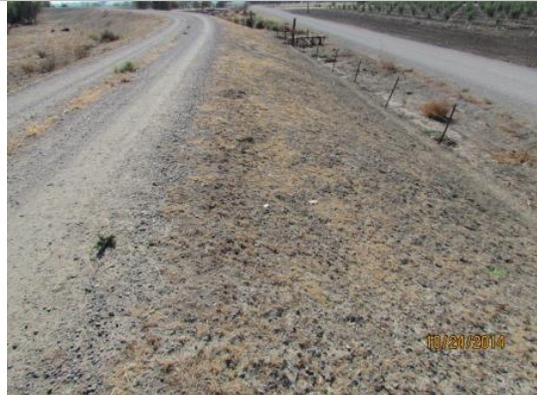
Photo 1 of 2 : FA_2014_RD1602_110_173_20141027_00116.jpg

View of the landside shoulder of the levee looking upstream during fall 2014 inspection.

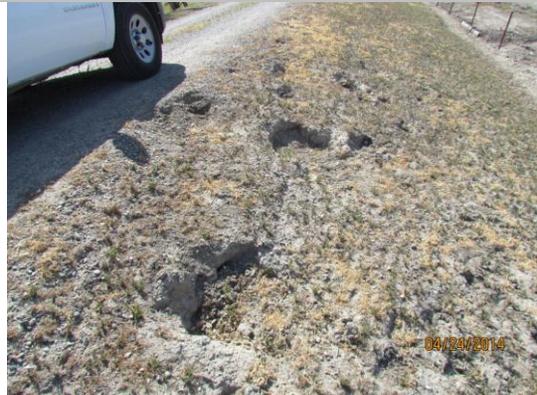
Photo 2 of 2 : FA_2014_RD1602_110_173_20141021_00088.jpg

The rodent holes were filled with material on the landside shoulder of the levee looking upstream.

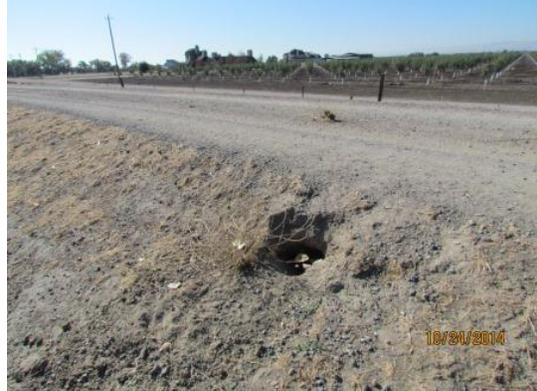
Photo 1 of 2 : FA_2014_RD1602_110_26_20141027_00117.jpg

Updated picture of the rodent hole on the waterside shoulder of the levee looking upstream during fall 2014 inspection.

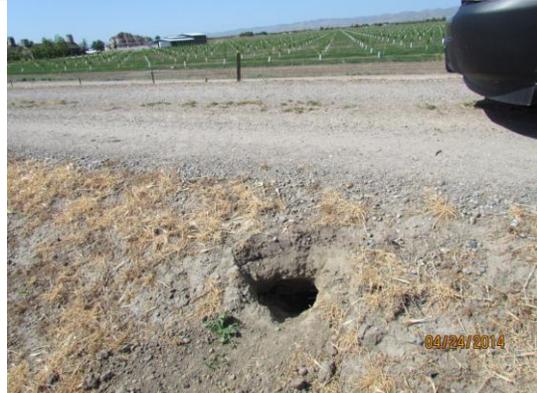
Photo 2 of 2 : FA_2014_RD1602_110_26_20141021_00020.jpg

View of the rodent hole on the waterside shoulder of the levee during spring 2014 inspection.

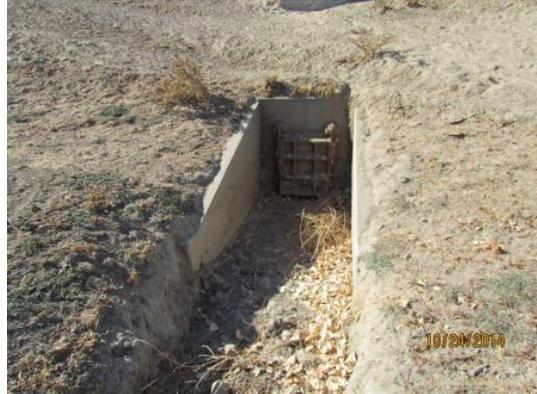
Photo 1 of 4 : FA_2014_RD1602_110_72_20141027_00118.jpg

View of the flap gate on the waterside of the levee during fall 2014 inspection.

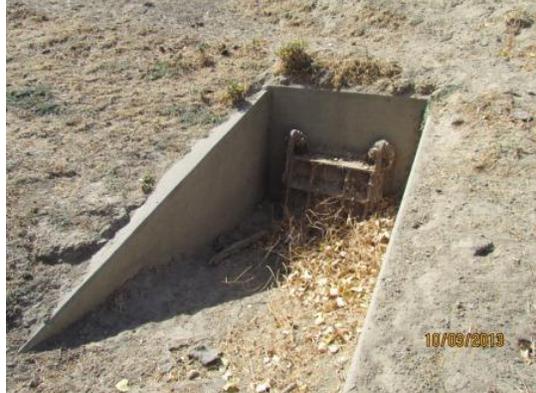
Photo 2 of 4 : FA_2014_RD1602_110_72_20141021_00056.jpg

Debris were obstructing the flap gate from closing completely. The picture was taken from toe of waterside of the levee during the fall 2013 inspection.

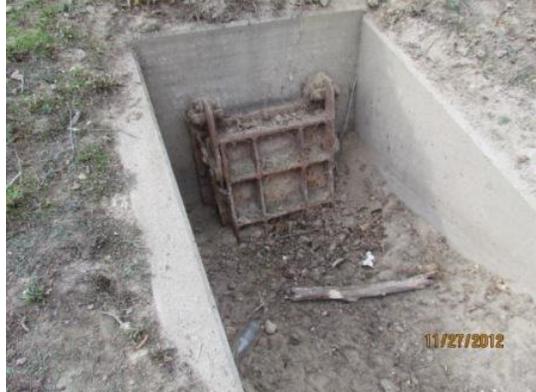
Photo 3 of 4 : FA_2014_RD1602_110_72_20141021_00057.jpg

Debris and sediments were obstructing the flap gate from closing completely. The picture was taken from toe of waterside of the levee during the fall 2012 inspection.

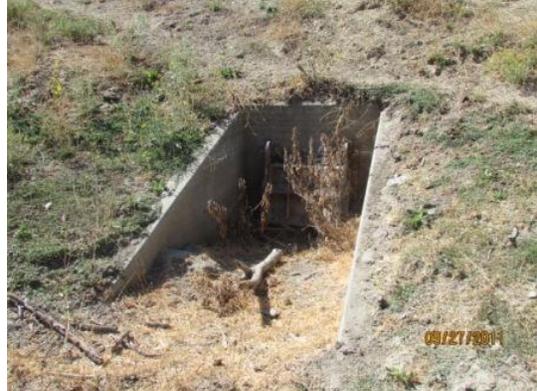
Photo 4 of 4 : FA_2014_RD1602_110_72_20141021_00058.jpg

Debris and sediments were obstructing the flap gate. The picture was taken from toe of waterside of the levee looking towards the crown. This picture was taken during the fall 2011 inspection.

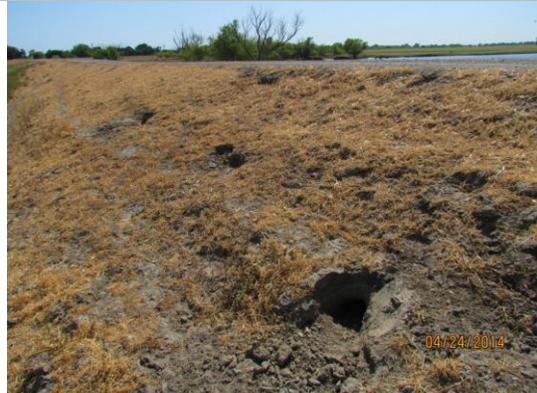
Photo 1 of 3 : FA_2014_RD1602_110_76_20141021_00061.jpg

Updated picture of the rodent holes on the waterside of the levee looking upstream during spring 2014 inspection.

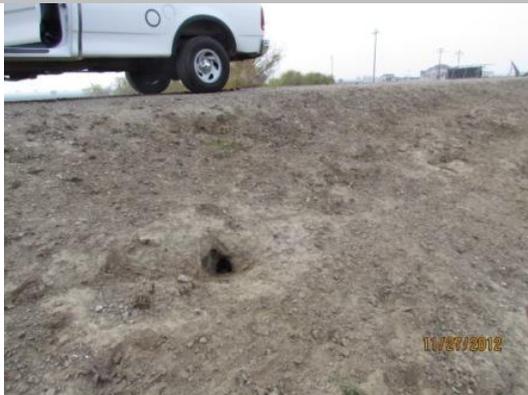
Photo 2 of 3 : FA_2014_RD1602_110_76_20141021_00062.jpg

Updated picture of the rodent hole on the waterside slope of the levee looking downstream.

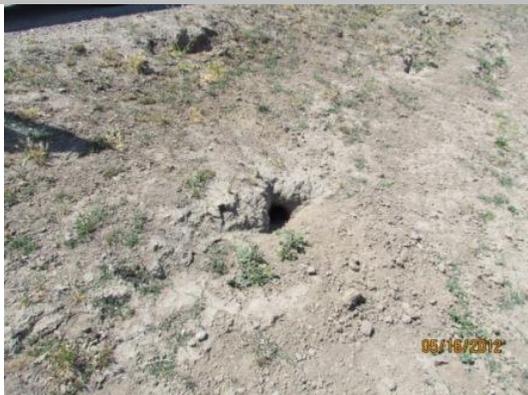
Photo 3 of 3 : FA_2014_RD1602_110_76_20141021_00063.jpg

A rodent hole was found on the waterside of the levee looking downstream.

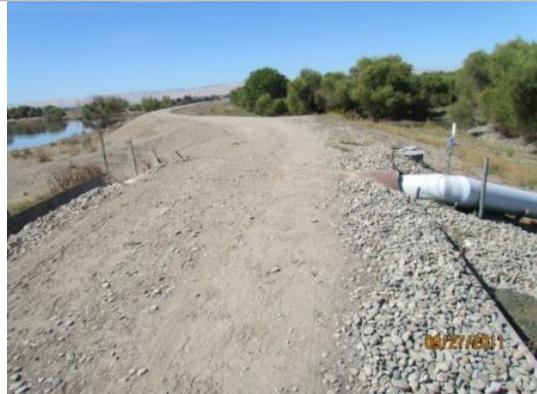
Photo 1 of 1 : FA_2014_RD1602_110_36_20141021_00025.jpg

View of the ramp on the crown. The picture was taken from crown looking downstream.

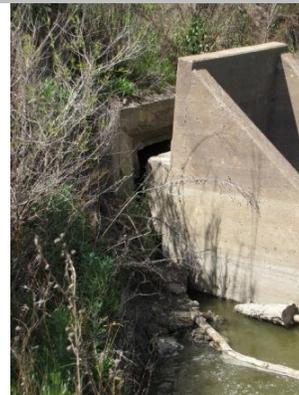
Photo 2 of 2 : FA_2014_RD1602_110_55_20141021_00040.jpg

LM Start	1.04	Rating **	M	Issue No.	55 (cont)
LM End	1.04	Issue Type +	Ma	Location *	WS
Category	Interior Drainage & Piping Systems			GPS Latitude/Longitude	
				Start	End
Item	Concrete Tilting / Settlement			37.478678 °	37.478678 °
				-121.068305 °	-121.068305 °
DWR ID	DWR_RD1602_01_s_2012_55				
Action/Comments					
Inspector Comments: The outlet headwall is tilting away from the pipe rendering the existing flap gate ineffective. Repair gap between pipe and headwall and stabilize headwall to prevent further damage.

Separation of outfall structure from the outlet pipe at LM 1.04.

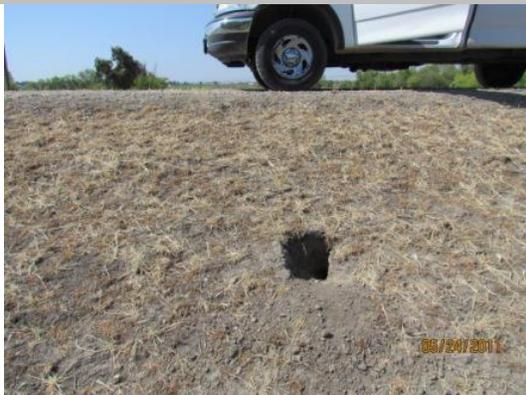
Photo 2 of 2 : FA_2014_RD1602_110_8_20141021_00005.jpg

Rodent hole was found on the waterside of the levee. The picture was taken from waterside looking upstream.

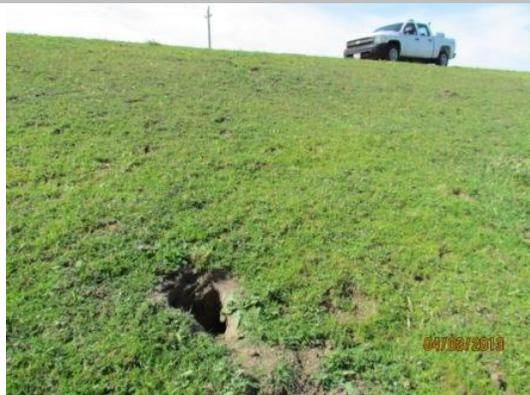
Photo 2 of 2 : FA_2014_RD1602_110_11_20141021_00007.jpg

A rodent hole was found on the waterside toe of the levee looking downstream.

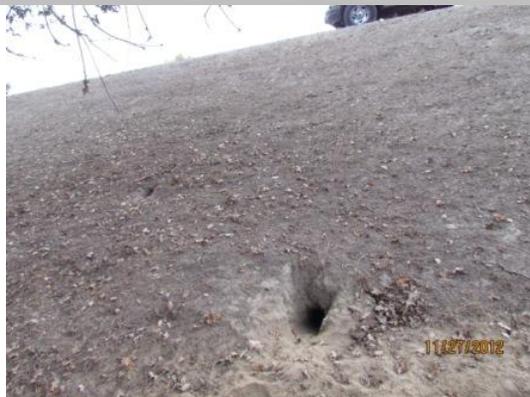
Photo 1 of 1 : FA_2014_RD1602_110_56_20141021_00041.jpg

A rodent hole was found on the waterside toe of the levee looking upstream.

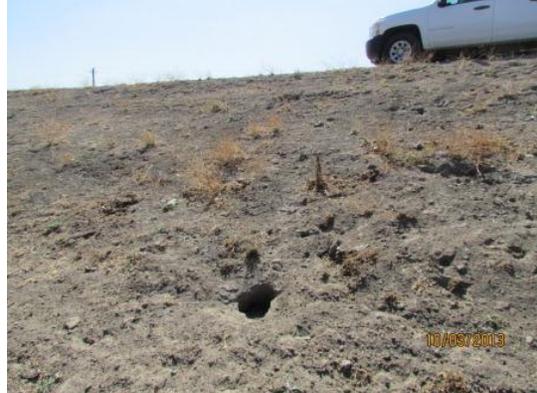
Photo 1 of 2 : FA_2014_RD1602_110_65_20141021_00049.jpg

Updated picture of rodent hole on the waterside slope of the levee looking upstream during fall 2013 inspection.

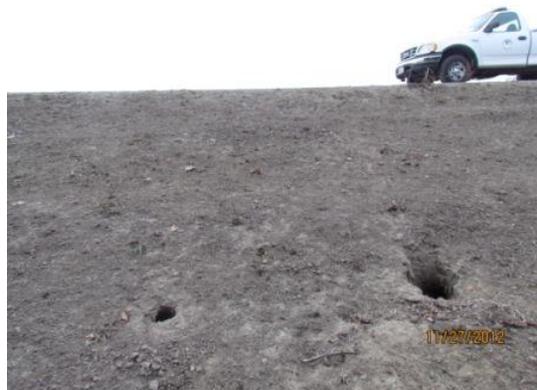
Photo 2 of 2 : FA_2014_RD1602_110_65_20141021_00050.jpg

Rodent holes were found on the waterside toe of the levee. The picture was taken from toe of the levee looking towards the crown.

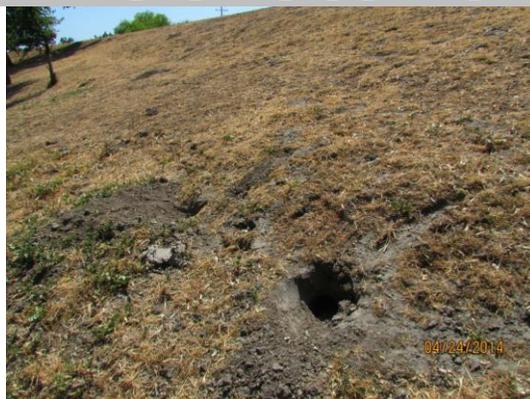
Photo 1 of 2 : FA_2014_RD1602_110_79_20141021_00065.jpg

Updated picture of the rodent holes on the waterside toe of the levee during spring 2014 inspection.

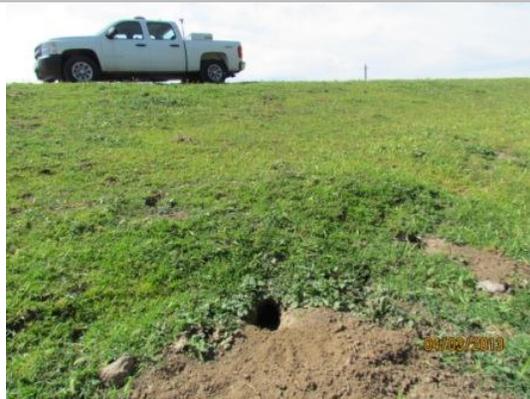
Photo 2 of 2 : FA_2014_RD1602_110_79_20141021_00066.jpg

A rodent hole was found on the waterside toe of the levee looking downstream.

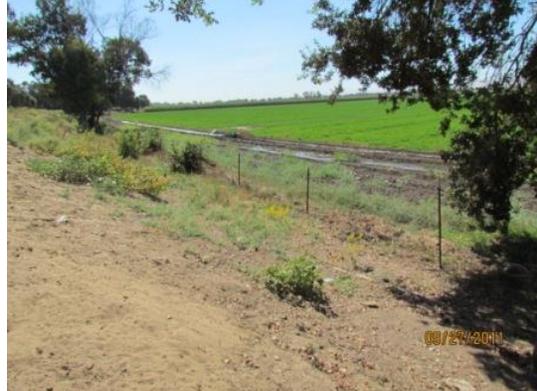
Photo 1 of 1 : FA_2014_RD1602_110_43_20141021_00030.jpg

View of the fence on the landside toe of the levee. The picture was taken from crown looking upstream.

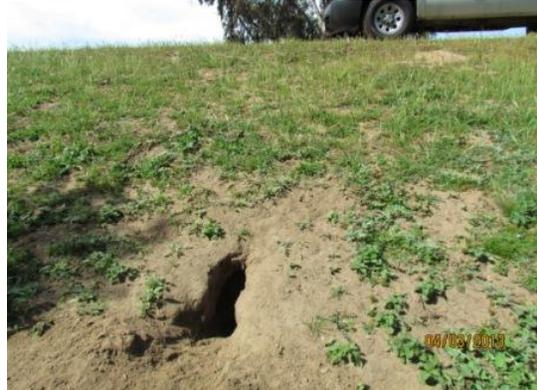
Photo 1 of 1 : FA_2014_RD1602_110_18_20141021_00016.jpg

A rodent hole was found on the waterside toe of the levee looking downstream.

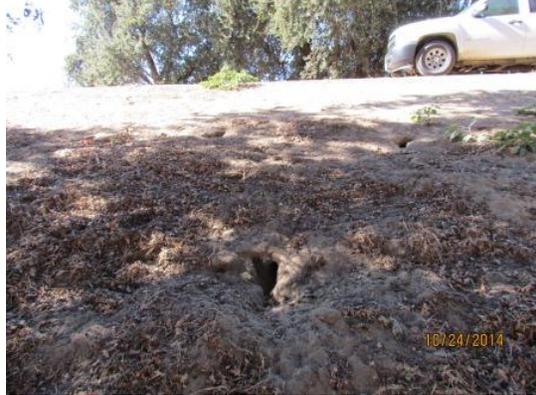
Photo 1 of 1 : FA_2014_RD1602_110_32_20141027_00121.jpg

View of the rodent holes on the waterside of the levee looking from the toe.

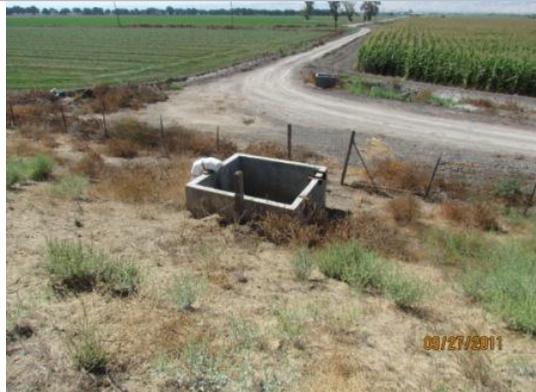
Photo 1 of 1 : FA_2014_RD1602_110_45_20141021_00031.jpg

A well is located at the landside toe of the levee. The picture was taken from the crown looking toward the landside of the levee.

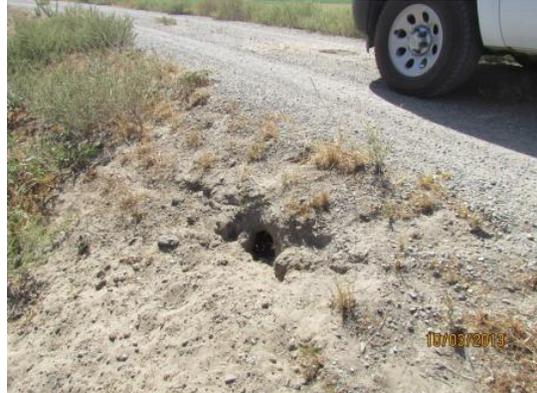
Photo 1 of 2 : FA_2014_RD1602_110_85_20141021_00070.jpg

Updated picture of a rodent hole on the waterside shoulder of the levee looking upstream during fall 2013 inspection.

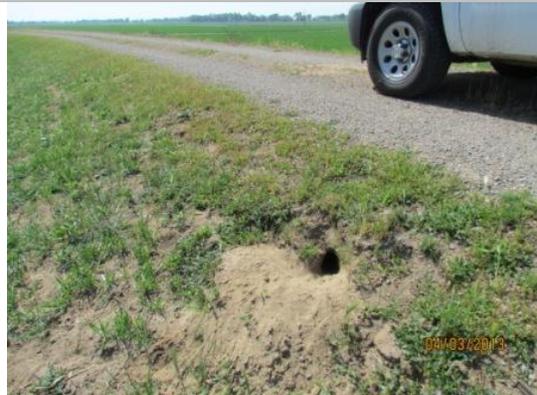
Photo 2 of 2 : FA_2014_RD1602_110_85_20141021_00071.jpg

A rodent hole was found on the waterside shoulder of the levee looking upstream.

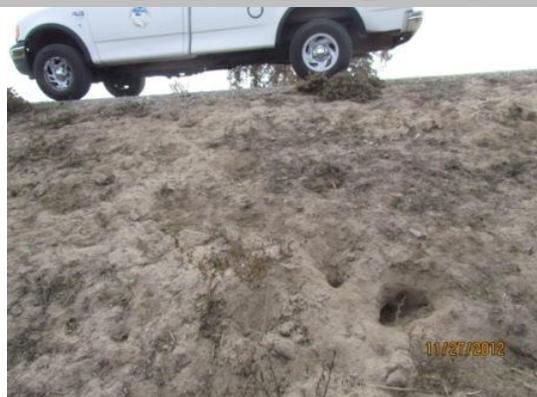
Photo 1 of 1 : FA_2014_RD1602_110_86_20141021_00072.jpg

Rodent holes were found on the waterside toe of the levee looking upstream.

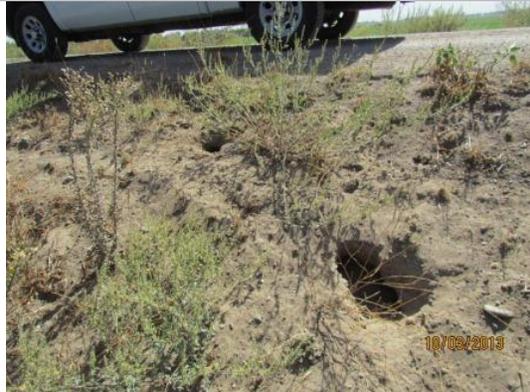
Photo 1 of 1 : FA_2014_RD1602_110_35_20141021_00024.jpg

Animal holes were found on the waterside shoulder of the levee looking upstream.

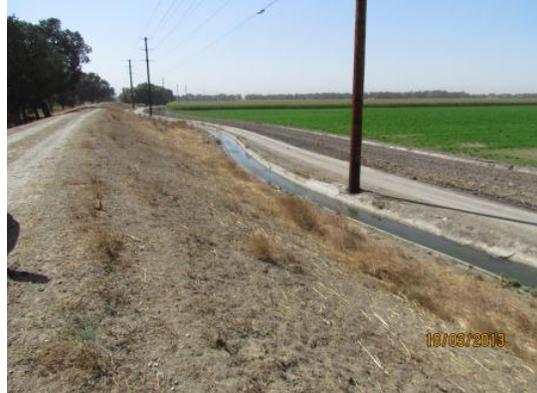
Photo 1 of 1 : FA_2014_RD1602_110_54_20141021_00038.jpg

A concrete lined ditch was found on the landside toe of the levee looking upstream.

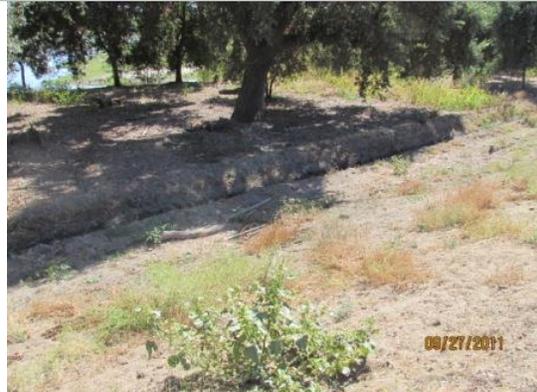
Photo 1 of 1 : FA_2014_RD1602_110_50_20141021_00034.jpg

A ditch was located on the waterside toe of the levee. The picture was taken from the crown looking upstream.

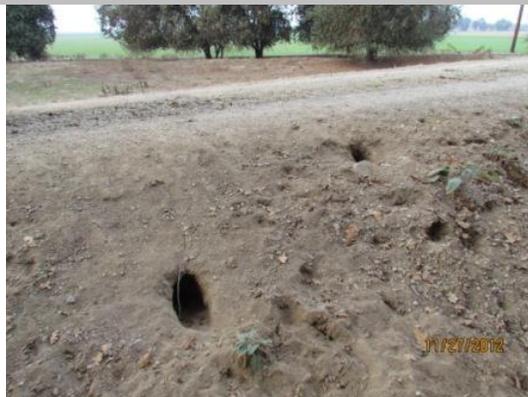
Photo 1 of 1 : FA_2014_RD1602_110_106_20141021_00081.jpg

Rodent holes were found on the waterside slope of the levee looking downstream.

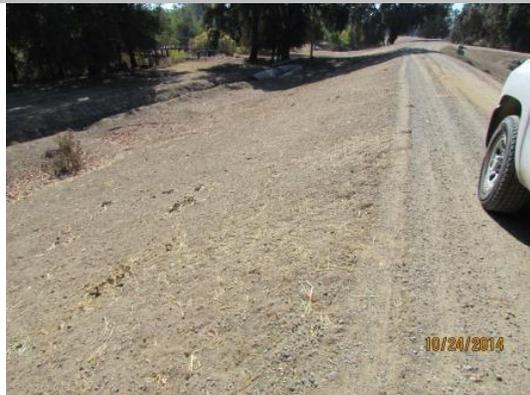
Photo 1 of 3 : FA_2014_RD1602_110_107_20141027_00122.jpg

LMA repaired the rodent holes on the waterside slope of the levee looking upstream during fall 2014 inspection.

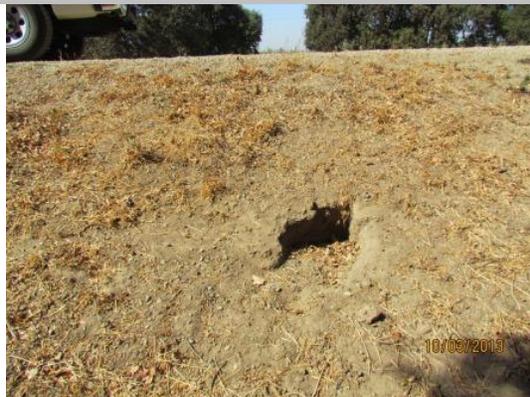
Photo 2 of 3 : FA_2014_RD1602_110_107_20141021_00082.jpg

Updated picture of rodent hole on the waterside shoulder of the levee looking upstream.

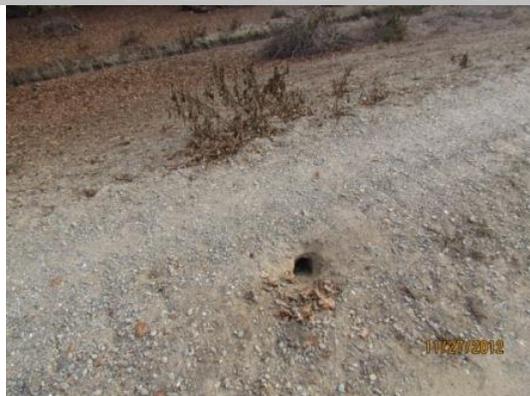
Photo 3 of 3 : FA_2014_RD1602_110_107_20141021_00083.jpg

A rodent hole was found on the waterside shoulder of the levee looking upstream.

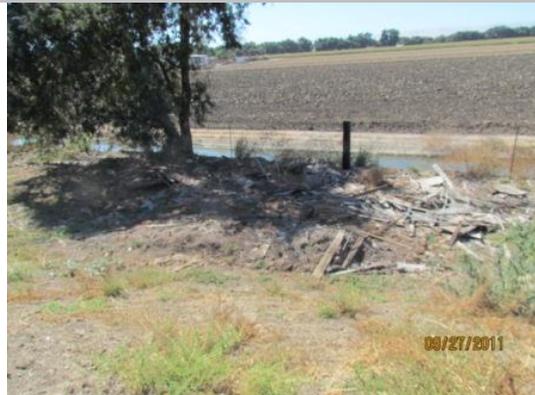
Photo 1 of 2 : FA_2014_RD1602_110_15_20141021_00010.jpg

Debris was located on the landside of the levee. The picture was taken from the crown looking upstream.

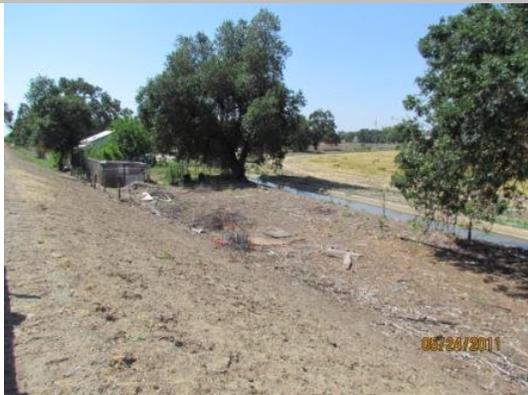
Photo 2 of 2 : FA_2014_RD1602_110_15_20141021_00011.jpg

Garbage was found on the landside of the levee. The picture was taken from the crown looking upstream.

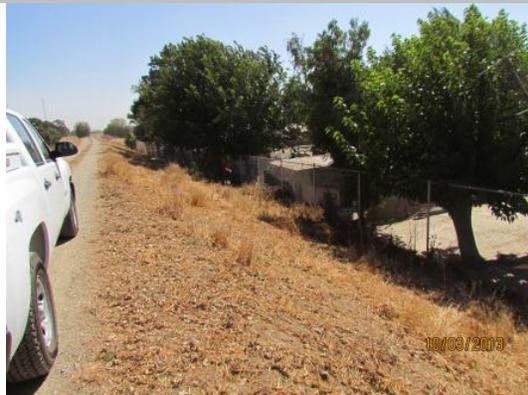
Photo 1 of 1 : FA_2014_RD1602_110_66_20141021_00051.jpg

Fences were found on the landside toe of the levee looking upstream.

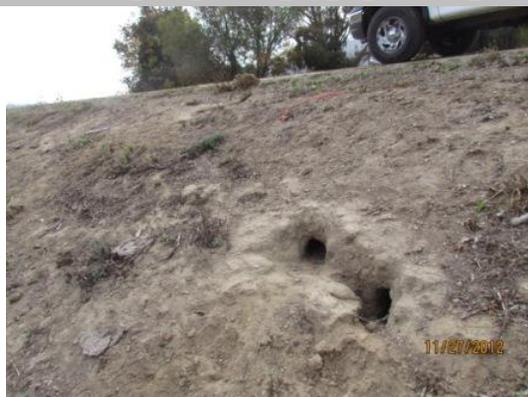
Photo 1 of 1 : FA_2014_RD1602_110_94_20141021_00075.jpg

Rodent holes were found on the waterside toe of the levee looking upstream.

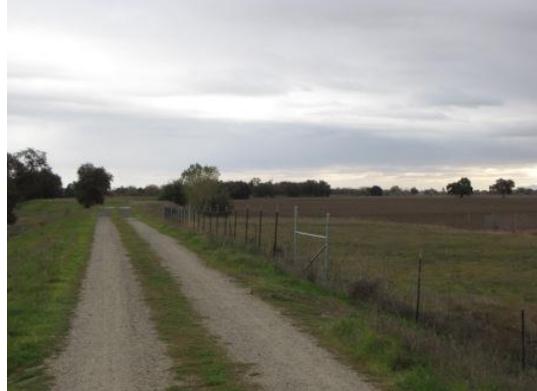
Photo 1 of 1 : FA_2014_RD1602_110_63_20141021_00048.jpg

View of a barbed wire fence on the landward slope looking upstream.

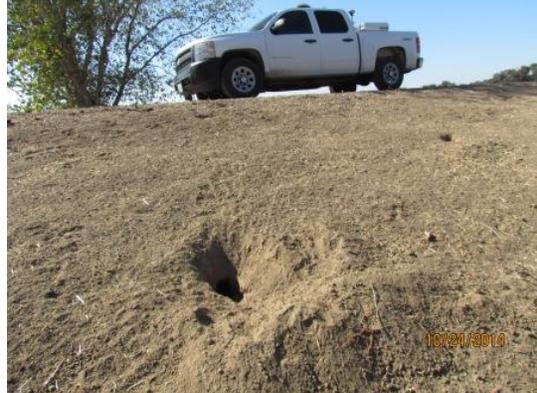
Photo 1 of 1 : FA_2014_RD1602_110_41_20141027_00123.jpg

View of a rodent hole on the waterside toe of the levee during fall 2014 inspection.

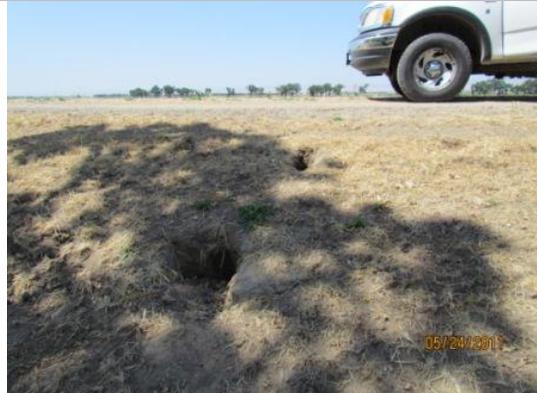
Photo 1 of 1 : FA_2014_RD1602_110_17_20141021_00015.jpg

Rodent hole was found on the waterside of the levee. The picture was taken from the crown looking upstream.

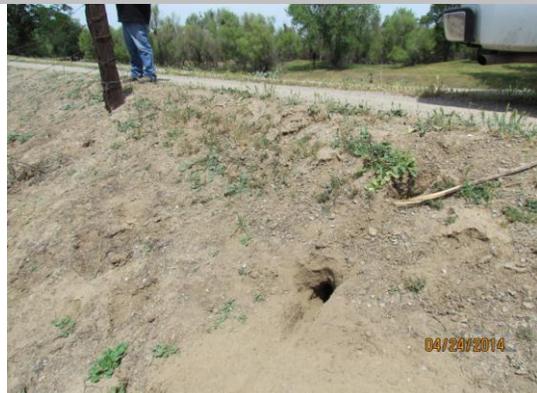
Photo 1 of 1 : FA_2014_RD1602_110_190_20141021_00098.jpg

A rodent hole was found on the waterside shoulder of the levee looking upstream.

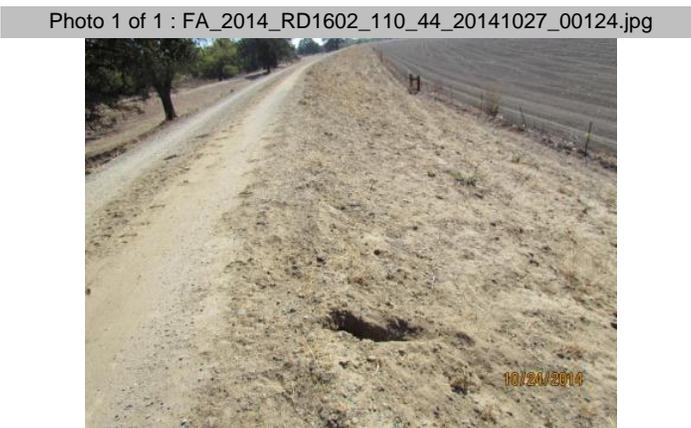
LM Start	4.22	Rating **	M	Issue No.	44
LM End	4.22	Issue Type +	Ma	Location *	LS
Category	Earthen Levee			GPS Latitude/Longitude	
				Start	End
Item	Animal Control			37.450195 °	37.450195 °
				-121.039406 °	-121.039406 °
DWR ID	DWR_RD1602_01_f_2014_44				
Action/Comments					
No rodents visible, but rodent burrows visible; need to backfill and compact or grout burrows.

A rodent hole was found on the landside shoulder of the levee looking upstream.

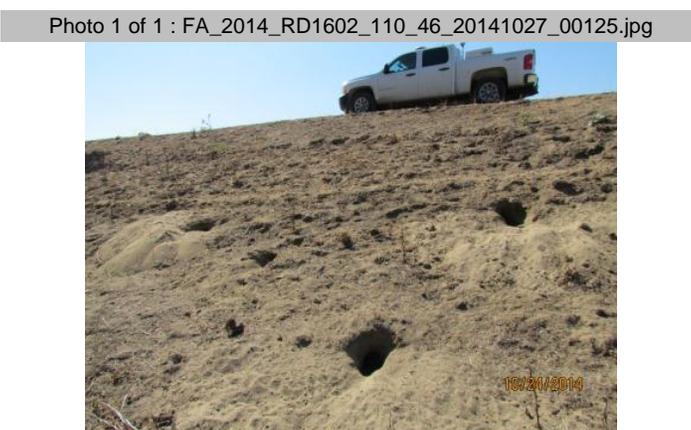
LM Start	4.22	Rating **	M	Issue No.	46
LM End	4.22	Issue Type +	Ma	Location *	WS
Category	Earthen Levee			GPS Latitude/Longitude	
				Start	End
Item	Animal Control			37.450195 °	37.450195 °
				-121.039406 °	-121.039406 °
DWR ID	DWR_RD1602_01_f_2014_46				
Action/Comments					
No rodents visible, but rodent burrows visible; need to backfill and compact or grout burrows.

View of the rodent holes on the waterside slope of the levee. The picture was taken from the toe of the levee during fall 2014 inspection.

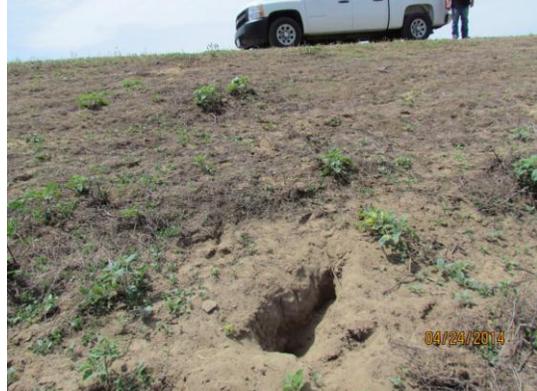
Photo 1 of 1 : FA_2014_RD1602_110_191_20141021_00099.jpg

A rodent hole was found on the waterside toe of the levee looking downstream.

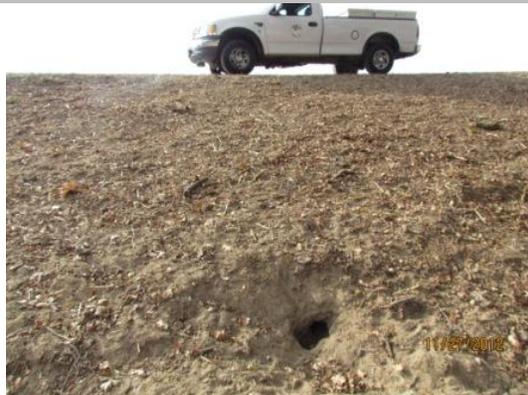
Photo 1 of 1 : FA_2014_RD1602_110_52_20141021_00036.jpg

A rodent hole was found on the waterside toe of the levee looking downstream.

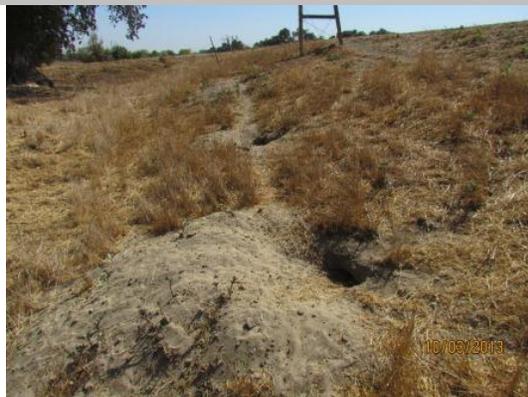
Photo 1 of 2 : FA_2014_RD1602_110_109_20141021_00085.jpg

Updated pictures of rodent holes were found on the waterside toe of the levee looking upstream.

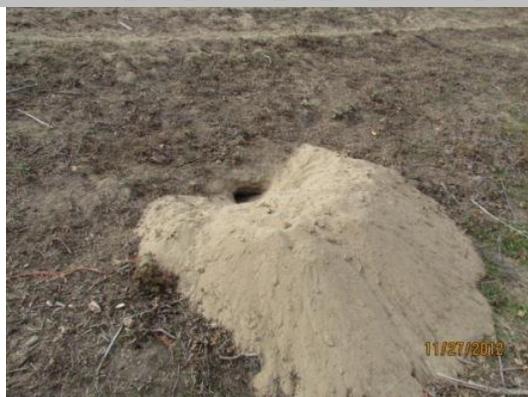
Photo 2 of 2 : FA_2014_RD1602_110_109_20141021_00086.jpg

A rodent hole was found on the waterside toe of the levee looking downstream.

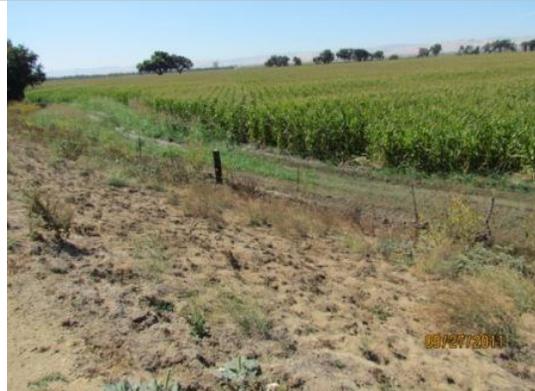
Photo 1 of 1 : FA_2014_RD1602_110_67_20141021_00052.jpg

View of the fence on the landside toe of the levee. The picture was taken from the crown looking upstream.

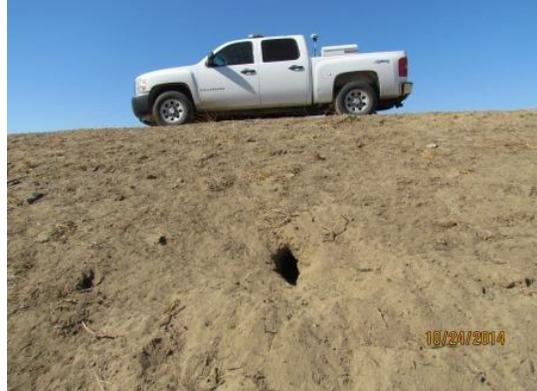
Photo 1 of 1 : FA_2014_RD1602_110_48_20141027_00126.jpg

View of a rodent hole on the waterside slope of the levee looking from the toe.

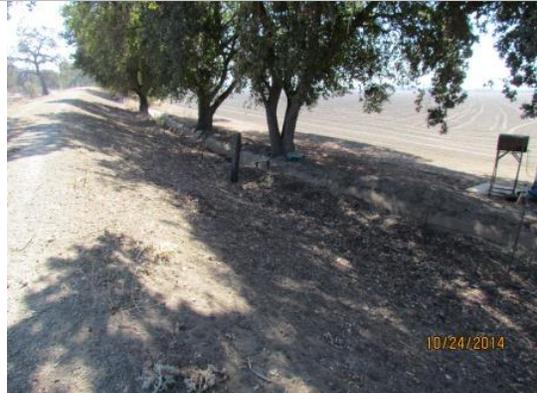
Photo 1 of 1 : FA_2014_RD1602_110_64_20141027_00127.jpg

View of a ditch on the landside toe of the levee looking upstream.

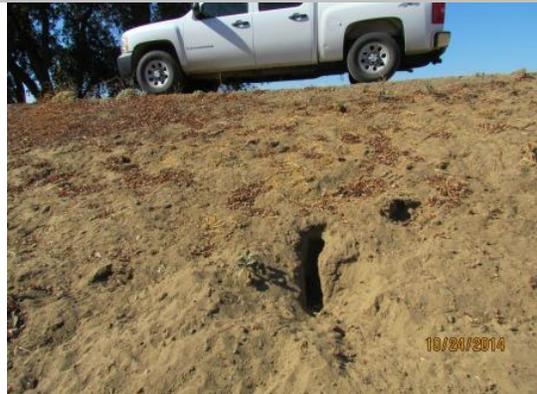
Photo 1 of 1 : FA_2014_RD1602_110_196_20141027_00128.jpg

Rodent holes were found on the waterside slope of the levee.

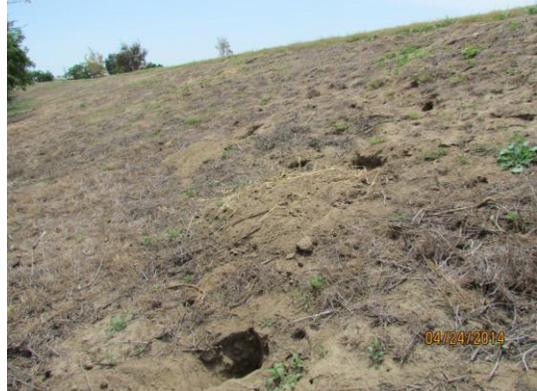
Photo 1 of 1 : FA_2014_RD1602_110_199_20141021_00102.jpg

Few rodent holes were found on the waterside toe of the levee looking upstream.

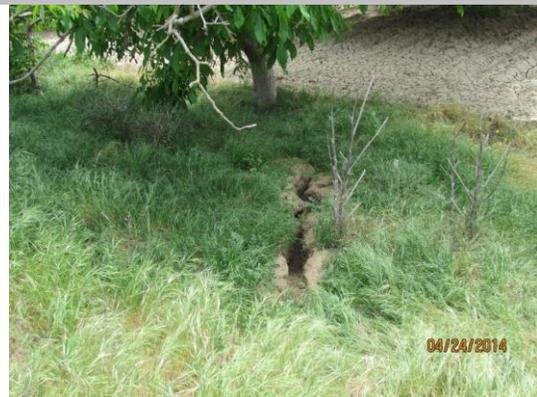
Photo 1 of 1 : FA_2014_RD1602_110_202_20141021_00103.jpg

Erosion was found on the landside slope of the levee looking upstream.

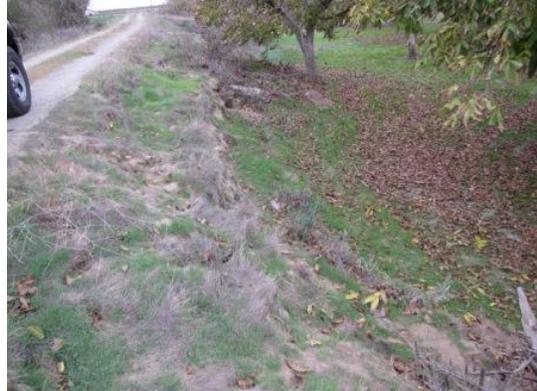
Photo 1 of 1 : FA_2014_RD1602_110_102_20141021_00078.jpg

View of significant damage and erosion to the landward slope looking upstream.

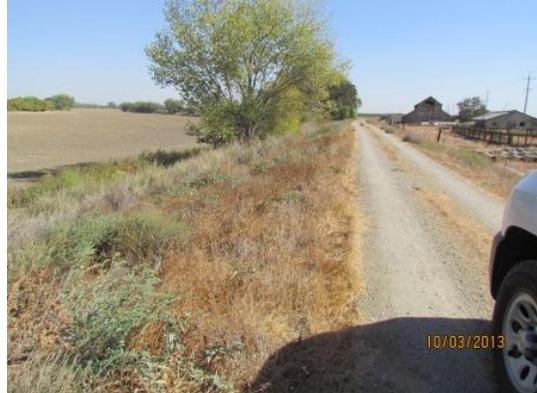
Photo 1 of 2 : FA_2014_RD1602_110_75_20141021_00059.jpg

Vegetation was found on the waterside slope of the levee looking upstream during fall 2013 inspection.

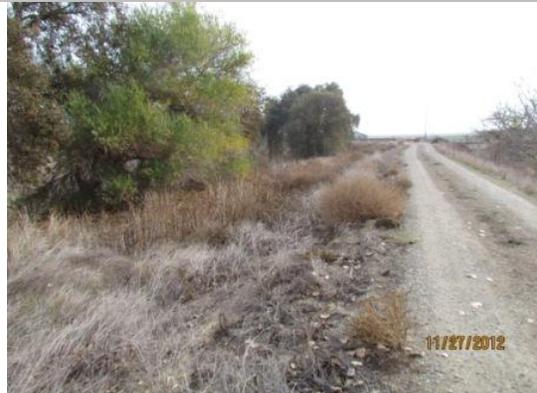
Overgrown vegetation was found on the waterside slope of the levee looking upstream.

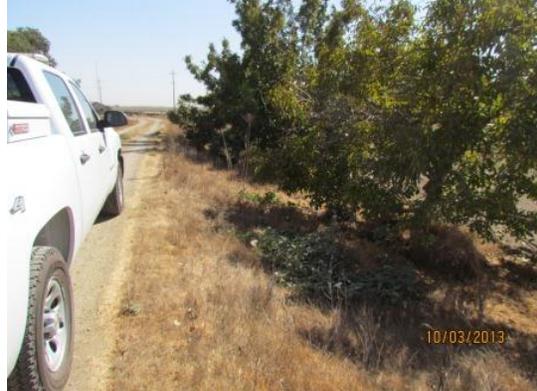
Updated picture of vegetation on the landside of the levee. The picture was taken from the crown looking upstream during fall 2013 inspection.

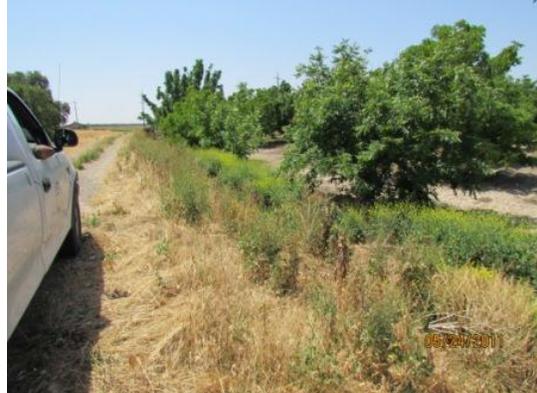
Vegetation was obstructing the view of the landside of the levee. The picture was taken from the crown looking upstream.

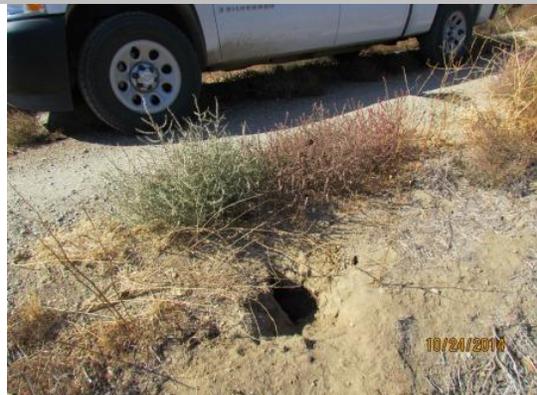
An animal hole was found on the waterside shoulder of the levee looking downstream.
