**Flood Control Project Maintenance
Levee Inspections**

Fall 2015 Levee Maintenance Deficiency Summary Report

San Joaquin River Basin

Reclamation District No. 1602 Del Puerto

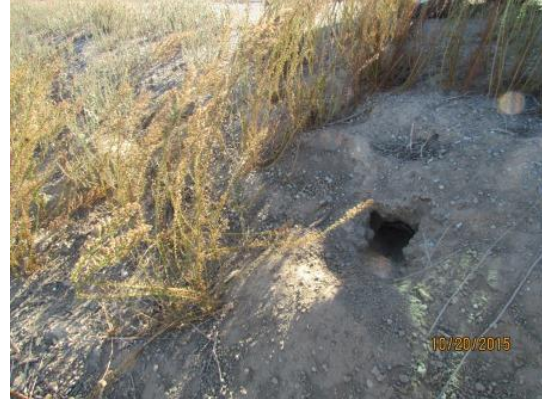
Photo 1 of 1 : FA_2015_RD1602_110_28_20151023_00088.jpg

A rodent hole was found on the waterside of the levee.

LM Start	0.47	Rating **	M	Issue No.	31
LM End	0.47	Issue Type +	Ma	Location *	WS
Category	Earthen Levee			GPS Latitude/Longitude	
				Start	End
Item	Animal Control			37.479659 °	37.479659
				-121.076419 °	-121.076419
DWR ID	DWR_RD1602_01_f_2015_31				
Action/Comments					
No rodents visible, but rodent burrows visible; need to backfill and compact or grout burrows.

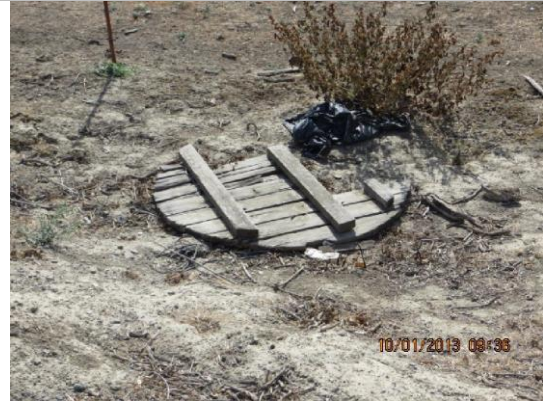
Photo 1 of 3 : UCIP_FA_2015_2266.jpg

Inspector Comments: FS_ID:21623
 DS_ID:20215
 EP_NO: N/A
 FS_HLM: 0.58
 Repair Type: Urgent
 Crossing Status: Found
 UCIP Comments: Open 60-inch CMP riser on WS needs lid as it's depth may be a hazard to the public.
 FIELD_STRUCT_DESC: 16-inch pipe through levee 11.3 feet below crown. Slide gate in 60-inch corrugated metal pipe riser on the waterward side. Concrete inlet 110-feet west of the levee crown. Originally included in 1964 O&M manual.
 FS Date: 10/01/2013

Damaged Wooden lid on WS toe.

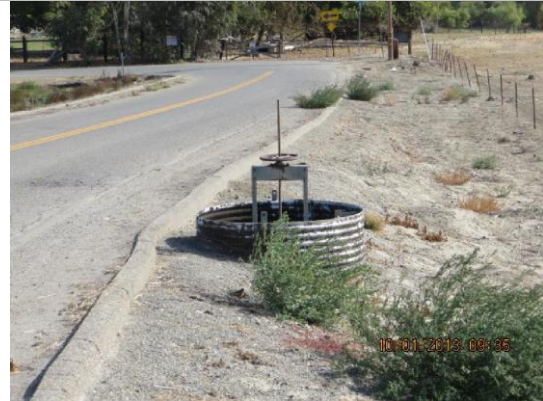
Photo 3 of 3 : UCIP_FA_2015_2268.jpg

LM Start	0.58	Rating **	U	Issue No.	205 (cont)
LM End	0.58	Issue Type +	En	Location *	WS
Category	Supplemental			GPS Latitude/Longitude	
				Start	End
Item	DWR UCIP Field Study			37.480182 °	37.480182 °
				-121.074765 °	-121.074765 °
DWR ID					
Action/Comments					
Inspector Comments: FS_ID:21623					
DS_ID:20215					
EP_NO: N/A					
FS_HLM: 0.58					
Repair Type: Urgent					
Crossing Status: Found

60-inch CMP riser on WS shoulder.

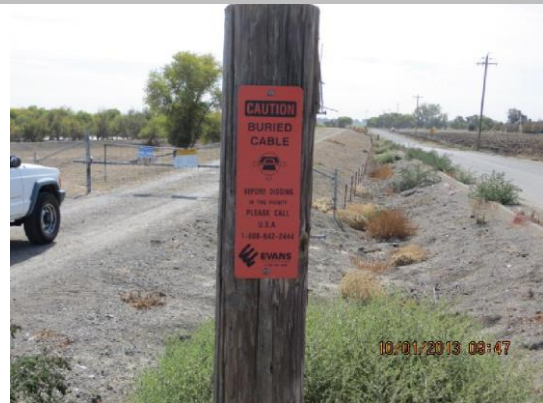
Photo 1 of 3 : UCIP_FA_2015_1912.jpg

LM Start	0.58	Rating **	M	Issue No.	206
LM End	0.58	Issue Type +	En	Location *	WS
Category	Supplemental			GPS Latitude/Longitude	
				Start	End
Item	DWR UCIP Field Study			37.480176 °	37.480176 °
				-121.074736 °	-121.074736 °
DWR ID					
Action/Comments					
Inspector Comments: FS_ID:22937					
DS_ID:24681					
EP_NO: N/A					
FS_HLM: 0.582					
Repair Type: Non-Urgent					
Crossing Status: Found					
UCIP Comments: No permit identified for this crossing.					
FIELD_STRUCT_DESC: Communication line through the levee at an unknown depth.					
FS Date: 10/01/2013

Communication line marker on LS shoulder.

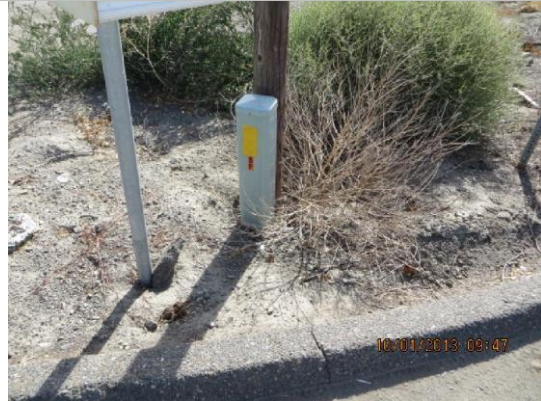
Photo 2 of 3 : UCIP_FA_2015_1913.jpg

LM Start	0.58	Rating **	M	Issue No.	206 (cont)	
LM End	0.58	Issue Type +	En	Location *	WS	
Category	Supplemental			GPS Latitude/Longitude		
				Start	End	
Item	DWR UCIP Field Study			37.480176 °	37.480176 °	
				-121.074736 °	-121.074736 °	
DWR ID						
Action/Comments						
Inspector Comments: FS_ID:22937						
DS_ID:24681						
EP_NO: N/A						
FS_HLM: 0.582						
Repair Type: Non-Urgent						
Crossing Status: Found						
UCIP Comments: No permit identified for this crossing.						
FIELD_STRUCT_DESC: Communication line through the levee at an unknown depth.						
FS Date: 10/01/2013

Communication line access box on LS shoulder.

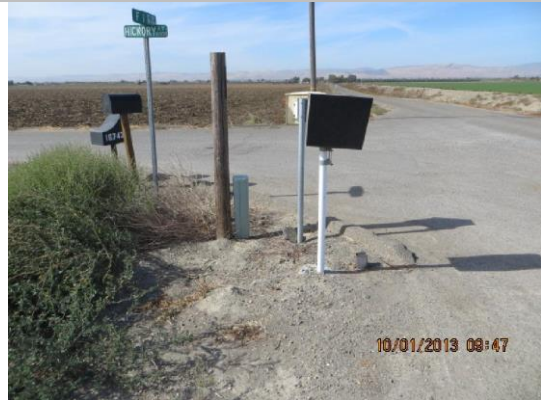
Photo 3 of 3 : UCIP_FA_2015_1914.jpg

Communication line access box on LS shoulder.

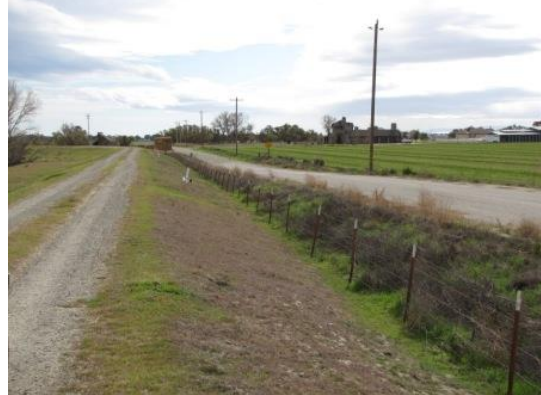
Photo 1 of 1 : FA_2015_RD1602_110_70_20150911_00049.jpg

View of barbed wire fence at landward toe looking upstream.

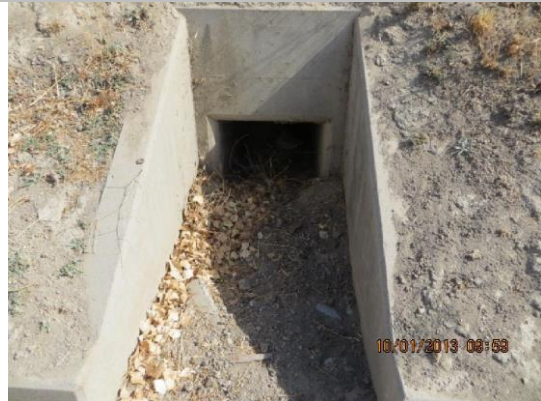
Photo 1 of 3 : UCIP_FA_2015_2269.jpg

LM Start	0.77	Rating **	U	Issue No.	207
LM End	0.77	Issue Type +	En	Location *	WS
Category	Supplemental			GPS Latitude/Longitude	
				Start	End
Item	DWR UCIP Field Study			37.477993 °	37.477993 °
				-121.072645 °	-121.072645 °
DWR ID					
Action/Comments					
Inspector Comments: FS_ID:43084					
DS_ID:20216					
EP_NO: N/A					
FS_HLM: 0.775					
Repair Type: Urgent					
Crossing Status: Found					
UCIP Comments: Flap gate blocked from functioning by soil buildup on WS toe. Soil should be cleared.					
FIELD_STRUCT_DESC: 30-inch square reinforced concrete box culvert through levee 14.4 feet below crown. Concrete "U" headwall on both ends. Slide gate in 6'X7' concrete surge box on the waterward shoulder. Flap gate on the waterward end. Originally included in 1964 O&M manual.					
FS Date: 10/01/2013

Concrete inlet on LS toe.

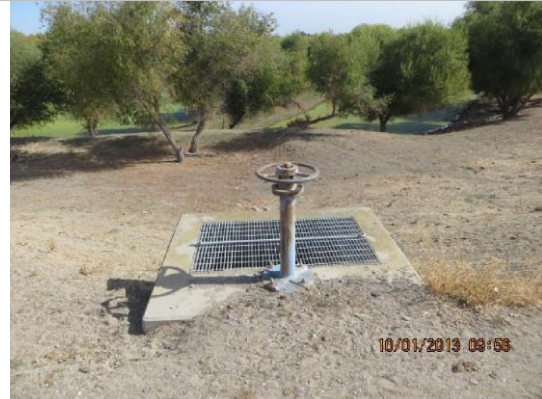
Photo 2 of 3 : UCIP_FA_2015_2270.jpg

LM Start	0.77	Rating **	U	Issue No.	207 (cont)	
LM End	0.77	Issue Type +	En	Location *	WS	
Category	Supplemental			GPS Latitude/Longitude		
				Start	End	
Item	DWR UCIP Field Study			37.477993 °	37.477993 °	
				-121.072645 °	-121.072645 °	
DWR ID						
Action/Comments						
Inspector Comments: FS_ID:43084						
DS_ID:20216						
EP_NO: N/A						
FS_HLM: 0.775						
Repair Type: Urgent						
Crossing Status: Found						
UCIP Comments: Flap gate blocked from functioning by soil buildup on WS toe. Soil should be cleared.						
FIELD_STRUCT_DESC: 30-inch square reinforced concrete box culvert through levee 14.4 feet below crown. Concrete "U" headwall on both ends. Slide gate in 6'X7' concrete surge box on the waterward shoulder. Flap gate on the waterward end. Originally included in 1964 O&M manual.						
FS Date: 10/01/2013

Slide gate in concrete box on WS shoulder.

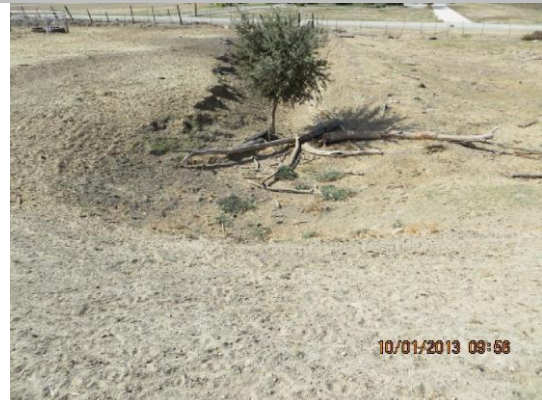
Photo 3 of 3 : UCIP_FA_2015_2271.jpg

Inlet on LS toe.

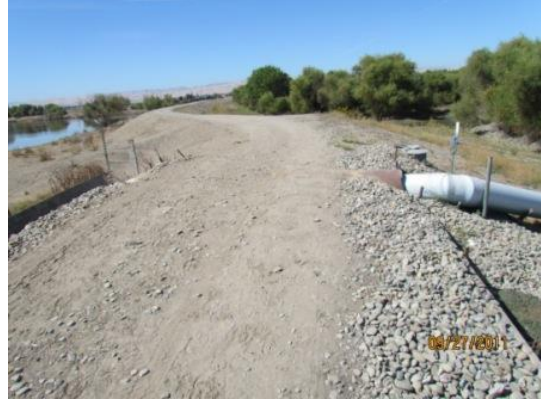
Photo 1 of 1 : FA_2015_RD1602_110_36_20150911_00015.jpg

View of the ramp on the crown. The picture was taken from crown looking downstream.

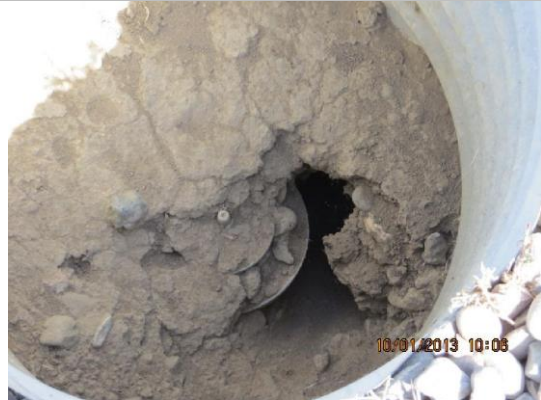
Photo 1 of 3 : UCIP_FA_2015_2283.jpg

LM Start	1.00	Rating **	U	Issue No.	208
LM End	1.00	Issue Type +	En	Location *	WS
Category	Supplemental			GPS Latitude/Longitude	
				Start	End
Item	DWR UCIP Field Study			37.478816 °	37.478816 °
				-121.068780 °	-121.068780 °
DWR ID					
Action/Comments					
Inspector Comments: FS_ID:21639					
DS_ID:20217					
EP_NO: N/A					
FS_HLM: 1.006					
Repair Type: Urgent					
Crossing Status: Found					
UCIP Comments: Appears abandoned and if so should be done so properly. Flapgate missing.					
FIELD_STRUCT_DESC: 1 of 2: 16-inch pipe through levee 17.0 feet below crown. Pumps on pump platform on the landward side. Siphon breaker in 24-inch CMP risers on the waterward shoulder. Concrete "U" headwall and flap gate on the waterward end. Originally included in 1964 O&M manual.					
FS Date: 10/01/2013

Siphon breaker in 24-inch CMP riser on WS shoulder.

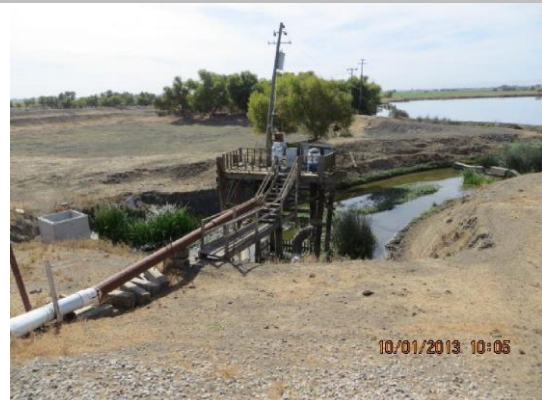
Photo 3 of 3 : UCIP_FA_2015_2285.jpg

Inspector Comments: FS_ID:21639
 DS_ID:20217
 EP_NO: N/A
 FS_HLM: 1.006
 Repair Type: Urgent
 Crossing Status: Found
 UCIP Comments: Appears abandoned and if so should be done so properly. Flapgate missing.
 FIELD_STRUCT_DESC: 1 of 2: 16-inch pipe through levee 17.0 feet below crown. Pumps on pump platform on the landward side. Siphon breaker in 24-inch CMP risers on the waterward shoulder. Concrete "U" headwall and flap gate on the waterward end. Originally included in 1964 O&M manual.
 FS Date: 10/01/2013

Pumping plant on LS toe. Pipe visible under walkway.

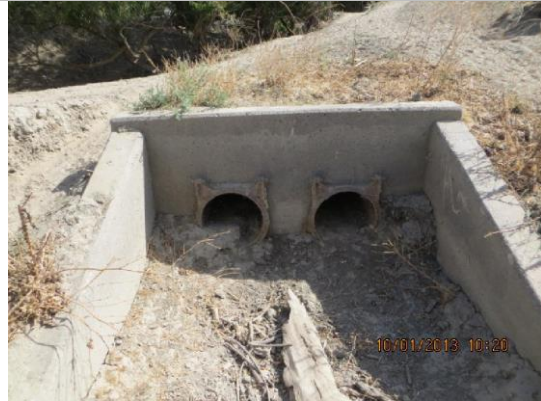
Photo 1 of 3 : UCIP_FA_2015_2286.jpg

LM Start	1.00	Rating **	U	Issue No.	209
LM End	1.00	Issue Type +	En	Location *	WS
Category	Supplemental			GPS Latitude/Longitude	
				Start	End
Item	DWR UCIP Field Study			37.478817 °	37.478817 °
				-121.068773 °	-121.068773 °
DWR ID					
Action/Comments					
Inspector Comments: FS_ID:21642 DS_ID:20219 EP_NO: N/A FS_HLM: 1.006 Repair Type: Urgent Crossing Status: Found

Concrete headwall on WS toe with missing flapgate.

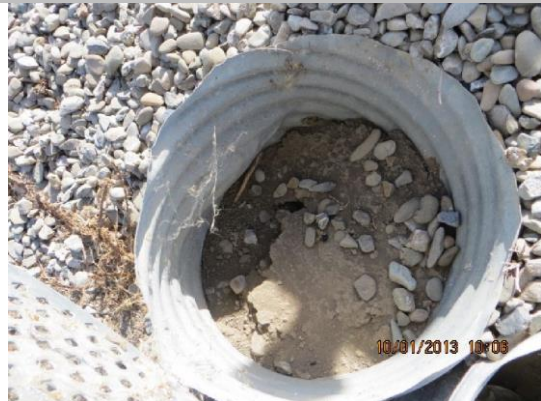
Photo 2 of 3 : UCIP_FA_2015_2287.jpg

Siphon breaker covered in soil at CMP riser on WS shoulder.

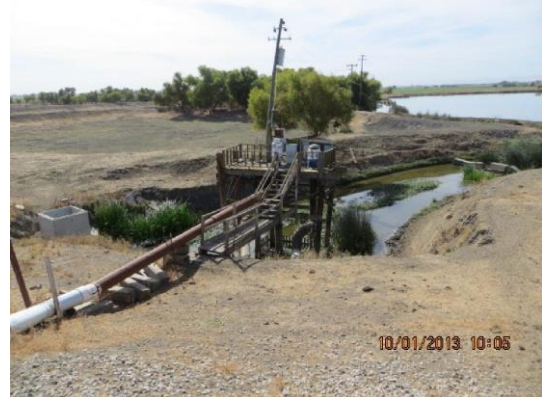
Photo 3 of 3 : UCIP_FA_2015_2288.jpg

LM Start	1.00	Rating **	U	Issue No.	209 (cont)
LM End	1.00	Issue Type +	En	Location *	WS
Category	Supplemental			GPS Latitude/Longitude	
				Start	End
Item	DWR UCIP Field Study			37.478817 °	37.478817 °
				-121.068773 °	-121.068773 °
DWR ID					
Action/Comments					
Inspector Comments: FS_ID:21642 DS_ID:20219 EP_NO: N/A FS_HLM: 1.006 Repair Type: Urgent Crossing Status: Found

Pipe visible under walkway at puming plant on LS toe.

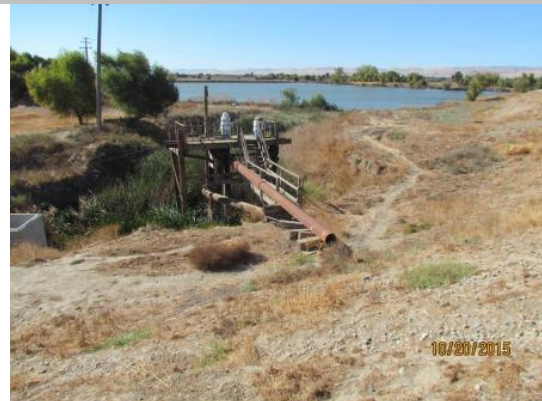
Photo 1 of 1 : FA_2015_RD1602_110_33_20151023_00091.jpg

An abandoned pipe was found on the landside of the levee.

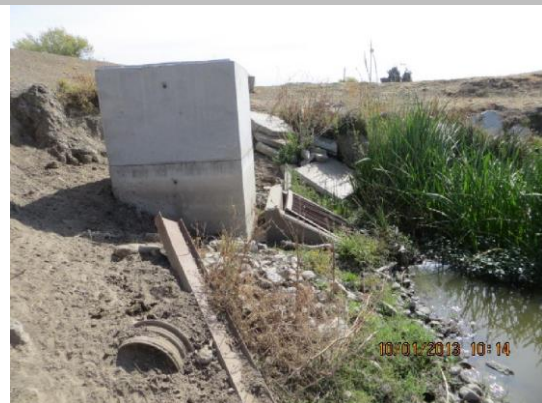
Photo 2 of 2 : UCIP_FA_2015_2290.jpg

UCIP Comments: Headwall on WS toe seperated from pipe. Erosion around concrete headwall and undermined at WS toe. Flapgate missing from WS toe headwall.

Grated inlet and 5'X5' concrete box on LS toe.

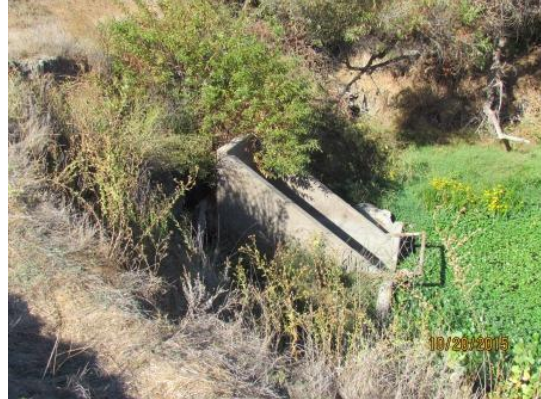
Photo 1 of 3 : FA_2015_RD1602_110_55_20151023_00090.jpg

LM Start	1.02	Rating **	U	Issue No.	55
LM End	1.02	Issue Type +	Ma	Location *	WS
Category	Interior Drainage & Piping Systems			GPS Latitude/Longitude	
				Start	End
Item	Concrete Tilting / Settlement			37.478772 °	37.478772 °
				-121.068454 °	-121.068454 °
DWR ID	DWR_RD1602_01_s_2012_55				
Action/Comments					
Inspector Comments: The outlet headwall is tilting away from the pipe rendering the existing flap gate ineffective. The LMA is planning to repair gap between pipe and headwall and stabilize headwall to prevent further damage.

View of the broken headwall on the waterside of the levee during fall 2015 inspection.

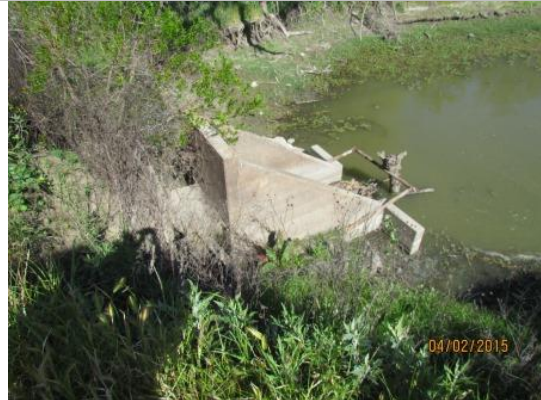
Photo 2 of 3 : FA_2015_RD1602_110_55_20150911_00032.jpg

LM Start	1.02	Rating **	U	Issue No.	55 (cont)
LM End	1.02	Issue Type +	Ma	Location *	WS

View of the broken headwall on the waterside of the levee during spring 2015 inspection.

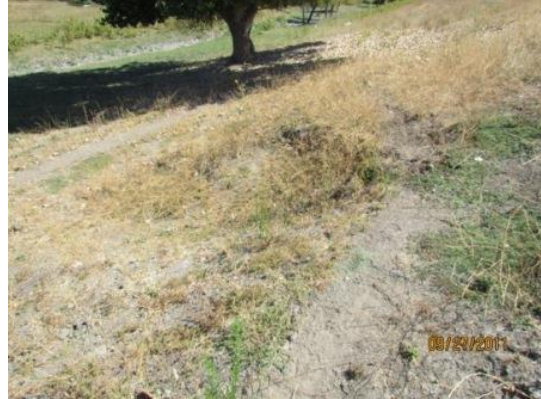
Photo 1 of 2 : FA_2015_RD1602_110_37_20150911_00017.jpg

LM Start	1.05	Rating **	M	Issue No.	37
LM End	1.05	Issue Type +	Ma	Location *	WS
Category	Earthen Levee			GPS Latitude/Longitude	
				Start	End
Item	Slope Stability			37.478567 °	37.478567 °
				-121.067847 °	-121.067847 °
DWR ID	DWR_RD1602_01_s _ 2012_37				
Action/Comments					
Repair slope instability. Inspector Comments: Small amount of slumping at waterside toe of the levee.

Updated picture of the depression at the waterside toe of the levee. The picture was taken from the crown of the levee looking upstream.

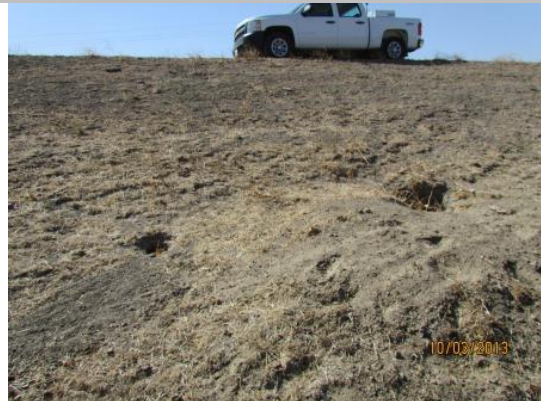
Photo 1 of 2 : FA_2015_RD1602_110_11_20150911_00002.jpg

Rodent holes were found on the waterside slope of the levee looking downstream.

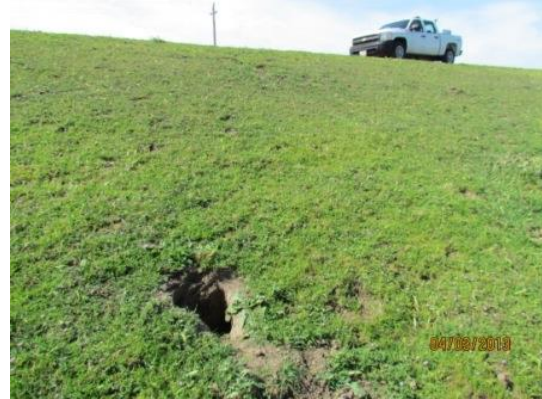
Photo 2 of 2 : FA_2015_RD1602_110_11_20150911_00003.jpg

A rodent hole was found on the waterside toe of the levee looking downstream.

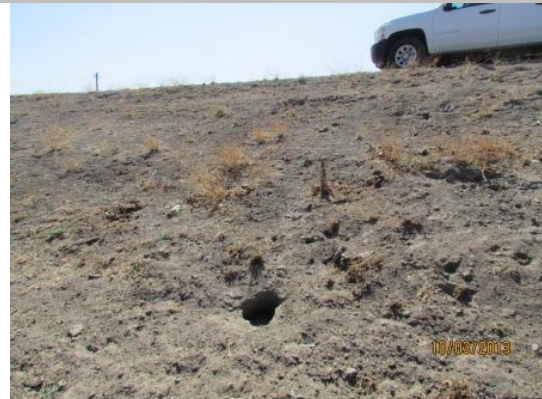
Photo 1 of 2 : FA_2015_RD1602_110_65_20150911_00043.jpg

Updated picture of rodent hole on the waterside slope of the levee looking upstream during fall 2013 inspection.

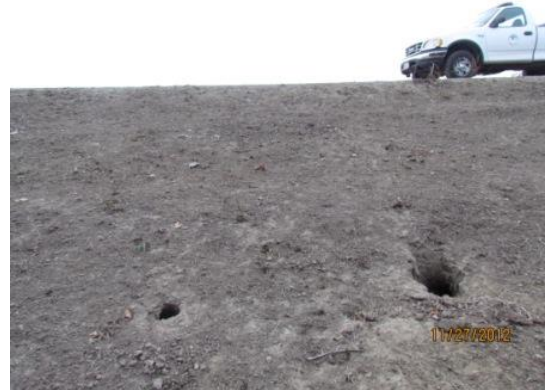
Photo 2 of 2 : FA_2015_RD1602_110_65_20150911_00044.jpg

Rodent holes were found on the waterside toe of the levee. The picture was taken from toe of the levee looking towards the crown.

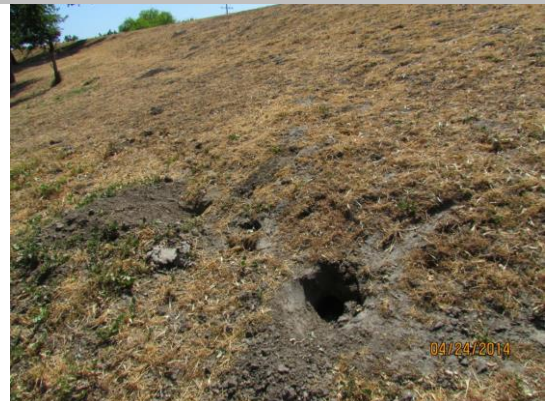
Photo 1 of 2 : FA_2015_RD1602_110_79_20150911_00059.jpg

Updated picture of the rodent holes on the waterside toe of the levee during spring 2014 inspection.

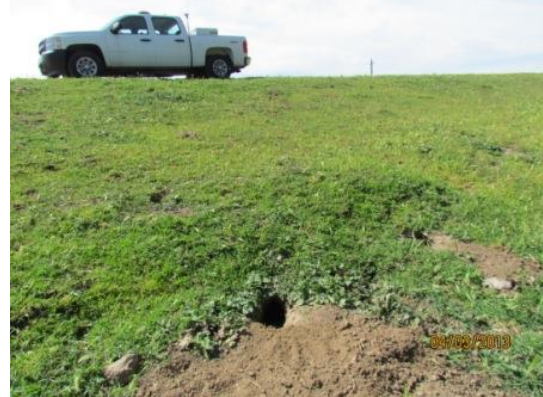
Photo 2 of 2 : FA_2015_RD1602_110_79_20150911_00060.jpg

A rodent hole was found on the waterside toe of the levee looking downstream.

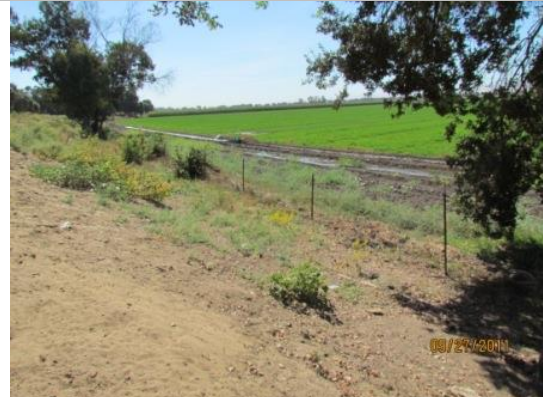
Photo 1 of 1 : FA_2015_RD1602_110_43_20150911_00021.jpg

View of the fence on the landside toe of the levee. The picture was taken from crown looking upstream.

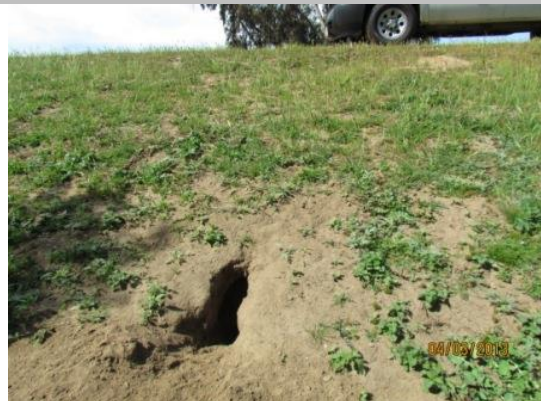
Photo 1 of 1 : FA_2015_RD1602_110_18_20150911_00007.jpg

A rodent hole was found on the waterside toe of the levee looking downstream.

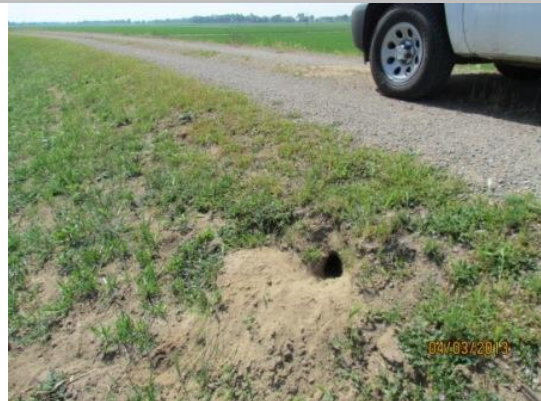
Photo 2 of 2 : FA_2015_RD1602_110_85_20150911_00063.jpg

A rodent hole was found on the waterside shoulder of the levee looking upstream.

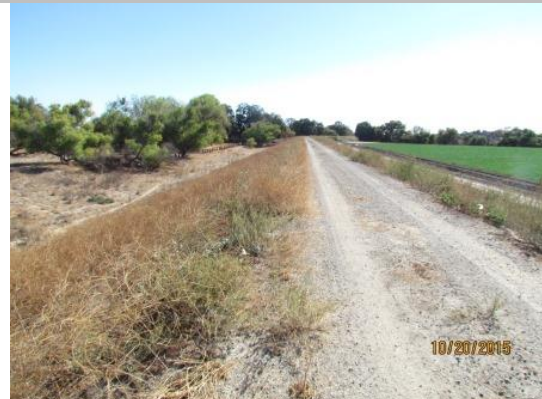
Photo 1 of 1 : FA_2015_RD1602_110_38_20151023_00094.jpg

View of the vegetation on the waterside of the levee.

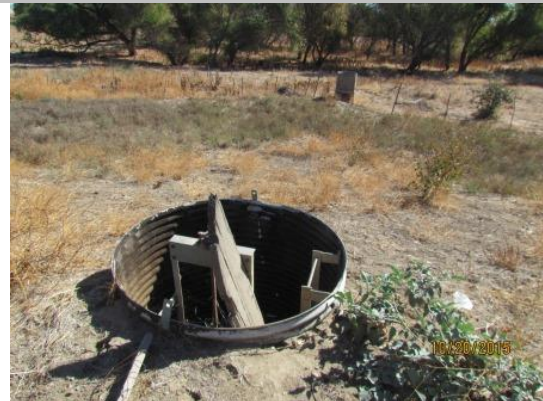
Photo 1 of 1 : FA_2015_RD1602_110_84_20151023_00095.jpg

View of abandoned pipe and slide gate on the waterside of the levee.

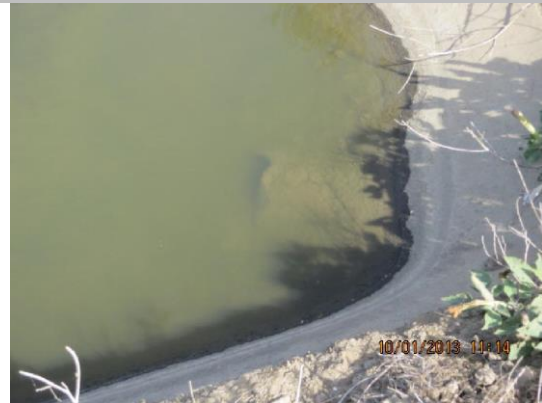
Photo 2 of 2 : UCIP_FA_2015_2292.jpg

Pipe visible in concrete channel on LS toe.

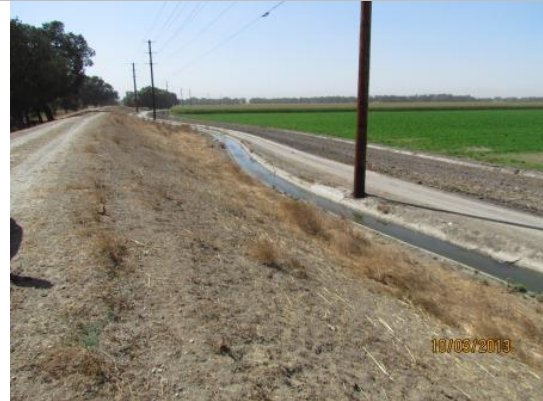
Photo 1 of 1 : FA_2015_RD1602_110_54_20150911_00031.jpg

A concrete lined ditch was found on the landside toe of the levee looking upstream.

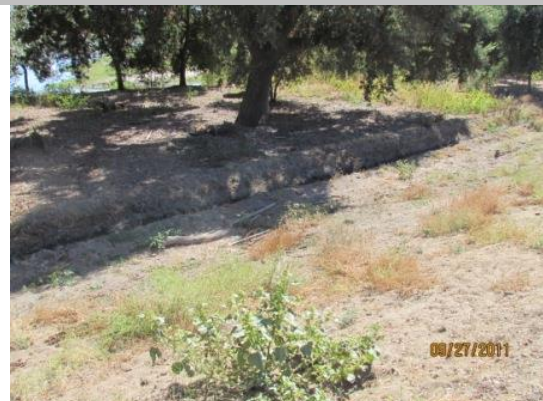
Photo 1 of 1 : FA_2015_RD1602_110_50_20150911_00027.jpg

A ditch was located on the waterside toe of the levee. The picture was taken from the crown looking upstream.

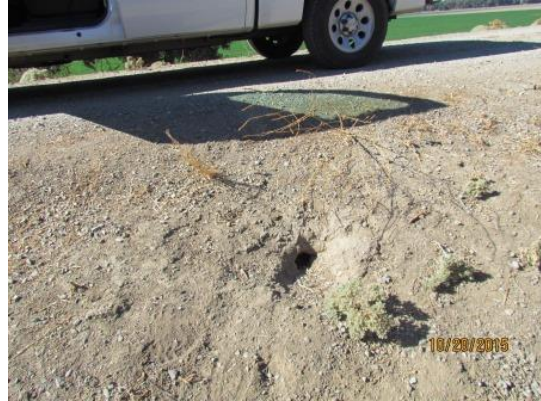
Photo 1 of 1 : FA_2015_RD1602_110_86_20151023_00096.jpg

A rodent hole was found on the waterside of the levee.

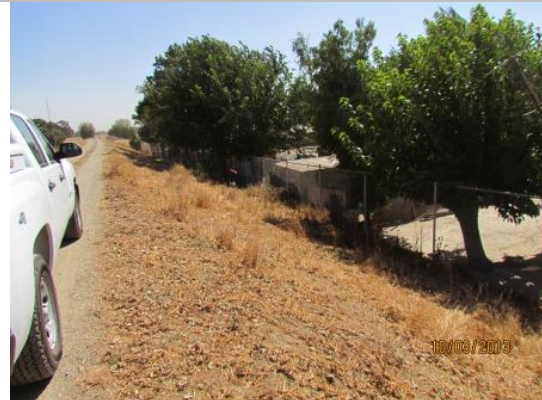
Photo 1 of 1 : FA_2015_RD1602_110_66_20150911_00045.jpg

Fences were found on the landside toe of the levee looking upstream.

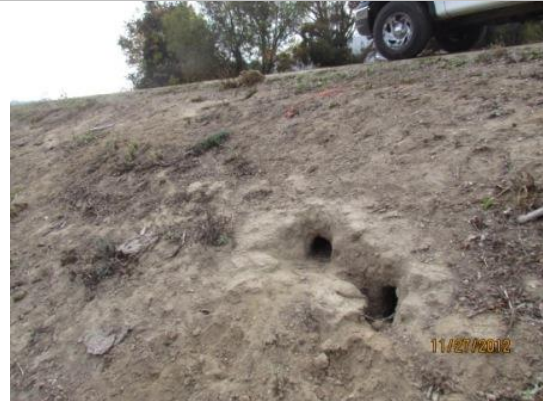
Photo 1 of 1 : FA_2015_RD1602_110_94_20150911_00064.jpg

Rodent holes were found on the waterside toe of the levee looking upstream.

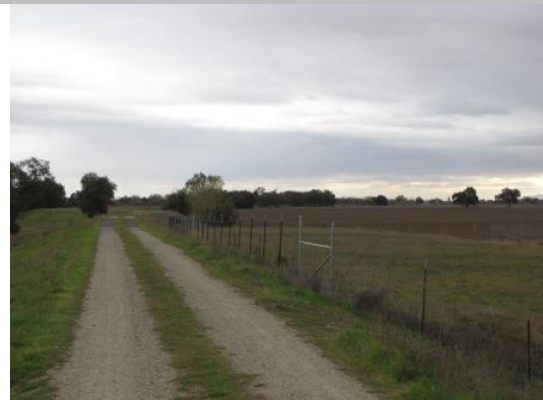
Photo 1 of 1 : FA_2015_RD1602_110_63_20150911_00041.jpg

View of a barbed wire fence on the landward slope looking upstream.

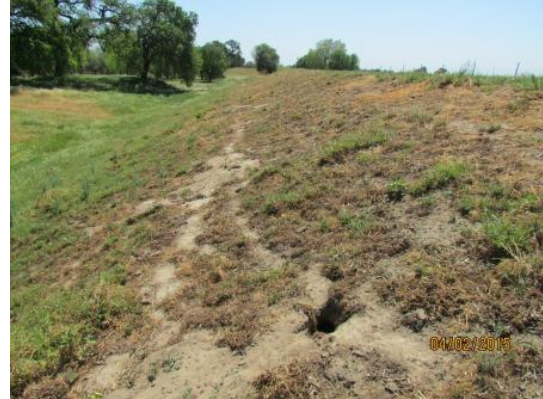
Photo 1 of 1 : FA_2015_RD1602_110_47_20150911_00025.jpg

Rodent holes were found on the waterside of the levee looking upstream.

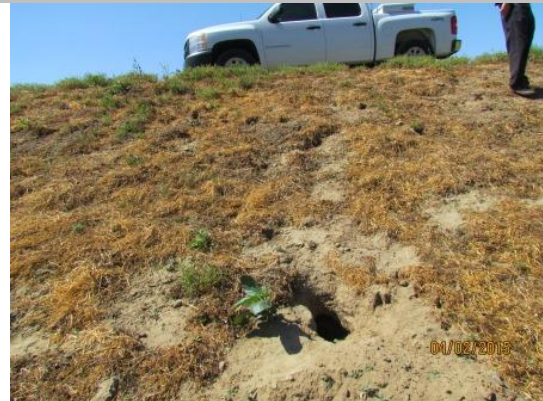
Photo 1 of 1 : FA_2015_RD1602_110_51_20150911_00028.jpg

A number of rodent holes were found on the waterside slope of the levee.

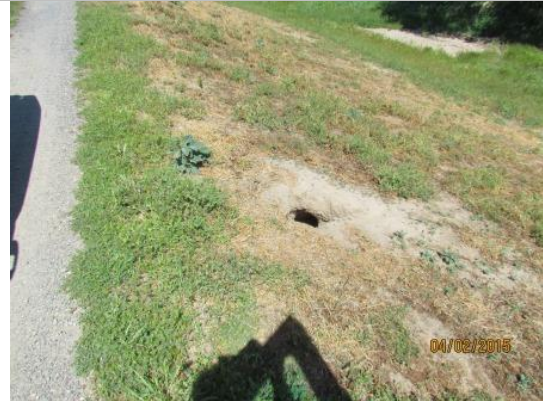
Photo 1 of 1 : FA_2015_RD1602_110_53_20150911_00030.jpg

A rodent hole was found on the waterside shoulder of the levee looking downstream.

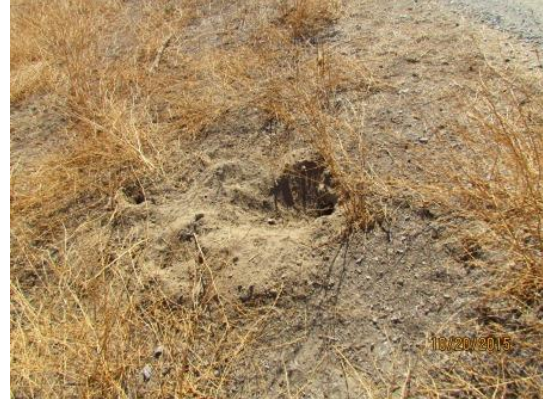
Photo 1 of 1 : FA_2015_RD1602_110_88_20151023_00097.jpg

An animal borrow was found on the waterside of the levee.

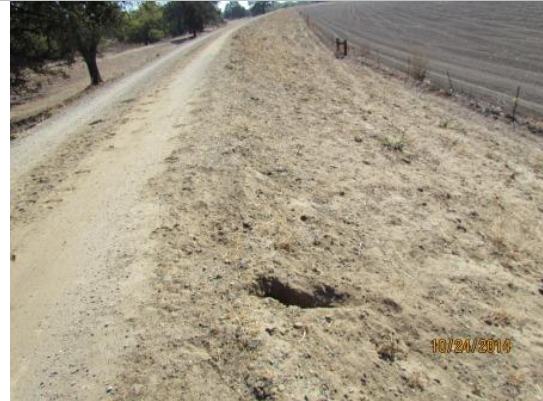
Photo 1 of 1 : FA_2015_RD1602_110_44_20150911_00022.jpg

A rodent hole was found on the landside shoulder of the levee looking upstream.

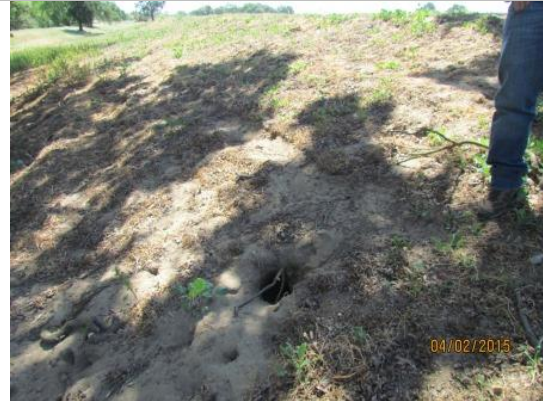
Photo 1 of 1 : FA_2015_RD1602_110_57_20150911_00035.jpg

Rodent holes were found on the waterside of the levee looking upstream.

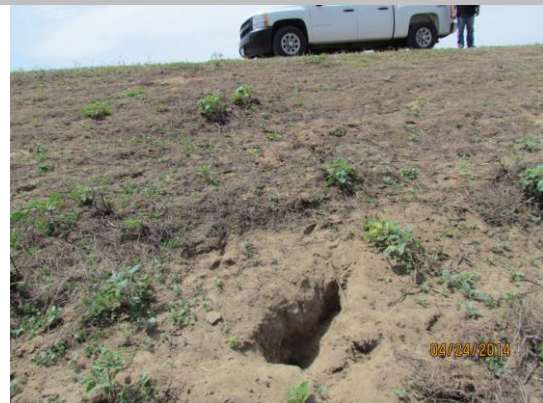
Photo 1 of 1 : FA_2015_RD1602_110_191_20150911_00071.jpg

A rodent hole was found on the waterside toe of the levee looking downstream.

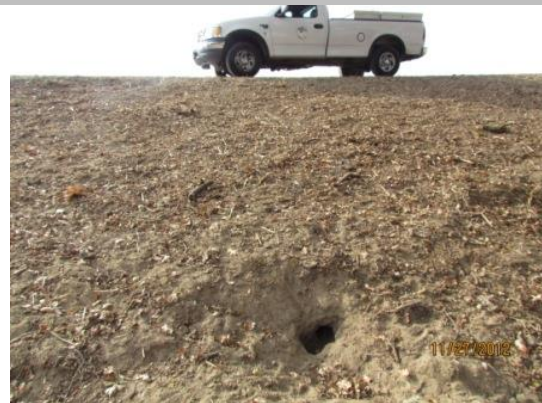
Photo 1 of 1 : FA_2015_RD1602_110_52_20150911_00029.jpg

A rodent hole was found on the waterside toe of the levee looking downstream.

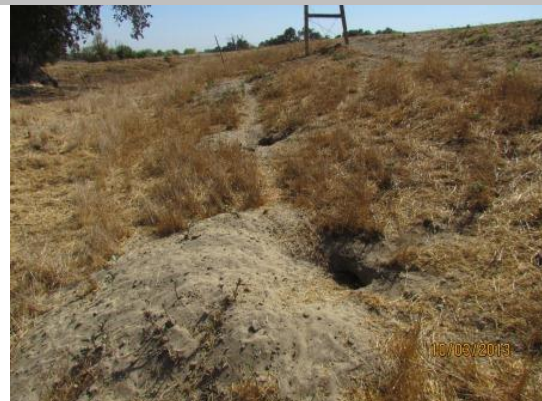
Photo 1 of 2 : FA_2015_RD1602_110_109_20150911_00068.jpg

Updated pictures of rodent holes were found on the waterside toe of the levee looking upstream.

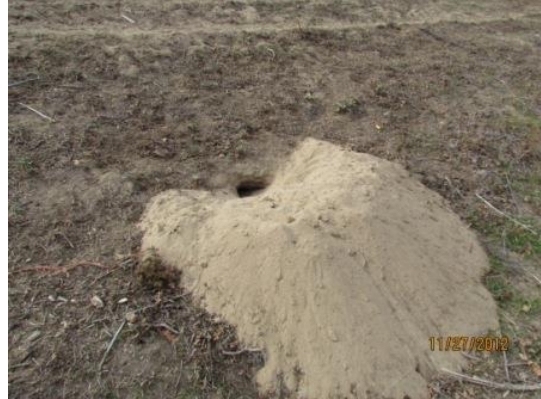
Photo 2 of 2 : FA_2015_RD1602_110_109_20150911_00069.jpg

A rodent hole was found on the waterside toe of the levee looking downstream.

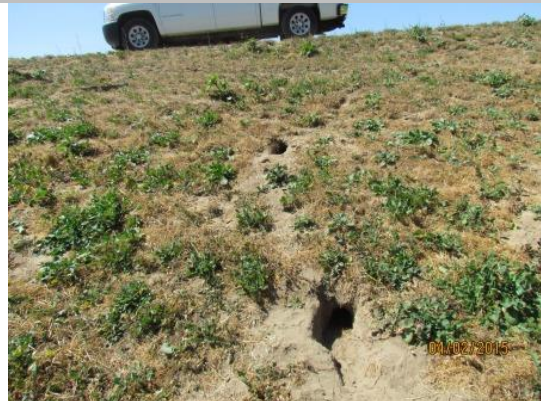
Photo 1 of 1 : FA_2015_RD1602_110_60_20150911_00037.jpg

Animal holes were found on the waterside slope of the levee looking upstream.

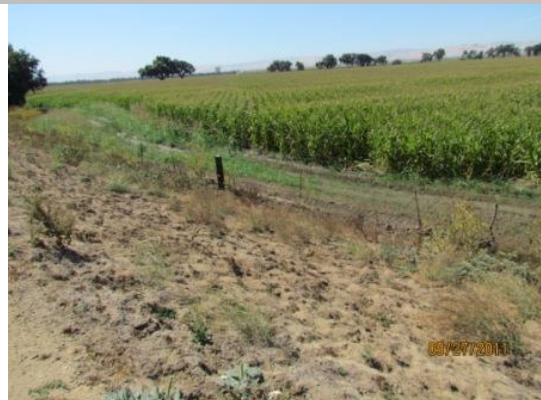
Photo 1 of 1 : FA_2015_RD1602_110_67_20150911_00046.jpg

View of the fence on the landside toe of the levee. The picture was taken from the crown looking upstream.

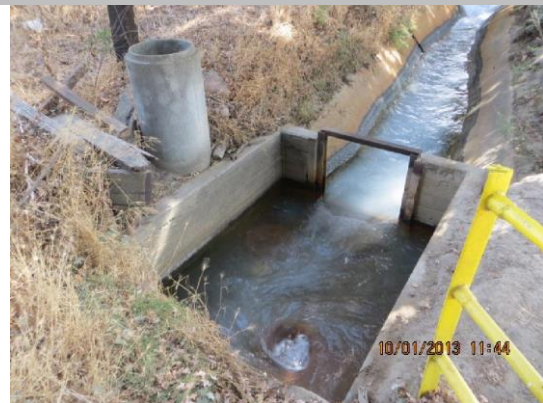
Photo 1 of 3 : UCIP_FA_2015_0558.jpg

Concrete ditch at outlet from pipe on LS toe.

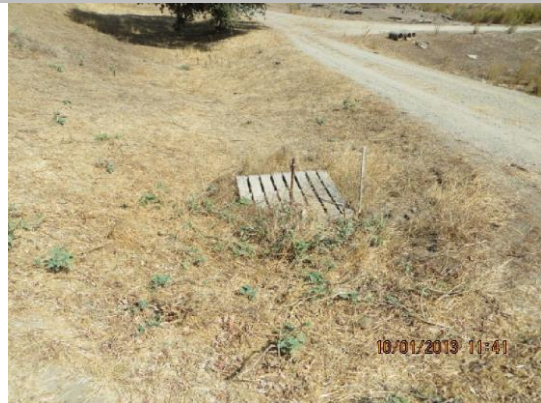
Photo 3 of 3 : UCIP_FA_2015_0560.jpg

Slide gate in CMP riser on WS slope.

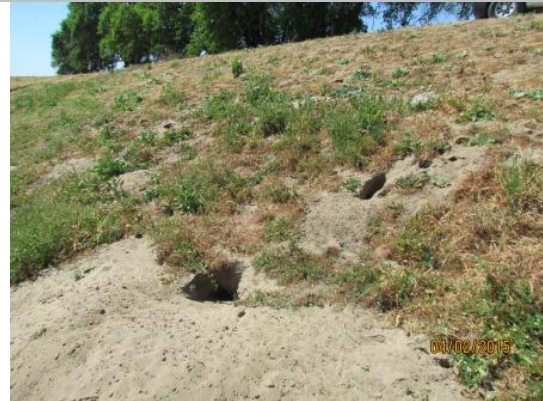
Photo 1 of 1 : FA_2015_RD1602_110_68_20150911_00047.jpg

A number of rodent holes were found on the waterside slope of the levee looking upstream.

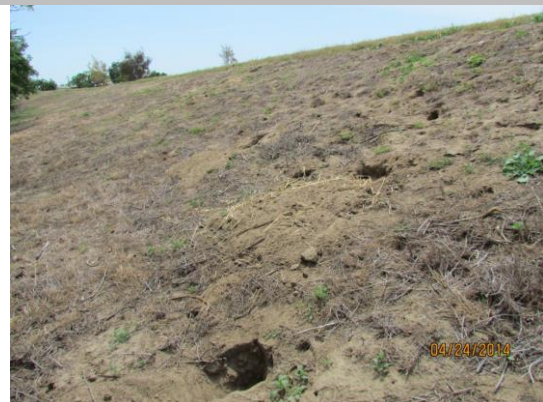
Photo 1 of 1 : FA_2015_RD1602_110_199_20150911_00073.jpg

Rodent holes were found on the waterside toe of the levee looking upstream.

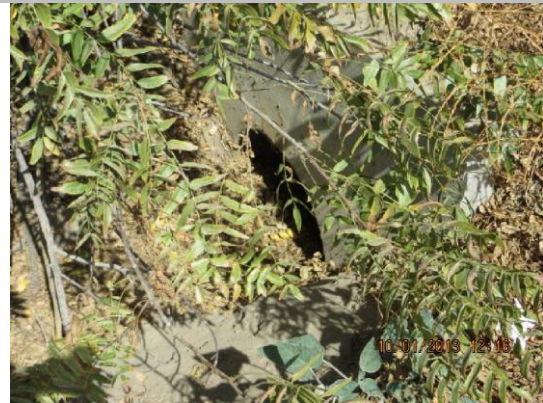
Photo 1 of 3 : UCIP_FA_2015_0561.jpg

Concrete headwall at inlet on LS toe.

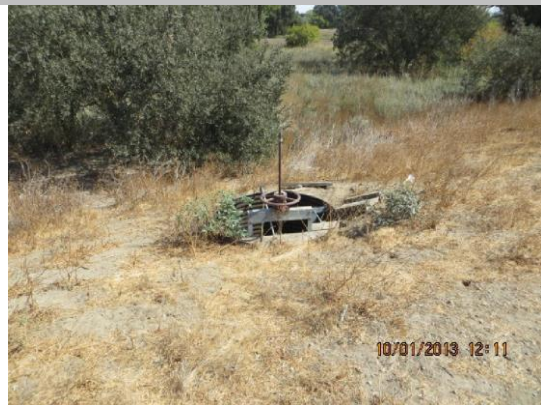
Photo 3 of 3 : UCIP_FA_2015_0563.jpg

Slide gate in CMP riser on WS slope. Outlet visible under tree in background.

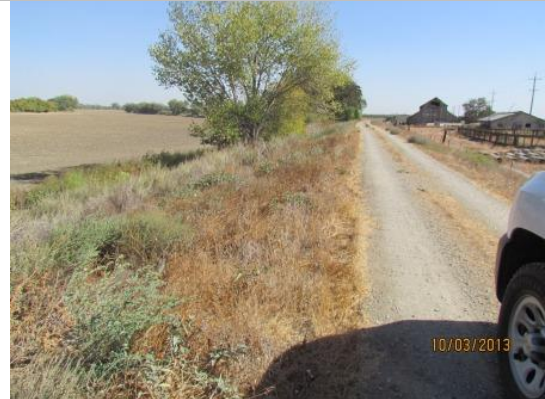
Photo 1 of 2 : FA_2015_RD1602_110_75_20150911_00054.jpg

Vegetation was found on the waterside slope of the levee looking upstream during fall 2013 inspection.

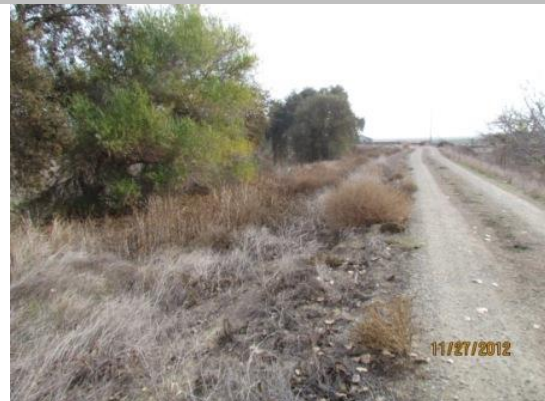
Photo 2 of 2 : FA_2015_RD1602_110_75_20150911_00055.jpg

Overgrown vegetation was found on the waterside slope of the levee looking upstream.

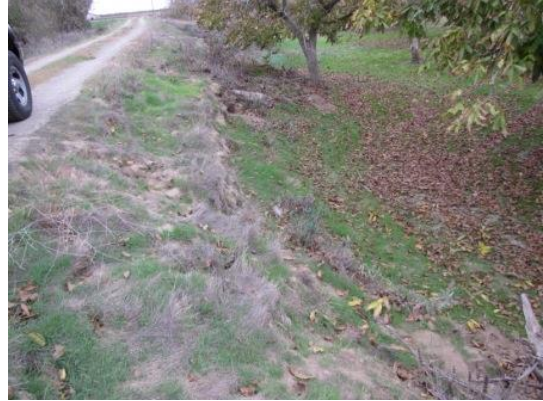
Photo 1 of 1 : FA_2015_RD1602_110_102_20150911_00065.jpg

View of significant damage and erosion to the landward slope looking upstream.

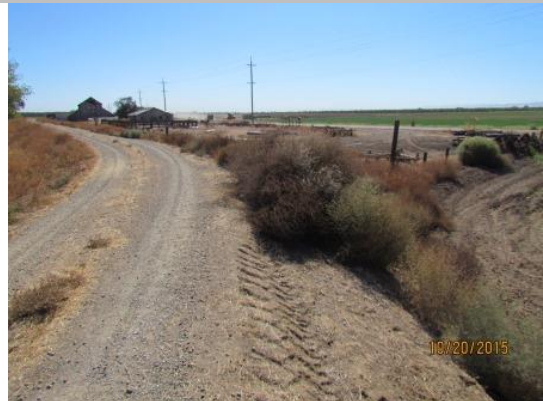
Photo 1 of 1 : FA_2015_RD1602_110_61_20151023_00098.jpg

Vegetation was obstructing the view of the landside of the levee.

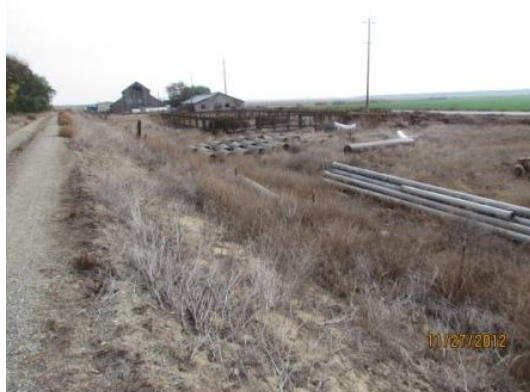
Photo 1 of 1 : FA_2015_RD1602_110_22_20150911_00009.jpg

A fence was found on the landside toe of the levee looking upstream.

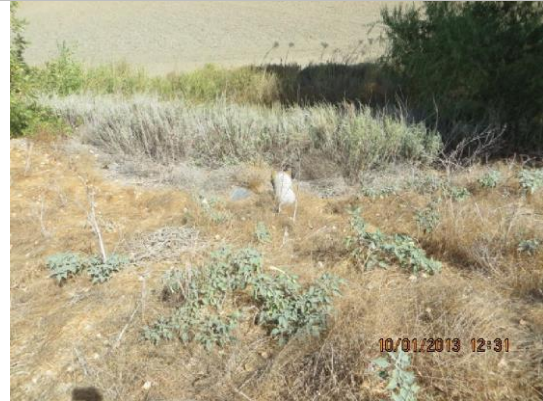
Photo 1 of 1 : UCIP_FA_2015_0720.jpg

Pipe and flapgate visible on WS toe.

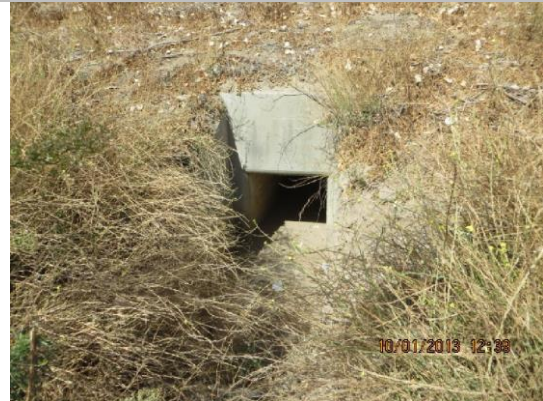
Photo 1 of 3 : UCIP_FA_2015_0725.jpg

Concrete U-shaped headwall on LS toe.

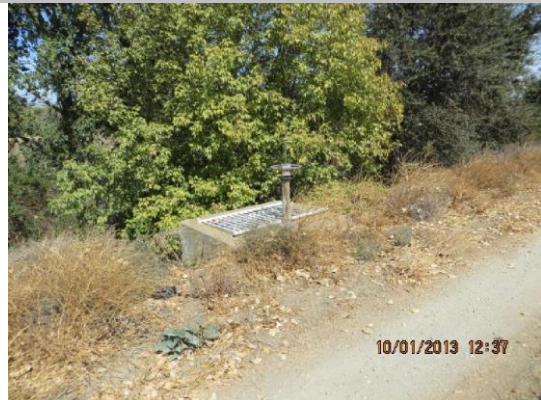
Photo 3 of 3 : UCIP_FA_2015_0727.jpg

Slide gate in concrete riser on WS shoulder.

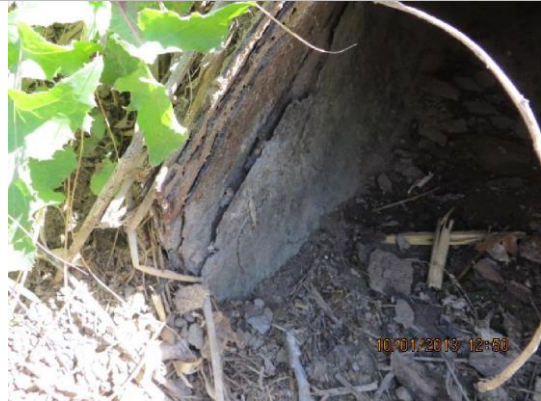
Photo 1 of 3 : UCIP_FA_2015_0728.jpg

Pipe deteriorated on LS at outlet.

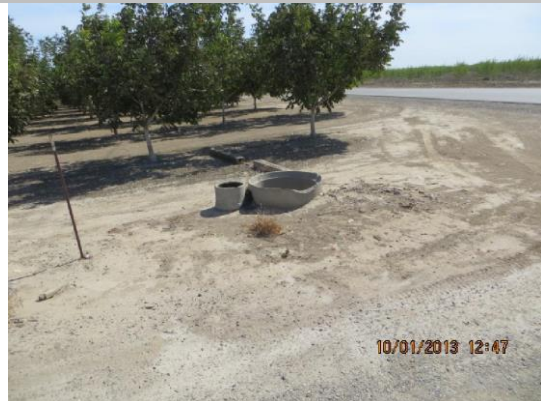
Photo 2 of 3 : UCIP_FA_2015_0729.jpg

36-inch concrete standpipe on WS shoulder.

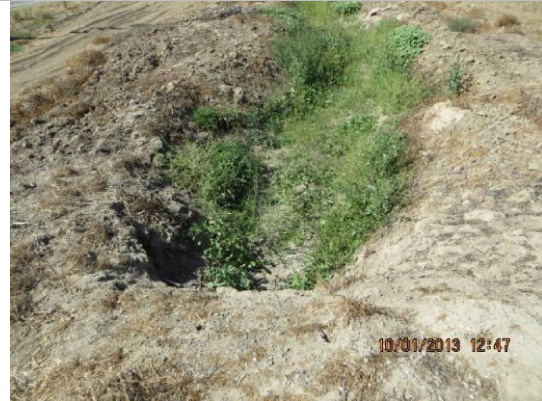
Photo 3 of 3 : UCIP_FA_2015_0730.jpg

Drainage/irrigation canal on LS toe.
