**Flood Control Project Maintenance  
Levee Inspections**

**Fall 2016 Levee Maintenance Deficiency Summary Report**

***San Joaquin River Basin***

**Reclamation District No. 1602 Del Puerto**

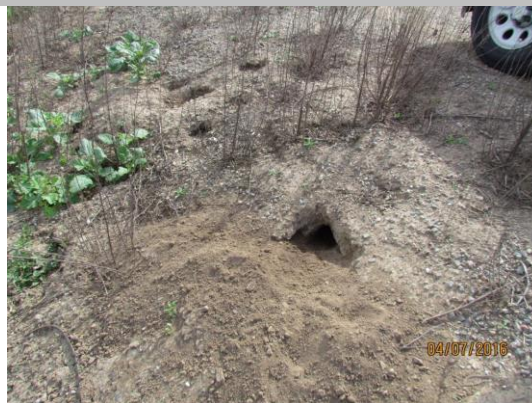
Photo 1 of 2 : FA\_2016\_RD1602\_110\_28\_20160823\_00009.jpg

Updated picture of the rodent hole on the waterside of the levee during spring 2016 inspection.

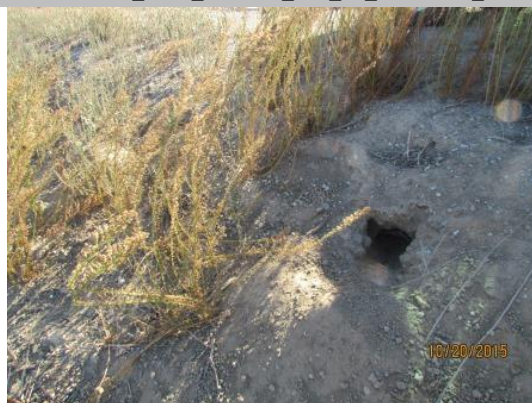
Photo 2 of 2 : FA\_2016\_RD1602\_110\_28\_20160823\_00010.jpg

LM Start	<b>0.20</b>	Rating **	M	Issue No.	<b>28 (cont)</b>
LM End	<b>0.20</b>	Issue Type +	Ma	Location *	WS

A rodent hole was found on the waterside of the levee.

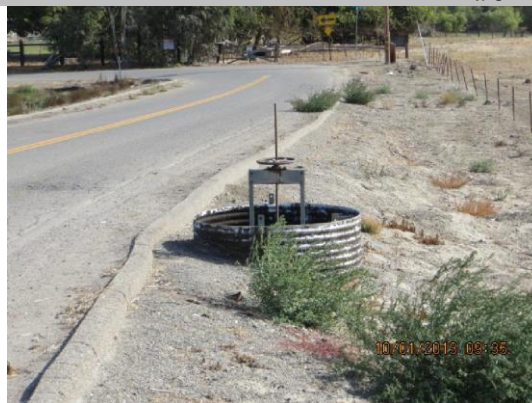
Photo 1 of 2 : UCIP\_FA\_2016\_21623\_36702.jpg

LM Start	0.58	Rating **	U	Issue No.	204
LM End	0.58	Issue Type +	En	Location *	WS
Category	Supplemental			GPS Latitude/Longitude	
				Start	End
Item	DWR UCIP Field Study			37.480182 °	37.480182 °
				-121.074765 °	-121.074765 °
DWR ID					
Comment Code					
Inspector Comment					
FS_ID:21623					
DS_ID:20215					
EP_NO: N/A					
Repair Type: Urgent					
Crossing Status: Found					
UCIP Comments: Open 60-inch CMP riser on WS needs lid as it's depth may be a hazard to the public.					
FIELD_STRUCT_DESC: 16-inch pipe through levee 11.3 feet below crown. Slide gate in 60-inch corrugated metal pipe riser on the waterward side. Concrete inlet 110-feet west of the levee crown. Originally included in 1964 O&M manual.					
FS Date: 10/1/2013 7:57:22 AM

60-inch CMP riser on WS shoulder.

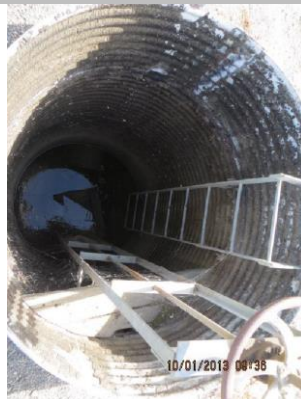
Photo 2 of 2 : UCIP\_FA\_2016\_21623\_36701.jpg

LM Start	0.58	Rating **	U	Issue No.	204 (cont)	
LM End	0.58	Issue Type +	En	Location *	WS	
Category	Supplemental			GPS Latitude/Longitude		
				Start	End	
Item	DWR UCIP Field Study			37.480182 °	37.480182 °	
				-121.074765 °	-121.074765 °	
DWR ID						
Comment Code						
Inspector Comment						
FS_ID:21623						
DS_ID:20215						
EP_NO: N/A						
Repair Type: Urgent						
Crossing Status: Found						
UCIP Comments: Open 60-inch CMP riser on WS needs lid as it's depth may be a hazard to the public.						
FIELD_STRUCT_DESC: 16-inch pipe through levee 11.3 feet below crown. Slide gate in 60-inch corrugated metal pipe riser on the waterward side. Concrete inlet 110-feet west of the levee crown. Originally included in 1964 O&M manual.						
FS Date: 10/1/2013 7:57:22 AM

CMP riser with slide gate on WS shoulder.

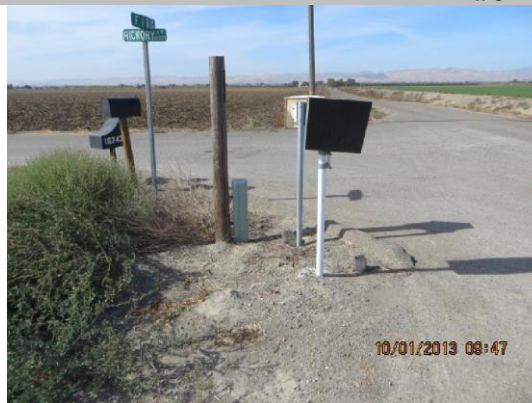
Photo 1 of 2 : UCIP\_FA\_2016\_22937\_39050.jpg

LM Start	0.58	Rating **	M	Issue No.	208
LM End	0.58	Issue Type +	En	Location *	WS
Category	Supplemental			GPS Latitude/Longitude	
				Start	End
Item	DWR UCIP Field Study			37.480176 °	37.480176 °
				-121.074736 °	-121.074736 °
DWR ID					
Comment Code					
Inspector Comment					
FS_ID:22937					
DS_ID:24681					
EP_NO: N/A					
Repair Type: Non-Urgent					
Crossing Status: Found					
UCIP Comments: No permit identified for this crossing.					
FIELD_STRUCT_DESC: Communication line through the levee at an unknown depth.					
FS Date: 10/1/2013

Communication line access box on LS shoulder.

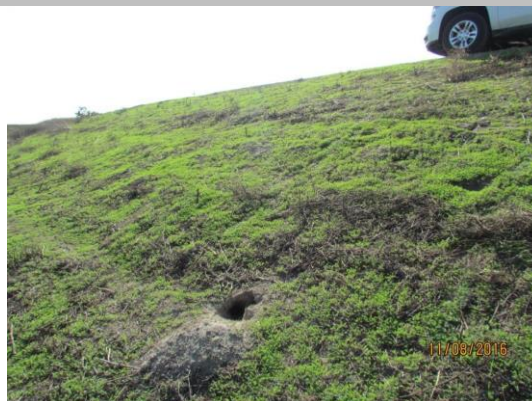
Photo 1 of 1 : FA\_2016\_RD1602\_110\_21\_20161109\_00075.jpg

View of a rodent holes on the waterside of the levee. Fall 2016

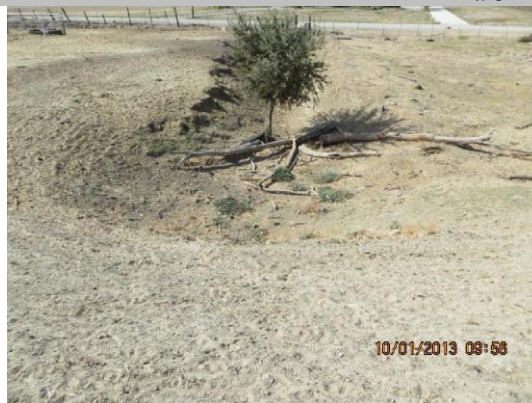
Photo 1 of 2 : UCIP\_FA\_2016\_43084\_36723.jpg

LM Start	0.77	Rating **	U	Issue No.	211
LM End	0.77	Issue Type +	En	Location *	WS
Category	Supplemental			GPS Latitude/Longitude	
				Start	End
Item	DWR UCIP Field Study			37.477993 °	37.477993 °
				-121.072645 °	-121.072645 °
DWR ID					
Comment Code					
Inspector Comment					
FS_ID:43084 DS_ID:20216 EP_NO: N/A Repair Type: Urgent Crossing Status: Found UCIP Comments: Flap gate blocked from functioning by soil buildup on WS toe. Soil should be cleared. FIELD_STRUCT_DESC: 30-inch square reinforced concrete box culvert through levee 14.4 feet below crown. Concrete "U" headwall on both ends. Slide gate in 6'X7' concrete surge box on the waterward shoulder. Flap gate on the waterward end. Originally included in 1964 O&M manual. FS Date: 10/1/2013

Inlet on LS toe.

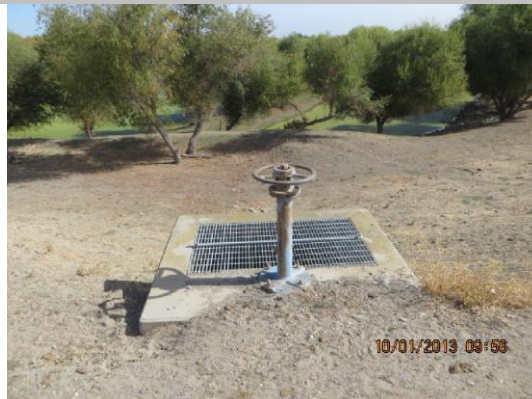
Photo 2 of 2 : UCIP\_FA\_2016\_43084\_36722.jpg

LM Start	0.77	Rating **	U	Issue No.	211 (cont)	
LM End	0.77	Issue Type +	En	Location *	WS	
Category	Supplemental			GPS Latitude/Longitude		
				Start	End	
Item	DWR UCIP Field Study			37.477993 °	37.477993 °	
				-121.072645 °	-121.072645 °	
DWR ID						
Comment Code						
Inspector Comment						
FS_ID:43084						
DS_ID:20216						
EP_NO: N/A						
Repair Type: Urgent						
Crossing Status: Found						
UCIP Comments: Flap gate blocked from functioning by soil buildup on WS toe. Soil should be cleared.						
FIELD_STRUCT_DESC: 30-inch square reinforced concrete box culvert through levee 14.4 feet below crown. Concrete "U" headwall on both ends. Slide gate in 6'X7' concrete surge box on the waterward shoulder. Flap gate on the waterward end. Originally included in 1964 O&M manual.						
FS Date: 10/1/2013

Slide gate in concrete box on WS shoulder.

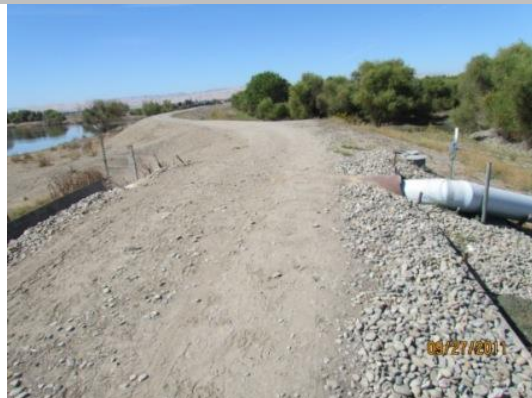
Photo 1 of 1 : FA\_2016\_RD1602\_110\_36\_20160823\_00014.jpg

LM Start	1.00	Rating **	M	Issue No.	36
LM End	1.00	Issue Type +	En	Location *	WS
Category	Earthen Levee			GPS Latitude/Longitude	
				Start	End
Item	Encroachments			37.478810 °	37.478810 °
				-121.068738 °	-121.068738 °
DWR ID	DWR_RD1602_01_s_2012_36				
Comment Code					
RA : Ramp					
Inspector Comment

View of the ramp on the crown. The picture was taken from crown looking downstream.

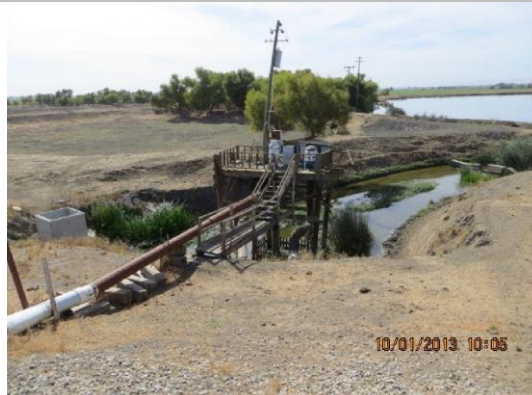
Photo 1 of 2 : UCIP\_FA\_2016\_21639\_36758.jpg

LM Start	1.00	Rating **	U	Issue No.	205
LM End	1.00	Issue Type +	En	Location *	WS
Category	Supplemental			GPS Latitude/Longitude	
				Start	End
Item	DWR UCIP Field Study			37.478816 °	37.478816 °
				-121.068780 °	-121.068780 °
DWR ID					
Comment Code					
Inspector Comment					
FS_ID:21639 DS_ID:20217 EP_NO: N/A Repair Type: Urgent Crossing Status: Found UCIP Comments: Appears abandoned and if so should be done so properly. Flapgate missing. FIELD_STRUCT_DESC: *ABANDONED* 1 of 2: 16-inch pipe through levee 17.0 feet below crown. Pumps on pump platform on the landward side. Siphon breaker in 24-inch CMP risers on the waterward shoulder. Concrete "U" headwall and flap gate on the waterward end. Originally included in 1964 O&M manual. FS Date: 10/1/2013

Pumping plant on LS toe. Pipe visible under walkway.

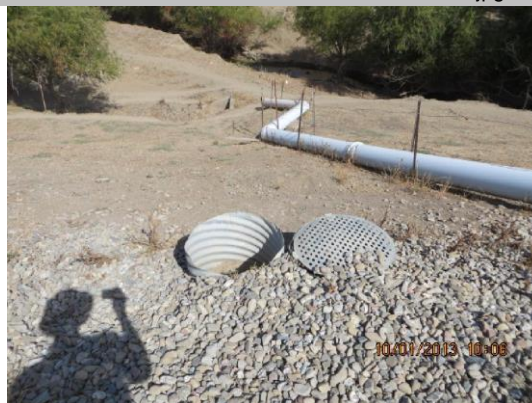
Photo 2 of 2 : UCIP\_FA\_2016\_21639\_36757.jpg

Siphon breaker in 24-inch CMP riser on WS shoulder.

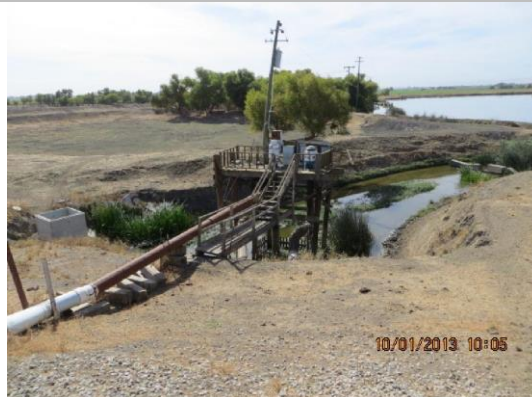
Photo 1 of 2 : UCIP\_FA\_2016\_21642\_36772.jpg

LM Start	1.00	Rating **	U	Issue No.	206
LM End	1.00	Issue Type +	En	Location *	WS
Category	Supplemental			GPS Latitude/Longitude	
				Start	End
Item	DWR UCIP Field Study			37.478817 °	37.478817 °
				-121.068773 °	-121.068773 °
DWR ID					
Comment Code					
Inspector Comment					
FS_ID:21642 DS_ID:20219 EP_NO: N/A Repair Type: Urgent Crossing Status: Found UCIP Comments: Appears abandoned siphon breakers covered in soil and flapgate missing. FIELD_STRUCT_DESC: *ABANDONED* 2 of 2: 16-inch pipe through levee 17.0 feet below crown. Pumps on pump platform on the landward side. Siphon breakers in 24-inch risers on the waterward shoulder. Concrete "U" headwall and flap gate on the waterward end. Originally included in 1964 O&M manual. FS Date: 10/1/2013

Pipe visible under walkway at puming plant on LS toe.

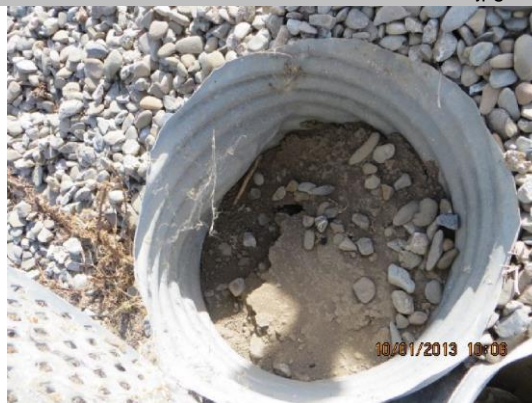
Photo 2 of 2 : UCIP\_FA\_2016\_21642\_36771.jpg

LM Start	<b>1.00</b>	Rating **	<b>U</b>	Issue No.	<b>206 (cont)</b>
LM End	<b>1.00</b>	Issue Type +	<b>En</b>	Location *	<b>WS</b>

Siphon breaker covered in soil at CMP riser on WS shoulder.

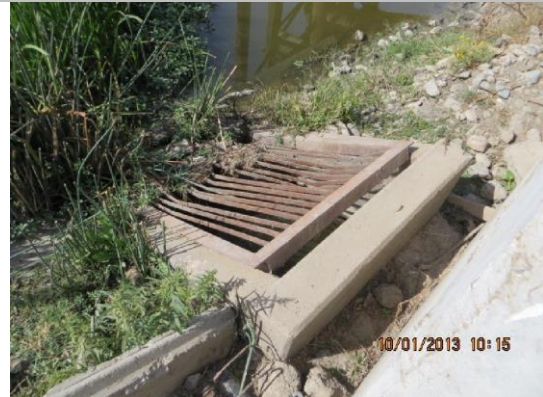
Photo 2 of 2 : UCIP\_FA\_2016\_41771\_36785.jpg

Grated inlet at LS toe.

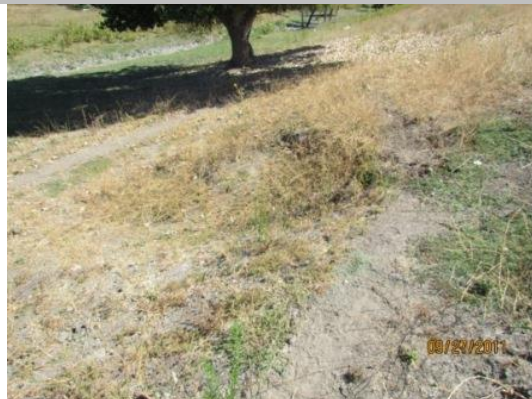
Photo 1 of 2 : FA\_2016\_RD1602\_110\_37\_20160823\_00015.jpg

LM Start	1.05	Rating **	M	Issue No.	37
LM End	1.05	Issue Type +	Ma	Location *	WS
Category	Earthen Levee			GPS Latitude/Longitude	
				Start	End
Item	Slope Stability			37.478567 °	37.478567 °
				-121.067847 °	-121.067847 °
DWR ID	DWR_RD1602_01_s_2012_37				
Comment Code					
S1 : Repair slope instability.					
Inspector Comment					
Small amount of slumping at waterside toe of the levee.

Updated picture of the depression at the waterside toe of the levee. The picture was taken from the crown of the levee looking upstream.

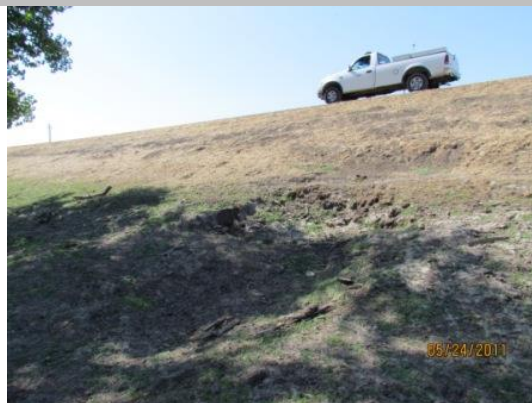
Photo 2 of 2 : FA\_2016\_RD1602\_110\_37\_20160823\_00016.jpg

Depression at the waterside slope of the levee during Spring 2011 inspection.

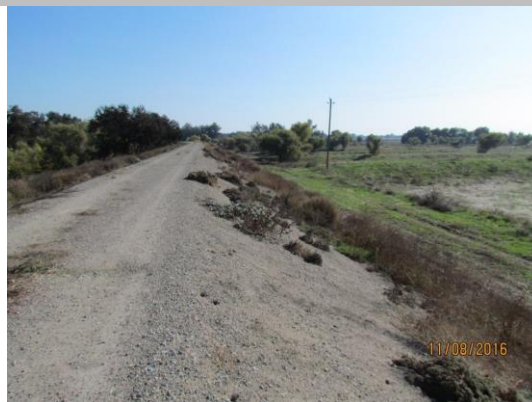
Photo 1 of 1 : FA\_2016\_RD1602\_110\_23\_20161109\_00076.jpg

LM Start	1.06	Rating **	M	Issue No.	23
LM End	1.49	Issue Type +	Ma	Location *	LS
Category	Earthen Levee			GPS Latitude/Longitude	
				Start	End
Item	Vegetation			37.478525 °	37.478702 °
				-121.067700 °	-121.060421 °
DWR ID	DWR_RD1602_01_f_2016_23				
Comment Code					
V1 : Control annual grass and weeds on the levee slopes and easements.					
Inspector Comment

View of the landside slope of the levee. Fall 2016

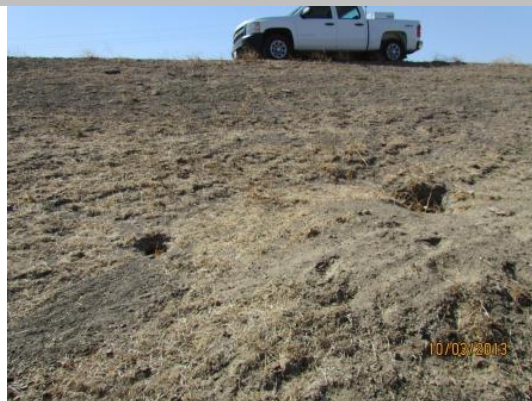
Photo 1 of 2 : FA\_2016\_RD1602\_110\_11\_20160823\_00002.jpg

Rodent holes were found on the waterside slope of the levee looking downstream. Fall 2013

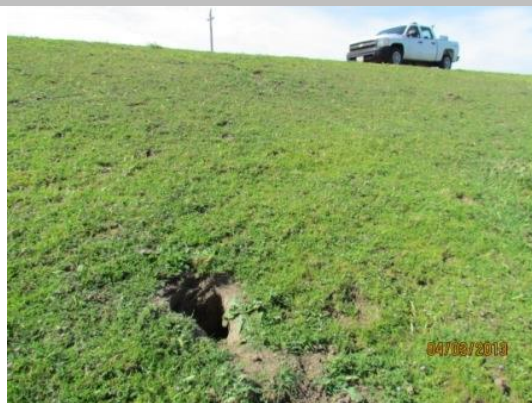
Photo 2 of 2 : FA\_2016\_RD1602\_110\_11\_20160823\_00003.jpg

LM Start	<b>1.11</b>	Rating **	M	Issue No.	<b>11 (cont)</b>
LM End	<b>1.11</b>	Issue Type +	Ma	Location *	WS

A rodent hole was found on the waterside toe of the levee looking downstream.

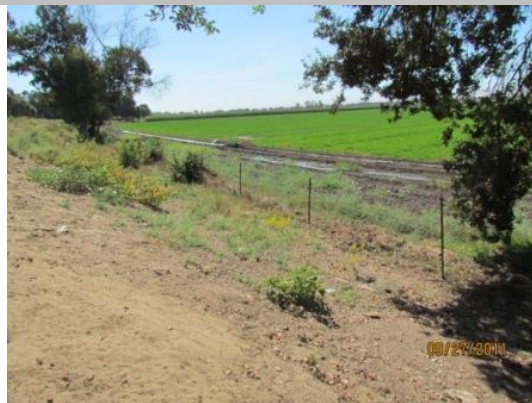
Photo 1 of 1 : FA\_2016\_RD1602\_110\_43\_20160823\_00018.jpg

View of the fence on the landside toe of the levee. The picture was taken from crown looking upstream.

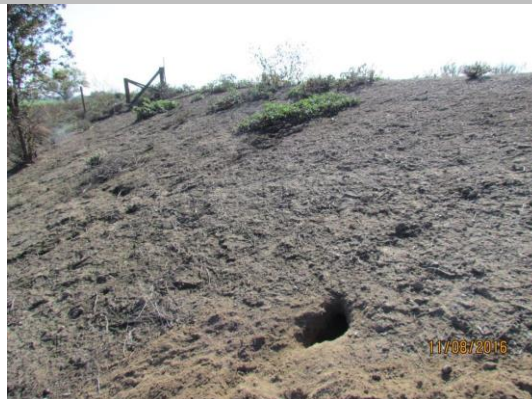
Photo 1 of 1 : FA\_2016\_RD1602\_110\_41\_20161109\_00081.jpg

View of rodent holes on the waterside slope of the levee. Fall 2016

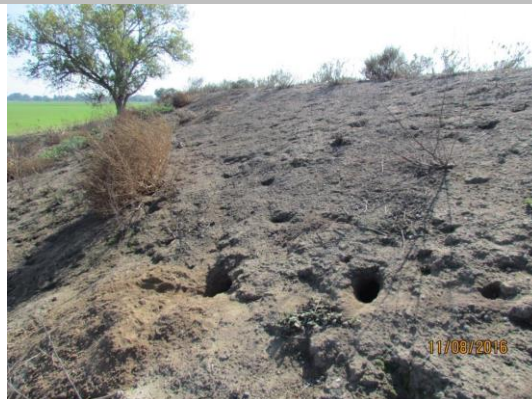
Photo 1 of 1 : FA\_2016\_RD1602\_110\_47\_20161109\_00082.jpg

View of rodent holes on the waterside of the levee. Fall 2016

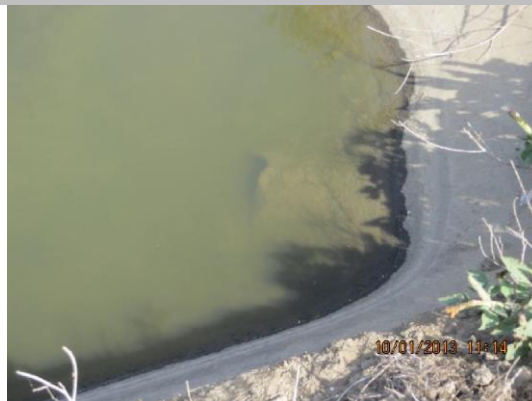
Photo 1 of 2 : UCIP\_FA\_2016\_21652\_36805.jpg

LM Start	3.27	Rating **	U	Issue No.	207
LM End	3.27	Issue Type +	En	Location *	WS
Category	Supplemental			GPS Latitude/Longitude	
				Start	End
Item	DWR UCIP Field Study			37.461507°	37.461507°
				-121.041609°	-121.041609°
DWR ID					
Comment Code					
Inspector Comment					
FS_ID:21652 DS_ID:20204 EP_NO: 8193 Repair Type: Urgent Crossing Status: Found UCIP Comments: Appears abandoned, and if so should be done so properly. No handle on slide gate, no cover on CMP standpipe on WS shoulder. FIELD_STRUCT_DESC: 16-inch pipe through levee 11.5 feet below crown. Slide gate in 60-inch corrugated metal pipe riser on the waterward slope. Discharge into concrete-lined ditch on the landward side (Permit No. 8193, 1964). Originally included in 1964 O&M manual. FS Date: 10/1/2013

Pipe visible in concrete channel on LS toe.

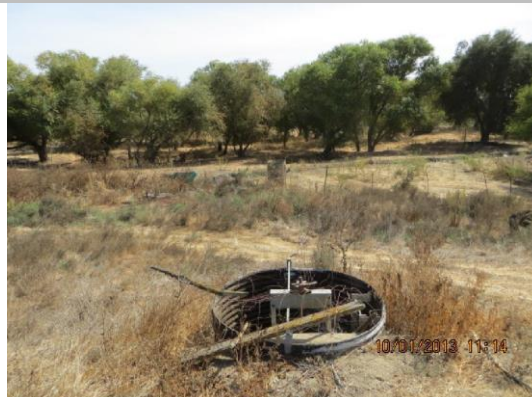
Photo 2 of 2 : UCIP\_FA\_2016\_21652\_36804.jpg

LM Start	<b>3.27</b>	Rating **	U	Issue No.	<b>207 (cont)</b>
LM End	<b>3.27</b>	Issue Type +	En	Location *	WS

Slide gate in 60-inch CMP riser on WS shoulder.

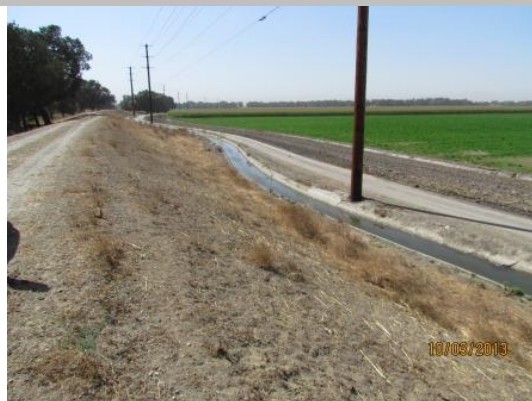
Photo 1 of 1 : FA\_2016\_RD1602\_110\_54\_20160823\_00022.jpg

A concrete lined ditch was found on the landside toe of the levee looking upstream.

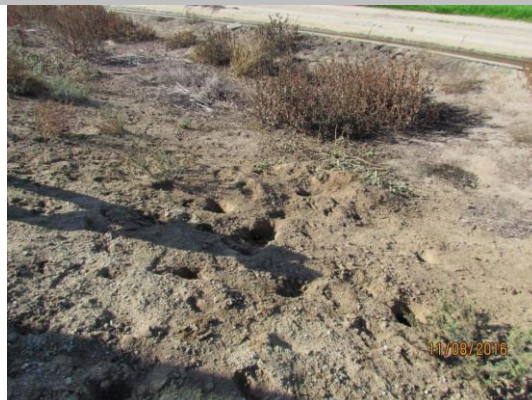
Photo 1 of 1 : FA\_2016\_RD1602\_110\_56\_20161109\_00085.jpg

View of rodent holes on the landside of the levee. Fall 2016

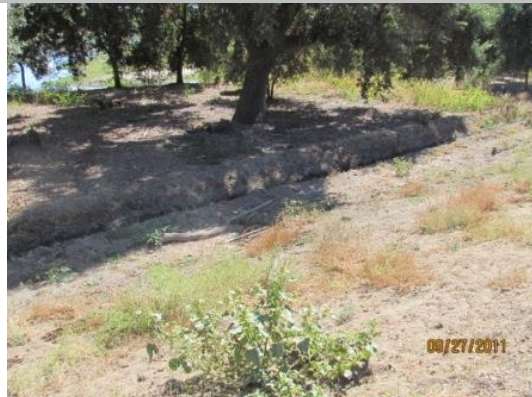
Photo 1 of 1 : FA\_2016\_RD1602\_110\_50\_20160823\_00021.jpg

A ditch was located on the waterside toe of the levee. The picture was taken from the crown looking upstream.

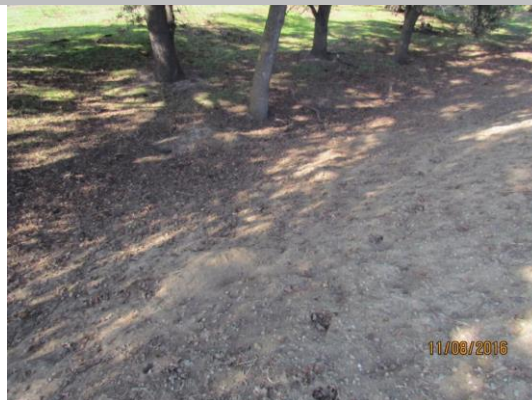
Photo 1 of 1 : FA\_2016\_RD1602\_110\_60\_20161109\_00086.jpg

View of rodent hole on the landside toe of the levee. Fall 2016

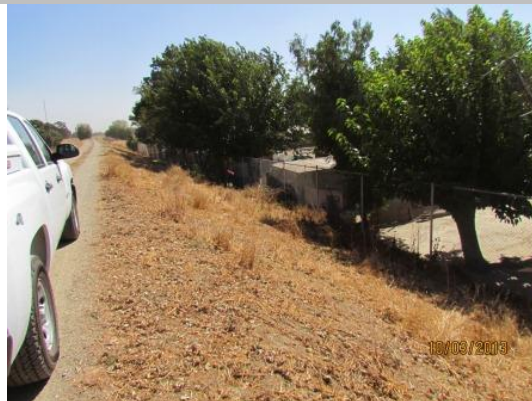
Photo 1 of 1 : FA\_2016\_RD1602\_110\_66\_20160823\_00033.jpg

Fences were found on the landside toe of the levee looking upstream.

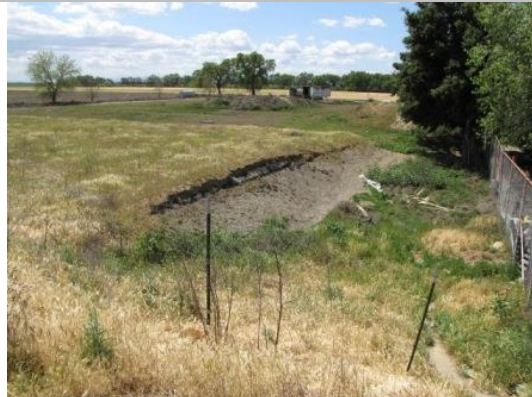
Photo 1 of 1 : FA\_2016\_RD1602\_110\_62\_20160823\_00028.jpg

LM Start	3.93	Rating **	M	Issue No.	62
LM End	3.93	Issue Type +	Ma	Location *	LS
Category	Earthen Levee			GPS Latitude/Longitude	
				Start	End
Item	Slope Stability			37.453216 °	37.453216 °
				-121.042127 °	-121.042127 °
DWR ID	DWR_RD1602_01_s_2012_62				
Comment Code					
S3 : Repair the levee slope damaged by vehicle traffic and prevent access where possible.					
Inspector Comment					
Significant damage to USACE constructed seepage berm due to human activity.

Repair damage to USACE constructed seepage berm by pedestrian and cycle traffic.

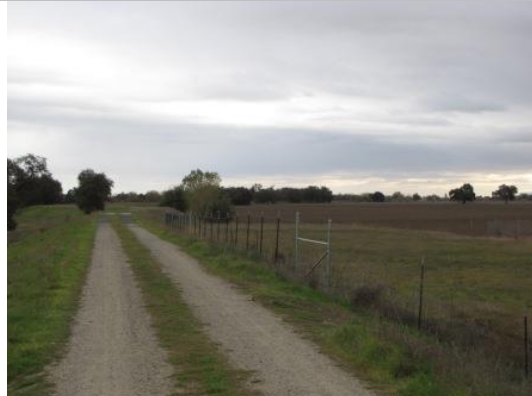
Photo 1 of 1 : FA\_2016\_RD1602\_110\_63\_20160823\_00029.jpg

View of a barbed wire fence on the landward slope looking upstream.

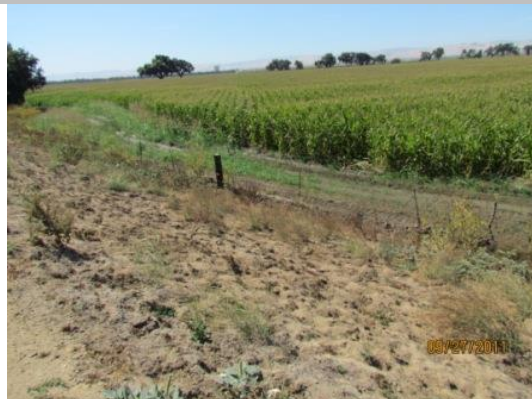
Photo 1 of 1 : FA\_2016\_RD1602\_110\_67\_20160823\_00034.jpg

View of the fence on the landside toe of the levee. The picture was taken from the crown looking upstream.

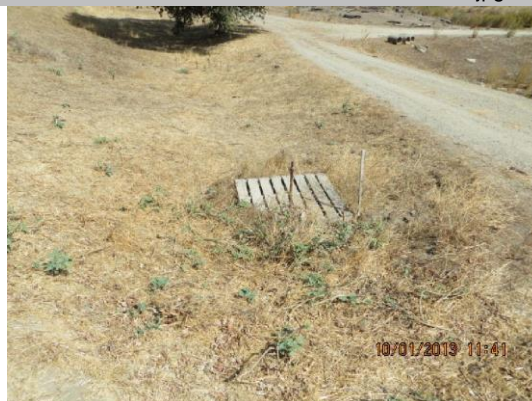
Photo 1 of 2 : UCIP\_FA\_2016\_21657\_36819.jpg

LM Start	4.47	Rating **	U	Issue No.	202
LM End	4.47	Issue Type +	En	Location *	LS
Category	Supplemental			GPS Latitude/Longitude	
				Start	End
Item	DWR UCIP Field Study			37.446545 °	37.446545 °
				-121.037941 °	-121.037941 °
DWR ID					
Comment Code					
Inspector Comment					
FS_ID:21657 DS_ID:20207 EP_NO: 8195 Repair Type: Urgent Crossing Status: Found UCIP Comments: Lid missing from 60-inch CMP riser, may be an attractive nuisance or hazard to public. FIELD_STRUCT_DESC: 18-inch pipe through levee 10.0 feet below crown. Slide gate in 60-inch corrugated metal pipe riser on the waterward slope. Concrete discharge box on landward end. Pipe is buried across waterward berm to pump on the riverbank approximately 1,000 feet from the levee. (Permit No. 8195, 1972). Originally included in 1964 O&M manual. FS Date: 10/1/2013

Slide gate in CMP riser on WS slope.

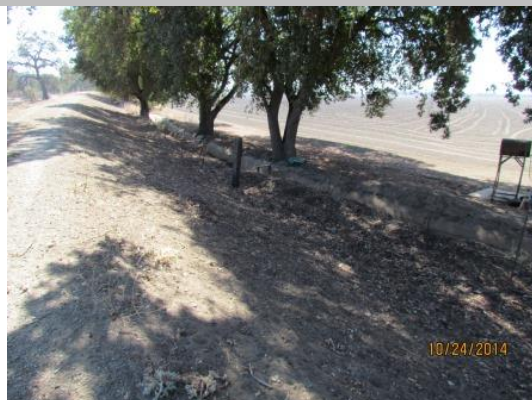
Photo 1 of 1 : FA\_2016\_RD1602\_110\_64\_20160823\_00030.jpg

View of a ditch on the landside toe of the levee looking upstream.

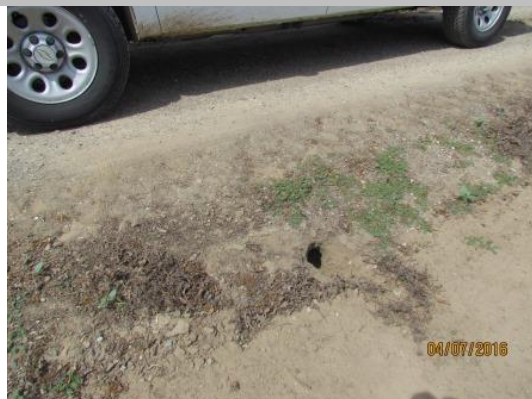
Photo 1 of 1 : FA\_2016\_RD1602\_110\_35\_20160823\_00013.jpg

View of an animal hole on the waterside shoulder of the levee looking downstream.

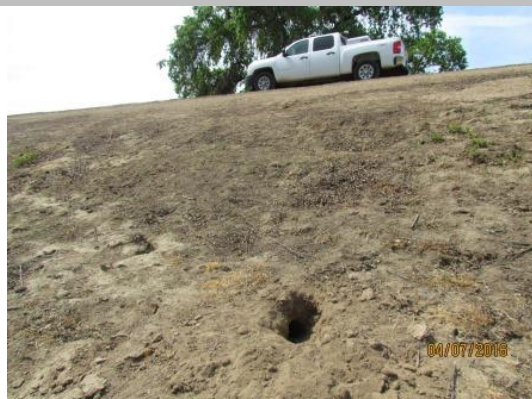
Photo 1 of 1 : FA\_2016\_RD1602\_110\_74\_20160823\_00036.jpg

View of a rodent hole on the waterside toe of the levee.

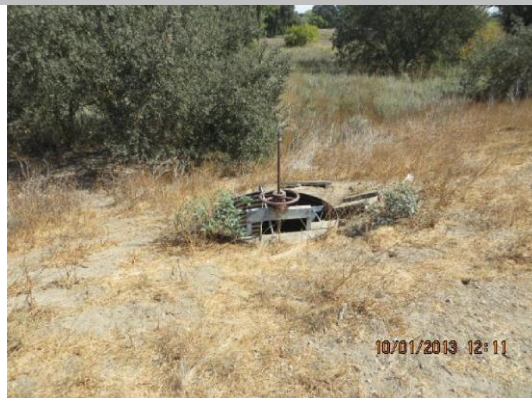
Photo 1 of 2 : UCIP\_FA\_2016\_42983\_36822.jpg

LM Start	5.19	Rating **	U	Issue No.	212
LM End	5.19	Issue Type +	En	Location *	WS
Category	Supplemental			GPS Latitude/Longitude	
				Start	End
Item	DWR UCIP Field Study			37.436748 °	37.436748 °
				-121.036597 °	-121.036597 °
DWR ID					
Comment Code					
Inspector Comment					
FS_ID:42983 DS_ID:20208 EP_NO: N/A Repair Type: Urgent Crossing Status: Found UCIP Comments: Soil and debris prevent flapgate from proper function. Slide gate won't close completely due to sediment buildup. CMP riser needs cover. FIELD_STRUCT_DESC: 24-inch pipe through levee 11.6 feet below crown. Concrete headwall on the landward end. Concrete "U" headwall and flap gate on the waterward end. Slide gate in 60-inch corrugated metal pipe riser on the waterward slope. Originally included in 1964 O&M manual. FS Date: 10/1/2013

Slide gate in CMP riser on WS slope. Outlet visible under tree in background.

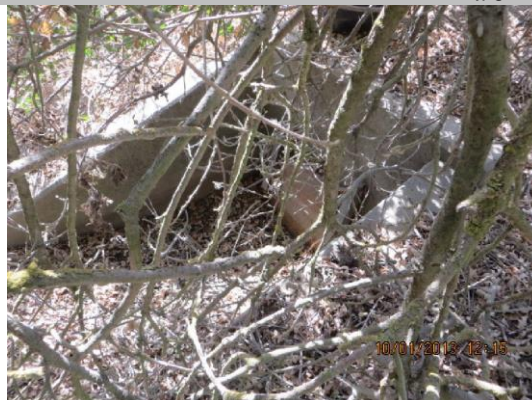
Photo 2 of 2 : UCIP\_FA\_2016\_42983\_36821.jpg

LM Start	<b>5.19</b>	Rating **	U	Issue No.	<b>212 (cont)</b>
LM End	<b>5.19</b>	Issue Type +	En	Location *	WS

Flapgate in Concrete headwall on WS toe under tree.

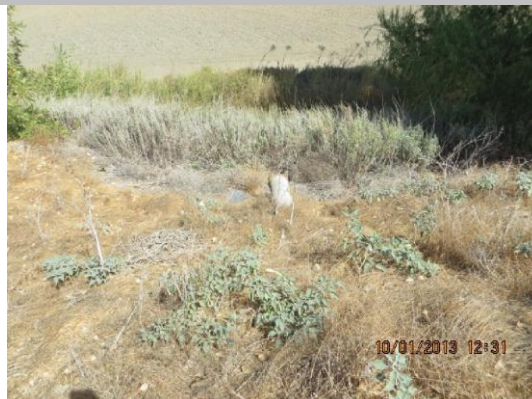
Photo 1 of 1 : UCIP\_FA\_2016\_21674\_36854.jpg

Pipe and flapgate visible on WS toe.

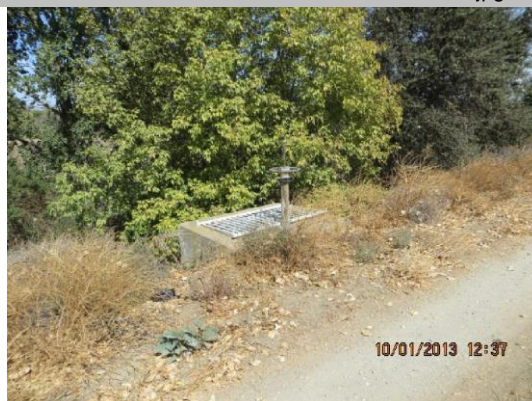
Photo 1 of 2 : UCIP\_FA\_2016\_43100\_36878.jpg

Slide gate in concrete riser on WS shoulder.

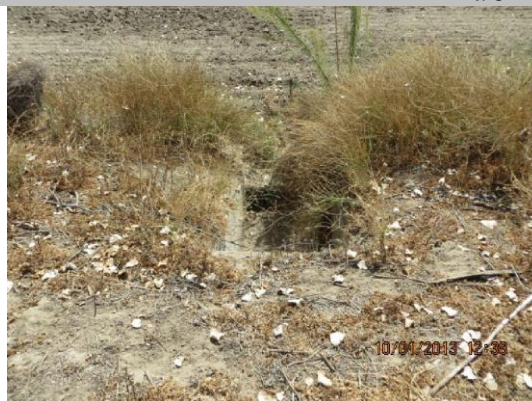
Photo 2 of 2 : UCIP\_FA\_2016\_43100\_36877.jpg

Concrete U-shaped headwall on LS toe.

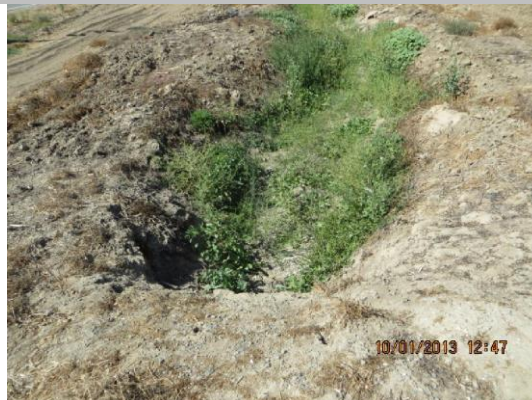
Photo 1 of 2 : UCIP\_FA\_2016\_21683\_36882.jpg

Drainage/irrigation canal on LS toe.

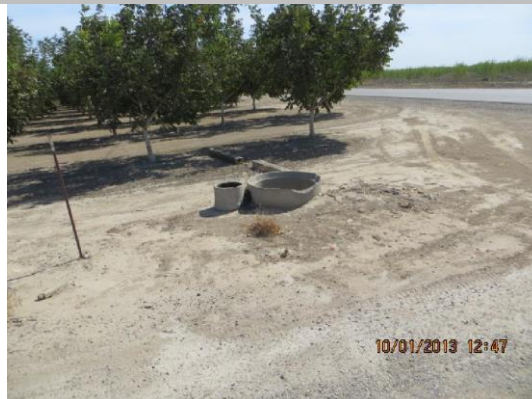
Photo 2 of 2 : UCIP\_FA\_2016\_21683\_36881.jpg

36-inch concrete standpipe on WS shoulder.
