**Flood Control Project Maintenance
Levee Inspections**

Fall 2017 Levee Maintenance Deficiency Summary Report

Reclamation District No. 1602 Del Puerto

Waterway			Bank	Unit Miles
Unit No. 01 San Joaquin River			Left	6.24
	Spring (March - May)	Summer (June - August)	(September - November) Fall	Winter (December - February)
Unit Maintenance Rating (Fall Only)			U	
Date of Inspection	4/6/2017 - 4/6/2017		11/2/2017 - 11/2/2017	
DWR Inspector	Pavel Kazi		Pavel Kazi	
Accompanied By	Tony Martinez RD 1602		Tony Martinez RD 1602

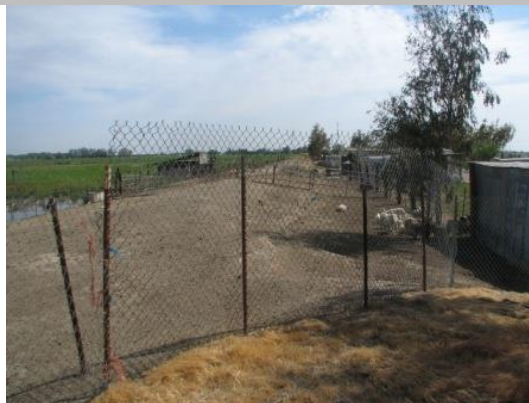
Photo 1 of 1 : FA_2017_RD1602_110_1_20170921_00001.jpg

Looking at animal pens on crown of levee from LM 0.00 to 0.11.

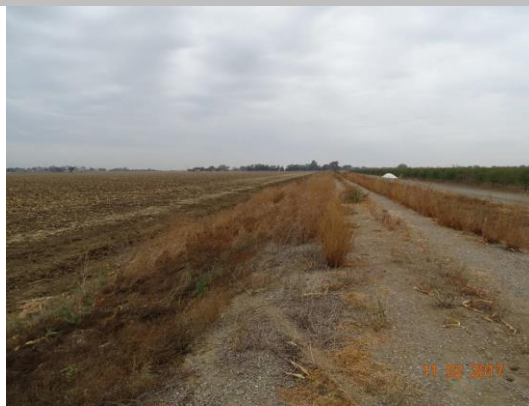
Photo 1 of 1 : FA_2017_RD1602_110_26_20171108_00121.jpg

LM Start	0.14	Rating **	M	Issue No.	26
LM End	1.63	Issue Type +	Ma	Location *	WS
Category	Earthen Levee			GPS Latitude/Longitude	
				Start	End
Item	Vegetation			37.477291 °	37.477498 °
				-121.081613 °	-121.058624 °
DWR ID	DWR_RD1602_01_f_2017_26				
Comment Code					
V1 : Control annual grass and weeds on the levee slopes and easements.					
Inspector Comment

View of the waterside vegetation. Fall 2017

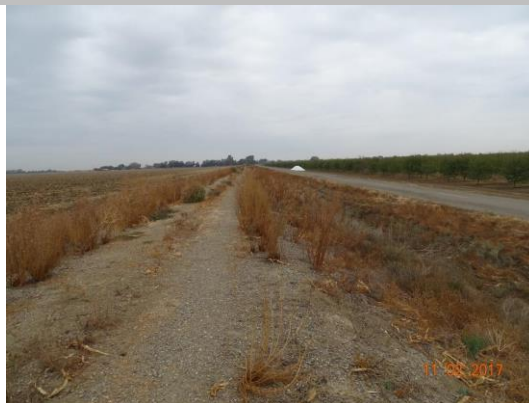
Photo 1 of 1 : FA_2017_RD1602_110_27_20171108_00122.jpg

LM Start	0.14	Rating **	M	Issue No.	27
LM End	1.63	Issue Type +	Ma	Location *	LS
Category	Earthen Levee			GPS Latitude/Longitude	
				Start	End
Item	Vegetation			37.477292 °	37.477499 °
				-121.081613 °	-121.058624 °
DWR ID	DWR_RD1602_01_f_2017_27				
Comment Code					
V1 : Control annual grass and weeds on the levee slopes and easements.					
Inspector Comment

View of the vegetation on the landside of the levee. Fall 2017

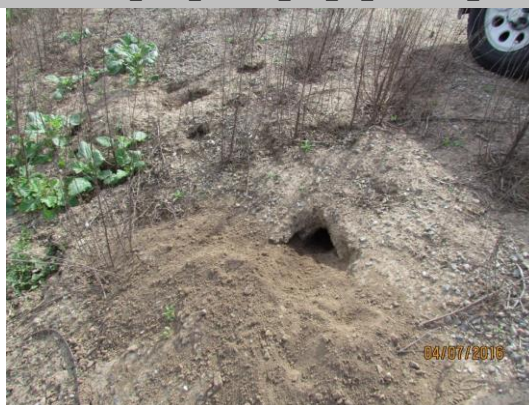
Photo 1 of 2 : FA_2017_RD1602_110_28_20170921_00006.jpg

Updated picture of the rodent hole on the waterside of the levee during spring 2016 inspection.

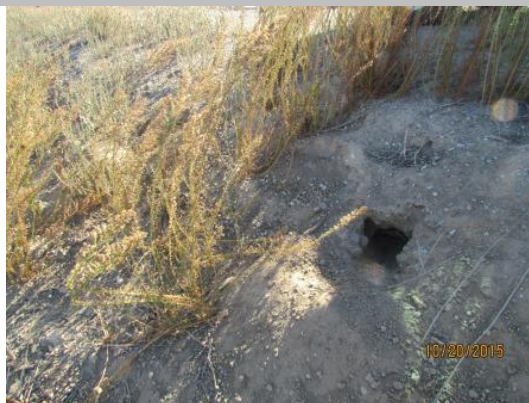
Photo 2 of 2 : FA_2017_RD1602_110_28_20170921_00007.jpg

LM Start	0.20	Rating **	M	Issue No.	28 (cont)
LM End	0.20	Issue Type +	Ma	Location *	WS

A rodent hole was found on the waterside of the levee.

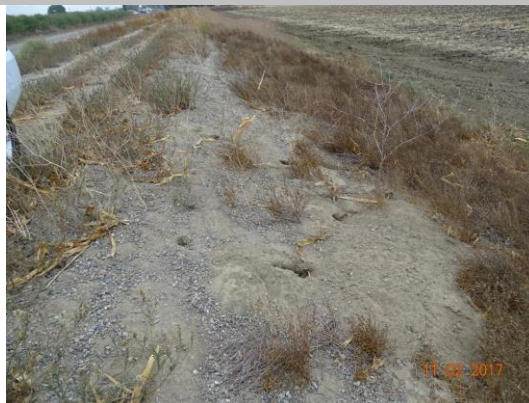
Photo 1 of 1 : FA_2017_RD1602_110_29_20171109_00123.jpg

View of a rodent hole on the waterside of the levee. Fall 2017

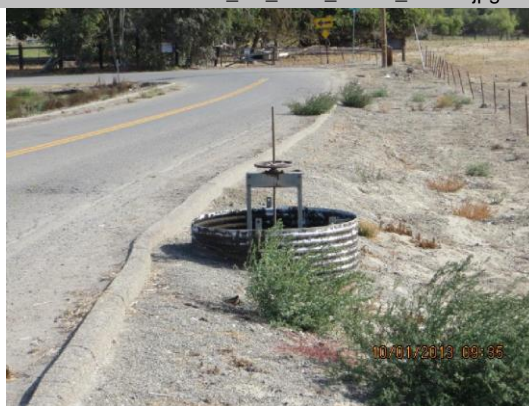
Photo 1 of 3 : UCIP_FA_2017_51325_36702.jpg

FS_ID:51325
DS_ID:20215
EP_NO: N/A
Repair Type: No Action Needed
Crossing Status: Found
UCIP Comments: 11/18/2016 Crossing has been downgraded from Urgent to No Action Needed a cover has been added to the CMP riser. (O. Magana - DWR UCIP)10/01/2013 Open 60-inch CMP riser on WS needs lid as it's depth may be a hazard to the public. (W. Wylie - DWR UCIP)
FIELD_STRUCT_DESC: 16-inch steel drainage pipe through levee, 11.3 feet below crown. Slide gate in 60-inch corrugated metal pipe (CMP) riser located on the waterside (WS). Concrete inlet is approximately 110 feet west of the levee crown or 110 feet off landside (LS) toe next to roadway. [Additional Reference(s): DWR Levee Log, 1992. USACE San Joaquin River O&M Manual Unit 13, April 1964, (HLM 0.58), Drawing No. 7-4-1784].
FS Date: 11/18/2016

60-inch CMP riser on WS shoulder.

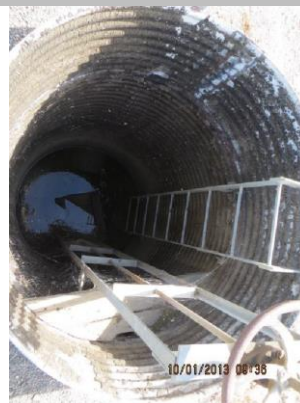
Photo 2 of 3 : UCIP_FA_2017_51325_36701.jpg

CMP riser with slide gate on WS shoulder.

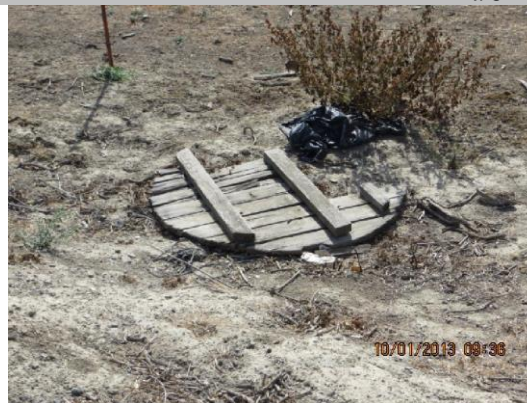
Photo 3 of 3 : UCIP_FA_2017_51325_36700.jpg

Item	DWR UCIP LMA Responsibility			37.480182 °	37.480182 °	
				-121.074765 °	-121.074765 °	
DWR ID						
Comment Code						
Inspector Comment						
FS_ID:51325 DS_ID:20215 EP_NO: N/A Repair Type: No Action Needed Crossing Status: Found UCIP Comments: 11/18/2016 Crossing has been downgraded from Urgent to No Action Needed a cover has been added to the CMP riser. (O. Magana - DWR UCIP)10/01/2013 Open 60-inch CMP riser on WS needs lid as it's depth may be a hazard to the public. (W. Wylie - DWR UCIP) FIELD_STRUCT_DESC: 16-inch steel drainage pipe through levee, 11.3 feet below crown. Slide gate in 60-inch corrugated metal pipe (CMP) riser located on the waterside (WS). Concrete inlet is approximately 110 feet west of the levee crown or 110 feet off landside (LS) toe next to roadway. [Additional Reference(s): DWR Levee Log, 1992. USACE San Joaquin River O&M Manual Unit 13, April 1964, (HLM 0.58), Drawing No. 7-4-1784]. FS Date: 11/18/2016

Damaged Wooden lid on WS toe.

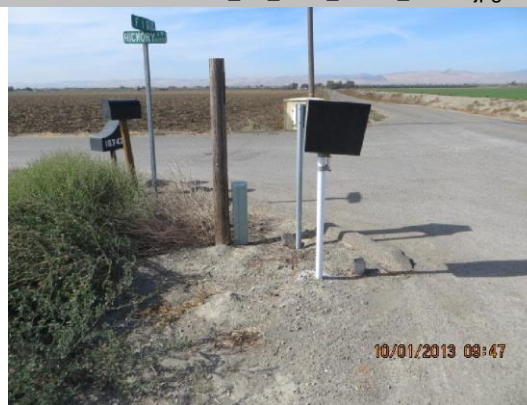
Photo 1 of 3 : UCIP_FA_2017_22937_39050.jpg

LM Start	0.58	Rating **	M	Issue No.	201
LM End	0.58	Issue Type +	En	Location *	
Category	Supplemental			GPS Latitude/Longitude	
				Start	End
Item	DWR UCIP Field Study			37.480176 °	37.480176 °
				-121.074736 °	-121.074736 °
DWR ID					
Comment Code					
Inspector Comment					
FS_ID:22937 DS_ID:24681 EP_NO: N/A Repair Type: Non-Urgent Crossing Status: Found UCIP Comments: No permit identified for this crossing. FIELD_STRUCT_DESC: Communications line of an unknown size or material through the levee, at an unknown depth. FS Date: 10/1/2013

Communication line access box on LS shoulder.

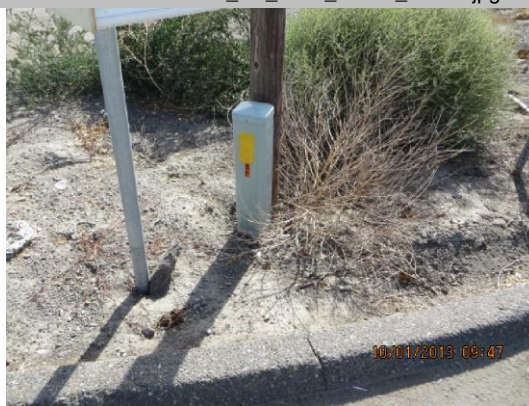
Photo 2 of 3 : UCIP_FA_2017_22937_39049.jpg

LM Start	0.58	Rating **	M	Issue No.	201 (cont)	
LM End	0.58	Issue Type +	En	Location *		
Category	Supplemental			GPS Latitude/Longitude		
				Start	End	
Item	DWR UCIP Field Study			37.480176 °	37.480176 °	
				-121.074736 °	-121.074736 °	
DWR ID						
Comment Code						
Inspector Comment						
FS_ID:22937						
DS_ID:24681						
EP_NO: N/A						
Repair Type: Non-Urgent						
Crossing Status: Found						
UCIP Comments: No permit identified for this crossing.						
FIELD_STRUCT_DESC: Communications line of an unknown size or material through the levee, at an unknown depth.						
FS Date: 10/1/2013

Communication line access box on LS shoulder.

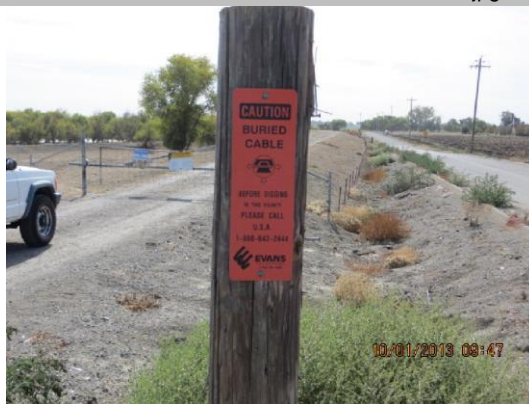
Photo 3 of 3 : UCIP_FA_2017_22937_39048.jpg

LM Start	0.58	Rating **	M	Issue No.	201 (cont)
LM End	0.58	Issue Type +	En	Location *

Communication line marker on LS shoulder.

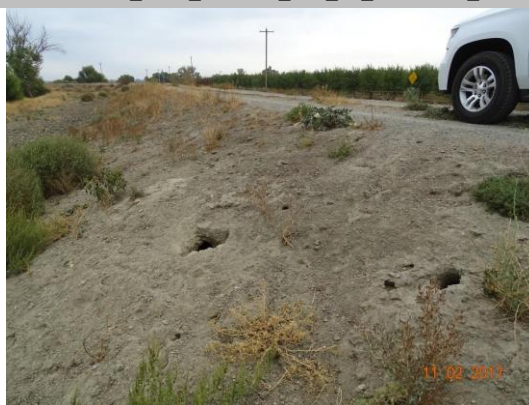
Photo 1 of 1 : FA_2017_RD1602_110_30_20171109_00124.jpg

View of rodent holes on the waterside slope of the levee. Fall 2017

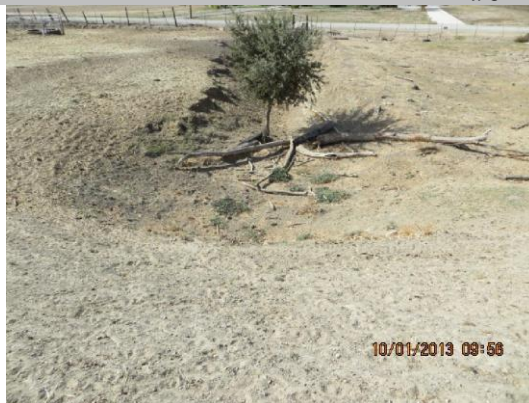
Photo 1 of 3 : UCIP_FA_2017_51634_36723.jpg

Comment Code						
Inspector Comment						
FS_ID:51634 DS_ID:20216 EP_NO: N/A Repair Type: No Action Needed Crossing Status: Found UCIP Comments: 11/18/2016 Crossing has been downgraded from Urgent to No Action Needed the debris blocking the outlet has been cleared. (O. Magana - DWR UCIP)10/01/2013 Flap gate blocked from functioning by soil buildup on WS toe. Soil should be cleared. (W. Wylie - DWR UCIP) FIELD_STRUCT_DESC: 30-inch square reinforced concrete box culvert through levee, 14.4 feet below crown. Concrete "U" headwall on the waterside (WS) and landside (LS) ends. Slide gate in 6-foot by 7-foot concrete surge box is located on the WS shoulder. Flap gate is located on the WS end. [Additional Reference(s): DWR Levee Log, 1992. USACE San Joaquin River O&M Manual Unit 13, April 1964, (HLM 0.78), Drawing No. 7-4-1784]. FS Date: 11/18/2016

Inlet on LS toe.

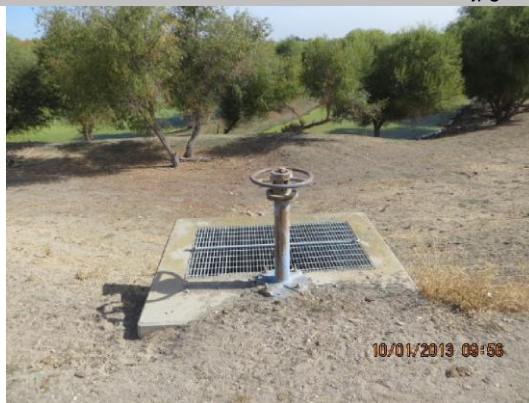
Photo 2 of 3 : UCIP_FA_2017_51634_36722.jpg

Slide gate in concrete box on WS shoulder.

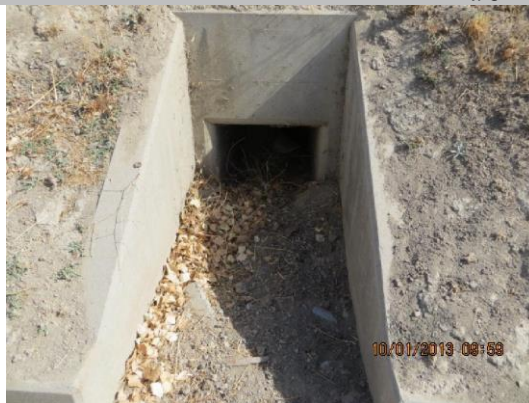
Photo 3 of 3 : UCIP_FA_2017_51634_36721.jpg

Item	DWR UCIP LMA Responsibility			37.477993 °	37.477993 °	
				-121.072645 °	-121.072645 °	
DWR ID						
Comment Code						
Inspector Comment						
FS_ID:51634 DS_ID:20216 EP_NO: N/A Repair Type: No Action Needed Crossing Status: Found UCIP Comments: 11/18/2016 Crossing has been downgraded from Urgent to No Action Needed the debris blocking the outlet has been cleared. (O. Magana - DWR UCIP)10/01/2013 Flap gate blocked from functioning by soil buildup on WS toe. Soil should be cleared. (W. Wylie - DWR UCIP) FIELD_STRUCT_DESC: 30-inch square reinforced concrete box culvert through levee, 14.4 feet below crown. Concrete "U" headwall on the waterside (WS) and landside (LS) ends. Slide gate in 6-foot by 7-foot concrete surge box is located on the WS shoulder. Flap gate is located on the WS end. [Additional Reference(s): DWR Levee Log, 1992. USACE San Joaquin River O&M Manual Unit 13, April 1964, (HLM 0.78), Drawing No. 7-4-1784]. FS Date: 11/18/2016

Concrete inlet on LS toe.

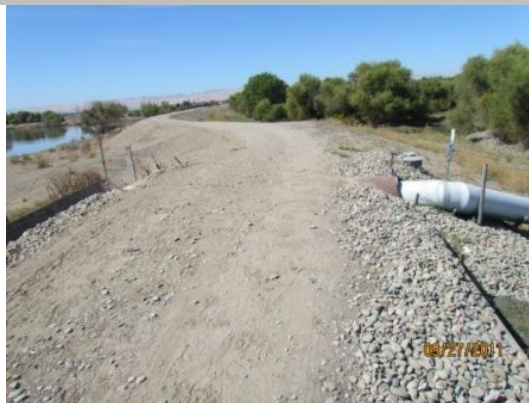
Photo 1 of 1 : FA_2017_RD1602_110_36_20170921_00009.jpg

LM Start	1.00	Rating **	M	Issue No.	36
LM End	1.00	Issue Type +	En	Location *	WS
Category	Earthen Levee			GPS Latitude/Longitude	
				Start	End
Item	Encroachments			37.478810 °	37.478810 °
				-121.068738 °	-121.068738 °
DWR ID	DWR_RD1602_01_s_2012_36				
Comment Code					
RA : Ramp					
Inspector Comment

View of the ramp on the crown. The picture was taken from crown looking downstream.

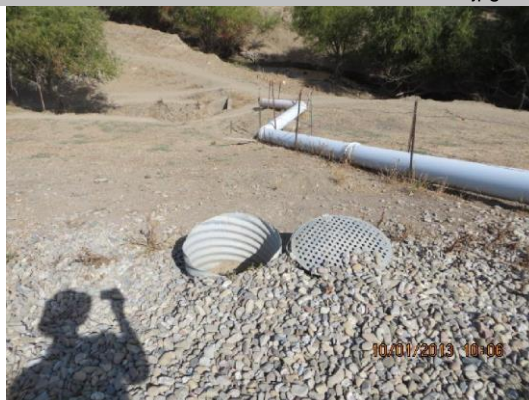
Photo 2 of 3 : UCIP_FA_2017_51636_36757.jpg

Comment Code						
Inspector Comment						
FS_ID:51636 DS_ID:20217 EP_NO: N/A Repair Type: Non-Urgent Crossing Status: Found UCIP Comments: 11/18/2016 Crossing has been downgraded from Urgent to Non-Urgent a flap gate has been added to the WS but pipe is currently not connected to pump. According to Tony Martinez, LMA representative, this crossing is currently not in use. Owner will need to coordinate with CVFPB to obtain permit. (O. Magana - DWR UCIP)10/01/2013 Appears abandoned and if so should be done so properly. Flapgate missing. (W. Wylie - DWR UCIP) FIELD_STRUCT_DESC: *ABANDONED* 1 of 2: 16-inch steel drainage pipe through levee, 17 feet below crown. Pumps on the pump platform are located on the landside (LS). Siphon breaker in 24-inch corrugated metal pipe (CMP) riser is located on the waterside (WS) shoulder. Concrete "U" headwall and flap gate are located on the WS end. [Additional Reference(s): DWR Levee Log, 1992. USACE San Joaquin River O&M Manual Unit 13, April 1964, (HLM 1.01), Drawing No. 7-4-1784]. FS Date: 11/18/2016

Siphon breaker in 24-inch CMP riser on WS shoulder.

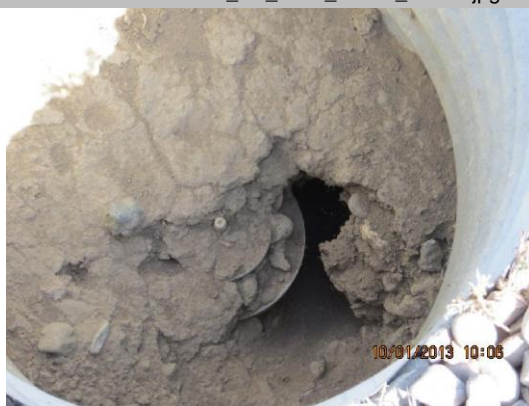
Photo 3 of 3 : UCIP_FA_2017_51636_36756.jpg

Comment Code						
Inspector Comment						
FS_ID:51636 DS_ID:20217 EP_NO: N/A Repair Type: Non-Urgent Crossing Status: Found UCIP Comments: 11/18/2016 Crossing has been downgraded from Urgent to Non-Urgent a flap gate has been added to the WS but pipe is currently not connected to pump. According to Tony Martinez, LMA representative, this crossing is currently not in use. Owner will need to coordinate with CVFPB to obtain permit. (O. Magana - DWR UCIP)10/01/2013 Appears abandoned and if so should be done so properly. Flapgate missing. (W. Wylie - DWR UCIP) FIELD_STRUCT_DESC: *ABANDONED* 1 of 2: 16-inch steel drainage pipe through levee, 17 feet below crown. Pumps on the pump platform are located on the landside (LS). Siphon breaker in 24-inch corrugated metal pipe (CMP) riser is located on the waterside (WS) shoulder. Concrete "U" headwall and flap gate are located on the WS end. [Additional Reference(s): DWR Levee Log, 1992. USACE San Joaquin River O&M Manual Unit 13, April 1964, (HLM 1.01), Drawing No. 7-4-1784]. FS Date: 11/18/2016

Siphon breaker in 24-inch CMP riser on WS shoulder.

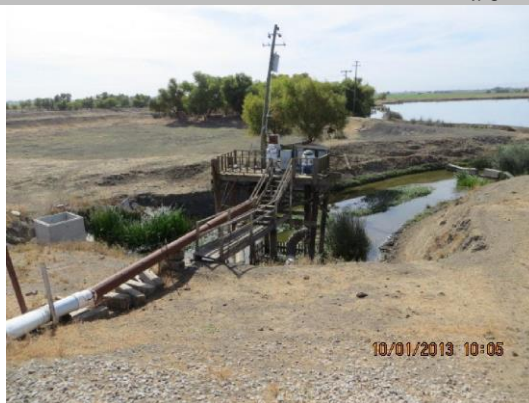
Photo 1 of 3 : UCIP_FA_2017_51637_36772.jpg

FS_ID:51637
DS_ID:20219
EP_NO: N/A
Repair Type: Non-Urgent
Crossing Status: Found
UCIP Comments: 11/18/2016 Crossing has been downgraded from Urgent to Non-Urgent a flap gate has been added to the WS. According to Tony Martinez, LMA representative, this crossing is currently not in use. Owner will need to coordinate with CVFPB to obtain permit. (O. Magana - DWR UCIP)10/01/2013 Appears abandoned siphon breakers covered in soil and flapgate missing. (W. Wylie - DWR UCIP) FIELD_STRUCT_DESC: *ABANDONED* 2 of 2: 16-inch steel drainage pipe through levee, 17 feet below crown. Pump on pump platform located on the landside (LS). Siphon breaker in 24-inch riser located on the waterside (WS) shoulder. Concrete "U" headwall and flap gate are located on the WS end. [Additional Reference(s): DWR Levee Log, 1992. USACE San Joaquin River O&M Manual Unit 13, April 1964, (HLM 1.01), Drawing No. 7-4-1784].
FS Date: 11/18/2016

Pipe visible under walkway at puming plant on LS toe.

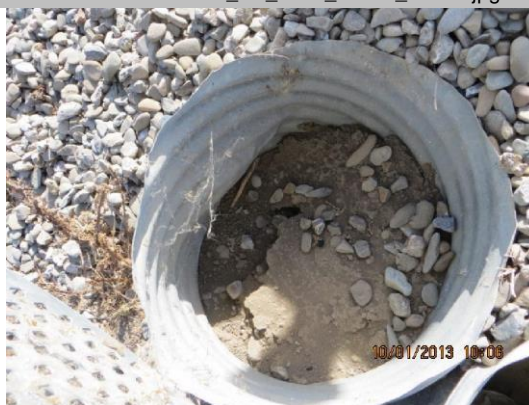
Photo 2 of 3 : UCIP_FA_2017_51637_36771.jpg

Siphon breaker covered in soil at CMP riser on WS shoulder.

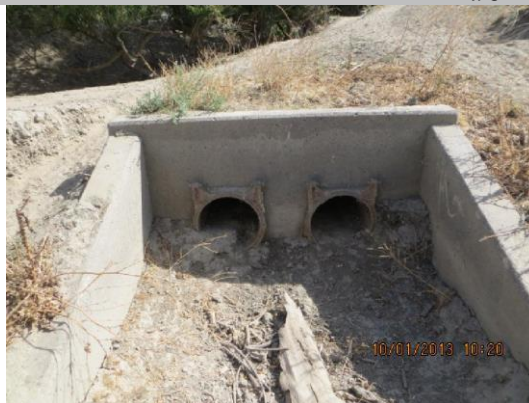
Photo 3 of 3 : UCIP_FA_2017_51637_36770.jpg

Comment Code						
Inspector Comment						
FS_ID:51637 DS_ID:20219 EP_NO: N/A Repair Type: Non-Urgent Crossing Status: Found UCIP Comments: 11/18/2016 Crossing has been downgraded from Urgent to Non-Urgent a flap gate has been added to the WS. According to Tony Martinez, LMA representative, this crossing is currently not in use. Owner will need to coordinate with CVFPB to obtain permit. (O. Magana - DWR UCIP)10/01/2013 Appears abandoned siphon breakers covered in soil and flapgate missing. (W. Wylie - DWR UCIP) FIELD_STRUCT_DESC: *ABANDONED* 2 of 2: 16-inch steel drainage pipe through levee, 17 feet below crown. Pump on pump platform located on the landside (LS). Siphon breaker in 24-inch riser located on the waterside (WS) shoulder. Concrete "U" headwall and flap gate are located on the WS end. [Additional Reference(s): DWR Levee Log, 1992. USACE San Joaquin River O&M Manual Unit 13, April 1964, (HLM 1.01), Drawing No. 7-4-1784]. FS Date: 11/18/2016

Concrete headwall on WS toe with missing flapgate.

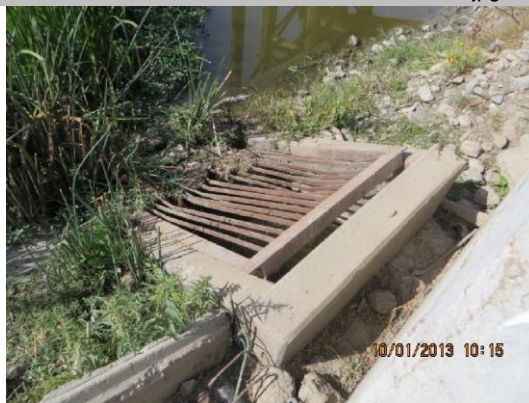
Photo 2 of 3 : UCIP_FA_2017_51329_36785.jpg

UCIP Comments: 11/18/2016 Same as previous inspection headwall on the WS toe has separated from pipe and flap gate is still missing. Erosion around concrete headwall and undermined WS slope are visible from WS. The slope undermined appears to have progressed but no photos were taken due to the dense vegetation covering area.

According to Tony Martinez, LMA representative, the WS concrete headwall has been detached since 2008/2009. LMA has been in contact with CVFPB, DWR, and USACE regarding this site. (O. Magana - DWR UCIP)10/01/2013 Headwall on WS toe separated from pipe. Erosion around concrete headwall and undermined at WS toe. Flap gate missing from WS toe headwall. (W. Wylie - DWR UCIP) FIELD_STRUCT_DESC: 30-inch square reinforced concrete box culvert through levee, 25.4 feet below crown. Concrete "U" headwalls on both waterside (WS) and landside (LS) ends. Slide gate in concrete surge box located on the WS slope. A 5-foot by 5-foot concrete box is located on LS toe. Flap gate is located on the WS end. [Additional Reference(s): DWR Levee Log, 1992. USACE San Joaquin River O&M Manual Unit 13, April 1964, (HLM 1.02), Drawing No. 7-4-1784].

Grated inlet at LS toe.

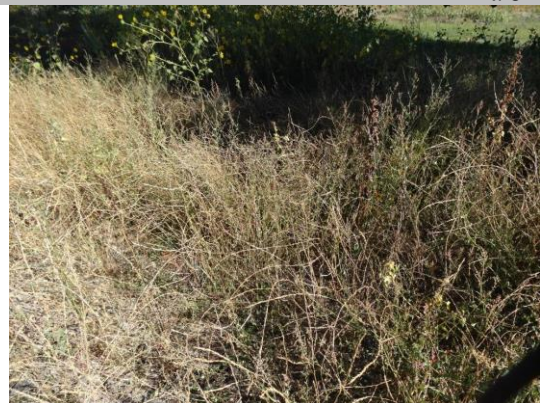
Photo 1 of 4 : SJR2017_RD1602U01RM97.68_1.jpg

Close view of the erosion. The erosion is covered by dense vegetation at the site.

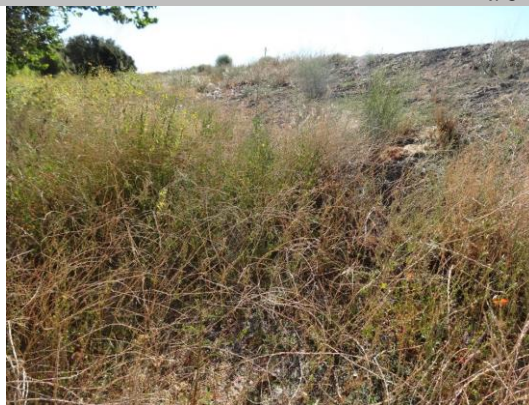
Photo 3 of 4 : SJR2017_RD1602U01RM97.68_3.jpg

Looking up at the erosion from the levee toe.

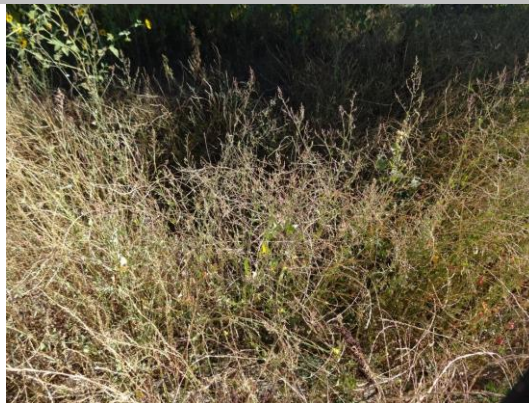
Photo 4 of 4 : SJR2017_RD1602U01RM97.68_4.jpg

Close view of the erosion.

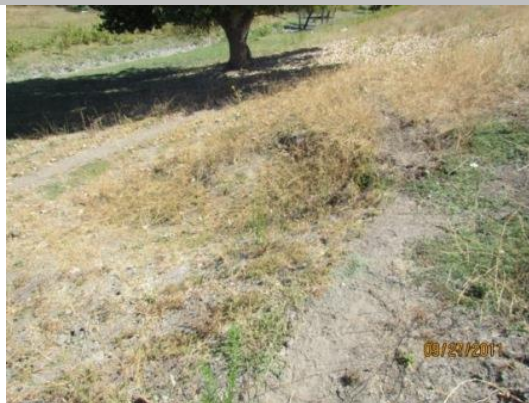
Photo 1 of 2 : FA_2017_RD1602_110_37_20170921_00010.jpg

LM Start	1.05	Rating **	M	Issue No.	37
LM End	1.05	Issue Type +	Ma	Location *	WS
Category	Earthen Levee			GPS Latitude/Longitude	
				Start	End
Item	Slope Stability			37.478567 °	37.478567 °
				-121.067847 °	-121.067847 °
DWR ID	DWR_RD1602_01_s_2012_37				
Comment Code					
S1 : Repair slope instability.					
Inspector Comment					
Small amount of slumping at waterside toe of the levee.

View of the depression at the waterside toe of the levee. The picture was taken from the crown of the levee looking upstream during fall 2011 inspection.

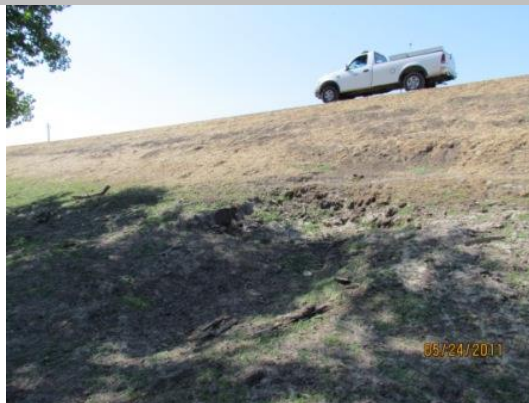
Photo 2 of 2 : FA_2017_RD1602_110_37_20170921_00011.jpg

Depression at the waterside slope of the levee during Spring 2011 inspection.

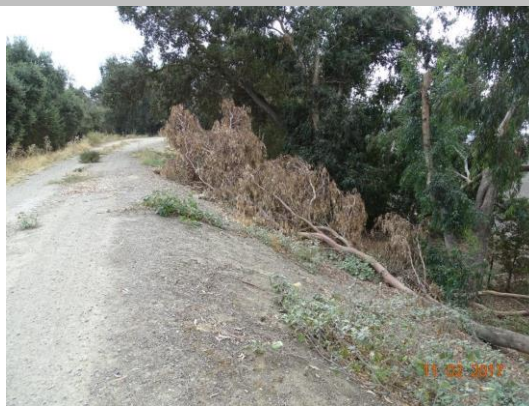
Photo 1 of 1 : FA_2017_RD1602_110_33_20171109_00125.jpg

View of prunings on the landside of the levee.

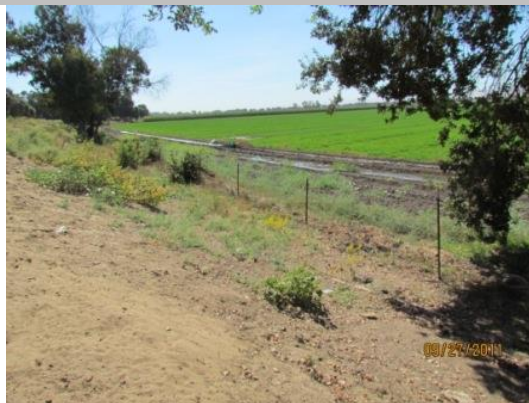
Photo 1 of 1 : FA_2017_RD1602_110_43_20170921_00016.jpg

View of the fence on the landside toe of the levee. The picture was taken from crown looking upstream.

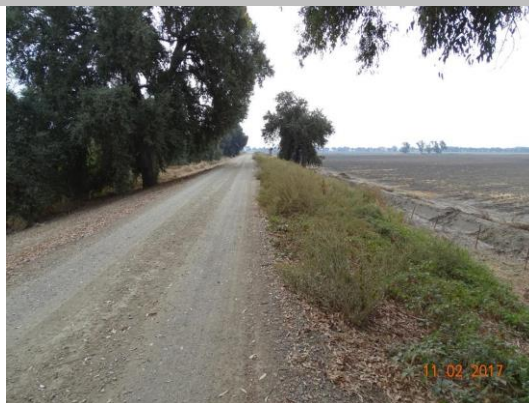
Photo 1 of 1 : FA_2017_RD1602_110_34_20171109_00126.jpg

View of vegetation on the landside of the levee looking upstream. Fall 2017

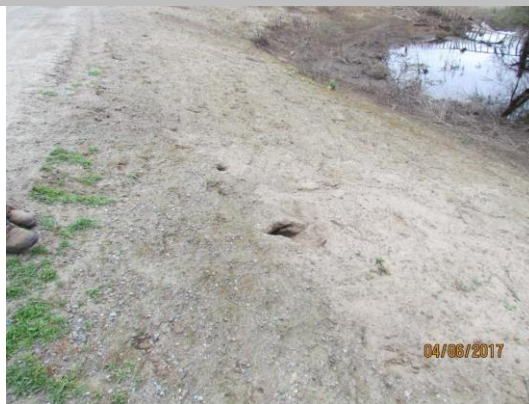
Photo 1 of 1 : FA_2017_RD1602_110_81_20170921_00037.jpg

View of a rodent hole on the waterside slope of the levee.

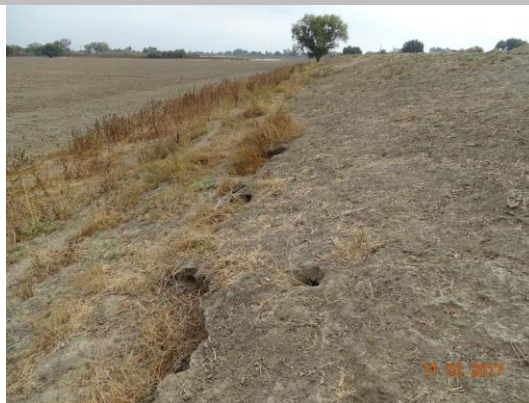
Photo 1 of 1 : FA_2017_RD1602_110_44_20171109_00128.jpg

View of redoent holes on the landside of the levee.

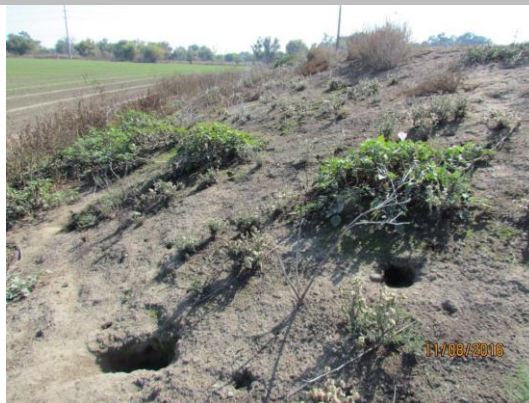
Photo 1 of 1 : FA_2017_RD1602_110_25_20170921_00005.jpg

View of rodent holes on the waterside toe of the levee looking upstream.
Fall 2016

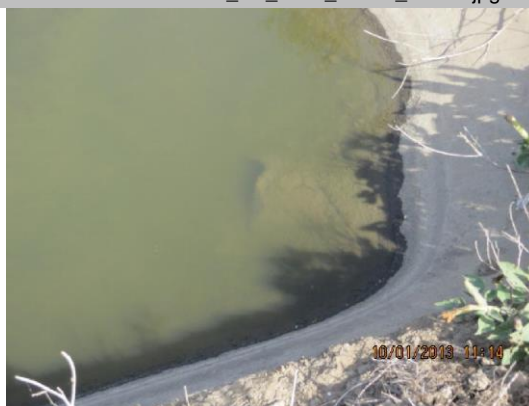
Photo 1 of 3 : UCIP_FA_2017_51330_36805.jpg

Pipe visible in concrete channel on LS toe.

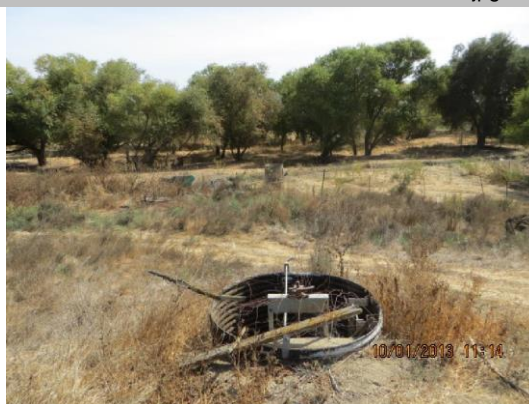
Photo 2 of 3 : UCIP_FA_2017_51330_36804.jpg

Slide gate in 60-inch CMP riser on WS shoulder.

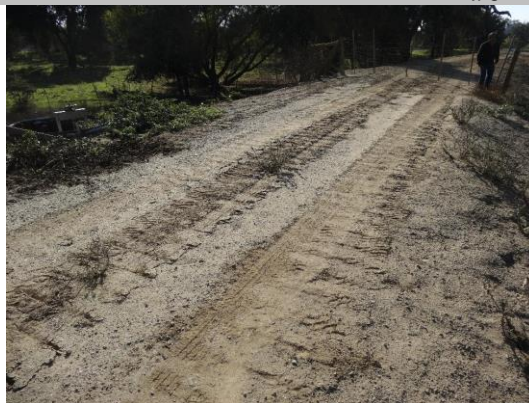
Photo 3 of 3 : UCIP_FA_2017_51330_76527.jpg

Overview of levee crown at pipe crossing.

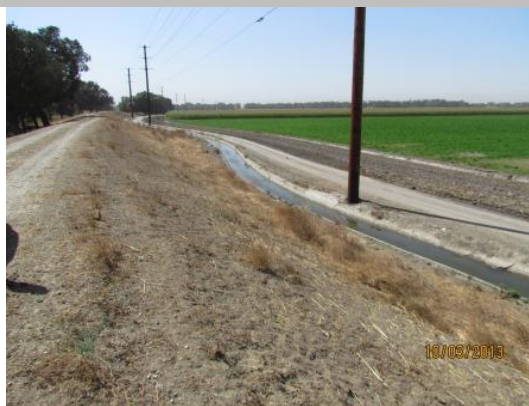
Photo 1 of 1 : FA_2017_RD1602_110_54_20170921_00022.jpg

A concrete lined ditch was found on the landside toe of the levee looking upstream.

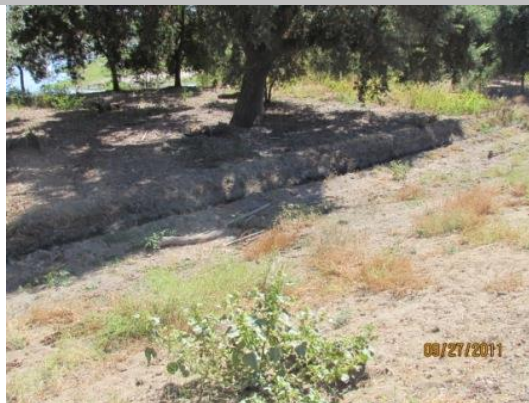
Photo 1 of 1 : FA_2017_RD1602_110_50_20170921_00021.jpg

A ditch was located on the waterside toe of the levee. The picture was taken from the crown looking upstream.

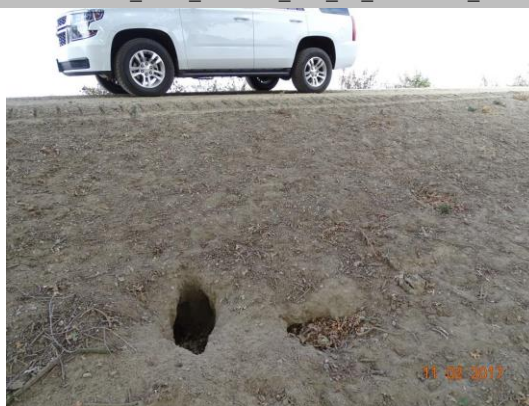
Photo 1 of 1 : FA_2017_RD1602_110_57_20171109_00130.jpg

View of a rodent hole on the waterside of the levee.

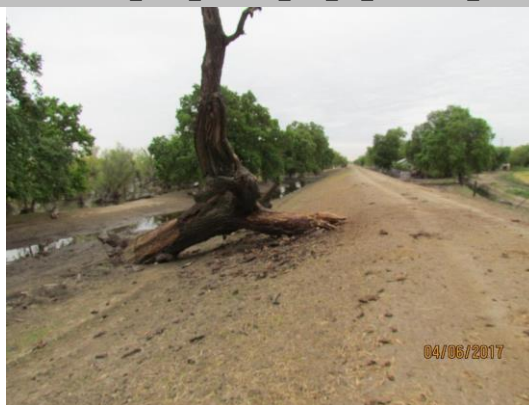
Photo 1 of 1 : FA_2017_RD1602_110_83_20170921_00039.jpg

View of a tree trunk on the waterside slope of the levee.

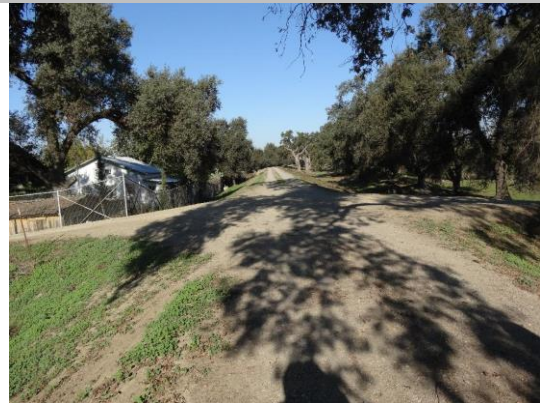
Photo 1 of 3 : UCIP_FA_2017_51331_76534.jpg

Overview of levee crown at pipe crossing.

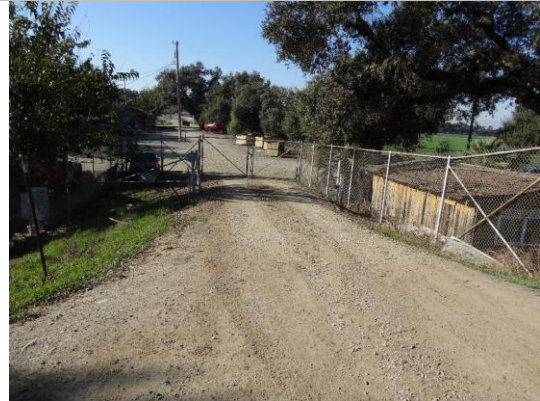
Photo 2 of 3 : UCIP_FA_2017_51331_76535.jpg

View of LS.

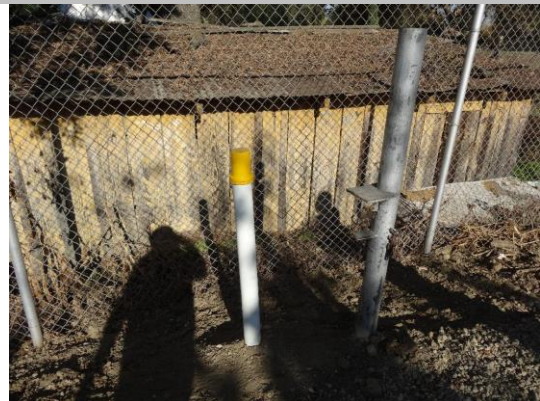
Photo 3 of 3 : UCIP_FA_2017_51331_76536.jpg

PVC riser with yellow cover located along fence on LS.

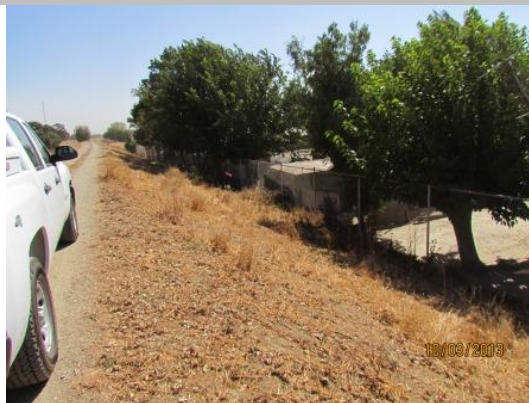
Photo 1 of 1 : FA_2017_RD1602_110_66_20170921_00031.jpg

Fences were found on the landside toe of the levee looking upstream.

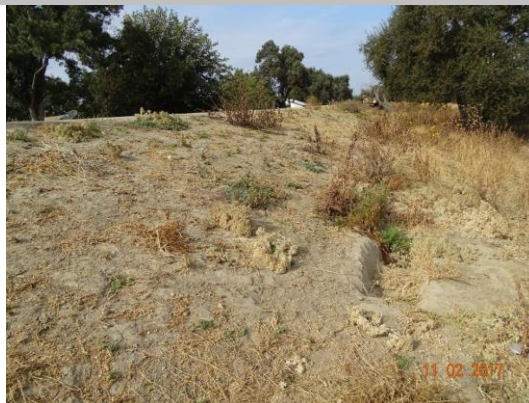
Photo 1 of 1 : FA_2017_RD1602_110_84_20171109_00131.jpg

View of rodent holes on the waterside of the levee.

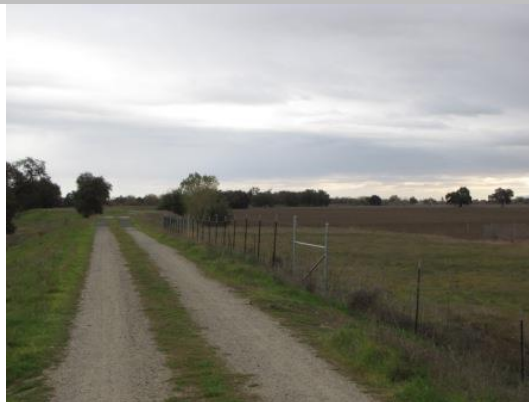
Photo 1 of 1 : FA_2017_RD1602_110_63_20170921_00029.jpg

View of a barbed wire fence on the landward slope looking upstream.

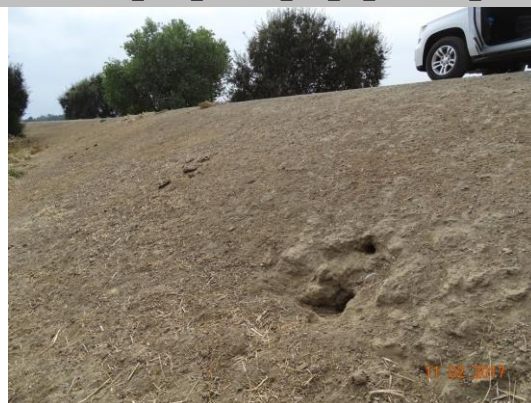
Photo 1 of 1 : FA_2017_RD1602_110_58_20171109_00132.jpg

View of rodent holes on the waterside of the levee.

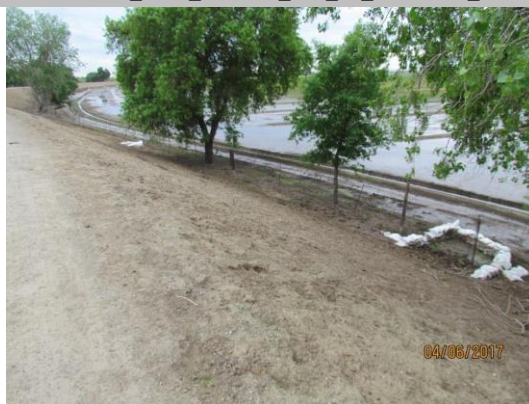
Photo 1 of 1 : FA_2017_RD1602_110_86_20170921_00040.jpg

View of sack rings on the landside toe of the levee. Spring 2017

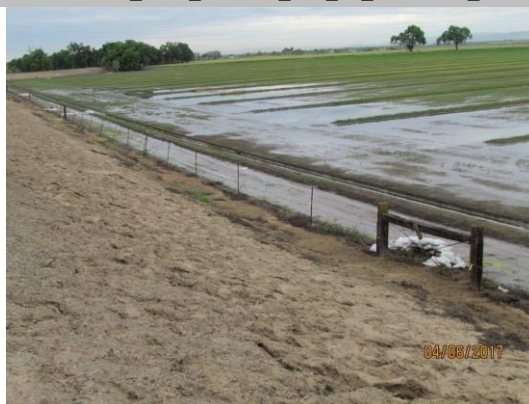
Photo 1 of 1 : FA_2017_RD1602_110_87_20170921_00041.jpg

View of a sack ring on the landside toe of the levee looking upstream.
Spring 2017

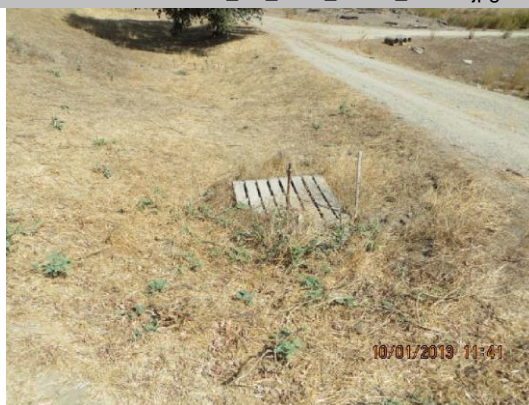
Photo 1 of 3 : UCIP_FA_2017_51332_36819.jpg

Slide gate in CMP riser on WS slope.

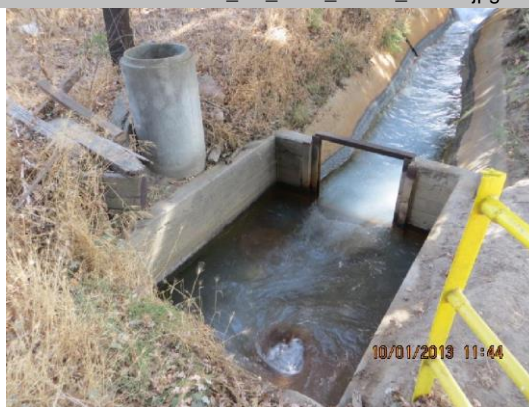
Photo 3 of 3 : UCIP_FA_2017_51332_36817.jpg

Concrete ditch at outlet from pipe on LS toe.

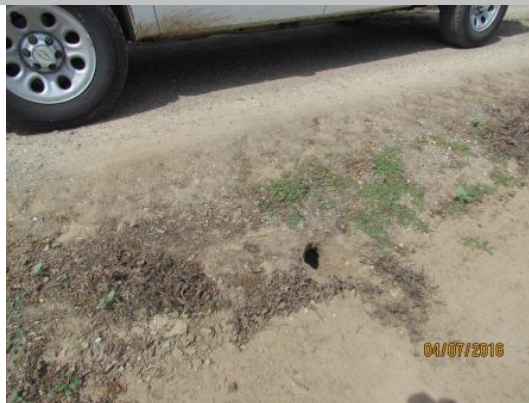
Photo 1 of 1 : FA_2017_RD1602_110_35_20170921_00008.jpg

View of an animal hole on the waterside shoulder of the levee looking downstream.

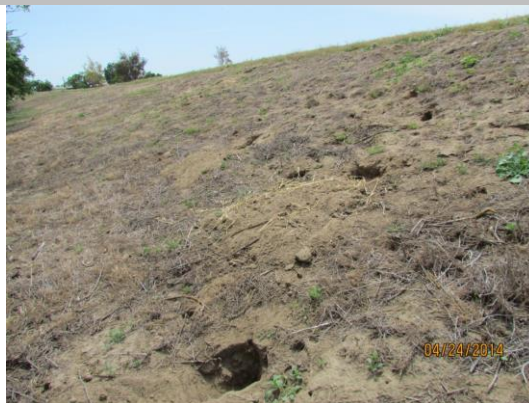
Photo 1 of 1 : FA_2017_RD1602_110_199_20170921_00047.jpg

Rodent holes were found on the waterside toe of the levee looking upstream.

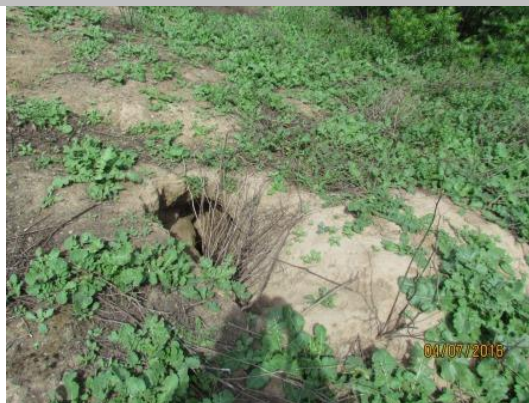
Photo 1 of 1 : FA_2017_RD1602_110_48_20170921_00019.jpg

View of rodent holes on the waterside of the levee looking downstream.

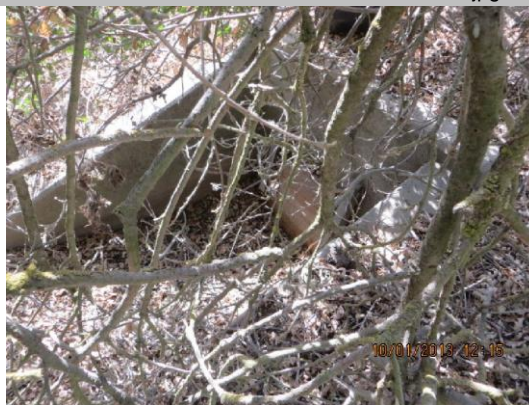
Photo 2 of 3 : UCIP_FA_2017_51336_36821.jpg

Flapgate in Concrete headwall on WS toe under tree.

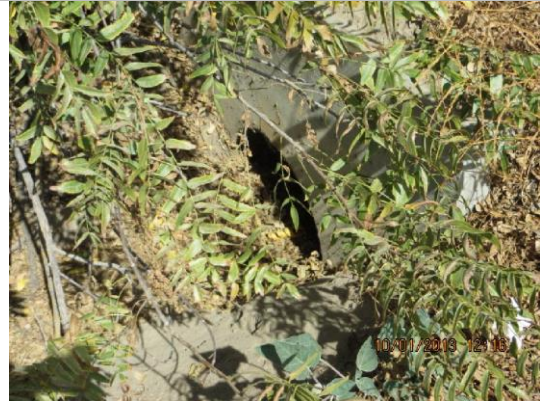
Photo 3 of 3 : UCIP_FA_2017_51336_36820.jpg

Concrete headwall at inlet on LS toe.

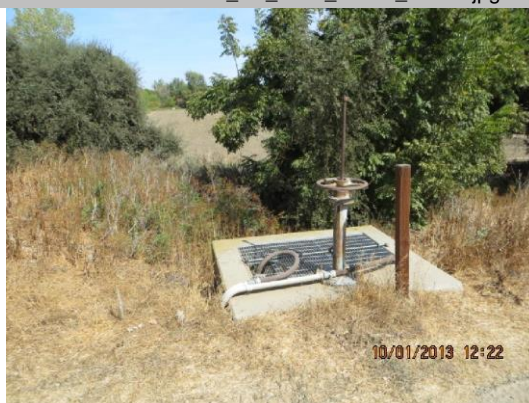
Photo 1 of 3 : UCIP_FA_2017_21672_36848.jpg

Slidegate in concrete riser on WS shoulder.

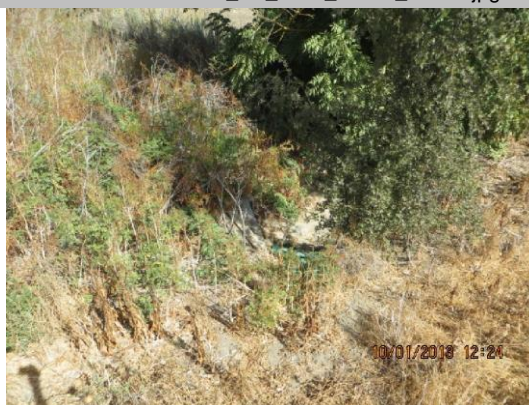
Photo 2 of 3 : UCIP_FA_2017_21672_36847.jpg

Concrete outlet on WS toe.

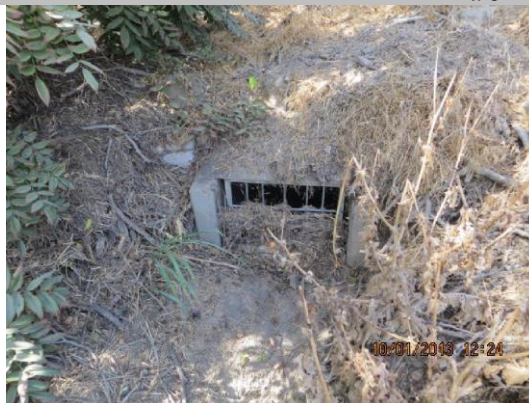
Photo 3 of 3 : UCIP_FA_2017_21672_36846.jpg

Concrete inlet on LS toe.

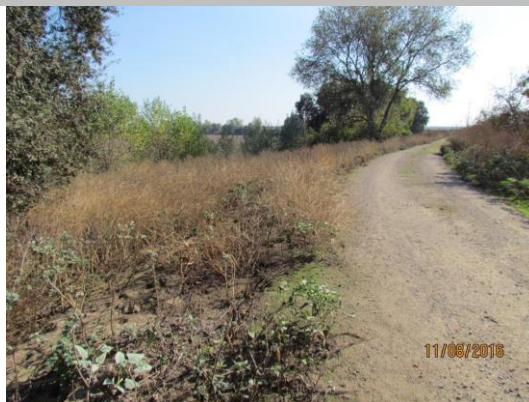
Photo 1 of 1 : FA_2017_RD1602_110_75_20170921_00035.jpg

Vegetation was found on the waterside slope of the levee looking upstream during fall 2016 inspection.

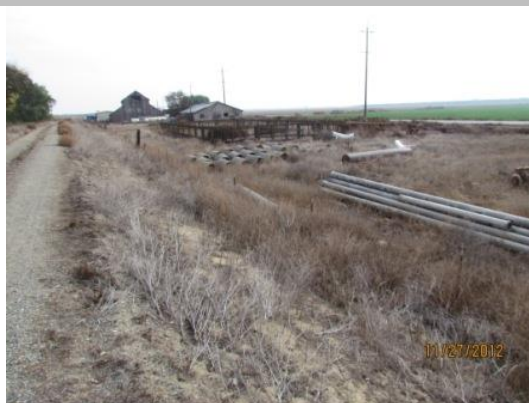
Photo 1 of 1 : FA_2017_RD1602_110_22_20170921_00003.jpg

A fence was found on the landside toe of the levee looking upstream.

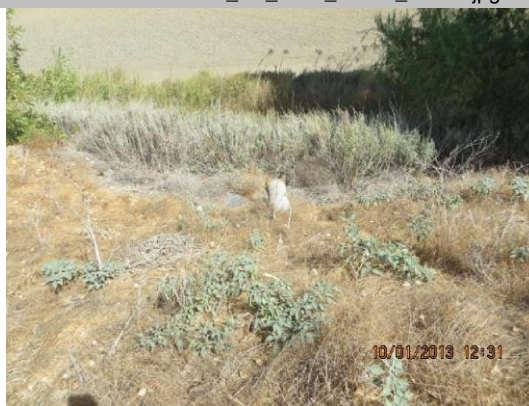
Photo 1 of 1 : UCIP_FA_2017_21674_36854.jpg

Pipe and flapgate visible on WS toe.

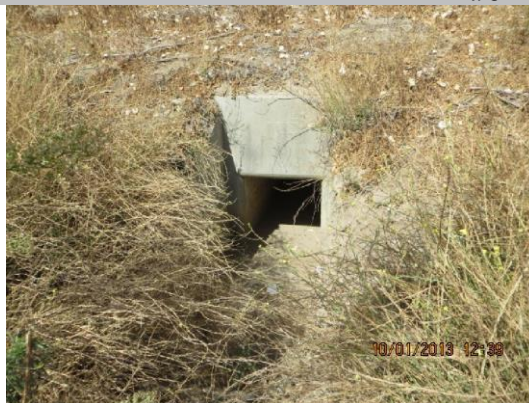
Photo 3 of 3 : UCIP_FA_2017_51337_36876.jpg

Concrete U-shaped headwall on LS toe.

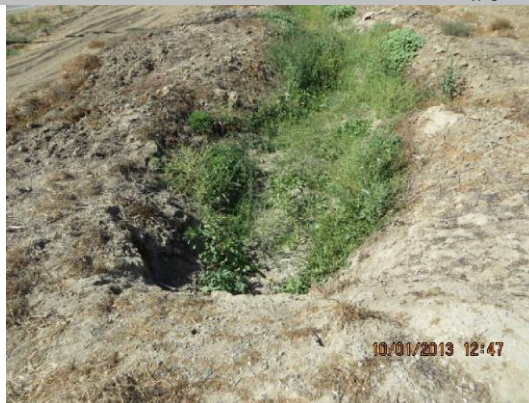
Photo 1 of 3 : UCIP_FA_2017_21683_36882.jpg

Drainage/irrigation canal on LS toe.

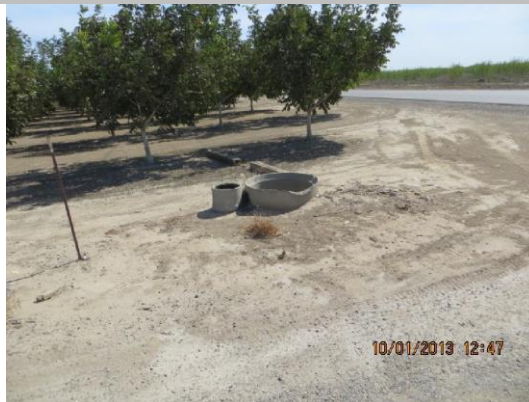
Photo 2 of 3 : UCIP_FA_2017_21683_36881.jpg

36-inch concrete standpipe on WS shoulder.

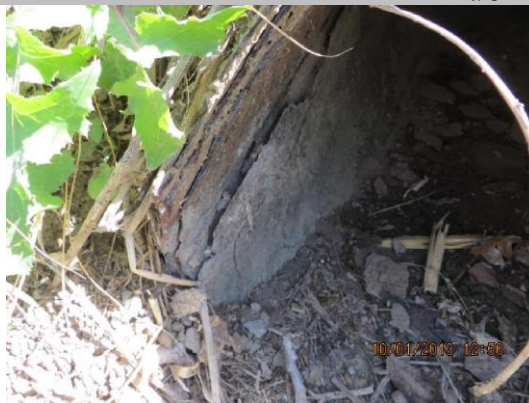
Photo 3 of 3 : UCIP_FA_2017_21683_36880.jpg

Pipe deteriorated on LS at outlet.
