**Flood Control Project Maintenance
Levee Inspections**

Fall 2018 Levee Maintenance Deficiency Summary Report

Reclamation District No. 1602 Del Puerto

Waterway			Bank	Unit Miles
Unit No. 01 San Joaquin River			Left	6.24
	Spring (March - May)	Summer (June - August)	(September - November) Fall	Winter (December - February)
Unit Maintenance Rating (Fall Only)			U	
Date of Inspection	3/13/2018 - 3/13/2018		11/6/2018 - 11/6/2018	
DWR Inspector	Richard Willoughby		Corey Fujitani	
Accompanied By	Tony Martinez RD 1602		Tony Martinez RD 1602

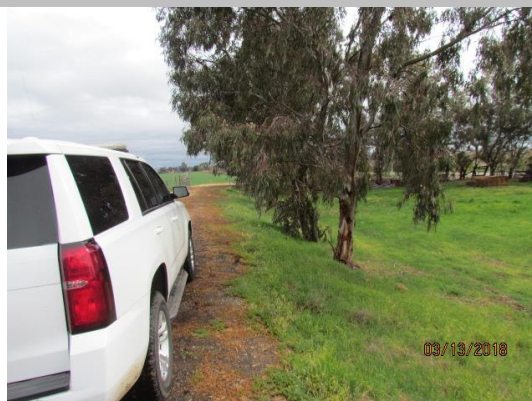
Photo 1 of 1 : FA_2018_RD1602_110_60_20180905_00032.jpg

Looking upstream at trees on landward slope.

LM Start	0.13	Rating **	M	Issue No.	108
LM End	0.56	Issue Type +	Ma	Location *	LS
Category	Earthen Levee			GPS Latitude/Longitude	
				Start	End
Item	Vegetation			37.477232°	37.480281°
				-121.081856°	-121.075095°
DWR ID	DWR_RD1602_01_f_2018_108				
Comment Code					
V1 : Control annual grass and weeds on the levee slopes and easements.					
Inspector Comment

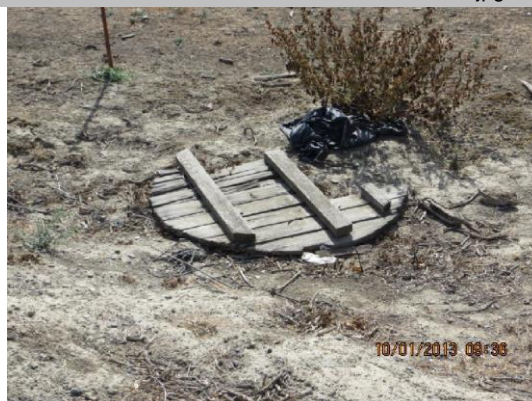
Photo 3 of 3 : UCIP_FA_2018_51325_36700.jpg

Damaged Wooden lid on WS toe.

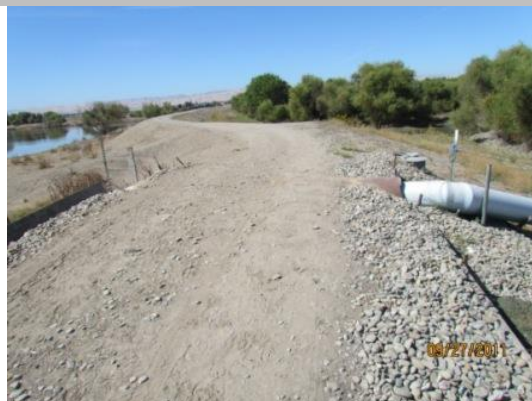
Photo 1 of 1 : FA_2018_RD1602_110_36_20180905_00015.jpg

LM Start	1.00	Rating **	M	Issue No.	36
LM End	1.00	Issue Type +	En	Location *	WS
Category	Earthen Levee			GPS Latitude/Longitude	
				Start	End
Item	Encroachments			37.478810 °	37.478810 °
				-121.068738 °	-121.068738 °
DWR ID	DWR_RD1602_01_s_2012_36				
Comment Code					
RA : Ramp					
Inspector Comment

View of the ramp on the crown. The picture was taken from crown looking downstream.

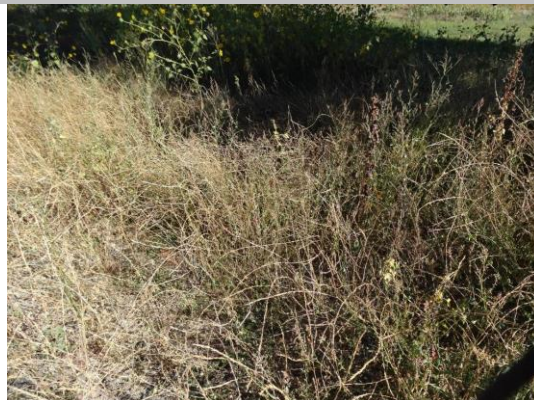
Photo 1 of 4 : FA_2018_RD1602_110_2_20180905_00001.jpg

Close view of the erosion. The erosion is covered by dense vegetation at the site.

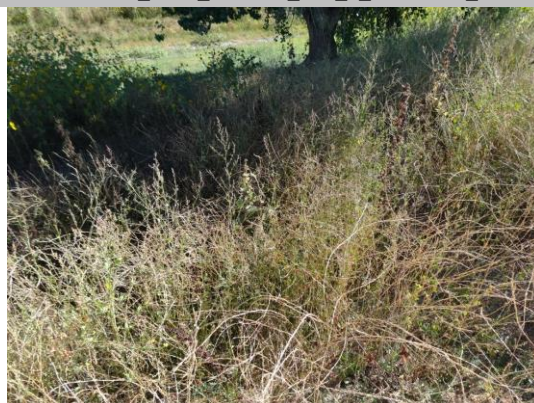
Photo 2 of 4 : FA_2018_RD1602_110_2_20180905_00002.jpg

Close view of the erosion.

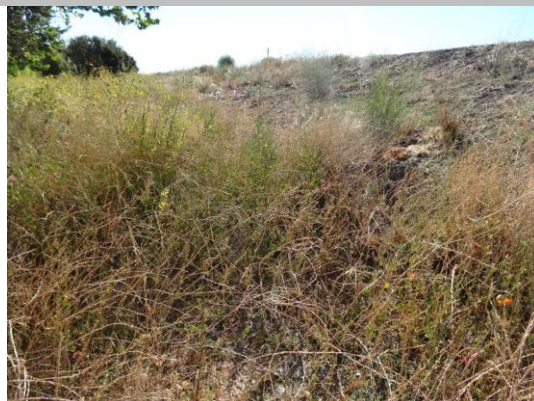
Photo 3 of 4 : FA_2018_RD1602_110_2_20180905_00003.jpg

Looking up at the erosion from the levee toe.

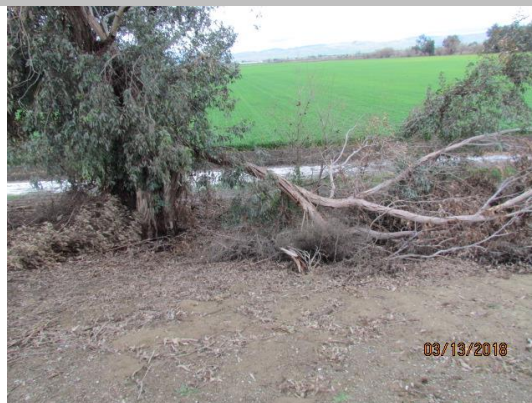
Photo 1 of 2 : FA_2018_RD1602_110_80_20180905_00048.jpg

LM Start	1.65	Rating **	U	Issue No.	80
LM End	1.65	Issue Type +	En	Location *	LS
Category	Earthen Levee			GPS Latitude/Longitude	
				Start	End
Item	Encroachments			37.477218 °	37.477218 °
				-121.058505 °	-121.058505 °
DWR ID	DWR_RD1602_01_s_2018_80				
Comment Code					
TR : Tree or limb					
Inspector Comment					
Broken tree branch on landward slope and toe.

Looking at broken branch on landward slope and toe.

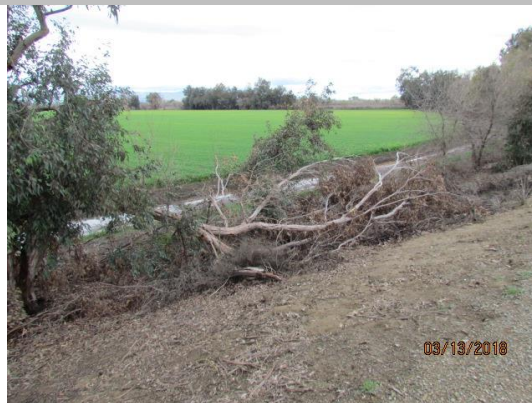
Photo 2 of 2 : FA_2018_RD1602_110_80_20180905_00049.jpg

Looking downstream at broke branch on landward slope and toe.

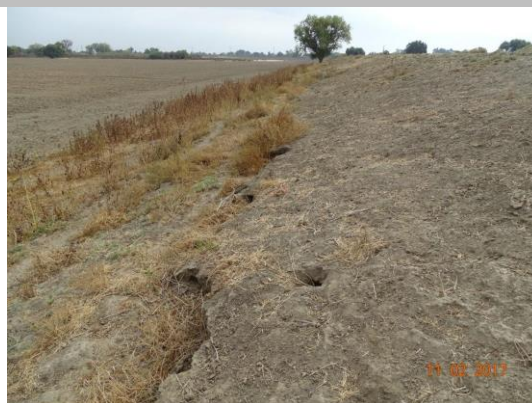
Photo 1 of 1 : FA_2018_RD1602_110_44_20180905_00019.jpg

View of redoent holes on the landside of the levee.

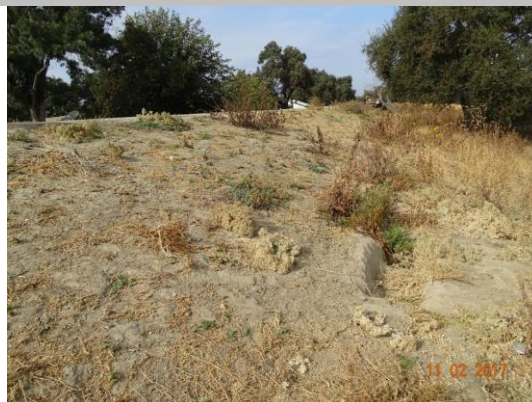
Photo 1 of 1 : FA_2018_RD1602_110_84_20180905_00055.jpg

View of rodent holes on the waterside of the levee.

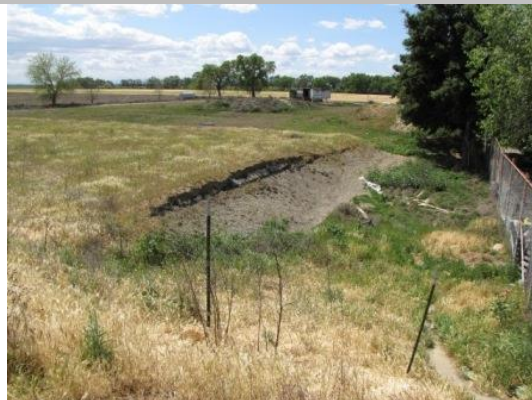
Photo 1 of 1 : FA_2018_RD1602_110_62_20180905_00034.jpg

Repair damage to USACE constructed seepage berm by pedestrian and cycle traffic.

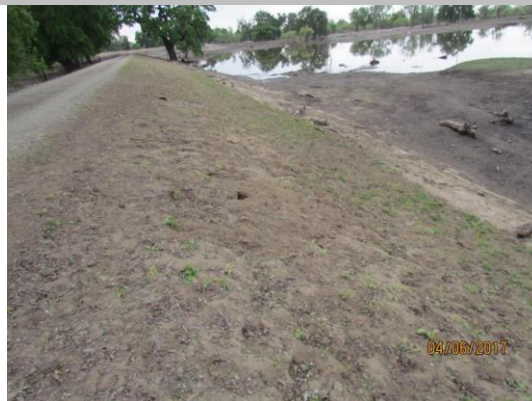
Photo 1 of 1 : FA_2018_RD1602_110_91_20180905_00058.jpg

View of rodent holes on the waterside of the levee looking downstream.
Spring 2017

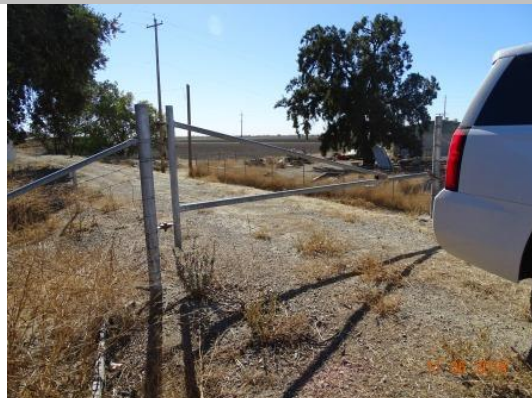
Photo 1 of 1 : FA_2018_RD1602_110_40_20181109_00115.jpg

DWR and LMA do not have keys for locks on gate. (Fall 2018)

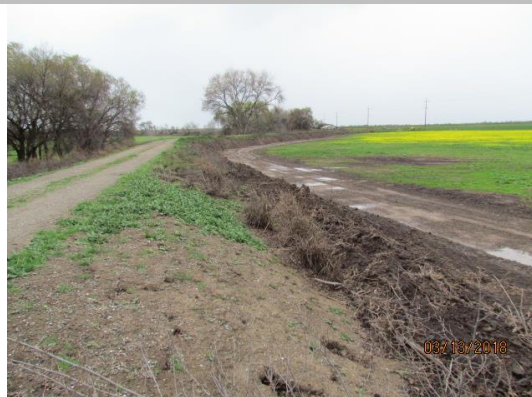
Photo 1 of 3 : FA_2018_RD1602_110_82_20180905_00051.jpg

Looking southwest at earthen material pile on landward toe.

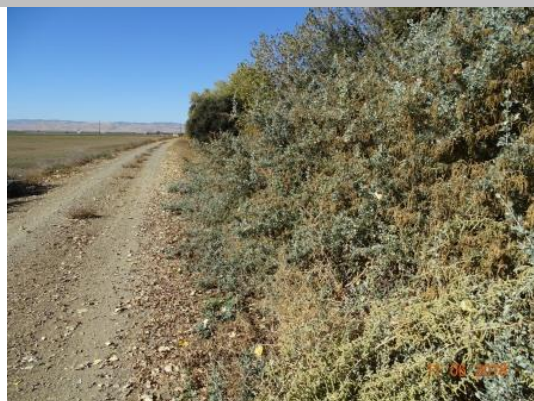
Photo 1 of 2 : FA_2018_RD1602_110_37_20181109_00117.jpg

Large bush on levee shoulder. (Fall 2018)

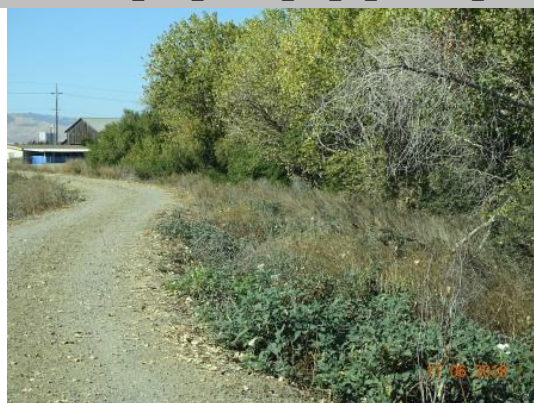
Photo 2 of 2 : FA_2018_RD1602_110_37_20181109_00118.jpg

wild growth on waterside slope (Fall 2018)

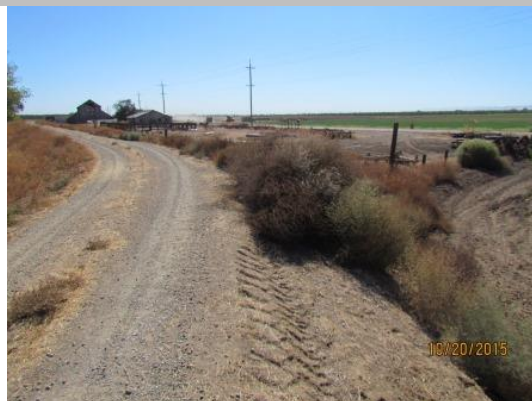
Photo 2 of 2 : FA_2018_RD1602_110_61_20180905_00033.jpg

Vegetation was obstructing the view of the landside of the levee.

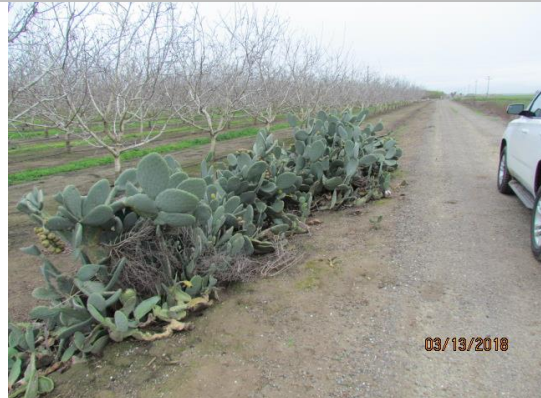
Photo 1 of 1 : FA_2018_RD1602_110_86_20180905_00056.jpg

Looking south at dense cactus on waterward slope.

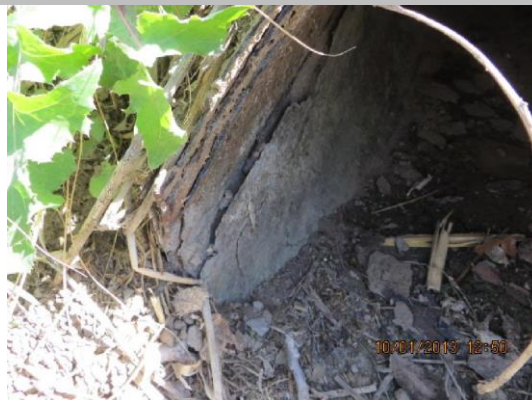
Photo 3 of 3 : UCIP_FA_2018_21683_36880.jpg

Pipe deteriorated on LS at outlet.
