**Flood Control Project Maintenance  
Levee Inspections**

**Fall 2019 Levee Maintenance Deficiency Summary Report**

**Reclamation District No. 1602 Del Puerto**

Waterway			Bank	Unit Miles
Unit No. 01 San Joaquin River			Left	6.24
	Spring (March - May)	Summer (June - August)	(September - November) Fall	Winter (December - February)
Unit Maintenance Rating (Fall Only)			<b>U</b>	
Date of Inspection	4/16/2019 - 4/16/2019		11/6/2019 - 11/6/2019	
DWR Inspector	Corey Fujitani		Corey Fujitani	
Accompanied By	Tony Martinez RD 1602		Tony Martinez RD 1602

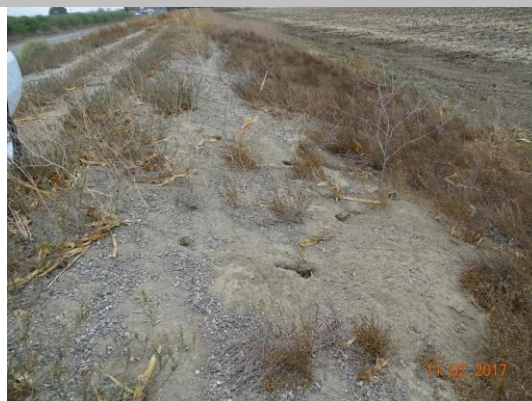
Photo 1 of 2 : FA\_2019\_RD1602\_110\_29\_20190912\_00010.jpg

LM Start	0.26	Rating **	M	Issue No.	29
LM End	0.26	Issue Type +	Ma	Location *	WS
Category	Earthen Levee			GPS Latitude/Longitude	
				Start	End
Item	Animal Control			37.478138 °	37.478138 °
				-121.079810 °	-121.079810 °
DWR ID	DWR_RD1602_01_f_2017_29				
Comment Code					
A3 : No rodents visible, but rodent burrows visible; need to backfill and compact or grout burrows.					
Inspector Comment

View of a rodent hole on the waterside of the levee. Fall 2017

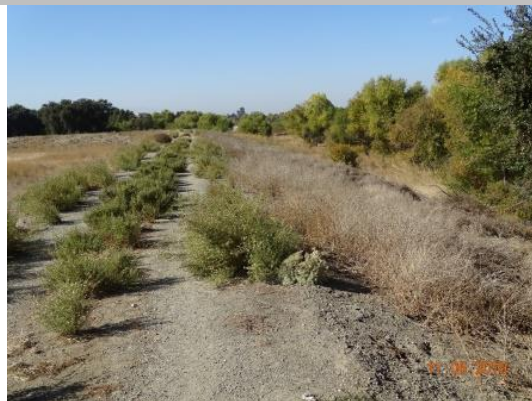
Photo 1 of 1 : FA\_2019\_RD1602\_110\_124\_20191114\_00107.jpg

View of the waterside slope looking downstream. (Fall 2019)

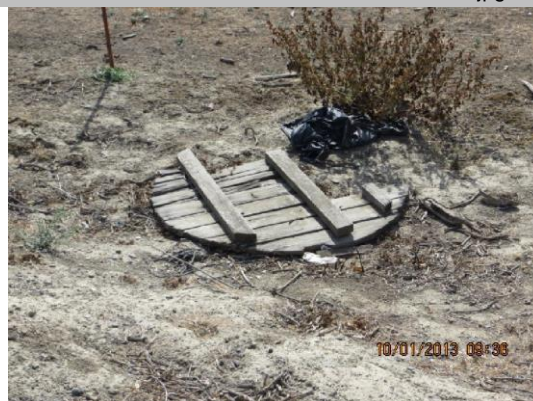
Photo 3 of 3 : UCIP\_FA\_2019\_51325\_36700.jpg

Item	DRAFT DWR UCIP LMA Responsibility			37.480182°	37.480182°	
				-121.074765°	-121.074765°	
DWR ID	20215					
Comment Code						
Inspector Comment						
DS_ID:20215 FS_ID:51325 EP_NO: N/A Repair Type: No Action Needed Crossing Status: Found UCIP Comments: 11/18/2016 Crossing has been downgraded from Urgent to No Action Needed a cover has been added to the CMP riser. (O. Magana - DWR UCIP)10/01/2013 Open 60-inch CMP riser on WS needs lid as it's depth may be a hazard to the public. (W. Wylie - DWR UCIP) FIELD_STRUCT_DESC: 16-inch steel drainage pipe through levee, 11.3 feet below crown. Slide gate in 60-inch corrugated metal pipe (CMP) riser located on the waterside (WS). Concrete inlet is approximately 110 feet west of the levee crown or 110 feet off landside (LS) toe next to roadway. [Additional Reference(s): DWR Levee Log, 1992. USACE San Joaquin River O&M Manual Unit 13, April 1964, (HLM 0.58), Drawing No. 7-4-1784]. FS Date: 11/18/2016

Damaged Wooden lid on WS toe.

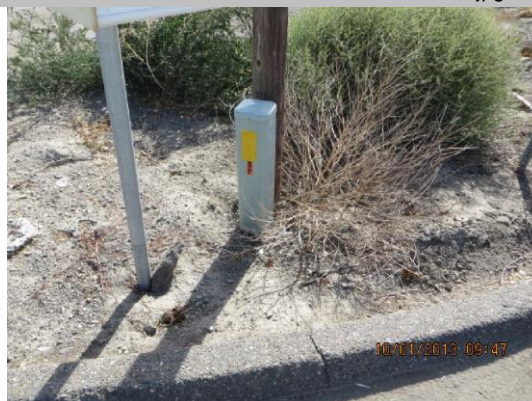
Photo 2 of 3 : UCIP\_FA\_2019\_22937\_39049.jpg

LM Start	0.58	Rating **	M	Issue No.	201 (cont)	
LM End	0.58	Issue Type +	En	Location *		
Category	Supplemental			GPS Latitude/Longitude		
				Start	End	
Item	DRAFT DWR UCIP Field Study			37.480176°	37.480176°	
				-121.074736°	-121.074736°	
DWR ID	24681					
Comment Code						
Inspector Comment						
DS_ID:24681						
FS_ID:22937						
EP_NO: N/A						
Repair Type: Non-Urgent						
Crossing Status: Found						
UCIP Comments: 10/01/2013 No permit identified for this crossing. (W. Wylie - DWR UCIP)						
FIELD_STRUCT_DESC: Communications line of an unknown size or material through the levee, at an unknown depth.						
FS Date: 10/1/2013

Communication line access box on LS shoulder.

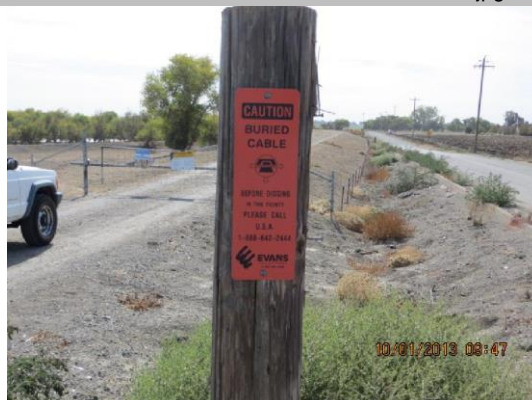
Photo 3 of 3 : UCIP\_FA\_2019\_22937\_39048.jpg

Communication line marker on LS shoulder.

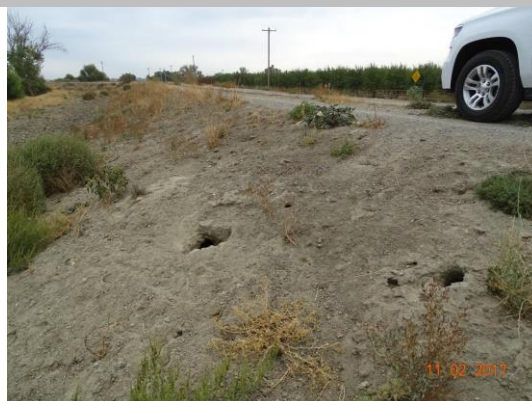
Photo 1 of 1 : FA\_2019\_RD1602\_110\_30\_20190912\_00012.jpg

View of rodent holes on the waterside slope of the levee. Fall 2017

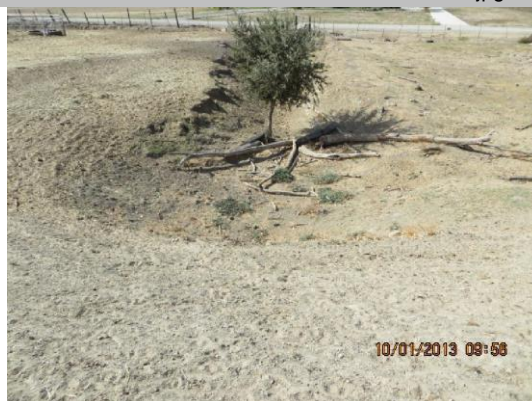
Photo 1 of 3 : UCIP\_FA\_2019\_51634\_36723.jpg

Comment Code					
Inspector Comment					
DS_ID:20216 FS_ID:51634 EP_NO: N/A Repair Type: No Action Needed Crossing Status: Found UCIP Comments: 11/18/2016 Crossing has been downgraded from Urgent to No Action Needed the debris blocking the outlet has been cleared. (O. Magana - DWR UCIP)10/01/2013 Flap gate blocked from functioning by soil buildup on WS toe. Soil should be cleared. (W. Wylie - DWR UCIP) FIELD_STRUCT_DESC: 30-inch square reinforced concrete box culvert through levee, 14.4 feet below crown. Concrete "U" headwall on the waterside (WS) and landside (LS) ends. Slide gate in 6-foot by 7-foot concrete surge box is located on the WS shoulder. Flap gate is located on the WS end. [Additional Reference(s): DWR Levee Log, 1992. USACE San Joaquin River O&M Manual Unit 13, April 1964, (HLM 0.78), Drawing No. 7-4-1784]. FS Date: 11/18/2016

Inlet on LS toe.

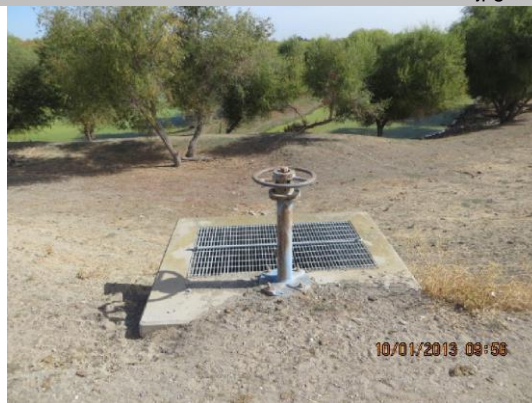
Photo 2 of 3 : UCIP\_FA\_2019\_51634\_36722.jpg

Slide gate in concrete box on WS shoulder.

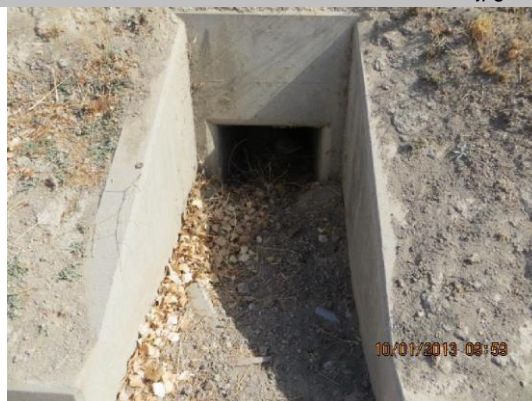
Photo 3 of 3 : UCIP\_FA\_2019\_51634\_36721.jpg

Item	DRAFT DWR UCIP LMA Responsibility			37.477993 °	37.477993 °	
				-121.072645 °	-121.072645 °	
DWR ID	20216					
Comment Code						
Inspector Comment						
DS_ID:20216 FS_ID:51634 EP_NO: N/A Repair Type: No Action Needed Crossing Status: Found UCIP Comments: 11/18/2016 Crossing has been downgraded from Urgent to No Action Needed the debris blocking the outlet has been cleared. (O. Magana - DWR UCIP)10/01/2013 Flap gate blocked from functioning by soil buildup on WS toe. Soil should be cleared. (W. Wylie - DWR UCIP) FIELD_STRUCT_DESC: 30-inch square reinforced concrete box culvert through levee, 14.4 feet below crown. Concrete "U" headwall on the waterside (WS) and landside (LS) ends. Slide gate in 6-foot by 7-foot concrete surge box is located on the WS shoulder. Flap gate is located on the WS end. [Additional Reference(s): DWR Levee Log, 1992. USACE San Joaquin River O&M Manual Unit 13, April 1964, (HLM 0.78), Drawing No. 7-4-1784]. FS Date: 11/18/2016

Concrete inlet on LS toe.

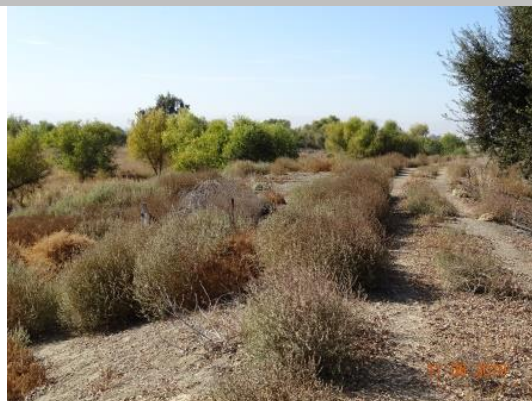
Photo 1 of 1 : FA\_2019\_RD1602\_110\_125\_20191114\_00112.jpg

LM Start	0.98	Rating **	U	Issue No.	125
LM End	1.20	Issue Type +	Ma	Location *	LS
Category	Earthen Levee			GPS Latitude/Longitude	
				Start	End
Item	Vegetation			37.478705 °	37.478321 °
				-121.069081 °	-121.065333 °
DWR ID	DWR_RD1602_01_f_2019_125				
Comment Code					
V1 : Control annual grass and weeds on the levee slopes and easements.					
Inspector Comment

Looking downstream along the landside slope. (Fall 2019)

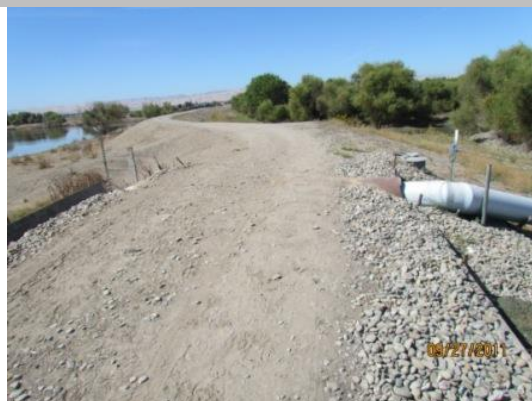
Photo 1 of 1 : FA\_2019\_RD1602\_110\_36\_20190912\_00015.jpg

View of the ramp on the crown. The picture was taken from crown looking downstream.

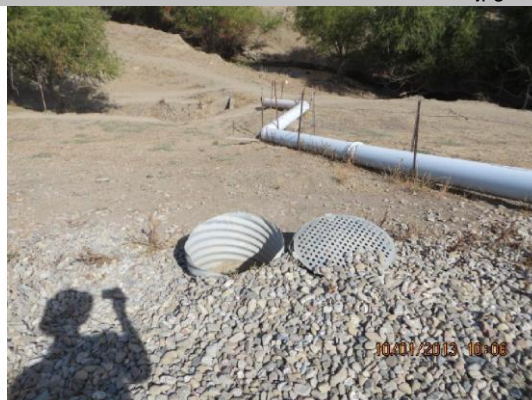
Photo 2 of 3 : UCIP\_FA\_2019\_51636\_36757.jpg

Comment Code						
Inspector Comment						
DS_ID:20217 FS_ID:51636 EP_NO: N/A Repair Type: Non-Urgent Crossing Status: Found UCIP Comments: 11/18/2016 Crossing has been downgraded from Urgent to Non-Urgent a flap gate has been added to the WS but pipe is currently not connected to pump. According to Tony Martinez, LMA representative, this crossing is currently not in use. Owner will need to coordinate with CVFPB to obtain permit. (O. Magana - DWR UCIP)10/01/2013 Appears abandoned and if so should be done so properly. Flapgate missing. (W. Wylie - DWR UCIP) FIELD_STRUCT_DESC: *ABANDONED* 1 of 2: 16-inch steel drainage pipe through levee, 17 feet below crown. Pumps on the pump platform are located on the landside (LS). Siphon breaker in 24-inch corrugated metal pipe (CMP) riser is located on the waterside (WS) shoulder. Concrete "U" headwall and flap gate are located on the WS end. [Additional Reference(s): DWR Levee Log, 1992. USACE San Joaquin River O&M Manual Unit 13, April 1964, (HLM 1.01), Drawing No. 7-4-1784]. FS Date: 11/18/2016

Siphon breaker in 24-inch CMP riser on WS shoulder.

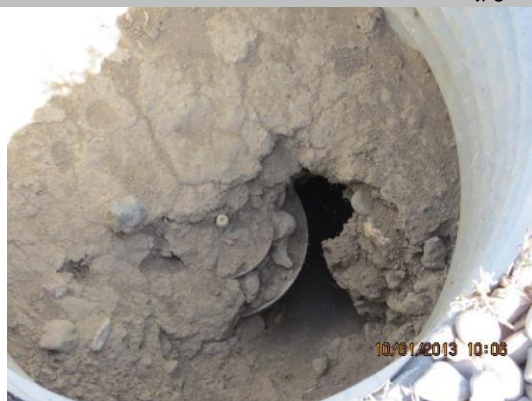
Photo 3 of 3 : UCIP\_FA\_2019\_51636\_36756.jpg

Item	DRAFT DWR UCIP LMA Responsibility			37.478816 °	37.478816 °
				-121.068780 °	-121.068780 °
DWR ID	20217				
Comment Code					
Inspector Comment					
DS_ID:20217 FS_ID:51636 EP_NO: N/A Repair Type: Non-Urgent Crossing Status: Found UCIP Comments: 11/18/2016 Crossing has been downgraded from Urgent to Non-Urgent a flap gate has been added to the WS but pipe is currently not connected to pump. According to Tony Martinez, LMA representative, this crossing is currently not in use. Owner will need to coordinate with CVFPB to obtain permit. (O. Magana - DWR UCIP)10/01/2013 Appears abandoned and if so should be done so properly. Flapgate missing. (W. Wylie - DWR UCIP) FIELD_STRUCT_DESC: *ABANDONED* 1 of 2: 16-inch steel drainage pipe through levee, 17 feet below crown. Pumps on the pump platform are located on the landside (LS). Siphon breaker in 24-inch corrugated metal pipe (CMP) riser is located on the waterside (WS) shoulder. Concrete "U" headwall and flap gate are located on the WS end. [Additional Reference(s): DWR Levee Log, 1992. USACE San Joaquin River O&M Manual Unit 13, April 1964, (HLM 1.01), Drawing No. 7-4-1784]. FS Date: 11/18/2016

Siphon breaker in 24-inch CMP riser on WS shoulder.

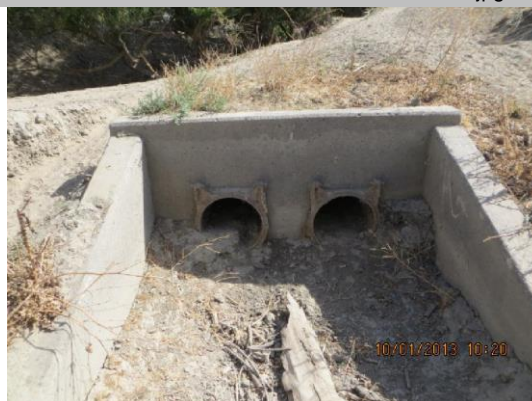
Photo 3 of 3 : UCIP\_FA\_2019\_51637\_36770.jpg

Comment Code						
Inspector Comment						
DS_ID:20219 FS_ID:51637 EP_NO: N/A Repair Type: Non-Urgent Crossing Status: Found UCIP Comments: 11/18/2016 Crossing has been downgraded from Urgent to Non-Urgent a flap gate has been added to the WS. According to Tony Martinez, LMA representative, this crossing is currently not in use. Owner will need to coordinate with CVFPB to obtain permit. (O. Magana - DWR UCIP)10/01/2013 Appears abandoned siphon breakers covered in soil and flapgate missing. (W. Wylie - DWR UCIP) FIELD_STRUCT_DESC: *ABANDONED* 2 of 2: 16-inch steel drainage pipe through levee, 17 feet below crown. Pump on pump platform located on the landside (LS). Siphon breaker in 24-inch riser located on the waterside (WS) shoulder. Concrete "U" headwall and flap gate are located on the WS end. [Additional Reference(s): DWR Levee Log, 1992. USACE San Joaquin River O&M Manual Unit 13, April 1964, (HLM 1.01), Drawing No. 7-4-1784]. FS Date: 11/18/2016

Concrete headwall on WS toe with missing flapgate.

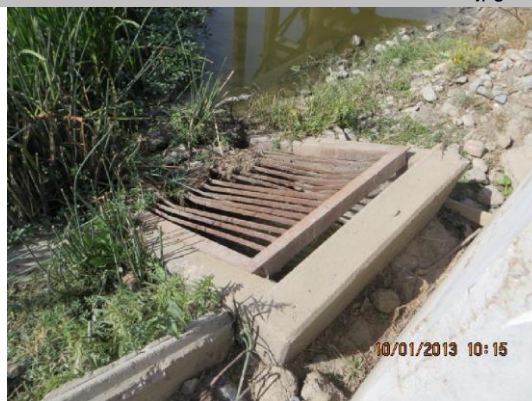
Photo 2 of 3 : UCIP\_FA\_2019\_53521\_36785.jpg

UCIP Comments: 10/19/2018 Pipe remains the same. WS concrete headwall is still detached with vertical erosion on the WS slope. Dense vegetation along pipe alignment made it difficult to inspect levee slopes and identify any potential issues present at this site. Recommend clearing vegetation along pipe alignment to be able to conduct a proper UCIP inspection. This crossing is part of DWR's Flood System Repair Project (FSRP) and Deferred Maintenance Project (DMP). Crossing will be monitored to identify progress of erosion on the WS slope. Crossing remains Urgent due to the detachment of the concrete wall and vertical cut on the WS. (O. Magana - DWR UCIP)11/18/2016 Same as previous inspection headwall on the WS toe has separated from pipe and flap gate is still missing. Erosion around concrete headwall and undermined WS slope are visible from WS. The slope undermined appears to have progressed but no photos were taken due to the dense vegetation covering area. According to Tony Martinez, LMA representative, the WS concrete headwall has been detached since 2008/2009. LMA has been in contact with CVFPB, DWR, and USACE regarding this site. (O. Magana - DWR UCIP)10/01/2013 Headwall on WS toe separated from pipe. Erosion around concrete headwall and undermined at WS toe. Flap gate missing from WS toe headwall. (W. Wylie - DWR UCIP)

Grated inlet at LS toe.

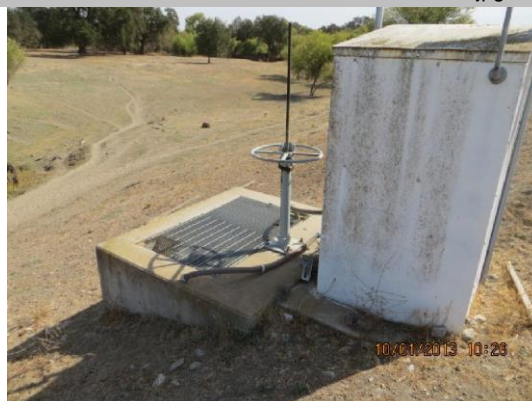
Photo 3 of 3 : UCIP\_FA\_2019\_53521\_36789.jpg

UCIP Comments: 10/19/2018 Pipe remains the same. WS concrete headwall is still detached with vertical erosion on the WS slope. Dense vegetation along pipe alignment made it difficult to inspect levee slopes and identify any potential issues present at this site. Recommend clearing vegetation along pipe alignment to be able to conduct a proper UCIP inspection. This crossing is part of DWR's Flood System Repair Project (FSRP) and Deferred Maintenance Project (DMP). Crossing will be monitored to identify progress of erosion on the WS slope. Crossing remains Urgent due to the detachment of the concrete wall and vertical cut on the WS. (O. Magana - DWR UCIP)11/18/2016 Same as previous inspection headwall on the WS toe has separated from pipe and flap gate is still missing. Erosion around concrete headwall and undermined WS slope are visible from WS. The slope undermined appears to have progressed but no photos were taken due to the dense vegetation covering area. According to Tony Martinez, LMA representative, the WS concrete headwall has been detached since 2008/2009. LMA has been in contact with CVFPB, DWR, and USACE regarding this site. (O. Magana - DWR UCIP)10/01/2013 Headwall on WS toe separated from pipe. Erosion around concrete headwall and undermined at WS toe. Flap gate missing from WS toe headwall. (W. Wylie - DWR UCIP)

Slide gate in concrete riser next to shed on WS shoulder.

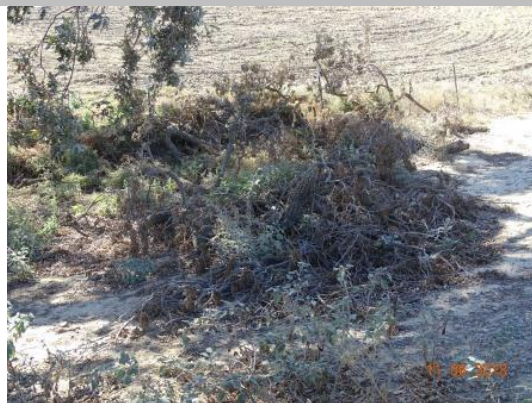
Photo 1 of 1 : FA\_2019\_RD1602\_110\_101\_20190912\_00058.jpg

pruning pile at landside toe. (Fall 2018)

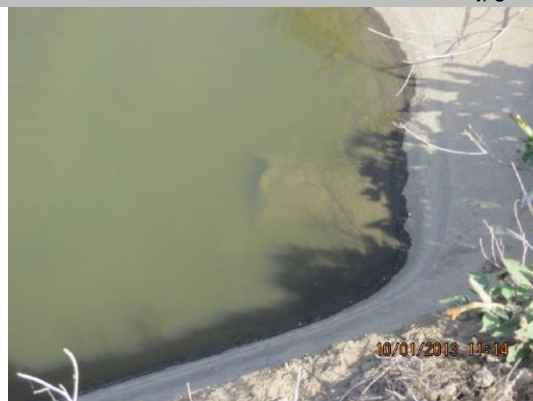
Photo 1 of 3 : UCIP\_FA\_2019\_53522\_36805.jpg

Pipe visible in concrete channel on LS toe.

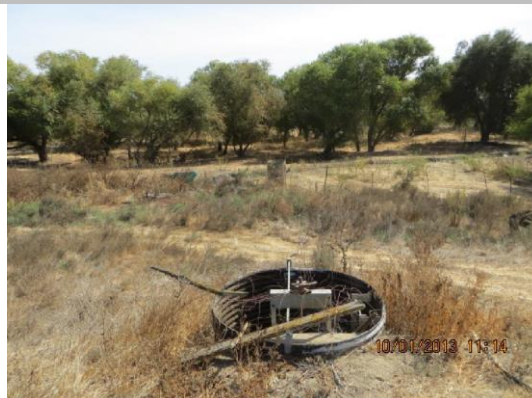
Photo 2 of 3 : UCIP\_FA\_2019\_53522\_36804.jpg

Slide gate in 60-inch CMP riser on WS shoulder.

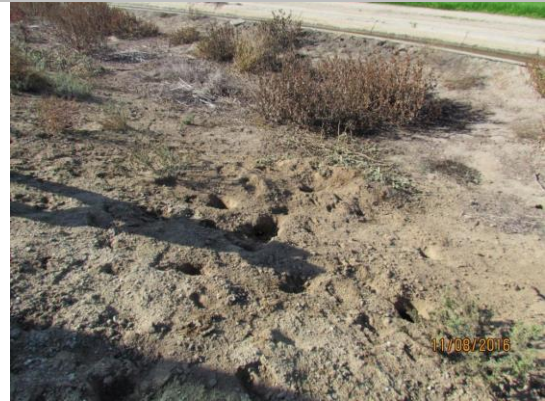
Photo 1 of 1 : FA\_2019\_RD1602\_110\_56\_20190912\_00027.jpg

View of rodent holes on the landside of the levee. Fall 2016

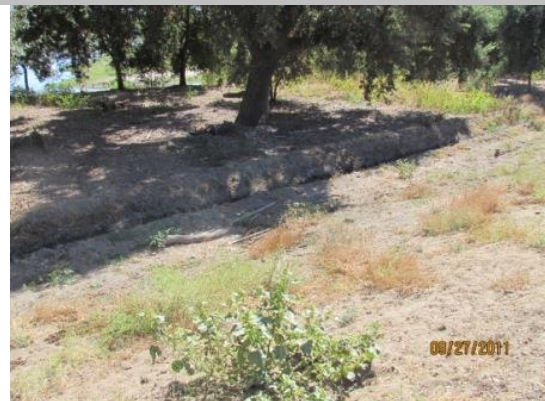
Photo 1 of 1 : FA\_2019\_RD1602\_110\_50\_20190912\_00024.jpg

A ditch was located on the waterside toe of the levee. The picture was taken from the crown looking upstream.

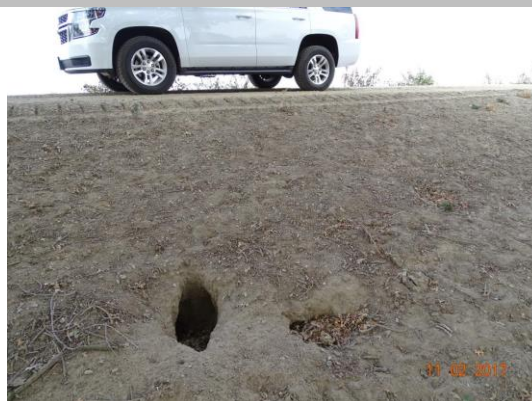
Photo 1 of 1 : FA\_2019\_RD1602\_110\_57\_20190912\_00028.jpg

View of a rodent hole on the waterside of the levee.

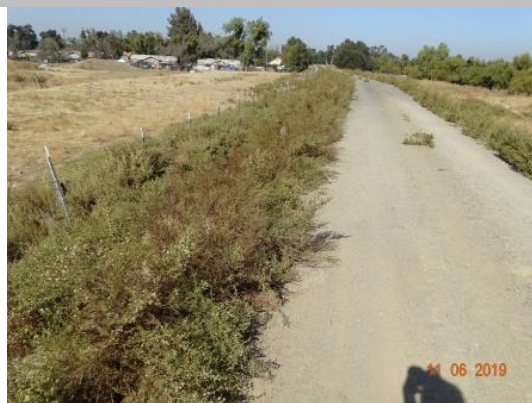
Photo 1 of 1 : FA\_2019\_RD1602\_110\_99\_20191114\_00119.jpg

Looking upstream along the landside slope. (Fall 2019)

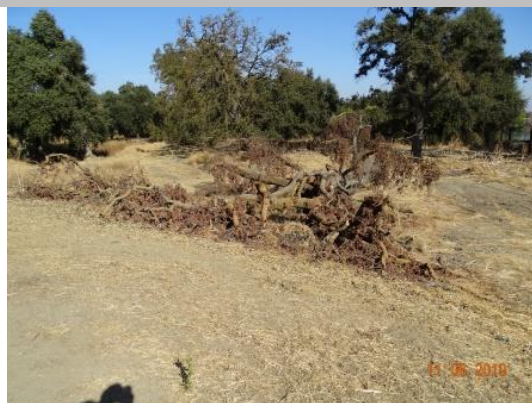
Photo 1 of 1 : FA\_2019\_RD1602\_110\_102\_20191114\_00120.jpg

View of fallen tree on the waterside slope and toe. (Fall 2019)

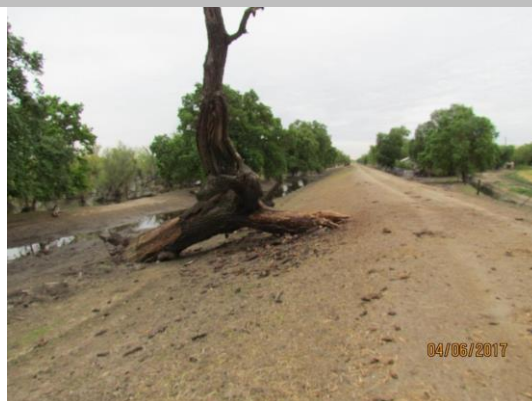
Photo 1 of 1 : FA\_2019\_RD1602\_110\_83\_20190912\_00048.jpg

View of a tree trunk on the waterside slope of the levee.

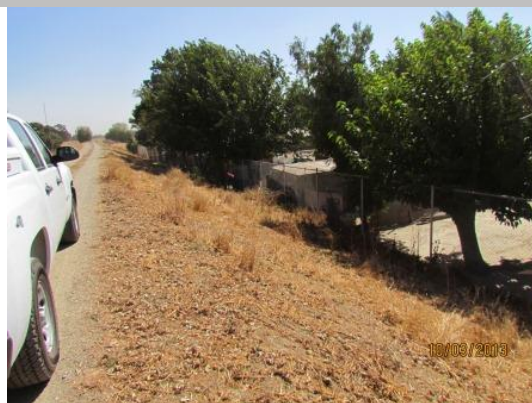
Photo 1 of 3 : FA\_2019\_RD1602\_110\_66\_20190912\_00036.jpg

Fences were found on the landside toe of the levee looking upstream.

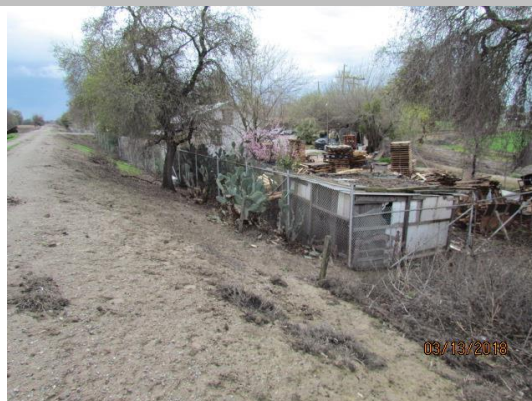
Photo 2 of 3 : FA\_2019\_RD1602\_110\_66\_20190912\_00037.jpg

Looking southwest at animal pens and other encroachments on landward toe. (Spring 2018)

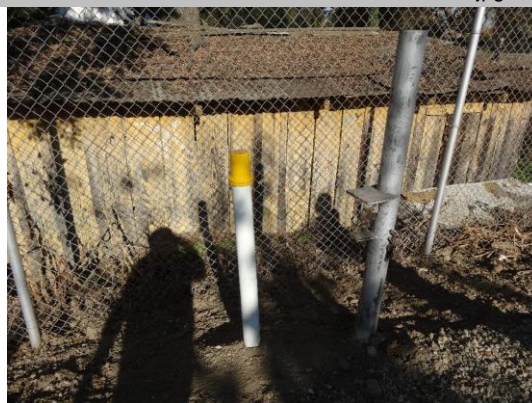
Photo 3 of 3 : UCIP\_FA\_2019\_53523\_76536.jpg

PVC riser with yellow cover located along fence on LS.

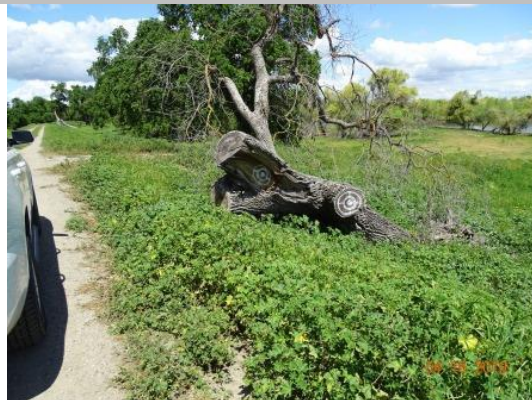
Photo 1 of 1 : FA\_2019\_RD1602\_110\_90\_20190912\_00053.jpg

Fallen tree trunk on waterside slope. (Spring 2019)

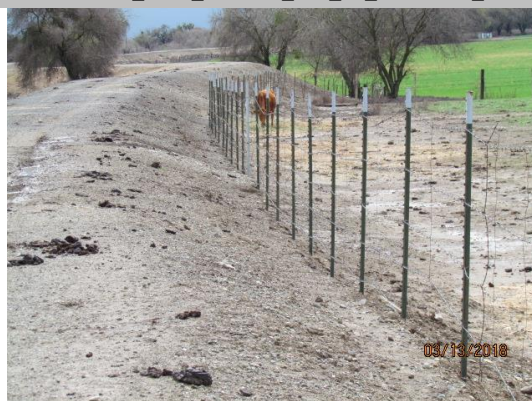
Photo 2 of 2 : FA\_2019\_RD1602\_110\_63\_20190912\_00034.jpg

Looking upstream at new fence on landward slope. (Spring 2018)

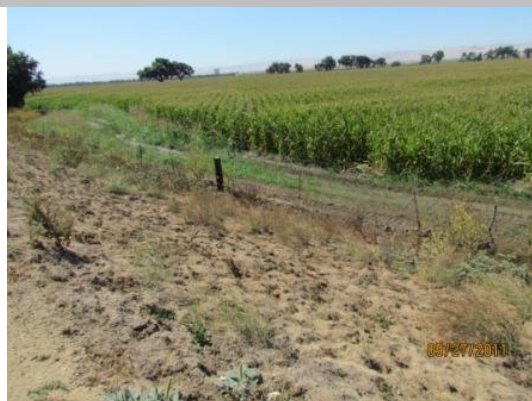
Photo 1 of 1 : FA\_2019\_RD1602\_110\_67\_20190912\_00039.jpg

View of the fence on the landside toe of the levee. The picture was taken from the crown looking upstream.

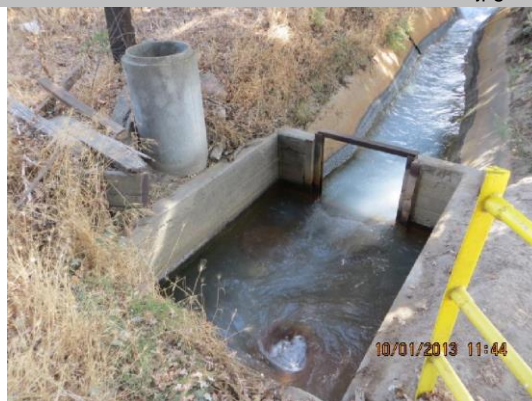
Photo 3 of 3 : UCIP\_FA\_2019\_51332\_36817.jpg

Concrete ditch at outlet from pipe on LS toe.

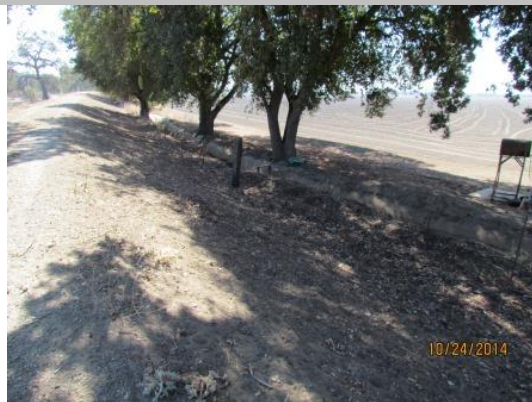
Photo 1 of 1 : FA\_2019\_RD1602\_110\_64\_20190912\_00035.jpg

View of a ditch on the landside toe of the levee looking upstream.

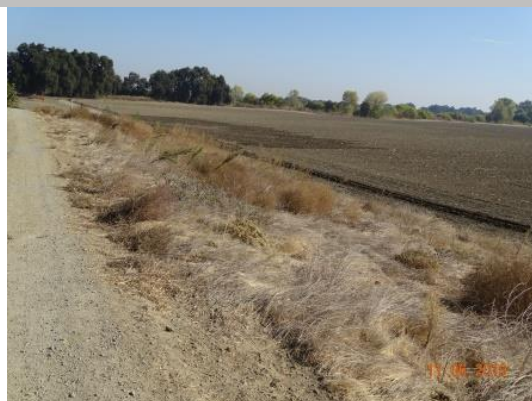
Photo 1 of 1 : FA\_2019\_RD1602\_110\_37\_20191114\_00124.jpg

Looking downstream along the waterside slope. (Fall 2019)

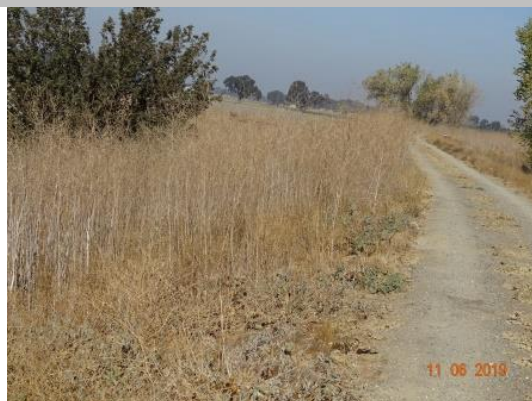
Photo 1 of 1 : FA\_2019\_RD1602\_110\_72\_20191114\_00125.jpg

View of vegetation along the landside slope looking downstream. (Fall 2019)

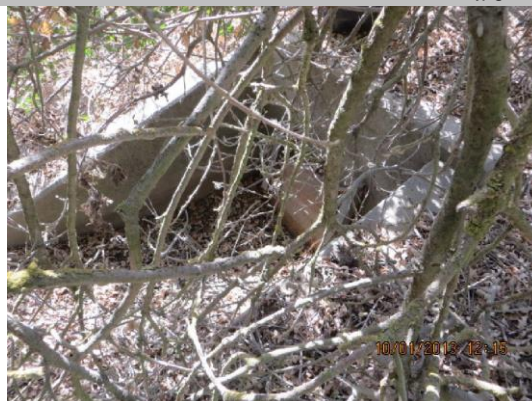
Photo 2 of 3 : UCIP\_FA\_2019\_51336\_36821.jpg

Flapgate in Concrete headwall on WS toe under tree.

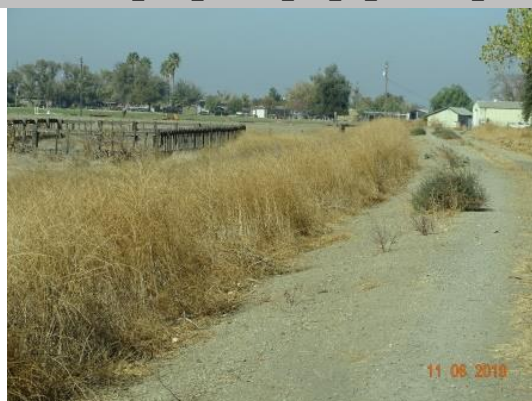
Photo 1 of 1 : FA\_2019\_RD1602\_110\_58\_20191114\_00126.jpg

View of the landside slope looking downstream. (Fall 2019)

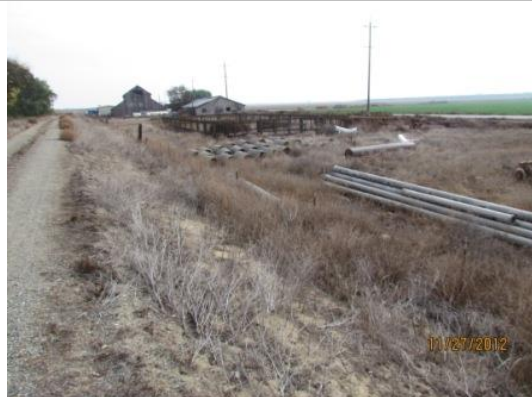
Photo 1 of 1 : FA\_2019\_RD1602\_110\_22\_20190912\_00006.jpg

A fence was found on the landside toe of the levee looking upstream.

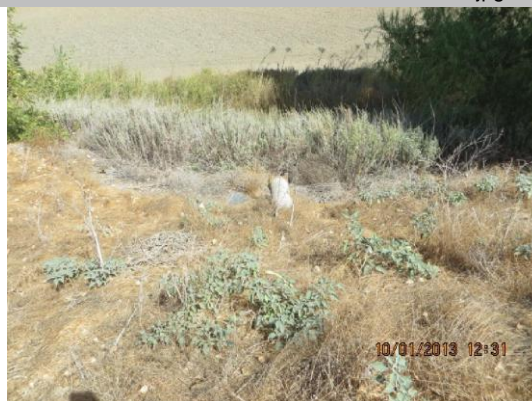
Photo 1 of 1 : UCIP\_FA\_2019\_21674\_36854.jpg

Pipe and flapgate visible on WS toe.

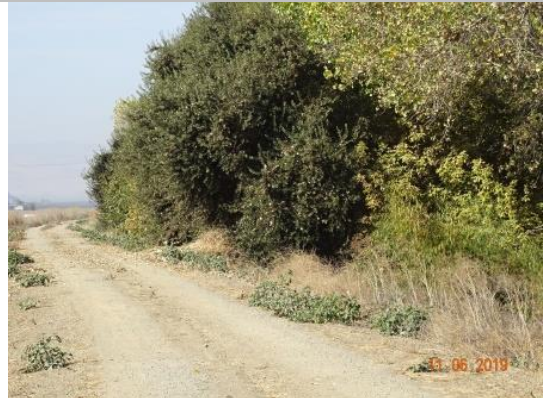
Photo 1 of 2 : FA\_2019\_RD1602\_110\_34\_20191114\_00128.jpg

Looking upstream along the waterside shoulder. (Fall 2019)

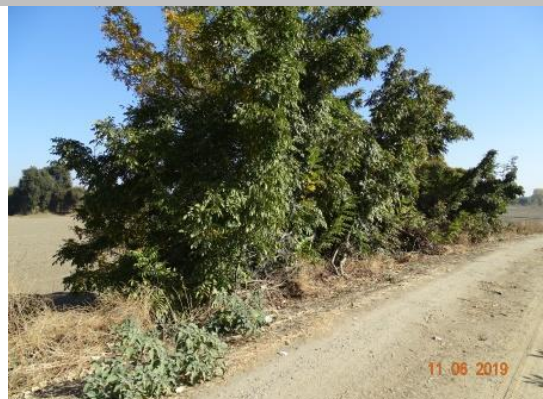
Photo 1 of 1 : FA\_2019\_RD1602\_110\_26\_20191114\_00129.jpg

View of trees growing on the waterside slope. (Fall 2019)

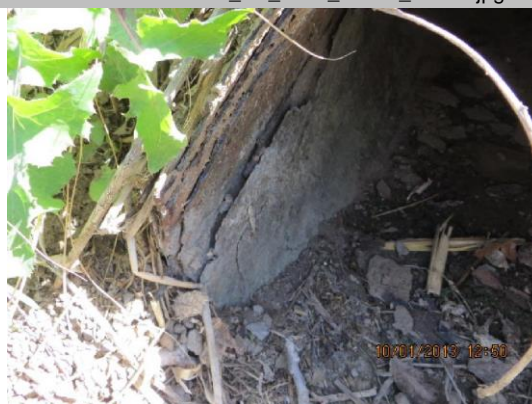
Photo 3 of 3 : UCIP\_FA\_2019\_21683\_36880.jpg

Pipe deteriorated on LS at outlet.
