Flood Control Project Maintenance Levee Inspections

Fall 2020 Levee Maintenance Deficiency Summary Report

San Joaquin River Basin

Reclamation District No. 1602 Del Puerto

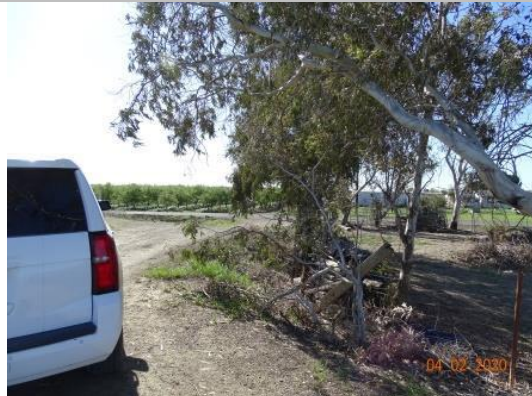
Photo 1 of 1 : FA_2020_RD1602_110_60_20200901_00026.jpg

View of trees on landside slope looking towards Fig Ave. (Spring 2020)

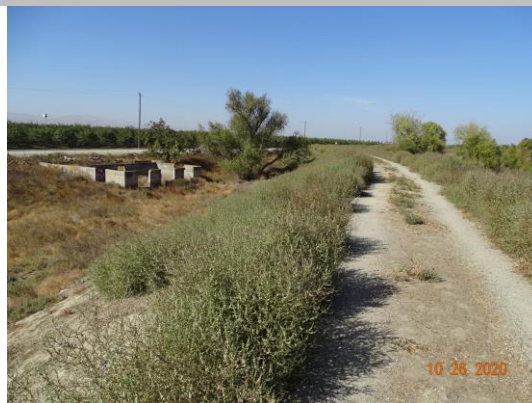
Photo 1 of 1 : FA_2020_RD1602_110_81_20201109_00109.jpg

View of the landside slope looking downstream. (Fall 2020)

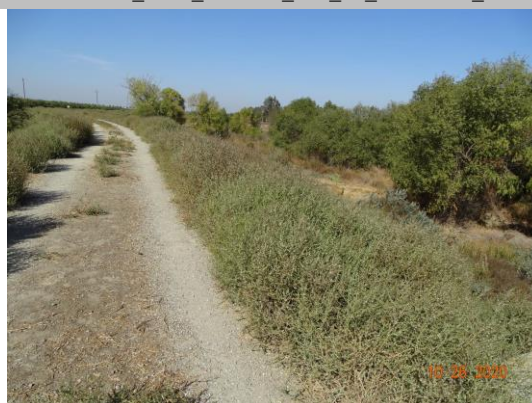
Photo 1 of 1 : FA_2020_RD1602_110_75_20201109_00110.jpg

LM Start	0.31	Rating **	U	Issue No.	75
LM End	0.79	Issue Type +	Ma	Location *	WS
Category	Earthen Levee			GPS Latitude/Longitude	
				Start	End
Item	Vegetation			37.478499 °	37.477835 °
				-121.078935 °	-121.072388 °
DWR ID	DWR_RD1602_01_f_2020_75				
Comment Code					
V1 : Control annual grass and weeds on the levee slopes and easements.					
Inspector Comment

View of the waterside slope looking downstream. (Fall 2020)

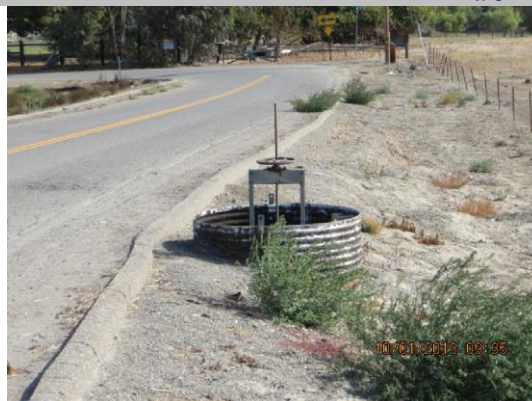
Photo 1 of 3 : UCIP_FA_2020_51325_36702.jpg

DS_ID:20215
FS_ID:51325
EP_NO: N/A
Repair Type: No Action Needed
EVAL Issue:
Crossing Status: Found
UCIP Comments: 11/18/2016 Crossing has been downgraded from Urgent to No Action Needed a cover has been added to the CMP riser. (O. Magana - DWR UCIP)10/01/2013 Open 60-inch CMP riser on WS needs lid as it's depth may be a hazard to the public. (W. Wylie - DWR UCIP)
FIELD_STRUCT_DESC: 16-inch steel drainage pipe through levee, 11.3 feet below crown. Slide gate in 60-inch corrugated metal pipe (CMP) riser located on the waterside (WS). Concrete inlet is approximately 110 feet west of the levee crown or 110 feet off landside (LS) toe next to roadway. [Additional Reference(s): DWR Levee Log, 1992. USACE San Joaquin River O&M Manual Unit 13, April 1964, (HLM 0.58), Drawing No. 7-4-1784].
FS Date: 11/18/2016

60-inch CMP riser on WS shoulder.

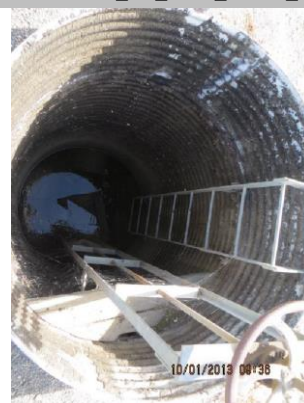
Photo 2 of 3 : UCIP_FA_2020_51325_36701.jpg

CMP riser with slide gate on WS shoulder.

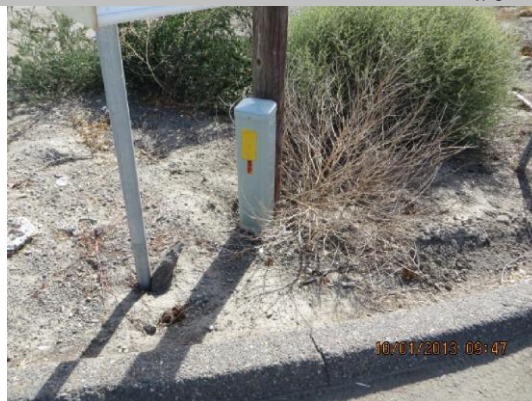
Photo 2 of 3 : UCIP_FA_2020_22937_39049.jpg

Comment Code
Inspector Comment
DS_ID:24681 FS_ID:22937 EP_NO: N/A Repair Type: Non-Urgent EVAL Issue: Crossing Status: Found UCIP Comments: 10/01/2013 No permit identified for this crossing. (W. Wylie - DWR UCIP) FIELD_STRUCT_DESC: Communications line of an unknown size or material through the levee, at an unknown depth. FS Date: 10/1/2013

Communication line access box on LS shoulder.

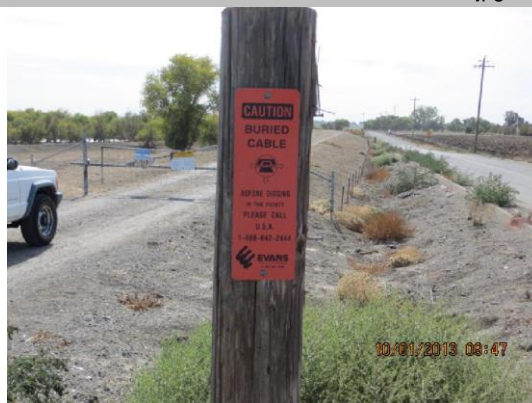
Photo 3 of 3 : UCIP_FA_2020_22937_39048.jpg

Communication line marker on LS shoulder.

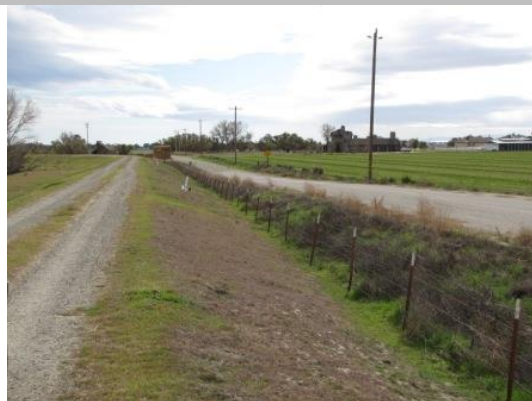
Photo 1 of 1 : FA_2020_RD1602_110_70_20200901_00035.jpg

LM Start	0.60	Rating **	M	Issue No.	70
LM End	0.71	Issue Type +	En	Location *	LS
Category	Earthen Levee			GPS Latitude/Longitude	
				Start	End
Item	Encroachments			37.479967 °	37.478514 °
				-121.074582 °	-121.073435 °
DWR ID	DWR_RD1602_01_s_2012_70				
Comment Code					
FE : Fence					
Inspector Comment					
Barbed wire fence along the landward toe.

View of barbed wire fence at landward toe looking upstream.

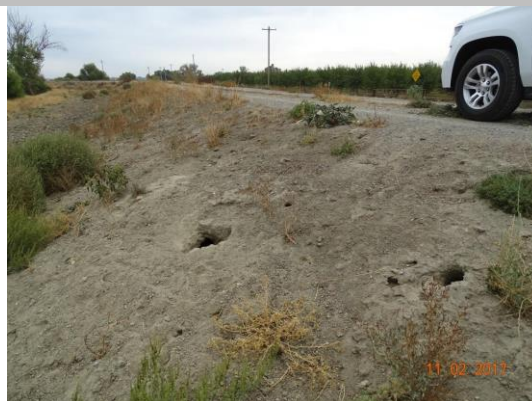
Photo 1 of 1 : FA_2020_RD1602_110_30_20200901_00007.jpg

View of rodent holes on the waterside slope of the levee. Fall 2017

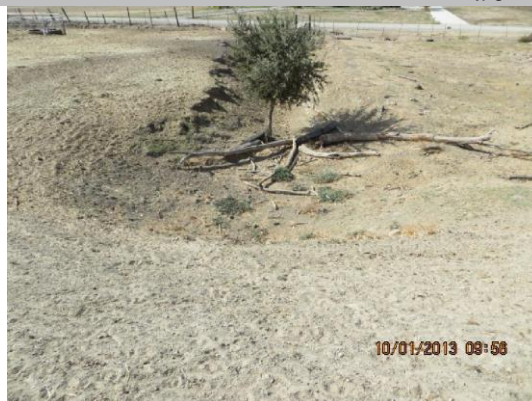
Photo 1 of 3 : UCIP_FA_2020_51634_36723.jpg

DS_ID:20216
FS_ID:51634
EP_NO: N/A
Repair Type: No Action Needed
EVAL Issue:
Crossing Status: Found
UCIP Comments: 11/18/2016 Crossing has been downgraded from Urgent to No Action Needed the debris blocking the outlet has been cleared. (O. Magana - DWR UCIP)10/01/2013 Flap gate blocked from functioning by soil buildup on WS toe. Soil should be cleared. (W. Wylie - DWR UCIP)
FIELD_STRUCT_DESC: 30-inch square reinforced concrete box culvert through levee, 14.4 feet below crown. Concrete "U" headwall on the waterside (WS) and landside (LS) ends. Slide gate in 6-foot by 7-foot concrete surge box is located on the WS shoulder. Flap gate is located on the WS end. [Additional Reference(s): DWR Levee Log, 1992. USACE San Joaquin River O&M Manual Unit 13, April 1964, (HLM 0.78), Drawing No. 7-4-1784].
FS Date: 11/18/2016

Inlet on LS toe.

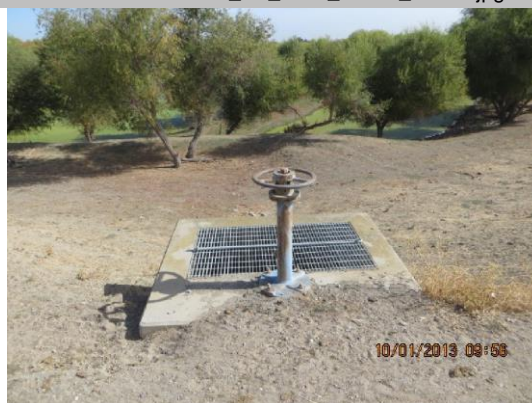
Photo 2 of 3 : UCIP_FA_2020_51634_36722.jpg

Slide gate in concrete box on WS shoulder.

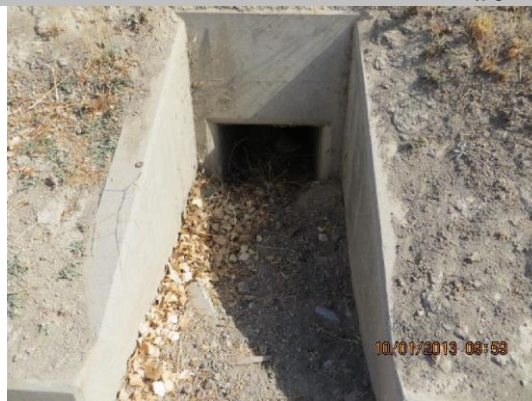
Photo 3 of 3 : UCIP_FA_2020_51634_36721.jpg

Concrete inlet on LS toe.

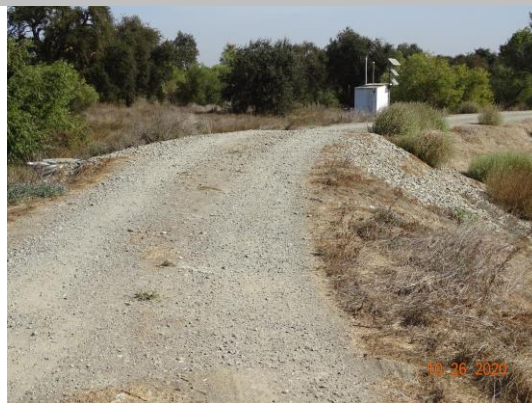
Photo 1 of 1 : FA_2020_RD1602_110_36_20201109_00111.jpg

LM Start	1.00	Rating **	A/W	Issue No.	36
LM End	1.00	Issue Type +	En	Location *	WS
Category	Earthen Levee			GPS Latitude/Longitude	
				Start	End
Item	Encroachments			37.478810 °	37.478810 °
				-121.068738 °	-121.068738 °
DWR ID	DWR_RD1602_01_s_2012_36				
Comment Code					
RA : Ramp					
Inspector Comment					
Pipe owner placed fill over pipe above crown of levee to build ramp over pipe.

View of ramp built up on levee crown. (Fall 2020)

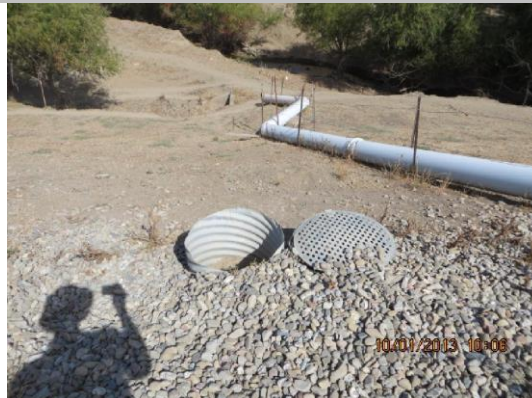
Photo 2 of 3 : UCIP_FA_2020_51636_36757.jpg

Comment Code						
Inspector Comment						
DS_ID:20217 FS_ID:51636 EP_NO: N/A Repair Type: Non-Urgent EVAL Issue: Crossing Status: Found UCIP Comments: 11/18/2016 Crossing has been downgraded from Urgent to Non-Urgent a flap gate has been added to the WS but pipe is currently not connected to pump. According to Tony Martinez, LMA representative, this crossing is currently not in use. Owner will need to coordinate with CVFPB to obtain permit. (O. Magana - DWR UCIP)10/01/2013 Appears abandoned and if so should be done so properly. Flapgate missing. (W. Wylie - DWR UCIP) FIELD_STRUCT_DESC: *ABANDONED* 1 of 2: 16-inch steel drainage pipe through levee, 17 feet below crown. Pumps on the pump platform are located on the landside (LS). Siphon breaker in 24-inch corrugated metal pipe (CMP) riser is located on the waterside (WS) shoulder. Concrete "U" headwall and flap gate are located on the WS end. [Additional Reference(s): DWR Levee Log, 1992. USACE San Joaquin River O&M Manual Unit 13, April 1964, (HLM 1.01), Drawing No. 7-4-1784]. FS Date: 11/18/2016

Siphon breaker in 24-inch CMP riser on WS shoulder.

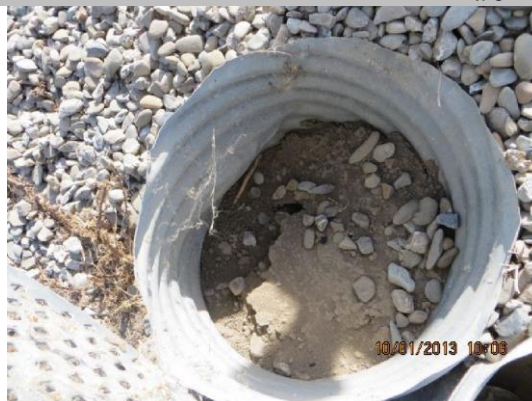
Photo 2 of 3 : UCIP_FA_2020_51637_36771.jpg

Comment Code
Inspector Comment
<p>DS_ID:20219</p> <p>FS_ID:51637</p> <p>EP_NO: N/A</p> <p>Repair Type: Non-Urgent</p> <p>EVAL Issue:</p> <p>Crossing Status: Found</p> <p>UCIP Comments: 11/18/2016 Crossing has been downgraded from Urgent to Non-Urgent a flap gate has been added to the WS. According to Tony Martinez, LMA representative, this crossing is currently not in use. Owner will need to coordinate with CVFPB to obtain permit. (O. Magana - DWR UCIP)10/01/2013 Appears abandoned siphon breakers covered in soil and flapgate missing. (W. Wylie - DWR UCIP)</p> <p>FIELD_STRUCT_DESC: *ABANDONED* 2 of 2: 16-inch steel drainage pipe through levee, 17 feet below crown. Pump on pump platform located on the landside (LS). Siphon breaker in 24-inch riser located on the waterside (WS) shoulder. Concrete "U" headwall and flap gate are located on the WS end. [Additional Reference(s): DWR Levee Log, 1992. USACE San Joaquin River O&M Manual Unit 13, April 1964, (HLM 1.01), Drawing No. 7-4-1784].</p> <p>FS Date: 11/18/2016</p>

Siphon breaker covered in soil at CMP riser on WS shoulder.

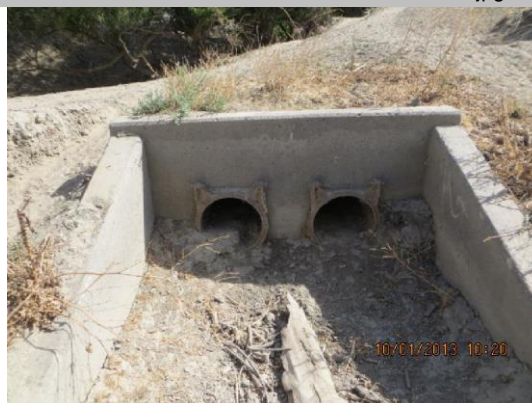
Photo 3 of 3 : UCIP_FA_2020_51637_36770.jpg

Concrete headwall on WS toe with missing flapgate.

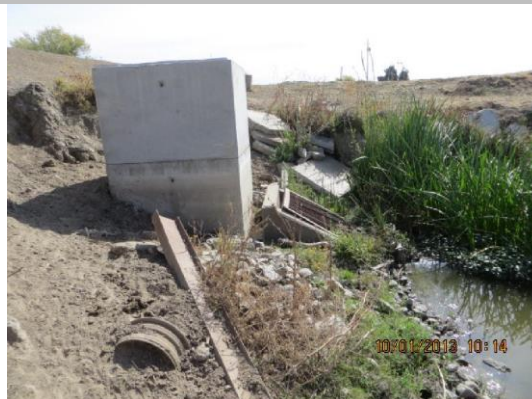
Photo 1 of 3 : UCIP_FA_2020_53521_36786.jpg

UCIP Comments: 10/19/2018 Pipe remains the same. WS concrete headwall is still detached with vertical erosion on the WS slope. Dense vegetation along pipe alignment made it difficult to inspect levee slopes and identify any potential issues present at this site. Recommend clearing vegetation along pipe alignment to be able to conduct a proper UCIP inspection. This crossing is part of DWR's Flood System Repair Project (FSRP) and Deferred Maintenance Project (DMP). Crossing will be monitored to identify progress of erosion on the WS slope. Crossing remains Urgent due to the detachment of the concrete wall and vertical cut on the WS. (O. Magana - DWR UCIP)11/18/2016 Same as previous inspection headwall on the WS toe has separated from pipe and flap gate is still missing. Erosion around concrete headwall and undermined WS slope are visible from WS. The slope undermined appears to have progressed but no photos were taken due to the dense vegetation covering area. According to Tony Martinez, LMA representative, the WS concrete headwall has been detached since 2008/2009. LMA has been in contact with CVFPB, DWR, and USACE regarding this site. (O. Magana - DWR UCIP)10/01/2013 Headwall on WS toe separated from pipe. Erosion around concrete headwall and undermined at WS toe. Flap gate missing from WS toe headwall. (W. Wylie - DWR UCIP)

Grated inlet and 5'X5' concrete box on LS toe.

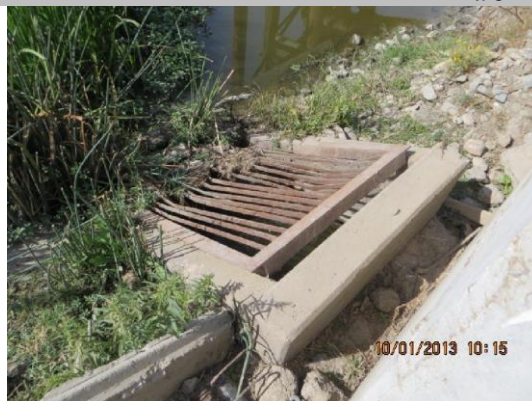
Photo 2 of 3 : UCIP_FA_2020_53521_36785.jpg

Grated inlet at LS toe.

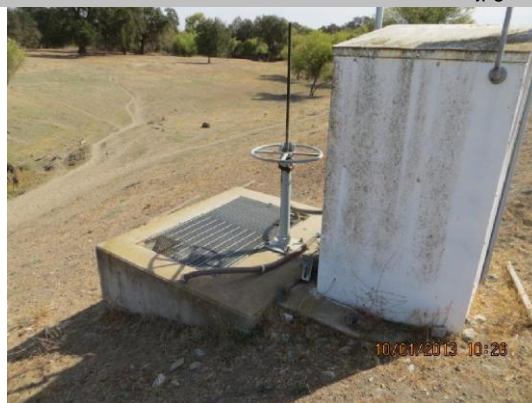
Photo 3 of 3 : UCIP_FA_2020_53521_36789.jpg

Slide gate in concrete riser next to shed on WS shoulder.

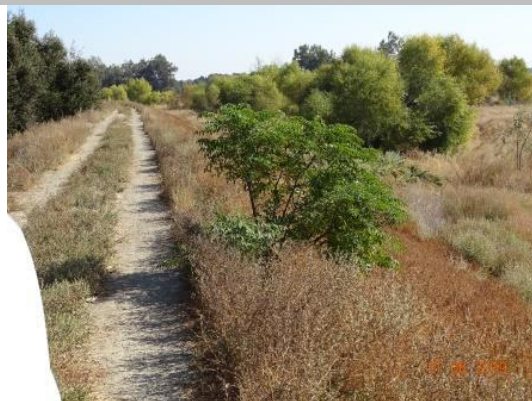
Photo 1 of 1 : FA_2020_RD1602_110_127_20200901_00058.jpg

LM Start	1.09	Rating **	M	Issue No.	127
LM End	1.09	Issue Type +	Ma	Location *	LS
Category	Earthen Levee			GPS Latitude/Longitude	
				Start	End
Item	Trim / Thin Trees			37.478449 °	37.478449 °
				-121.067261 °	-121.067261 °
DWR ID	DWR_RD1602_01_f_2019_127				
Comment Code					
T2 : Thin trees to allow visibility of the ground and room to flood fight.					
Inspector Comment					
Young tree growing in the landside shoulder should be removed before it can establish.

Young tree growing on the landside shoulder should be removed. (Fall 2019)

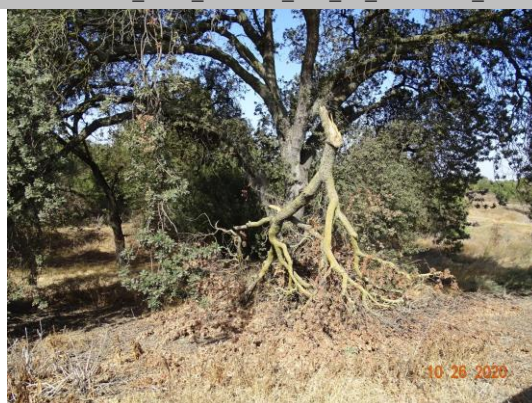
Photo 1 of 1 : FA_2020_RD1602_110_72_20201109_00112.jpg

Tree limb hanging on the waterside slope. (Fall 2020)

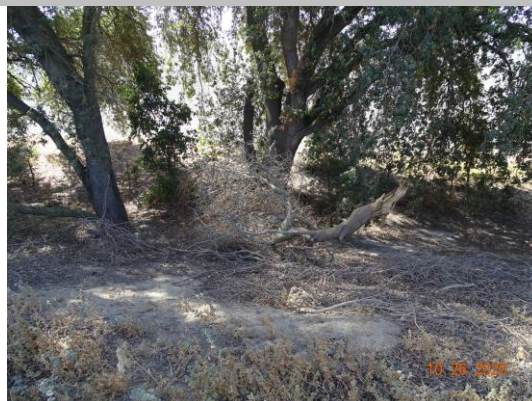
Photo 1 of 1 : FA_2020_RD1602_110_40_20201109_00113.jpg

Broken tree limb left on the landside toe. (Fall 2020)

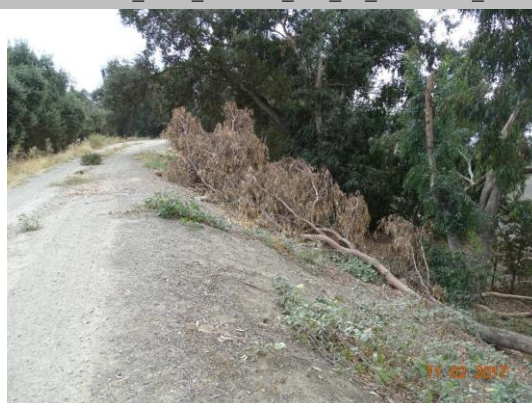
Photo 1 of 1 : FA_2020_RD1602_110_33_20200901_00008.jpg

View of prunings on the landside of the levee.

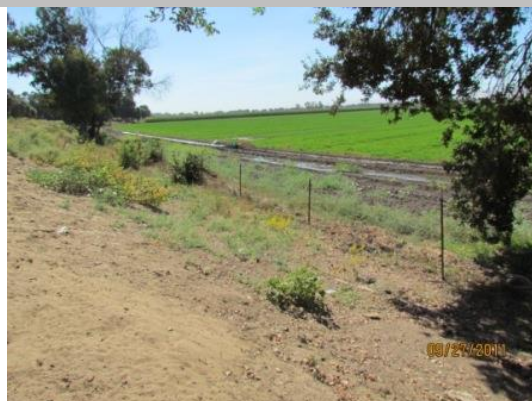
Photo 1 of 1 : FA_2020_RD1602_110_43_20200901_00015.jpg

View of the fence on the landside toe of the levee. The picture was taken from crown looking upstream.

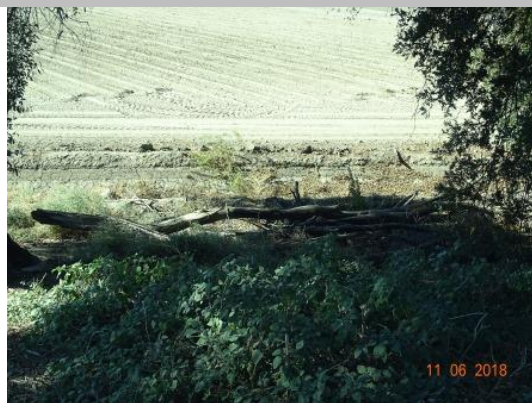
Photo 1 of 1 : FA_2020_RD1602_110_104_20200901_00055.jpg

tree limbs on landside toe. (Fall 2018)

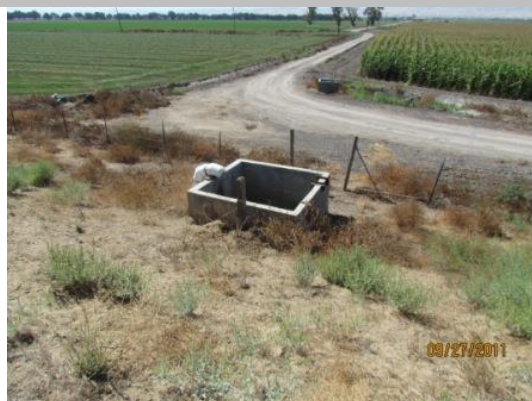
Photo 1 of 1 : FA_2020_RD1602_110_45_20200901_00016.jpg

A well is located at the landside toe of the levee. The picture was taken from the crown looking toward the landside of the levee.

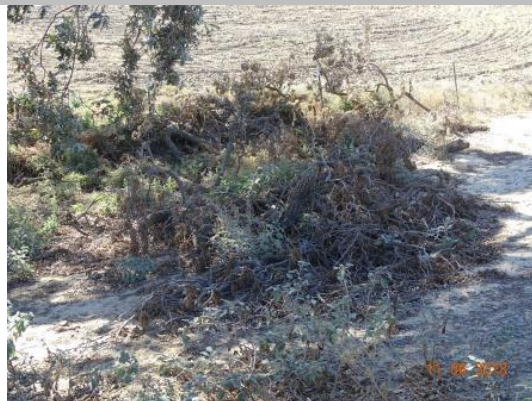
Photo 1 of 1 : FA_2020_RD1602_110_101_20200901_00053.jpg

Pruning pile at landside toe. (Fall 2018)

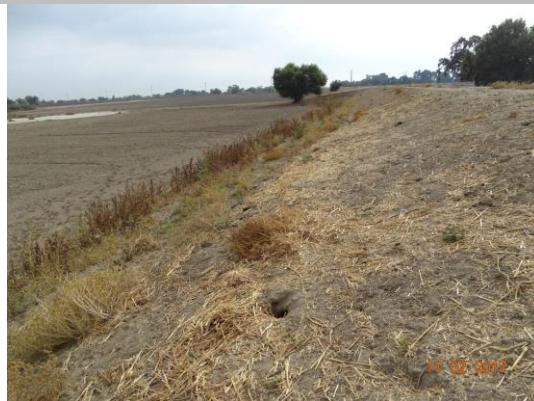
Photo 1 of 1 : FA_2020_RD1602_110_51_20200901_00023.jpg

View of a rodent hole on the waterside of the levee.

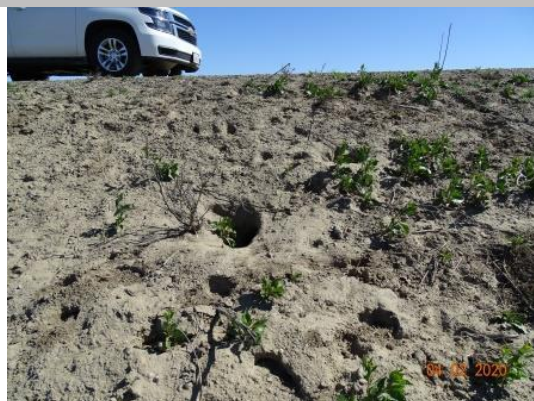
Photo 1 of 1 : FA_2020_RD1602_110_95_20200901_00052.jpg

View of the landside slope from the toe of the levee. (Spring 2020)

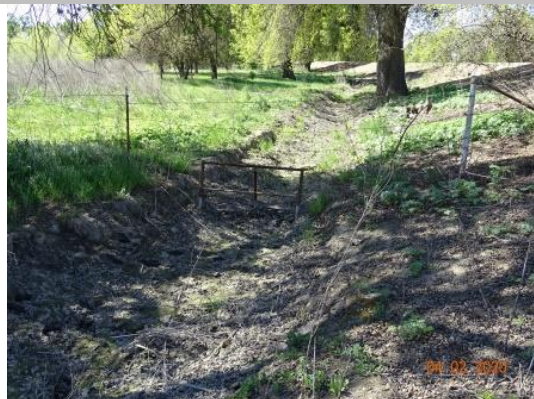
Photo 1 of 1 : FA_2020_RD1602_110_50_20200901_00021.jpg

Looking upstream along the waterside toe. (Spring 2020)

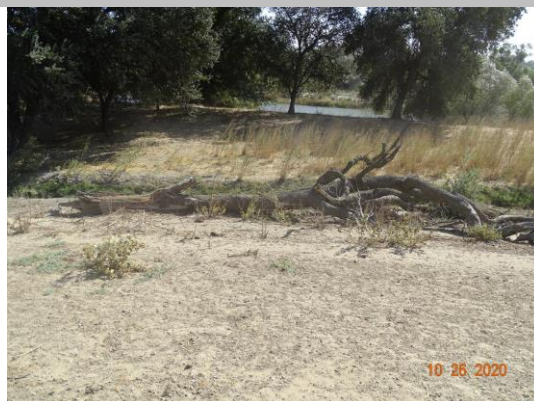
Photo 1 of 1 : FA_2020_RD1602_110_58_20201109_00114.jpg

Large tree limb left on the waterside slope. (Fall 2020)

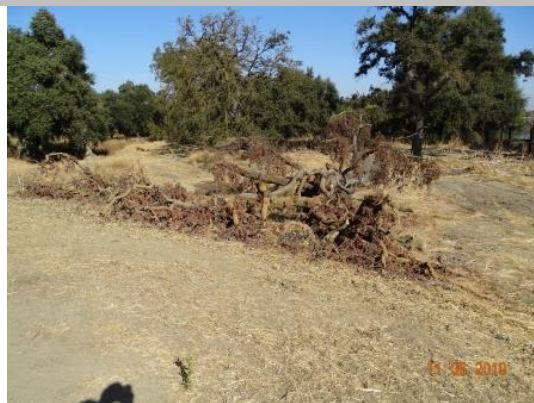
Photo 1 of 1 : FA_2020_RD1602_110_102_20200901_00054.jpg

View of fallen tree on the waterside slope and toe. (Fall 2019)

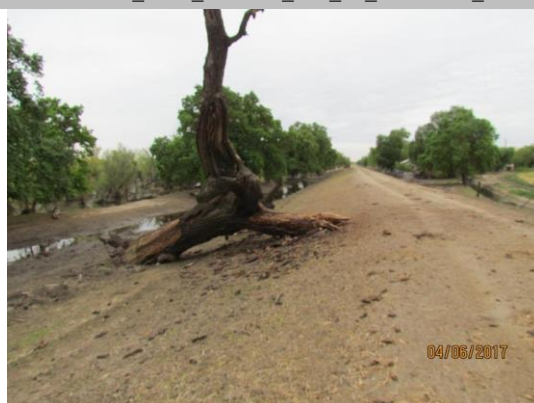
Photo 1 of 1 : FA_2020_RD1602_110_83_20200901_00039.jpg

View of a tree trunk on the waterside slope of the levee.

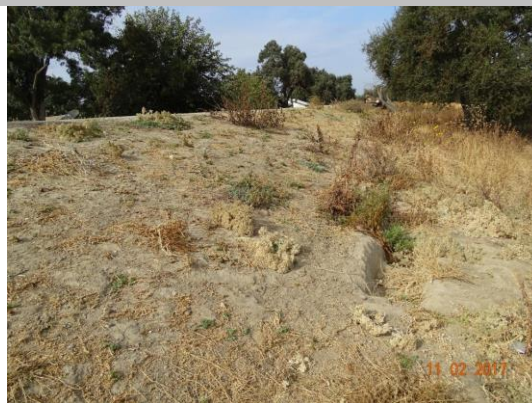
Photo 1 of 1 : FA_2020_RD1602_110_84_20200901_00040.jpg

View of rodent holes on the waterside of the levee.

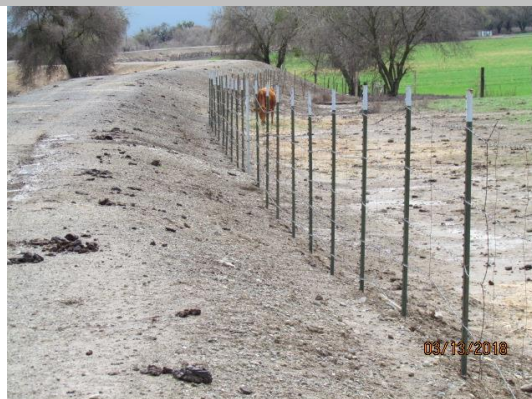
Photo 1 of 1 : FA_2020_RD1602_110_63_20200901_00030.jpg

Looking upstream at fence on landward slope. (Spring 2018)

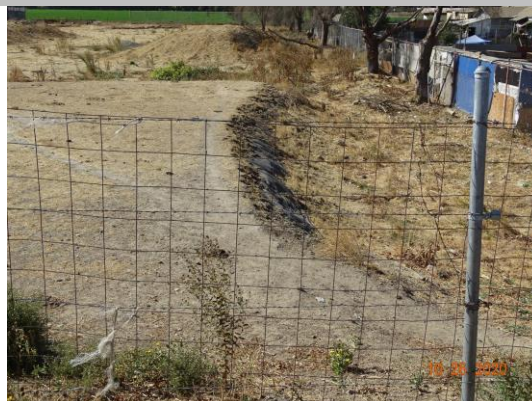
Photo 1 of 1 : FA_2020_RD1602_110_62_20201109_00116.jpg

LM Start	3.93	Rating **	M	Issue No.	62
LM End	3.93	Issue Type +	Ma	Location *	LS
Category	Earthen Levee			GPS Latitude/Longitude	
				Start	End
Item	Slope Stability			37.453216 °	37.453216 °
				-121.042127 °	-121.042127 °
DWR ID	DWR_RD1602_01_s_2012_62				
Comment Code					
S3 : Repair the levee slope damaged by vehicle traffic and prevent access where possible.					
Inspector Comment					
Significant damage to USACE constructed seepage berm due to human activity.

View of damage to seepage berm constructed on the landside toe. (Fall 2020)

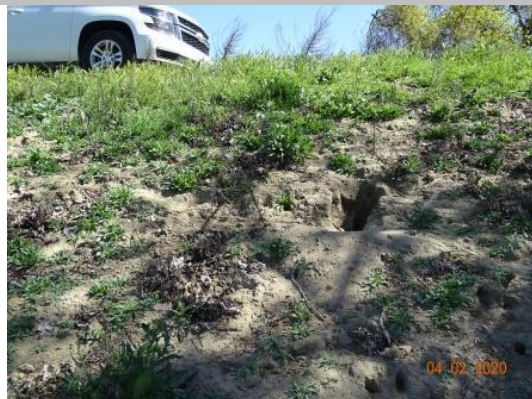
Photo 1 of 1 : FA_2020_RD1602_110_74_20200901_00036.jpg

Looking at the landside slope from the levee toe. (Spring 2020)

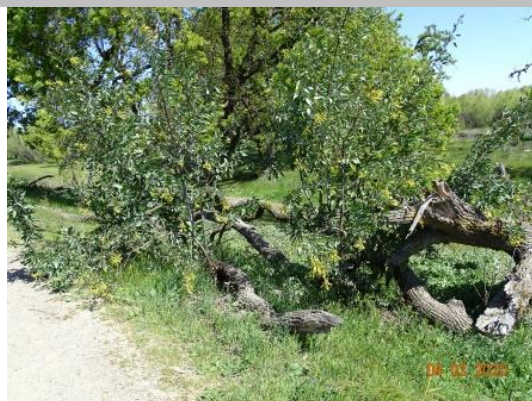
Photo 1 of 1 : FA_2020_RD1602_110_134_20200901_00060.jpg

View of young trees growing around tree limb on the waterside slope.
(Spring 2020)

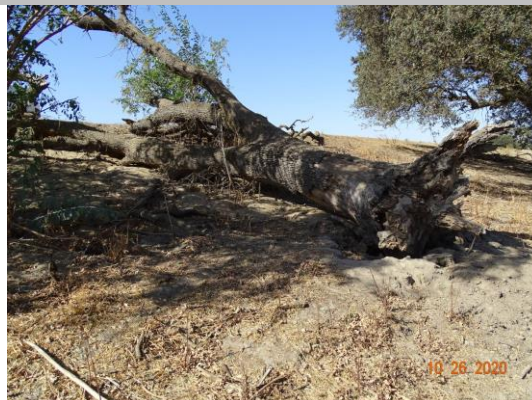
Photo 1 of 1 : FA_2020_RD1602_110_73_20201109_00117.jpg

Large tree has fallen on the waterside slope. (Fall 2020)

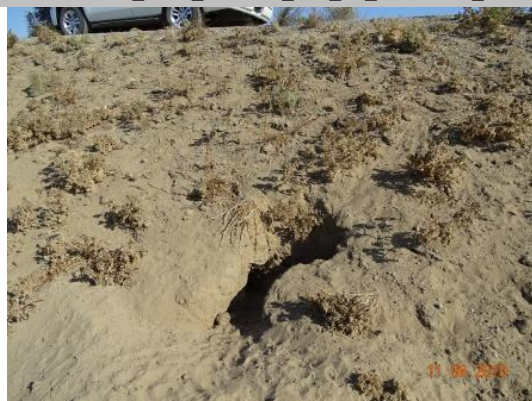
Photo 1 of 1 : FA_2020_RD1602_110_87_20200901_00043.jpg

View of rodent burrows in the landside slope. (Fall 2019)

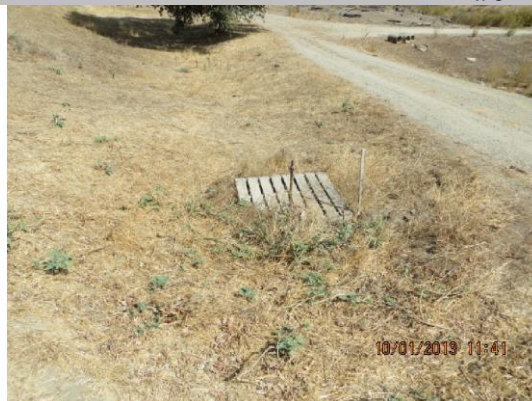
Photo 1 of 3 : UCIP_FA_2020_51332_36819.jpg

Slide gate in CMP riser on WS slope.

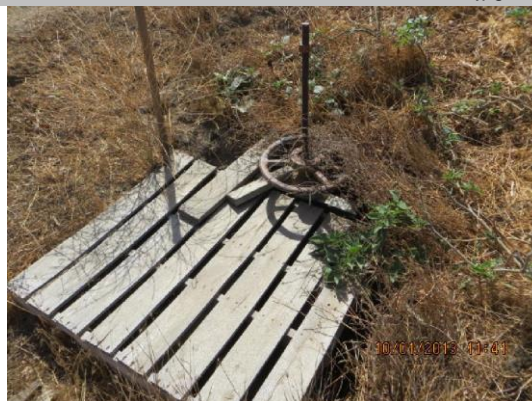
Photo 2 of 3 : UCIP_FA_2020_51332_36818.jpg

Slide gate in CMP riser on WS slope.

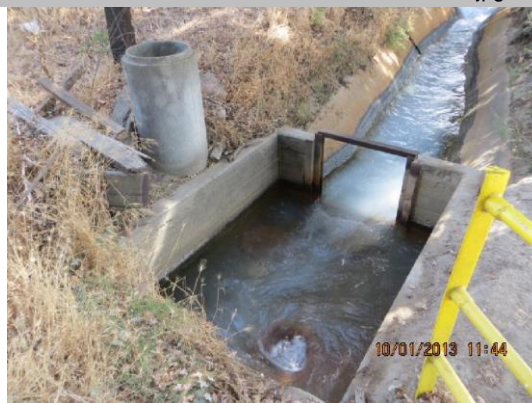
Photo 3 of 3 : UCIP_FA_2020_51332_36817.jpg

Concrete ditch at outlet from pipe on LS toe.

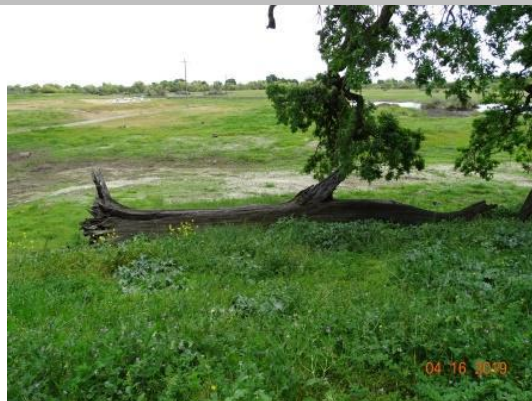
Photo 1 of 1 : FA_2020_RD1602_110_69_20200901_00034.jpg

View of fallen tree trunk on waterside slope. (Spring 2019)

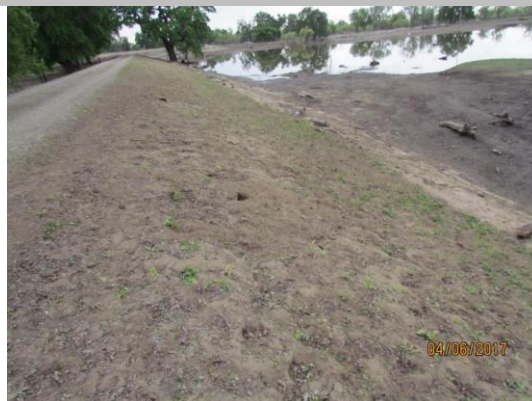
Photo 1 of 1 : FA_2020_RD1602_110_91_20200901_00048.jpg

View of rodent holes on the waterside of the levee looking downstream.
Spring 2017

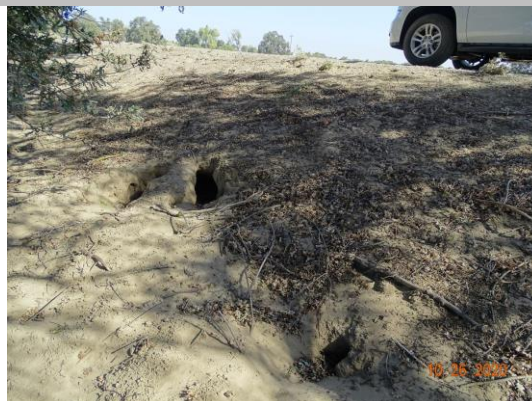
Photo 1 of 1 : FA_2020_RD1602_110_55_20201109_00118.jpg

Large animal burrows in the landside slope. (Fall 2020)

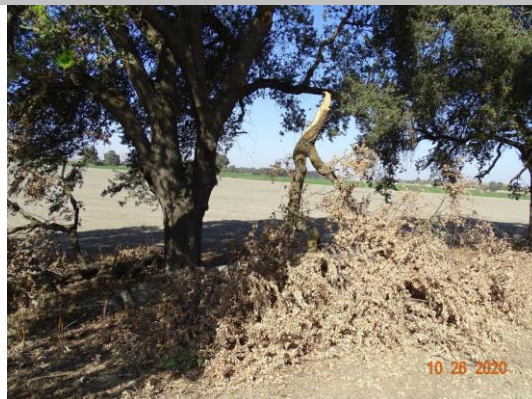
Photo 1 of 1 : FA_2020_RD1602_110_54_20201109_00119.jpg

View of broken tree branch that has fallen on the landside slope. (Fall 2020)

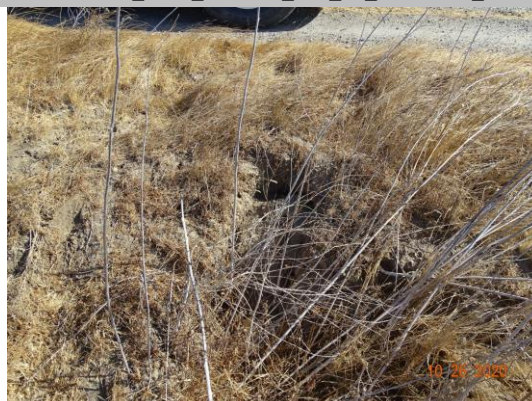
Photo 1 of 1 : FA_2020_RD1602_110_44_20201109_00121.jpg

Several rodent holes noted at this location. (Fall 2020)

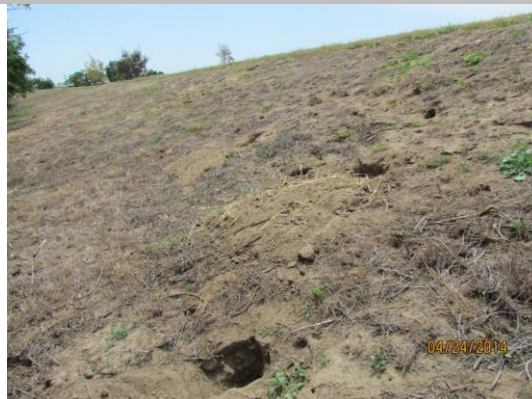
Photo 1 of 1 : FA_2020_RD1602_110_199_20200901_00064.jpg

Rodent holes were found on the waterside toe of the levee looking upstream.

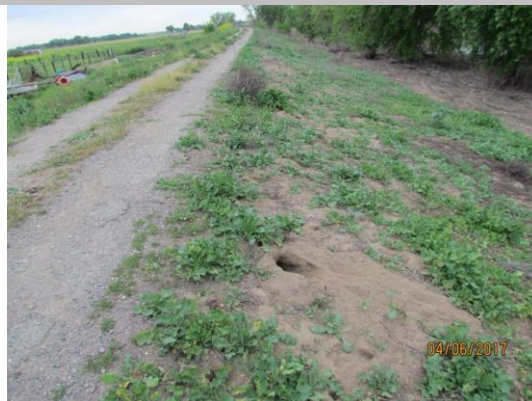
Photo 1 of 1 : FA_2020_RD1602_110_92_20200901_00049.jpg

View of a rodent hole on the waterside shoulder of the levee looking downstream.

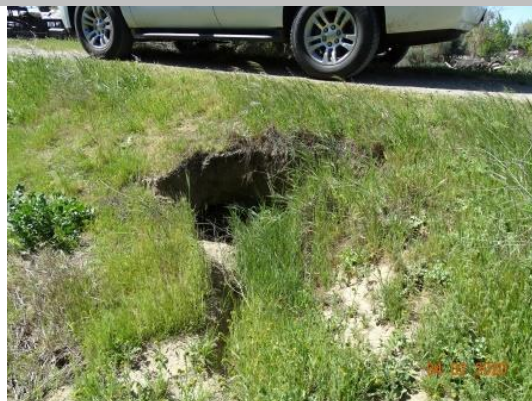
Photo 1 of 1 : FA_2020_RD1602_110_141_20200901_00062.jpg

View of burrow in the waterside shoulder. (Spring 2020)

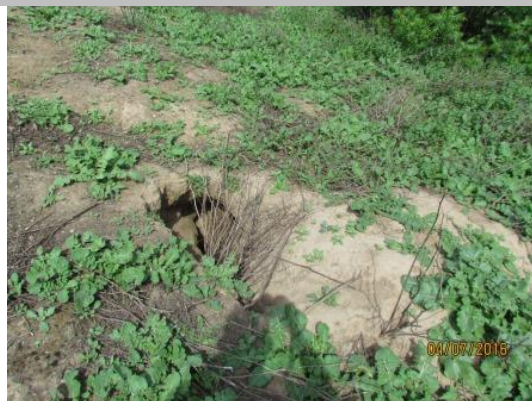
Photo 1 of 1 : FA_2020_RD1602_110_48_20200901_00018.jpg

View of rodent holes on the waterside of the levee looking downstream.

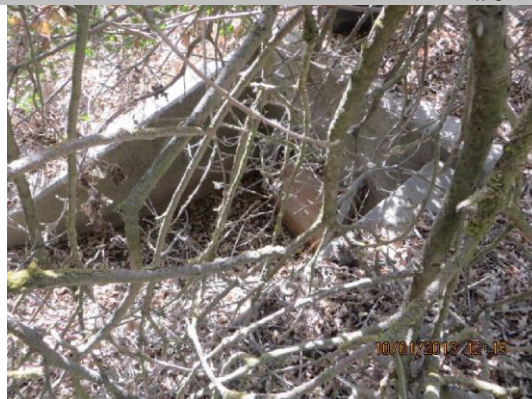
Photo 2 of 3 : UCIP_FA_2020_51336_36821.jpg

Flapgate in Concrete headwall on WS toe under tree.

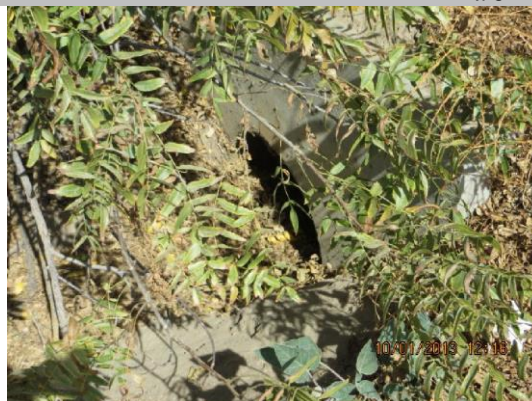
Photo 3 of 3 : UCIP_FA_2020_51336_36820.jpg

Concrete headwall at inlet on LS toe.

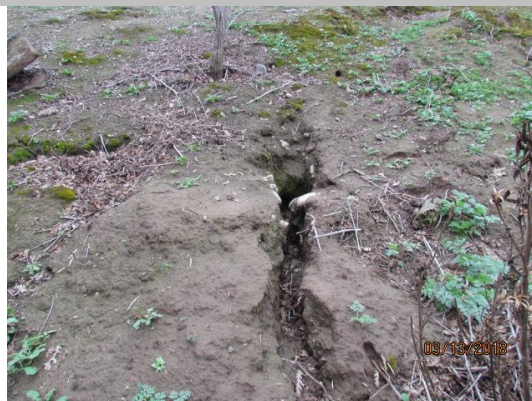
Photo 1 of 1 : FA_2020_RD1602_110_52_20200901_00024.jpg

Looking at rodent hole and erosion around rodent hole on waterward slope.

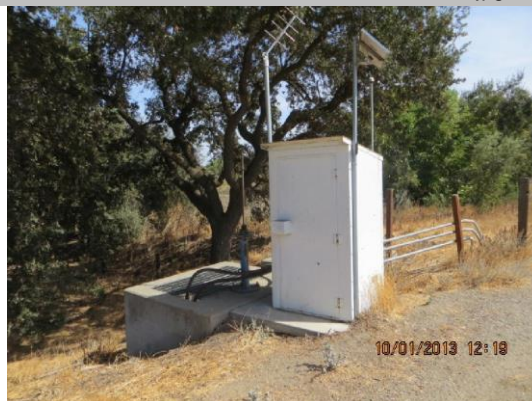
Photo 1 of 2 : UCIP_FA_2020_21665_36829.jpg

Shed with slide gate in Concrete riser on WS shoulder.

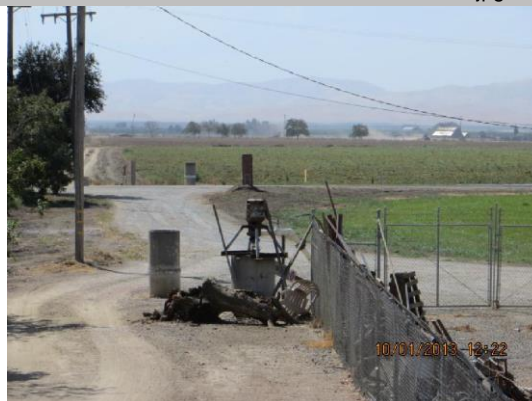
Photo 2 of 2 : UCIP_FA_2020_21665_36828.jpg

Likely risers for pipe off LS toe.

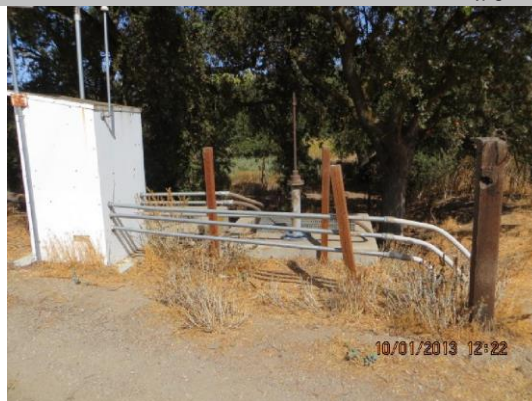
Photo 1 of 2 : UCIP_FA_2020_21668_36835.jpg

Slide gate in Concrete vault on WS shoulder.

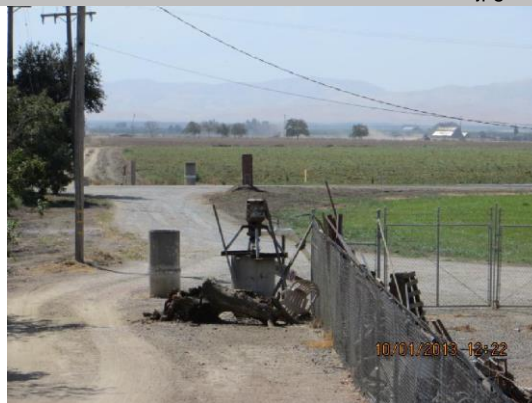
Photo 2 of 2 : UCIP_FA_2020_21668_36834.jpg

Possible concrete risers for pipe off LS toe.

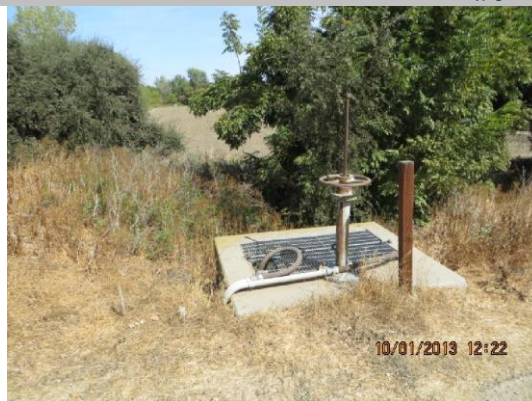
Photo 1 of 3 : UCIP_FA_2020_21672_36848.jpg

Slidegate in concrete riser on WS shoulder.

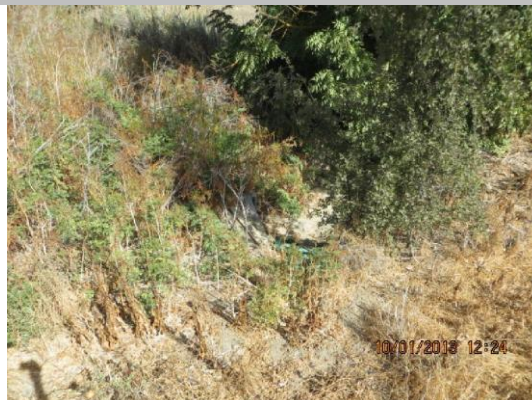
Photo 2 of 3 : UCIP_FA_2020_21672_36847.jpg

Concrete outlet on WS toe.

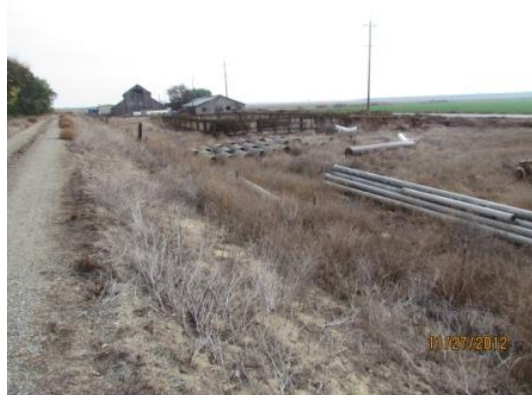
Photo 1 of 1 : FA_2020_RD1602_110_22_20200901_00005.jpg

A fence was found on the landside toe of the levee looking upstream.

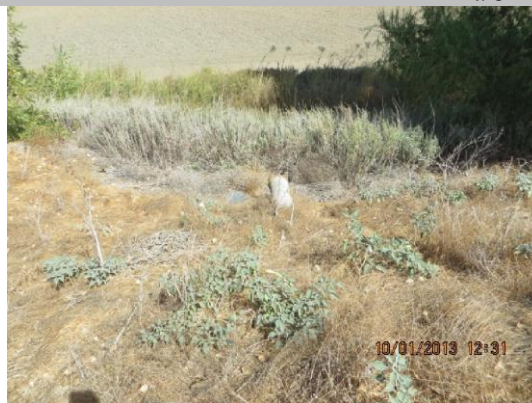
Photo 1 of 1 : UCIP_FA_2020_21674_36854.jpg

Pipe and flapgate visible on WS toe.

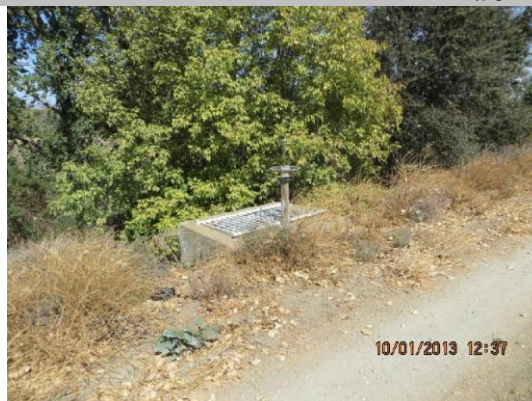
Photo 1 of 3 : UCIP_FA_2020_51337_36878.jpg

Slide gate in concrete riser on WS shoulder.

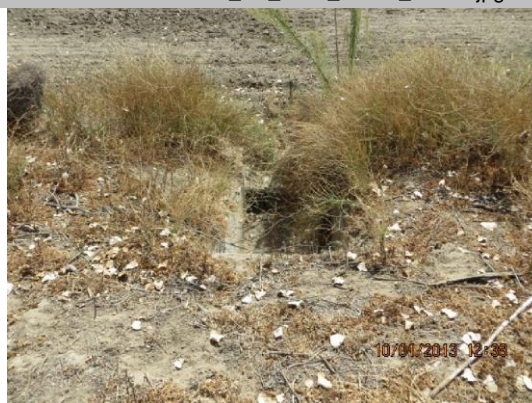
Photo 2 of 3 : UCIP_FA_2020_51337_36877.jpg

Concrete U-shaped headwall on LS toe.

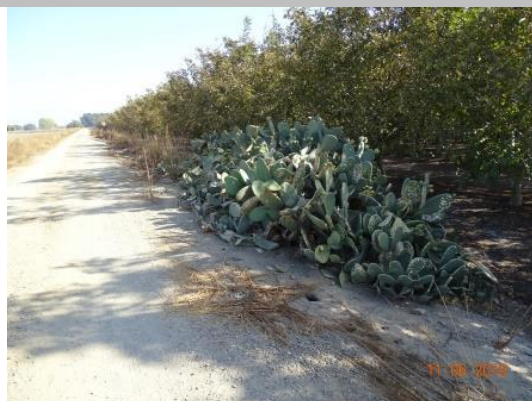
Photo 1 of 1 : FA_2020_RD1602_110_86_20200901_00041.jpg

Looking at dense cactus growth on the waterside slope. (Fall 2019)

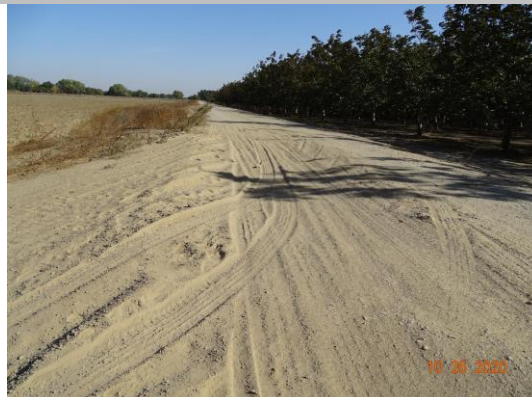
Photo 1 of 1 : FA_2020_RD1602_110_24_20201109_00122.jpg

Depression in levee crown from vehicle traffic. (Fall 2020)

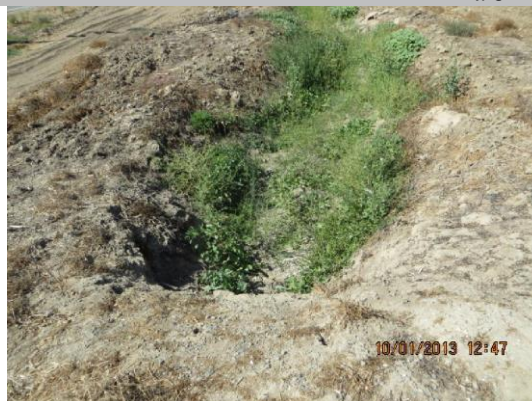
Photo 1 of 3 : UCIP_FA_2020_21683_36882.jpg

Drainage/irrigation canal on LS toe.

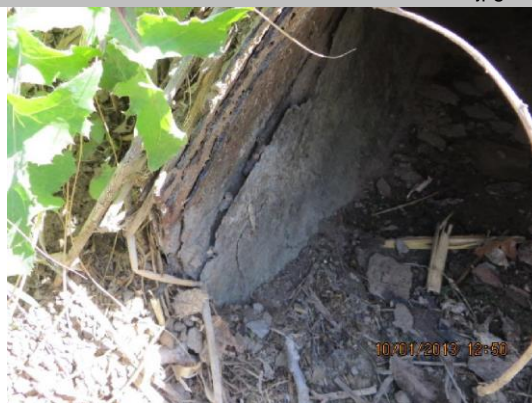
Photo 3 of 3 : UCIP_FA_2020_21683_36880.jpg

Pipe deteriorated on LS at outlet.
