Flood Control Project Maintenance Levee Inspections

Fall 2021 Levee Maintenance Deficiency Summary Report

San Joaquin River Basin

Reclamation District No. 1602 Del Puerto

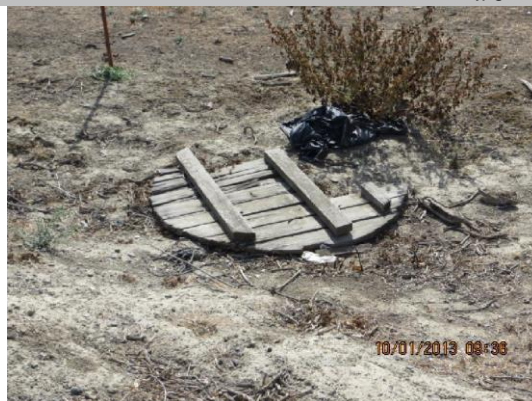
Photo 3 of 3 : UCIP_FA_2021_51325_36700.jpg

Damaged Wooden lid on WS toe.

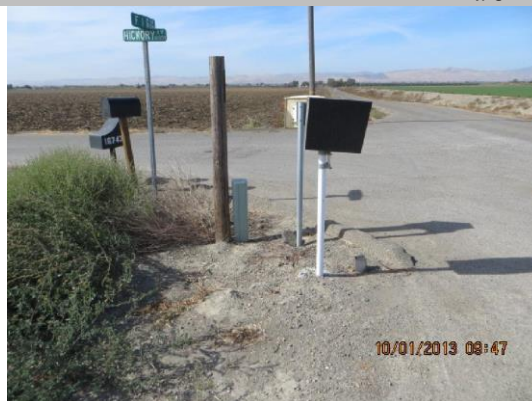
Photo 1 of 3 : UCIP_FA_2021_22937_39050.jpg

DS_ID:24681
 FS_ID:22937
 EP_NO: N/A
 Repair Type: Non-Urgent
 EVAL Issue:
 Crossing Status: Found
 UCIP Comments: 10/01/2013 No permit identified for this crossing. (W. Wylie - DWR UCIP)
 FIELD_STRUCT_DESC: Communications line of an unknown size or material through the levee, at an unknown depth.
 FS Date: 10/1/2013

Communication line access box on LS shoulder.

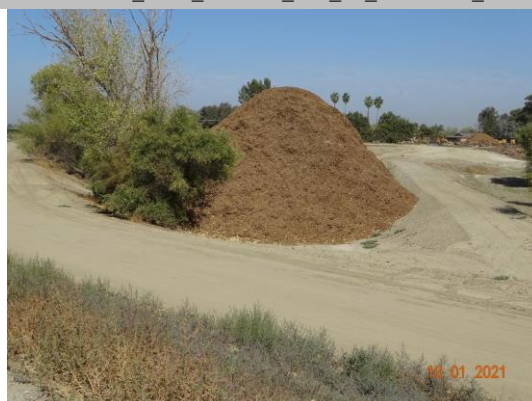
Photo 1 of 1 : FA_2021_RD1602_110_29_20211011_00094.jpg

LM Start	0.73	Rating **	U	Issue No.	29
LM End	0.73	Issue Type +	Ma	Location *	WS
Category	Rivers, Channels & Designated Floodways			GPS Latitude/Longitude	
				Start	End
Item	Encroachments			37.478415 °	37.478415 °
				-121.073284 °	-121.073284 °
DWR ID	DWR_RD1602_01_f_2021_29				
Comment Code					
Inspector Comment					
Material piled within the channel. Part of bmx course.

Haul road constructed by an adjacent landowner and material piled in the channel. (Fall 2021)

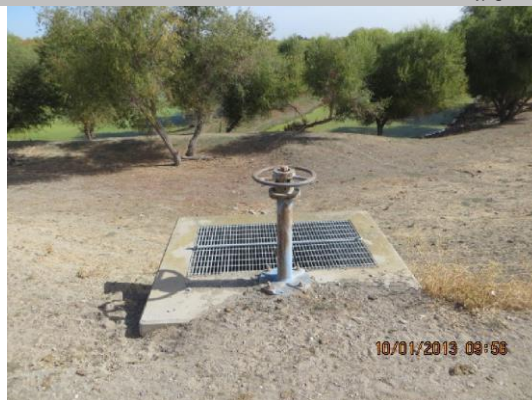
Photo 2 of 3 : UCIP_FA_2021_51634_36722.jpg

Slide gate in concrete box on WS shoulder.

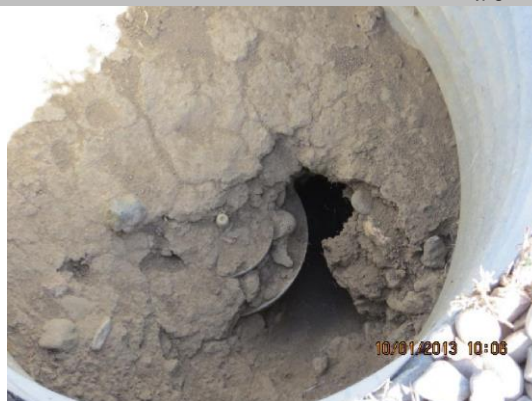
Photo 3 of 3 : UCIP_FA_2021_51636_36756.jpg

Siphon breaker in 24-inch CMP riser on WS shoulder.

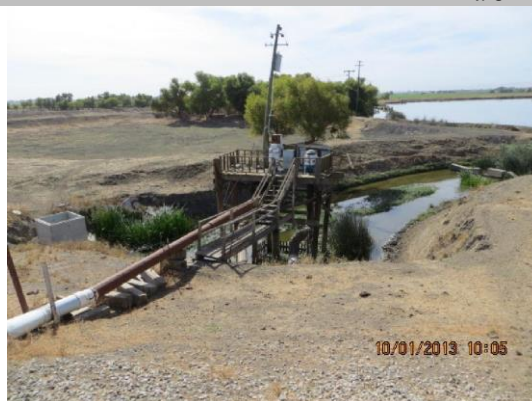
Photo 1 of 3 : UCIP_FA_2021_51637_36772.jpg

DS_ID:20219
FS_ID:51637
EP_NO: N/A
Repair Type: Non-Urgent
EVAL Issue:
Crossing Status: Found
UCIP Comments: 11/18/2016 Crossing has been downgraded from Urgent to Non-Urgent a flap gate has been added to the WS. According to Tony Martinez, LMA representative, this crossing is currently not in use. Owner will need to coordinate with CVFPB to obtain permit. (O. Magana - DWR UCIP)10/01/2013 Appears abandoned siphon breakers covered in soil and flapgate missing. (W. Wylie - DWR UCIP) FIELD_STRUCT_DESC: *ABANDONED* 2 of 2: 16-inch steel drainage pipe through levee, 17 feet below crown. Pump on pump platform located on the landside (LS). Siphon breaker in 24-inch riser located on the waterside (WS) shoulder. Concrete "U" headwall and flap gate are located on the WS end. [Additional Reference(s): DWR Levee Log, 1992. USACE San Joaquin River O&M Manual Unit 13, April 1964, (HLM 1.01), Drawing No. 7-4-1784].

Pipe visible under walkway at puming plant on LS toe.

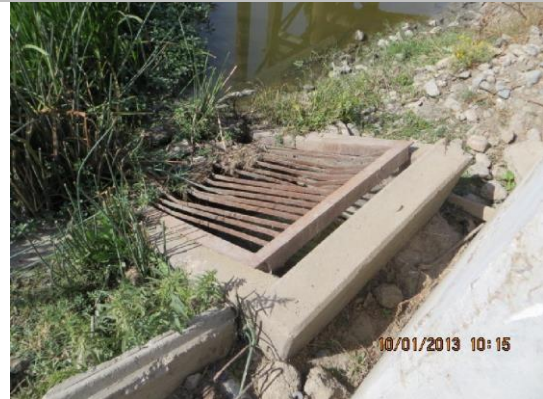
Photo 2 of 3 : UCIP_FA_2021_53521_36785.jpg

Grated inlet at LS toe.

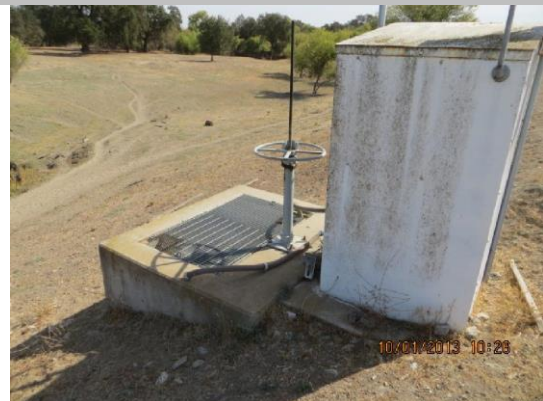
Photo 3 of 3 : UCIP_FA_2021_53521_36789.jpg

Slide gate in concrete riser next to shed on WS shoulder.

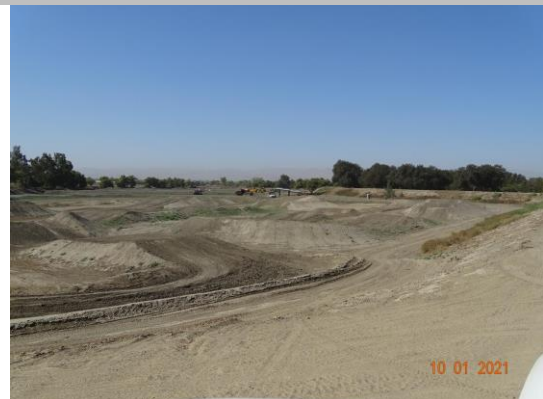
Photo 1 of 1 : FA_2021_RD1602_110_28_20211011_00091.jpg

Landowner is constructing a BMX track on the landside toe. (Fall 2021)

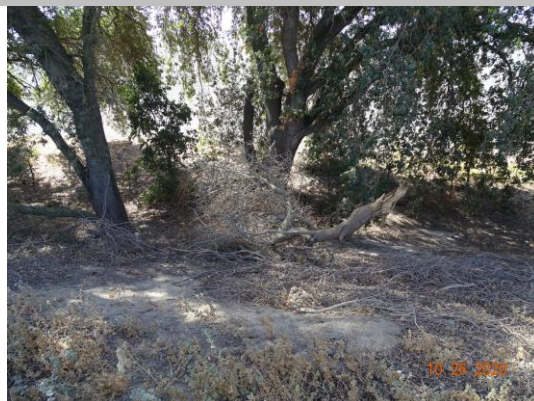
Photo 1 of 1 : FA_2021_RD1602_110_40_20210830_00010.jpg

Broken tree limb left on the landside toe. (Fall 2020)

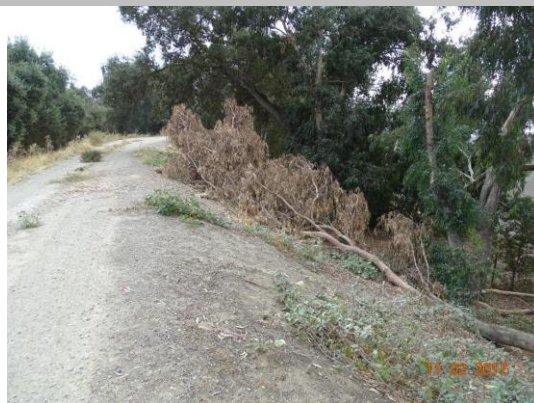
Photo 1 of 1 : FA_2021_RD1602_110_33_20210830_00007.jpg

View of tree limb on the landside of the levee.

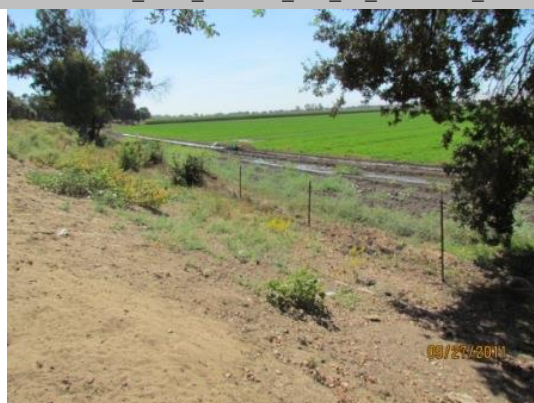
Photo 1 of 1 : FA_2021_RD1602_110_43_20210830_00012.jpg

View of the fence on the landside toe of the levee. The picture was taken from crown looking upstream.

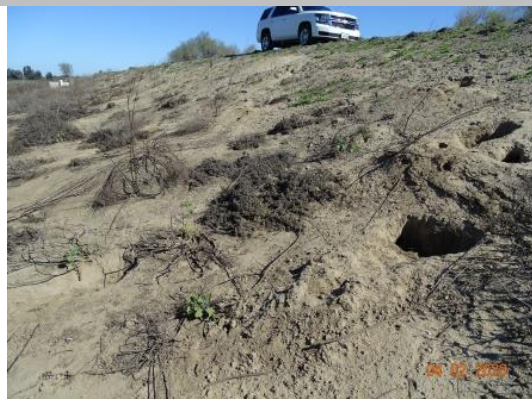
Photo 1 of 1 : FA_2021_RD1602_110_93_20210830_00039.jpg

View of rodent burrows on the landside slope. (Spring 2020)

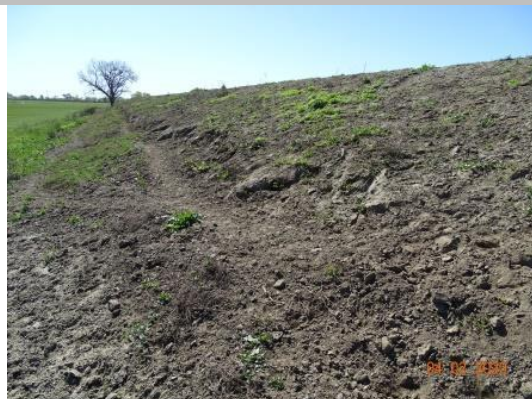
Photo 1 of 1 : FA_2021_RD1602_110_119_20210830_00043.jpg

LM Start	2.81	Rating **	M	Issue No.	119
LM End	3.01	Issue Type +	Ma	Location *	WS
Category	Earthen Levee			GPS Latitude/Longitude	
				Start	End
Item	Animal Control			37.466673 °	37.464528 °
				-121.046185 °	-121.044012 °
DWR ID	DWR_RD1602_01_s_2020_119				
Comment Code					
A2 : Repair the levee slope damaged by livestock and prevent large animal access.					
Inspector Comment					
Cattle trail beginning to cut in to the waterside slope.

Looking upstream along the waterside slope at cattle trail. (Spring 2020)

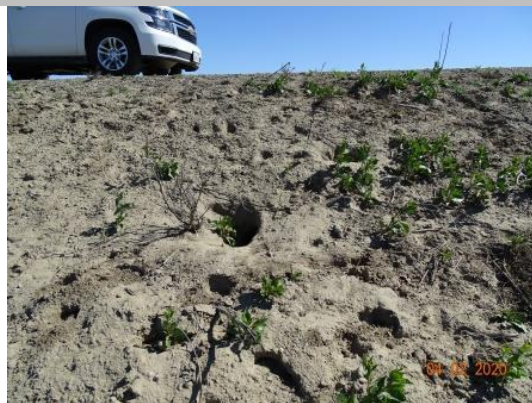
Photo 1 of 1 : FA_2021_RD1602_110_95_20210830_00040.jpg

View of the landside slope from the toe of the levee. (Spring 2020)

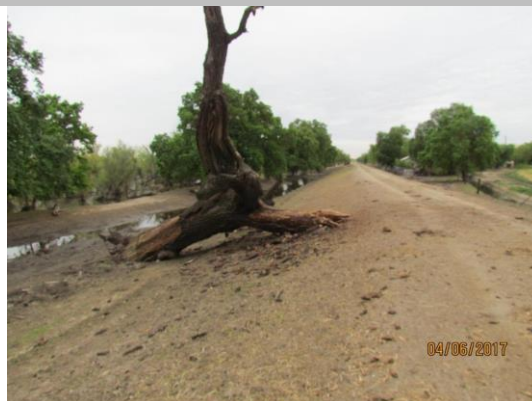
Photo 1 of 1 : FA_2021_RD1602_110_83_20210830_00032.jpg

View of a tree trunk on the waterside slope of the levee.

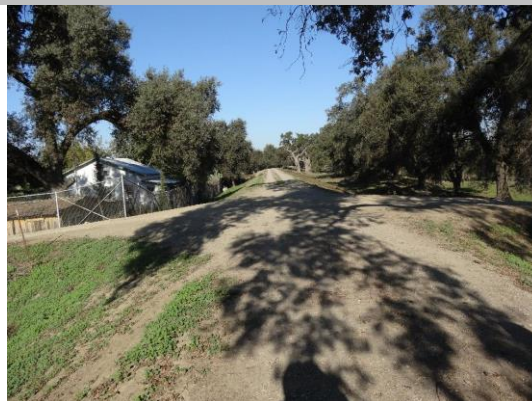
Photo 1 of 3 : UCIP_FA_2021_53523_76534.jpg

DS_ID:20206
FS_ID:53523
EP_NO: 7796
Repair Type: Non-Urgent
EVAL Issue:
Crossing Status: Indicator Found
UCIP Comments: 10/19/2018 Pipe section through the WS ramp was exposed during the 2017 storms. According to LMA representative, adjacent property owner has backfilled the pipe with soil to avoid damage to line. Contacted Mr. Chris Williams with PG&E and Mr. Williams mentioned that PG&E is planning to abandon the line and install a new line. The new line will be bored through the levee. Mr. Williams also mentioned that the line was inspected in 2016-17 and was found to be functional. However, due to the pipe exposure in 2017 PG&E has decided to abandon the current line. PG&E is working with the CVFPB to obtain the proper permits and complete the final design for the new line. This crossing has been downgraded from Urgent to Non-Urgent due to the updated UCIP reclassification evaluations. Pending action for this crossing includes line abandonment documentation from CVFPB and closeout files for this crossing. Primary PG&E contact for this crossing is Carlos Carbrera, Stanislaus and San Joaquin PG&E Local Engineer. He can be reached at 1-925-789-0509 or by email at c4ch@pge.com. (O. Magana - DWR UCIP)11/18/2016 Same as previous inspection crossing is missing markers visible from levee crown. PG&E completed some construction work on this line from September - November 3rd, 2016 and installed a marker on WS approximately 341 feet from levee crown. UCIP inspector will need to contact Mr. Chris Williams, Associate Construction Specialist, Gas Construction Management Central Valley Region with PG&E at 1-209-272-2811 to determine extent of inspection through levee. (O. Magana - DWR UCIP)10/01/2013 Gasline needs sign markers at levee. (W. Wylie - DWR UCIP)

Overview of levee crown at pipe crossing.

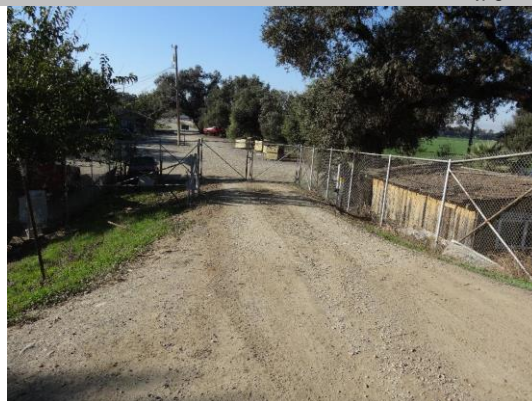
Photo 2 of 3 : UCIP_FA_2021_53523_76535.jpg

View of LS.

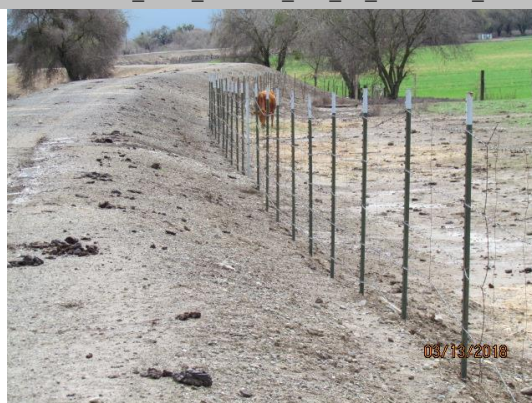
Photo 1 of 1 : FA_2021_RD1602_110_63_20210830_00023.jpg

Looking upstream at fence on landward slope. (Spring 2018)

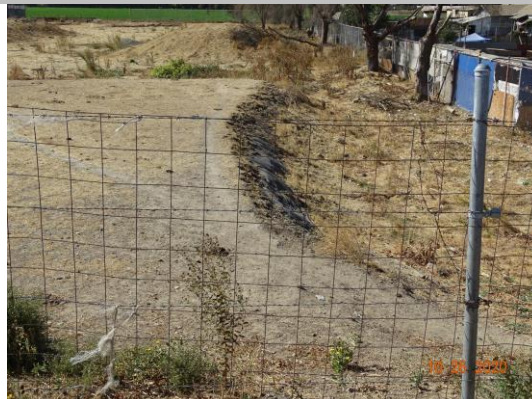
Photo 1 of 1 : FA_2021_RD1602_110_62_20210830_00022.jpg

LM Start	3.93	Rating **	M	Issue No.	62
LM End	3.93	Issue Type +	Ma	Location *	LS
Category	Earthen Levee			GPS Latitude/Longitude	
				Start	End
Item	Slope Stability			37.453216 °	37.453216 °
				-121.042127 °	-121.042127 °
DWR ID	DWR_RD1602_01_s_2012_62				
Comment Code					
S3 : Repair the levee slope damaged by vehicle traffic and prevent access where possible.					
Inspector Comment					
Significant damage to USACE constructed seepage berm due to human activity.

View of damage to seepage berm constructed on the landside toe. (Fall 2020)

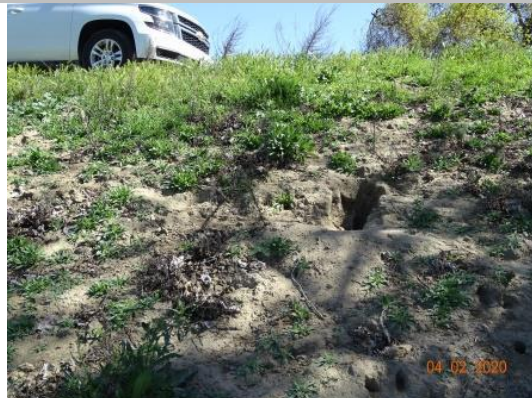
Photo 1 of 1 : FA_2021_RD1602_110_74_20210830_00030.jpg

LM Start	4.03	Rating **	A/W	Issue No.	21
LM End	4.03	Issue Type +	Ob	Location *	LS
Category	Earthen Levee			GPS Latitude/Longitude	
				Start	End
Item	Seepage / Sandboils			37.451990 °	37.451990 °
				-121.041240 °	-121.041240 °
DWR ID	190-FOC-2				
Comment Code					
Inspector Comment					
2017 Storm Damage					
Site ID No:119					
Site Designation:190-FOC-2

Looking at the landside slope from the levee toe. (Spring 2020)

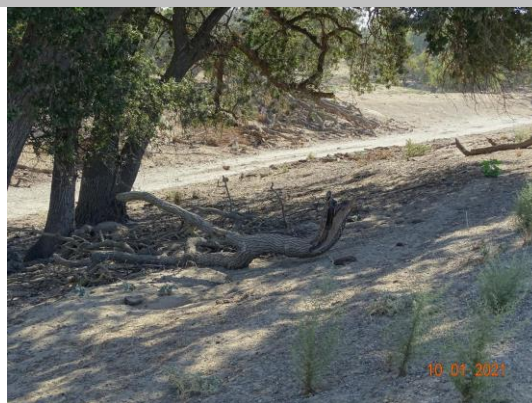
Photo 1 of 1 : FA_2021_RD1602_110_73_20211011_00093.jpg

Branches should be removed from the waterside slope. (Fall 2021)

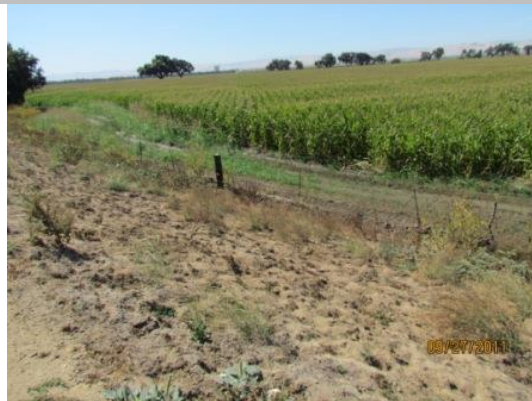
Photo 1 of 1 : FA_2021_RD1602_110_67_20210830_00025.jpg

View of the fence on the landside toe of the levee. The picture was taken from the crown looking upstream.

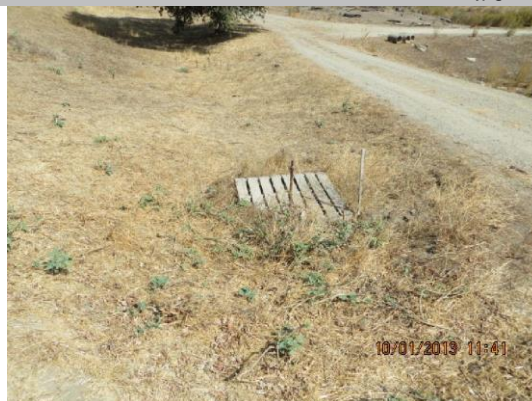
Photo 1 of 3 : UCIP_FA_2021_51332_36819.jpg

Slide gate in CMP riser on WS slope.

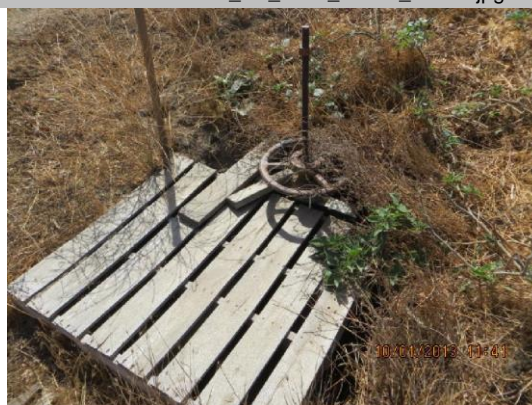
Photo 2 of 3 : UCIP_FA_2021_51332_36818.jpg

Slide gate in CMP riser on WS slope.

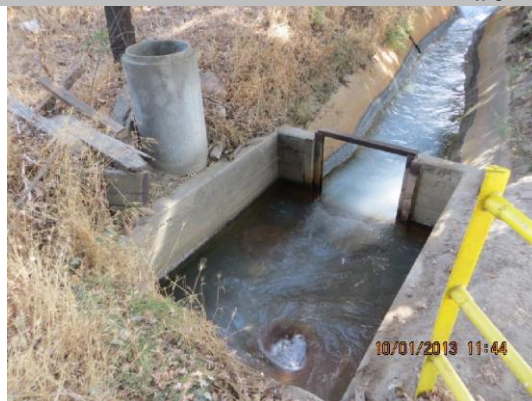
Photo 3 of 3 : UCIP_FA_2021_51332_36817.jpg

Concrete ditch at outlet from pipe on LS toe.

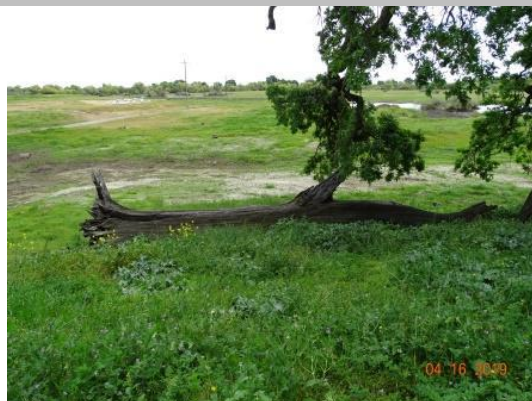
Photo 1 of 1 : FA_2021_RD1602_110_69_20210830_00026.jpg

View of fallen tree trunk on waterside slope. (Spring 2019)

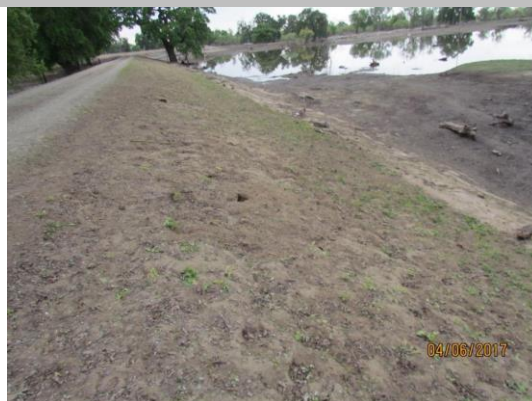
Photo 1 of 1 : FA_2021_RD1602_110_91_20210830_00037.jpg

View of rodent holes on the waterside of the levee looking downstream.
Spring 2017

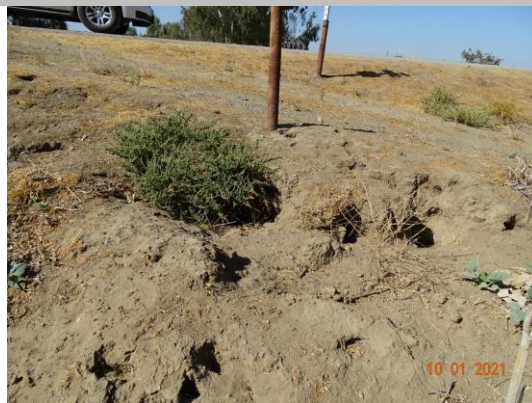
Photo 1 of 1 : FA_2021_RD1602_110_48_20211011_00096.jpg

View of rodent holes on the waterside of the levee looking downstream. (Fall 2021)

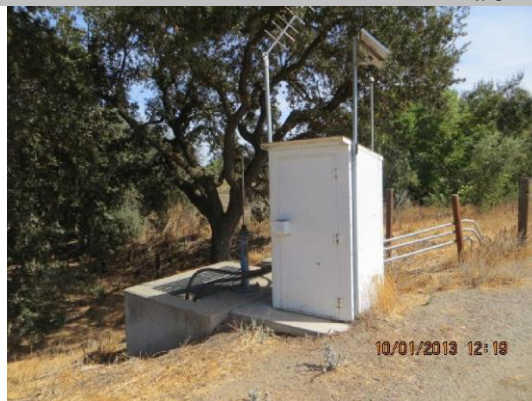
Photo 1 of 2 : UCIP_FA_2021_21665_36829.jpg

Shed with slide gate in Concrete riser on WS shoulder.

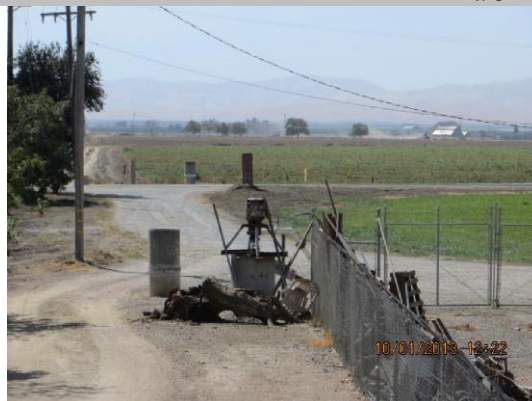
Photo 2 of 2 : UCIP_FA_2021_21665_36828.jpg

Likely risers for pipe off LS toe.

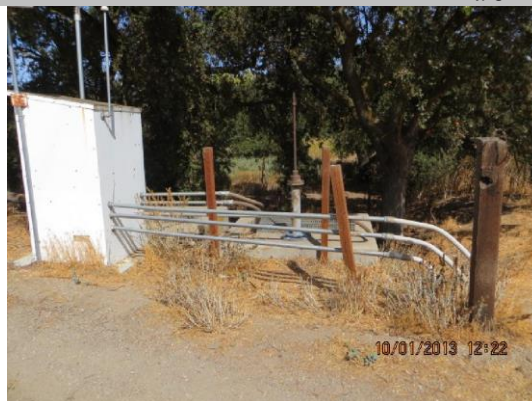
Photo 1 of 2 : UCIP_FA_2021_21668_36835.jpg

Slide gate in Concrete vault on WS shoulder.

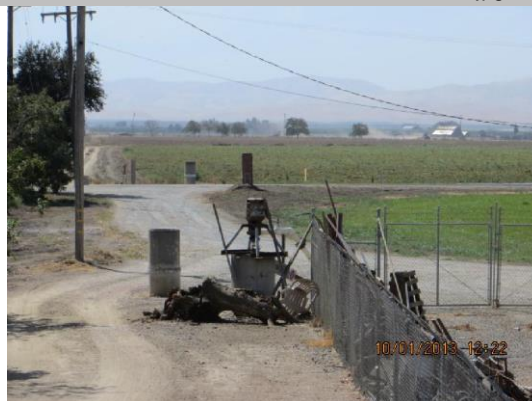
Photo 2 of 2 : UCIP_FA_2021_21668_36834.jpg

Possible concrete risers for pipe off LS toe.

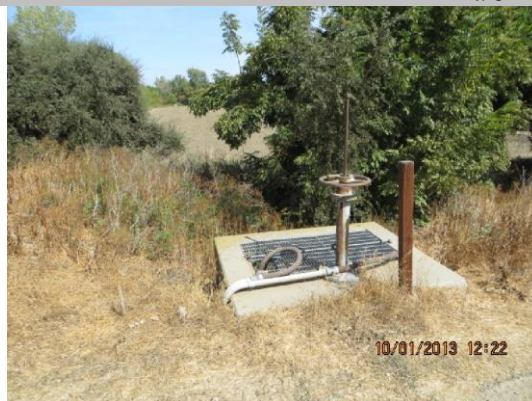
Photo 1 of 3 : UCIP_FA_2021_21672_36848.jpg

Slidegate in concrete riser on WS shoulder.

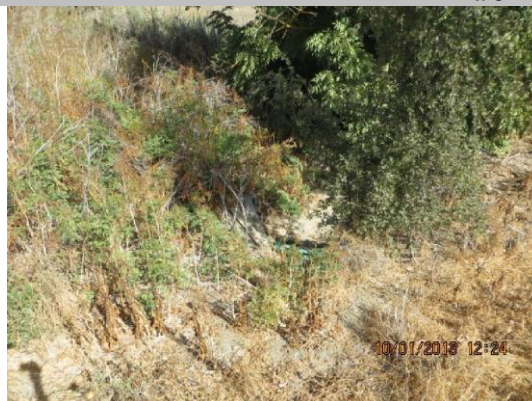
Photo 2 of 3 : UCIP_FA_2021_21672_36847.jpg

Concrete outlet on WS toe.

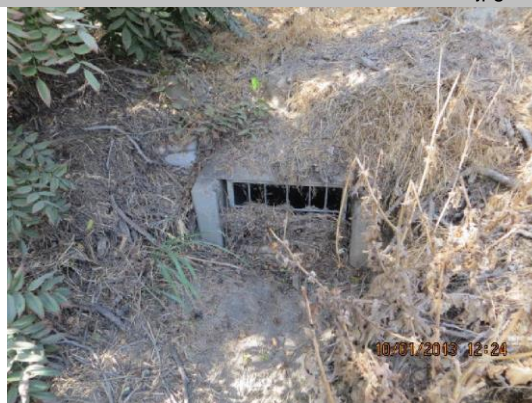
Photo 3 of 3 : UCIP_FA_2021_21672_36846.jpg

Concrete inlet on LS toe.

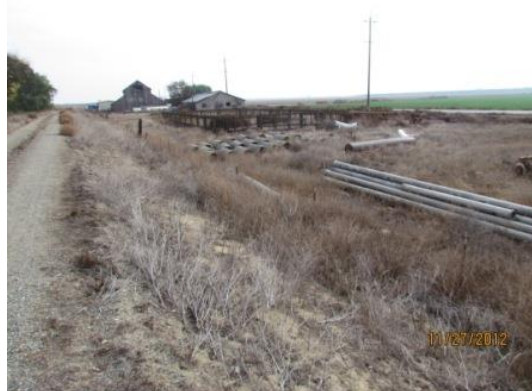
Photo 1 of 1 : FA_2021_RD1602_110_22_20210830_00002.jpg

A fence was found on the landside toe of the levee looking upstream.

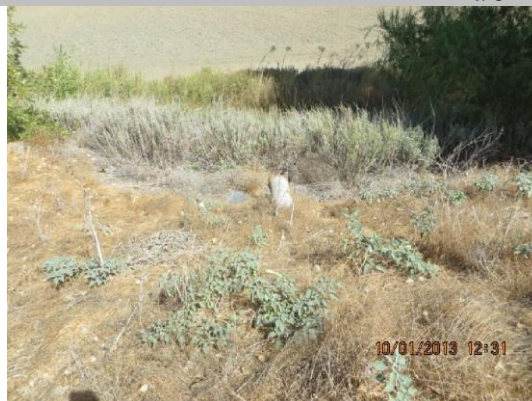
Photo 1 of 1 : UCIP_FA_2021_21674_36854.jpg

Pipe and flapgate visible on WS toe.

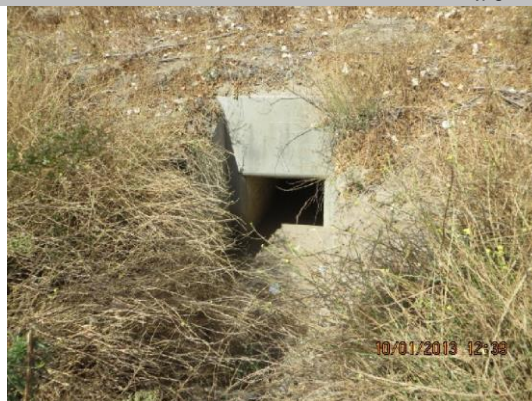
Photo 3 of 3 : UCIP_FA_2021_51337_36876.jpg

Concrete U-shaped headwall on LS toe.

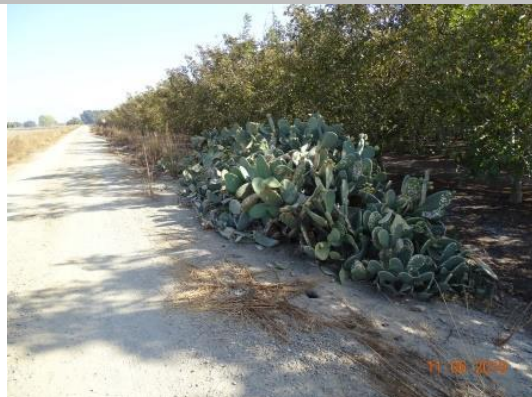
Photo 1 of 1 : FA_2021_RD1602_110_86_20210830_00034.jpg

Looking at dense cactus growth on the waterside slope. (Fall 2019)

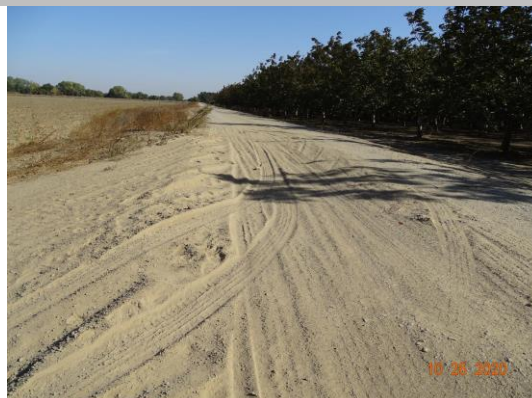
Photo 1 of 1 : FA_2021_RD1602_110_24_20210830_00003.jpg

Depression in levee crown from vehicle traffic. (Fall 2020)

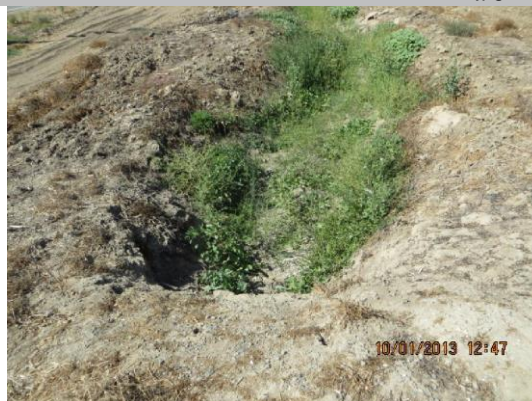
Photo 1 of 3 : UCIP_FA_2021_21683_36882.jpg

Drainage/irrigation canal on LS toe.

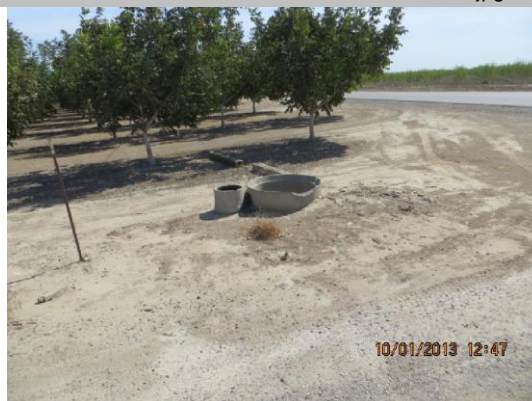
Photo 2 of 3 : UCIP_FA_2021_21683_36881.jpg

36-inch concrete standpipe on WS shoulder.

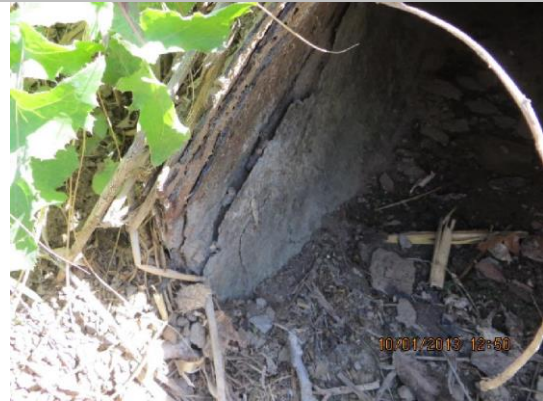
Photo 3 of 3 : UCIP_FA_2021_21683_36880.jpg

Pipe deteriorated on LS at outlet.
