## Flood Control Project Maintenance Levee Inspections

### Fall 2022 Levee Maintenance Deficiency Summary Report

#### ***San Joaquin River Basin***

**Reclamation District No. 1602 Del Puerto**

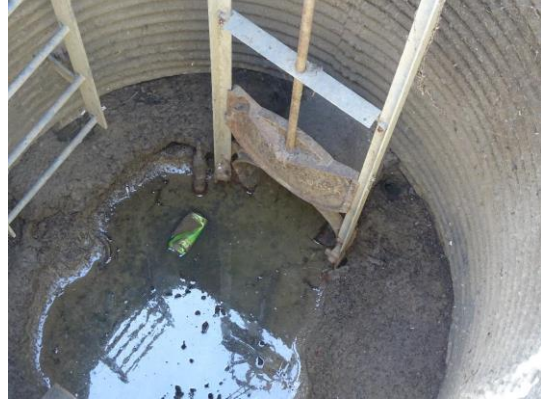
Photo 1 of 2 : UCIP\_FA\_2022\_74549\_111308.jpg

Comment Code					
Inspector Comment					
DS_ID:20215 FS_ID:74549 EP_NO: N/A Repair Type: Urgent EVAL Issue: 1, Pipe Integrity Crossing Status: Found UCIP Comments: 04/05/2022 Record remains Urgent. DMP internal video inspection has found pipe integrity issues. LOF of crossing is between 5 and 6. Crossing will be monitored until funding becomes available to address the issues. No cover on CMP riser causing a safety hazard. (M.Thao - DWR UCIP) 11/18/2016 Crossing has been downgraded from Urgent to No Action Needed a cover has been added to the CMP riser. (O. Magana - DWR UCIP)10/01/2013 Open 60-inch CMP riser on WS needs lid as it's depth may be a hazard to the public. (W. Wylie - DWR UCIP) FIELD_STRUCT_DESC: 16-inch steel drainage pipe through levee, 11.3 feet below crown. Slide gate in 60-inch corrugated metal pipe (CMP) riser located on the waterside (WS). Concrete inlet is approximately 110 feet west of the levee crown or 110 feet off landside (LS) toe next to roadway. [Additional Reference(s): DWR Levee Log, 1992. USACE San Joaquin River O&M Manual Unit 13, April 1964, (HLM 0.58), Drawing No. 7-4-1784]. FS Date: 4/5/2022

WS view: Looking into CMP riser at slide gate.

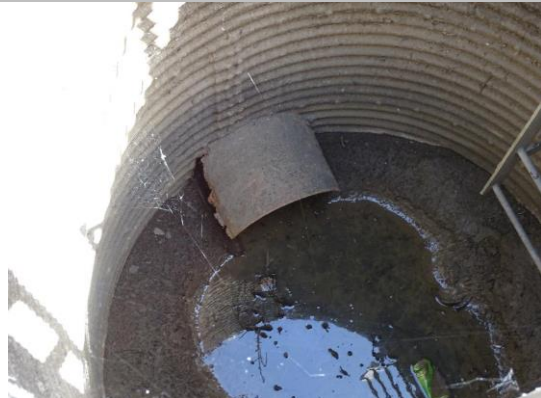
Photo 2 of 2 : UCIP\_FA\_2022\_74549\_111309.jpg

WS view: Looking into CMP riser at deteriorated pipe inlet.

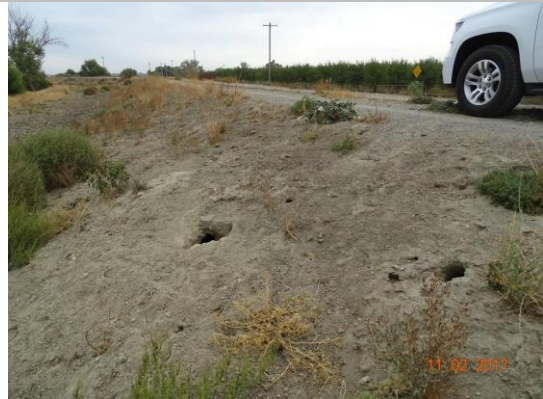
Photo 1 of 1 : FA\_2022\_RD1602\_110\_30\_20220822\_00009.jpg

View of rodent holes on the waterside slope of the levee. Fall 2017

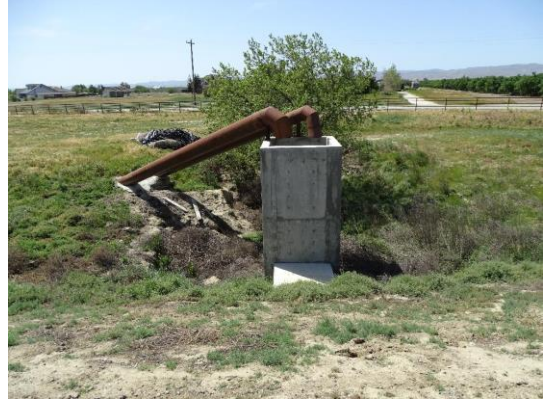
Photo 1 of 1 : UCIP\_FA\_2022\_75648\_111281.jpg

Comment Code						
Inspector Comment						
DS_ID:20216 FS_ID:75648 EP_NO: N/A Repair Type: Non-Urgent EVAL Issue: 10, Unauthorized Modification or Non-Compliant Permit Crossing Status: Found UCIP Comments: 04/05/2022 Record updated from No Action Needed to Non-Urgent. A new concrete discharge box was installed on the LS toe since the last inspection; unable to find a permit for modification. (M.Thao - DWR UCIP) 11/18/2016 Crossing has been downgraded from Urgent to No Action Needed the debris blocking the outlet has been cleared. (O. Magana - DWR UCIP)10/01/2013 Flap gate blocked from functioning by soil buildup on WS toe. Soil should be cleared. (W. Wylie - DWR UCIP) FIELD_STRUCT_DESC: 30-inch square reinforced concrete box culvert through levee, 14.4 feet below crown. Concrete "U" headwall on the waterside (WS) and landside (LS) ends. Slide gate in 6-foot by 7-foot concrete surge box is located on the WS shoulder. Flap gate is located on the WS end. [Additional Reference(s): DWR Levee Log, 1992. USACE San Joaquin River O&M Manual Unit 13, April 1964, (HLM 0.78), Drawing No. 7-4-1784]. FS Date: 4/5/2022

LS view: Looking from crown; new concrete drainage box on toe.

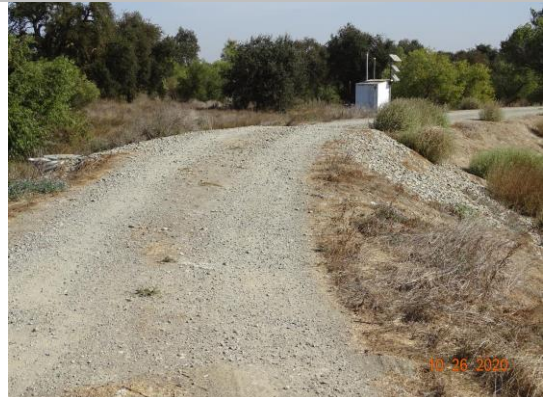
Photo 1 of 1 : FA\_2022\_RD1602\_110\_36\_20220822\_00012.jpg

LM Start	1.00	Rating **	A/W	Issue No.	36
LM End	1.00	Issue Type +	En	Location *	CR
Category	Earthen Levee			GPS Latitude/Longitude	
				Start	End
Item	Encroachments			37.478810 °	37.478810 °
				-121.068738 °	-121.068738 °
DWR ID	DWR_RD1602_01_s_2012_36				
Comment Code					
RA : Ramp					
Inspector Comment					
Pipe owner placed fill over pipe above crown of levee to build ramp over pipe.

View of ramp built up on levee crown. (Fall 2020)

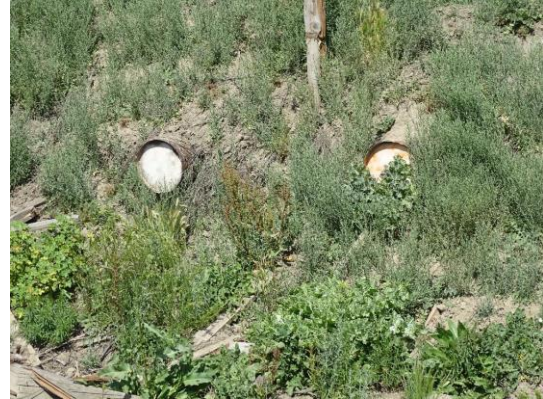
Photo 1 of 2 : UCIP\_FA\_2022\_74539\_111263.jpg

Comment Code					
Inspector Comment					
DS_ID:20217 FS_ID:74539 EP_NO: N/A Repair Type: Non-Urgent EVAL Issue: 4b, Safety Issue Crossing Status: Found UCIP Comments: 04/05/2022 Record remains Non-Urgent. Pump and platform on LS has been removed. The crossing has been capped and exposed on the LS toe. Unable to find a permit for modification. Crossing appears abandoned. Unable to locate a permit and confirm proper pipe abandonment. Recommend owner to contact CVFPB to abandon or remove pipe from levee. Cover missing on CMP riser causing a safety hazard. (M.Thao - DWR UCIP) 11/18/2016 Crossing has been downgraded from Urgent to Non-Urgent a flap gate has been added to the WS but pipe is currently not connected to pump. According to Tony Martinez, LMA representative, this crossing is currently not in use. Owner will need to coordinate with CVFPB to obtain permit. (O. Magana - DWR UCIP)10/01/2013 Appears abandoned and if so should be done so properly. Flapgate missing. (W. Wylie - DWR UCIP) FIELD_STRUCT_DESC: *ABANDONED* 1 of 2: 16-inch steel drainage pipe through levee, 17 feet below crown. Pumps on the pump platform are located on the landside (LS). Siphon breaker in 24-inch corrugated metal pipe (CMP) riser is located on the waterside (WS) shoulder. Concrete "U" headwall and flap gate are located on the WS end. [Additional Reference(s): DWR Levee Log, 1992. USACE San Joaquin River O&M Manual Unit 13, April 1964, (HLM 1.01), Drawing No. 7-4-1784]. FS Date: 4/5/2022

LS view: Close-up view of pipe inlet capped.

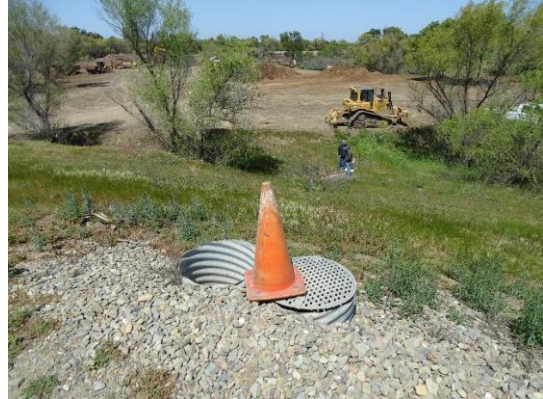
Photo 2 of 2 : UCIP\_FA\_2022\_74539\_111264.jpg

WS view: Siphon breaker in CMP riser on shoulder; missing cover on riser. Concrete headwall on toe in background.

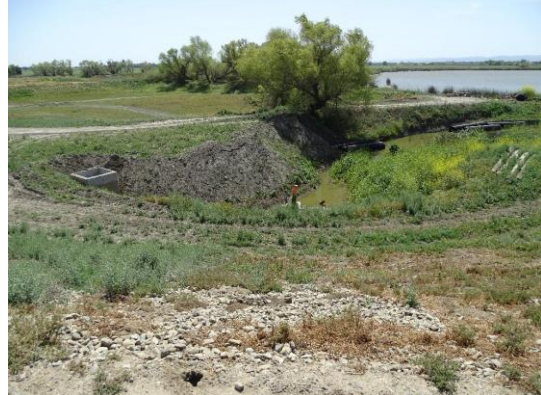
Photo 1 of 2 : UCIP\_FA\_2022\_74536\_111245.jpg

Comment Code						
Inspector Comment						
DS_ID:20219 FS_ID:74536 EP_NO: N/A Repair Type: Non-Urgent EVAL Issue: 10, Unauthorized Modification or Non-Compliant Permit Crossing Status: Found UCIP Comments: 04/05/2022 Record remains Non-Urgent. Pump and platform on LS has been removed. The crossing has been capped and exposed on the LS toe. Unable to find a permit for modification. Crossing appears abandoned. Unable to locate a permit and confirm proper pipe abandonment. Recommend owner to contact CVFPB to abandon or remove pipe from levee. (M.Thao - DWR UCIP) 11/18/2016 Crossing has been downgraded from Urgent to Non-Urgent a flap gate has been added to the WS. According to Tony Martinez, LMA representative, this crossing is currently not in use. Owner will need to coordinate with CVFPB to obtain permit. (O. Magana - DWR UCIP) 10/01/2013 Appears abandoned siphon breakers covered in soil and flapgate missing. (W. Wylie - DWR UCIP) FIELD_STRUCT_DESC: *ABANDONED* 2 of 2: 16-inch steel drainage pipe through levee, 17 feet below crown. Pump on pump platform located on the landside (LS). Siphon breaker in 24-inch riser located on the waterside (WS) shoulder. Concrete "U" headwall and flap gate are located on the WS end. [Additional Reference(s): DWR Levee Log, 1992. USACE San Joaquin River O&M Manual Unit 13, April 1964, (HLM 1.01), Drawing No. 7-4-1784]. FS Date: 4/5/2022

LS view: Looking from crown; general overview.

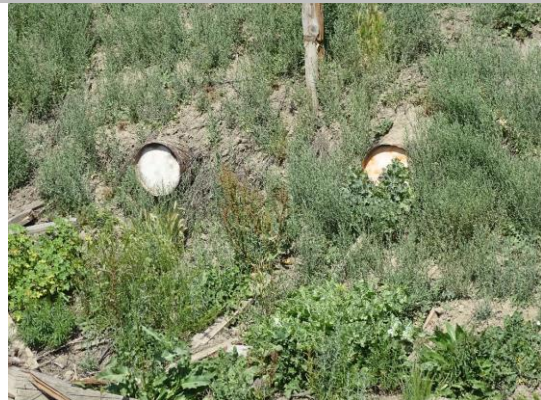
Photo 2 of 2 : UCIP\_FA\_2022\_74536\_111247.jpg

LS view: Close-up view of pipe inlet capped.

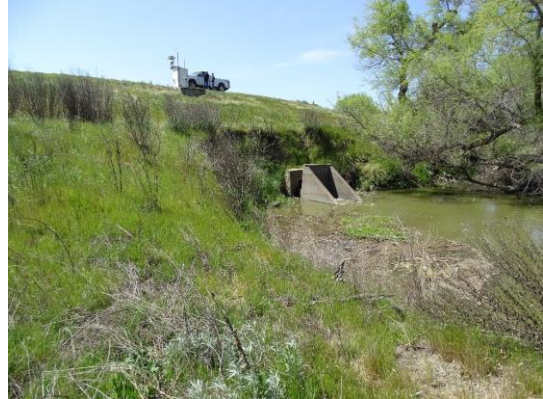
Photo 1 of 2 : UCIP\_FA\_2022\_75649\_111240.jpg

DS\_ID:20218  
FS\_ID:75649  
EP\_NO: N/A  
Repair Type: Urgent  
EVAL Issue: 2b, Levee Integrity  
Crossing Status: Found  
UCIP Comments: 04/05/2022 Record remains Urgent. WS concrete headwall is still detached with vertical erosion behind the headwall on the WS slope. Was not able to inspect the flap gate due to water on present on WS. Modification was made on the LS to move the grated inlet at the toe landward approximately 100 feet; unable to find a permit for modification. (M.Thao - DWR UCIP)  
10/19/2018 Pipe remains the same. WS concrete headwall is still detached with vertical erosion on the WS slope. Dense vegetation along pipe alignment made it difficult to inspect levee slopes and identify any potential issues present at this site. Recommend clearing vegetation along pipe alignment to be able to conduct a proper UCIP inspection. This crossing is part of DWR's Flood System Repair Project (FSRP) and Deferred Maintenance Project (DMP). Crossing will be monitored to identify progress of erosion on the WS slope. Crossing remains Urgent due to the detachment of the concrete wall and vertical cut on the WS. (O. Magana - DWR UCIP)

11/18/2016 Same as previous inspection headwall on the WS toe has separated from pipe and flap gate is still missing. Erosion around concrete headwall and undermined WS slope are visible from WS. The slope undermined appears to have progressed but no photos were taken due to the dense vegetation covering area. According to Tony Martinez, LMA representative, the WS concrete headwall has been detached since 2008/2009. LMA has been in contact with CVFPB, DWR, and USACE regarding this site. (O. Magana - DWR UCIP)  
10/01/2013 Headwall on WS toe separated from pipe. Erosion around concrete headwall and undermined at WS toe. Flap gate missing from WS toe headwall. (W. Wylie - DWR UCIP)  
FIELD\_STRUCT\_DESC: 30-inch square reinforced concrete box culvert through levee, 25.4 feet below crown. Concrete "U" headwalls on both waterside (WS) and landside (LS) ends. Slide gate in concrete surge box located on the WS slope. A 5-foot by 5-foot concrete box is located on LS toe. Flap gate is located on the WS end. [Additional Reference(s): DWR Levee Log, 1992. USACE San Joaquin River O&M Manual Unit 13, April 1964, (HLM 1.02), Drawing No. 7-4-1784].

WS view: Looking toward levee; concrete headwall on toe with erosion.

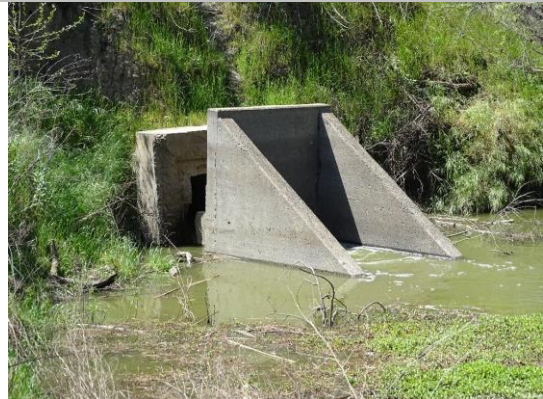
Photo 2 of 2 : UCIP\_FA\_2022\_75649\_111241.jpg

WS view: Close-up view of detached concrete headwall on toe.

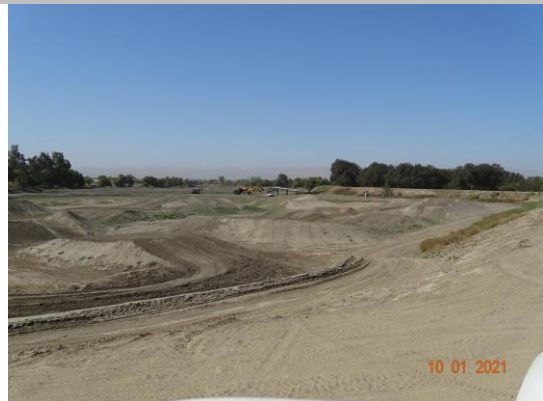
Photo 1 of 1 : FA\_2022\_RD1602\_110\_28\_20220822\_00007.jpg

LM Start	<b>1.06</b>	Rating **	U	Issue No.	<b>28</b>
LM End	<b>1.44</b>	Issue Type +	En	Location *	LS
Category	Earthen Levee		GPS Latitude/Longitude		
			Start	End	
Item	Encroachments		37.478535 °	37.478997 °	
			-121.067746 °	-121.061409 °	
DWR ID	DWR_RD1602_01_f_2021_28

Landowner is constructing a BMX track on the landside toe. (Fall 2021)

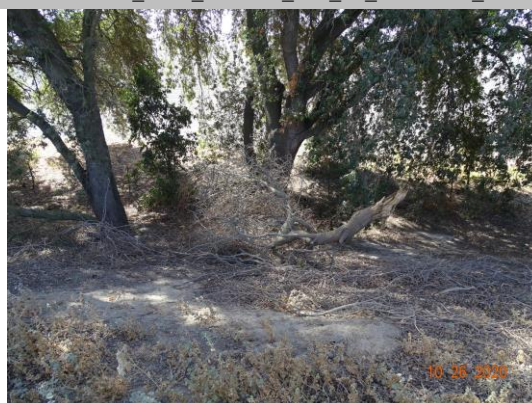
Photo 1 of 1 : FA\_2022\_RD1602\_110\_40\_20220822\_00013.jpg

Broken tree limb left on the landside toe. (Fall 2020)

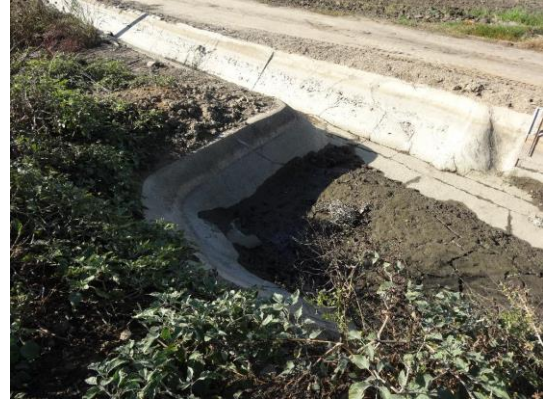
Photo 1 of 3 : UCIP\_FA\_2022\_74530\_76528.jpg

Comment Code					
Inspector Comment					
DS_ID:20204 FS_ID:74530 EP_NO: 8193 Repair Type: Urgent EVAL Issue: 1, Pipe Integrity Crossing Status: Found UCIP Comments: 04/05/2022 Record remains Urgent. Pipe inlet within CMP riser is deteriorated. CMP riser cover has broken and fallen into the riser; no cover on the riser causing a safety hazard. Crossing appears abandoned. Recommend owner to contact CVFPB to abandon or remove pipe from levee. (M.Thao - DWR UCIP) 10/19/2018 Pipe is deteriorated on the LS toe (pipe section missing at inlet). This crossing remains Urgent due to the wall deterioration at the inlet. If wall is rusted out at the inlet, need to determine the condition of the pipe section through the levee. According to the LMA representative, this crossing is no longer in use (crossing is abandoned). LMA is interested in abandoning crossing in place. LMA was referred to the CVFPB staff for direction regarding proper action under Title 23 for this crossing. (O. Magana - DWR UCIP) 11/18/2016 Same as previous inspection riser cover and handle on slide gate are still missing. Crossing remains Urgent due to the public safety issue of the 60-inch CMP cover still missing. According to Tony Martinez, LMA representative, the condition and future use of this crossing is being evaluated. Owner will need to coordinate with CVFPB for future use requirements or proper abandonment/removal. (O. Magana - DWR UCIP) 10/01/2013 Appears abandoned, and if so should be done so properly. No handle on slide gate, no cover on CMP standpipe on WS shoulder. (W. Wylie - DWR UCIP) FIELD_STRUCT_DESC: 16-inch steel irrigation pipe through levee, 11.5 feet below crown. Slide gate in 60-inch corrugated metal pipe riser is located on the waterside (WS) slope. Pipe discharges into concrete-lined ditch on the landside (LS) (irrigation pipe was authorized under Automatic Board Order (ABO) issued as Permit No. 8193, 1964 - Sabatte). [Additional Reference(s): DWR Levee Log, 1992. USACE San Joaquin River O&M Manual Unit 13, April 1964, (HLM 0.58), Drawing No. 7-4-1784]. FS Date: 4/5/2022

Concrete drain channel located on LS toe.

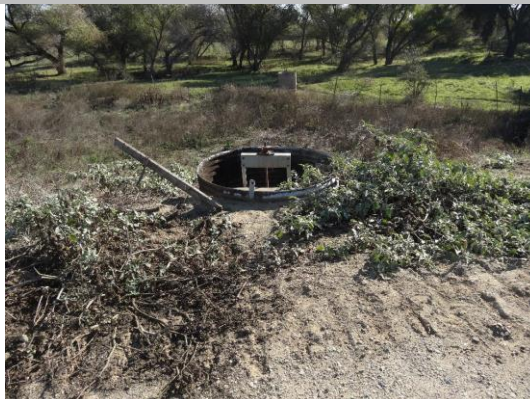
Photo 2 of 3 : UCIP\_FA\_2022\_74530\_76529.jpg

View of WS--CMP riser located on WS shoulder and concrete riser approximately 100 feet from levee crown.

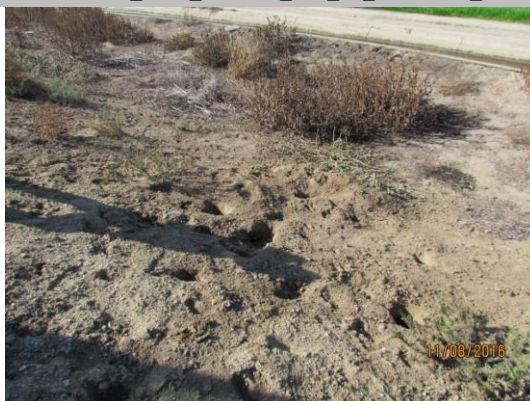
Photo 1 of 1 : FA\_2022\_RD1602\_110\_56\_20220822\_00023.jpg

View of rodent holes on the landside of the levee. Fall 2016

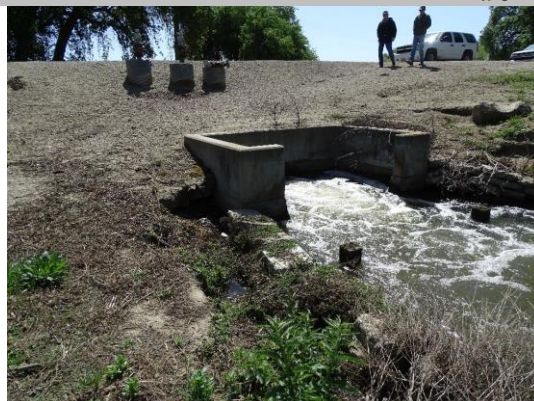
Photo 1 of 2 : UCIP\_FA\_2022\_74520\_111227.jpg

Comment Code						
Inspector Comment						
DS_ID:20221 FS_ID:74520 EP_NO: 8191 Repair Type: Non-Urgent EVAL Issue: 6, Levee Damage or Threat for Levee Damage Crossing Status: Found UCIP Comments: 04/05/2022 Record updated from No Action Needed to Non-Urgent. Minor erosion was present around the downstream sides of the concrete distribution box on the LS toe. (M.Thao - DWR UCIP) FIELD_STRUCT_DESC: 1 of 3: 18-inch irrigation pipe of an unknown material through the levee, 10.2 feet below the crown. Pump on pump platform on the bank. Siphon breaker in a 24-inch riser on the landside (LS) shoulder. Concrete discharge box on the LS end. (two 18-inch and one 20-inch pipes were authorized under Automatic Board Order (ABO) issued as Permit No. 8191, 1972 - Twin Oaks Irrigation District c/o Mr. V. R. Peterson). [Additional Reference(s): DWR Levee Log, 1992. USACE San Joaquin O&M Manual 13, April 1964, (HLM 3.57), Drawing No. 7-4-1784]. FS Date: 4/5/2022

LS view: Concrete discharge box on toe; erosion around downstream sides.

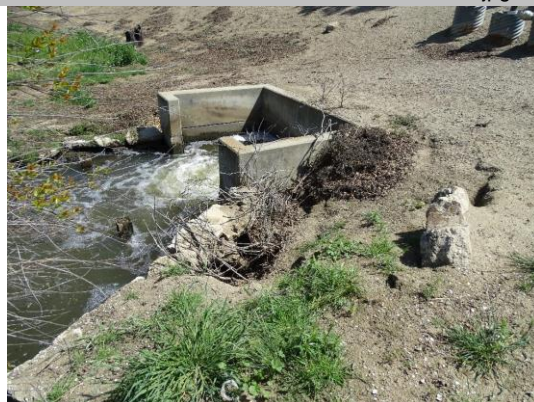
Photo 2 of 2 : UCIP\_FA\_2022\_74520\_111228.jpg

LS view: Concrete discharge box on toe; erosion around downstream sides.

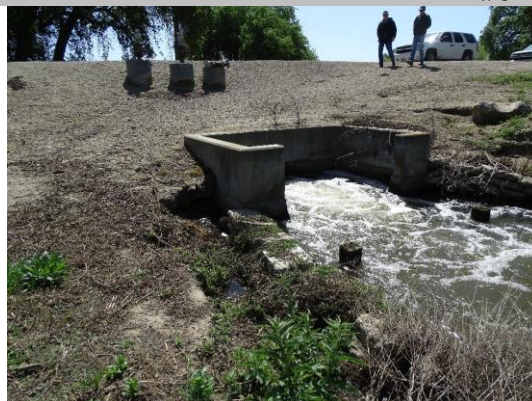
Photo 1 of 2 : UCIP\_FA\_2022\_74519\_111221.jpg

Comment Code						
Inspector Comment						
DS_ID:20220 FS_ID:74519 EP_NO: 8191 Repair Type: Non-Urgent EVAL Issue: 6, Levee Damage or Threat for Levee Damage Crossing Status: Found UCIP Comments: 04/05/2022 Record updated from No Action Needed to Non-Urgent. Minor erosion was present around the downstream sides of the concrete distribution box on the LS toe. (M.Thao - DWR UCIP) FIELD_STRUCT_DESC: 2 of 3: 18-inch irrigation pipe of an unknown material through the levee, 10.2 feet below the crown. Pump on pump platform on the bank. Siphon breaker in a 24-inch riser on the landside (LS) shoulder. Concrete discharge box on the LS end. (two 18-inch and one 20-inch pipes were authorized under Automatic Board Order (ABO) issued as Permit No. 8191, 1972 - Twin Oaks Irrigation District c/o Mr. V. R. Peterson). [Additional Reference(s): DWR Levee Log, 1992. USACE San Joaquin O&M Manual 13, April 1964, (HLM 3.57), Drawing No. 7-4-1784]. FS Date: 4/5/2022

LS view: Concrete discharge box on toe; erosion around downstream sides.

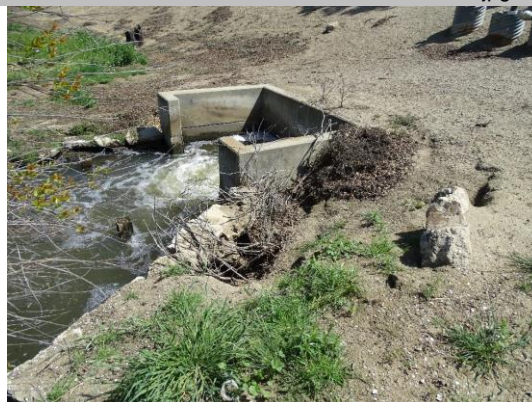
Photo 2 of 2 : UCIP\_FA\_2022\_74519\_111222.jpg

LS view: Concrete discharge box on toe; erosion around downstream sides.

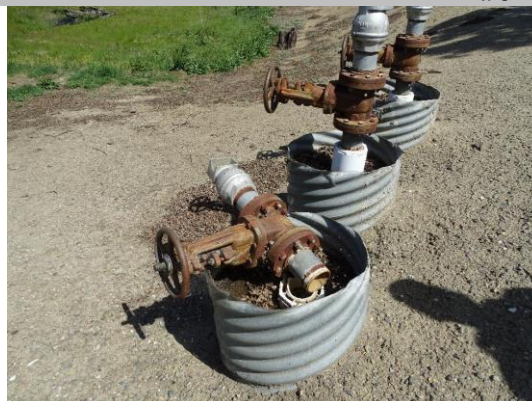
Photo 1 of 3 : UCIP\_FA\_2022\_74503\_111215.jpg

Comment Code					
Inspector Comment					
DS_ID:20205 FS_ID:74503 EP_NO: 8191 Repair Type: Non-Urgent EVAL Issue: 6, Levee Damage or Threat for Levee Damage Crossing Status: Found UCIP Comments: 04/05/2022 Record updated from No Action Needed to Non-Urgent. Siphon breaker in CMP riser is broken; recommend repairing the siphon breaker. Minor erosion was present around the downstream sides of the concrete distribution box on the LS toe. (M.Thao - DWR UCIP)					
FIELD_STRUCT_DESC: 3 of 3: 18-inch irrigation pipe of an unknown material through the levee, 10.2 feet below the crown. Pump on pump platform on the bank. Siphon breaker in a 24-inch riser on the landside (LS) shoulder. Concrete discharge box on the LS end. (two 18-inch and one 20-inch pipes were authorized under Automatic Board Order (ABO) issued as Permit No. 8191, 1972 - Twin Oaks Irrigation District c/o Mr. V. R. Peterson). [Additional Reference(s): DWR Levee Log, 1992. USACE San Joaquin O&M Manual 13, April 1964, (HLM 3.57), Drawing No. 7-4-1784, (20-inch pipe listed)]. FS Date: 4/5/2022

LS view: Close-up view of broken siphon breaker.

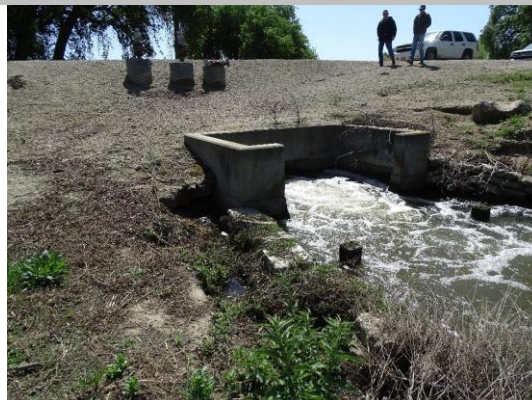
Photo 2 of 3 : UCIP\_FA\_2022\_74503\_111216.jpg

LS view: Concrete discharge box on toe; erosion around downstream sides.

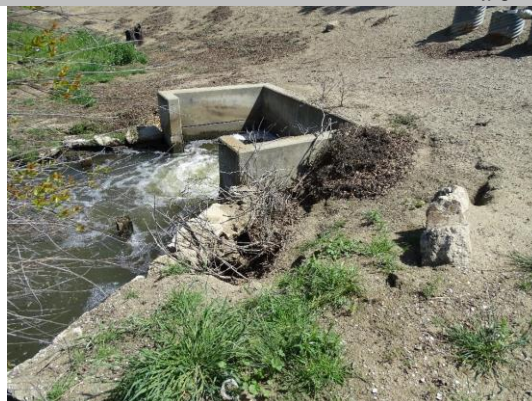
Photo 3 of 3 : UCIP\_FA\_2022\_74503\_111217.jpg

LS view: Concrete discharge box on toe; erosion around downstream sides.

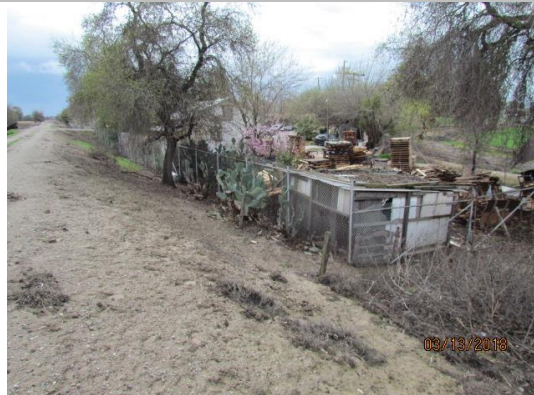
Photo 1 of 1 : FA\_2022\_RD1602\_110\_66\_20220822\_00026.jpg

Looking southwest at animal pens and other encroachments on landward toe. (Spring 2018)

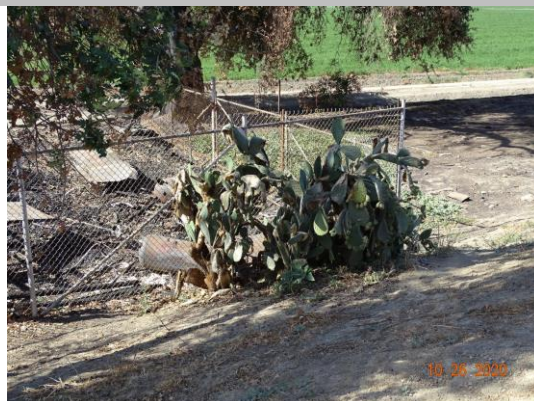
Photo 1 of 1 : FA\_2022\_RD1602\_110\_42\_20220822\_00014.jpg

Cactus growing on the landside slope. (Fall 2020)

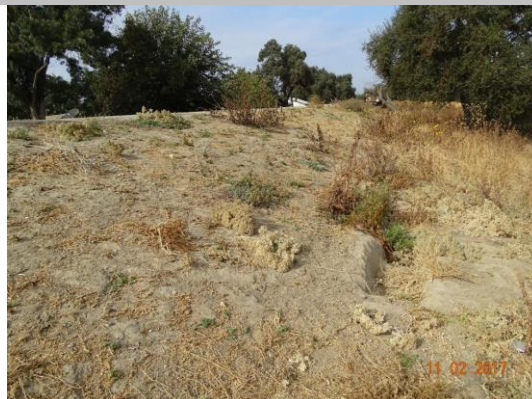
Photo 1 of 1 : FA\_2022\_RD1602\_110\_84\_20220822\_00035.jpg

View of rodent holes on the waterside of the levee.

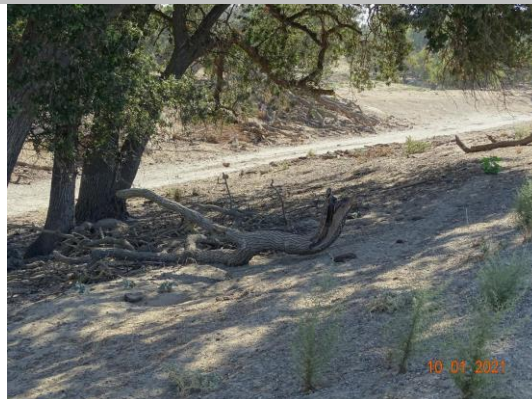
Photo 1 of 1 : FA\_2022\_RD1602\_110\_73\_20220822\_00031.jpg

Branches should be removed from the waterside slope. (Fall 2021)

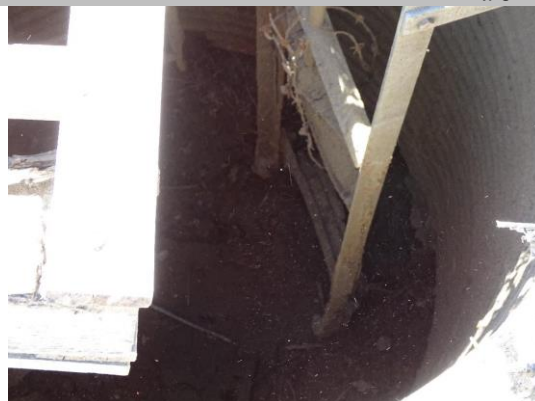
Photo 2 of 2 : UCIP\_FA\_2022\_74531\_111174.jpg

WS view: Looking into CMP riser; inlet of pipe through levee is deteriorating.

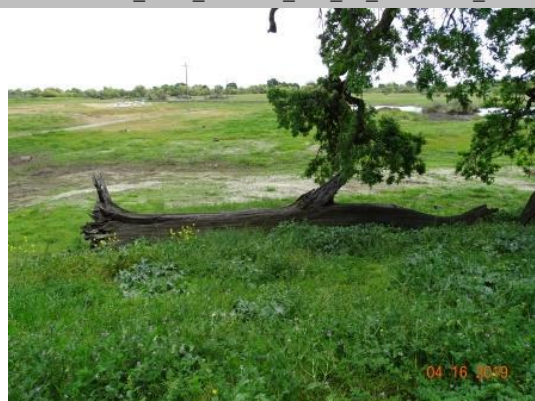
Photo 1 of 1 : FA\_2022\_RD1602\_110\_69\_20220822\_00028.jpg

View of fallen tree trunk on waterside slope. (Spring 2019)

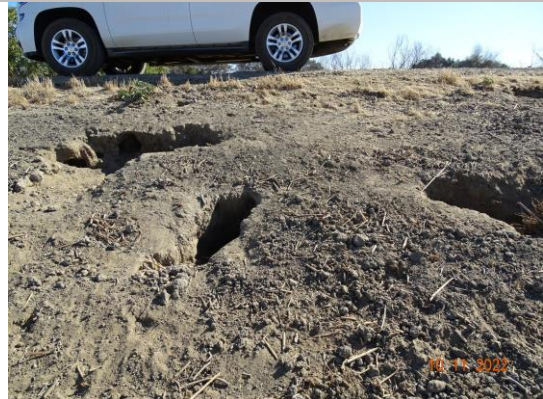
Photo 1 of 1 : FA\_2022\_RD1602\_110\_53\_20221021\_00051.jpg

Several large animal burrows were observed at this location. (Fall 2022)

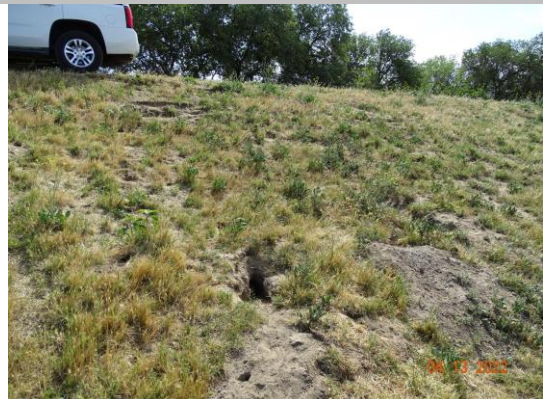
Photo 1 of 1 : FA\_2022\_RD1602\_110\_25\_20220822\_00005.jpg

View of rodent burrows in the landside slope. (Spring 2022)

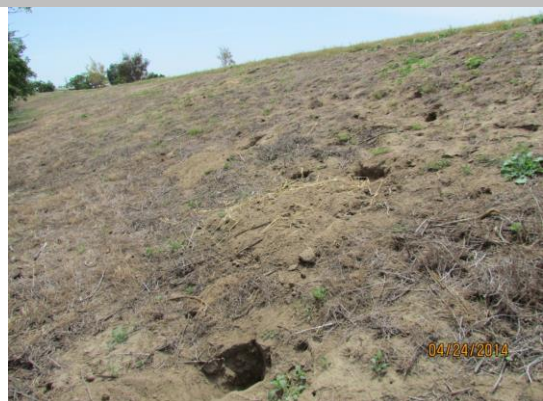
Photo 1 of 1 : FA\_2022\_RD1602\_110\_199\_20220822\_00045.jpg

Rodent holes were found on the waterside toe of the levee looking upstream.

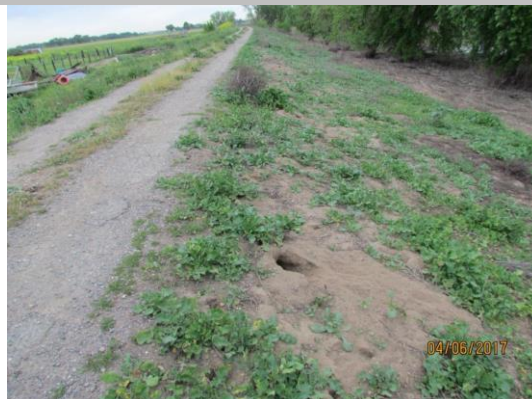
Photo 1 of 1 : FA\_2022\_RD1602\_110\_92\_20220822\_00039.jpg

View of a rodent hole on the waterside shoulder of the levee looking downstream.

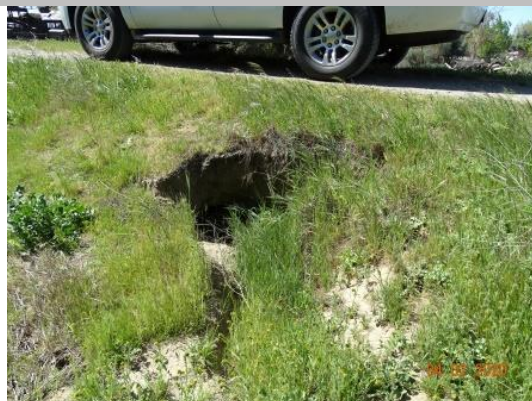
Photo 1 of 1 : FA\_2022\_RD1602\_110\_141\_20220822\_00044.jpg

View of burrow in the waterside shoulder. (Spring 2020)

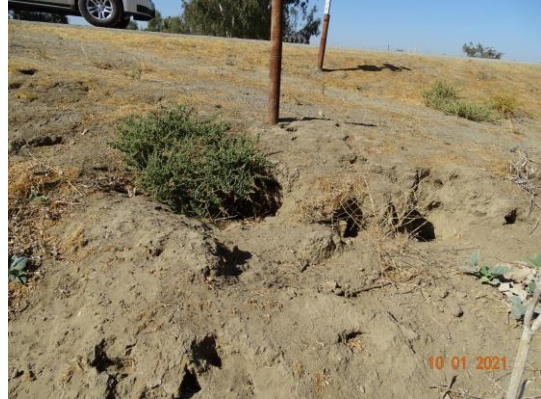
Photo 1 of 1 : FA\_2022\_RD1602\_110\_48\_20220822\_00018.jpg

View of rodent holes on the waterside of the levee looking downstream.  
(Fall 2021)

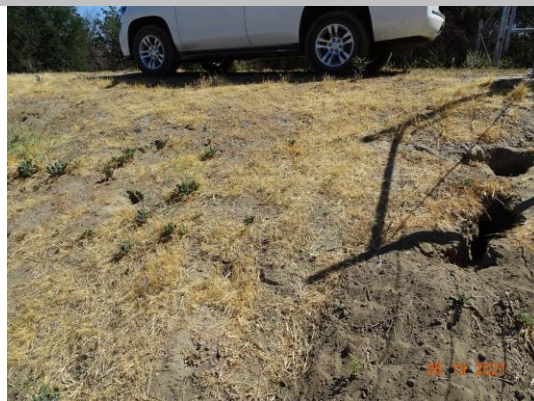
Photo 1 of 1 : FA\_2022\_RD1602\_110\_27\_20220822\_00006.jpg

Large rodent burrows in the landside slope. (Spring 2021)

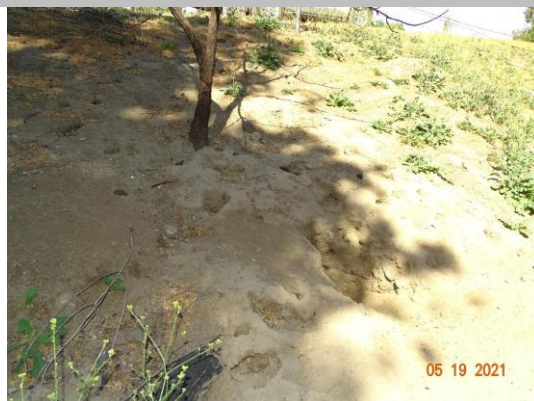
Photo 1 of 1 : FA\_2022\_RD1602\_110\_52\_20220822\_00021.jpg

View of large rodent burrow on the waterside slope. (Spring 2021)

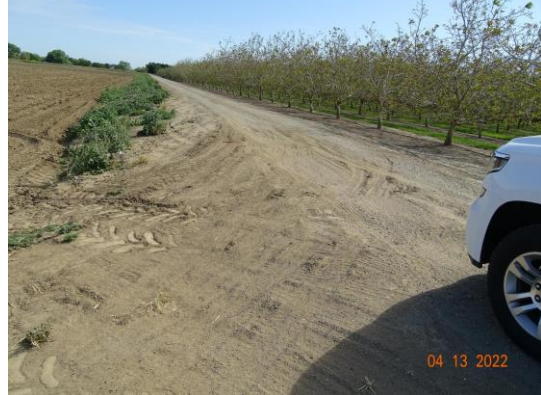
Photo 1 of 1 : FA\_2022\_RD1602\_110\_24\_20220822\_00004.jpg

Depression in levee crown from vehicle traffic. (Spring 2022)
