Flood Control Project Maintenance Levee Inspections

Fall 2023 Levee Maintenance Deficiency Summary Report

San Joaquin River Basin

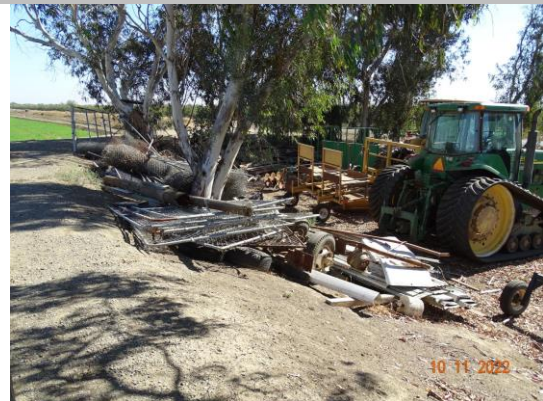
Photo 1 of 1 : FA_2023_RD1602_110_60_20230905_00025.jpg

Equipment should be moved off of the landside slope and toe. (Fall 2022)

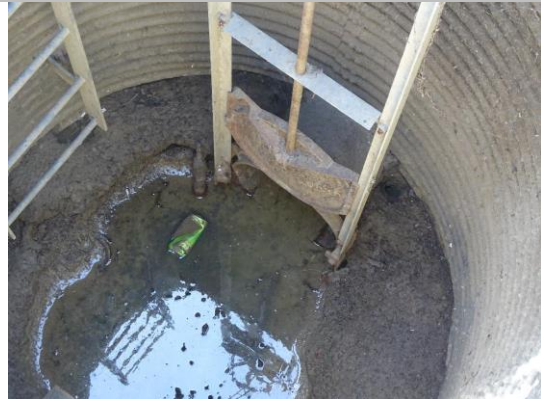
Photo 1 of 2 : UCIP_FA_2023_74549_111308.jpg

DS_ID:20215
FS_ID:74549
EP_NO: N/A
Repair Type: Urgent
EVAL Issue: 1, Pipe Integrity
Crossing Status: Found
UCIP Comments: 04/05/2022 Record remains Urgent. DMP internal video inspection has found pipe integrity issues. LOF of crossing is between 5 and 6. Crossing will be monitored until funding becomes available to address the issues. No cover on CMP riser causing a safety hazard. (M. Thao - DWR UCIP)
11/18/2016 Crossing has been downgraded from Urgent to No Action Needed a cover has been added to the CMP riser. (O. Magana - DWR UCIP)10/01/2013 Open 60-inch CMP riser on WS needs lid as it's depth may be a hazard to the public. (W. Wylie - DWR UCIP)
FIELD_STRUCT_DESC: 16-inch steel drainage pipe through levee, 11.3 feet below crown. Slide gate in 60-inch corrugated metal pipe (CMP) riser located on the waterside (WS). Concrete inlet is approximately 110 feet west of the levee crown or 110 feet off landside (LS) toe next to roadway. [Additional Reference(s): DWR Levee Log, 1992 (HLM 0.58). USACE San Joaquin River O&M Manual Unit 13, April 1964, (HLM 0.58), Station 290+48, Drawing No. 7-4-1784].

WS view: Looking into CMP riser at slide gate.

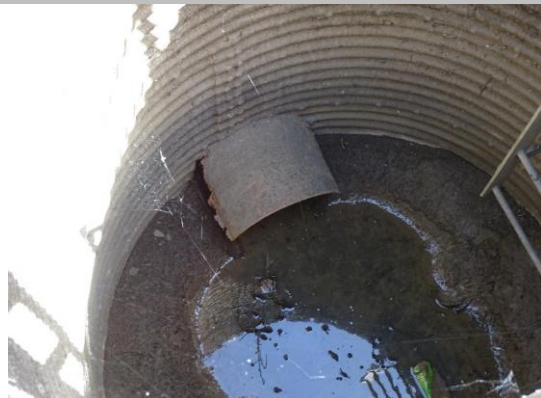
Photo 2 of 2 : UCIP_FA_2023_74549_111309.jpg

WS view: Looking into CMP riser at deteriorated pipe inlet.

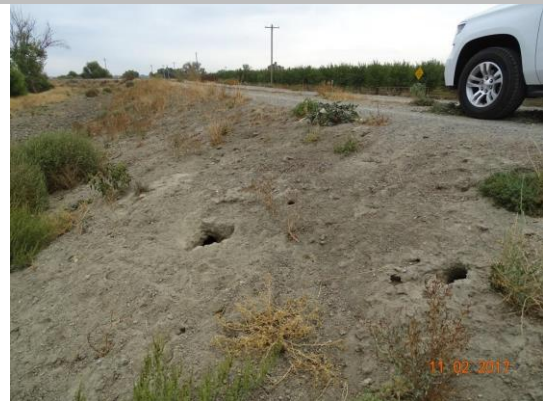
Photo 1 of 1 : FA_2023_RD1602_110_30_20230905_00009.jpg

View of rodent holes on the waterside slope of the levee. Fall 2017

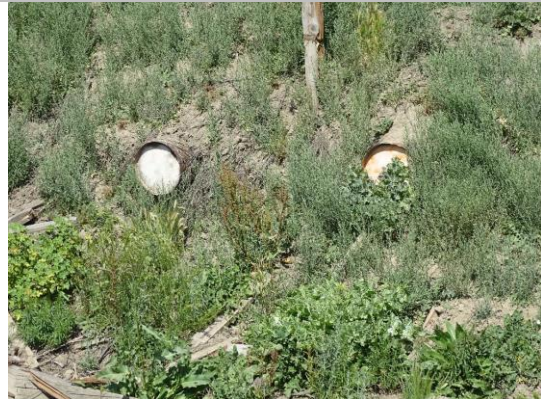
Photo 1 of 2 : UCIP_FA_2023_74539_111263.jpg

| DS_ID:20217 FS_ID:74539 EP_NO: N/A Repair Type: Non-Urgent EVAL Issue: 4b, Safety Issue Crossing Status: Found UCIP Comments: 04/05/2022 Record remains Non-Urgent. Pump and platform on LS has been removed. The crossing has been capped and exposed on the LS toe. Unable to find a permit for modification. Crossing appears abandoned. Unable to locate a permit and confirm proper pipe abandonment. Recommend owner to contact CVFPB to abandon or remove pipe from levee. Cover missing on CMP riser causing a safety hazard. (M. Thao - DWR UCIP) 11/18/2016 Crossing has been downgraded from Urgent to Non-Urgent a flap gate has been added to the WS but pipe is currently not connected to pump. According to Tony Martinez, LMA representative, this crossing is currently not in use. Owner will need to coordinate with CVFPB to obtain permit. (O. Magana - DWR UCIP)10/01/2013 Appears abandoned and if so should be done so properly. Flapgate missing. (W. Wylie - DWR UCIP) FIELD_STRUCT_DESC: 1 of 2: 16-inch steel drainage pipe through levee, 17 feet below crown. Pipe is capped on the landside (LS) end. Pumps on the pump platform are located on LS. Siphon breaker in 24-inch corrugated metal pipe (CMP) riser is located on the waterside (WS) shoulder. Concrete "U" headwall and flap gate are located on the WS end. [Additional Reference(s): DWR Levee Log, 1992 (HLM 1.01). USACE San Joaquin River O&M Manual Unit 13, April 1964, (HLM 1.01), Station 266+68, listed as 16-inch pipe, Drawing No. 7-4-1784]. FS Date: 4/5/2022 | | | | | |

LS view: Close-up view of pipe inlet capped.

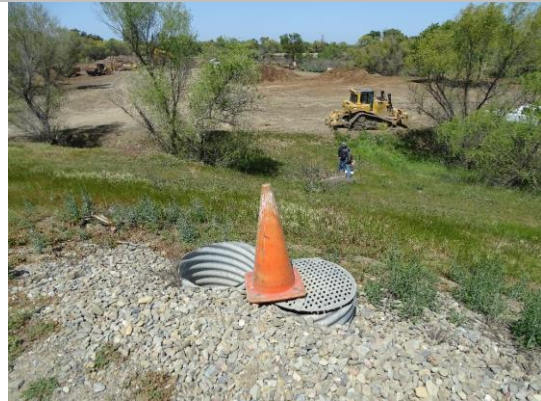
Photo 2 of 2 : UCIP_FA_2023_74539_111264.jpg

WS view: Siphon breaker in CMP riser on shoulder; missing cover on riser. Concrete headwall on toe in background.

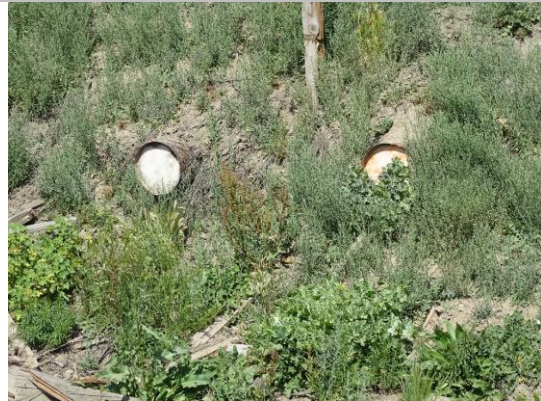
Photo 2 of 2 : UCIP_FA_2023_74536_111247.jpg

| DS_ID:20219 FS_ID:74536 EP_NO: N/A Repair Type: Non-Urgent EVAL Issue: 10, Unauthorized Modification or Non-Compliant Permit Crossing Status: Found UCIP Comments: 04/05/2022 Record remains Non-Urgent. Pump and platform on LS has been removed. The crossing has been capped and exposed on the LS toe. Unable to find a permit for modification. Crossing appears abandoned. Unable to locate a permit and confirm proper pipe abandonment. Recommend owner to contact CVFPB to abandon or remove pipe from levee. (M. Thao - DWR UCIP) 11/18/2016 Crossing has been downgraded from Urgent to Non-Urgent a flap gate has been added to the WS. According to Tony Martinez, LMA representative, this crossing is currently not in use. Owner will need to coordinate with CVFPB to obtain permit. (O. Magana - DWR UCIP) 10/01/2013 Appears abandoned siphon breakers covered in soil and flapgate missing. (W. Wylie - DWR UCIP) FIELD_STRUCT_DESC: 2 of 2: 16-inch steel drainage pipe through levee, 17 feet below crown. Pipe is capped on the landside (LS) end. Pumps on the pump platform are located on LS. Siphon breaker in 24-inch riser located on the waterside (WS) shoulder. Concrete "U" headwall and flap gate are located on the WS end. [Additional Reference(s): DWR Levee Log, 1992 (HLM 1.01). USACE San Joaquin River O&M Manual Unit 13, April 1964, (HLM 1.01), Station 266+68, listed as 16-inch pipe, Drawing No. 7-4-1784]. FS Date: 4/5/2022 | | | | | |

LS view: Close-up view of pipe inlet capped.

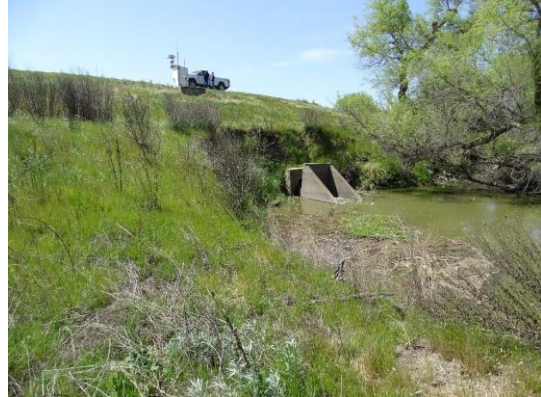
Photo 1 of 2 : UCIP_FA_2023_75649_111240.jpg

DS_ID:20218
FS_ID:75649
EP_NO: N/A
Repair Type: Urgent
EVAL Issue: 2b, Levee Integrity
Crossing Status: Found
UCIP Comments: 04/05/2022 Record remains Urgent. WS concrete headwall is still detached with vertical erosion behind the headwall on the WS slope. Was not able to inspect the flap gate due to water on present on WS. Modification was made on the LS to move the grated inlet at the toe landward approximately 100 feet; unable to find a permit for modification. (M. Thao - DWR UCIP)
10/19/2018 Pipe remains the same. WS concrete headwall is still detached with vertical erosion on the WS slope. Dense vegetation along pipe alignment made it difficult to inspect levee slopes and identify any potential issues present at this site. Recommend clearing vegetation along pipe alignment to be able to conduct a proper UCIP inspection. This crossing is part of DWR's Flood System Repair Project (FSRP) and Deferred Maintenance Project (DMP). Crossing will be monitored to identify progress of erosion on the WS slope. Crossing remains Urgent due to the detachment of the concrete wall and vertical cut on the WS. (O. Magana - DWR UCIP)

11/18/2016 Same as previous inspection headwall on the WS toe has seperated from pipe and flap gate is still missing. Erosion around concrete headwall and undermined WS slope are visible from WS. The slope undermined appears to have progressed but no photos were taken due to the dense vegetation covering area. According to Tony Martinez, LMA representative, the WS concrete headwall has been detached since 2008/2009. LMA has been in contact with CVFPB, DWR, and USACE regarding this site. (O. Magana - DWR UCIP)
10/01/2013 Headwall on WS toe seperated from pipe. Erosion around concrete headwall and undermined at WS toe. Flap gate missing from WS toe headwall. (W. Wylie - DWR UCIP)
FIELD_STRUCT_DESC: 30-inch square reinforced concrete box culvert through levee, 25.4 feet below crown. Concrete "U" headwalls on both waterside (WS) and landside (LS) ends. Slide gate in concrete surge box located on the WS slope. A 5-foot by 5-foot concrete box is located on LS toe. Flap gate is located on the WS end. [Additional Reference(s): DWR Levee Log, 1992 (HLM 1.03). USACE San Joaquin River O&M Manual Unit 13, April 1964, (HLM 1.02), Station 266+29, listed as 30-inch pipe, Drawing No. 7-4-1784].

WS view: Looking toward levee; concrete headwall on toe with erosion.

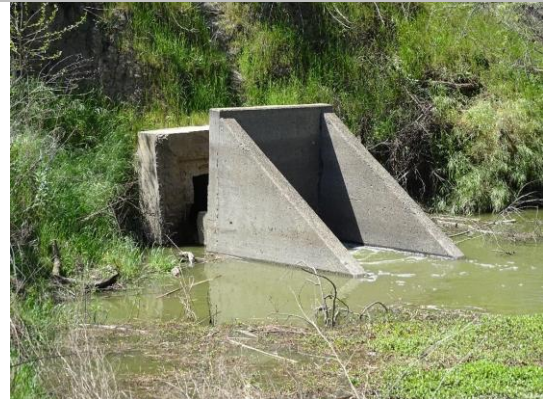
Photo 2 of 2 : UCIP_FA_2023_75649_111241.jpg

WS view: Close-up view of detached concrete headwall on toe.

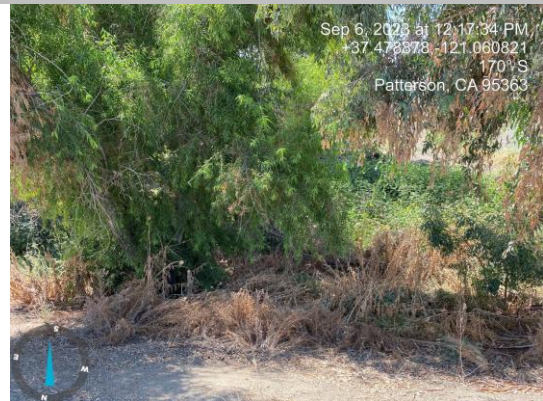
Photo 1 of 1 : FA_2023_RD1602_110_38_20230919_00084.jpg

View of downed trees and woody vegetation on the landside easement (Fall 2023).

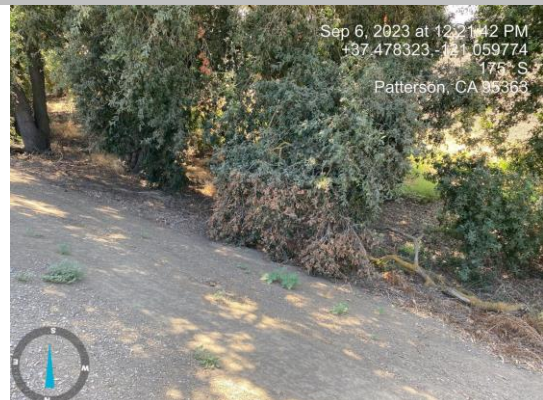
Photo 1 of 1 : FA_2023_RD1602_110_40_20230919_00086.jpg

Broken tree limb left on the landside toe (Fall 2023).

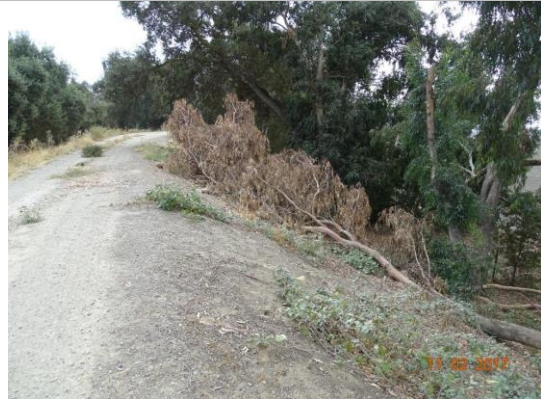
Photo 1 of 1 : FA_2023_RD1602_110_33_20230905_00010.jpg

View of tree limb on the landside of the levee.

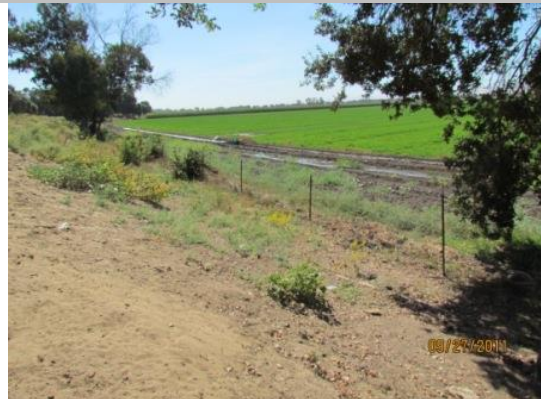
Photo 1 of 1 : FA_2023_RD1602_110_43_20230905_00014.jpg

View of the fence on the landside toe of the levee. The picture was taken from crown looking upstream.

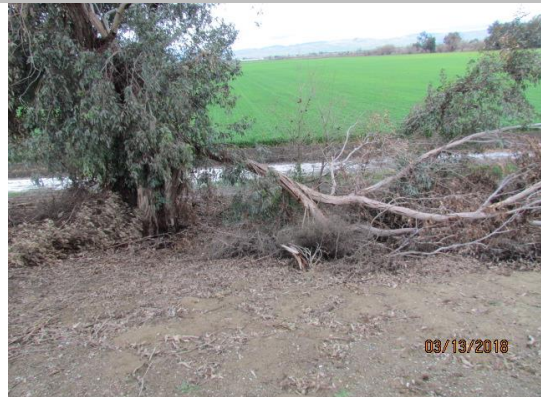
Photo 1 of 1 : FA_2023_RD1602_110_80_20230905_00034.jpg

Looking at fallen branch on landward slope and toe.

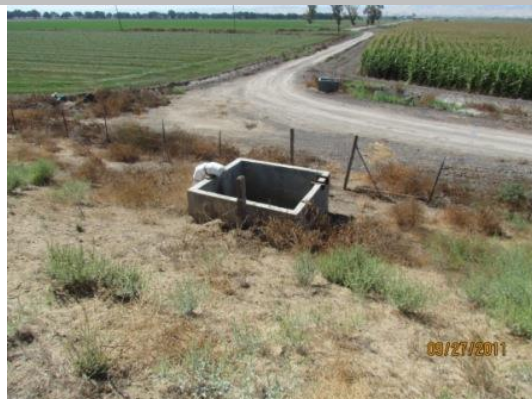
Photo 1 of 1 : FA_2023_RD1602_110_45_20230905_00016.jpg

A well is located at the landside toe of the levee. The picture was taken from the crown looking toward the landside of the levee.

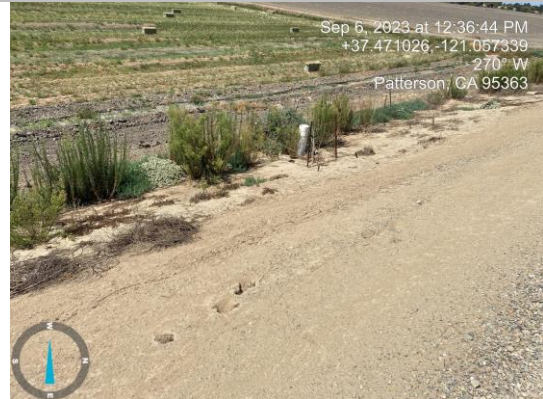
Photo 1 of 1 : FA_2023_RD1602_110_93_20230919_00087.jpg

View of rodent burrows on the landside slope (Fall 2023).

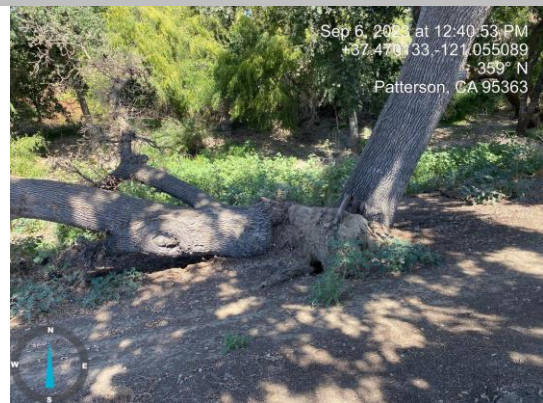
Photo 1 of 1 : FA_2023_RD1602_110_41_20230919_00085.jpg

View of downed tree with root ball exposed on waterside slope (Fall 2023).

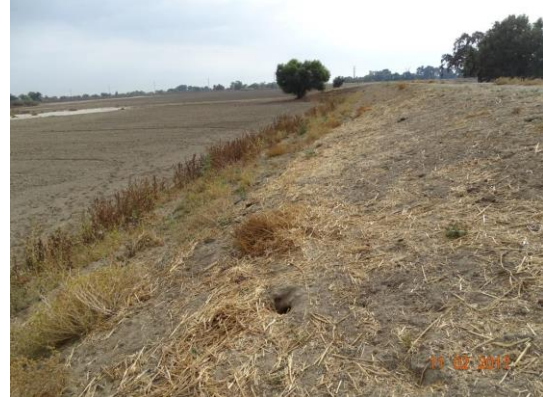
Photo 1 of 1 : FA_2023_RD1602_110_51_20230905_00019.jpg

View of a rodent hole on the waterside of the levee.

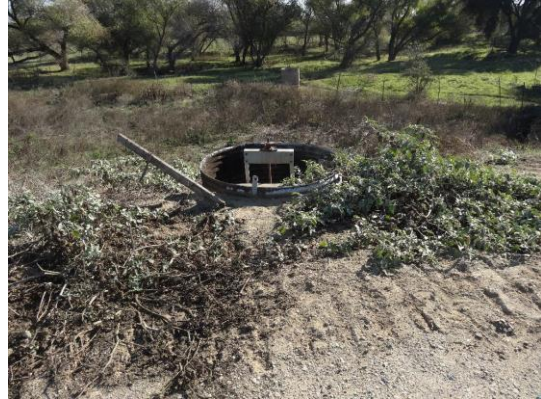
Photo 2 of 3 : UCIP_FA_2023_74530_76529.jpg

| DS_ID:20204 FS_ID:74530 EP_NO: 8193 Repair Type: Urgent EVAL Issue: 1, Pipe Integrity Crossing Status: Found UCIP Comments: 04/05/2022 Record remains Urgent. Pipe inlet within CMP riser is deteriorated. CMP riser cover has broken and fallen into the riser; no cover on the riser causing a safety hazard. Crossing appears abandoned. Recommend owner to contact CVFPB to abandon or remove pipe from levee. (M. Thao - DWR UCIP) 10/19/2018 Pipe is deteriorated on the LS toe (pipe section missing at inlet). This crossing remains Urgent due to the wall deterioration at the inlet. If wall is rusted out at the inlet, need to determine the condition of the pipe section through the levee. According to the LMA representative, this crossing is no longer in use (crossing is abandoned). LMA is interested in abandoning crossing in place. LMA was referred to the CVFPB staff for direction regarding proper action under Title 23 for this crossing. (O. Magana - DWR UCIP) 11/18/2016 Same as previous inspection riser cover and handle on slide gate are still missing. Crossing remains Urgent due to the public safety issue of the 60-inch CMP cover still missing. According to Tony Martinez, LMA representative, the condition and future use of this crossing is being evaluated. Owner will need to coordinate with CVFPB for future use requirements or proper abandonment/removal. (O. Magana - DWR UCIP) 10/01/2013 Appears abandoned, and if so should be done so properly. No handle on slide gate, no cover on CMP standpipe on WS shoulder. (W. Wylie - DWR UCIP) FIELD_STRUCT_DESC: 16-inch steel irrigation pipe through levee, 11.5 feet below crown. Slide gate in 60-inch corrugated metal pipe riser is located on the waterside (WS) slope. Pipe discharges into concrete-lined ditch on the landside (LS) (irrigation pipe was authorized under Automatic Board Order (ABO) issued as Permit No. 8193, 1964 - Sabatte). [Additional Reference(s): DWR Levee Log, 1992 (HLM 3.30). USACE San Joaquin River O&M Manual Unit 13, April 1964, (HLM 3.30), Station 146+62, listed as 16-inch pipe, Drawing No. 7-4-1784]. FS Date: 4/5/2022 | | | | | |

View of WS--CMP riser located on WS shoulder and concrete riser approximately 100 feet from levee crown.

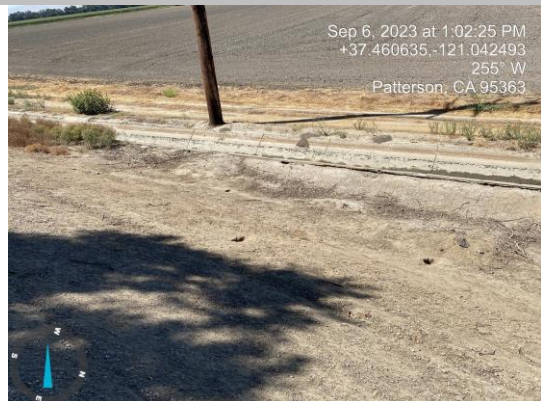
Photo 1 of 1 : FA_2023_RD1602_110_56_20230919_00088.jpg

View of rodent holes on the landside of the levee (Fall 2023).

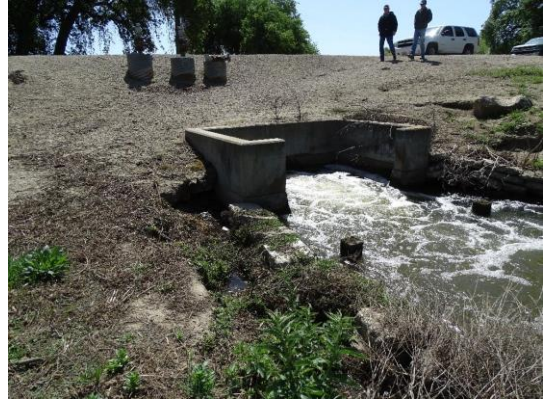
Photo 1 of 2 : UCIP_FA_2023_74520_111227.jpg

| DS_ID:20221 FS_ID:74520 EP_NO: 8191 Repair Type: Non-Urgent EVAL Issue: 6, Levee Damage or Threat for Levee Damage Crossing Status: Found UCIP Comments: 04/05/2022 Record updated from No Action Needed to Non-Urgent. Minor erosion was present around the downstream sides of the concrete distribution box on the LS toe. (M. Thao - DWR UCIP) FIELD_STRUCT_DESC: 1 of 3: 20-inch steel irrigation pipe through the levee, 3.7 feet below the crown. Pump on pump platform on the waterside (WS) bank. Siphon breaker in a 24-inch riser on the landside (LS) shoulder. Concrete discharge box on the LS end. (two 18-inch and one 20-inch pipes were authorized under Automatic Board Order (ABO) issued as Permit No. 8191, 1972 - Twin Oaks Irrigation District c/o Mr. V. R. Peterson). [Additional Reference(s): DWR Levee Log, 1992 (HLM 3.57). USACE San Joaquin O&M Manual 13, April 1964, (HLM 3.57), Station 132+32, listed as 20-inch pipe, Drawing No. 7-4-1784]. FS Date: 4/5/2022 | | | | | |

LS view: Concrete discharge box on toe; erosion around downstream sides.

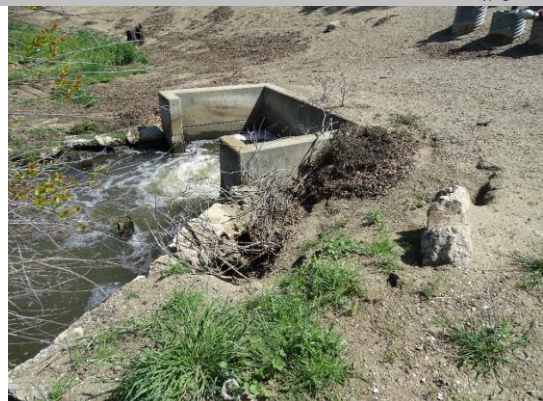
Photo 2 of 2 : UCIP_FA_2023_74520_111228.jpg

LS view: Concrete discharge box on toe; erosion around downstream sides.

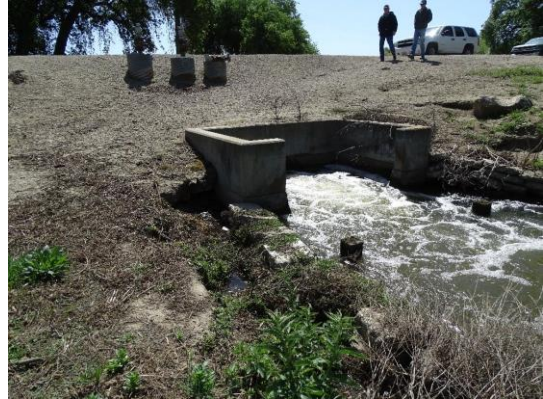
Photo 1 of 2 : UCIP_FA_2023_74519_111221.jpg

| DS_ID:20220 FS_ID:74519 EP_NO: 8191 Repair Type: Non-Urgent EVAL Issue: 6, Levee Damage or Threat for Levee Damage Crossing Status: Found UCIP Comments: 04/05/2022 Record updated from No Action Needed to Non-Urgent. Minor erosion was present around the downstream sides of the concrete distribution box on the LS toe. (M. Thao - DWR UCIP) FIELD_STRUCT_DESC: 2 of 3: 18-inch steel irrigation pipe through the levee, 3.7 feet below the crown. Pump on pump platform on the waterside (WS) bank. Siphon breaker in a 24-inch riser on the landside (LS) shoulder. Concrete discharge box on the LS end. (Two 18-inch and one 20-inch pipes were authorized under Automatic Board Order (ABO) issued as Permit No. 8191, 1972 - Twin Oaks Irrigation District c/o Mr. V. R. Peterson). [Additional Reference(s): DWR Levee Log, 1992 (HLM 3.57). USACE San Joaquin O&M Manual 13, April 1964, (HLM 3.57), Station 132+32, listed as 18-inch pipe, Drawing No. 7-4-1784]. FS Date: 4/5/2022 | | | | | |

LS view: Concrete discharge box on toe; erosion around downstream sides.

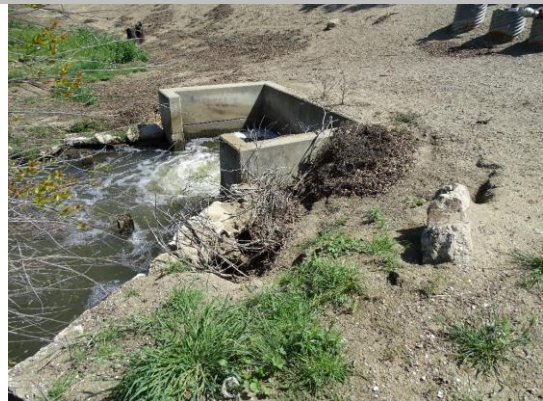
Photo 2 of 2 : UCIP_FA_2023_74519_111222.jpg

LS view: Concrete discharge box on toe; erosion around downstream sides.

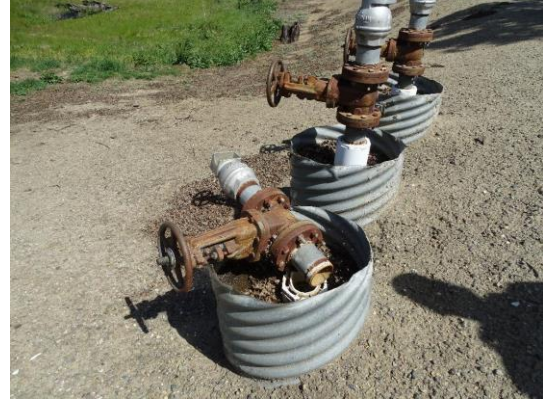
Photo 1 of 3 : UCIP_FA_2023_74503_111215.jpg

| DS_ID:20205 FS_ID:74503 EP_NO: 8191 Repair Type: Non-Urgent EVAL Issue: 6, Levee Damage or Threat for Levee Damage Crossing Status: Found UCIP Comments: 04/05/2022 Record updated from No Action Needed to Non-Urgent. Siphon breaker in CMP riser is broken; recommend repairing the siphon breaker. Minor erosion was present around the downstream sides of the concrete distribution box on the LS toe. (M. Thao - DWR UCIP) FIELD_STRUCT_DESC: 3 of 3: 18-inch steel irrigation pipe through the levee, 3.7 feet below the crown. Pump on pump platform on the waterside (WS) bank. Siphon breaker in a 24-inch riser on the landside (LS) shoulder. Concrete discharge box on the LS end. (two 18-inch and one 20-inch pipes were authorized under Automatic Board Order (ABO) issued as Permit No. 8191, 1972 - Twin Oaks Irrigation District c/o Mr. V. R. Peterson). [Additional Reference(s): DWR Levee Log, 1992 (HLM 3.57). USACE San Joaquin O&M Manual 13, April 1964, (HLM 3.57), Station 132+32, listed as 18-inch pipe, Drawing No. 7-4-1784]. FS Date: 4/5/2022 | | | | | |

LS view: Close-up view of broken siphon breaker.

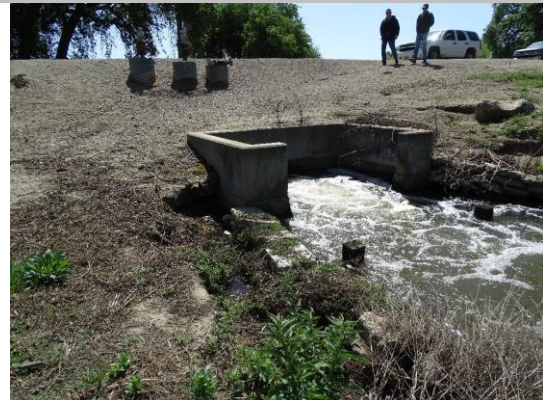
Photo 2 of 3 : UCIP_FA_2023_74503_111216.jpg

LS view: Concrete discharge box on toe; erosion around downstream sides.

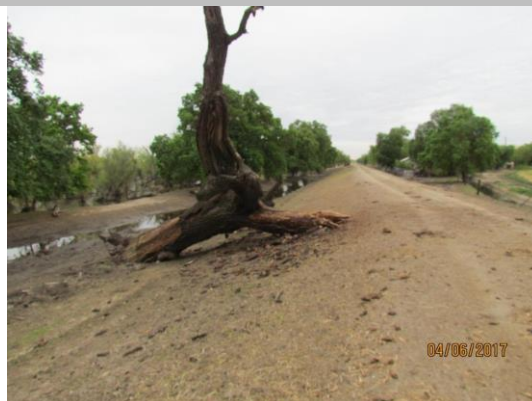
Photo 1 of 1 : FA_2023_RD1602_110_83_20230905_00035.jpg

View of a tree trunk on the waterside slope of the levee.

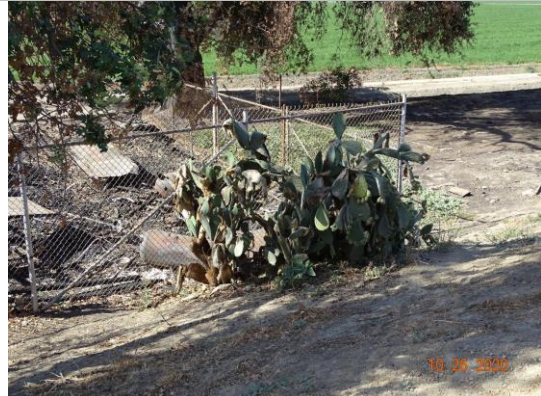
Photo 1 of 1 : FA_2023_RD1602_110_42_20230905_00013.jpg

Cactus growing on the landside slope. (Fall 2020)

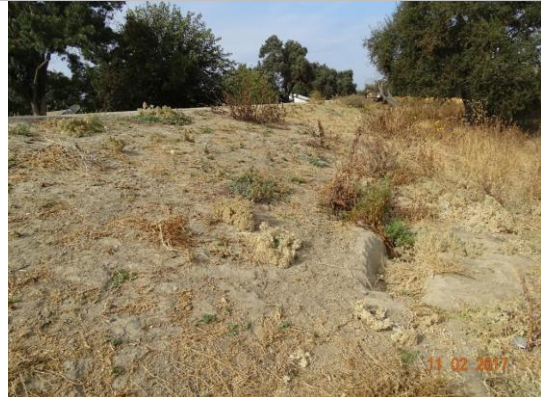
Photo 1 of 1 : FA_2023_RD1602_110_84_20230905_00036.jpg

View of rodent holes on the waterside of the levee.

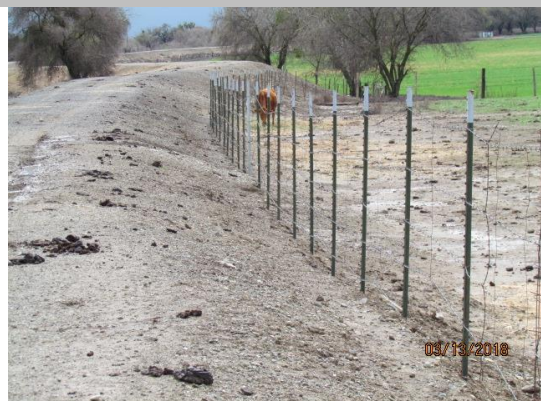
Photo 1 of 1 : FA_2023_RD1602_110_63_20230905_00027.jpg

Looking upstream at fence on landward slope. (Spring 2018)

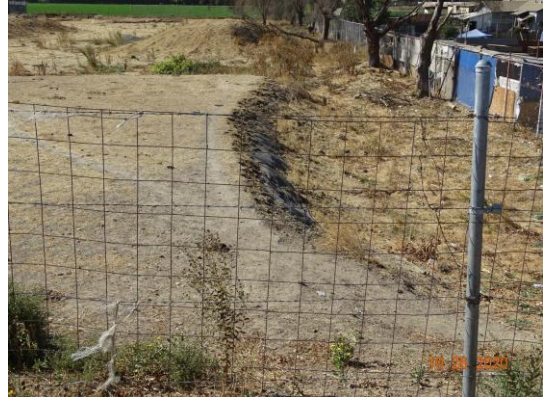
Photo 1 of 1 : FA_2023_RD1602_110_62_20230905_00026.jpg

View of damage to seepage berm constructed on the landside toe. (Fall 2020)

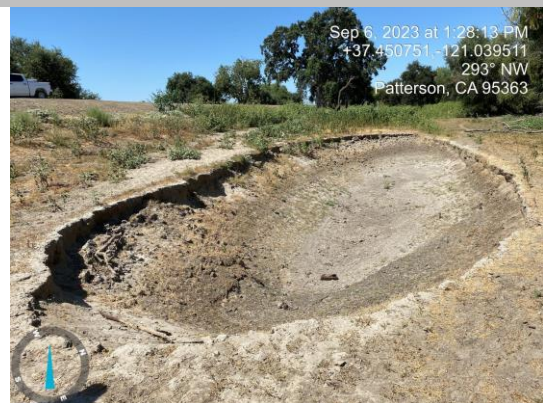
Photo 1 of 1 : FA_2023_RD1602_110_65_20230919_00094.jpg

View of erosion off the waterside toe (Fall 2023).

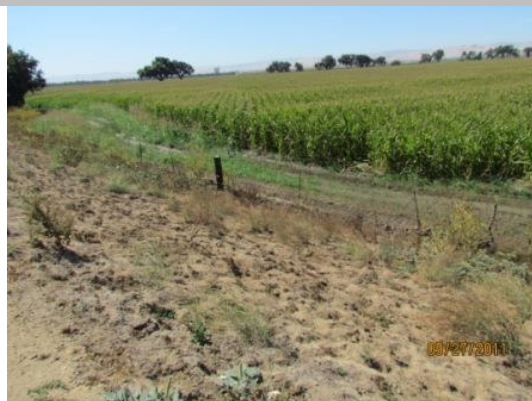
Photo 1 of 1 : FA_2023_RD1602_110_67_20230905_00029.jpg

View of the fence on the landside toe of the levee. The picture was taken from the crown looking upstream.

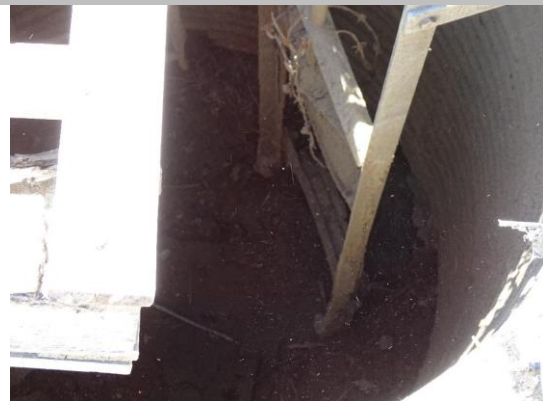
Photo 2 of 2 : UCIP_FA_2023_74531_111174.jpg

WS view: Looking into CMP riser; inlet of pipe through levee is deteriorating.

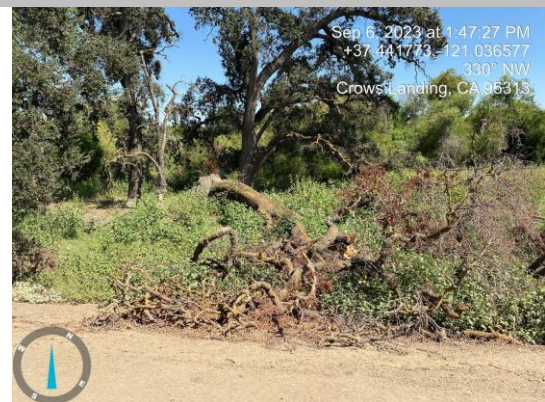
Photo 1 of 1 : FA_2023_RD1602_110_68_20230919_00093.jpg

View of fallen tree on waterside slope (Fall 2023).

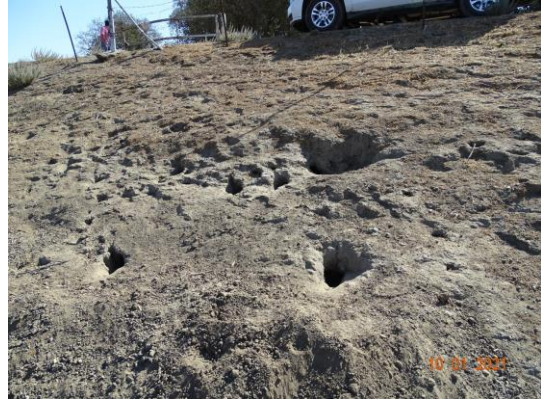
Photo 1 of 1 : FA_2023_RD1602_110_19_20230905_00002.jpg

View of several rodent burrows in the landside slope. (Fall 2021)

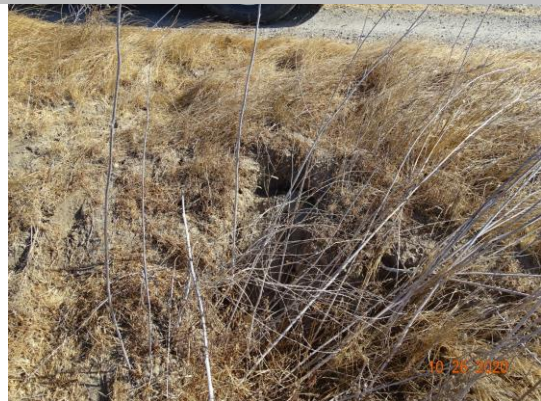
Photo 1 of 1 : FA_2023_RD1602_110_44_20230905_00015.jpg

Several rodent holes noted at this location. (Fall 2020)

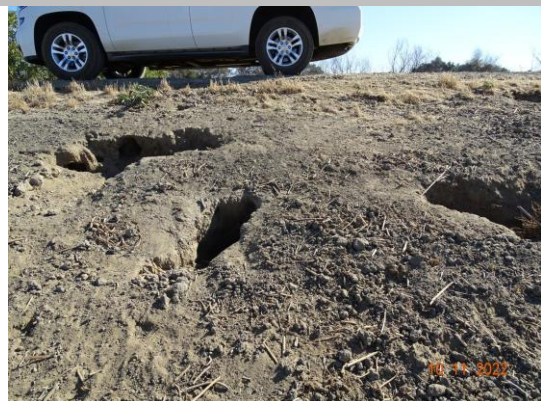
Photo 1 of 1 : FA_2023_RD1602_110_53_20230905_00021.jpg

Several large animal burrows were observed at this location. (Fall 2022)

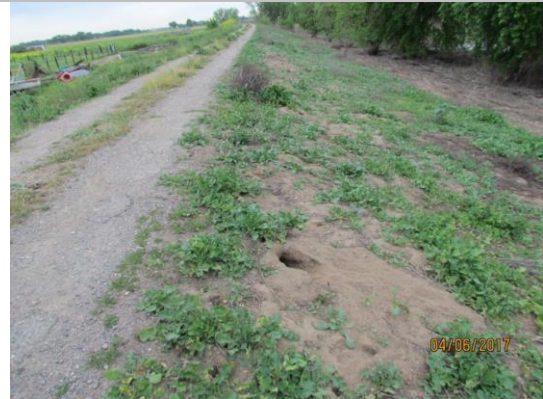
Photo 1 of 1 : FA_2023_RD1602_110_92_20230905_00039.jpg

View of a rodent hole on the waterside shoulder of the levee looking downstream.

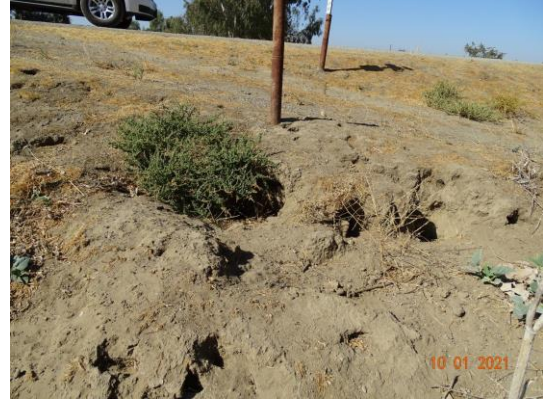
Photo 1 of 1 : FA_2023_RD1602_110_48_20230905_00017.jpg

View of rodent holes on the waterside of the levee looking downstream.
(Fall 2021)

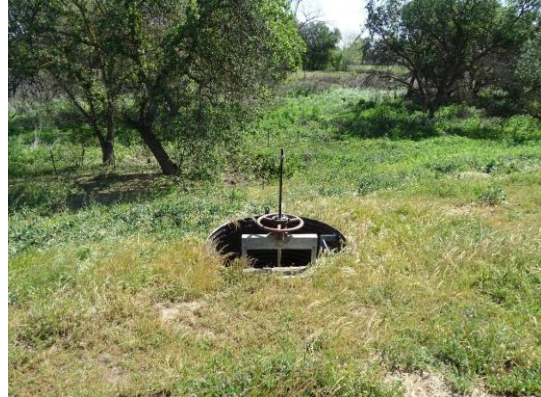
Photo 1 of 2 : UCIP_FA_2023_74358_111160.jpg

WS view: Looking from crown; CMP riser with no cover on slope.

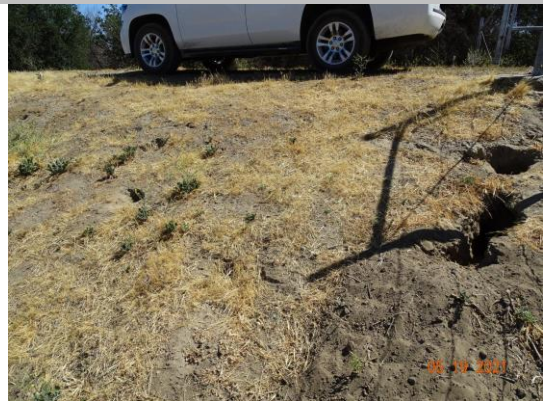
Photo 1 of 1 : FA_2023_RD1602_110_27_20230905_00006.jpg

Large rodent burrows in the landside slope. (Spring 2021)

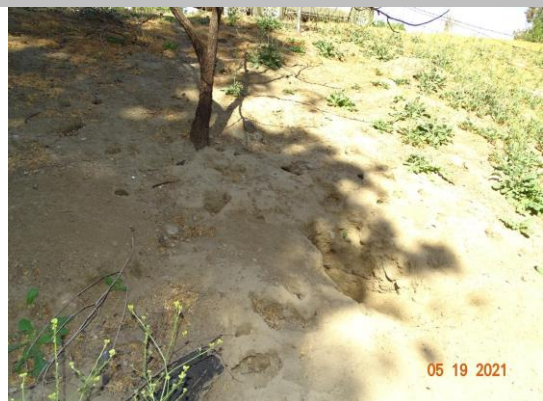
Photo 1 of 1 : FA_2023_RD1602_110_52_20230905_00020.jpg

View of large rodent burrow on the waterside slope. (Spring 2021)

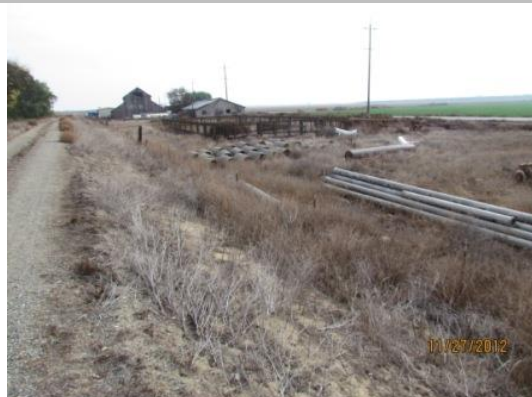
Photo 1 of 1 : FA_2023_RD1602_110_22_20230905_00003.jpg

A fence was found on the landside toe of the levee looking upstream.

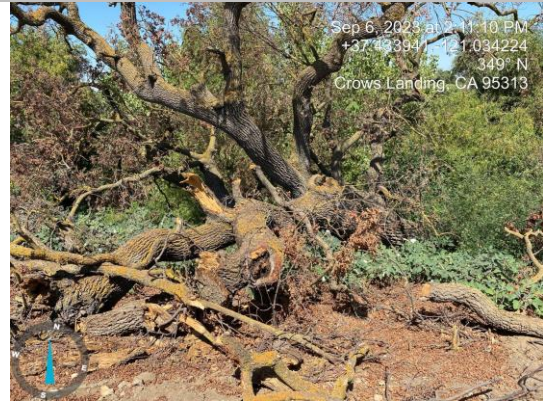
Photo 1 of 1 : FA_2023_RD1602_110_75_20230919_00091.jpg

View of fallen tree on waterside slope (Fall 2023).

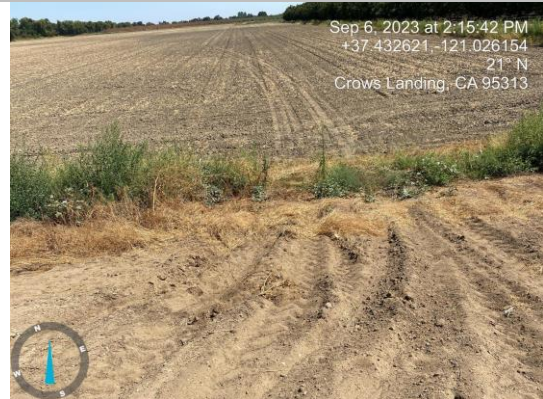
Photo 1 of 1 : FA_2023_RD1602_110_76_20230919_00092.jpg

View of vehicle traffic on waterside slope (Fall 2023).

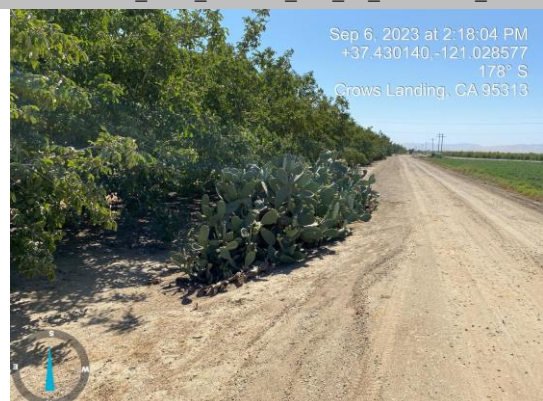
Photo 1 of 1 : FA_2023_RD1602_110_86_20230919_00090.jpg

Looking at dense cactus growth on the waterside slope (Fall 2023).

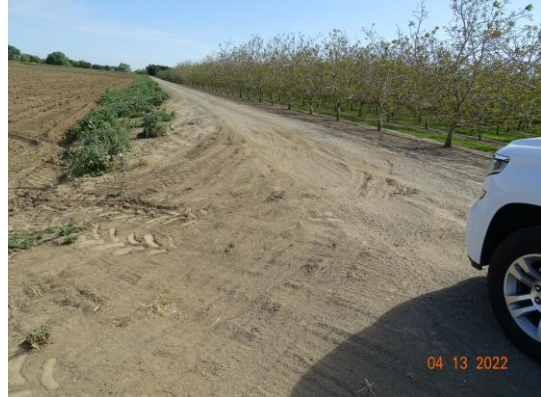
Photo 1 of 1 : FA_2023_RD1602_110_24_20230905_00004.jpg

Depression in levee crown from vehicle traffic. (Spring 2022)

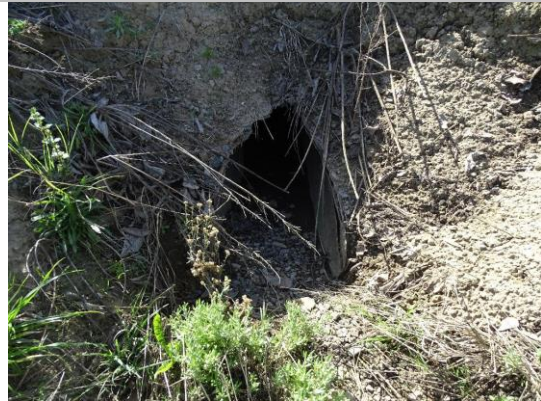
Photo 1 of 2 : UCIP_FA_2023_77638_111103.jpg

LS view: Outlet of irrigation pipe is deteriorated.
