**Flood Control Project Maintenance
Levee Inspections
Fall 2024 Levee Maintenance Deficiency Summary Report**

San Joaquin River Basin

Reclamation District No. 1602 Del Puerto

Waterway			Bank	Unit Miles
Unit No. 01 San Joaquin River			Left	6.24
	Spring (March - May)	Summer (June - August)	(September - November) Fall	Winter (December - February)
Unit Maintenance Rating (Fall Only)			U	
Date of Inspection	3/27/2024 - 3/27/2024		10/15/2024 - 10/15/2024	
DWR Inspector	Nate Hicks		Nate Hicks	
Accompanied By	Nick Short RD1602

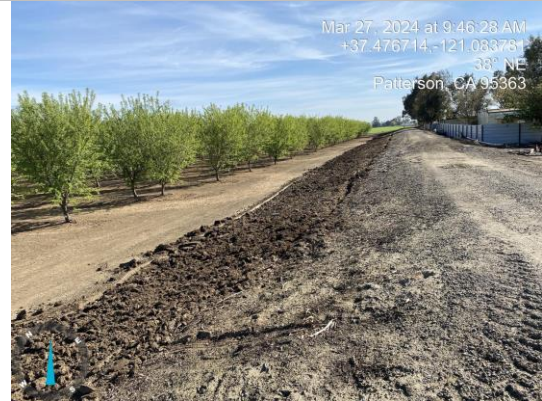
Photo 1 of 1 : FA_2024_RD1602_110_34_20241015_00009.jpg

LM Start	0.00	Rating **	M	Issue No.	34
LM End	0.12	Issue Type +	Ma	Location *	WS
Category	Earthen Levee			GPS Latitude/Longitude	
				Start	End
Item	Erosion / Bank Caving			37.476578 °	37.477252 °
				-121.083898 °	-121.081967 °
DWR ID	DWR_RD1602_01_s _ 2024_34				
Comment Code					
E2 : Schedule repair of erosion site prior to the next inspection.					
Inspector Comment					
Repair waterside slope damaged by tilling.

View of tilling along the waterside slope (Spring 2024).

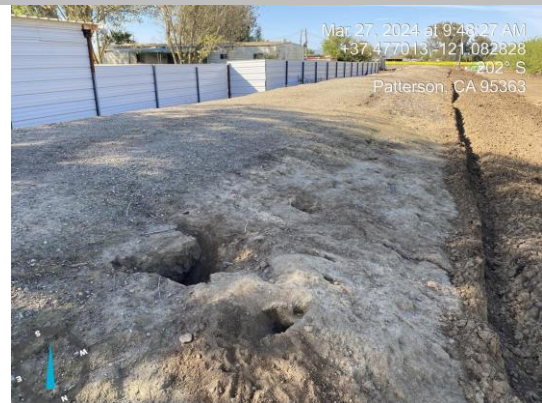
Photo 1 of 1 : FA_2024_RD1602_110_28_20241015_00005.jpg

LM Start	0.00	Rating **	U	Issue No.	28
LM End	0.12	Issue Type +	Ma	Location *	WS
Category	Earthen Levee			GPS Latitude/Longitude	
				Start	End
Item	Animal Control			37.476578 °	37.477248 °
				-121.083898 °	-121.081971 °
DWR ID	DWR_RD1602_01_s _ 2024_28				
Comment Code					
A1 : Exterminate rodents and backfill and compact or grout burrows.					
Inspector Comment					
Rodent burrows in the crown and waterside shoulder should be backfilled and compacted.

View of animal holes along the waterside slope (Spring 2024).

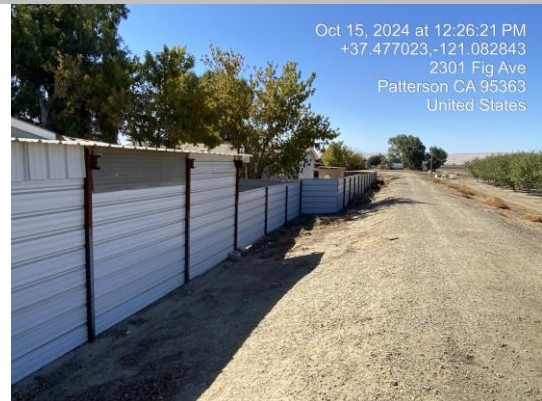
Photo 1 of 1 : FA_2024_RD1602_110_57_20241021_00090.jpg

LM Start	0.02	Rating **	U	Issue No.	57
LM End	0.07	Issue Type +	En	Location *	LS
Category	Earthen Levee			GPS Latitude/Longitude	
				Start	End
Item	Encroachments			37.476719 °	37.477058 °
				-121.083580 °	-121.082833 °
DWR ID	DWR_RD1602_01_f _ 2024_57				
Comment Code					
FE : Fence					
Inspector Comment

View of fence along the landside toe (Fall 2024).

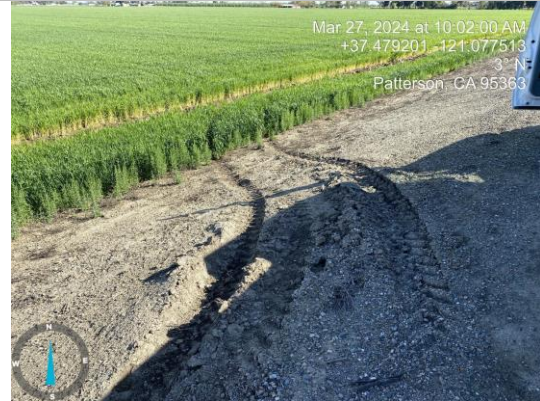
Photo 1 of 1 : FA_2024_RD1602_110_73_20241015_00024.jpg

LM Start	0.40	Rating **	M	Issue No.	73
LM End	0.40	Issue Type +	Ma	Location *	WS
Category	Earthen Levee			GPS Latitude/Longitude	
				Start	End
Item	Erosion / Vehicle Traffic			37.479172°	37.479172°
				-121.077494°	-121.077494°
DWR ID	DWR_RD1602_01_s_2024_73				
Comment Code					
E6 : Repair the levee slope damaged by vehicle traffic and prevent access where possible.					
Inspector Comment

View of vehicle traffic that has cut ruts into the waterside slope (Spring 2024).

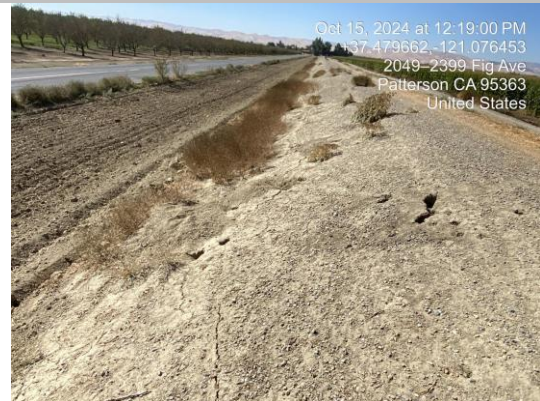
Photo 1 of 1 : FA_2024_RD1602_110_110_20241021_00089.jpg

LM Start	0.44	Rating **	U	Issue No.	110
LM End	0.50	Issue Type +	Ma	Location *	LS
Category	Earthen Levee			GPS Latitude/Longitude	
				Start	End
Item	Animal Control			37.479443 °	37.479899 °
				-121.076912 °	-121.075930 °
DWR ID	DWR_RD1602_01_f_2018_110				
Comment Code					
A1 : Exterminate rodents and backfill and compact or grout burrows.					
Inspector Comment

View of animal burrows on the landside slope (Fall 2024).

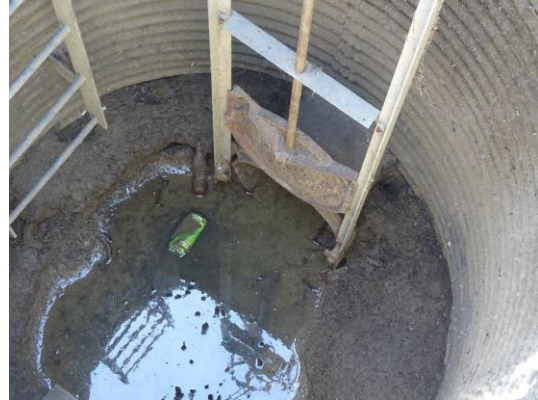
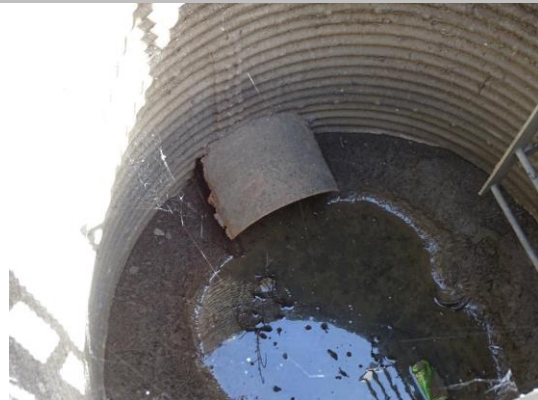
Comment Code					
Inspector Comment					
DS_ID:20215 FS_ID:74549 EP_NO: N/A Repair Type: Urgent EVAL Issue: 1, Pipe Integrity Crossing Status: Found UCIP Comments: 04/05/2022 Record remains Urgent. DMP internal video inspection has found pipe integrity issues. LOF of crossing is between 5 and 6. Crossing will be monitored until funding becomes available to address the issues. No cover on CMP riser causing a safety hazard. (M. Thao - DWR UCIP) 11/18/2016 Crossing has been downgraded from Urgent to No Action Needed a cover has been added to the CMP riser. (O. Magana - DWR UCIP) 01/01/2013 Open 60-inch CMP riser on WS needs lid as it's depth may be a hazard to the public. (W. Wylie - DWR UCIP) FIELD_STRUCT_DESC: 16-inch steel drainage pipe through levee, 11.3 feet below crown. Slide gate in 60-inch corrugated metal pipe (CMP) riser located on the waterside (WS). Concrete inlet is approximately 110 feet west of the levee crown or 110 feet off landside (LS) toe next to roadway. [Additional Reference(s): DWR Levee Log, 1992 (HLM 0.58). USACE San Joaquin River O&M Manual Unit 13, April 1964, (HLM 0.58), Station 290+48, Drawing No. 7-4-1784]. FS Date: 4/5/2022

WS view: Looking into CMP riser at slide gate.

WS view: Looking into CMP riser at deteriorated pipe inlet.

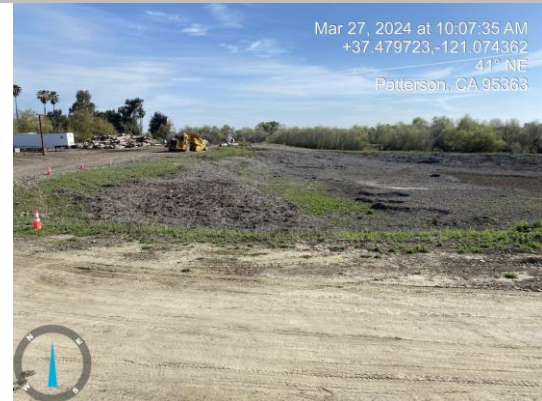
Photo 1 of 1 : FA_2024_RD1602_110_29_20241015_00006.jpg

Haul road constructed by an adjacent landowner and material piled in the channel (Spring 2024).

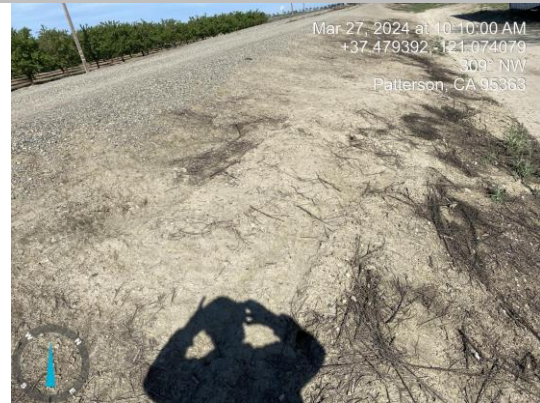
Photo 1 of 1 : FA_2024_RD1602_110_30_20241015_00007.jpg

View of collapsed rodent holes that need to be backfilled and compacted properly (Spring 2024).

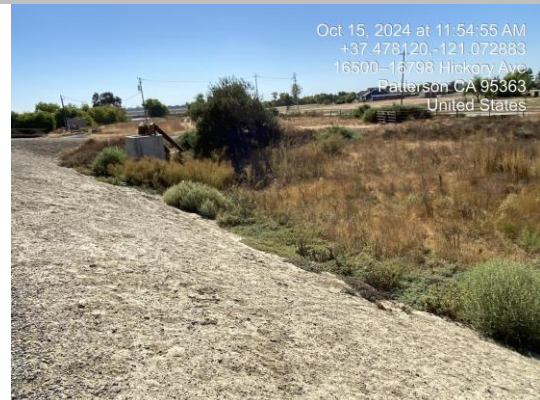
Photo 1 of 1 : FA_2024_RD1602_110_56_20241021_00088.jpg

LM Start	0.72	Rating **	M	Issue No.	56
LM End	0.78	Issue Type +	Ma	Location *	LS
Category	Earthen Levee			GPS Latitude/Longitude	
				Start	End
Item	Vegetation			37.478501 °	37.477929 °
				-121.073424 °	-121.072551 °
DWR ID	DWR_RD1602_01_f_2024_56				
Comment Code					
V1 : Control annual grass and weeds on the levee slopes and easements.					
Inspector Comment					
Remove vegetation off the landside easement.

View of vegetation on the landside hinge and easement (Fall 2024).

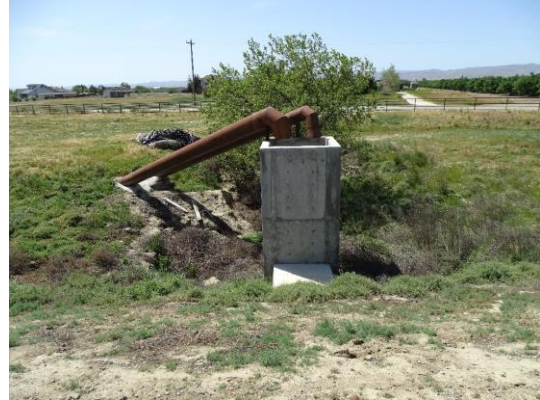
Photo 1 of 1 : UCIP_FA_2024_75648_111281.jpg

Comment Code					
Inspector Comment					
DS_ID:20216 FS_ID:75648 EP_NO: N/A Repair Type: Non-Urgent EVAL Issue: 10, Unauthorized Modification or Non-Compliant Permit Crossing Status: Found UCIP Comments: 04/05/2022 Record updated from No Action Needed to Non-Urgent. A new concrete discharge box was installed on the LS toe since the last inspection; unable to find a permit for modification. (M. Thao - DWR UCIP) 11/18/2016 Crossing has been downgraded from Urgent to No Action Needed the debris blocking the outlet has been cleared. (O. Magana - DWR UCIP) 01/2013 Flap gate blocked from functioning by soil buildup on WS toe. Soil should be cleared. (W. Wylie - DWR UCIP) FIELD_STRUCT_DESC: 30-inch square reinforced concrete box drainage culvert through levee, 14.4 feet below crown. Concrete "U" headwall on the waterside (WS) and landside (LS) ends. Slide gate in 6-foot by 7-foot concrete surge box is located on the WS shoulder. Flap gate is located on the WS end. [Additional Reference(s): DWR Levee Log, 1992 (HLM 0.78). USACE San Joaquin River O&M Manual Unit 13, April 1964, (HLM 0.78), Station 279+60, listed as 30-inch pipe, Drawing No. 7-4-1784]. FS Date: 4/5/2022

LS view: Looking from crown; new concrete drainage box on toe.

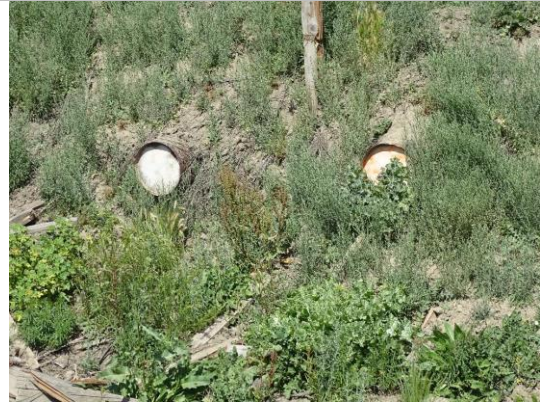
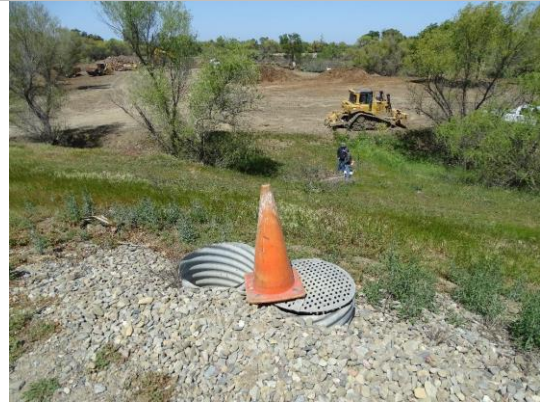
DS_ID:20217
FS_ID:74539
EP_NO: N/A
Repair Type: Non-Urgent
EVAL Issue: 4b, Safety Issue
Crossing Status: Found
UCIP Comments: 04/05/2022 Record remains Non-Urgent. Pump and platform on LS has been removed. The crossing has been capped and exposed on the LS toe. Unable to find a permit for modification. Crossing appears abandoned. Unable to locate a permit and confirm proper pipe abandonment. Recommend owner to contact CVFPB to abandon or remove pipe from levee. Cover missing on CMP riser causing a safety hazard. (M. Thao - DWR UCIP)
11/18/2016 Crossing has been downgraded from Urgent to Non-Urgent a flap gate has been added to the WS but pipe is currently not connected to pump. According to Tony Martinez, LMA representative, this crossing is currently not in use. Owner will need to coordinate with CVFPB to obtain permit. (O. Magana - DWR UCIP)
01/2013 Appears abandoned and if so should be done so properly. Flapgate missing. (W. Wylie - DWR UCIP)

LS view: Close-up view of pipe inlet capped.

WS view: Siphon breaker in CMP riser on shoulder; missing cover on riser. Concrete headwall on toe in background.

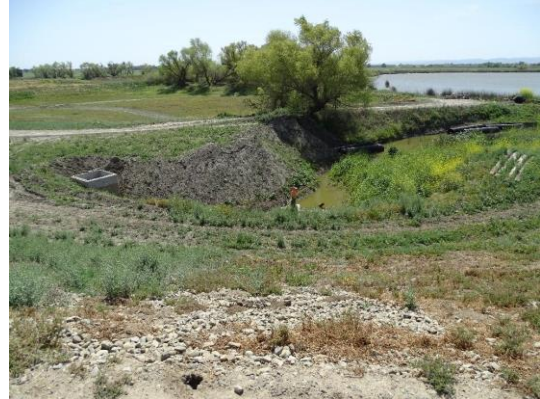
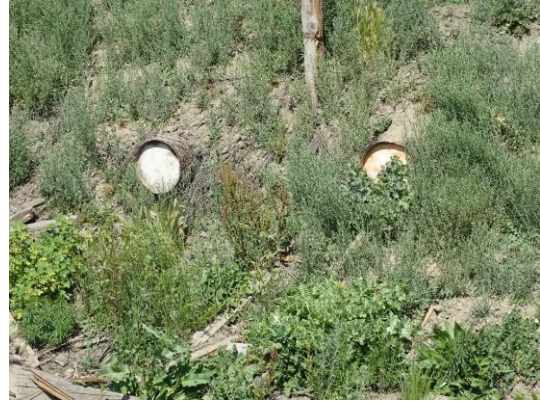
Comment Code					
Inspector Comment					
DS_ID:20219 FS_ID:74536 EP_NO: N/A Repair Type: Non-Urgent EVAL Issue: 10, Unauthorized Modification or Non-Compliant Permit Crossing Status: Found UCIP Comments: 04/05/2022 Record remains Non-Urgent. Pump and platform on LS has been removed. The crossing has been capped and exposed on the LS toe. Unable to find a permit for modification. Crossing appears abandoned. Unable to locate a permit and confirm proper pipe abandonment. Recommend owner to contact CVFPB to abandon or remove pipe from levee. (M. Thao - DWR UCIP) 11/18/2016 Crossing has been downgraded from Urgent to Non-Urgent a flap gate has been added to the WS. According to Tony Martinez, LMA representative, this crossing is currently not in use. Owner will need to coordinate with CVFPB to obtain permit. (O. Magana - DWR UCIP) 10/01/2013 Appears abandoned siphon breakers covered in soil and flapgate missing. (W. Wylie - DWR UCIP) FIELD_STRUCT_DESC: 2 of 2: 16-inch steel drainage pipe through levee, 17 feet below crown. Pipe is capped on the landside (LS) end. Pumps on the pump platform are located on LS. Siphon breaker in 24-inch riser located on the waterside (WS) shoulder. Concrete "U" headwall and flap gate are located on the WS end. [Additional Reference(s): DWR Levee Log, 1992 (HLM 1.01). USACE San Joaquin River O&M Manual Unit 13, April 1964, (HLM 1.01), Station 266+68, listed as 16-inch pipe, Drawing No. 7-4-1784]. FS Date: 4/5/2022

LS view: Looking from crown; general overview.

LS view: Close-up view of pipe inlet capped.

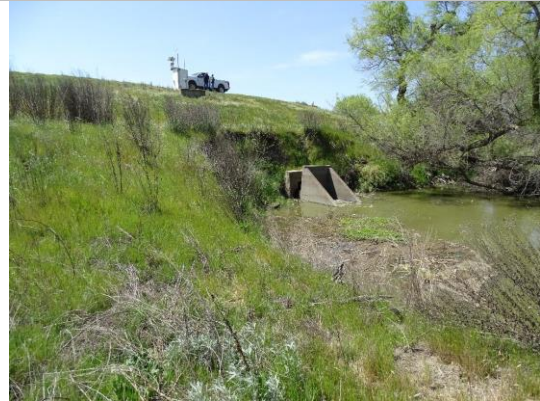
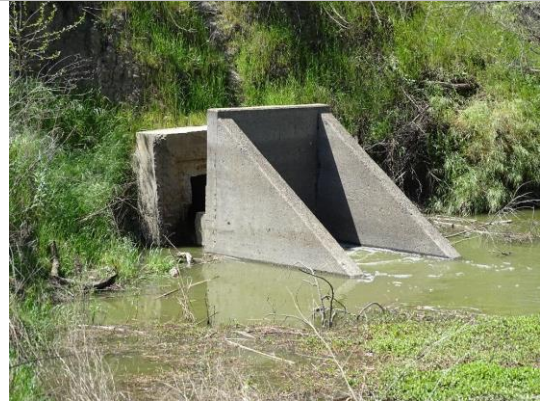
DS_ID:20218
FS_ID:75649
EP_NO: N/A
Repair Type: Urgent
EVAL Issue: 2b, Levee Integrity
Crossing Status: Found
UCIP Comments: 04/05/2022 Record remains Urgent. WS concrete headwall is still detached with vertical erosion behind the headwall on the WS slope. Was not able to inspect the flap gate due to water on present on WS. Modification was made on the LS to move the grated inlet at the toe landward approximately 100 feet; unable to find a permit for modification. (M. Thao - DWR UCIP)
10/19/2018 Pipe remains the same. WS concrete headwall is still detached with vertical erosion on the WS slope. Dense vegetation along pipe alignment made it difficult to inspect levee slopes and identify any potential issues present at this site. Recommend clearing vegetation along pipe alignment to be able to conduct a proper UCIP inspection. This crossing is part of DWR's Flood System Repair Project (FSRP) and Deferred Maintenance Project (DMP). Crossing will be monitored to identify progress of erosion on the WS slope. Crossing remains Urgent due to the detachment of the concrete wall and vertical cut on the WS. (O. Magana - DWR UCIP)

11/18/2016 Same as previous inspection headwall on the WS toe has separated from pipe and flap gate is still missing. Erosion around concrete headwall and undermined WS slope are visible from WS. The slope undermined appears to have progressed but no photos were taken due to the dense vegetation covering area. According to Tony Martinez, LMA representative, the WS concrete headwall has been detached since 2008/2009. LMA has been in contact with CVFPB, DWR, and USACE regarding this site. (O. Magana - DWR UCIP)
10/01/2013 Headwall on WS toe separated from pipe. Erosion around concrete headwall and undermined at WS toe. Flap gate missing from WS toe headwall. (W. Wylie - DWR UCIP)
FIELD_STRUCT_DESC: 30-inch square reinforced concrete box culvert through levee, 25.4 feet below crown. Concrete "U" headwalls on both waterside (WS) and landside (LS) ends. Slide gate in concrete surge box located on the WS slope. A 5-foot by 5-foot concrete box is located on LS toe. Flap gate is located on the WS end. [Additional Reference(s): DWR Levee Log, 1992 (HLM 1.03). USACE San Joaquin River O&M Manual Unit 13, April 1964, (HLM 1.02), Station 266+29, listed as 30-inch pipe, Drawing No. 7-4-1784].

WS view: Looking toward levee; concrete headwall on toe with erosion.

WS view: Close-up view of detached concrete headwall on toe.

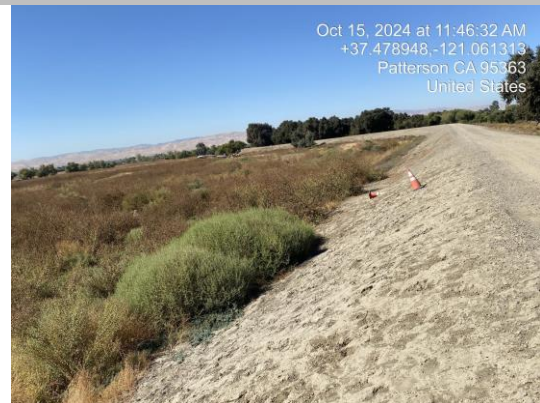
Photo 1 of 1 : FA_2024_RD1602_110_55_20241021_00087.jpg

View of vegetation on the landside hinge and easement (Fall 2024).

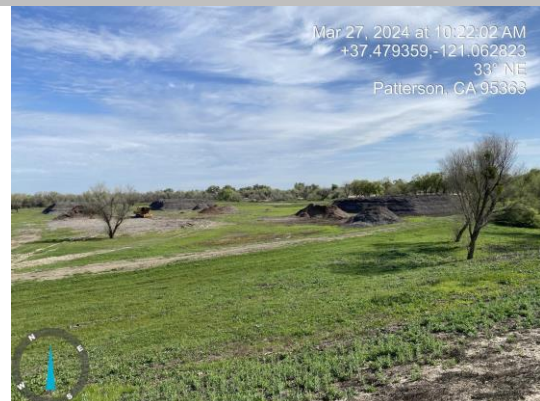
Photo 1 of 1 : FA_2024_RD1602_110_78_20241015_00026.jpg

View of wood chippings within the channel (Spring 2024).

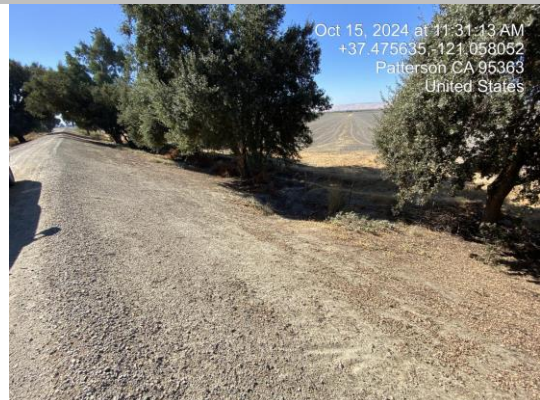
Photo 1 of 1 : FA_2024_RD1602_110_54_20241021_00086.jpg

LM Start	1.77	Rating **	M	Issue No.	54
LM End	1.77	Issue Type +	Ma	Location *	LS
Category	Earthen Levee			GPS Latitude/Longitude	
				Start	End
Item	Slope Stability			37.475546 °	37.475546 °
				-121.057980 °	-121.057980 °
DWR ID	DWR_RD1602_01_f_2024_54				
Comment Code					
S1 : Repair slope instability.					
Inspector Comment					
Depression in the landside slope and toe was observed.

View of depression on the landside slope near the hinge (Fall 2024).

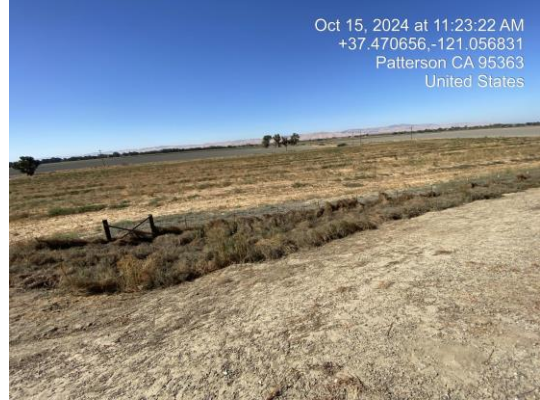
Photo 1 of 1 : FA_2024_RD1602_110_51_20241021_00085.jpg

View of vegetation on the landside hinge and easement (Fall 2024).

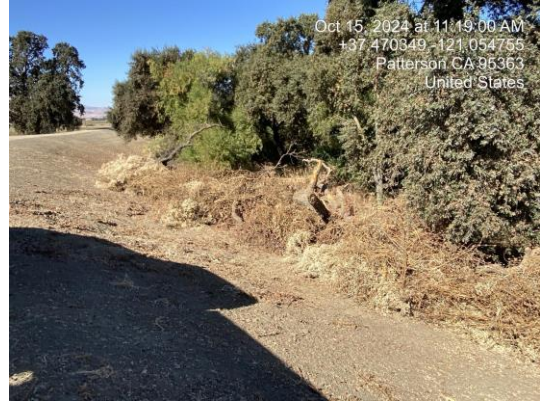
Photo 1 of 1 : FA_2024_RD1602_110_41_20241021_00084.jpg

View of fallen tree and limbs on the waterside slope (Fall 2024).

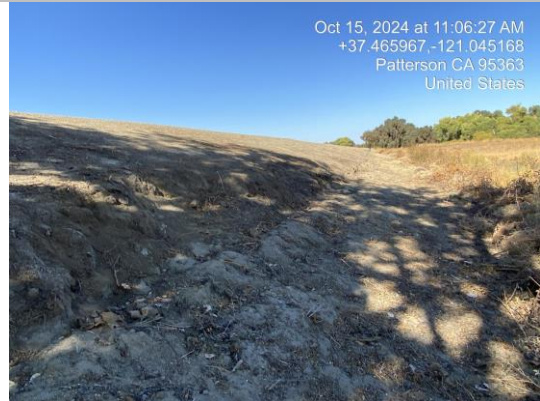
Photo 1 of 1 : FA_2024_RD1602_110_46_20241021_00083.jpg

LM Start	2.71	Rating **	U	Issue No.	46
LM End	2.90	Issue Type +	Ma	Location *	WS
Category	Earthen Levee			GPS Latitude/Longitude	
				Start	End
Item	Erosion / Bank Caving			37.467739°	37.465822°
				-121.047501°	-121.045137°
DWR ID	DWR_RD1602_01_f_2024_46				
Comment Code					
E2 : Schedule repair of erosion site prior to the next inspection.					
Inspector Comment					
Repair wavewash erosion. Site to be assessed by erosion survey program.

View of wavewash erosion on the waterside slope (Fall 2024).

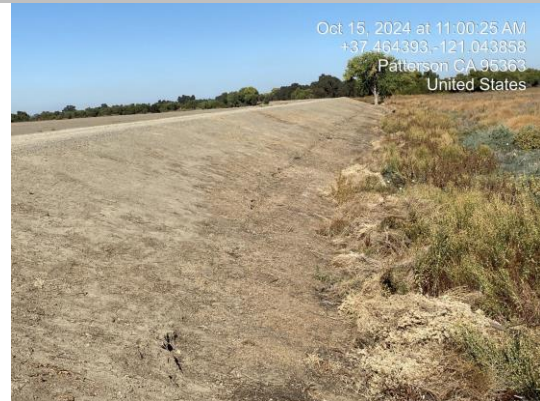
Photo 1 of 1 : FA_2024_RD1602_110_89_20241021_00082.jpg

LM Start	2.90	Rating **	M	Issue No.	89
LM End	3.20	Issue Type +	Ma	Location *	WS
Category	Earthen Levee			GPS Latitude/Longitude	
				Start	End
Item	Erosion / Bank Caving			37.465824 °	37.462472 °
				-121.045133 °	-121.041631 °
DWR ID	DWR_RD1602_01_s_2024_89				
Comment Code					
E2 : Schedule repair of erosion site prior to the next inspection.					
Inspector Comment					
Repair wavewash erosion.

View of wavewash erosion on the waterside slope (Fall 2024).

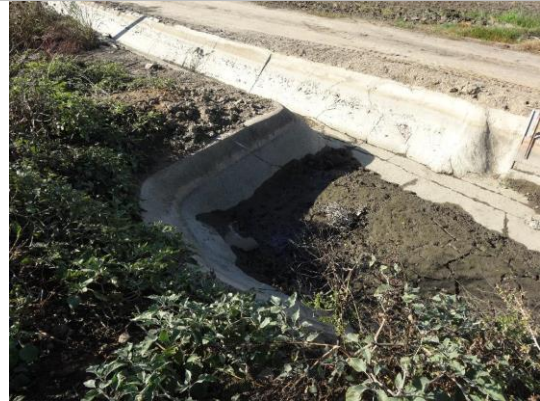
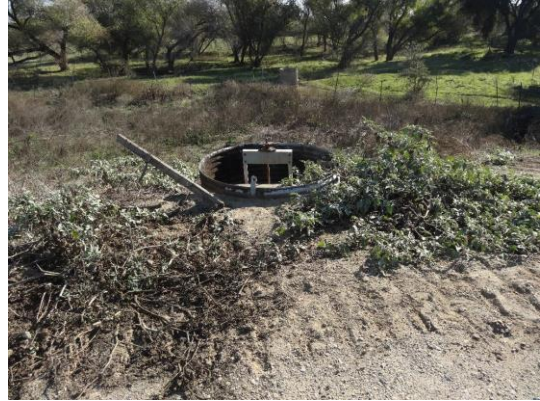
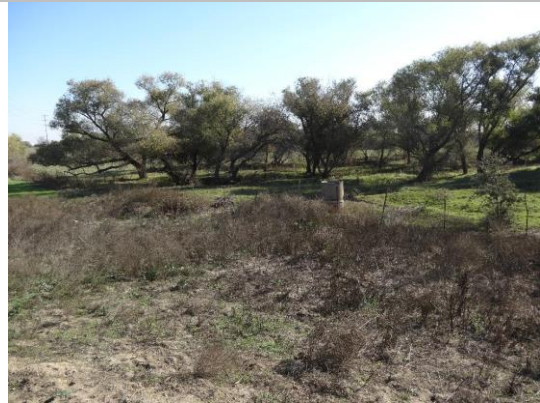
DS_ID:20204
FS_ID:74530
EP_NO: 8193
Repair Type: Urgent
EVAL Issue: 1, Pipe Integrity
Crossing Status: Found
UCIP Comments: 04/05/2022 Record remains Urgent. Pipe inlet within CMP riser is deteriorated. CMP riser cover has broken and fallen into the riser; no cover on the riser causing a safety hazard. Crossing appears abandoned. Recommend owner to contact CVFPB to abandon or remove pipe from levee. (M. Thao - DWR UCIP)
10/19/2018 Pipe is deteriorated on the LS toe (pipe section missing at inlet). This crossing remains Urgent due to the wall deterioration at the inlet. If wall is rusted out at the inlet, need to determine the condition of the pipe section through the levee. According to the LMA representative, this crossing is no longer in use (crossing is abandoned). LMA is interested in abandoning crossing in place. LMA was referred to the CVFPB staff for direction regarding proper action under Title 23 for this crossing. (O. Magana - DWR UCIP)

11/18/2016 Same as previous inspection riser cover and handle on slide gate are still missing. Crossing remains Urgent due to the public safety issue of the 60-inch CMP cover still missing. According to Tony Martinez, LMA representative, the condition and future use of this crossing is being evaluated. Owner will need to coordinate with CVFPB for future use requirements or proper abandonment/removal. (O. Magana - DWR UCIP)
10/01/2013 Appears abandoned, and if so should be done so properly. No handle on slide gate, no cover on CMP standpipe on WS shoulder. (W. Wylie - DWR UCIP)
FIELD_STRUCT_DESC: 16-inch steel irrigation pipe through levee, 11.5 feet below crown. Slide gate in 60-inch corrugated metal pipe riser is located on the waterside (WS) slope. Pipe discharges into concrete-lined ditch on the landside (LS) (irrigation pipe was authorized under Automatic Board Order (ABO) issued as Permit No. 8193, 1964 - Sabatte). [Additional Reference(s): DWR Levee Log, 1992 (HLM 3.30). USACE San Joaquin River O&M Manual Unit 13, April 1964, (HLM 3.30), Station 146+62, listed as 16-inch pipe, Drawing No. 7-4-1784].

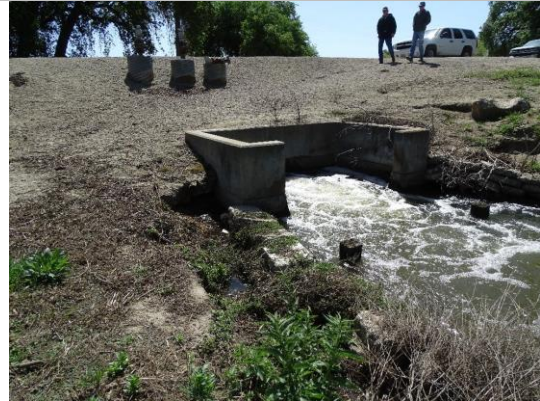
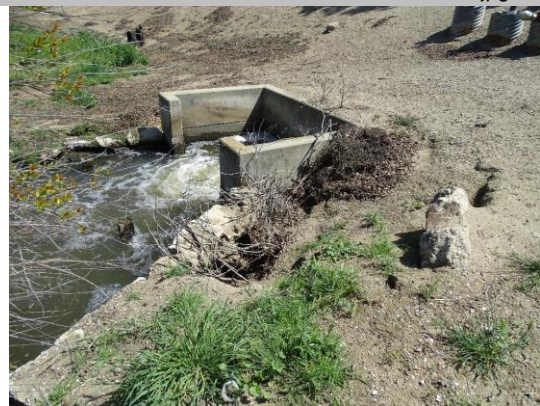
LS view: Concrete discharge box on toe; erosion around downstream sides.

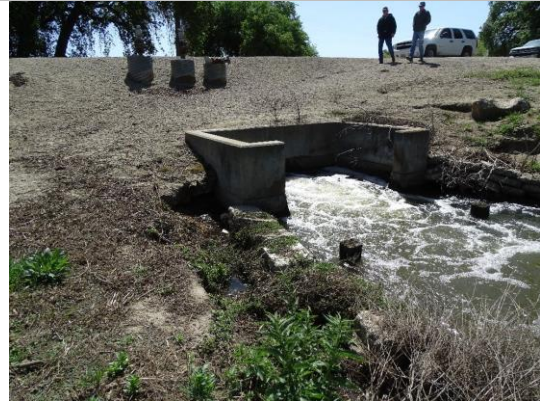
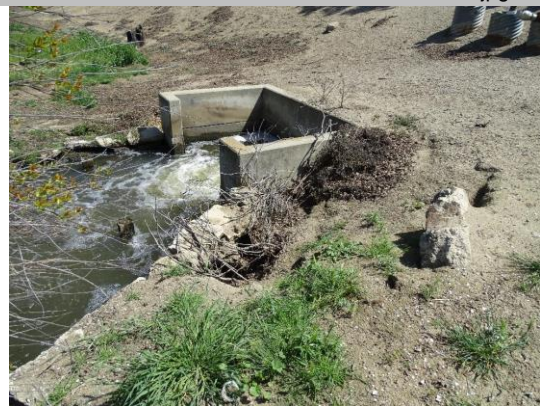
LS view: Concrete discharge box on toe; erosion around downstream sides.

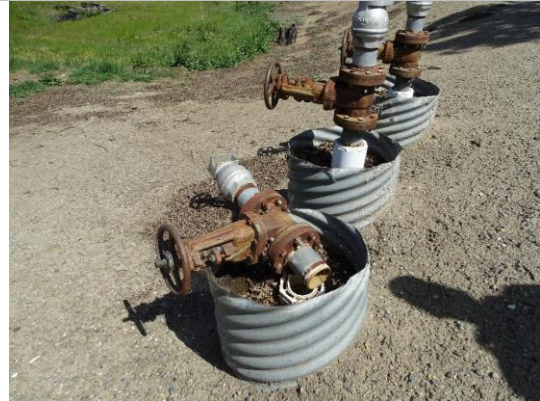
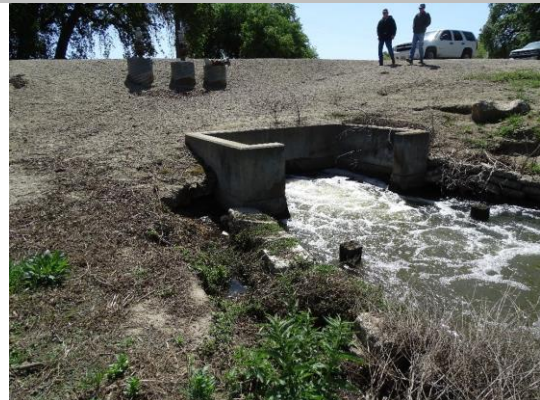
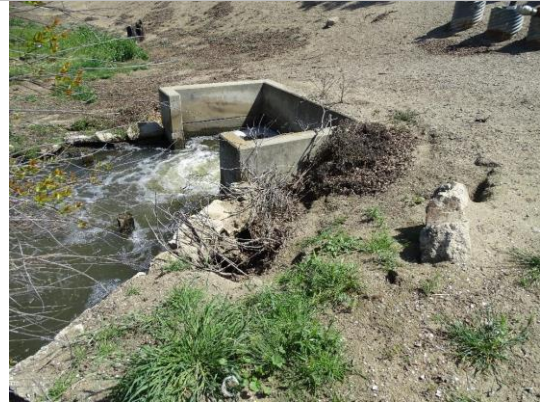
LS view: Close-up view of broken siphon breaker.

LS view: Concrete discharge box on toe; erosion around downstream sides.

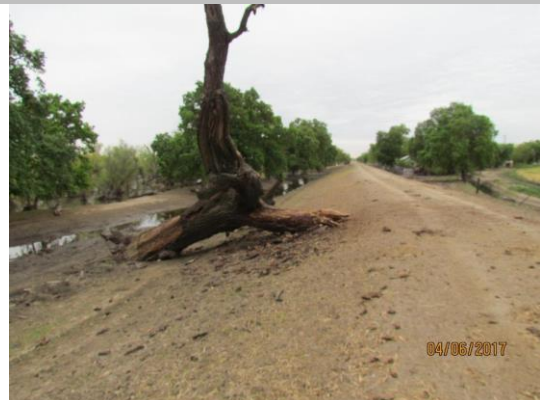
Photo 1 of 1 : FA_2024_RD1602_110_83_20241015_00027.jpg

View of a tree trunk on the waterside slope of the levee.

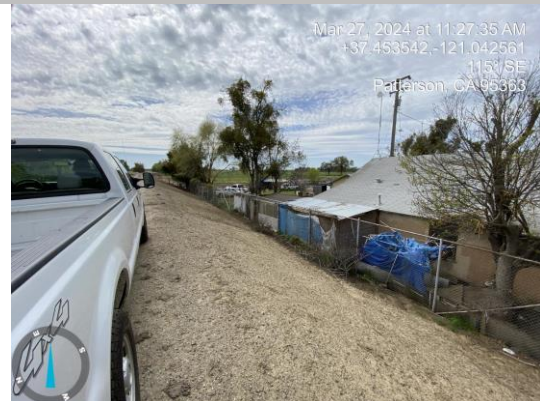
Photo 1 of 1 : FA_2024_RD1602_110_66_20241015_00021.jpg

Looking southwest at fence and other encroachments on landward toe (Spring 2024).

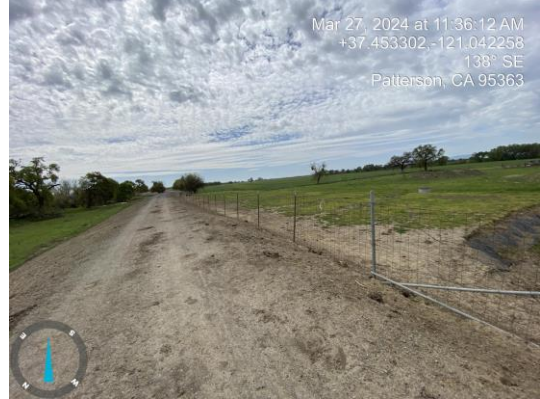
Photo 1 of 1 : FA_2024_RD1602_110_63_20241015_00020.jpg

View of fence along the landside slope and shoulder (Spring 2024).

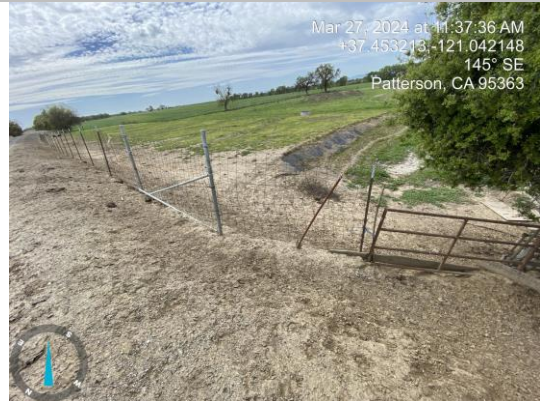
Photo 1 of 1 : FA_2024_RD1602_110_62_20241015_00019.jpg

View of damage to USACE seepage berm that appears to be caused by foot traffic (Spring 2024).

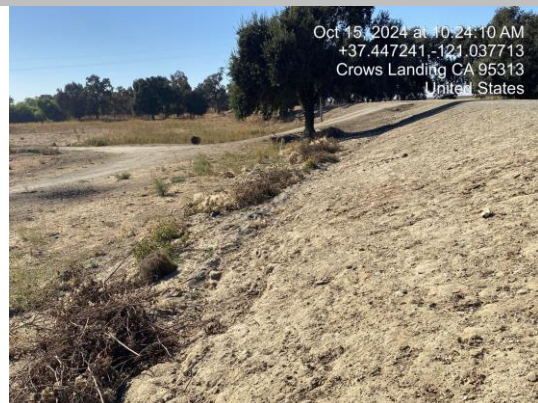
Photo 1 of 1 : FA_2024_RD1602_110_90_20241021_00079.jpg

View of wavewash erosion on the waterside slope (Fall 2024).

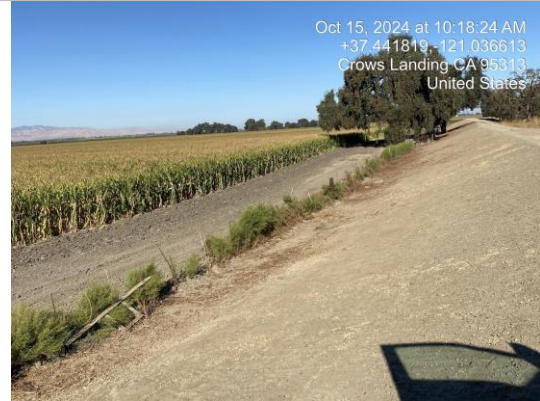
Photo 1 of 1 : FA_2024_RD1602_110_67_20241021_00078.jpg

View of fence along the landside toe (Fall 2024).

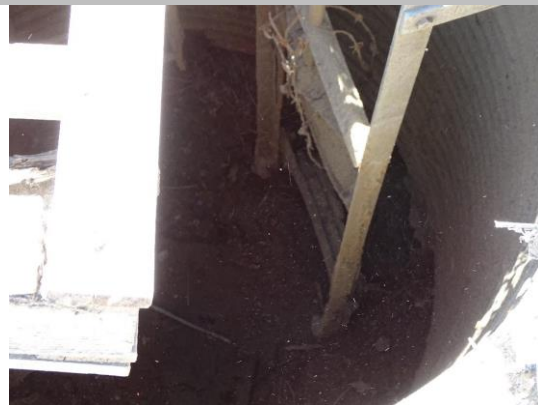
Photo 2 of 2 : UCIP_FA_2024_74531_111174.jpg

WS view: Looking into CMP riser; inlet of pipe through levee is deteriorating.

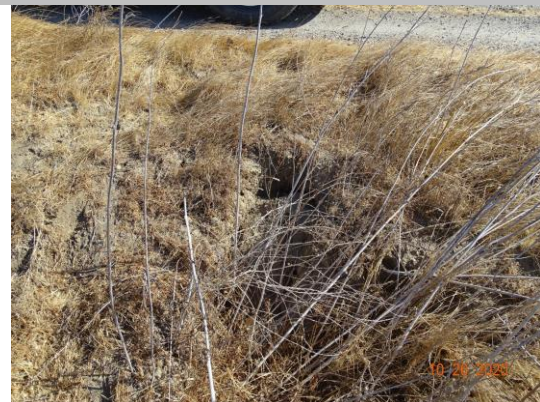
Photo 1 of 1 : FA_2024_RD1602_110_44_20241015_00012.jpg

Several rodent holes noted at this location. (Fall 2020)

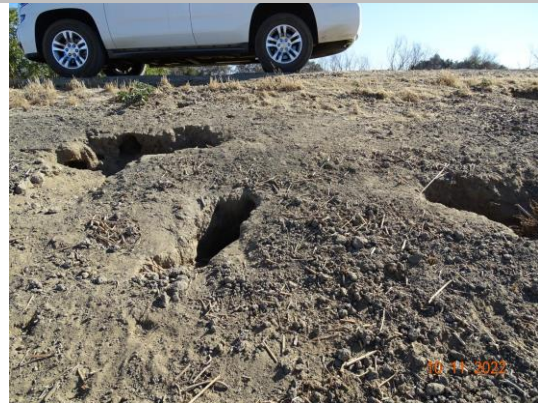
Photo 1 of 1 : FA_2024_RD1602_110_53_20241015_00017.jpg

Several large animal burrows were observed at this location. (Fall 2022)

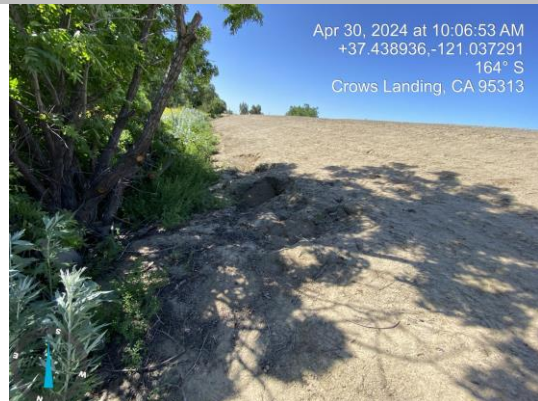
Photo 1 of 1 : FA_2024_RD1602_110_33_20241015_00008.jpg

View of erosion pocket on the waterside slope near the toe (Spring 2024).

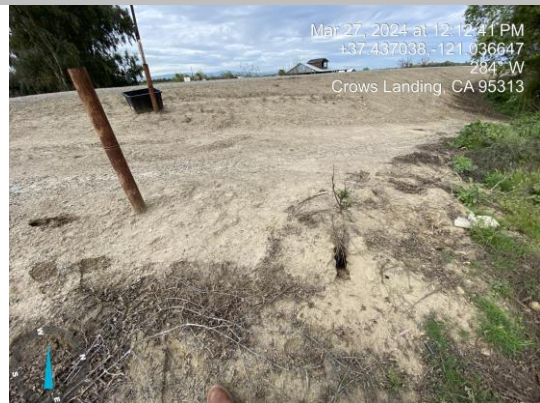
Photo 1 of 1 : FA_2024_RD1602_110_48_20241015_00014.jpg

View of animal burrows along the waterside slope near the gate (Spring 2024).

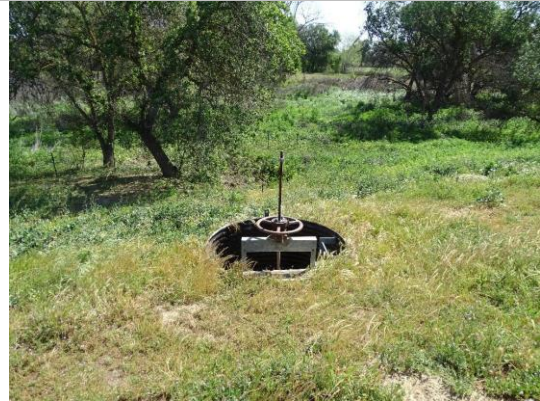
Photo 1 of 2 : UCIP_FA_2024_74358_111160.jpg

WS view: Looking from crown; CMP riser with no cover on slope.

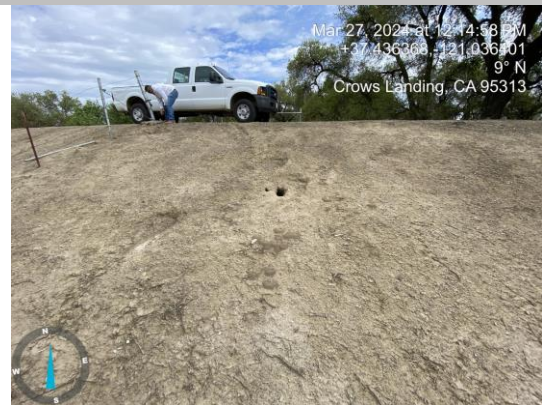
Photo 1 of 1 : FA_2024_RD1602_110_27_20241015_00004.jpg

View of animal burrow along the landside slope (Spring 2024).

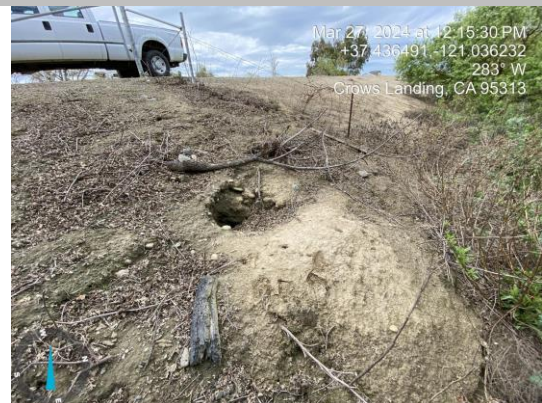
Photo 1 of 1 : FA_2024_RD1602_110_52_20241015_00016.jpg

View of animal burrow on the waterside slope (Spring 2024).

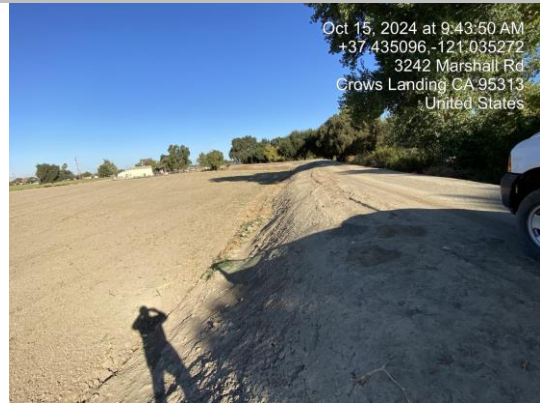
Photo 1 of 1 : FA_2024_RD1602_110_36_20241021_00076.jpg

View of degraded landside slope (Fall 2024).

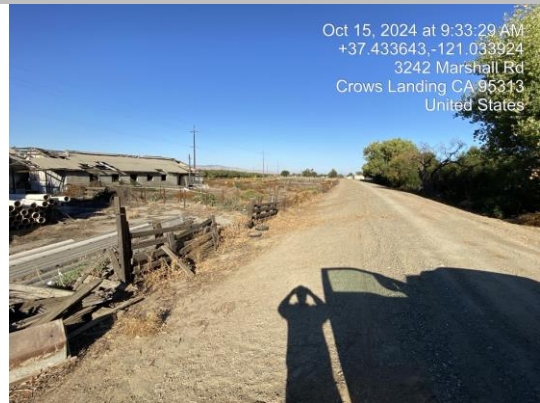
Photo 1 of 1 : FA_2024_RD1602_110_22_20241021_00074.jpg

View of fence along the landside toe (Fall 2024).

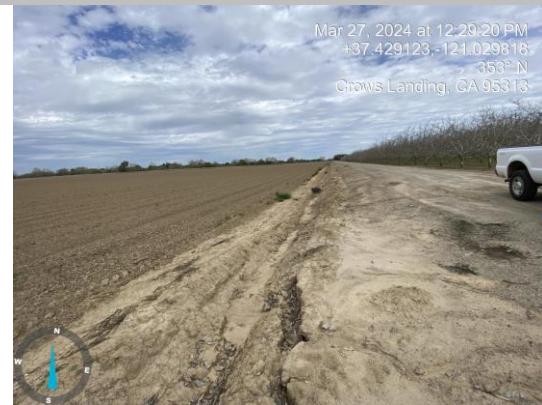
Photo 1 of 1 : FA_2024_RD1602_110_98_20241015_00031.jpg

View of ditch along the landward toe (Spring 2024).

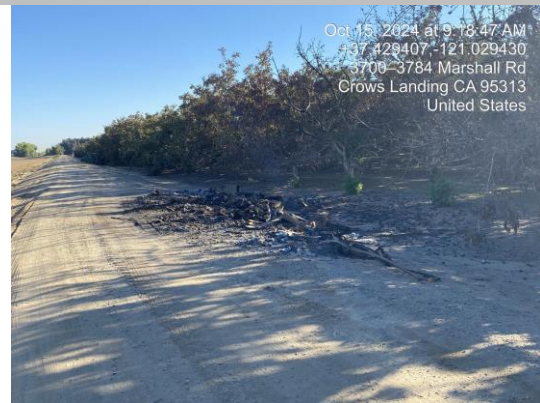
Photo 1 of 1 : FA_2024_RD1602_110_26_20241021_00072.jpg

View of burned gargabe pile on the waterside shoulder and slope (Fall 2024).

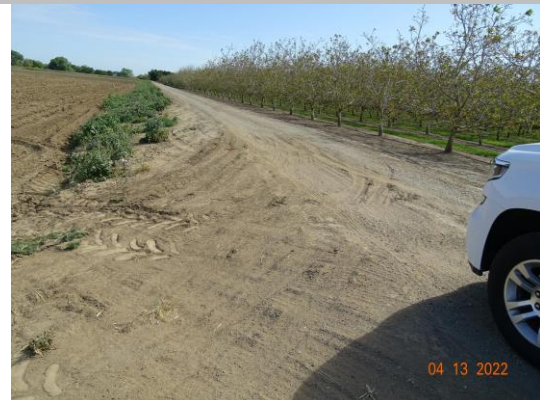
Photo 1 of 1 : FA_2024_RD1602_110_24_20241015_00002.jpg

Depression in levee crown from vehicle traffic. (Spring 2022)

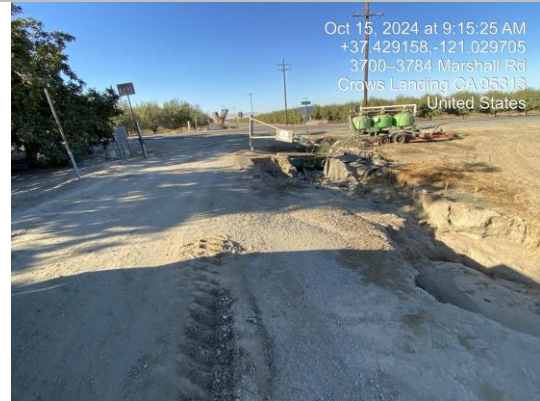
Photo 1 of 1 : FA_2024_RD1602_110_19_20241021_00071.jpg

View of erosion encroaching into the theoretical levee prism (Fall 2024).

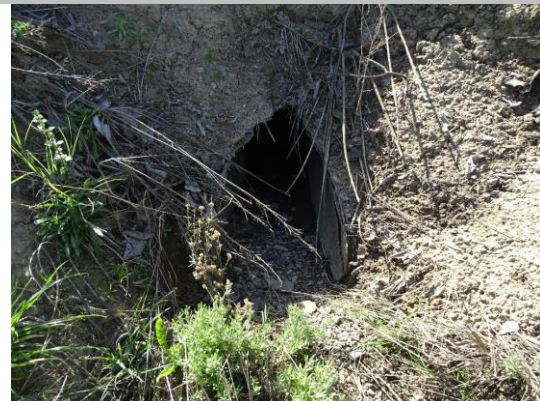
Photo 1 of 2 : UCIP_FA_2024_77638_111103.jpg

LS view: Outlet of irrigation pipe is deteriorated.
