**Flood Control Project Maintenance  
Levee Inspections**  
**LMA District Cover Sheet**  
**Spring 2008 Levee Inspection Results**

**Reclamation District No. 1602**

**Levee Inspection Report By Mile - Spring 2008**

Waterway						Bank	Unit Miles	Inspection Date	Inspector
Unit No. 01 San Joaquin River						Left	6.30	04/22/2008	Richard Willoughby

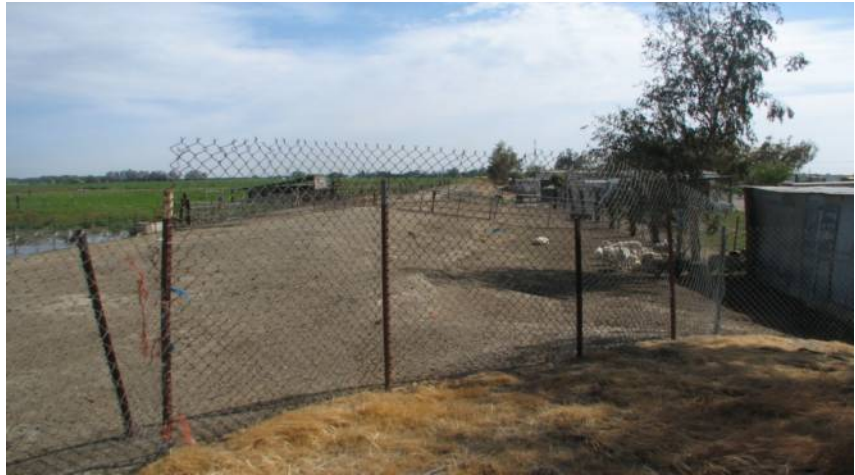
Levee Mile Report Line	1
Start Levee Mile	0.00
End Levee Mile	0.11
Location	
Category	Earthen Levee
Item	Encroachments
Looking at animal pens on crown of levee from LM 0.00 to 0.11

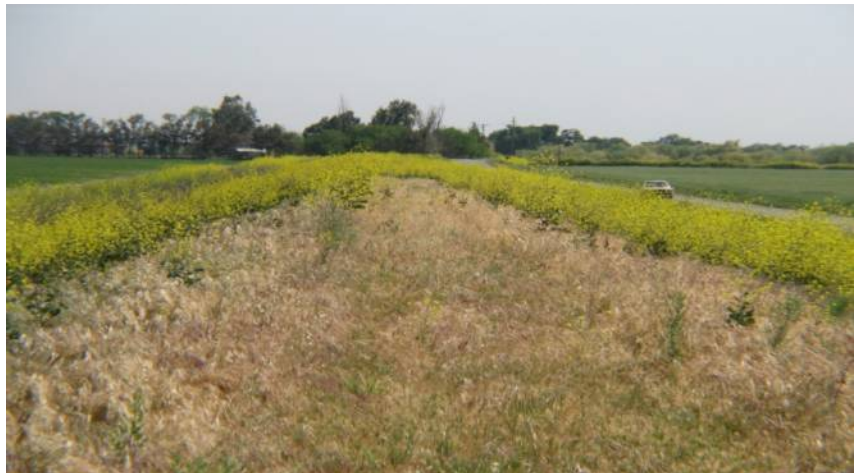
Levee Mile Report Line	5
Start Levee Mile	0.11
End Levee Mile	0.58
Location	
Category	Earthen Levee
Item	Crown Surface / Depressions / Rutting
Vegetation overgrown of levee crown from LM 0.11 to 0.58

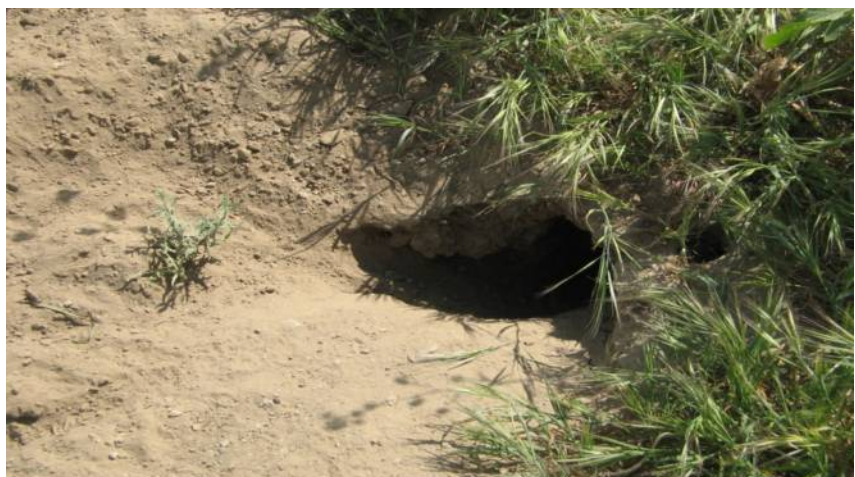
Levee Mile Report Line	6
Start Levee Mile	0.11
End Levee Mile	1.12
Location	
Category	Earthen Levee
Item	Animal Control
Typical picture of animal borrows on landward slope from LM 0.11 to 0.58

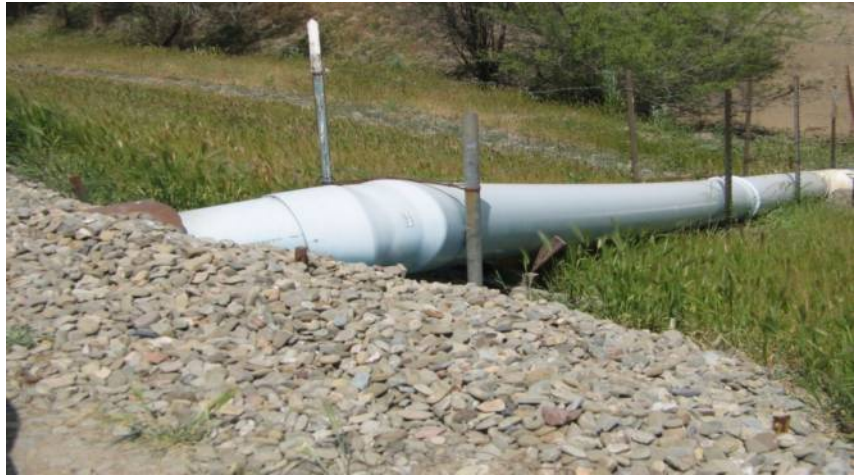
Levee Mile Report Line	10
Start Levee Mile	1.02
End Levee Mile	1.02
Location	
Category	Interior Drainage & Piping Systems
Item	Encroachments
PVC sleeve through steel pipe on waterward slope at LM 1.02

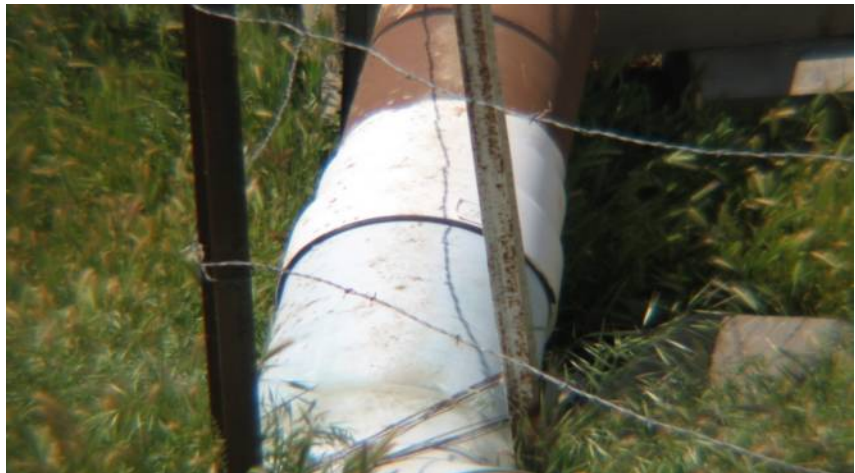
Levee Mile Report Line	10
Start Levee Mile	1.02
End Levee Mile	1.02
Location	
Category	Interior Drainage & Piping Systems
Item	Encroachments
PVC pipe connected to steel pipe on landward toe at LM 1.02

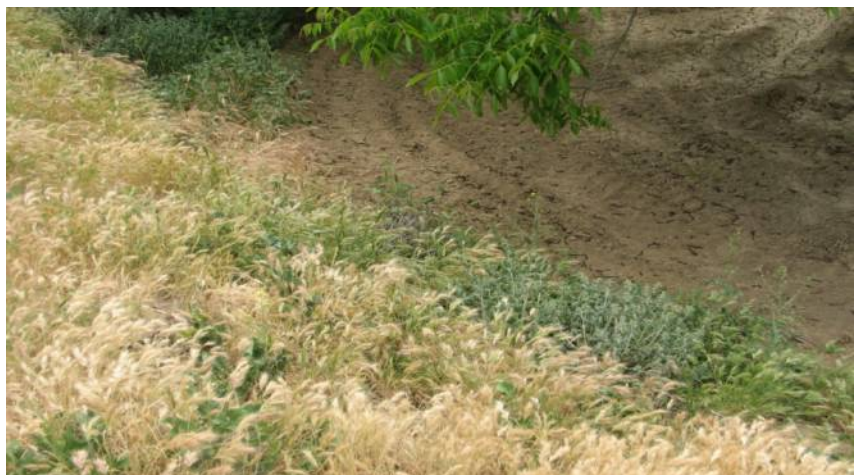
Levee Mile Report Line	23
Start Levee Mile	5.34
End Levee Mile	5.34
Location	
Category	Earthen Levee
Item	Encroachments
Landowner discing into landward toe at LM 5.34
