**Flood Control Project Maintenance
Levee Inspections**
LMA District Cover Sheet
Spring 2009 Levee Inspection Results

Reclamation District No. 1602

Waterway		Bank	Unit Miles
Unit No. 01 San Joaquin River		Left	6.30

Levee Inspection Report By Mile - Spring 2009

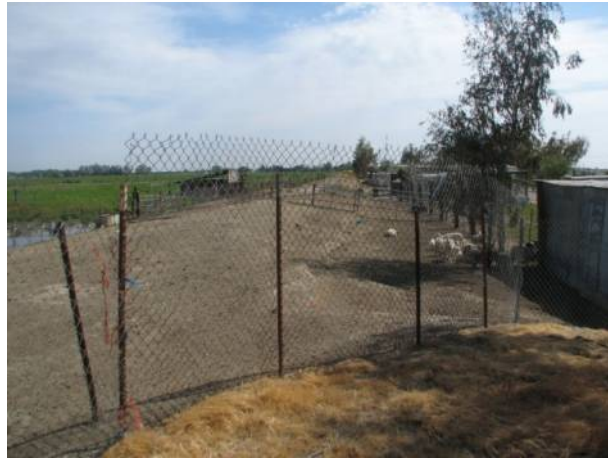
Levee Mile Report Line	1
Start Levee Mile	0.00
End Levee Mile	0.11
Location	Crown
Category	Earthen Levee
Item	Encroachments
Looking at animal pens on crown of levee from LM 0.00 to 0.11

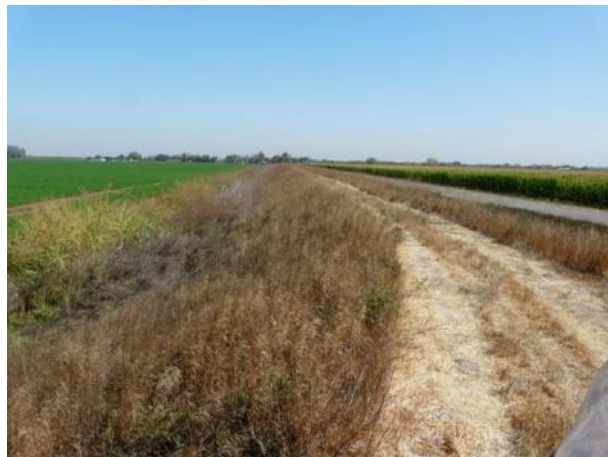
Levee Mile Report Line	2
Start Levee Mile	0.11
End Levee Mile	0.58
Location	Water Side
Category	Earthen Levee
Item	Vegetation
Levee overgrown-mow weeds/wild growth on crown, waterside & landside

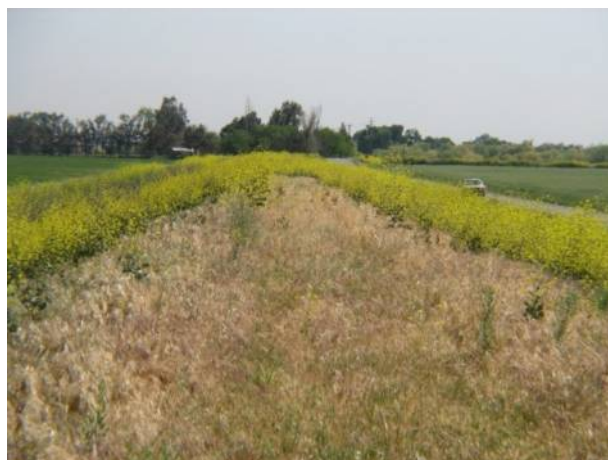
Levee Mile Report Line	4
Start Levee Mile	0.11
End Levee Mile	0.58
Location	Crown
Category	Earthen Levee
Item	Crown Surface / Depressions / Rutting
Vegetation overgrown of levee crown from LM 0.11 to 0.58

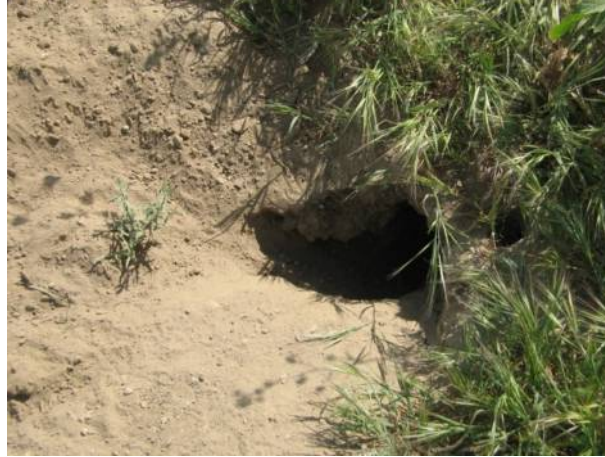
Levee Mile Report Line	5
Start Levee Mile	0.11
End Levee Mile	1.12
Location	Water Side
Category	Earthen Levee
Item	Animal Control

Typical picture of animal borrows on landward slope from LM 0.11 to 0.58

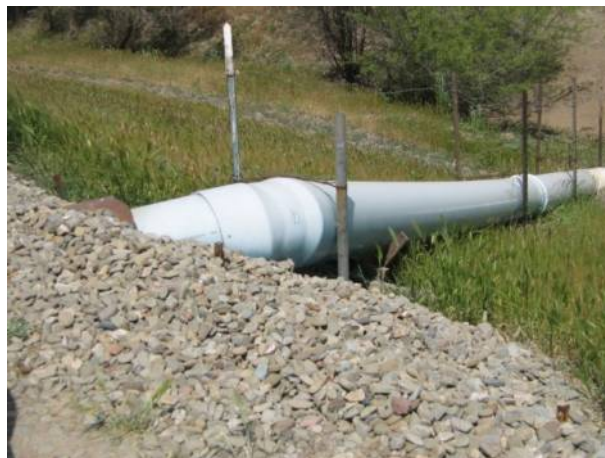
Levee Mile Report Line	13
Start Levee Mile	1.02
End Levee Mile	1.02
Location	Water Side
Category	Interior Drainage & Piping Systems
Item	Encroachments

PVC sleeve through steel pipe on waterward slope at LM 1.02

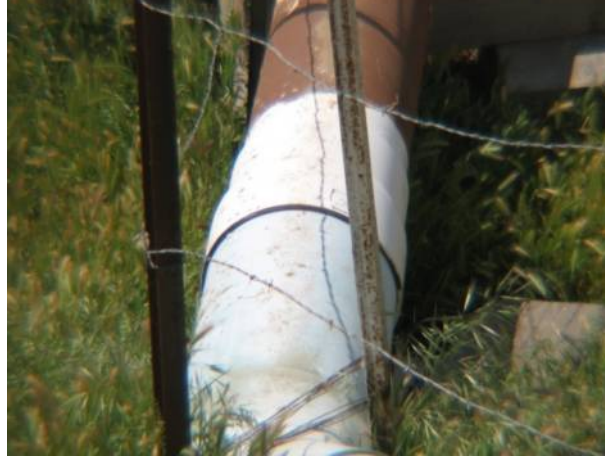
Levee Mile Report Line	13
Start Levee Mile	1.02
End Levee Mile	1.02
Location	Water Side
Category	Interior Drainage & Piping Systems
Item	Encroachments
PVC pipe connected to steel pipe on landward toe at LM 1.02

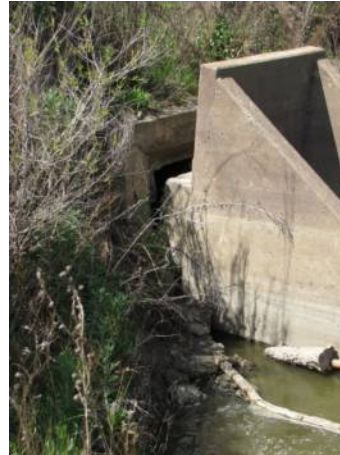
Levee Mile Report Line	14
Start Levee Mile	1.04
End Levee Mile	1.04
Location	Water Side
Category	Interior Drainage & Piping Systems
Item	Concrete Tilting / Settlement
Separation of outfall structure from the outlet pipe at LM 1.04.

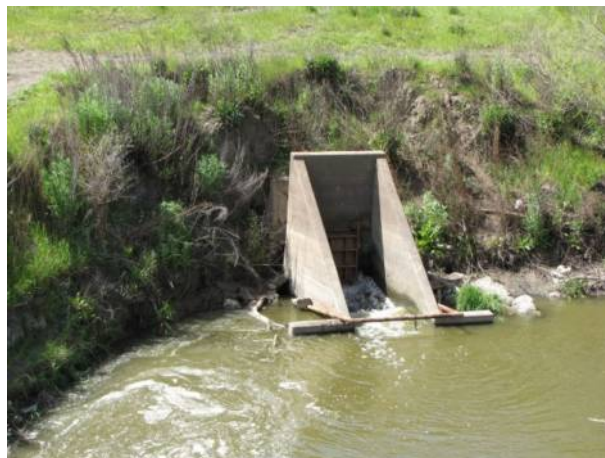
Levee Mile Report Line	14
Start Levee Mile	1.04
End Levee Mile	1.04
Location	Water Side
Category	Interior Drainage & Piping Systems
Item	Concrete Tilting / Settlement
Additional view of outfall structure at LM 1.04.

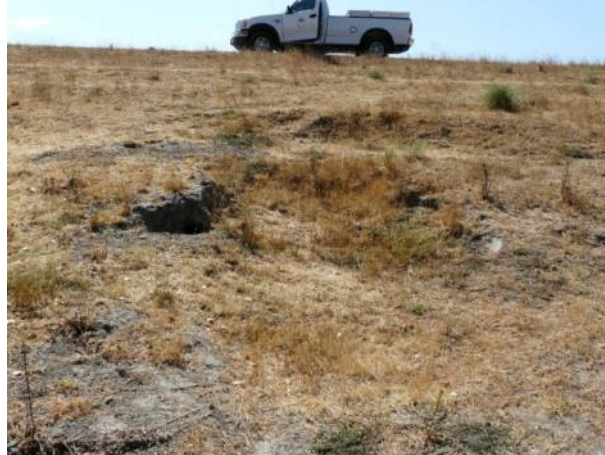
Levee Mile Report Line	15
Start Levee Mile	1.07
End Levee Mile	1.07
Location	Water Side
Category	Earthen Levee
Item	Slope Stability
small amount of slumping at water toe

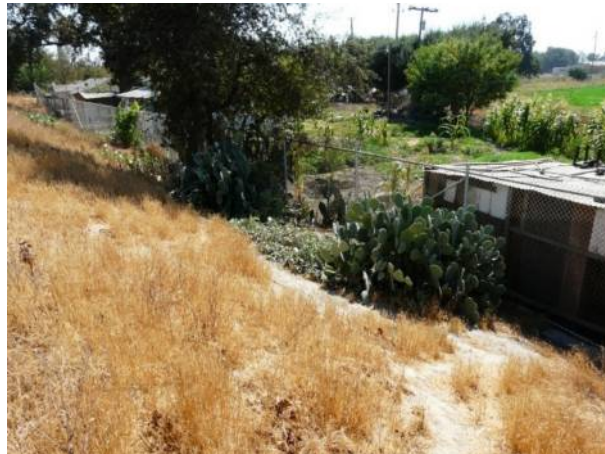
Levee Mile Report Line	27
Start Levee Mile	3.85
End Levee Mile	3.85
Location	Land Side
Category	Earthen Levee
Item	Encroachments
Remove landscaping from within 10' of landside toe

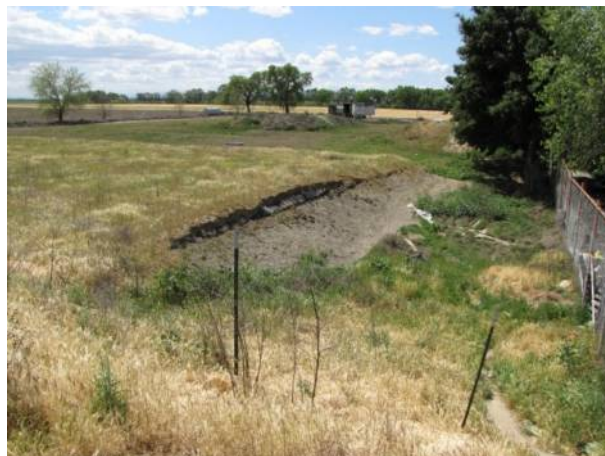
Levee Mile Report Line	29
Start Levee Mile	3.96
End Levee Mile	3.96
Location	Land Side
Category	Earthen Levee
Item	Slope Stability
Repair damage to Corp constructed seepage berm by pedestrian and cycle traffic at LM 3.96.
