**Flood Control Project Maintenance
Levee Inspections
LMA District Cover Sheet
Spring 2010 Levee Inspection Results**

Reclamation District No. 1602 Del Puerto

Waterway			Bank	Unit Miles
Unit No. 01 San Joaquin River			Left	6.29

Levee Inspection Report By Mile - Spring 2010

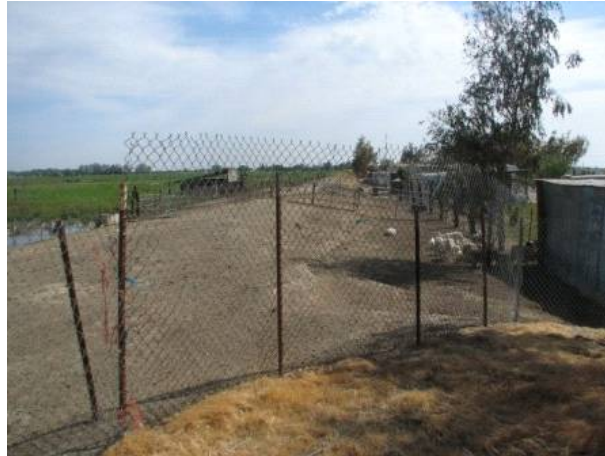
Levee Mile Report Line	1
Start Levee Mile	0.00
End Levee Mile	0.11
Location	Crown
Category	Earthen Levee
Item	Encroachments

Looking at animal pens on crown of levee from LM 0.00 to 0.11

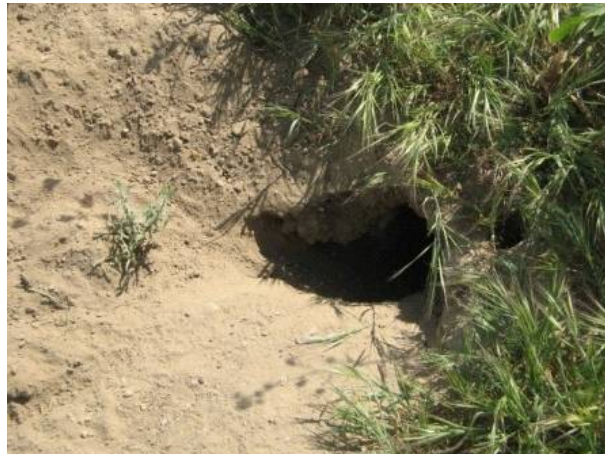
Levee Mile Report Line	2
Start Levee Mile	0.11
End Levee Mile	0.54
Location	Water Side
Category	Earthen Levee
Item	Animal Control

Typical picture of animal borrows on landward slope from LM 0.11 to 0.58

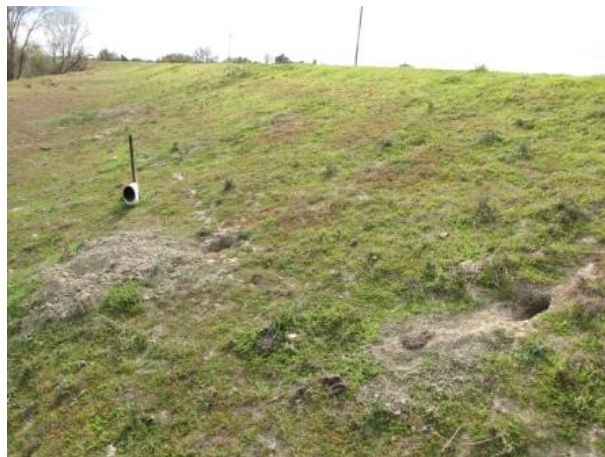
Levee Mile Report Line	7
Start Levee Mile	0.60
End Levee Mile	1.28
Location	Water Side
Category	Earthen Levee
Item	Animal Control

View of rodent holes in the waterward slope looking upstream.

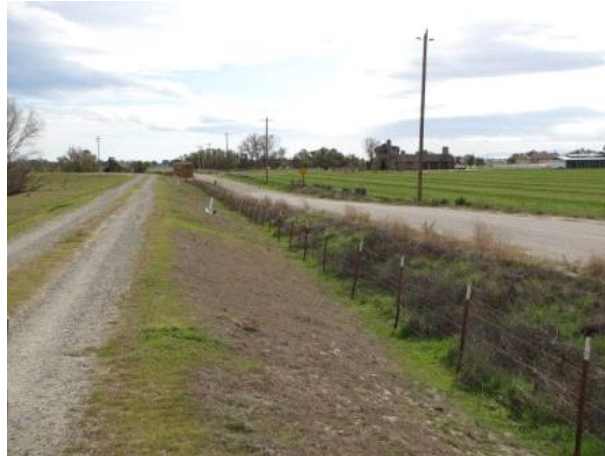
Levee Mile Report Line	8
Start Levee Mile	0.60
End Levee Mile	0.72
Location	Water Side
Category	Earthen Levee
Item	Encroachments

View of barbed wire fence at landward toe looking upstream.

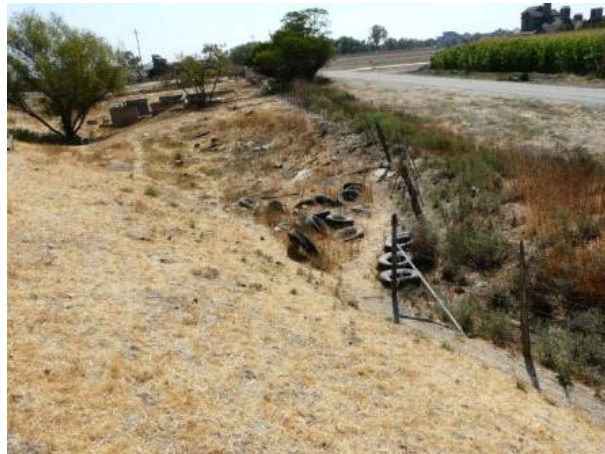
Levee Mile Report Line	11
Start Levee Mile	0.73
End Levee Mile	0.73
Location	Water Side
Category	Earthen Levee
Item	Encroachments

11	0.73	0.73	Earthen Levee	Encroachments	WS	M	Debris Inspector Comments: Tires & trash at land toe	37.478489 ° -121.073388 °	37.478489 ° -121.073388 °	35 Y
12	0.78	0.78	Earthen Levee	Animal Control	WS	M	Exterminate rodents and backfill and compact or grout borrows.	37.477994 ° -121.072629 °	37.477994 ° -121.072629 °	26
13	0.78	0.78	Interior Drainage & Piping Systems	Flap Gates	WS	M	Inspector Comments: Sediment has built up at the pipe outlet preventing the flap gate from closing.	37.477965 ° -121.072595 °	37.477965 ° -121.072595 °	72 Y
14	0.88	1.01	Earthen Levee	Vegetation	LS	M	Control annual grass and weeds on the levee slopes and easements.	37.478156 ° -121.070786 °	37.478823 ° -121.068730 °	27
15	0.95	0.97	Earthen Levee	Animal Control	LS	M	No rodents visible, but rodent burrows visible; need to backfill and compact or grout borrows.	37.478434 ° -121.069751 °	37.478679 ° -121.069145 °	28

Remove debris within 10 feet of landside toe

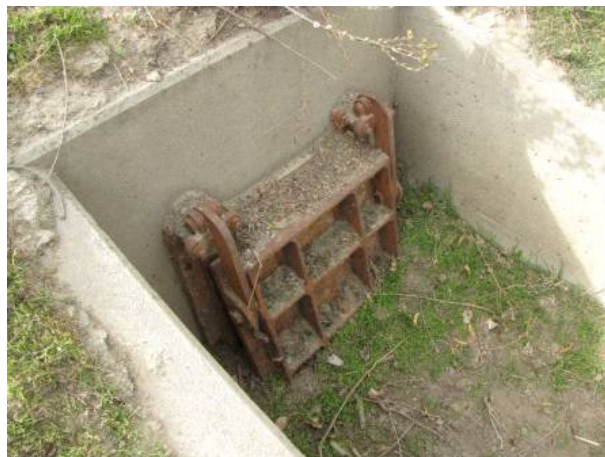
Levee Mile Report Line	13
Start Levee Mile	0.78
End Levee Mile	0.78
Location	Water Side
Category	Interior Drainage & Piping Systems
Item	Flap Gates

View of a flap gate with sediment preventing it from closing.

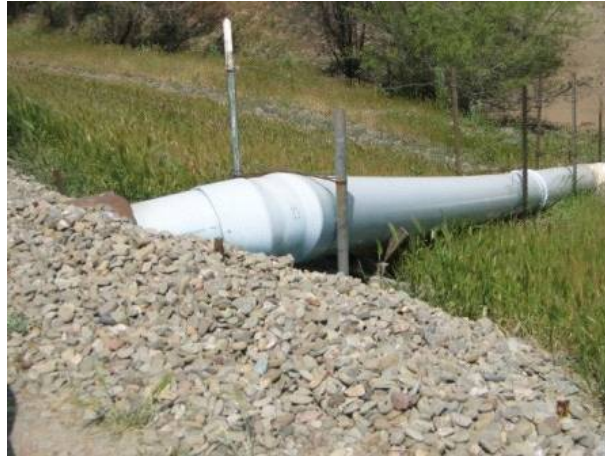
Levee Mile Report Line	18
Start Levee Mile	1.02
End Levee Mile	1.02
Location	Water Side
Category	Interior Drainage & Piping Systems
Item	Encroachments
PVC sleeve through steel pipe on waterward slope at LM 1.02	
dpesaven_s_20100316_518.jpg

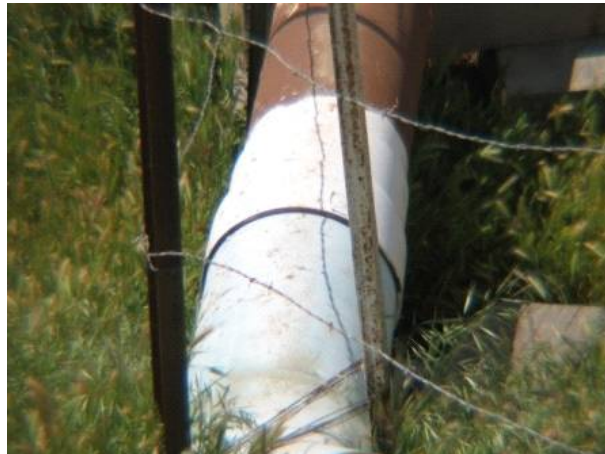
Levee Mile Report Line	18
Start Levee Mile	1.02
End Levee Mile	1.02
Location	Water Side
Category	Interior Drainage & Piping Systems
Item	Encroachments
PVC pipe connected to steel pipe on landward toe at LM 1.02	
dpesaven_s_20100316_519.jpg

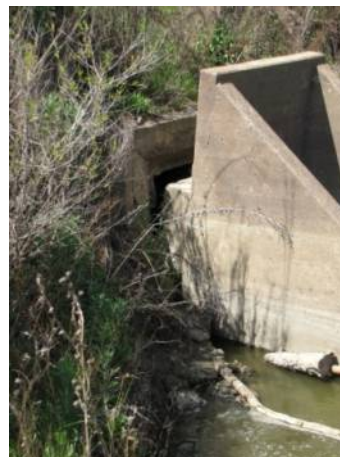
Levee Mile Report Line	19
Start Levee Mile	1.04
End Levee Mile	1.04
Location	Water Side
Category	Interior Drainage & Piping Systems
Item	Concrete Tilting / Settlement
Separation of outfall structure from the outlet pipe at LM 1.04.	
dpesaven_s_20100316_524.jpg

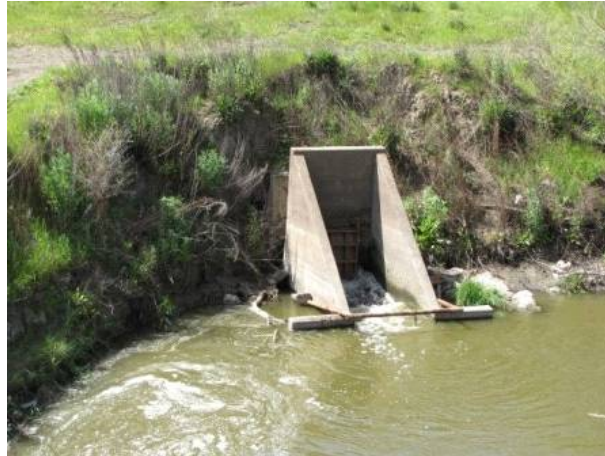
Levee Mile Report Line	19
Start Levee Mile	1.04
End Levee Mile	1.04
Location	Water Side
Category	Interior Drainage & Piping Systems
Item	Concrete Tilting / Settlement

Additional view of outfall structure at LM 1.04.

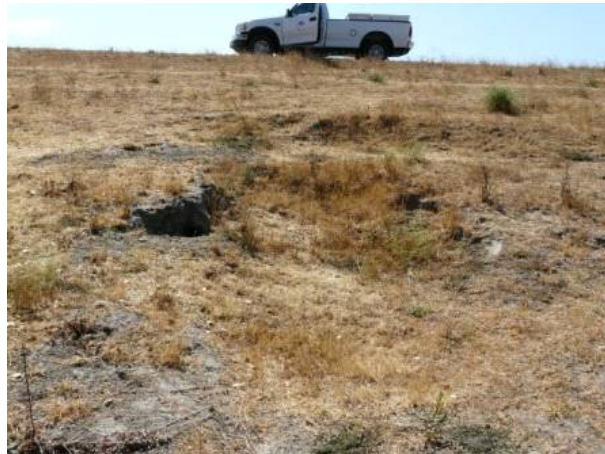
Levee Mile Report Line	20
Start Levee Mile	1.07
End Levee Mile	1.07
Location	Water Side
Category	Earthen Levee
Item	Slope Stability

20	1.07	1.07	Earthen Levee	Slope Stability	WS	M	Repair slope instability. Inspector Comments: small amount of slumping at water toe	37.478567 ° -121.067847 °	37.478567 ° -121.067847 °	37 Y
21	1.21	1.30	Earthen Levee	Vegetation	WS	M	Control annual grass and weeds on the levee slopes and easements.	37.478398 ° -121.065069 °	37.479067 ° -121.063878 °	30
22	1.21	3.69	Earthen Levee	Vegetation	LS	M	Control annual grass and weeds on the levee slopes and easements.	37.478374 ° -121.065159 °	37.456535 ° -121.044621 °	29
23	1.25	1.28	Earthen Levee	Animal Control	LS	M	No rodents visible, but rodent burrows visible; need to backfill and compact or grout borrows.	37.478587 ° -121.064592 °	37.478838 ° -121.064220 °	73
24	1.40	1.40	Earthen Levee	Animal Control	WS	M	No rodents visible, but rodent burrows visible; need to backfill and compact or grout borrows.	37.479145 ° -121.062265 °	37.479145 ° -121.062265 °	31

small amount of slumping at water toe

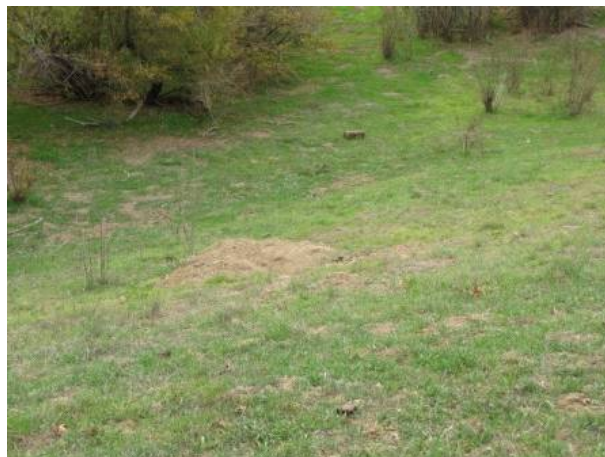
Levee Mile Report Line	47
Start Levee Mile	3.61
End Levee Mile	3.61
Location	Water Side
Category	Earthen Levee
Item	Animal Control

View of a large rodent hole in the waterward slope.

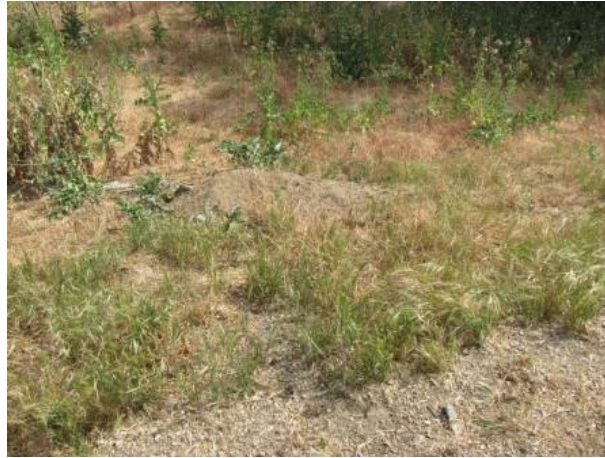
Levee Mile Report Line	49
Start Levee Mile	3.71
End Levee Mile	3.71
Location	Water Side
Category	Earthen Levee
Item	Animal Control

View of rodent holes on the waterward slope.

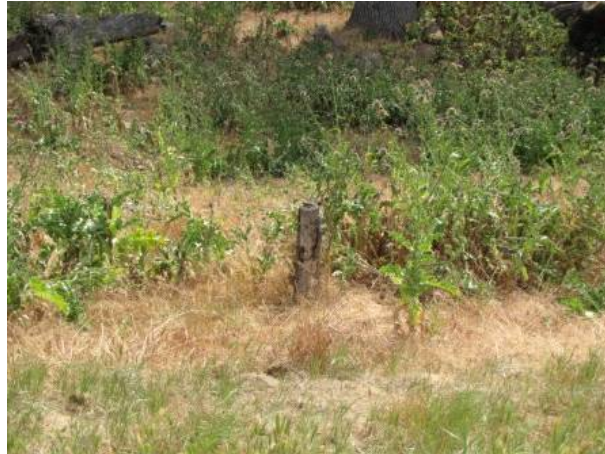
Levee Mile Report Line	50
Start Levee Mile	3.72
End Levee Mile	3.72
Location	Water Side
Category	Earthen Levee
Item	Trim / Thin Trees

View of stump on the waterward slope.

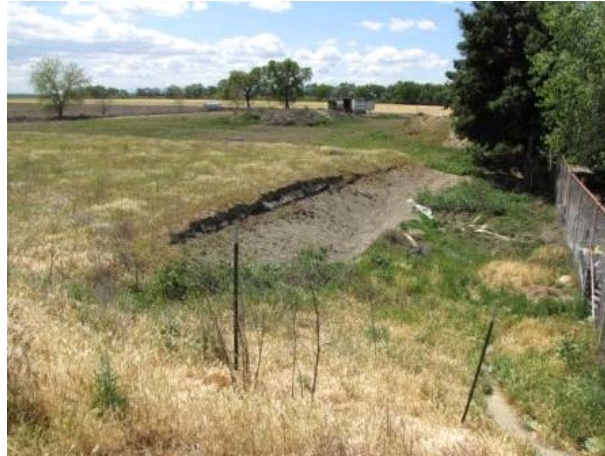
Levee Mile Report Line	54
Start Levee Mile	3.96
End Levee Mile	3.96
Location	Land Side
Category	Earthen Levee
Item	Slope Stability
Repair damage to USACE constructed seepage berm by pedestrian and cycle traffic at LM 3.96.	
dpesaven_s_20100316_526.jpg

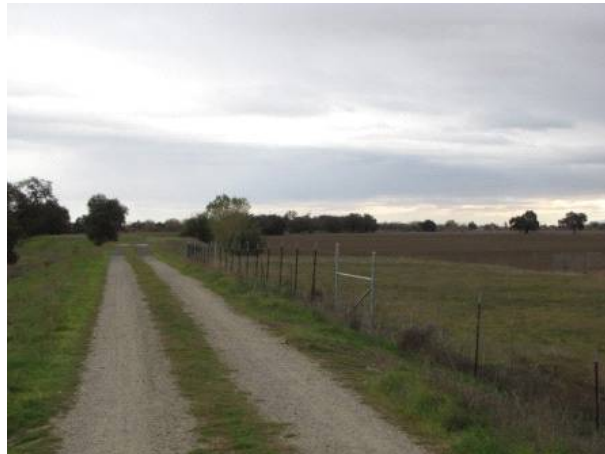
Levee Mile Report Line	55
Start Levee Mile	3.97
End Levee Mile	4.07
Location	Land Side
Category	Earthen Levee
Item	Encroachments
View of a barbed wire fence on the landward slope looking upstream.	
dpesaven_s_20100316_527.jpg

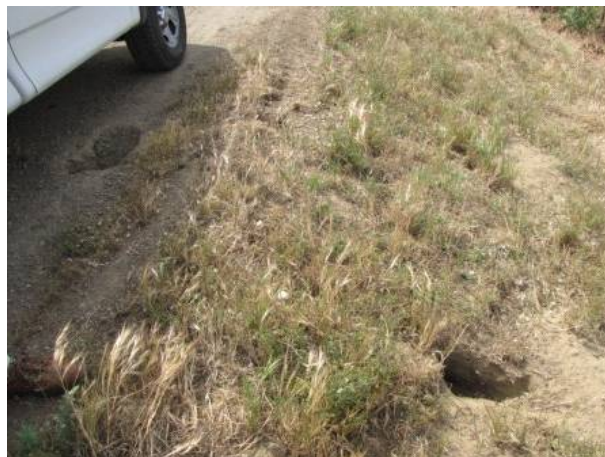
Levee Mile Report Line	70
Start Levee Mile	4.72
End Levee Mile	4.72
Location	Land Side
Category	Earthen Levee
Item	Animal Control
View of rodent holes on the landward slope looking upstream.	
dpesaven_s_20100520_613.jpg

70	4.72	4.72	Earthen Levee	Animal Control	LS	M	Exterminate rodents and backfill and compact or grout burrows.	37.443481 ° -121.037736 °	37.443481 ° -121.037736 °	13 Y
71	4.72	4.72	Earthen Levee	Trim / Thin Trees	LS	M	Trim and thin trees to allow visibility of the ground and room to flood fight.	37.443469 ° -121.037719 °	37.443469 ° -121.037719 °	11 Y
72	4.78	4.78	Earthen Levee	Animal Control	WS	M	Exterminate rodents and backfill and compact or grout burrows.	37.442742 ° -121.037174 °	37.442742 ° -121.037174 °	93
73	4.87	4.87	Earthen Levee	Encroachments	LS	C	Prunings	37.441550 ° -121.036583 °	37.441550 ° -121.036583 °	94
74	4.92	4.92	Earthen Levee	Trim / Thin Trees	LS	M	Trim and thin trees to allow visibility of the ground and room to flood fight.	37.440953 ° -121.036977 °	37.440953 ° -121.036977 °	14 Y
75	4.93	4.93	Earthen Levee	Animal Control	LS	M	Exterminate rodents and backfill and compact or grout burrows.	37.440850 ° -121.037045 °	37.440850 ° -121.037045 °	15

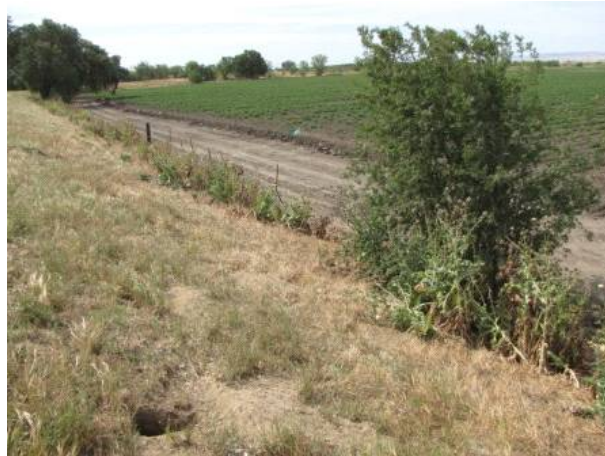
Levee Mile Report Line	71
Start Levee Mile	4.72
End Levee Mile	4.72
Location	Land Side
Category	Earthen Levee
Item	Trim / Thin Trees

View of a tree blocking visibility on the landward slope looking upstream.

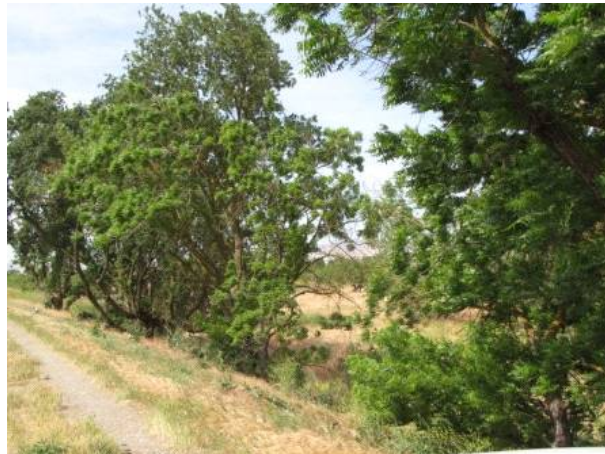
Levee Mile Report Line	74
Start Levee Mile	4.92
End Levee Mile	4.92
Location	Land Side
Category	Earthen Levee
Item	Trim / Thin Trees

View of trees blocking visibility on the landward slope looking upstream.

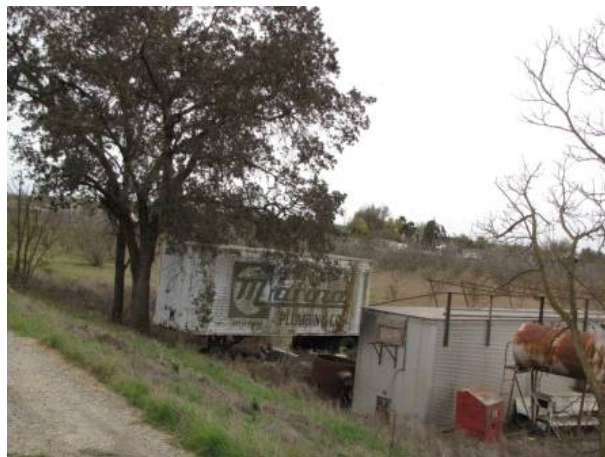
Levee Mile Report Line	77
Start Levee Mile	5.02
End Levee Mile	5.02
Location	Land Side
Category	Earthen Levee
Item	Encroachments

View of equipment at the landward toe blocking visibility and access.

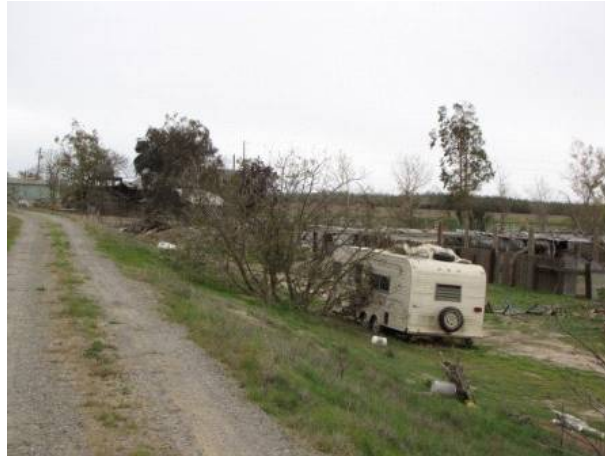
Levee Mile Report Line	81
Start Levee Mile	5.15
End Levee Mile	5.15
Location	Land Side
Category	Earthen Levee
Item	Encroachments

View of a trailer at the landward toe blocking visibility and access looking upstream.

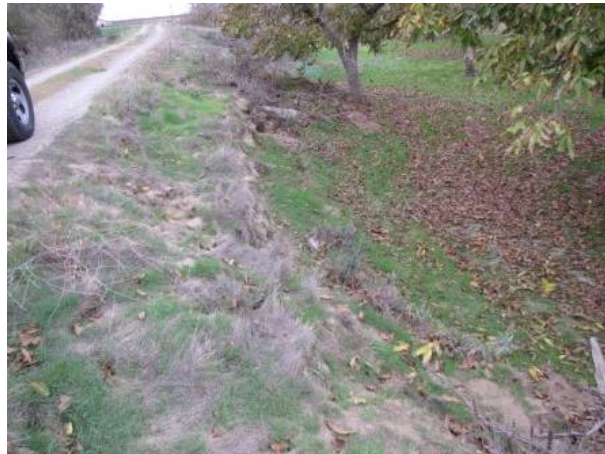
Levee Mile Report Line	89
Start Levee Mile	5.34
End Levee Mile	5.34
Location	Land Side
Category	Earthen Levee
Item	Slope Stability

View of significant damage and erosion to the landward slope looking upstream.

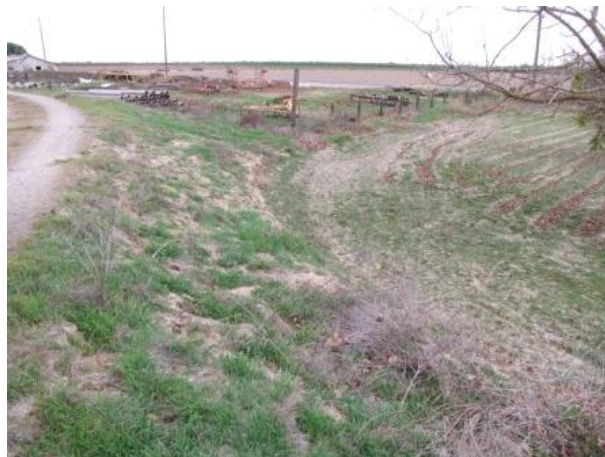
Levee Mile Report Line	93
Start Levee Mile	5.40
End Levee Mile	5.40
Location	Land Side
Category	Earthen Levee
Item	Slope Stability

View of tilling into the landward slope of the levee looking upstream. This slope has also been significantly damaged by rodent activity.

93	5.40	5.40	Earthen Levee	Slope Stability	LS	M	Repair slope instability.	37.434699 ° -121.035063 °	37.434699 ° -121.035063 °	105 Y
94	5.40	5.40	Earthen Levee	Animal Control	LS	C	Exterminate rodents and backfill and compact or grout burrows.	37.434698 ° -121.035060 °	37.434698 ° -121.035060 °	106
95	5.40	5.40	Earthen Levee	Animal Control	WS	C	Exterminate rodents and backfill and compact or grout burrows.	37.434698 ° -121.035060 °	37.434698 ° -121.035060 °	107
96	5.51	5.54	Earthen Levee	Encroachments	LS	PO	Fences	37.433482 ° -121.033616 °	37.433299 ° -121.033338 °	22
97	5.80	5.80	Earthen Levee	Animal Control	WS	M	Exterminate rodents and backfill and compact or grout burrows.	37.433029 ° -121.028727 °	37.433029 ° -121.028727 °	108
98	5.83	5.86	Earthen Levee	Trim / Thin Trees	WS	M	Thin trees to allow visibility of the ground and room to flood fight.	37.433066 ° -121.028123 °	37.433108 ° -121.027612 °	109
