**Flood Control Project Maintenance
Levee Inspections**
LMA District Cover Sheet
Spring 2011 Levee Inspection Results

Reclamation District No. 1602 Del Puerto

Levee Inspection Report By Mile - Spring 2011

| Waterway | Bank | Unit Miles | Inspection Start/End | Inspector |
|---|---|---|---|---|
| Unit No. 01 San Joaquin River | Left | 6.29 | 05/24/2011 05/24/2011 | Pavel Kazi |

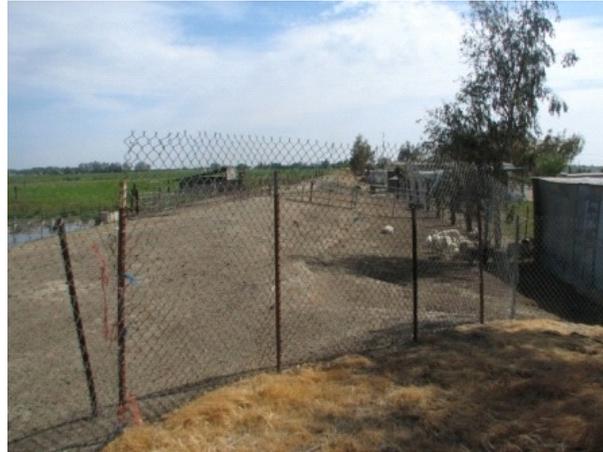
| pkazi_s_20110328_366.jpg | |

| LMR No. | Levee Mile | | Category | Item | Location | Rating | Action/Comment | GPS Latitude/Longitude | | Issue No. Photo |
|---|---|---|---|---|---|---|--|---|---|---|
| 1 | 0.00 | 0.11 | Earthen Levee | Encroachments | CR | PO | Buildings Inspector Comments: Animal pens across levee crown | 37.476560 ° -121.083862 ° | 37.477295 ° -121.082087 ° | 1 Y |

| Looking at animal pens on crown of levee from LM 0.00 to 0.11 | |

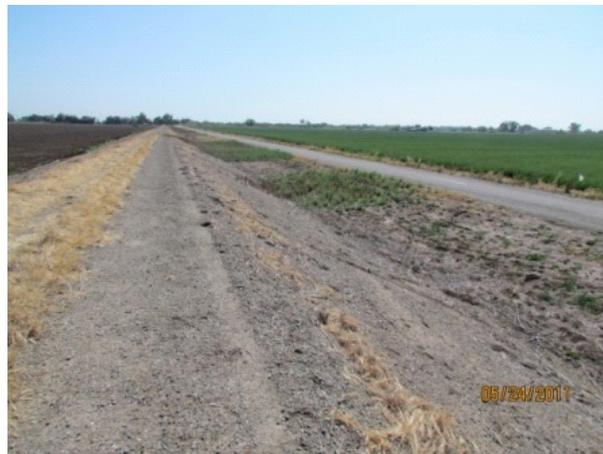
| pkazi_s_20110526_613.jpg | |

| LMR No. | Levee Mile | | Category | Item | Location | Rating | Action/Comment | GPS Latitude/Longitude | | Issue No. Photo |
|---|---|---|---|---|---|---|--|---|---|---|
| 3 | 0.14 | 0.56 | Earthen Levee | Vegetation | LS | A | Control annual grass and weeds on the levee slopes and easements. | 37.477230 ° -121.081700 ° | 37.480320 ° -121.075010 ° | 30 Y |

| Vegetation complies with the standards on the landside of the levee. The picture was taken from the crown looking upstream. | |

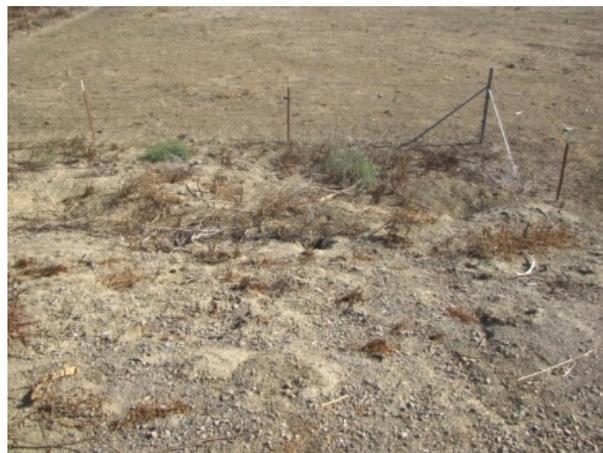
| pkazi_s_20110328_368.jpg | |

| LMR No. | Levee Mile | | Category | Item | Location | Rating | Action/Comment | GPS Latitude/Longitude | | Issue No. Photo |
|---|---|---|---|---|---|---|--|---|---|---|
| 4 | 0.56 | 0.56 | Earthen Levee | Animal Control | WS | M | Exterminate rodents and backfill and compact or grout burrows. | 37.480210 ° -121.074953 ° | 37.480210 ° -121.074953 ° | 5 Y |

| View of rodent holes on the waterward slope looking waterward. | |

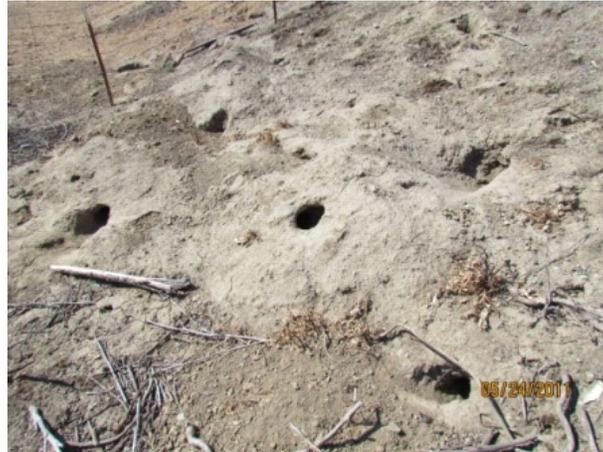
| <p>pkazi_s_20110526_614.jpg</p> | |

| LMR No. | Levee Mile | | Category | Item | Location | Rating | Action/Comment | GPS Latitude/Longitude | | Issue No. Photo |
|---|---|---|---|---|---|---|--|---|---|---|
| 5 | 0.59 | 0.59 | Earthen Levee | Animal Control | WS | M | Exterminate rodents and backfill and compact or grout burrows. | 37.480117 ° -121.074687 ° | 37.480117 ° -121.074687 ° | 3 Y |

| <p>Rodent holes were found on the waterside of the levee. The picture was taken from the toe of waterside of the levee looking upstream.</p> | |

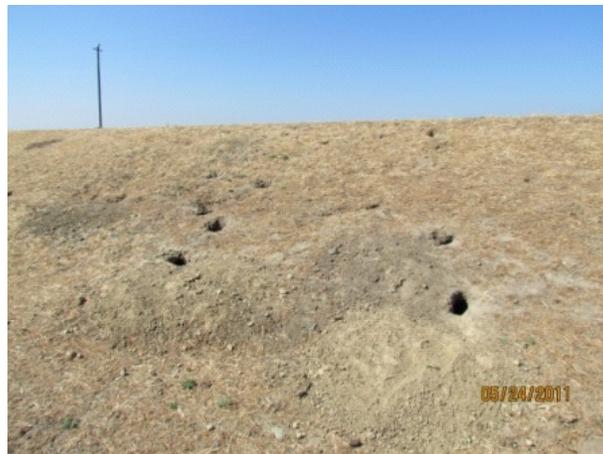
| <p>pkazi_s_20110526_615.jpg</p> | |

| LMR No. | Levee Mile | | Category | Item | Location | Rating | Action/Comment | GPS Latitude/Longitude | | Issue No. Photo |
|---|---|---|---|---|---|---|--|---|---|---|
| 6 | 0.60 | 0.60 | Earthen Levee | Animal Control | WS | M | Exterminate rodents and backfill and compact or grout burrows. | 37.479968 ° -121.074583 ° | 37.479968 ° -121.074583 ° | 4 Y |

| <p>Rodent holes were found on the waterside of the levee. The picture was taken from the toe of the waterside of the levee looking upstream.</p> | |

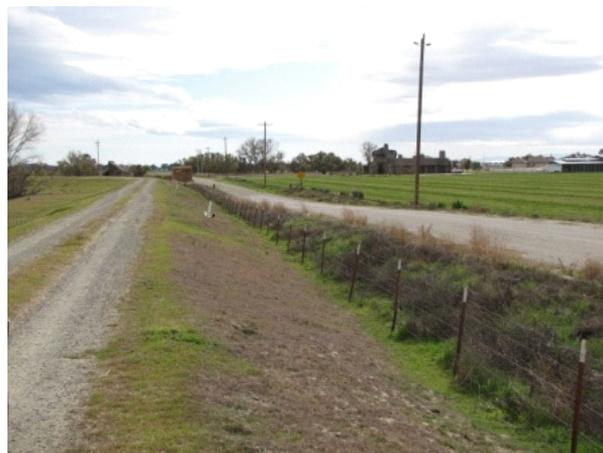
| <p>pkazi_s_20110328_380.jpg</p> | |

| LMR No. | Levee Mile | | Category | Item | Location | Rating | Action/Comment | GPS Latitude/Longitude | | Issue No. Photo |
|---|---|---|---|---|---|---|--|---|---|---|
| 7 | 0.60 | 0.72 | Earthen Levee | Encroachments | WS | PO | Fences Inspector Comments: Barbed wire fence along the landward toe. | 37.479967 ° -121.074582 ° | 37.478514 ° -121.073435 ° | 70 Y |

| <p>View of barbed wire fence at landward toe looking upstream.</p> | |

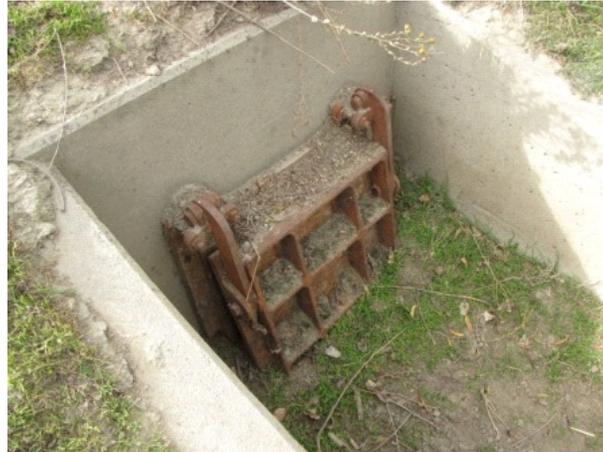
| pkazi_s_20110328_381.jpg | |

| LMR No. | Levee Mile | | Category | Item | Location | Rating | Action/Comment | GPS Latitude/Longitude | | Issue No. Photo |
|---|---|---|---|---|---|---|--|---|---|---|
| 9 | 0.78 | 0.78 | Interior Drainage & Piping Systems | Flap Gates | WS | M | Inspector Comments: Sediment has built up at the pipe outlet preventing the flap gate from closing. | 37.477965 ° -121.072595 ° | 37.477965 ° -121.072595 ° | 72 Y |

| View of a flap gate with sediment preventing it from closing. | |

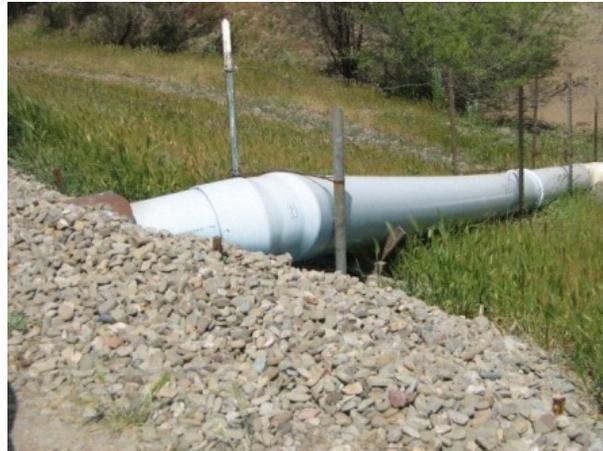
| pkazi_s_20110328_369.jpg | |

| LMR No. | Levee Mile | | Category | Item | Location | Rating | Action/Comment | GPS Latitude/Longitude | | Issue No. Photo |
|---|---|---|---|---|---|---|--|---|---|---|
| 11 | 1.02 | 1.02 | Interior Drainage & Piping Systems | Encroachments | WS | M | Inspector Comments: Installation is incorrect and type of pipe (PVC) | 37.478838 ° -121.068707 ° | 37.478838 ° -121.068707 ° | 9 Y |

| PVC sleeve through steel pipe on waterward slope at LM 1.02 | |

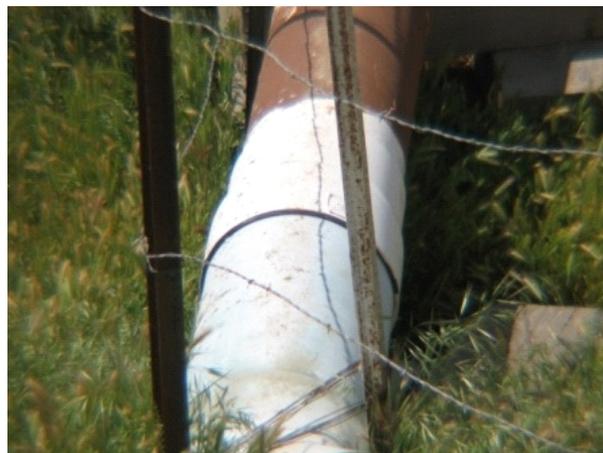
| pkazi_s_20110328_370.jpg | |

| PVC pipe connected to steel pipe on landward toe at LM 1.02 | |

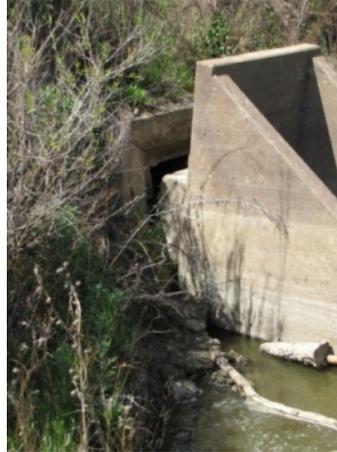
| pkazi_s_20110328_376.jpg | |

| LMR No. | Levee Mile | | Category | Item | Location | Rating | Action/Comment | GPS Latitude/Longitude | | Issue No. Photo |
|---|---|---|---|---|---|---|--|---|---|---|
| 12 | 1.04 | 1.04 | Interior Drainage & Piping Systems | Concrete Tilting / Settlement | WS | M | Inspector Comments: The outlet headwall is tilting away from the pipe rendering the existing flap gate ineffective. Repair gap between pipe and headwall and stabilize headwall to prevent further damage. | 37.478678 ° -121.068305 ° | 37.478678 ° -121.068305 ° | 55 Y |

| Separation of outfall structure from the outlet pipe at LM 1.04. | |

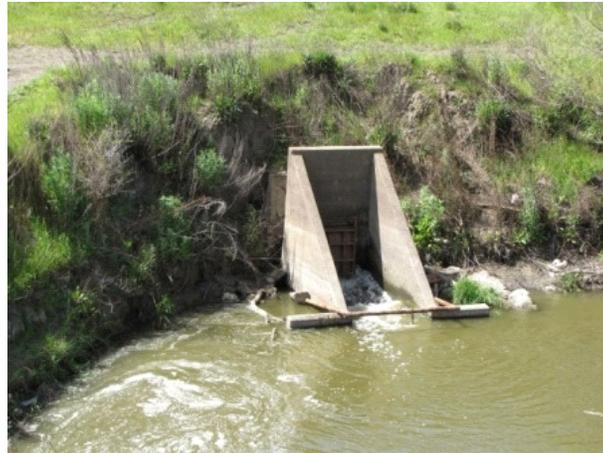
| pkazi_s_20110328_377.jpg | |

| Additional view of outfall structure at LM 1.04. | |

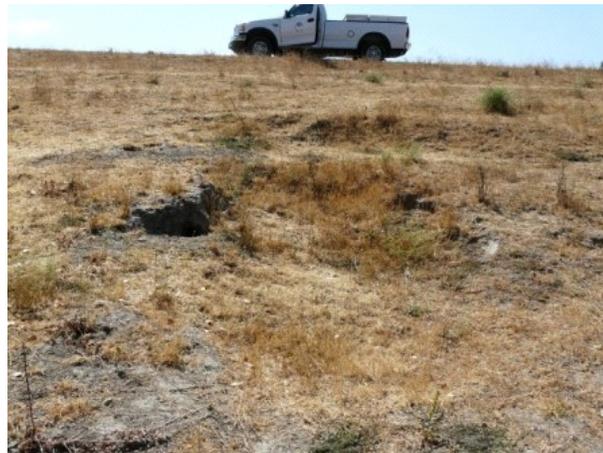
| pkazi_s_20110328_374.JPG | |

| LMR No. | Levee Mile | | Category | Item | Location | Rating | Action/Comment | GPS Latitude/Longitude | | Issue No. Photo |
|---|---|---|---|---|---|---|--|---|---|---|
| 13 | 1.07 | 1.07 | Earthen Levee | Slope Stability | WS | M | Repair slope instability. Inspector Comments: small amount of slumping at water toe | 37.478567 ° -121.067847 ° | 37.478567 ° -121.067847 ° | 37 Y |

| small amount of slumping at water toe | |

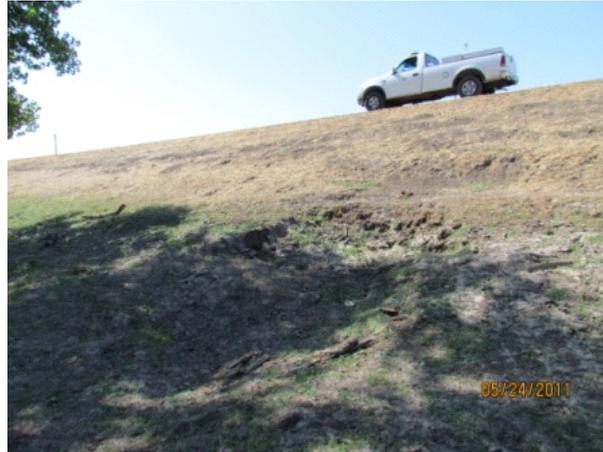
| pkazi_s_20110526_616.jpg | |

| Depression at the waterside slope of the levee during Spring 2011 inspection. | |

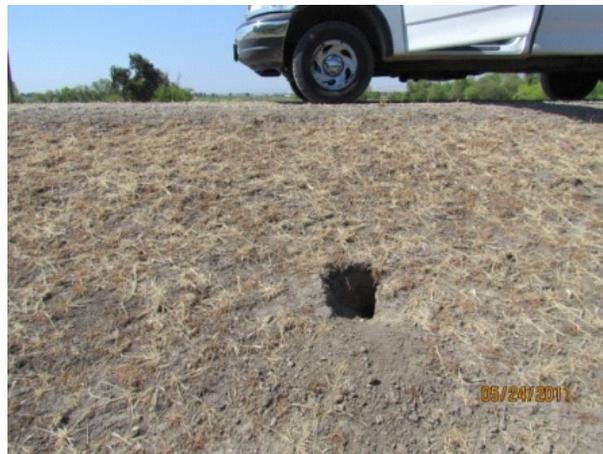
| pkazi_s_20110526_617.jpg | |

| LMR No. | Levee Mile | | Category | Item | Location | Rating | Action/Comment | GPS Latitude/Longitude | | Issue No. Photo |
|---|---|---|---|---|---|---|--|---|---|---|
| 14 | 1.10 | 1.10 | Earthen Levee | Animal Control | WS | M | Exterminate rodents and backfill and compact or grout burrows. | 37.478454 ° -121.067209 ° | 37.478454 ° -121.067209 ° | 8 Y |

| Rodent hole was found on the waterside of the levee. The picture was taken from waterside looking upstream. | |

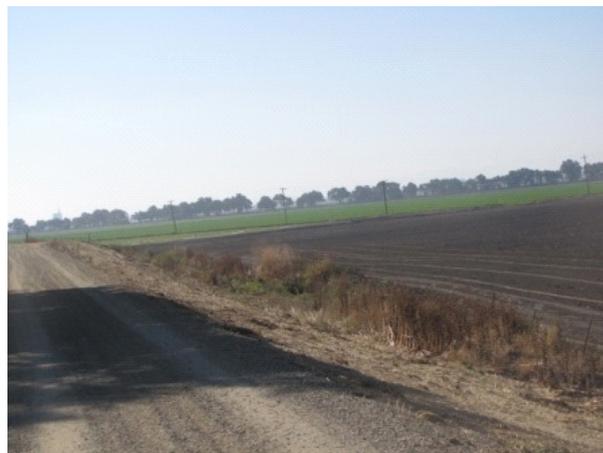
| pkazi_s_20110328_373.jpg | |

| View of vegetation along the landward slope and toe blocking visibility and access looking upstream. | |

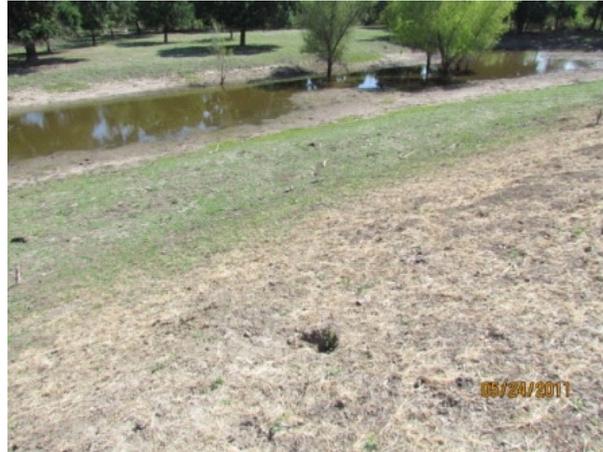
| <p>pkazi_s_20110526_618.jpg</p> | |

| LMR No. | Levee Mile | | Category | Item | Location | Rating | Action/Comment | GPS Latitude/Longitude | | Issue No. Photo |
|---|---|---|---|---|---|---|--|---|---|---|
| 17 | 1.32 | 1.32 | Earthen Levee | Animal Control | WS | M | No rodents visible, but rodent burrows visible; need to backfill and compact or grout burrows. | 37.479265 ° -121.063560 ° | 37.479265 ° -121.063560 ° | 20 Y |

| <p>Rodent hole on the waterside of the levee. The picture was taken from the crown looking upstream.</p> | |

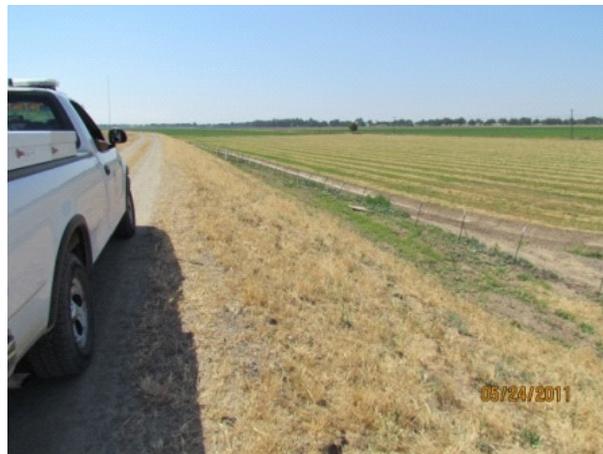
| <p>pkazi_s_20110526_620.jpg</p> | |

| LMR No. | Levee Mile | | Category | Item | Location | Rating | Action/Comment | GPS Latitude/Longitude | | Issue No. Photo |
|---|---|---|---|---|---|---|--|---|---|---|
| 20 | 1.94 | 2.00 | Earthen Levee | Vegetation | LS | A | Control annual grass and weeds on the levee slopes and easements. | 37.473210 ° -121.057930 ° | 37.472425 ° -121.057850 ° | 31 Y |

| <p>Vegetation complies with the standards on the landside of the levee. The picture was taken from the crown looking upstream.</p> | |

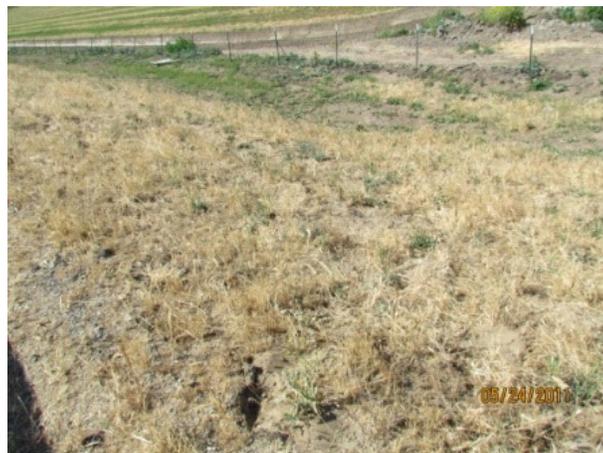
| <p>pkazi_s_20110526_619.jpg</p> | |

| LMR No. | Levee Mile | | Category | Item | Location | Rating | Action/Comment | GPS Latitude/Longitude | | Issue No. Photo |
|---|---|---|---|---|---|---|--|---|---|---|
| 23 | 2.06 | 2.06 | Earthen Levee | Animal Control | LS | W | No rodents visible, but rodent burrows visible; need to backfill and compact or grout burrows. Inspector Comments: Gopher holes | 37.471561 ° -121.057563 ° | 37.471561 ° -121.057563 ° | 11 Y |

| <p>Gopher holes were found on the landside of the levee. The picture was taken from the crown looking upstream.</p> | |

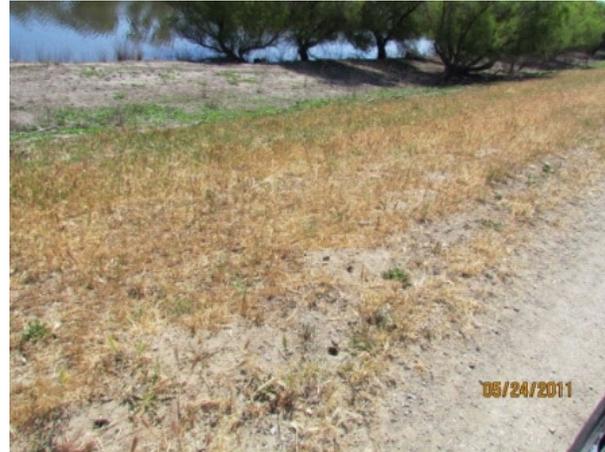
| <p>pkazi_s_20110526_621.jpg</p> | |

| LMR No. | Levee Mile | | Category | Item | Location | Rating | Action/Comment | GPS Latitude/Longitude | | Issue No. Photo |
|---|---|---|---|---|---|---|--|---|---|---|
| 24 | 2.08 | 2.08 | Earthen Levee | Animal Control | WS | M | No rodents visible, but rodent burrows visible; need to backfill and compact or grout burrows. | 37.471306 ° -121.057420 ° | 37.471306 ° -121.057420 ° | 39 Y |

| <p>Gopher holes on the waterside of the levee. The picture was taken from the crown looking upstream.</p> | |

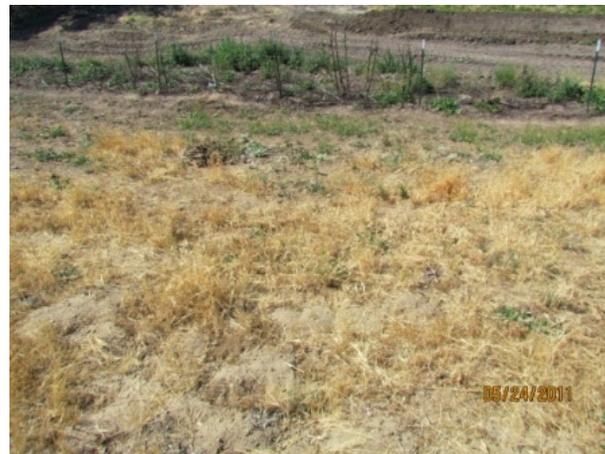
| <p>pkazi_s_20110526_623.jpg</p> | |

| LMR No. | Levee Mile | | Category | Item | Location | Rating | Action/Comment | GPS Latitude/Longitude | | Issue No. Photo |
|---|---|---|---|---|---|---|--|---|---|---|
| 26 | 2.12 | 2.17 | Earthen Levee | Animal Control | LS | A | No rodents visible, but rodent burrows visible; need to backfill and compact or grout burrows. | 37.470834 ° -121.057120 ° | 37.470356 ° -121.056330 ° | 33 Y |

| <p>No rodent holes were visible on the landside of the levee. The picture was taken from the crown looking toward the landside slope.</p> | |

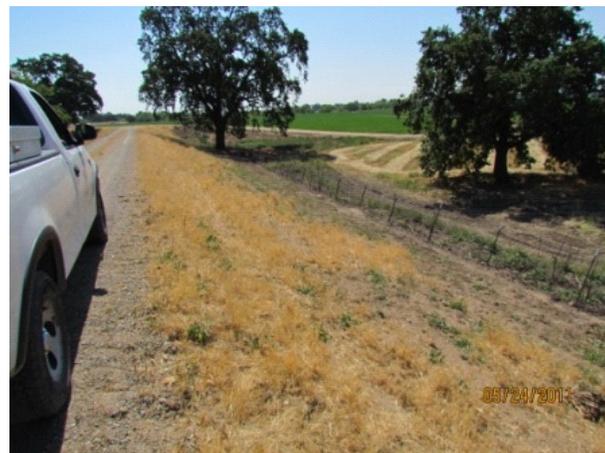
| <p>pkazi_s_20110526_622.jpg</p> | |

| LMR No. | Levee Mile | | Category | Item | Location | Rating | Action/Comment | GPS Latitude/Longitude | | Issue No. Photo |
|---|---|---|---|---|---|---|--|---|---|---|
| 27 | 2.12 | 2.19 | Earthen Levee | Vegetation | LS | A | Control annual grass and weeds on the levee slopes and easements. | 37.470697 ° -121.056990 ° | 37.470297 ° -121.056070 ° | 32 Y |

| <p>Vegetation complies with the standards on the landside of the levee. The picture was taken from the crown looking upstream.</p> | |

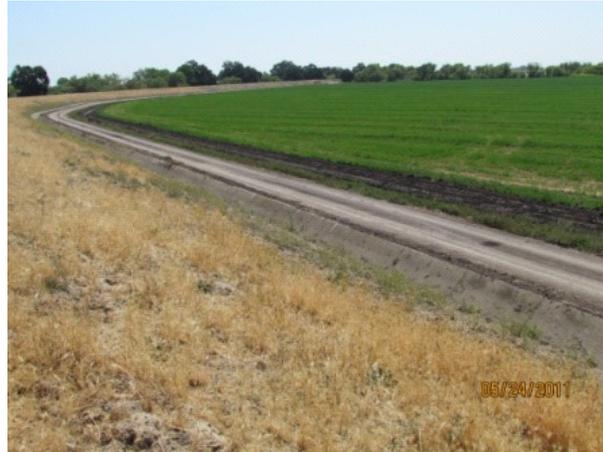
| pkazi_s_20110526_624.jpg | |

| LMR No. | Levee Mile | | Category | Item | Location | Rating | Action/Comment | GPS Latitude/Longitude | | Issue No. Photo |
|---|---|---|---|---|---|---|--|---|---|---|
| 29 | 2.24 | 3.45 | Earthen Levee | Encroachments | LS | PO | Agricultural Ditch Inspector Comments: Concrete ditch before the levee was built. | 37.470119 ° -121.055117 ° | 37.459606 ° -121.043240 ° | 59 Y |

| Concrete drain was built at the toe of the levee. The picture was taken from the crown looking upstream. | |

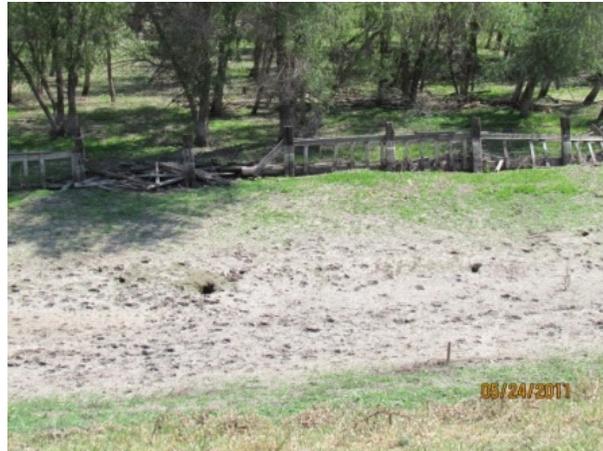
| pkazi_s_20110526_625.jpg | |

| LMR No. | Levee Mile | | Category | Item | Location | Rating | Action/Comment | GPS Latitude/Longitude | | Issue No. Photo |
|---|---|---|---|---|---|---|--|---|---|---|
| 30 | 2.49 | 2.49 | Earthen Levee | Animal Control | WS | M | No rodents visible, but rodent burrows visible; need to backfill and compact or grout burrows. | 37.469899 ° -121.050797 ° | 37.469899 ° -121.050797 ° | 12 Y |

| Rodent holes were found on the waterside of the levee. The picture was taken from the crown looking upstream. | |

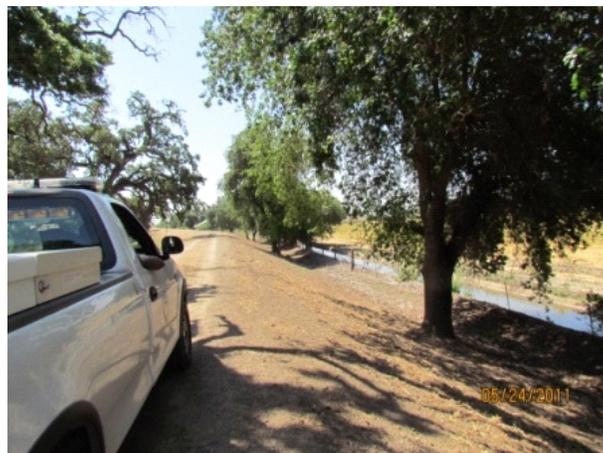
| pkazi_s_20110526_626.jpg | |

| LMR No. | Levee Mile | | Category | Item | Location | Rating | Action/Comment | GPS Latitude/Longitude | | Issue No. Photo |
|---|---|---|---|---|---|---|--|---|---|---|
| 32 | 3.73 | 3.73 | Earthen Levee | Trim / Thin Trees | LS | A | Trim trees to at least five feet above ground level. | 37.456063 ° -121.044150 ° | 37.456063 ° -121.044150 ° | 34 Y |

| Trees and vegetation complies with standards on the landside of the slope. The picture was taken from the crown looking upstream. | |

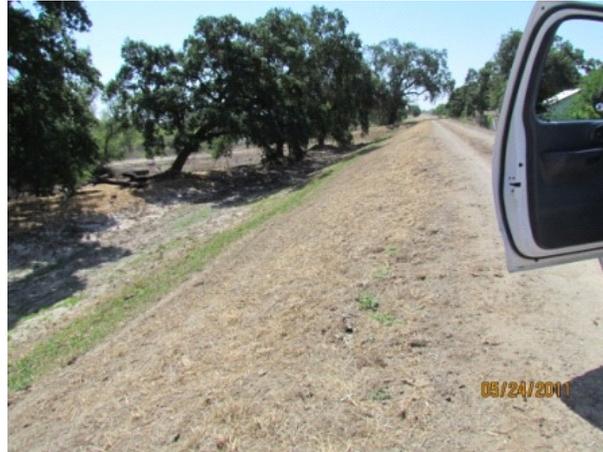
| pkazi_s_20110526_627.jpg | |

| Vegetation complies with standards on the waterside of the levee. The picture was taken from the crown looking upstream. | |

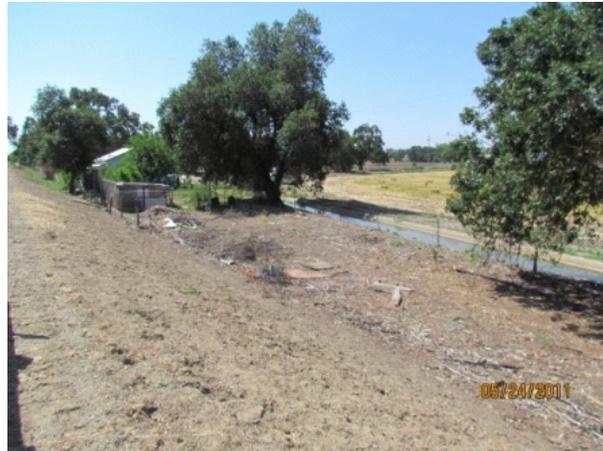
| pkazi_s_20110526_628.jpg | |

| Garbage was found on the landside of the levee. The picture was taken from the crown looking upstream. | |

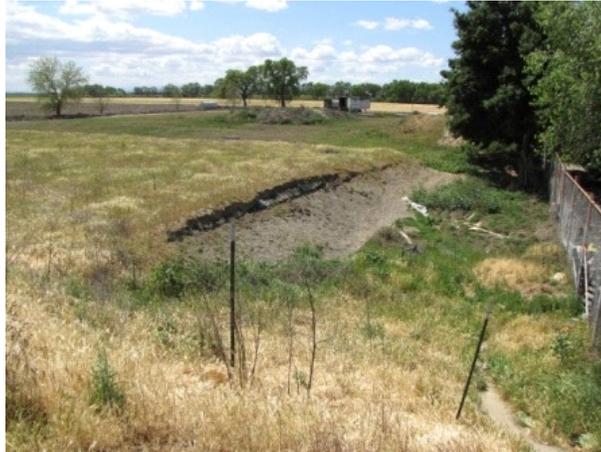
| pkazi_s_20110328_378.jpg | |

| LMR No. | Levee Mile | | Category | Item | Location | Rating | Action/Comment | GPS Latitude/Longitude | | Issue No. Photo |
|---|---|---|---|---|---|---|---|---|---|---|
| 39 | 3.96 | 3.96 | Earthen Levee | Slope Stability | LS | M | Repair the levee slope damaged by vehicle traffic and prevent access where possible. Inspector Comments: Significant damage to USACE constructed seepage berm due to human activity. | 37.453216 ° -121.042127 ° | 37.453216 ° -121.042127 ° | 62 Y |

| Repair damage to USACE constructed seepage berm by pedestrian and cycle traffic at LM 3.96. | |

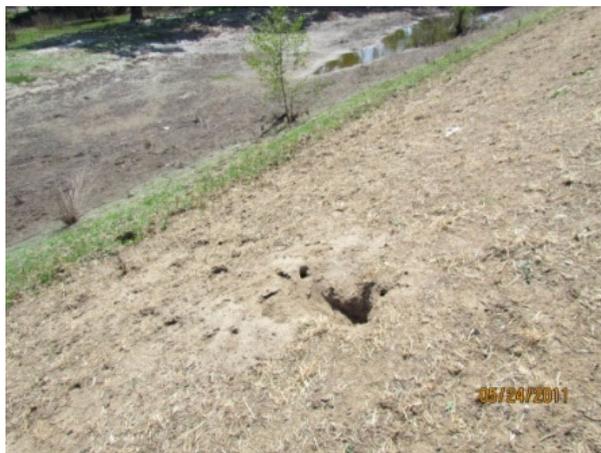
| pkazi_s_20110526_629.jpg | |

| Rodent hole at the waterside slope of the levee. The picture was taken from the crown looking upstream. | |

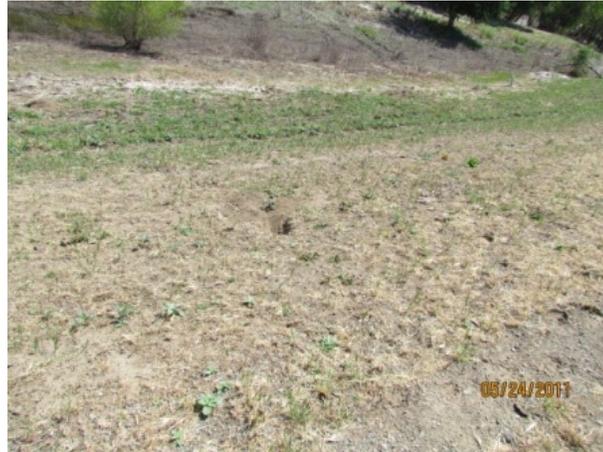
| <p>pkazi_s_20110526_630.jpg</p> | |

| <p>Rodent hole was found the waterside of the levee. The picture was taken from the crown looking upstream.</p> | |

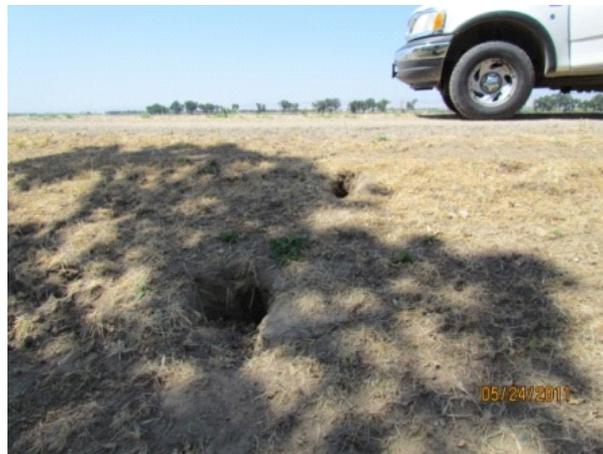
| <p>pkazi_s_20110526_631.jpg</p> | |

| <p>Rodent hole was found on the waterside of the levee. The picture was taken from the crown looking upstream.</p> | |

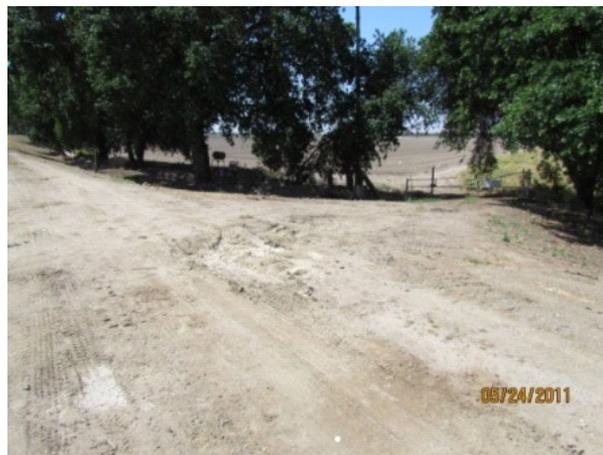
| <p>pkazi_s_20110526_632.jpg</p> | |

| <p>Crown depression on the levee looking upstream.</p> | |

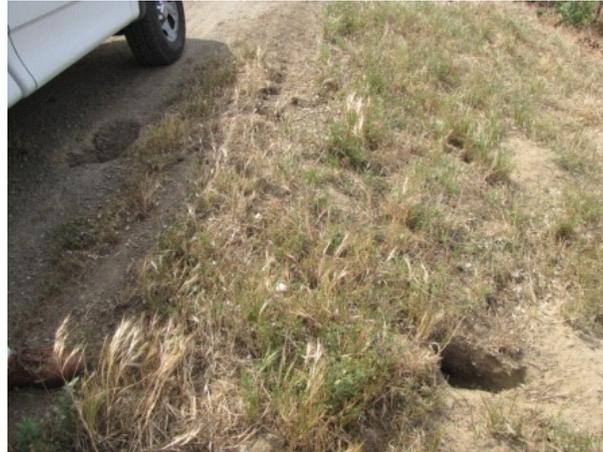
| pkazi_s_20110328_371.jpg | |

| View of rodent holes on the landward slope looking upstream. | |

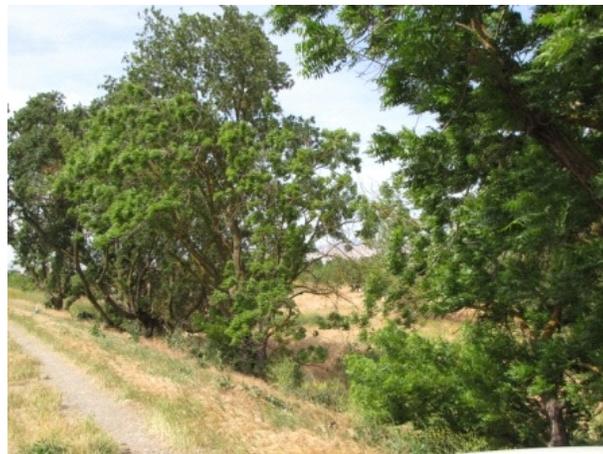
| pkazi_s_20110328_372.jpg | |

| View of trees blocking visibility on the landward slope looking upstream. | |

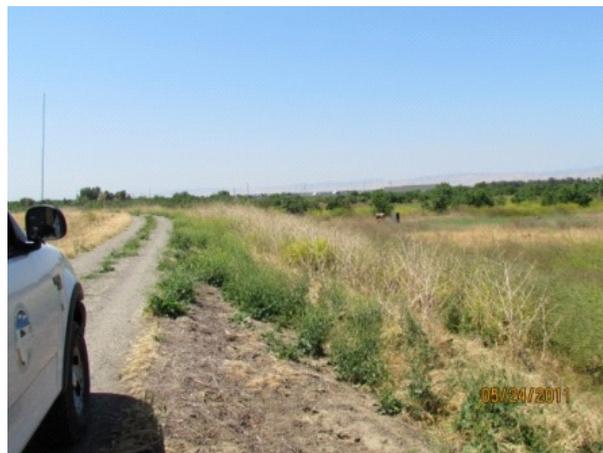
| pkazi_s_20110527_633.jpg | |

| Annual vegetation control needs to be done, but according to LMA the landside slope has been sprayed on (5-23-11). The picture is taken from the crown looking upstream. | |

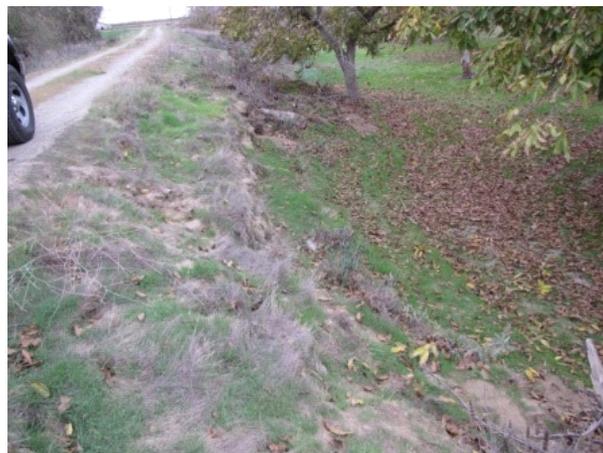
| <p>pkazi_s_20110328_382.jpg</p> | |

| LMR No. | Levee Mile | | Category | Item | Location | Rating | Action/Comment | GPS Latitude/Longitude | | Issue No. Photo |
|---|---|---|---|---|---|---|--|---|---|---|
| 59 | 5.34 | 5.34 | Earthen Levee | Slope Stability | LS | M | Repair slope instability. | 37.435533 ° -121.035371 ° | 37.435533 ° -121.035371 ° | 102 Y |

| <p>View of significant damage and erosion to the landward slope looking upstream.</p> | |

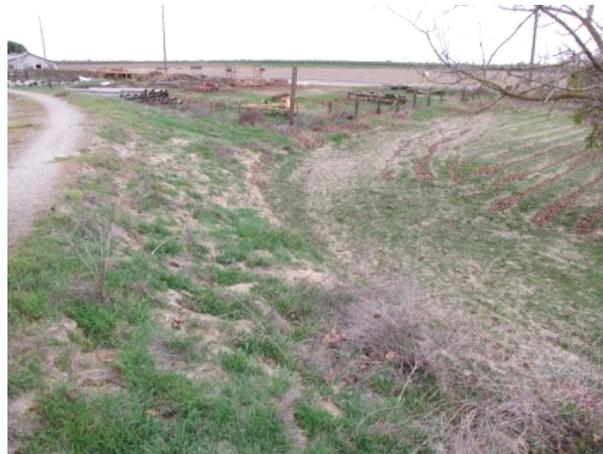
| <p>pkazi_s_20110328_383.jpg</p> | |

| LMR No. | Levee Mile | | Category | Item | Location | Rating | Action/Comment | GPS Latitude/Longitude | | Issue No. Photo |
|---|---|---|---|---|---|---|--|---|---|---|
| 63 | 5.40 | 5.40 | Earthen Levee | Slope Stability | LS | M | Repair slope instability. | 37.434699 ° -121.035063 ° | 37.434699 ° -121.035063 ° | 105 Y |

| <p>View of tilling into the landward slope of the levee looking upstream. This slope has also been significantly damaged by rodent activity.</p> | |
