**Flood Control Project Maintenance
Levee Inspections****LMA District Cover Sheet****Spring 2012 Levee Inspection Results****Reclamation District No. 1602 Del Puerto**

Spring 2012 Levee Inspection Results

Reclamation District No. 1602 Del Puerto

Levee Inspection Report By Mile - Spring 2012

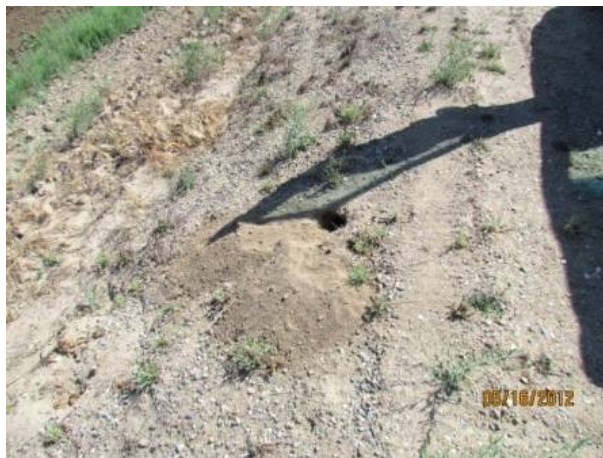
Levee Mile Report Line	8
Start Levee Mile	0.29
End Levee Mile	0.29
Location	Water Side
Category	Earthen Levee
Item	Animal Control

An animal hole was found on the waterside of the levee looking upstream.

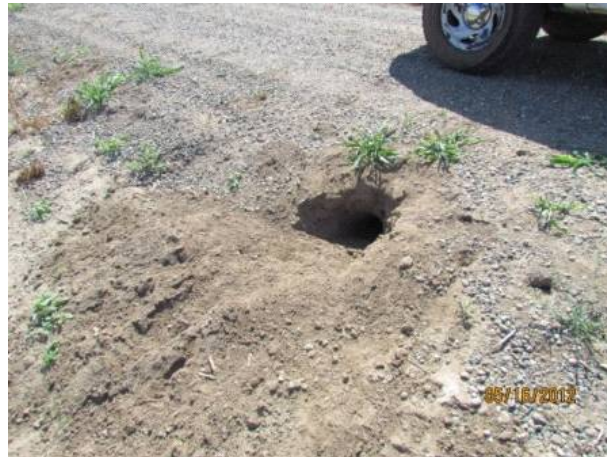
Levee Mile Report Line	9
Start Levee Mile	0.32
End Levee Mile	0.32
Location	Water Side
Category	Earthen Levee
Item	Animal Control

A rodent hole was found on the waterside of the slope taken from the toe looking toward the crown. This picture was taken during spring 2012 inspection.

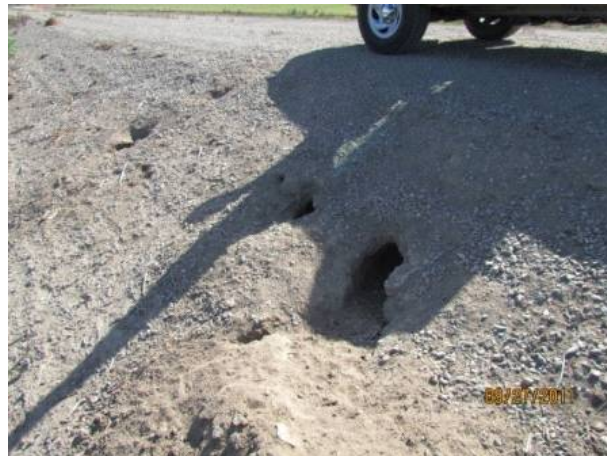
Levee Mile Report Line	10
Start Levee Mile	0.37
End Levee Mile	0.37
Location	Water Side
Category	Earthen Levee
Item	Animal Control

Rodent holes were found on the waterside of the slope. The picture was taken from the toe looking towards the crown of the levee.

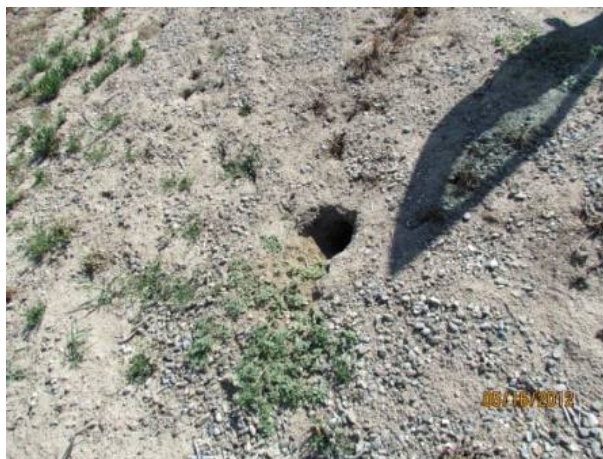
Levee Mile Report Line	12
Start Levee Mile	0.47
End Levee Mile	0.47
Location	Water Side
Category	Earthen Levee
Item	Animal Control

Animal holes were found on the waterside slope of the levee looking upstream.

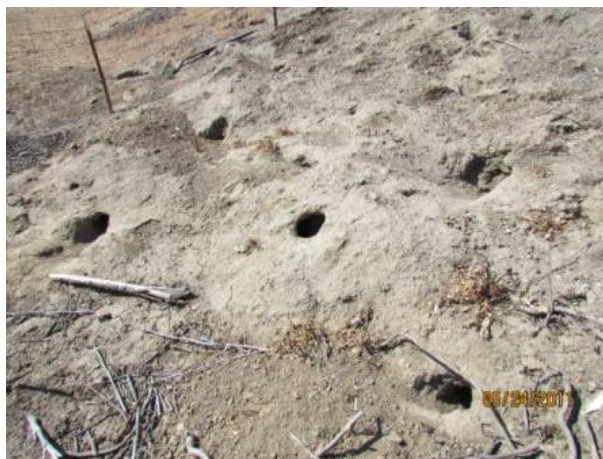
Levee Mile Report Line	14
Start Levee Mile	0.59
End Levee Mile	0.59
Location	Water Side
Category	Earthen Levee
Item	Animal Control

Rodent holes were found on the waterside of the levee. The picture was taken from the toe of waterside of the levee looking upstream.

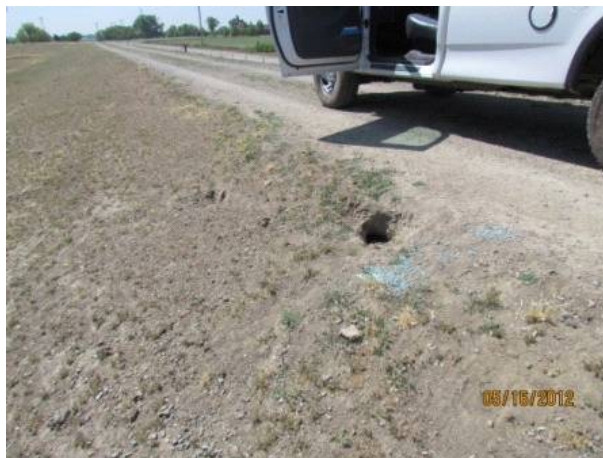
Levee Mile Report Line	17
Start Levee Mile	0.63
End Levee Mile	0.63
Location	Water Side
Category	Earthen Levee
Item	Animal Control

A rodent hole was found on the waterside shoulder of the levee looking upstream.

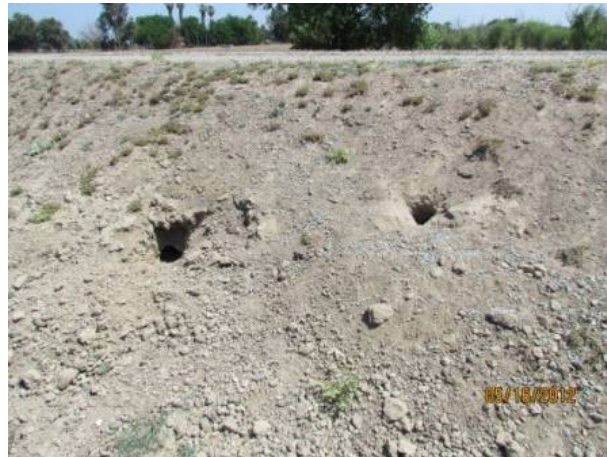
Levee Mile Report Line	19
Start Levee Mile	0.66
End Levee Mile	0.66
Location	Land Side
Category	Earthen Levee
Item	Animal Control

Rodent holes were found on the landside of the levee. The picture was taken from the toe of the levee looking towards the crown.

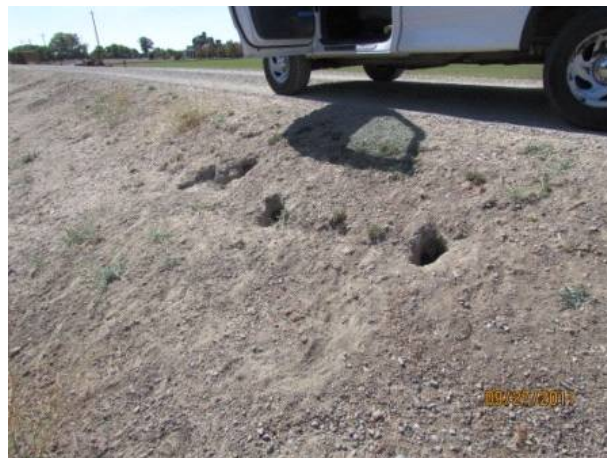
Levee Mile Report Line	20
Start Levee Mile	0.67
End Levee Mile	0.67
Location	Water Side
Category	Earthen Levee
Item	Animal Control

The rodent holes were found on the waterside of the levee. The picture was taken from toe looking towards the crown.

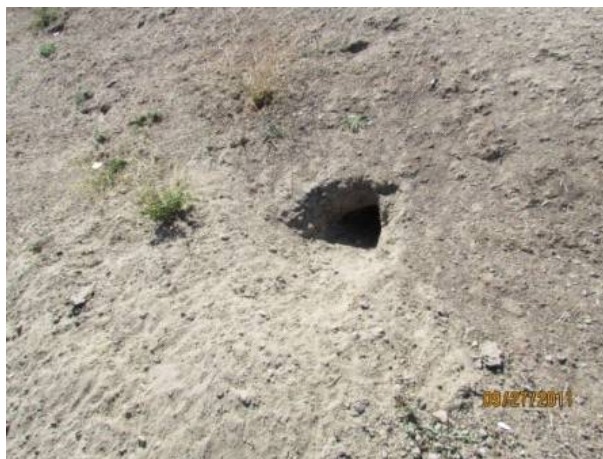
Levee Mile Report Line	22
Start Levee Mile	0.69
End Levee Mile	0.69
Location	Land Side
Category	Earthen Levee
Item	Animal Control

Animal burrow was found on the landside of the levee. The picture was taken from the toe of the levee looking upstream.

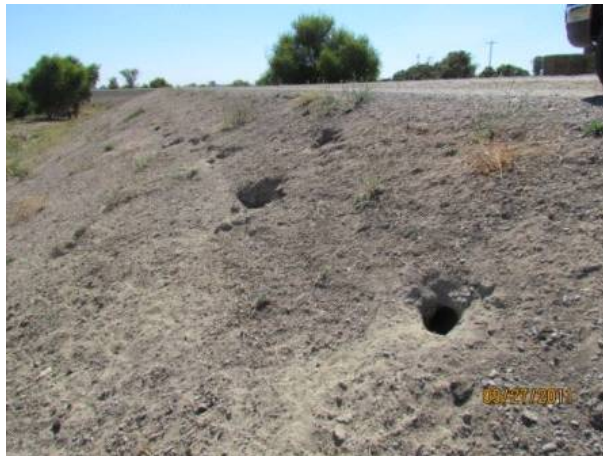
Levee Mile Report Line	23
Start Levee Mile	0.71
End Levee Mile	0.71
Location	Water Side
Category	Earthen Levee
Item	Animal Control

Rodent holes were found on the waterside of the levee. The picture was taken from toe of the levee looking upstream.

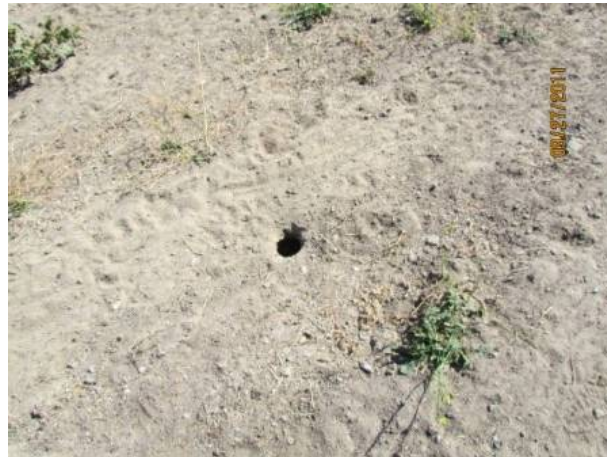
Levee Mile Report Line	25
Start Levee Mile	0.78
End Levee Mile	0.78
Location	Water Side
Category	Earthen Levee
Item	Animal Control

Animal burrow was found on the waterside of the levee. The picture was taken from the toe of the levee looking downstream.

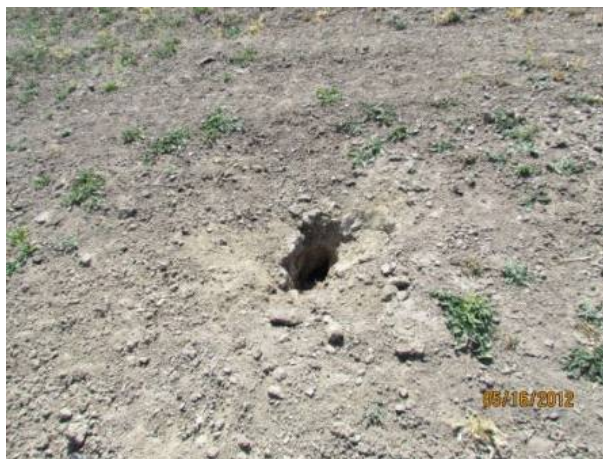
Levee Mile Report Line	27
Start Levee Mile	0.81
End Levee Mile	0.81
Location	Water Side
Category	Earthen Levee
Item	Animal Control

A rodent hole was found on the waterside of the levee looking upstream.

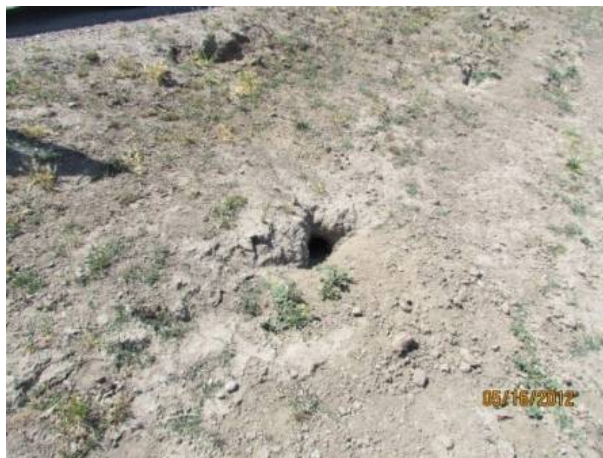
Levee Mile Report Line	29
Start Levee Mile	0.83
End Levee Mile	0.83
Location	Water Side
Category	Earthen Levee
Item	Animal Control

A rodent hole was found on the waterside of the levee looking downstream.

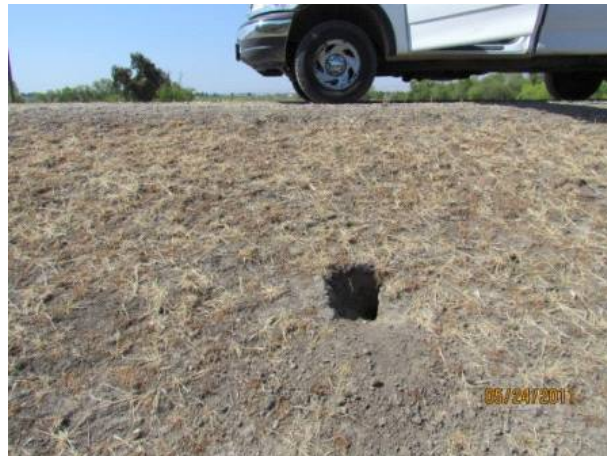
Levee Mile Report Line	35
Start Levee Mile	1.10
End Levee Mile	1.10
Location	Water Side
Category	Earthen Levee
Item	Animal Control

Rodent hole was found on the waterside of the levee. The picture was taken from waterside looking upstream.

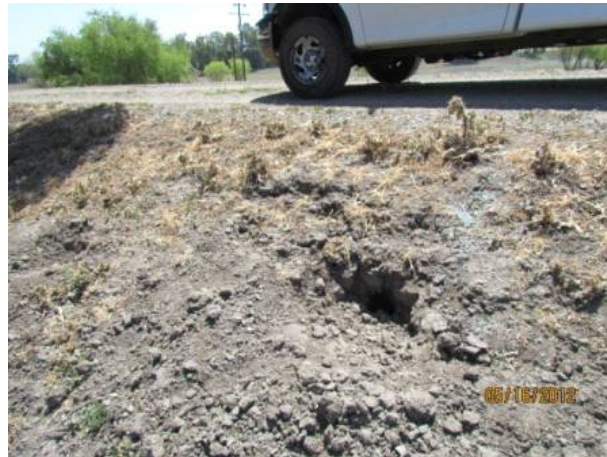
Levee Mile Report Line	39
Start Levee Mile	1.21
End Levee Mile	1.21
Location	Water Side
Category	Earthen Levee
Item	Animal Control
Rodent hole on the waterside shoulder of the levee looking upstream.	
pkazi_s_20120518_051.jpg

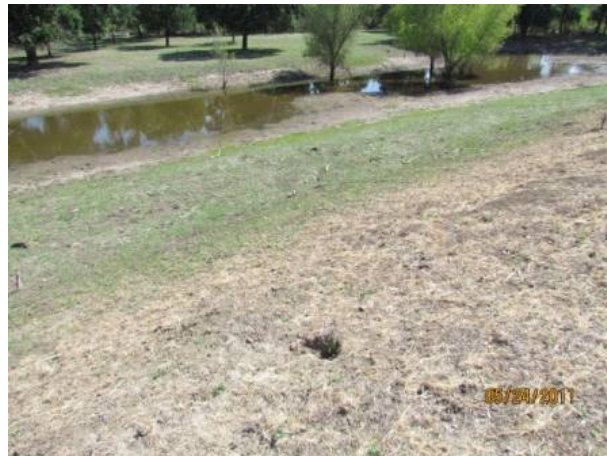
Levee Mile Report Line	41
Start Levee Mile	1.46
End Levee Mile	1.46
Location	Water Side
Category	Earthen Levee
Item	Animal Control
Rodent hole on the waterside of the levee. The picture was taken from the crown looking upstream.	
pkazi_s_20120305_680.jpg

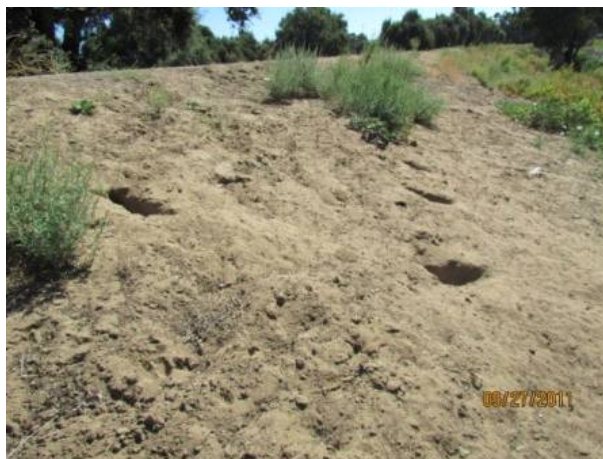
Levee Mile Report Line	44
Start Levee Mile	1.62
End Levee Mile	1.62
Location	Land Side
Category	Earthen Levee
Item	Animal Control

Animal burrows were found on the landside of the levee. The picture was taken from the toe of the levee looking upstream.

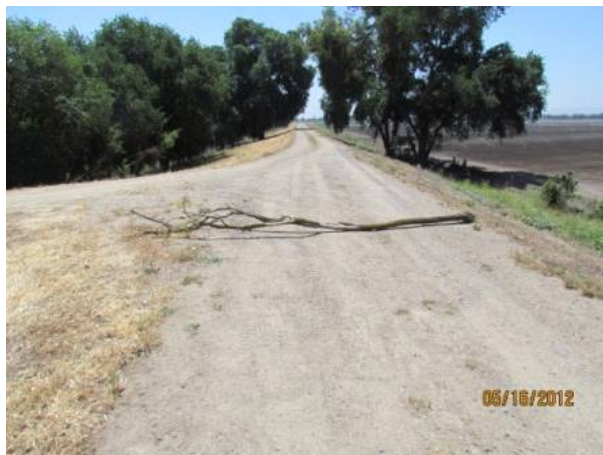
Levee Mile Report Line	45
Start Levee Mile	1.77
End Levee Mile	1.77
Location	Crown
Category	Earthen Levee
Item	Encroachments

A branch was found on the crown of the levee looking upstream.

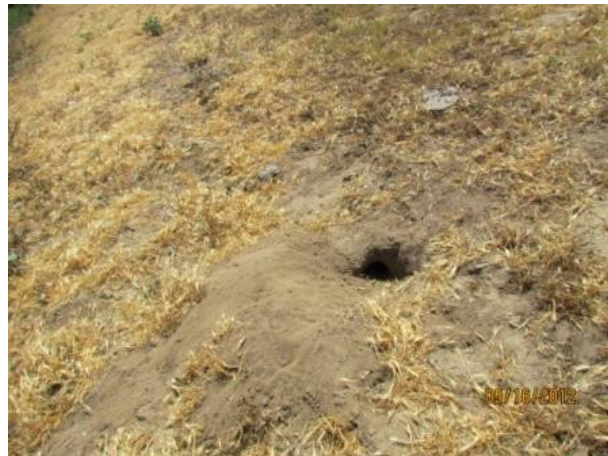
Levee Mile Report Line	50
Start Levee Mile	2.09
End Levee Mile	2.09
Location	Water Side
Category	Earthen Levee
Item	Animal Control

A rodent hole was found on the waterside of the levee looking upstream.

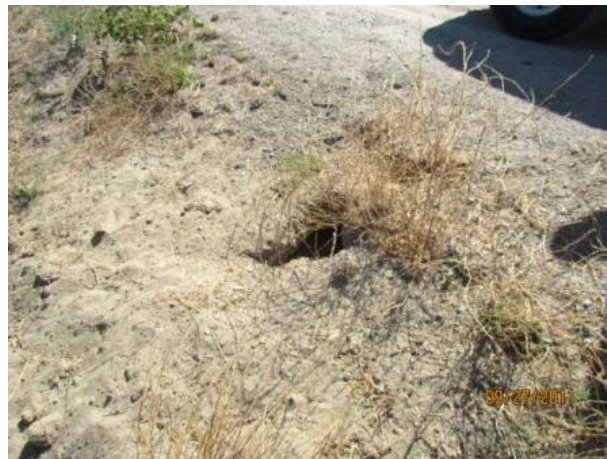
Levee Mile Report Line	54
Start Levee Mile	2.49
End Levee Mile	2.49
Location	Water Side
Category	Earthen Levee
Item	Animal Control

Animal burrow was found on the waterside of the levee. The picture was taken from the toe of the levee looking upstream.

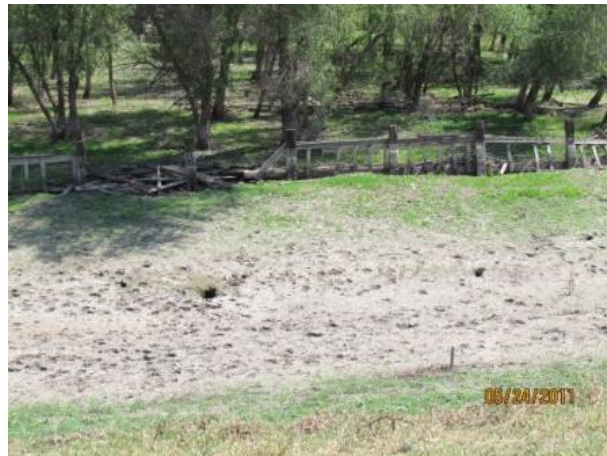
Levee Mile Report Line	55
Start Levee Mile	2.49
End Levee Mile	2.49
Location	Water Side
Category	Earthen Levee
Item	Animal Control

Rodent holes were found on the waterside of the levee. The picture was taken from the crown looking upstream.

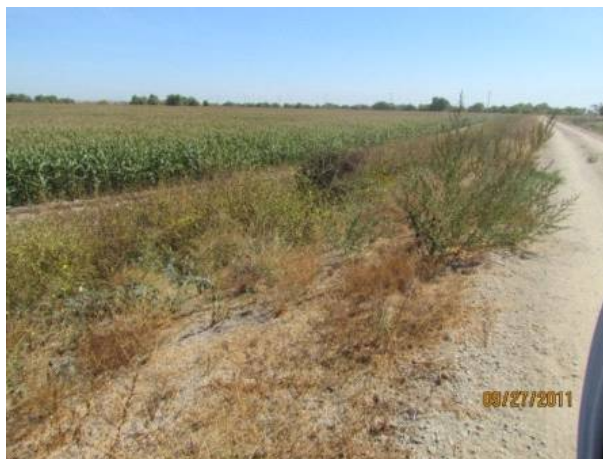
Levee Mile Report Line	60
Start Levee Mile	2.83
End Levee Mile	3.58
Location	Water Side
Category	Earthen Levee
Item	Vegetation

Wild growth was found on the waterside of the levee. The picture was taken from the crown looking upstream.

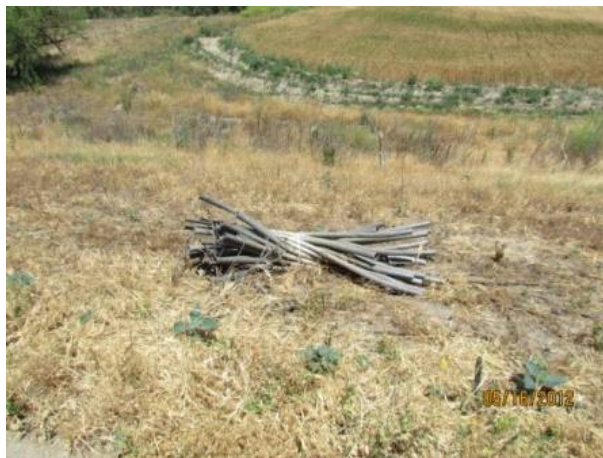
Levee Mile Report Line	61
Start Levee Mile	2.85
End Levee Mile	2.85
Location	Water Side
Category	Earthen Levee
Item	Encroachments

Debris were found on the waterside of the levee looking upstream.

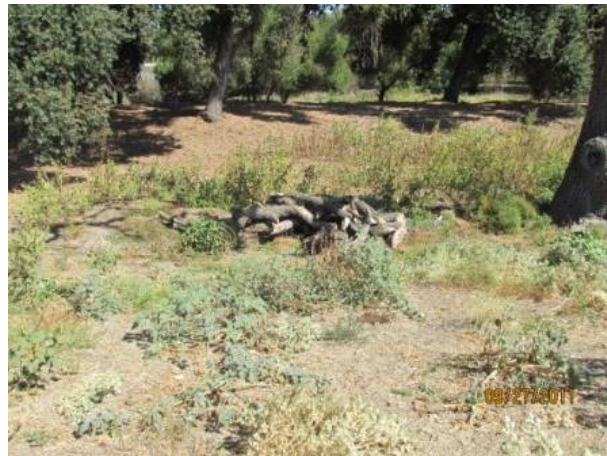
Levee Mile Report Line	67
Start Levee Mile	3.78
End Levee Mile	3.78
Location	Water Side
Category	Earthen Levee
Item	Encroachments

Firewood was found on the waterside slope of the levee. The picture was taken from the crown of the levee looking towards the toe.

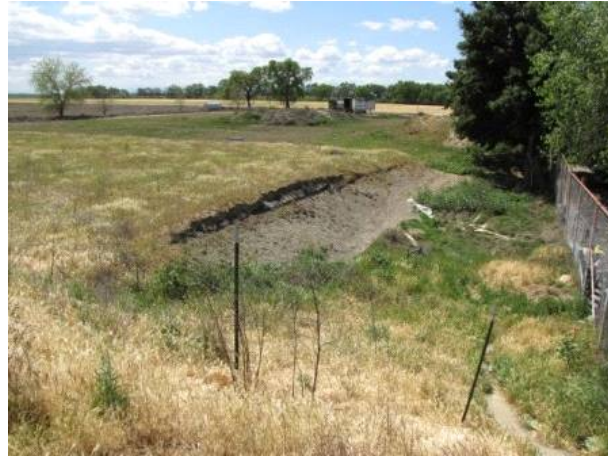
Levee Mile Report Line	73
Start Levee Mile	3.96
End Levee Mile	3.96
Location	Land Side
Category	Earthen Levee
Item	Slope Stability
Repair damage to USACE constructed seepage berm by pedestrian and cycle traffic at LM 3.96.	
pkazi_s_20120305_723.jpg

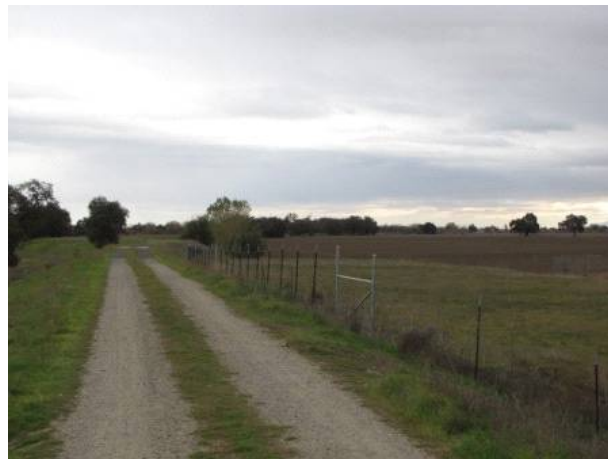
Levee Mile Report Line	74
Start Levee Mile	3.97
End Levee Mile	4.07
Location	Land Side
Category	Earthen Levee
Item	Encroachments
View of a barbed wire fence on the landward slope looking upstream.	
pkazi_s_20120305_724.jpg

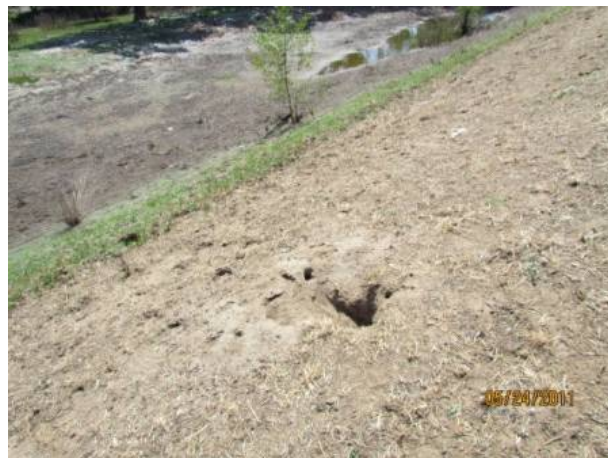
Levee Mile Report Line	75
Start Levee Mile	3.99
End Levee Mile	3.99
Location	Water Side
Category	Earthen Levee
Item	Animal Control
Rodent hole at the waterside slope of the levee. The picture was taken from the crown looking upstream.	
pkazi_s_20120305_686.jpg

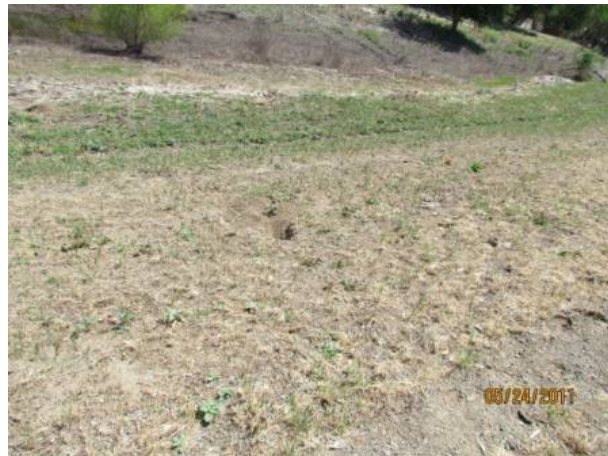
Levee Mile Report Line	77
Start Levee Mile	4.04
End Levee Mile	4.04
Location	Water Side
Category	Earthen Levee
Item	Animal Control

Rodent hole was found the waterside of the levee. The picture was taken from the crown looking upstream.

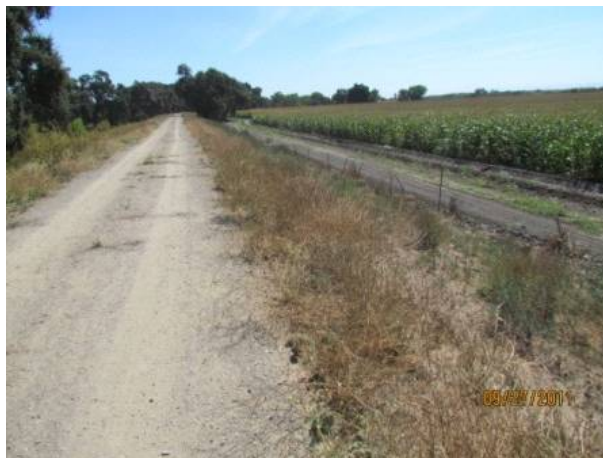
Levee Mile Report Line	83
Start Levee Mile	4.70
End Levee Mile	4.92
Location	Land Side
Category	Earthen Levee
Item	Vegetation

Wild growth was found on the landside of the levee looking upstream.

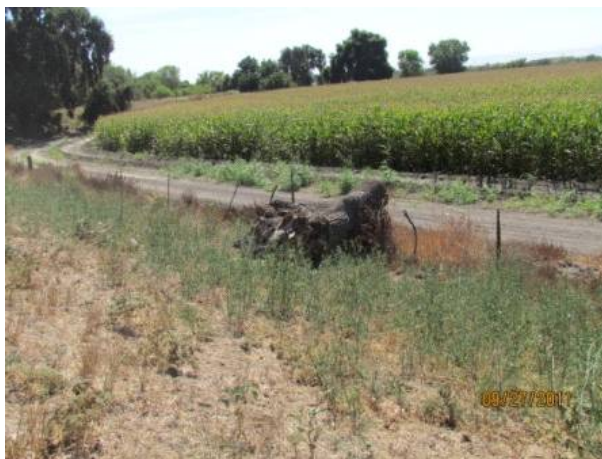
Levee Mile Report Line	85
Start Levee Mile	4.81
End Levee Mile	4.81
Location	Land Side
Category	Earthen Levee
Item	Encroachments

A broken tree trunk was found on the toe of the landside of the levee. The picture was taken from the crown looking upstream.

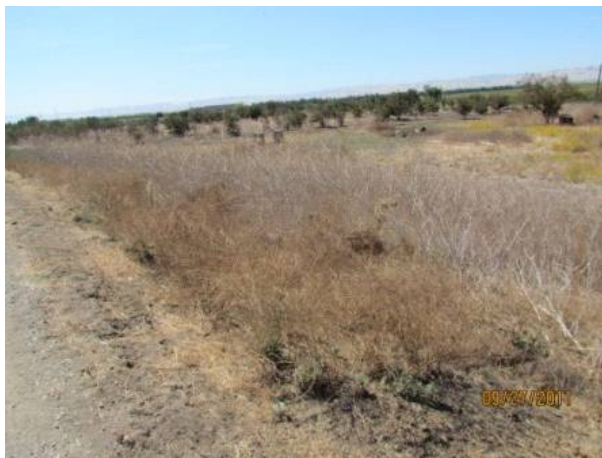
Levee Mile Report Line	88
Start Levee Mile	4.98
End Levee Mile	5.14
Location	Land Side
Category	Earthen Levee
Item	Vegetation

Wild growth was found on the landside of the levee looking upstream.

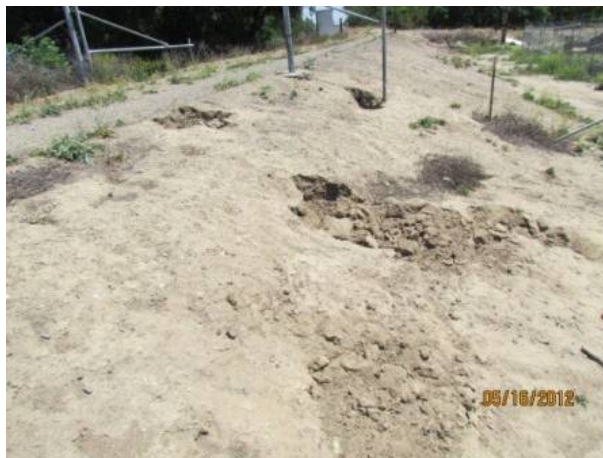
Levee Mile Report Line	90
Start Levee Mile	5.25
End Levee Mile	5.25
Location	Land Side
Category	Earthen Levee
Item	Animal Control

Rodent holes found possible were more damaged by dogs on the landside of the levee looking upstream. This picture was taken during spring 2012 inspection.

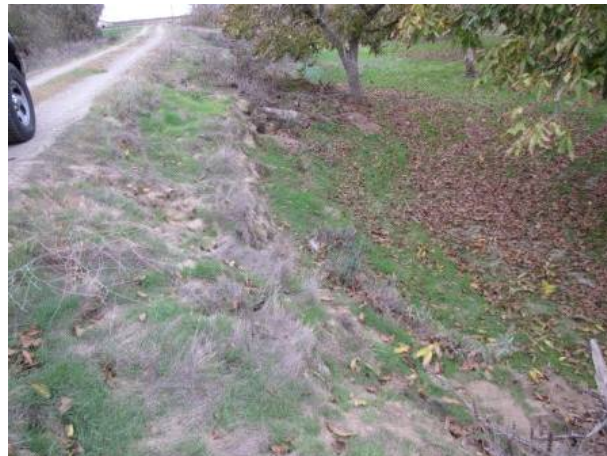
Levee Mile Report Line	94
Start Levee Mile	5.34
End Levee Mile	5.34
Location	Land Side
Category	Earthen Levee
Item	Slope Stability

View of significant damage and erosion to the landward slope looking upstream.

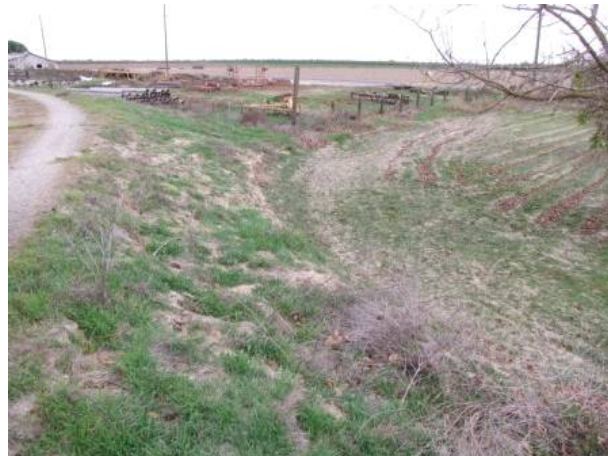
Levee Mile Report Line	98
Start Levee Mile	5.40
End Levee Mile	5.40
Location	Land Side
Category	Earthen Levee
Item	Slope Stability

View of tilling into the landward slope of the levee looking upstream. This slope has also been significantly damaged by rodent activity.
