**Flood Control Project Maintenance  
Levee Inspections**  
**LMA District Cover Sheet**  
**Spring 2013 Levee Inspection Results**

**Reclamation District No. 1602 Del Puerto**

**Levee Inspection Report By Mile - Spring 2013**

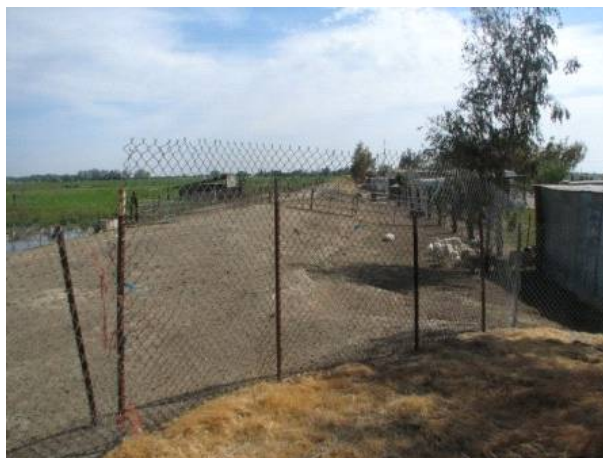
Levee Mile Report Line	6
Start Levee Mile	0.32
End Levee Mile	0.32
Location	Water Side
Category	
Item	Animal Control

A rodent hole was found on the waterside of the slope. The picture was taken from the toe looking toward the crown.

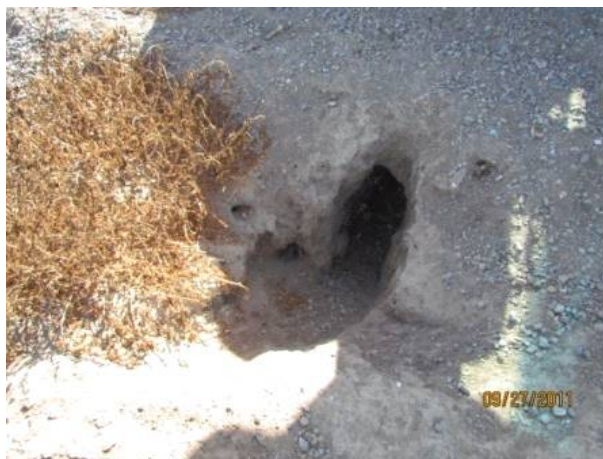
Levee Mile Report Line	6
Start Levee Mile	0.32
End Levee Mile	0.32
Location	Water Side
Category	
Item	Animal Control

A rodent hole was found on the waterside of the slope taken from the toe looking toward the crown. This picture was taken during the spring 2012 inspection.

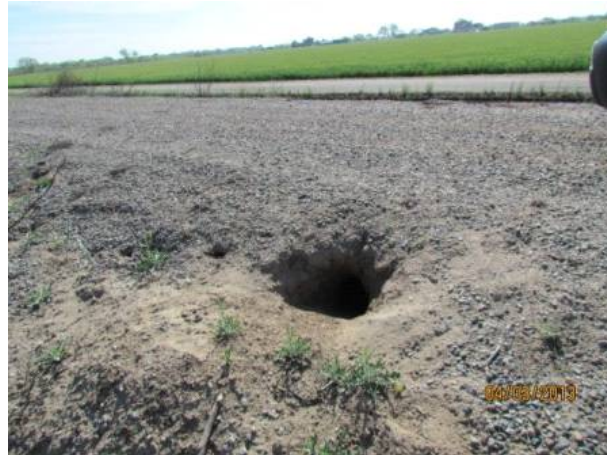
Levee Mile Report Line	7
Start Levee Mile	0.37
End Levee Mile	0.37
Location	Water Side
Category	
Item	Animal Control

Rodent holes were found on the waterside of the slope. The picture was taken from the toe looking towards the crown of the levee.

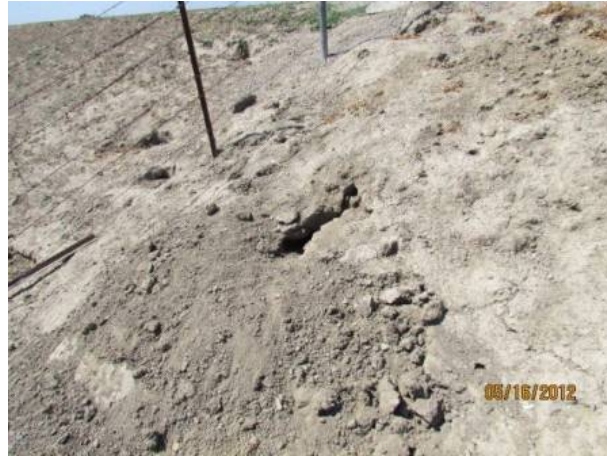
Levee Mile Report Line	9
Start Levee Mile	0.60
End Levee Mile	0.60
Location	Water Side
Category	
Item	Animal Control

Rodent holes were found on the waterside of the levee. The picture was taken from the toe of the waterside of the levee looking upstream.

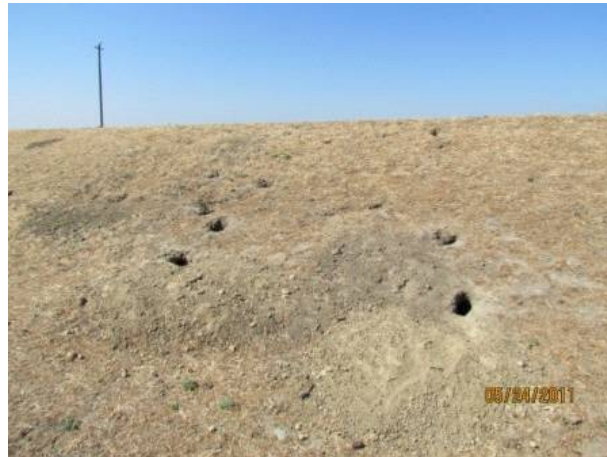
Levee Mile Report Line	9
Start Levee Mile	0.60
End Levee Mile	0.60
Location	Water Side
Category	
Item	Animal Control

A rodent hole was found on the waterside slope looking from the toe of the levee.

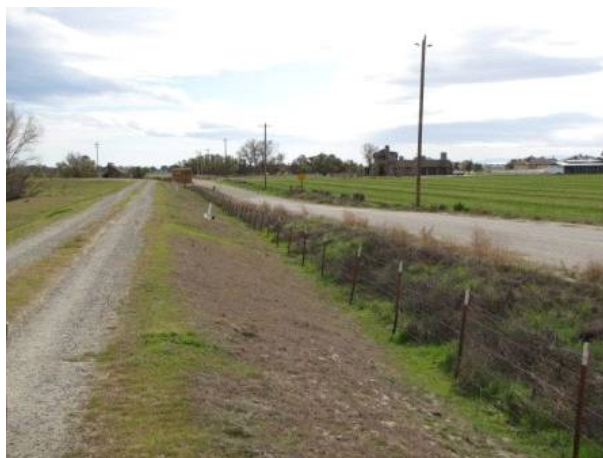
Levee Mile Report Line	11
Start Levee Mile	0.63
End Levee Mile	0.63
Location	Water Side
Category	
Item	Animal Control

Rodent holes were repaired on the waterside slope of the levee looking upstream.

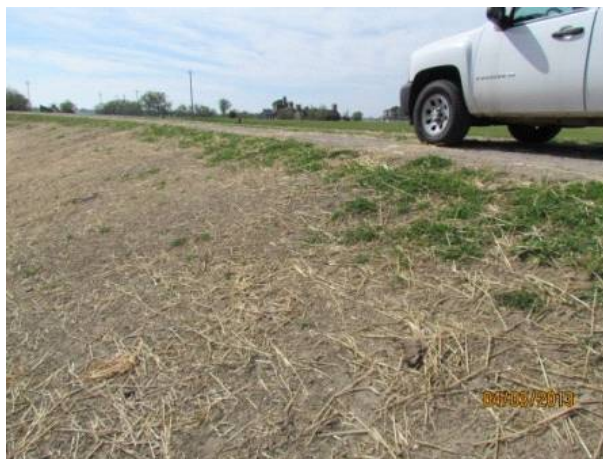
Levee Mile Report Line	13
Start Levee Mile	0.64
End Levee Mile	0.64
Location	Land Side
Category	
Item	Animal Control

A rodent hole was found on the landside shoulder of the levee looking upstream.

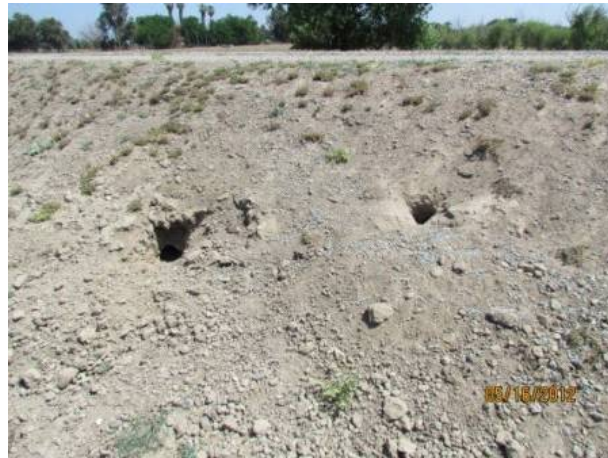
Levee Mile Report Line	15
Start Levee Mile	0.66
End Levee Mile	0.66
Location	Land Side
Category	
Item	Animal Control
Rodent holes were found on the landside of the levee. The picture was taken from the toe of the levee looking towards the crown.	
pkazi_s_20130404_773.jpg

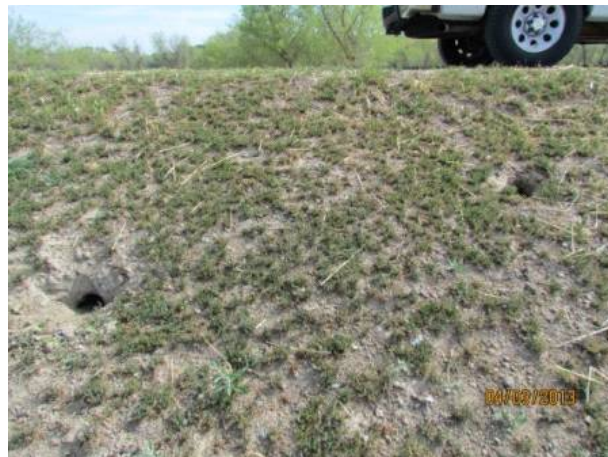
Levee Mile Report Line	15
Start Levee Mile	0.66
End Levee Mile	0.66
Location	Land Side
Category	
Item	Animal Control
Rodent holes were found on the waterside slope of the levee looking towards the crown during spring 2013 inspection.	
pkazi_s_20130405_841.JPG

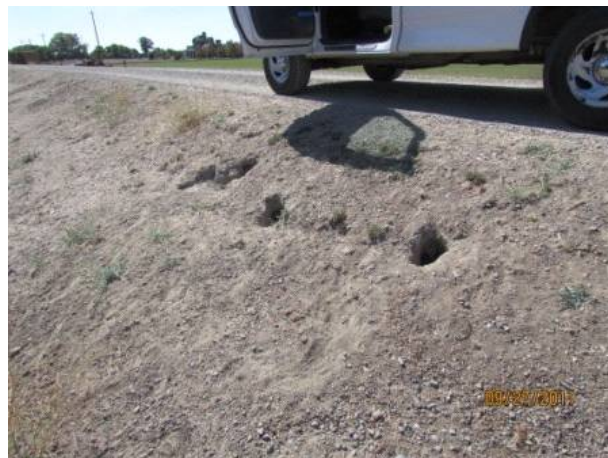
Levee Mile Report Line	16
Start Levee Mile	0.67
End Levee Mile	0.67
Location	Water Side
Category	
Item	Animal Control
The rodent holes were found on the waterside of the levee. The picture was taken from toe looking towards the crown.	
pkazi_s_20130404_761.jpg

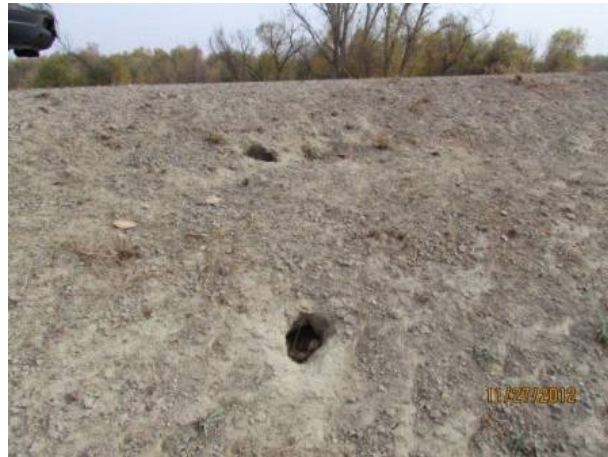
Levee Mile Report Line	18
Start Levee Mile	0.69
End Levee Mile	0.69
Location	Land Side
Category	
Item	Animal Control
Rodent holes were found on the landside of the levee looking upstream.	
pkazi_s_20130404_764.jpg

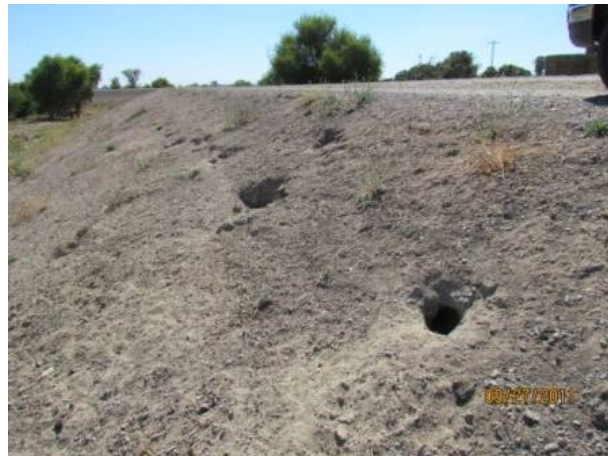
Levee Mile Report Line	19
Start Levee Mile	0.71
End Levee Mile	0.71
Location	Water Side
Category	
Item	Animal Control
Rodent holes were found on the waterside of the levee. The picture was taken from toe of the levee looking upstream.	
pkazi_s_20130404_765.jpg

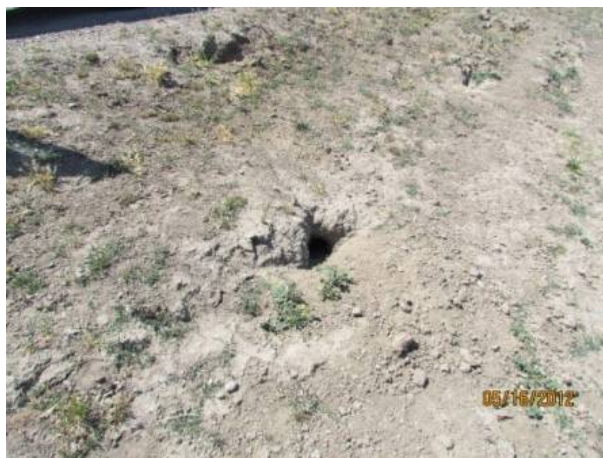
Levee Mile Report Line	23
Start Levee Mile	0.83
End Levee Mile	0.83
Location	Water Side
Category	
Item	Animal Control
A rodent hole was found on the waterside of the levee looking downstream.	
pkazi_s_20130404_802.jpg

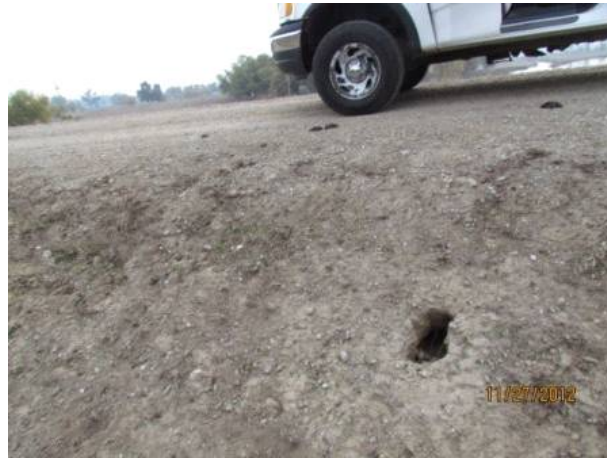
Levee Mile Report Line	25
Start Levee Mile	0.95
End Levee Mile	0.95
Location	Water Side
Category	
Item	Animal Control
A rodent hole was found on the waterside slope of the levee looking upstream.	
pkazi_s_20130404_779.jpg

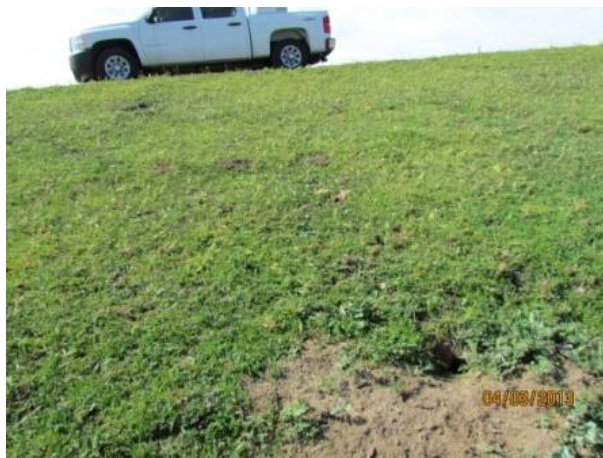
Levee Mile Report Line	31
Start Levee Mile	1.10
End Levee Mile	1.10
Location	Water Side
Category	
Item	Animal Control

Rodent hole was found on the waterside of the levee. The picture was taken from waterside looking upstream.

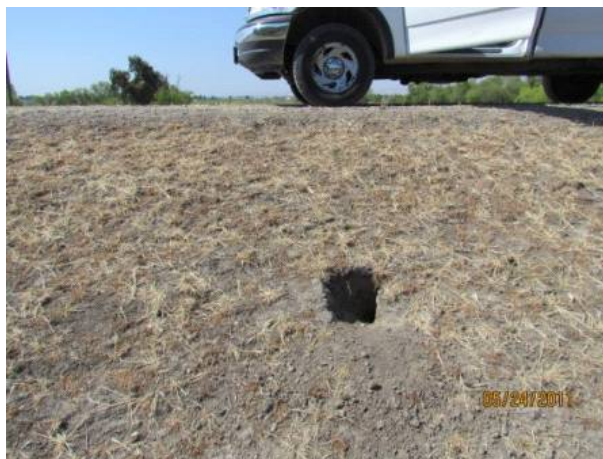
Levee Mile Report Line	32
Start Levee Mile	1.11
End Levee Mile	1.11
Location	Water Side
Category	
Item	Animal Control

A rodent hole was found on the waterside toe of the levee looking downstream.

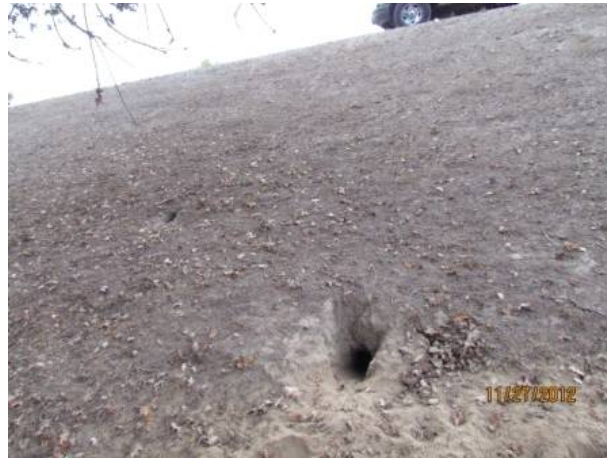
Levee Mile Report Line	34
Start Levee Mile	1.13
End Levee Mile	1.13
Location	Land Side
Category	
Item	Animal Control

Animal burrow was found on the landside of the levee. The picture was taken from the toe of the levee looking upstream.

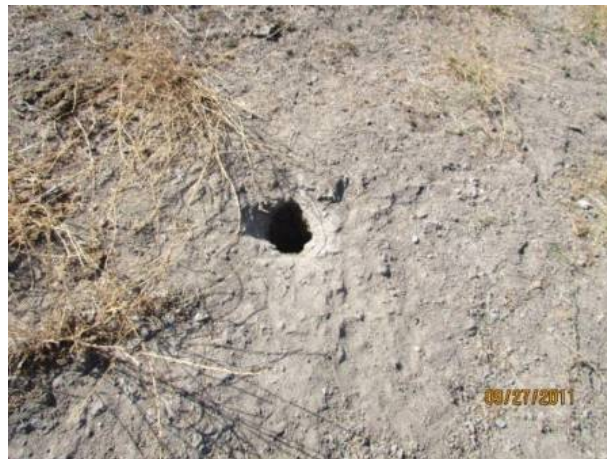
Levee Mile Report Line	35
Start Levee Mile	1.15
End Levee Mile	1.15
Location	Water Side
Category	
Item	Animal Control

Rodent holes were found on the waterside toe of the levee. The picture was taken from toe of the levee looking towards the crown.

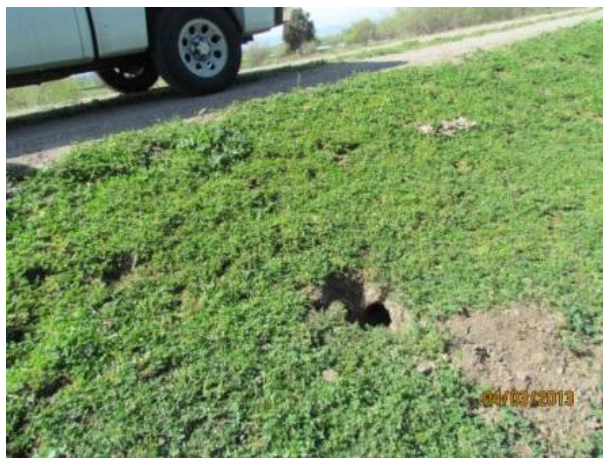
Levee Mile Report Line	37
Start Levee Mile	1.17
End Levee Mile	1.17
Location	Water Side
Category	
Item	Animal Control

A rodent hole was found on the waterside toe of the levee looking downstream.

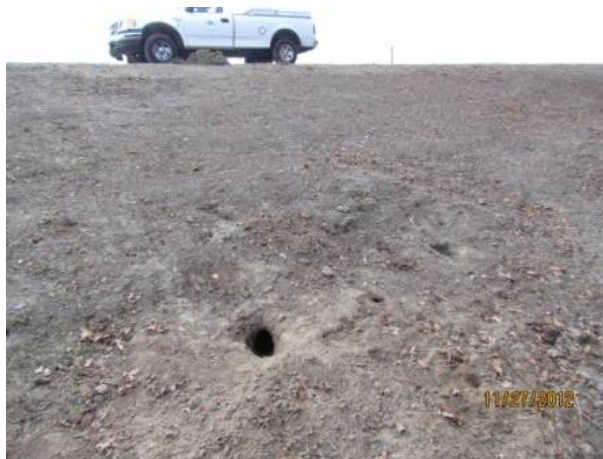
Levee Mile Report Line	38
Start Levee Mile	1.19
End Levee Mile	1.19
Location	Water Side
Category	
Item	Animal Control

A rodent hole was found on the waterside toe of the levee looking downstream.

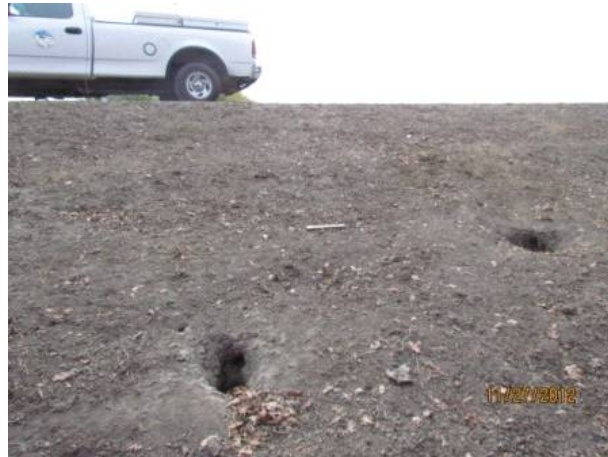
Levee Mile Report Line	40
Start Levee Mile	1.23
End Levee Mile	1.23
Location	Water Side
Category	
Item	Animal Control
Rodent holes were found on the waterside toe of the levee looking downstream.	
pkazi_s_20130404_815.jpg

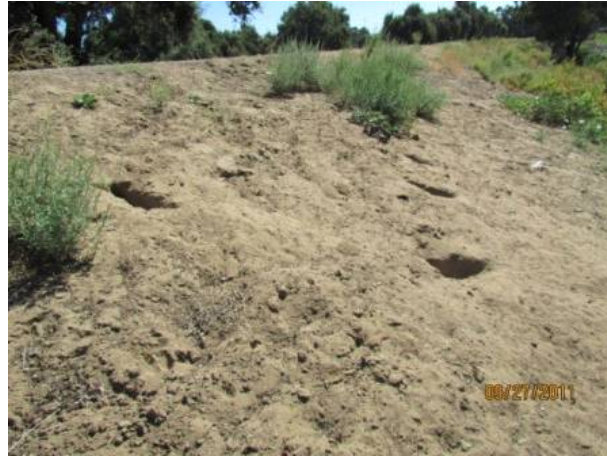
Levee Mile Report Line	44
Start Levee Mile	1.68
End Levee Mile	1.68
Location	Water Side
Category	
Item	Animal Control

Rodent holes were found on the waterside toe of the levee looking upstream.

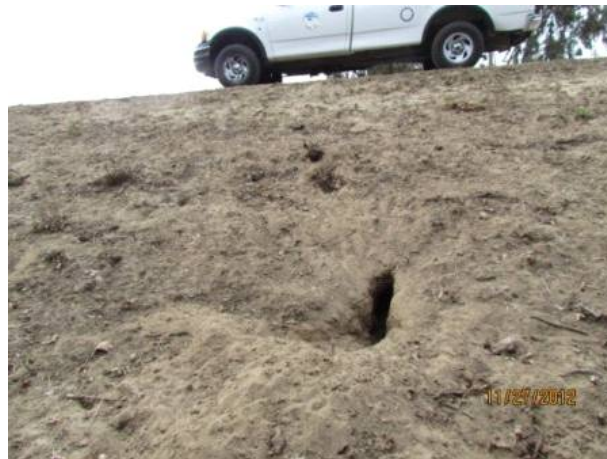
Levee Mile Report Line	45
Start Levee Mile	1.69
End Levee Mile	1.69
Location	Water Side
Category	
Item	Animal Control

A rodent hole was found on the waterside toe of the levee looking downstream.

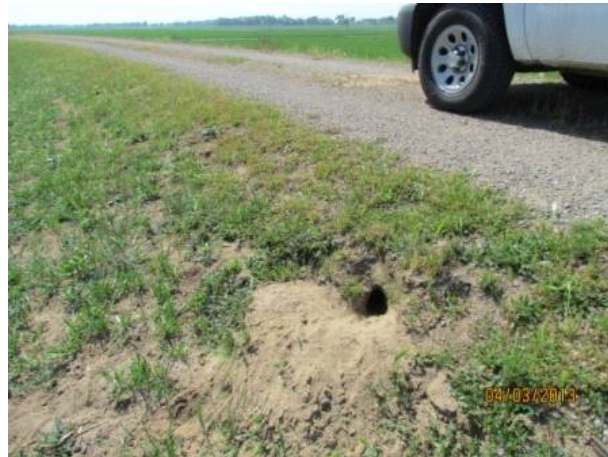
Levee Mile Report Line	51
Start Levee Mile	2.11
End Levee Mile	2.11
Location	Water Side
Category	
Item	Animal Control
A rodent hole was found on the waterside shoulder of the levee looking upstream.	
pkazi_s_20130405_848.JPG

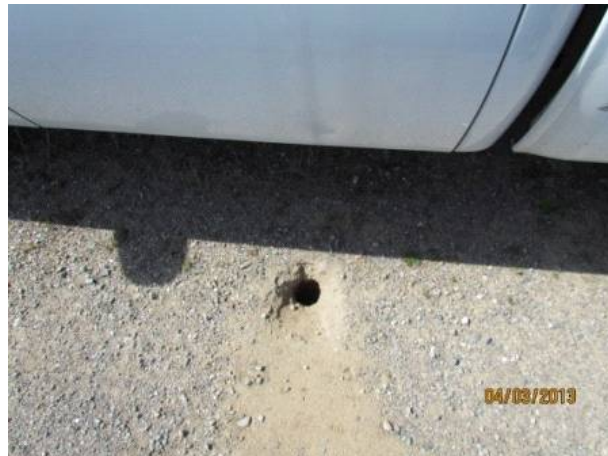
Levee Mile Report Line	52
Start Levee Mile	2.12
End Levee Mile	2.12
Location	Crown
Category	
Item	Animal Control
A rodent hole was found on the crown of the levee during spring 2013 inspection.	
pkazi_s_20130405_849.JPG

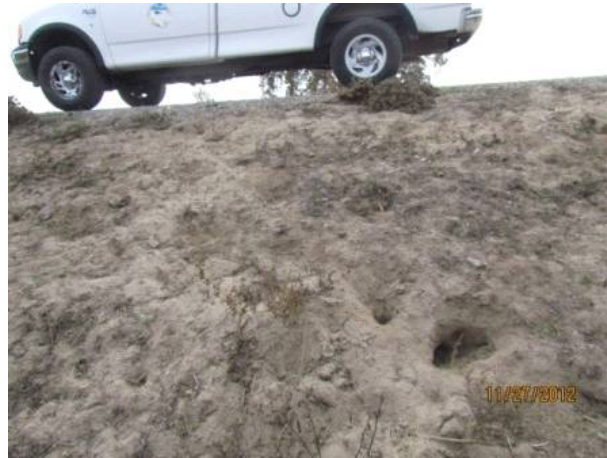
Levee Mile Report Line	53
Start Levee Mile	2.18
End Levee Mile	2.18
Location	Water Side
Category	
Item	Animal Control
Rodent holes were found on the waterside toe of the levee looking upstream.	
pkazi_s_20130404_809.jpg

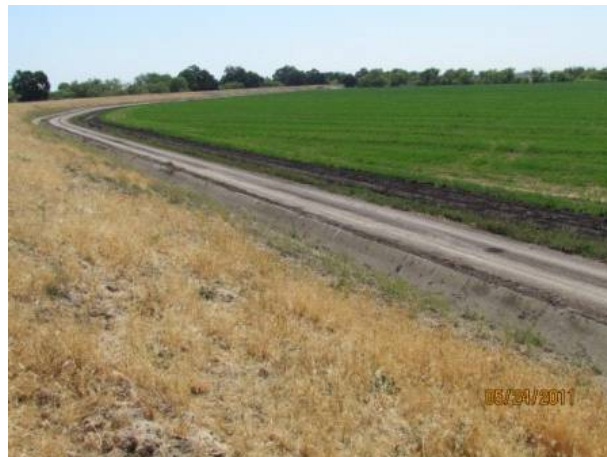
Levee Mile Report Line	54
Start Levee Mile	2.24
End Levee Mile	3.45
Location	Land Side
Category	
Item	Encroachments
Concrete drain was built at the toe of the levee. The picture was taken from the crown looking upstream.	
pkazi_s_20130404_788.jpg

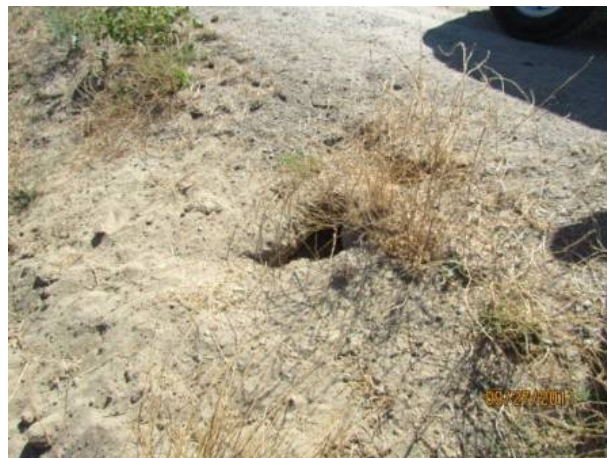
Levee Mile Report Line	55
Start Levee Mile	2.49
End Levee Mile	2.49
Location	Water Side
Category	
Item	Animal Control
Animal burrow was found on the waterside of the levee. The picture was taken from the toe of the levee looking upstream.	
pkazi_s_20130404_778.jpg

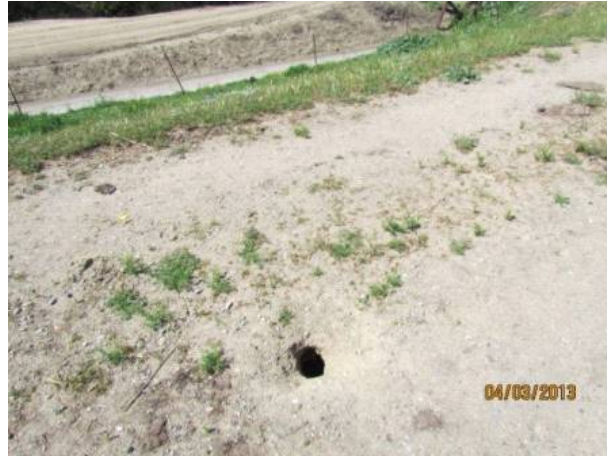
Levee Mile Report Line	56
Start Levee Mile	2.59
End Levee Mile	2.59
Location	Crown
Category	
Item	Animal Control
A rodent hole was found on the crown of the levee looking downstream.	
pkazi_s_20130405_850.JPG

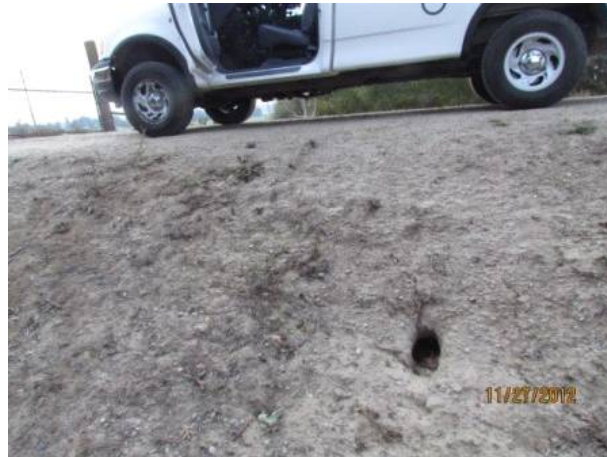
Levee Mile Report Line	57
Start Levee Mile	2.60
End Levee Mile	2.60
Location	Water Side
Category	
Item	Animal Control
A rodent hole was found on the waterside slope of the levee looking upstream.	
pkazi_s_20130404_810.jpg

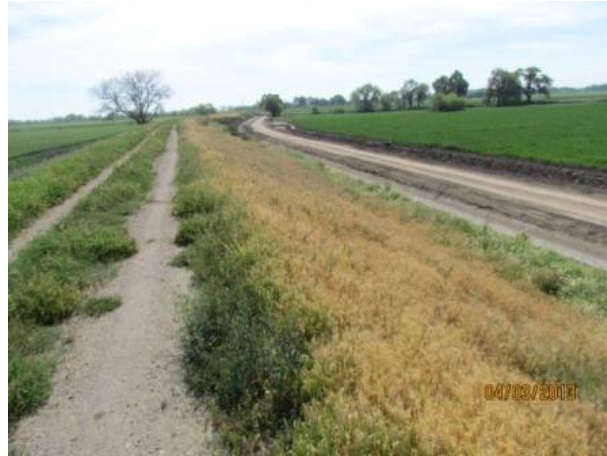
Levee Mile Report Line	58
Start Levee Mile	2.61
End Levee Mile	3.13
Location	Land Side
Category	
Item	Vegetation
Dense vegetation was found on the landside slope of the levee looking upstream.	
pkazi_s_20130405_851.JPG

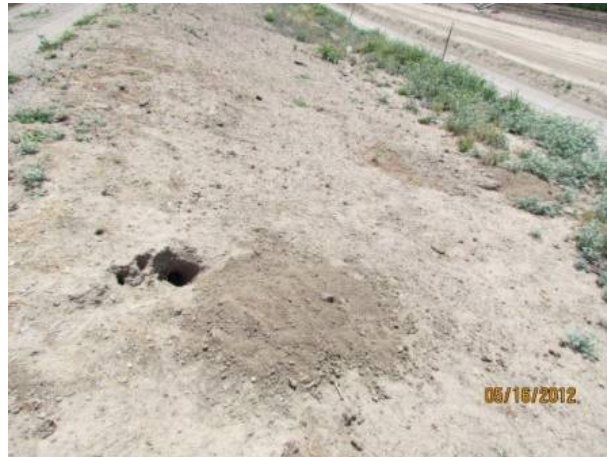
Levee Mile Report Line	60
Start Levee Mile	2.65
End Levee Mile	2.65
Location	Land Side
Category	
Item	Animal Control
Animal holes were found on the landside of the levee looking upstream.	
pkazi_s_20130404_811.jpg

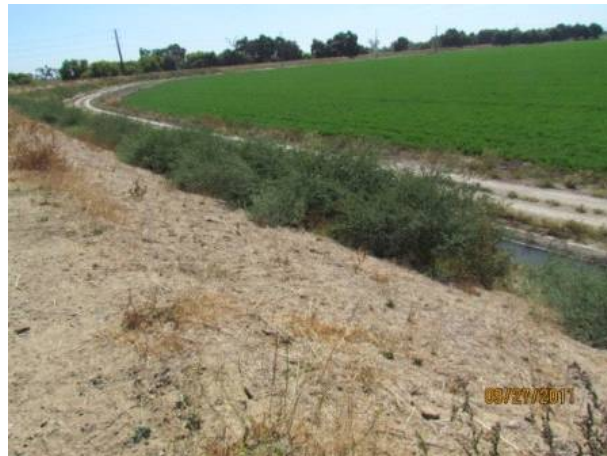
Levee Mile Report Line	62
Start Levee Mile	3.13
End Levee Mile	3.32
Location	Land Side
Category	
Item	Vegetation
Wild growth was found on the toe of the landside of the levee. The picture was taken from crown looking upstream.	
pkazi_s_20130404_780.jpg

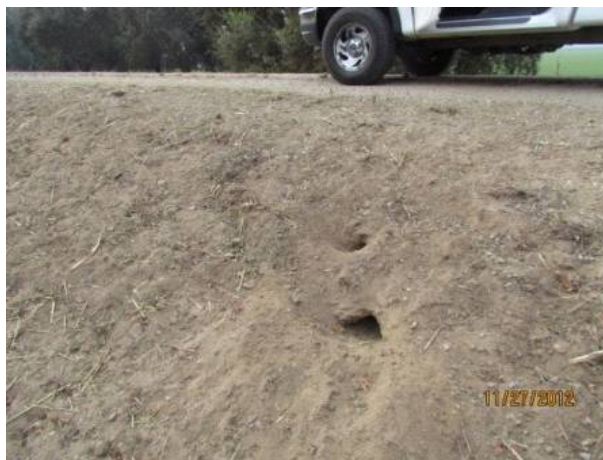
Levee Mile Report Line	64
Start Levee Mile	3.47
End Levee Mile	3.47
Location	Water Side
Category	
Item	Animal Control
Rodent holes were found on the waterside slope of the levee looking upstream.	
pkazi_s_20130404_812.jpg

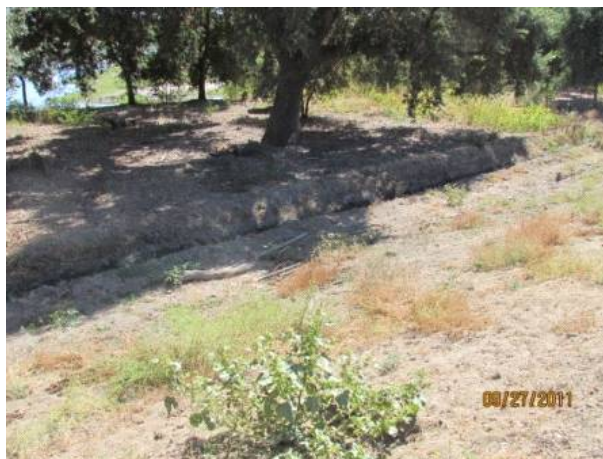
Levee Mile Report Line	65
Start Levee Mile	3.49
End Levee Mile	3.56
Location	Water Side
Category	
Item	Encroachments
A ditch was located on the waterside toe of the levee. The picture was taken from the crown looking upstream.	
pkazi_s_20130404_781.jpg

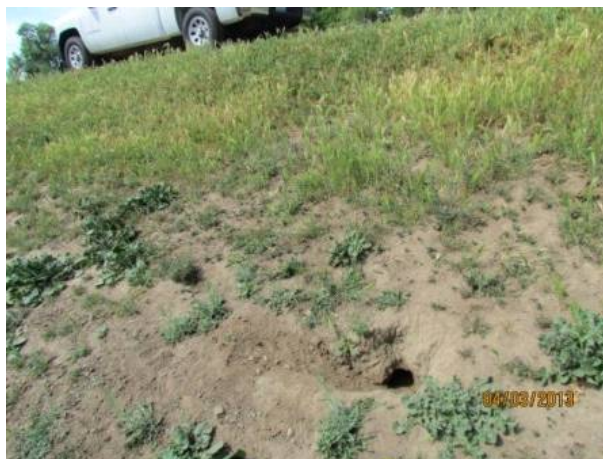
Levee Mile Report Line	69
Start Levee Mile	3.67
End Levee Mile	3.67
Location	Water Side
Category	
Item	Animal Control

A rodent hole was found on the waterside toe of the levee looking downstream.

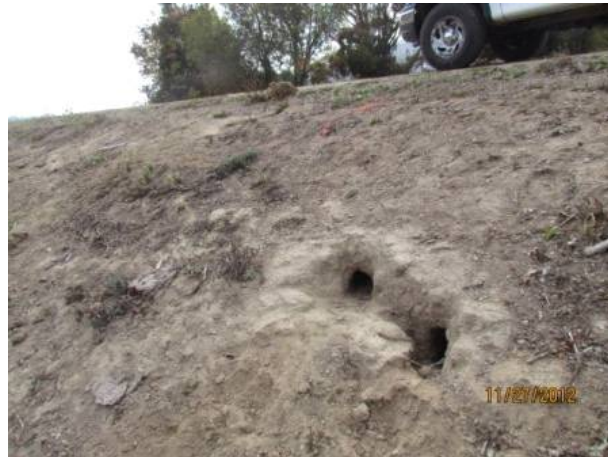
Levee Mile Report Line	73
Start Levee Mile	3.91
End Levee Mile	3.91
Location	Water Side
Category	
Item	Animal Control
Rodent holes were found on the waterside toe of the levee looking upstream.	
pkazi_s_20130404_813.jpg

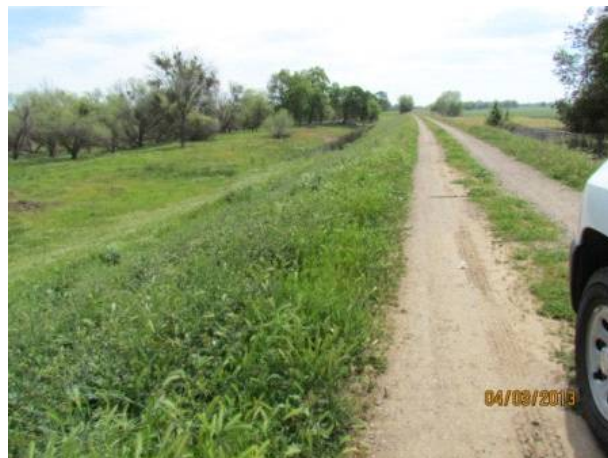
Levee Mile Report Line	74
Start Levee Mile	3.92
End Levee Mile	5.50
Location	Water Side
Category	
Item	Vegetation
Vegetation was found on the waterside slope of the levee looking upstream.	
pkazi_s_20130405_854.JPG

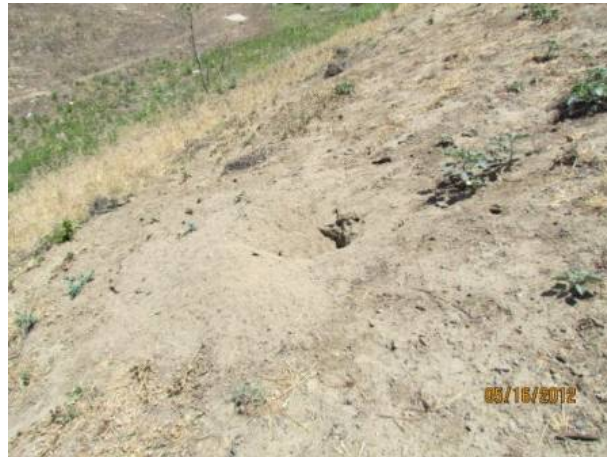
Levee Mile Report Line	78
Start Levee Mile	4.00
End Levee Mile	4.00
Location	Water Side
Category	
Item	Animal Control
A rodent hole was found on the waterside of the levee looking upstream.	
pkazi_s_20130404_814.jpg

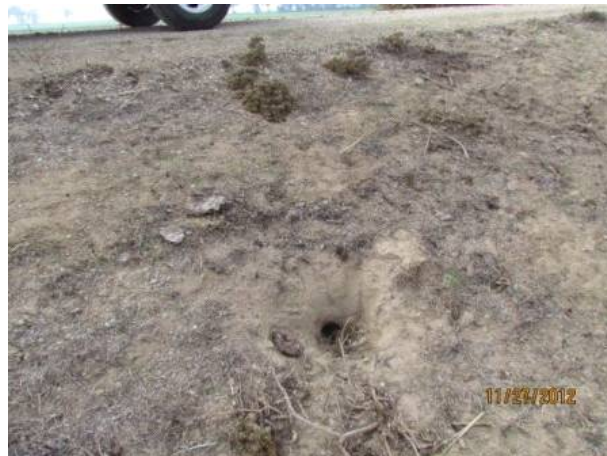
Levee Mile Report Line	79
Start Levee Mile	4.11
End Levee Mile	4.11
Location	Water Side
Category	
Item	Animal Control
A rodent hole was found on the waterside toe of the levee looking downstream.	
pkazi_s_20130404_782.jpg
