**Flood Control Project Maintenance  
Levee Inspections**  
**LMA District Cover Sheet**  
**Spring 2014 Levee Inspection Results**

**Reclamation District No. 1602 Del Puerto**

**Spring 2014 Levee Inspection Results**

Waterway	Bank	Unit Miles
Unit No. 01 San Joaquin River	Left	6.29

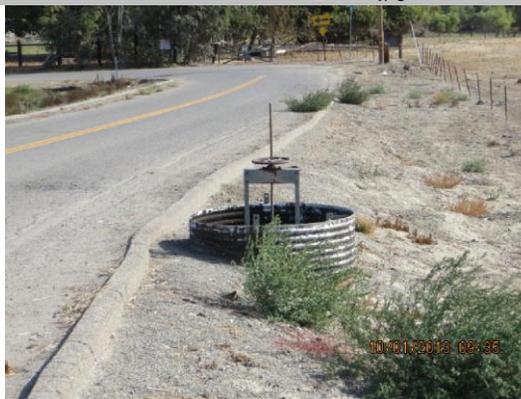
Photo 1 of 1 : UCIP\_2622.jpg

LM Start	<b>0.58</b>	Rating **	M	Issue No.	<b>159</b>
LM End	<b>0.58</b>	Issue Type +	En	Location *	WS
Category	Supplemental		GPS Latitude/Longitude		
			Start	End	
Item	DWR UCIP Field Study		37.480182 °	37.480182 °	
			-121.074765 °	-121.074765 °	
DWR ID	DWR_RD1602_01_s_2014_159				
Action/Comments					
Inspector Comments: FS_ID:21623 EP_NO: N/A Repair Type: Crossing Status: UCIP Comments: Open 60-inch CMP riser on WS needs lid as it's depth may be a hazard to the public. FIELD_STRUCT_DESC: 16-inch pipe through levee 11.3 feet below crown. Slide gate in 60-inch corrugated metal pipe riser on the waterward side. Concrete inlet 110-feet west of the levee crown. Originally included in 1964 O&M manual. FS Date: 10/1/2013 7:57:22 AM

60-inch CMP riser on WS shoulder.

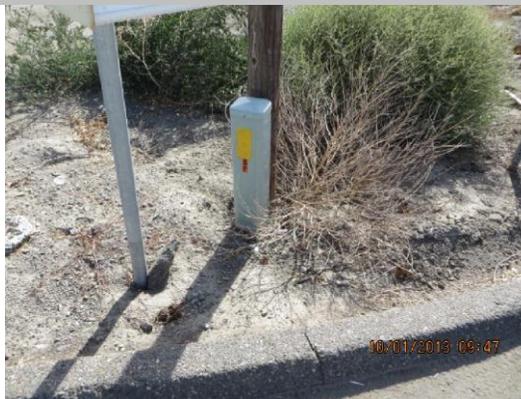
Photo 1 of 1 : UCIP\_3271.jpg

LM Start	<b>0.58</b>	Rating **	M	Issue No.	<b>160</b>
LM End	<b>0.58</b>	Issue Type +	En	Location *	WS
Category	Supplemental		GPS Latitude/Longitude		
			Start	End	
Item	DWR UCIP Field Study		37.480176 °	37.480176 °	
			-121.074736 °	-121.074736 °	
DWR ID	DWR_RD1602_01_s_2014_160				
Action/Comments					
Inspector Comments: FS_ID:22937 EP_NO: N/A Repair Type: Crossing Status: UCIP Comments: No permit identified for this crossing. FIELD_STRUCT_DESC: Communication line through the levee at an unknown depth. FS Date: 10/1/2013

Communication line access box on LS shoulder.

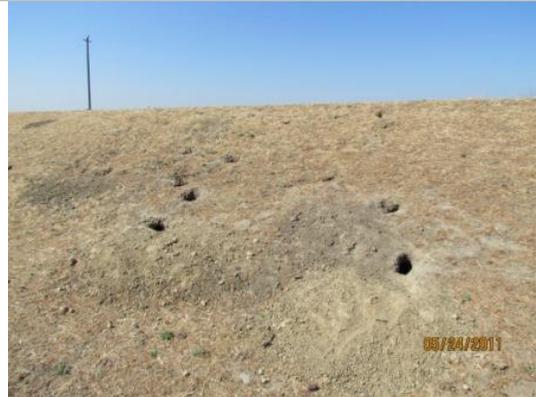
Photo 1 of 2 : pkazi\_s\_20140415\_639.jpg

Rodent holes were found on the waterside of the levee. The picture was taken from the toe of the waterside of the levee looking upstream.

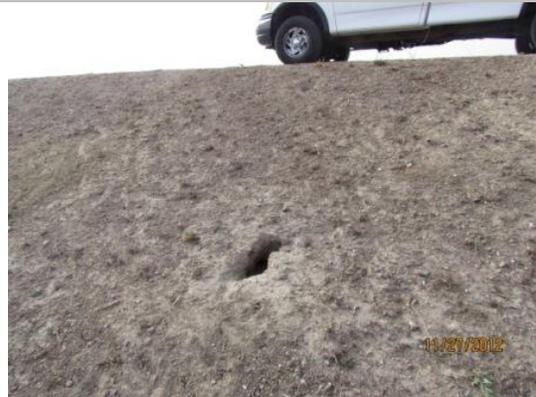
Photo 2 of 2 : pkazi\_s\_20140415\_640.jpg

A rodent hole was found on the waterside slope looking from the toe of the levee.

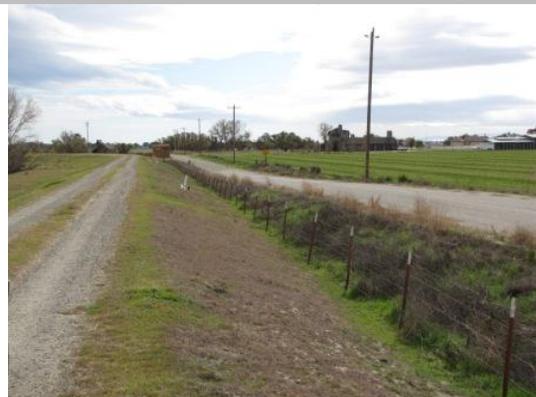
Photo 1 of 1 : pkazi\_s\_20140415\_719.jpg

LM Start	<b>0.60</b>	Rating **	M	Issue No.	<b>70</b>
LM End	<b>0.72</b>	Issue Type +	En	Location *	WS
Category	Earthen Levee		GPS Latitude/Longitude		
			Start	End	
Item	Encroachments		37.479967 °	37.478514 °	
			-121.074582 °	-121.073435 °	
DWR ID	DWR_RD1602_01_s_2012_70				
Action/Comments					
Fence

View of barbed wire fence at landward toe looking upstream.

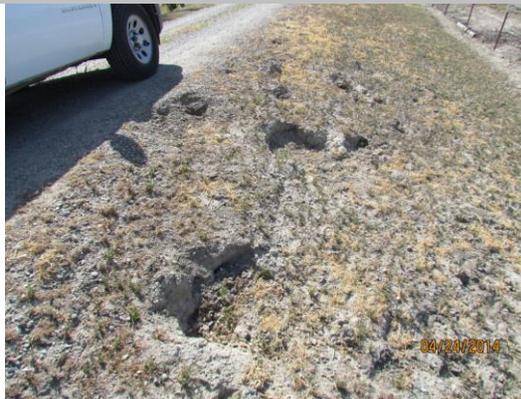
Photo 1 of 1 : pkazi\_s\_20140428\_910.jpg

The rodent holes were filled with material on the landside shoulder of the levee looking upstream.

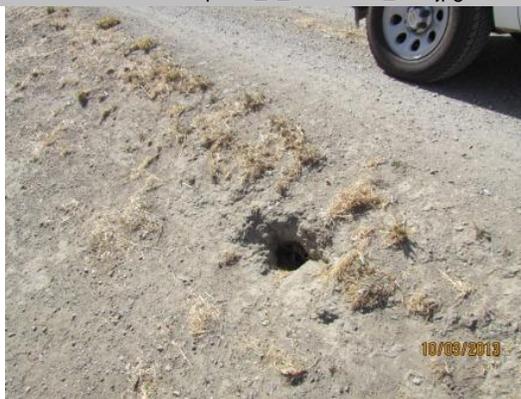
Photo 2 of 2 : pkazi\_s\_20140415\_674.jpg

An animal hole was found on the waterside shoulder of the levee looking upstream.

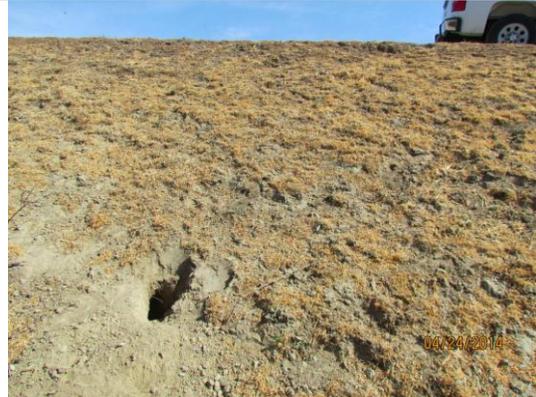
Photo 1 of 1 : pkazi\_s\_20140428\_912.jpg

A rodent hole was found on the landside toe of the levee looking upstream.

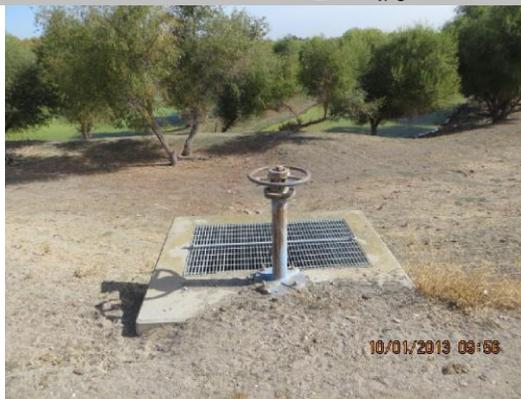
Photo 1 of 1 : UCIP\_2629.jpg

LM Start	<b>0.78</b>	Rating **	M	Issue No.	<b>161</b>
LM End	<b>0.78</b>	Issue Type +	En	Location *	LS
Category	Supplemental		GPS Latitude/Longitude		
			Start	End	
Item	DWR UCIP Field Study		37.477992 °	37.477992 °	
			-121.072645 °	-121.072645 °	
DWR ID	DWR_RD1602_01_s_2014_161				
Action/Comments					
Inspector Comments: FS_ID:21629 EP_NO: N/A Repair Type: Crossing Status: UCIP Comments: Flap gate blocked from functioning by soil buildup on WS toe. Soil should be cleared. FIELD_STRUCT_DESC: 30-inch square reinforced concrete box culvert through levee 14.4 feet below crown. Concrete "U" headwall on both ends. Slide gate in 6'X7' concrete surge box on the waterward shoulder. Flap gate on the waterward end. Originally included in 1964 O&M manual. FS Date: 10/1/2013

Slide gate in concrete box on WS shoulder.

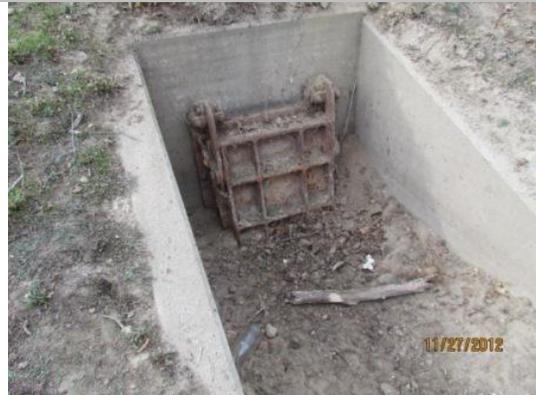
Photo 3 of 4 : pkazi\_s\_20140415\_722.jpg

Debris and sediments were obstructing the flap gate from closing completely. The picture was taken from toe of waterside of the levee during the fall 2012 inspection.

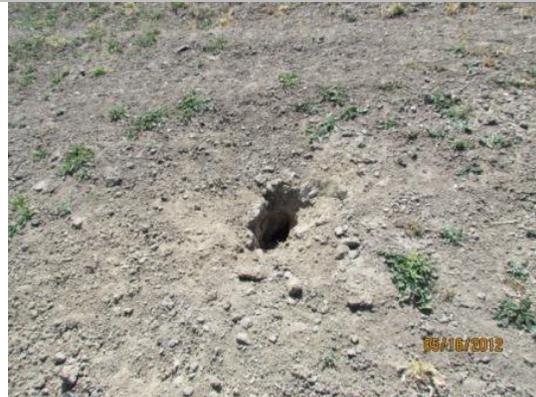
Photo 1 of 2 : pkazi\_s\_20140415\_707.jpg

A rodent hole was found on the waterside of the levee looking upstream.

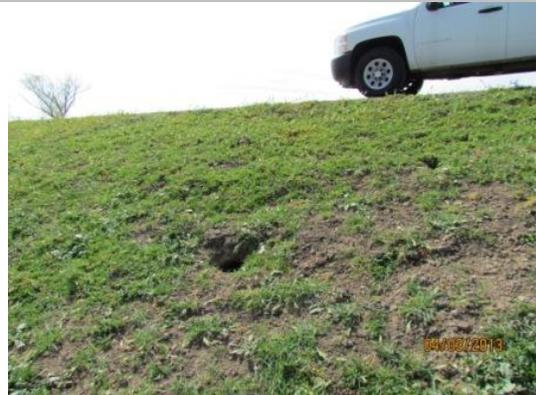
Photo 2 of 2 : pkazi\_s\_20140415\_708.jpg

Updated picture of the rodent hole on the waterside slope of the levee looking upstream during spring spring 2013 inspection.

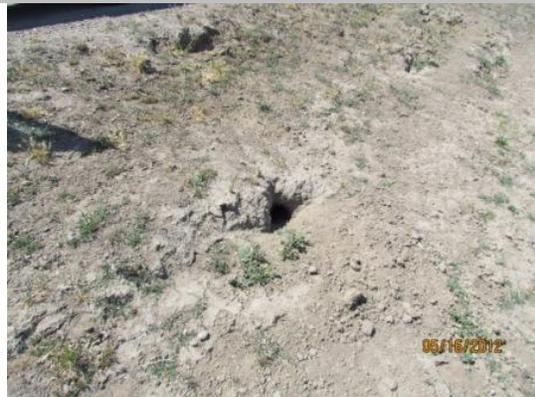
Photo 3 of 3 : pkazi\_s\_20140415\_726.jpg

A rodent hole was found on the waterside of the levee looking downstream.

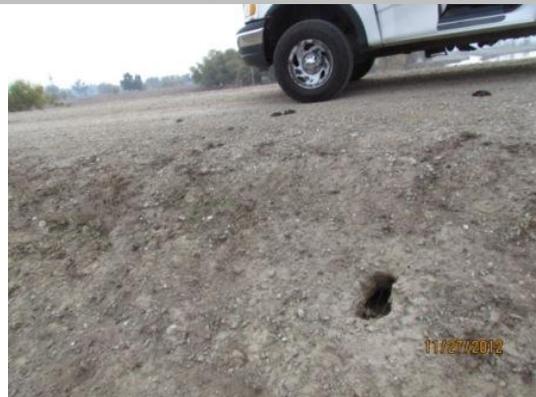
Photo 2 of 2 : pkazi\_s\_20140415\_695.jpg

A rodent hole was found on the waterside slope of the levee looking upstream.

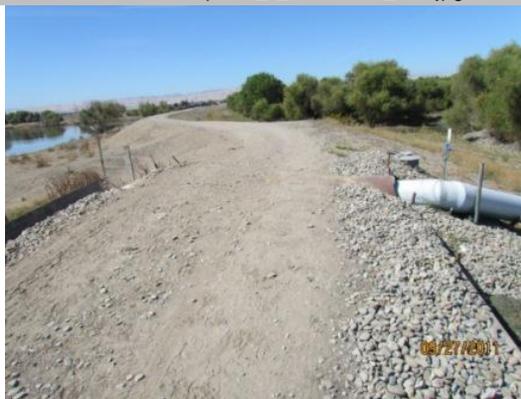
Photo 1 of 1 : pkazi\_s\_20140415\_683.jpg

View of the ramp on the crown. The picture was taken from crown looking downstream.

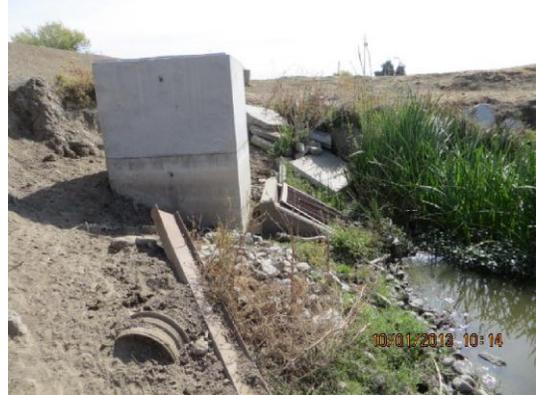
Photo 1 of 1 : UCIP\_2678.jpg

Grated inlet and 5'X5' concrete box on LS toe.

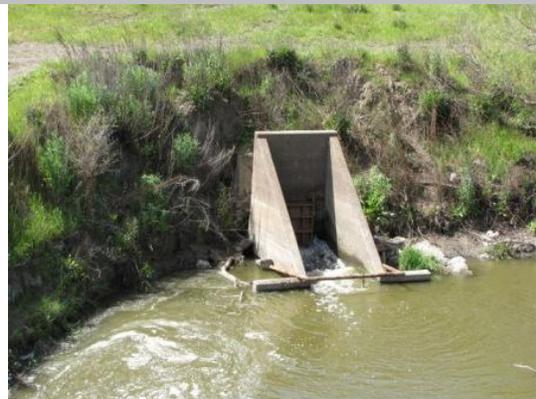
Photo 2 of 2 : pkazi\_s\_20140415\_705.jpg

LM Start	<b>1.04</b>	Rating **	M	Issue No.	<b>55</b>
LM End	<b>1.04</b>	Issue Type +	Ma	Location *	WS
Category	Interior Drainage & Piping Systems			GPS Latitude/Longitude	
				Start	End
Item	Concrete Tilting / Settlement			37.478678 °	37.478678 °
				-121.068305 °	-121.068305 °
DWR ID	DWR_RD1602_01_s_2012_55				
Action/Comments					
Inspector Comments: The outlet headwall is tilting away from the pipe rendering the existing flap gate ineffective. Repair gap between pipe and headwall and stabilize headwall to prevent further damage.

Additional view of outfall structure at LM 1.04.

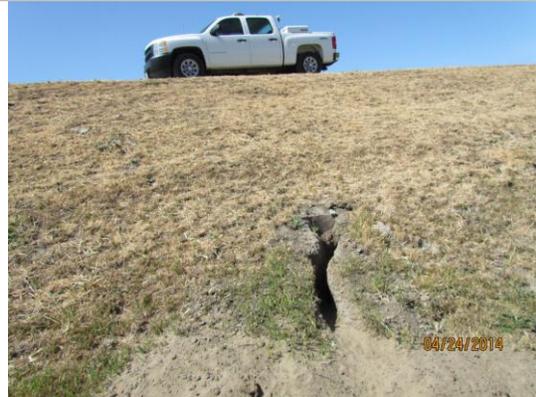
Photo 1 of 1 : pkazi\_s\_20140428\_915.jpg

A rodent hole was found on the waterside toe of the levee.

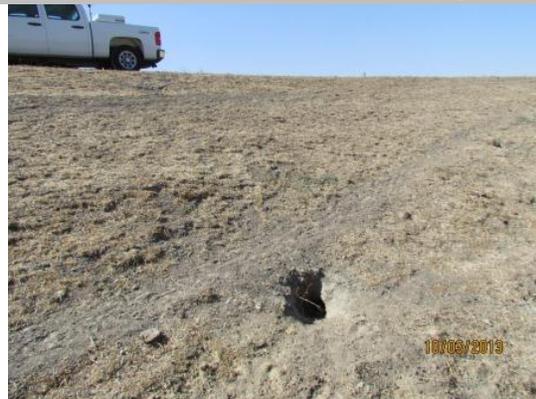
Photo 1 of 1 : pkazi\_s\_20140415\_675.jpg

A rodent hole was found on the waterside toe of the levee looking downstream.

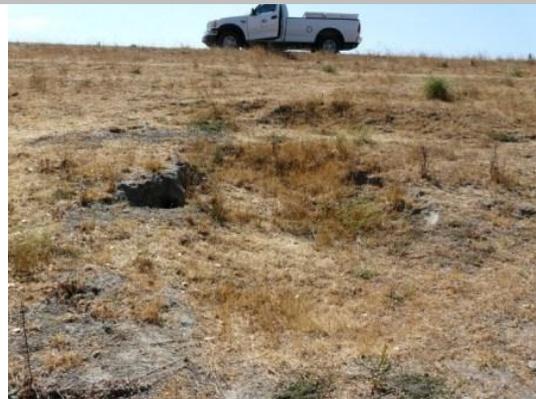
Photo 1 of 3 : pkazi\_s\_20140415\_684.jpg

LM Start	<b>1.07</b>	Rating **	M	Issue No.	<b>37</b>
LM End	<b>1.07</b>	Issue Type +	Ma	Location *	WS
Category	Earthen Levee		GPS Latitude/Longitude		
			Start	End	
Item	Slope Stability		37.478567 °	37.478567 °	
			-121.067847 °	-121.067847 °	
DWR ID	DWR_RD1602_01_s_2012_37				
Action/Comments					
Repair slope instability. Inspector Comments: Small amount of slumping at waterside toe of the levee.

Small amount of slumping at water toe.

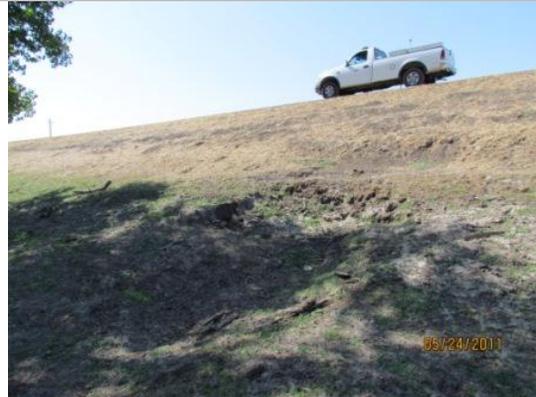
Photo 2 of 3 : pkazi\_s\_20140415\_685.jpg

LM Start	<b>1.07</b>	Rating **	M	Issue No.	<b>37 (cont)</b>
LM End	<b>1.07</b>	Issue Type +	Ma	Location *	WS
Category	Earthen Levee			GPS Latitude/Longitude	
				Start	End
Item	Slope Stability			37.478567 °	37.478567 °
				-121.067847 °	-121.067847 °
DWR ID	DWR_RD1602_01_s_2012_37				
Action/Comments					
Repair slope instability. Inspector Comments: Small amount of slumping at waterside toe of the levee.

Depression at the waterside slope of the levee during Spring 2011 inspection.

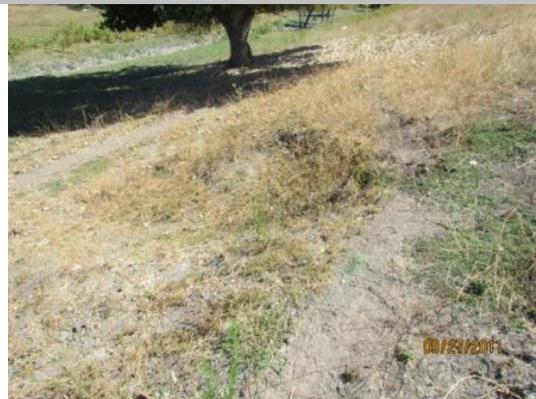
Photo 3 of 3 : pkazi\_s\_20140415\_686.jpg

Updated picture of the depression at the waterside toe of the levee. The picture was taken from the crown of the levee looking upstream.

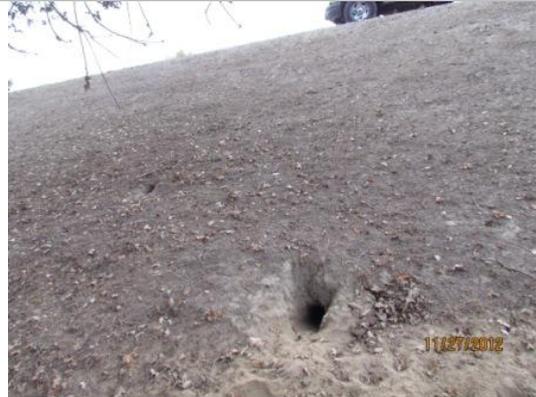
Photo 1 of 1 : pkazi\_s\_20140415\_706.jpg

A rodent hole was found on the waterside toe of the levee looking upstream.

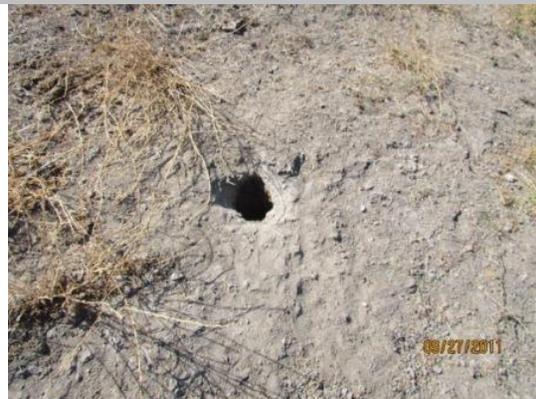
Photo 1 of 1 : pkazi\_s\_20140415\_641.jpg

Animal burrow was found on the landside of the levee. The picture was taken from the toe of the levee looking upstream.

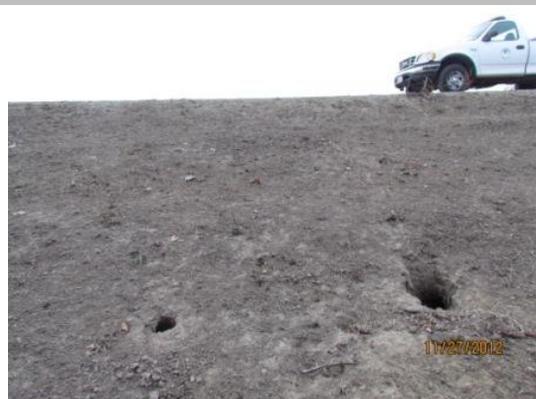
Photo 1 of 2 : pkazi\_s\_20140415\_714.jpg

Rodent holes were found on the waterside toe of the levee. The picture was taken from toe of the levee looking towards the crown.

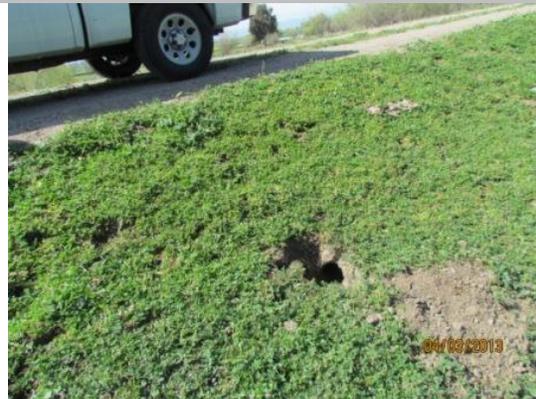
Photo 1 of 1 : pkazi\_s\_20140415\_647.jpg

A rodent hole was found on the waterside shoulder of the levee looking downstream.

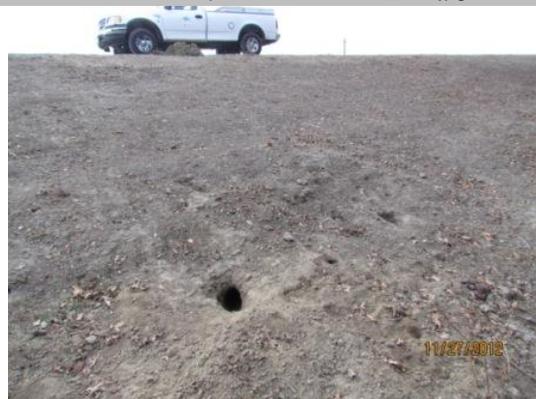
Photo 1 of 1 : pkazi\_s\_20140415\_728.jpg

A rodent hole was found on the waterside toe of the levee looking downstream.

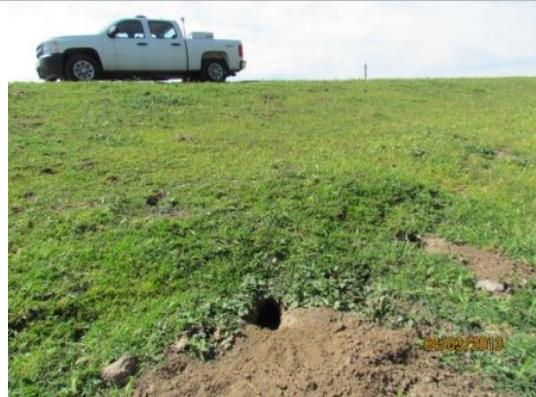
Photo 2 of 2 : pkazi\_s\_20140415\_729.jpg

A rodent hole was found on the waterside toe of the levee looking downstream.

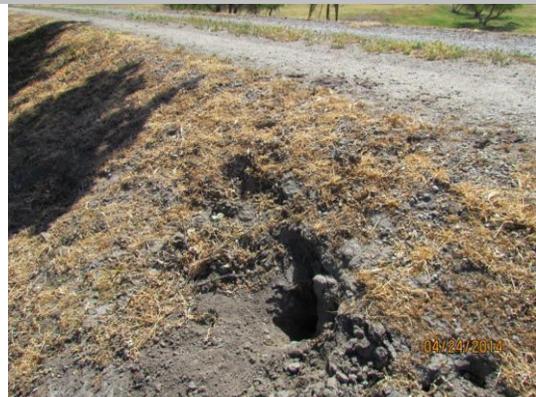
Photo 1 of 2 : pkazi\_s\_20140428\_917.jpg

Updated picture of the rodent holes on the waterside shoulder of the levee during spring 2014 inspection.

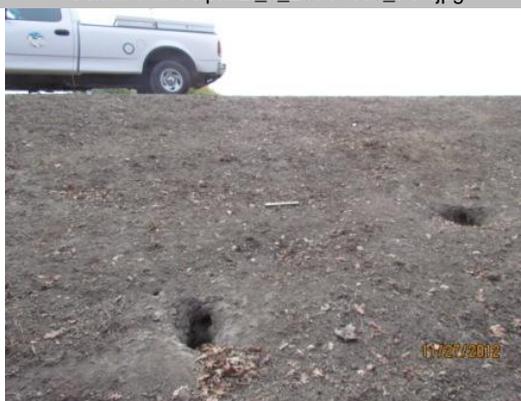
Photo 1 of 1 : pkazi\_s\_20140415\_740.jpg

Rodent holes were found on the waterside toe of the levee looking downstream.

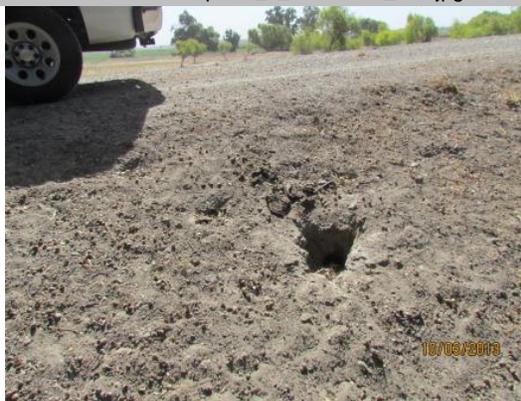
Photo 1 of 1 : pkazi\_s\_20140415\_676.jpg

A rodent hole was found on the waterside shoulder of the levee looking downstream.

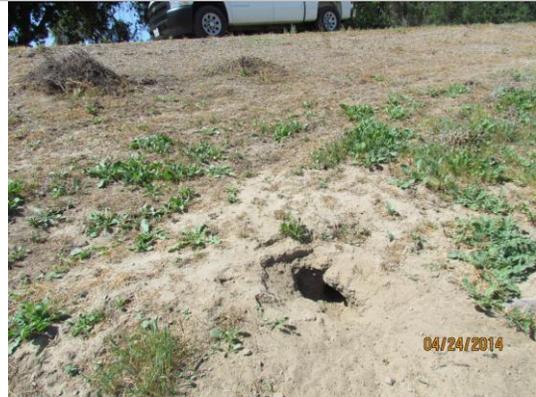
Photo 1 of 1 : pkazi\_s\_20140428\_918.jpg

A rodent hole was found on the waterside toe of the levee looking downstream.

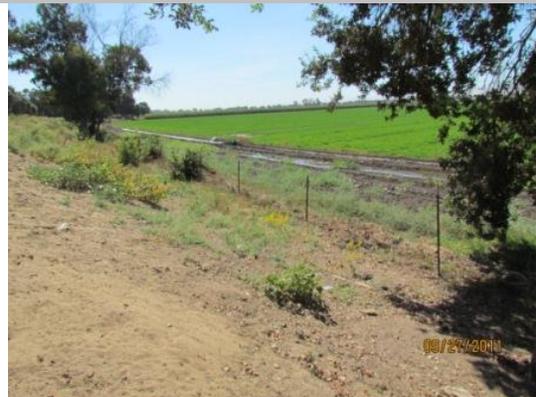
Photo 1 of 1 : pkazi\_s\_20140415\_693.jpg

View of the fence on the landside toe of the levee. The picture was taken from crown looking upstream.

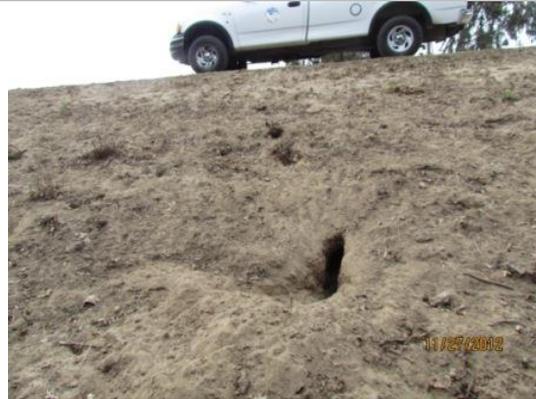
Photo 1 of 1 : pkazi\_s\_20140415\_742.jpg

Rodent holes were found on the waterside toe of the levee looking upstream.

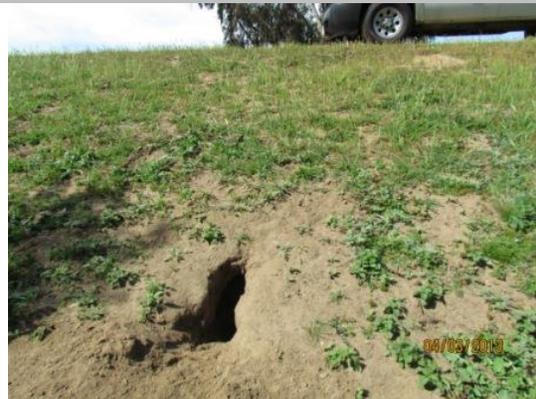
Photo 1 of 1 : pkazi\_s\_20140415\_656.jpg

A rodent hole was found on the waterside toe of the levee looking downstream.

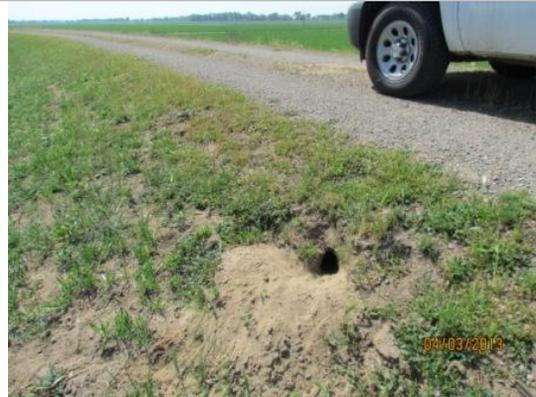
Photo 1 of 2 : pkazi\_s\_20140415\_733.jpg

A rodent hole was found on the waterside shoulder of the levee looking upstream.

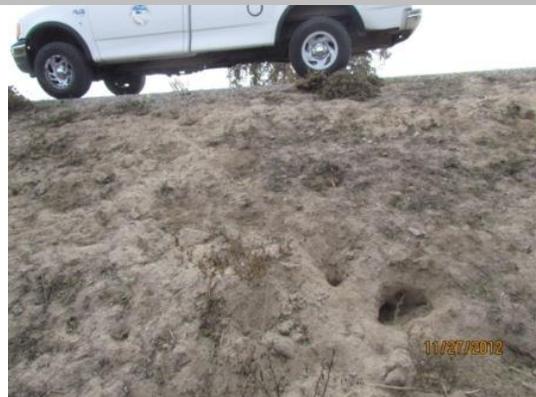
Photo 1 of 1 : pkazi\_s\_20140415\_735.jpg

Rodent holes were found on the waterside toe of the levee looking upstream.

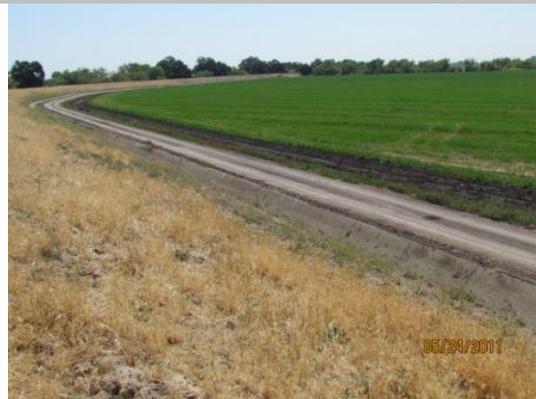
Photo 1 of 1 : pkazi\_s\_20140415\_709.jpg

Concrete drain was built at the toe of the levee. The picture was taken from the crown looking upstream.

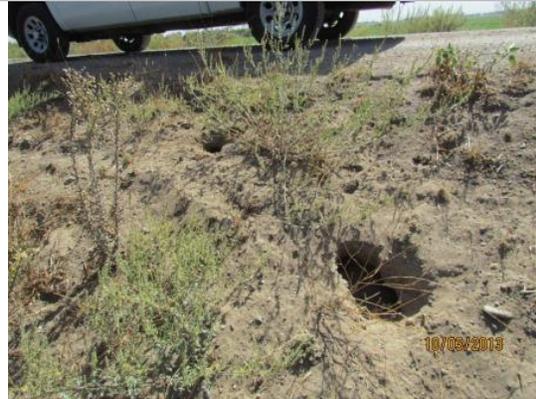
Photo 1 of 1 : pkazi\_s\_20140415\_682.jpg

Animal holes were found on the waterside shoulder of the levee looking upstream.

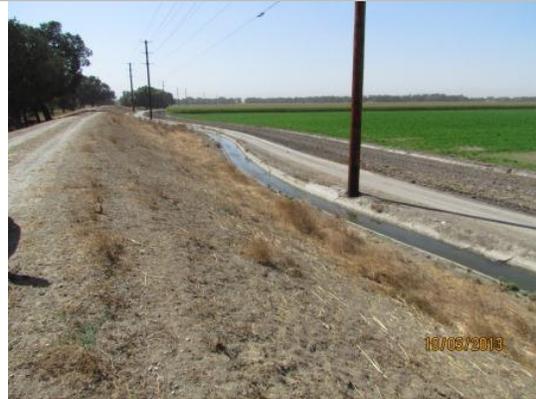
Photo 1 of 1 : pkazi\_s\_20140415\_703.jpg

A concrete lined ditch was found on the landside toe of the levee looking upstream.

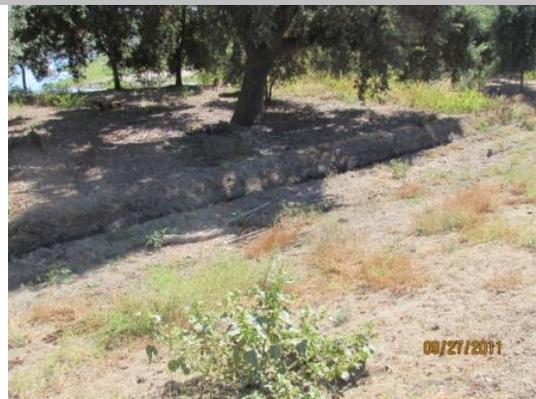
Photo 1 of 1 : pkazi\_s\_20140415\_699.jpg

A ditch was located on the waterside toe of the levee. The picture was taken from the crown looking upstream.

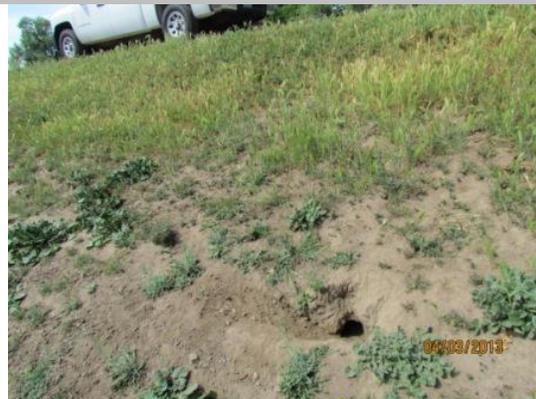
Photo 2 of 2 : pkazi\_s\_20140415\_673.jpg

A rodent hole was found on the waterside toe of the levee looking upstream.

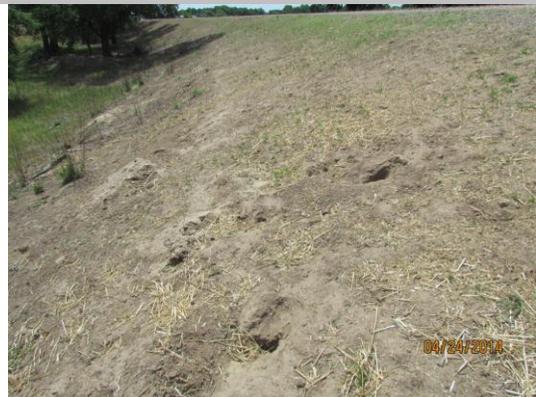
Photo 1 of 1 : pkazi\_s\_20140428\_923.jpg

View of the rodent holes on the waterside slope of the levee looking upstream.

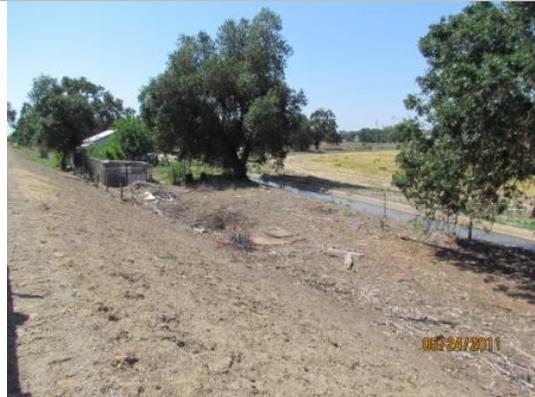
Photo 1 of 2 : pkazi\_s\_20140415\_650.jpg

Garbage was found on the landside of the levee. The picture was taken from the crown looking upstream.

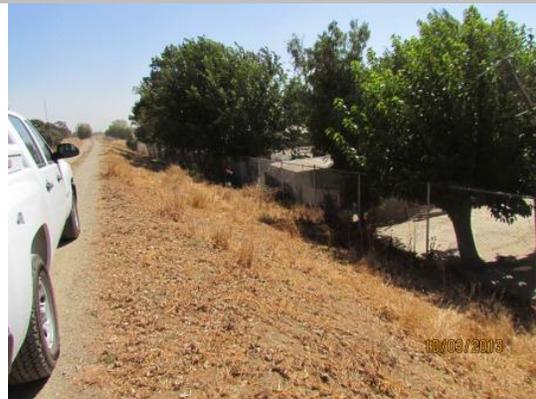
Photo 1 of 1 : pkazi\_s\_20140415\_716.jpg

Fences were found on the landside toe of the levee looking upstream.

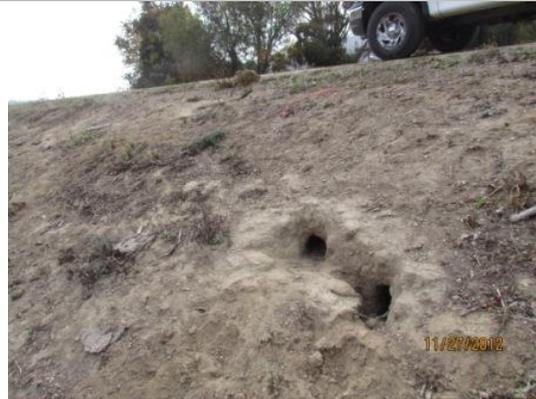
Photo 1 of 1 : pkazi\_s\_20140415\_738.jpg

Rodent holes were found on the waterside toe of the levee looking upstream.

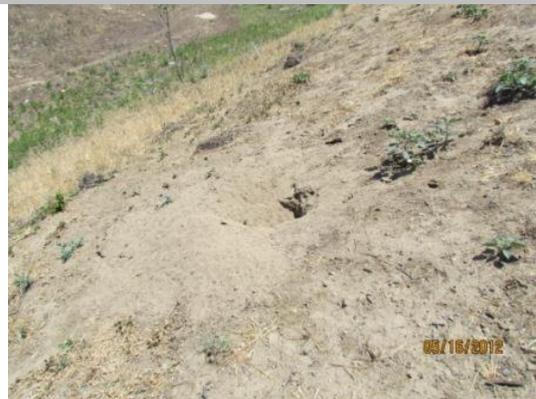
Photo 1 of 1 : pkazi\_s\_20140415\_739.jpg

A rodent hole was found on the waterside of the levee looking upstream.

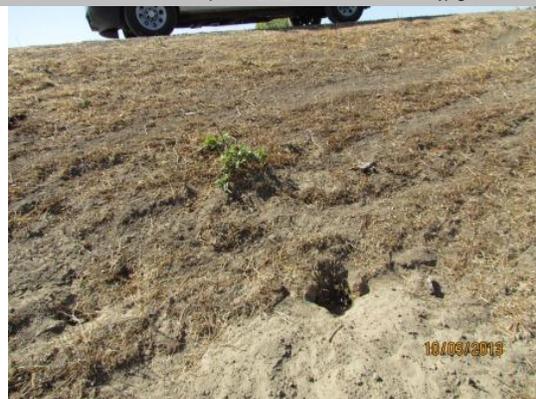
Photo 1 of 1 : pkazi\_s\_20140415\_718.jpg

A rodent hole was found on the waterside toe of the levee looking downstream.

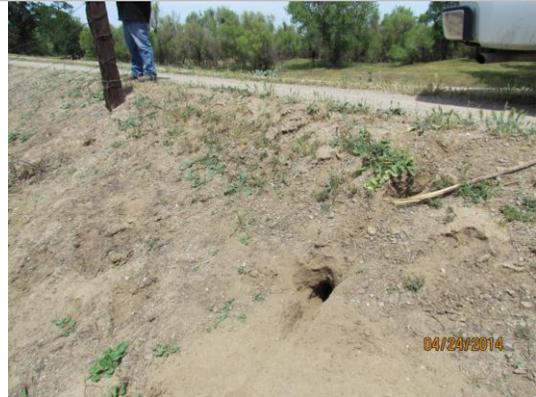
Photo 1 of 1 : pkazi\_s\_20140428\_926.jpg

A rodent hole was found on the waterside shoulder of the levee looking upstream.

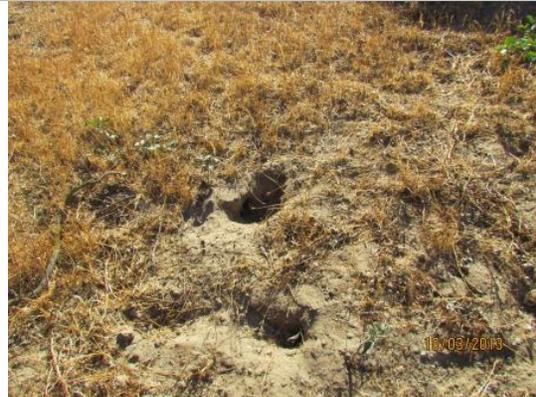
Photo 1 of 1 : pkazi\_s\_20140415\_702.jpg

Rodent holes were found on the waterside slope of the levee looking upstream.

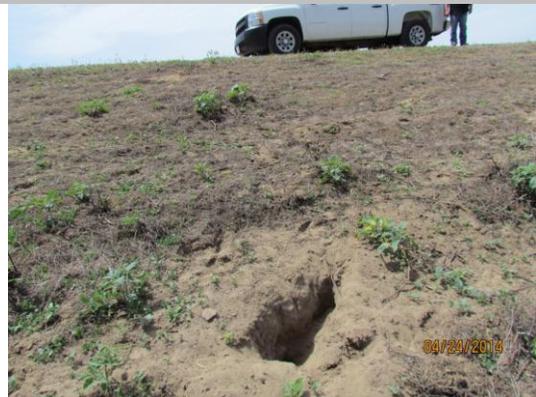
Photo 1 of 1 : pkazi\_s\_20140428\_927.jpg

A rodent hole was found on the waterside toe of the levee looking downstream.

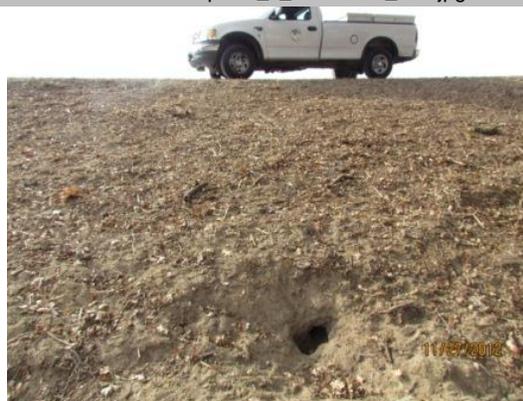
Photo 1 of 1 : pkazi\_s\_20140415\_701.jpg

A rodent hole was found on the waterside toe of the levee looking downstream.

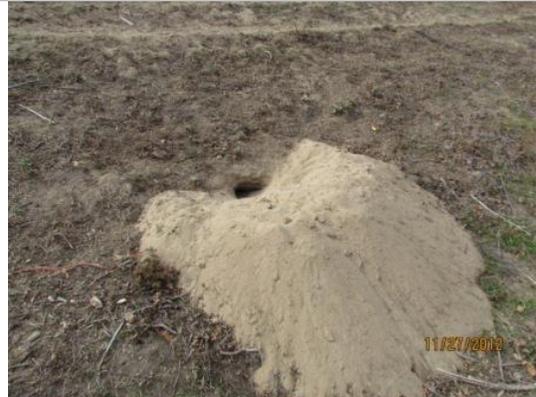
Photo 1 of 2 : pkazi\_s\_20140415\_748.jpg

A rodent hole was found on the waterside toe of the levee looking downstream.

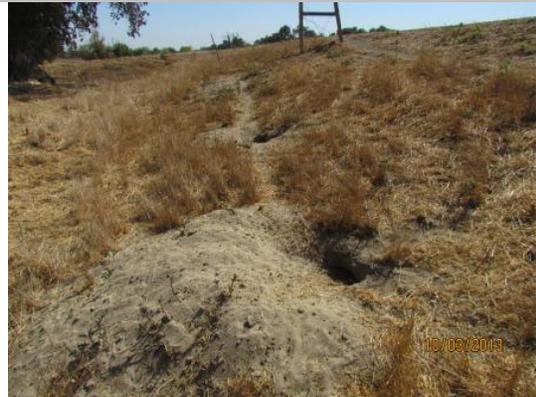
Photo 2 of 2 : pkazi\_s\_20140415\_749.jpg

Updated pictures of rodent holes were found on the waterside toe of the levee looking upstream.

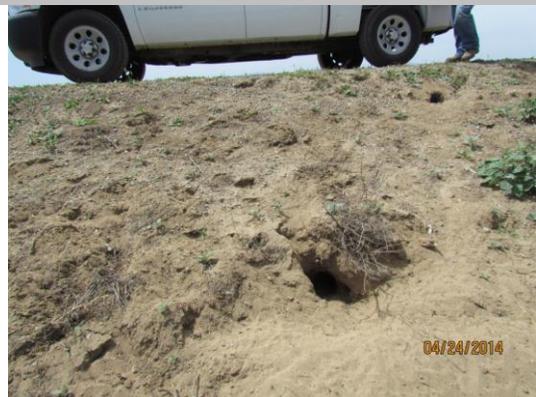
Photo 1 of 1 : pkazi\_s\_20140428\_928.jpg

A rodent hole was found on the waterside shoulder of the levee looking downstream.

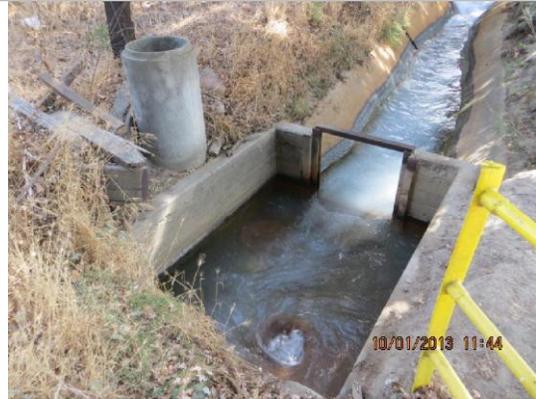
Photo 1 of 1 : UCIP\_2696.jpg

Concrete ditch at outlet from pipe on LS toe.

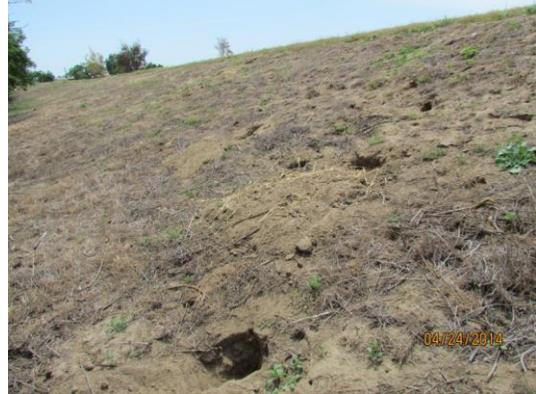
Photo 1 of 1 : pkazi\_s\_20140428\_930.jpg

Few rodent holes were found on the waterside toe of the levee looking upstream.

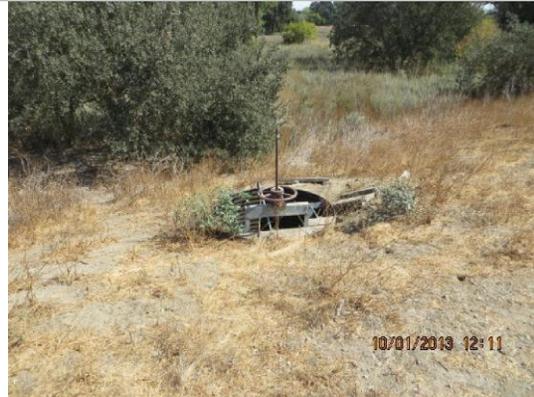
Photo 1 of 1 : UCIP\_2701.jpg

Slide gate in CMP riser on WS slope. Outlet visible under tree in background.

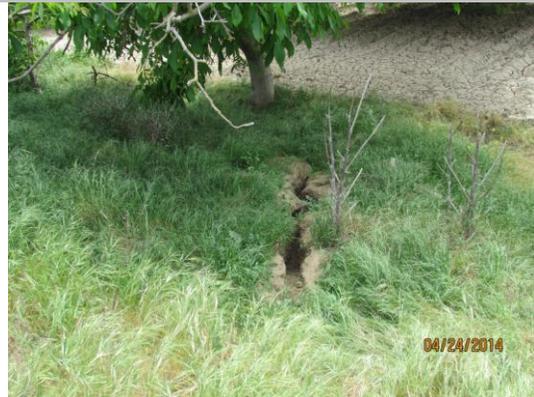
Photo 1 of 1 : pkazi\_s\_20140428\_931.jpg

Erosion was found on the landside slope of the levee looking upstream.

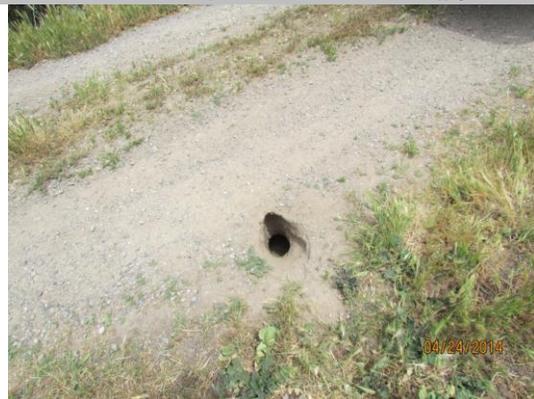
Photo 1 of 1 : pkazi\_s\_20140428\_932.jpg

A rodent hole was found on the crown of the levee looking upstream.

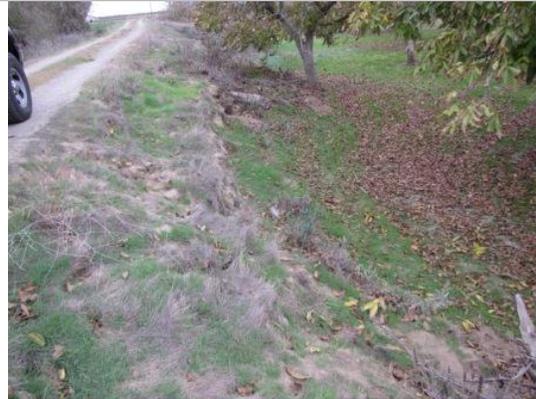
Photo 1 of 1 : pkazi\_s\_20140415\_741.jpg

View of significant damage and erosion to the landward slope looking upstream.

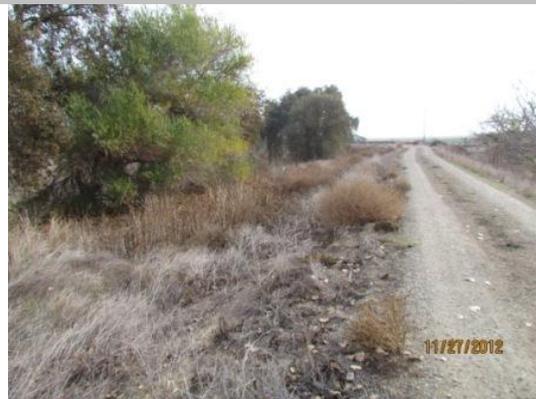
Photo 1 of 2 : pkazi\_s\_20140415\_724.jpg

Overgrown vegetation was found on the waterside slope of the levee looking upstream.

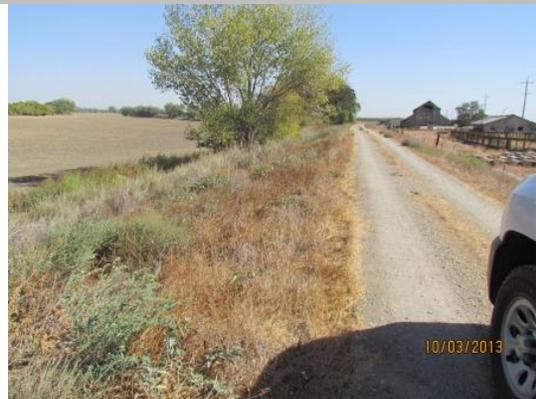
Photo 2 of 2 : pkazi\_s\_20140415\_725.jpg

Vegetation was found on the waterside slope of the levee looking upstream during fall 2013 inspection.

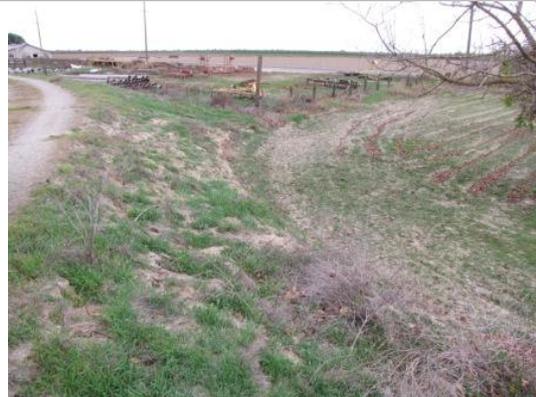
Photo 1 of 1 : pkazi\_s\_20140415\_743.jpg

View of tilling into the landward slope of the levee looking upstream. This slope has also been significantly damaged by rodent activity.

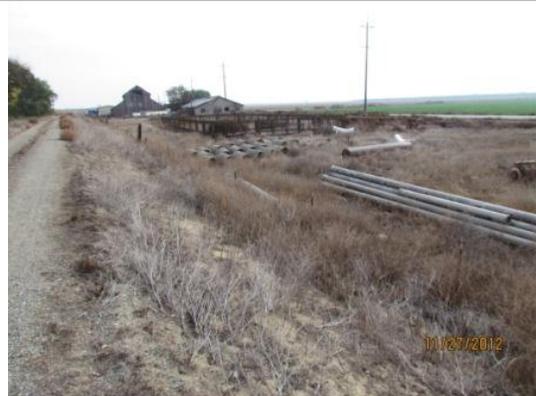
Photo 1 of 1 : pkazi\_s\_20140415\_663.jpg

A fence was found on the landside toe of the levee looking upstream.

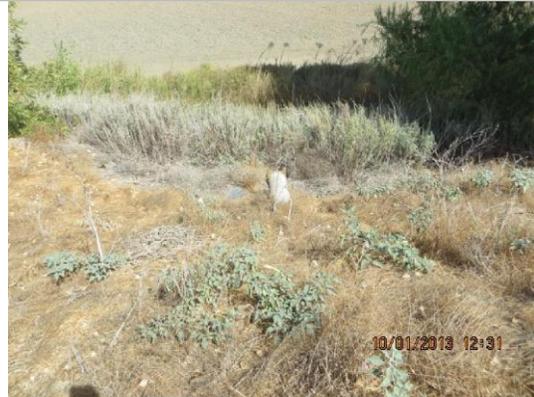
Photo 1 of 1 : UCIP\_2715.jpg

Pipe and flapgate visible on WS toe.

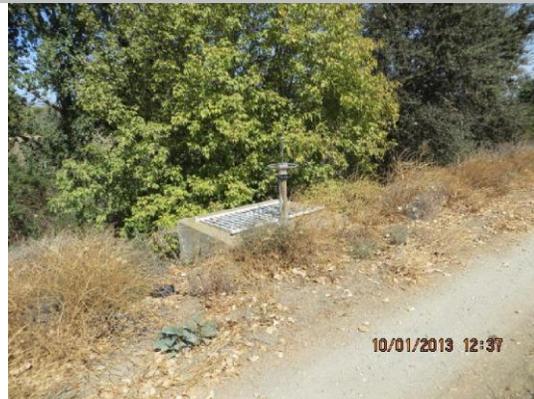
Photo 1 of 1 : UCIP\_2739.jpg

Slide gate in concrete riser on WS shoulder.

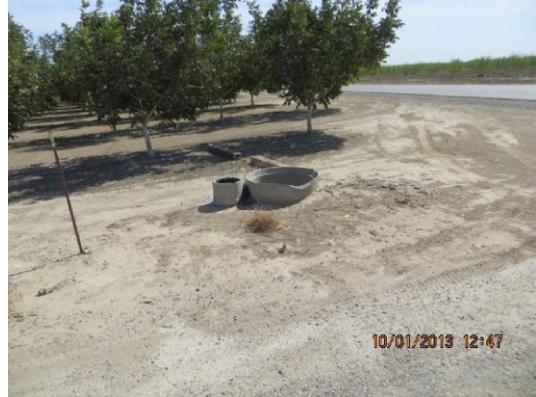
Photo 1 of 1 : UCIP\_2742.jpg

36-inch concrete standpipe on WS shoulder.
