**Flood Control Project Maintenance  
Levee Inspections****LMA District Cover Sheet  
Spring 2015 Levee Inspection Results****Reclamation District No. 1602 Del Puerto**

**Spring 2015 Levee Inspection Results**

**Reclamation District No. 1602 Del Puerto**

Waterway			Bank	Unit Miles
Unit No. 01 San Joaquin River			Left	6.24
	Spring (March - May)	Summer (June - August)	(September - November) Fall	Winter (December - February)
Unit Maintenance Rating (Fall Only)				
Date of Inspection	04/02/2015 - 04/02/2015			
DWR Inspector	Pavel Kazi			
Accompanied By	Tony Martinez RD 1602

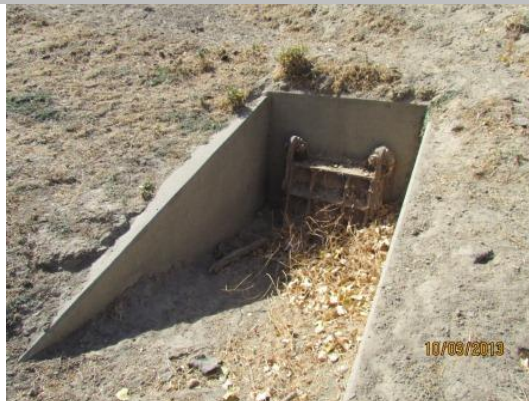
Photo 2 of 4 : SP\_2015\_RD1602\_110\_72\_20150313\_00043.jpg

Debris were obstructing the flap gate from closing completely. The picture was taken from toe of waterside of the levee during the fall 2013 inspection.

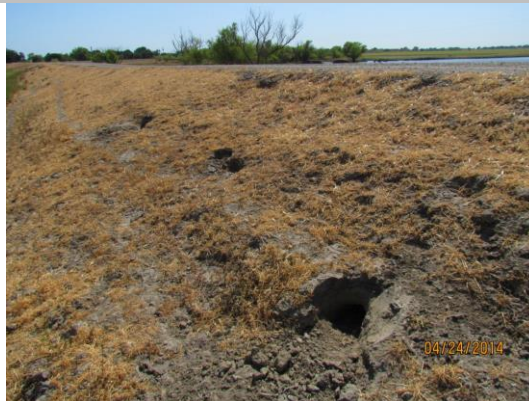
Photo 1 of 3 : SP\_2015\_RD1602\_110\_76\_20150313\_00048.jpg

Updated picture of the rodent holes on the waterside of the levee looking upstream during spring 2014 inspection.

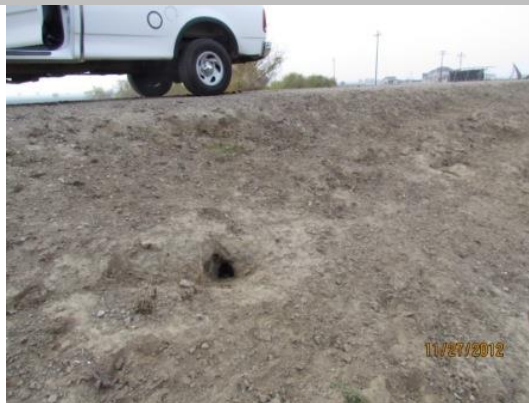
Photo 2 of 3 : SP\_2015\_RD1602\_110\_76\_20150313\_00049.jpg

Updated picture of the rodent hole on the waterside slope of the levee looking downstream.

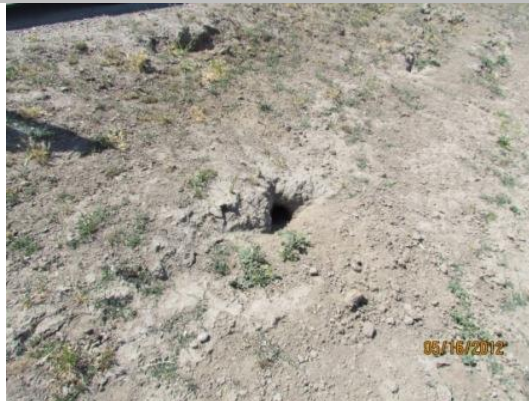
Photo 3 of 3 : SP\_2015\_RD1602\_110\_76\_20150313\_00050.jpg

A rodent hole was found on the waterside of the levee looking downstream.

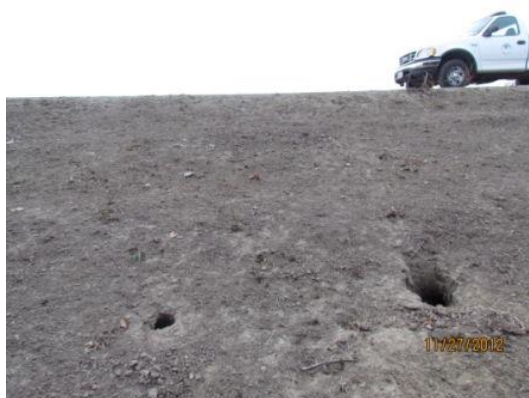
Photo 2 of 2 : SP\_2015\_RD1602\_110\_65\_20150313\_00038.jpg

Rodent holes were found on the waterside toe of the levee. The picture was taken from toe of the levee looking towards the crown.

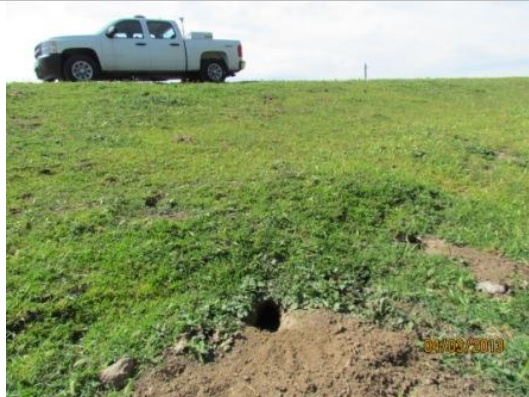
Photo 2 of 2 : SP\_2015\_RD1602\_110\_79\_20150313\_00052.jpg

A rodent hole was found on the waterside toe of the levee looking downstream.

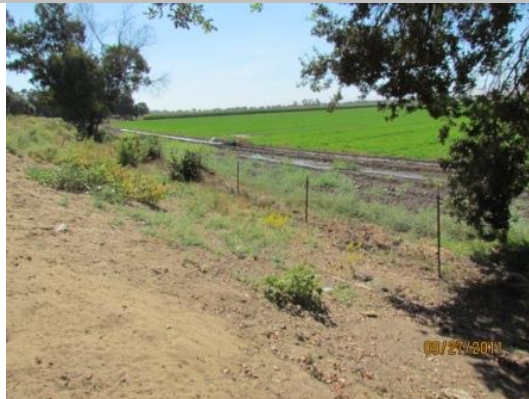
Photo 1 of 1 : SP\_2015\_RD1602\_110\_43\_20150313\_00020.jpg

View of the fence on the landside toe of the levee. The picture was taken from crown looking upstream.

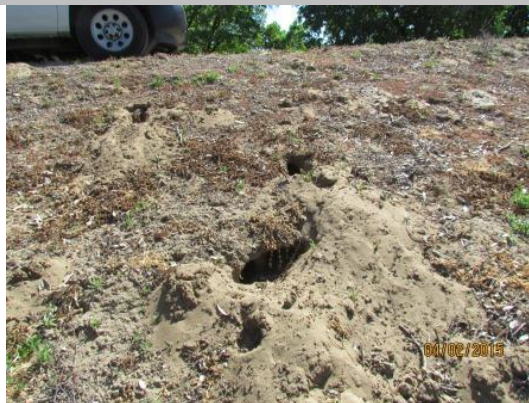
Photo 1 of 1 : SP\_2015\_RD1602\_110\_20\_20150406\_00080.jpg

View of rodent holes on the landside of the levee looking upstream.

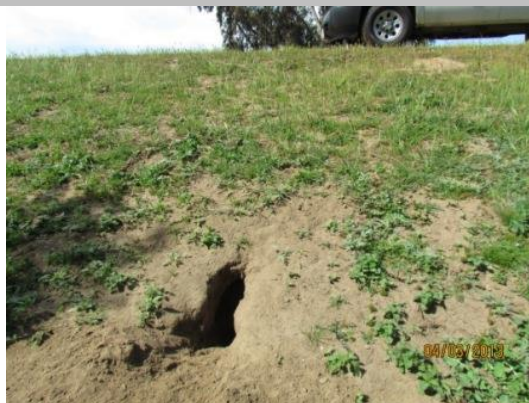
Photo 1 of 1 : SP\_2015\_RD1602\_110\_18\_20150313\_00007.jpg

A rodent hole was found on the waterside toe of the levee looking downstream.

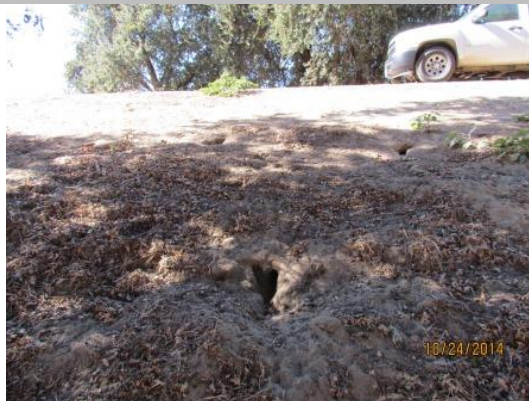
Photo 1 of 1 : SP\_2015\_RD1602\_110\_32\_20150313\_00012.jpg

View of the rodent holes on the waterside of the levee looking from the toe.

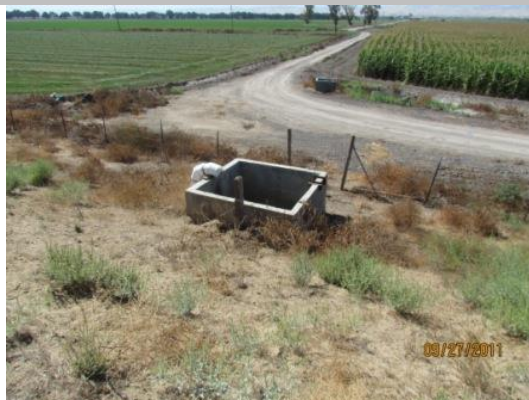
Photo 1 of 1 : SP\_2015\_RD1602\_110\_45\_20150313\_00022.jpg

A well is located at the landside toe of the levee. The picture was taken from the crown looking toward the landside of the levee.

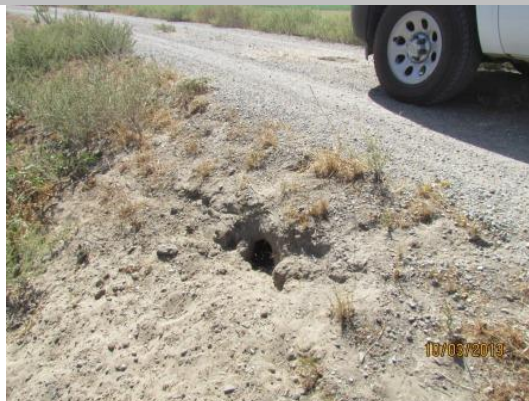
Photo 1 of 2 : SP\_2015\_RD1602\_110\_85\_20150313\_00053.jpg

Updated picture of a rodent hole on the waterside shoulder of the levee looking upstream during fall 2013 inspection.

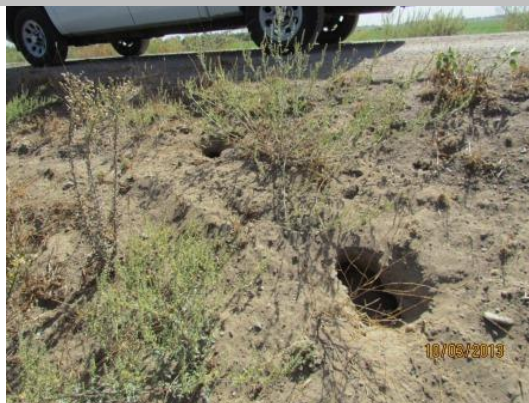
Photo 1 of 1 : SP\_2015\_RD1602\_110\_35\_20150313\_00013.jpg

Animal holes were found on the waterside shoulder of the levee looking upstream.

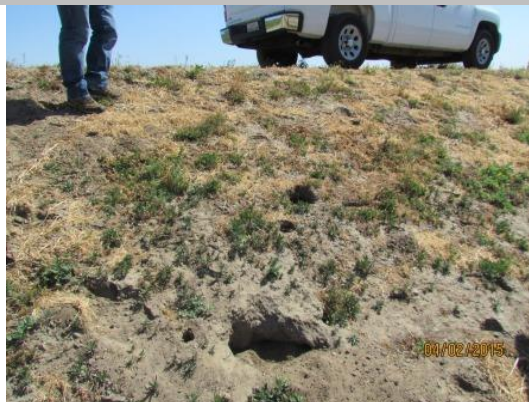
Photo 1 of 1 : SP\_2015\_RD1602\_110\_23\_20150406\_00081.jpg

View of rodent holes on the landside slope of the levee looking upstream.

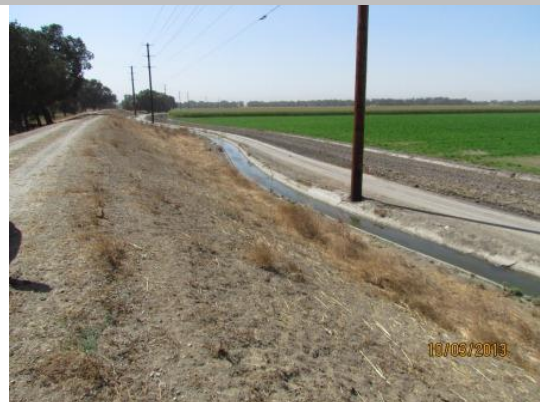
Photo 1 of 1 : SP\_2015\_RD1602\_110\_54\_20150313\_00027.jpg

A concrete lined ditch was found on the landside toe of the levee looking upstream.

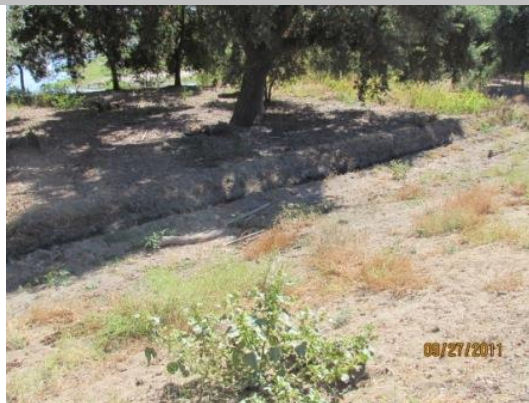
Photo 1 of 1 : SP\_2015\_RD1602\_110\_50\_20150313\_00025.jpg

A ditch was located on the waterside toe of the levee. The picture was taken from the crown looking upstream.

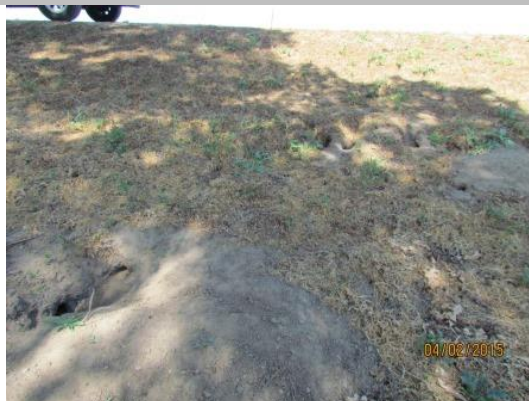
Photo 1 of 1 : SP\_2015\_RD1602\_110\_24\_20150406\_00082.jpg

Rodent holes were found on the waterside toe of the levee looking downstream.

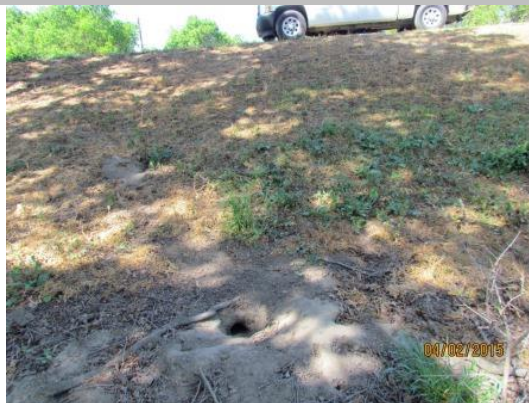
Photo 1 of 1 : SP\_2015\_RD1602\_110\_25\_20150406\_00083.jpg

Animal holes were found on the waterside of the levee looking upstream.

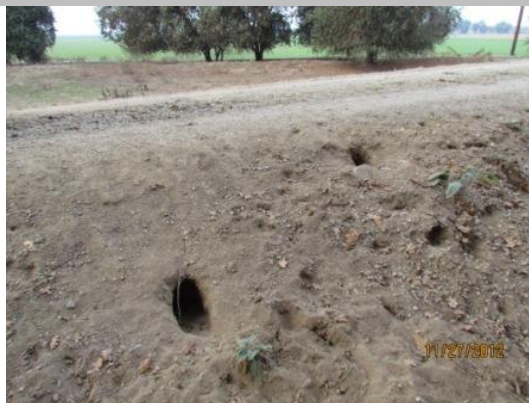
Photo 1 of 1 : SP\_2015\_RD1602\_110\_106\_20150313\_00059.jpg

Rodent holes were found on the waterside slope of the levee looking downstream.

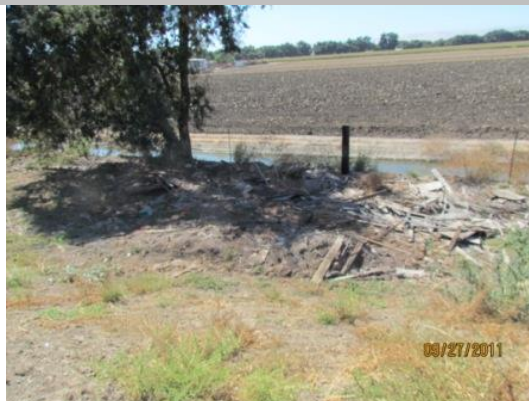
Photo 1 of 2 : SP\_2015\_RD1602\_110\_15\_20150313\_00004.jpg

Debris was located on the landside of the levee. The picture was taken from the crown looking upstream.

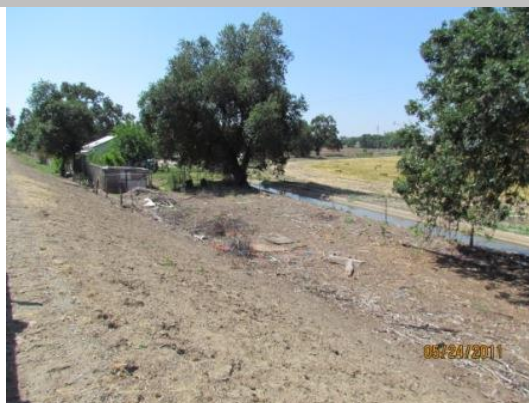
Photo 2 of 2 : SP\_2015\_RD1602\_110\_15\_20150313\_00005.jpg

Garbage was found on the landside of the levee. The picture was taken from the crown looking upstream.

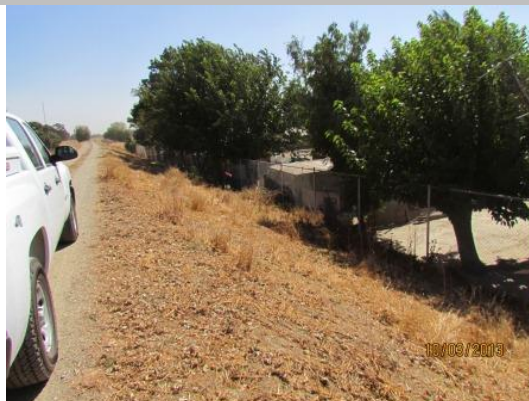
Photo 1 of 1 : SP\_2015\_RD1602\_110\_66\_20150313\_00039.jpg

Fences were found on the landside toe of the levee looking upstream.

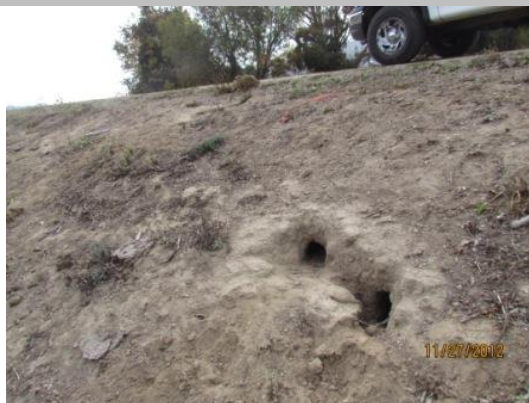
Photo 1 of 1 : SP\_2015\_RD1602\_110\_94\_20150313\_00056.jpg

Rodent holes were found on the waterside toe of the levee looking upstream.

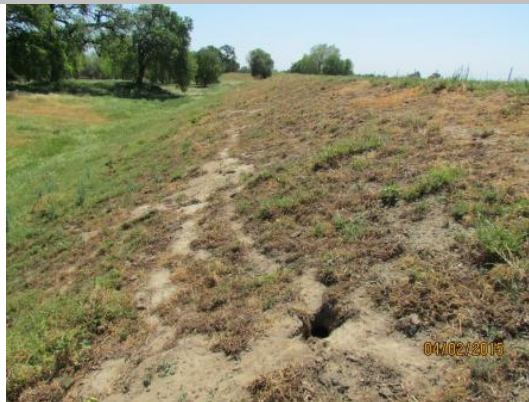
Photo 1 of 1 : SP\_2015\_RD1602\_110\_47\_20150406\_00084.jpg

Rodent holes were found on the waterside of the levee looking upstream.

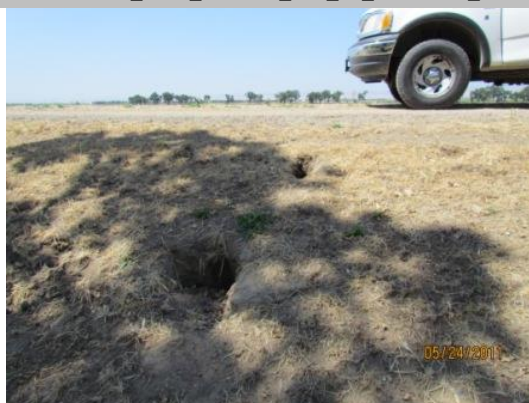
Photo 1 of 1 : SP\_2015\_RD1602\_110\_17\_20150313\_00006.jpg

Rodent hole was found on the waterside of the levee. The picture was taken from the crown looking upstream.

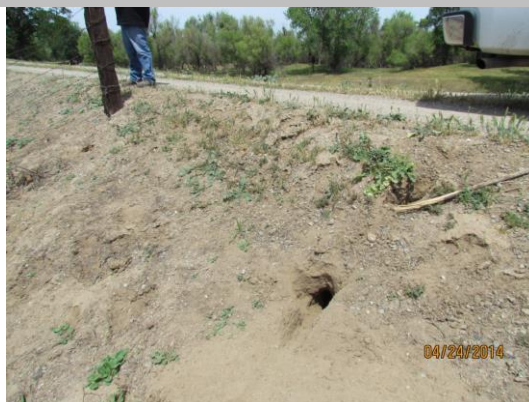
Photo 1 of 1 : SP\_2015\_RD1602\_110\_190\_20150313\_00062.jpg

A rodent hole was found on the waterside shoulder of the levee looking upstream.

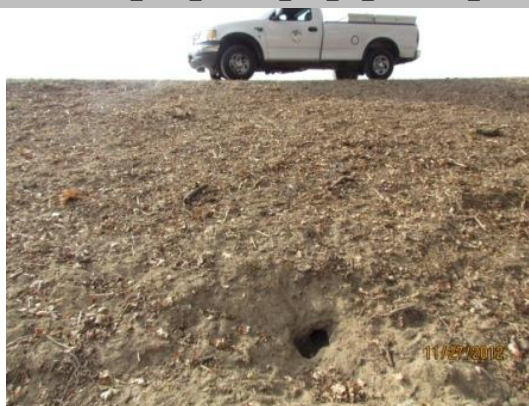
Photo 1 of 1 : SP\_2015\_RD1602\_110\_52\_20150313\_00026.jpg

A rodent hole was found on the waterside toe of the levee looking downstream.

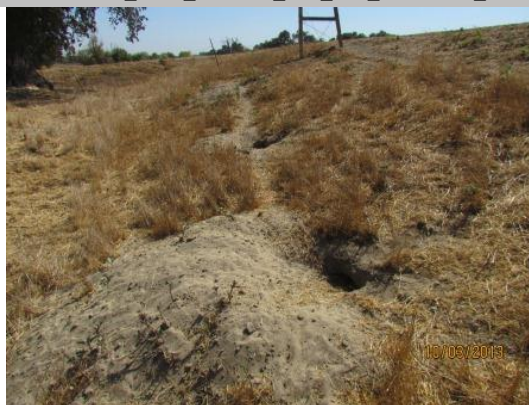
Photo 1 of 2 : SP\_2015\_RD1602\_110\_109\_20150313\_00060.jpg

Updated pictures of rodent holes were found on the waterside toe of the levee looking upstream.

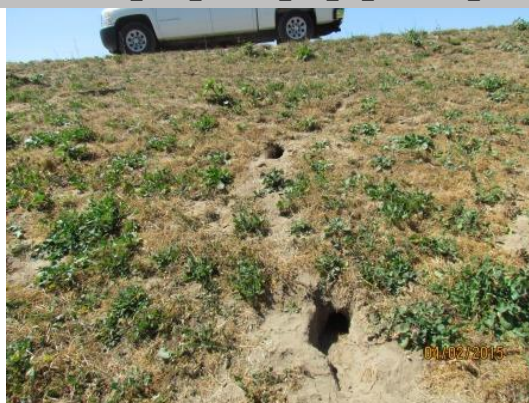
Photo 1 of 1 : SP\_2015\_RD1602\_110\_60\_20150406\_00088.jpg

Animal holes were found on the waterside slope of the levee looking upstream.

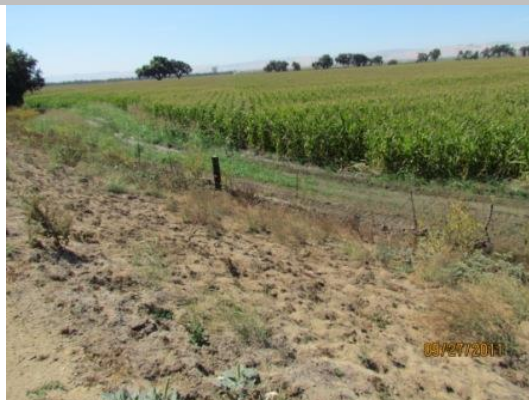
Photo 1 of 1 : SP\_2015\_RD1602\_110\_67\_20150313\_00040.jpg

View of the fence on the landside toe of the levee. The picture was taken from the crown looking upstream.

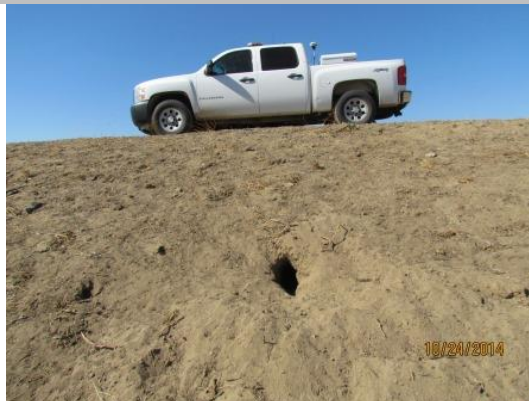
Photo 1 of 1 : SP\_2015\_RD1602\_110\_48\_20150313\_00024.jpg

View of a rodent hole on the waterside slope of the levee looking from the toe.

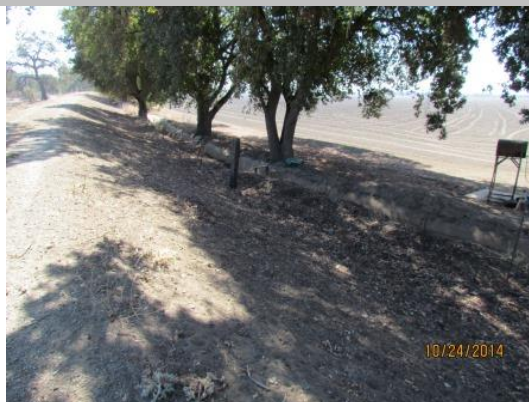
Photo 1 of 1 : SP\_2015\_RD1602\_110\_64\_20150313\_00036.jpg

View of a ditch on the landside toe of the levee looking upstream.

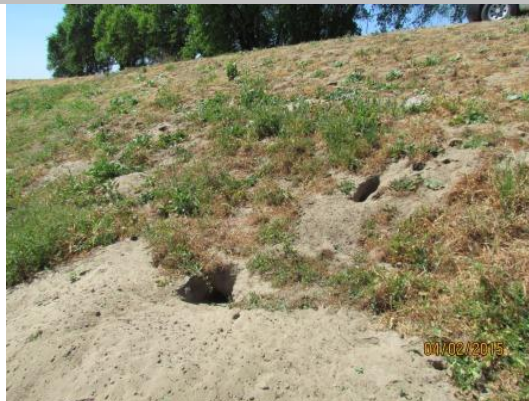
Photo 1 of 1 : SP\_2015\_RD1602\_110\_68\_20150406\_00089.jpg

A number of rodent holes were found on the waterside slope of the levee looking upstream.

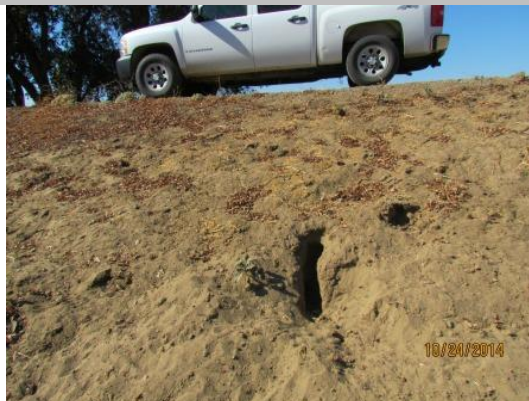
Photo 1 of 1 : SP\_2015\_RD1602\_110\_196\_20150313\_00064.jpg

Rodent holes were found on the waterside slope of the levee.

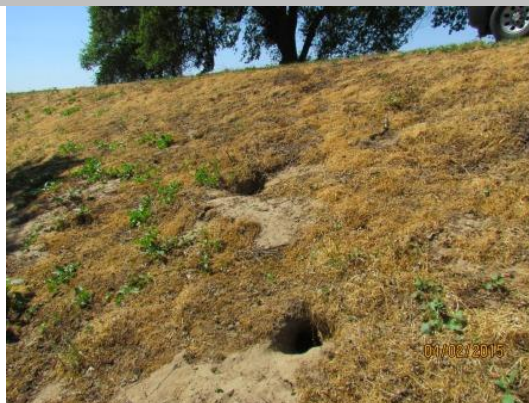
Photo 1 of 1 : SP\_2015\_RD1602\_110\_69\_20150406\_00090.jpg

Rodent holes were found on the waterside slope of the levee looking upstream.

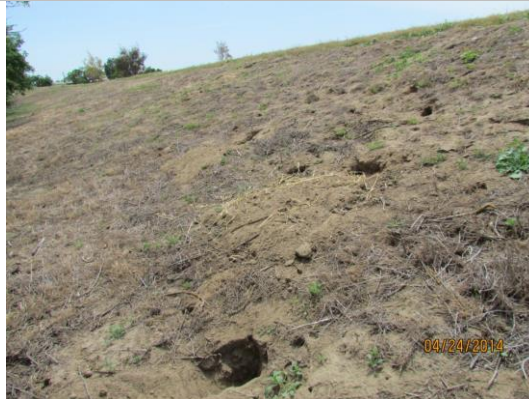
Photo 1 of 1 : SP\_2015\_RD1602\_110\_199\_20150313\_00065.jpg

Rodent holes were found on the waterside toe of the levee looking upstream.

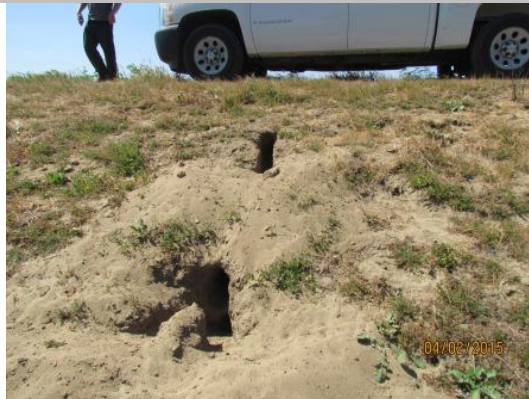
Photo 1 of 1 : SP\_2015\_RD1602\_110\_81\_20150406\_00091.jpg

A few animal holes were found on the waterside slope of the levee looking upstream.

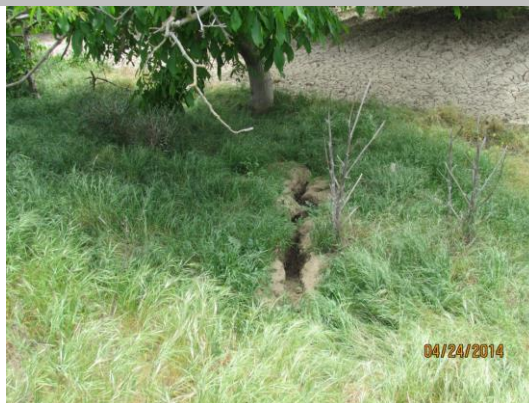
Photo 1 of 1 : SP\_2015\_RD1602\_110\_202\_20150313\_00066.jpg

Erosion was found on the landside slope of the levee looking upstream.

Action/Comments					
Schedule repair of erosion site prior to the next inspection.

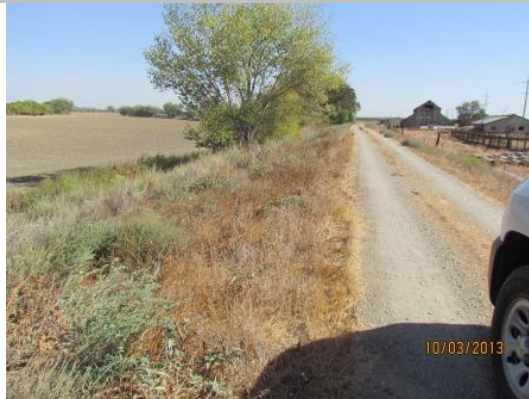
Photo 1 of 2 : SP\_2015\_RD1602\_110\_75\_20150313\_00046.jpg

Vegetation was found on the waterside slope of the levee looking upstream during fall 2013 inspection.

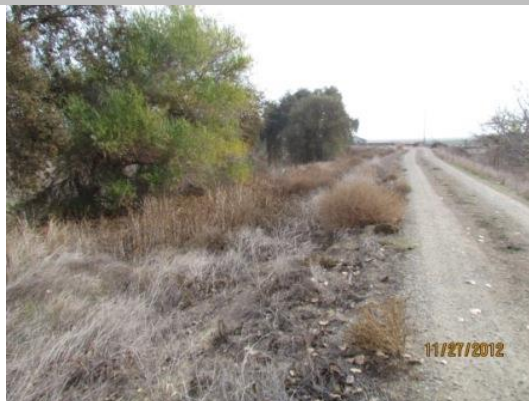
Photo 2 of 2 : SP\_2015\_RD1602\_110\_75\_20150313\_00047.jpg

Overgrown vegetation was found on the waterside slope of the levee looking upstream.

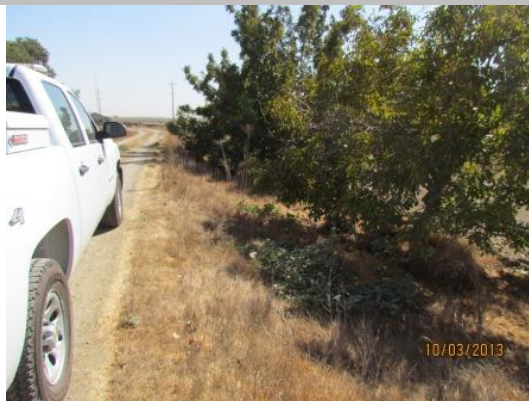
Photo 1 of 2 : SP\_2015\_RD1602\_110\_61\_20150313\_00032.jpg

Updated picture of vegetation on the landside of the levee. The picture was taken from the crown looking upstream during fall 2013 inspection.

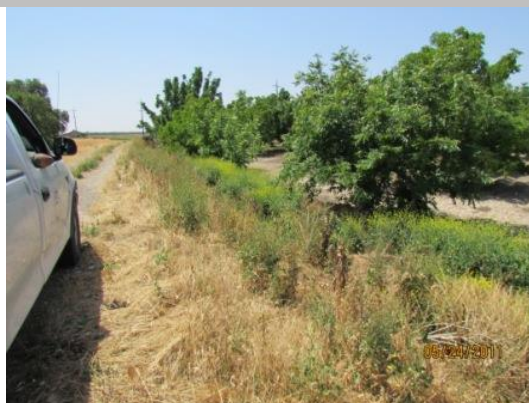
Photo 2 of 2 : SP\_2015\_RD1602\_110\_61\_20150313\_00033.jpg

Vegetation was obstructing the view of the landside of the levee. The picture was taken from the crown looking upstream.

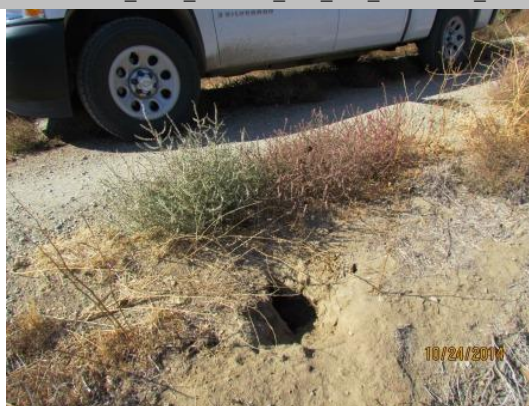
Photo 1 of 1 : SP\_2015\_RD1602\_110\_204\_20150313\_00067.jpg

An animal hole was found on the waterside shoulder of the levee looking downstream.

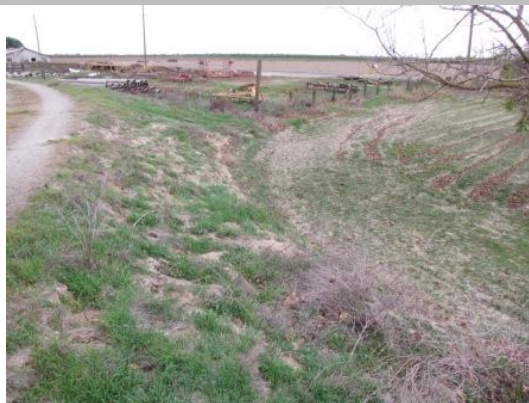
View of tilling into the landward slope of the levee looking upstream.  
This slope has also been significantly damaged by rodent activity.

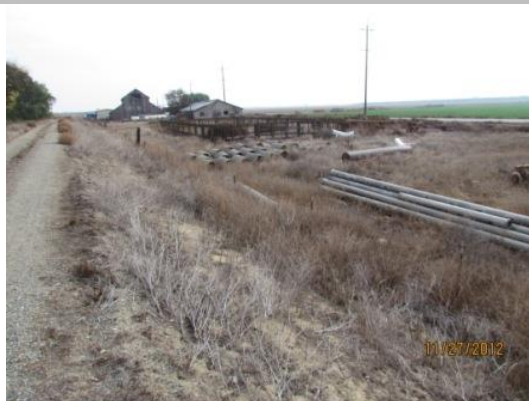
A fence was found on the landside toe of the levee looking upstream.
