**Flood Control Project Maintenance
Levee Inspections**
LMA District Cover Sheet
Spring 2016 Levee Inspection Results

Reclamation District No. 1602 Del Puerto

Spring 2016 Levee Inspection Results

Waterway			Bank	Unit Miles
Unit No. 01 San Joaquin River			Left	6.24
	Spring (March - May)	Summer (June - August)	(September - November) Fall	Winter (December - February)
Unit Maintenance Rating (Fall Only)				
Date of Inspection	4/7/2016 - 4/7/2016			
DWR Inspector	Pavel Kazi			
Accompanied By	Tony Martinez RD 1602

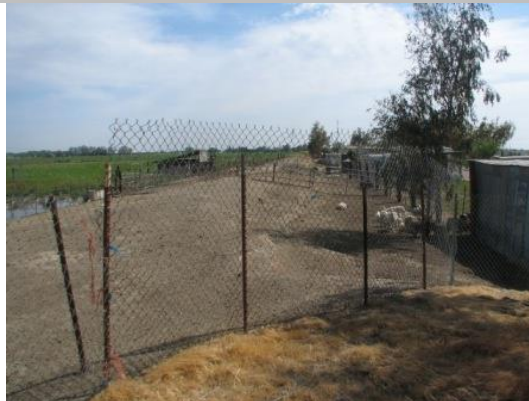
Photo 1 of 1 : SP_2016_RD1602_110_1_20160219_00001.jpg

Looking at animal pens on crown of levee from LM 0.00 to 0.11.

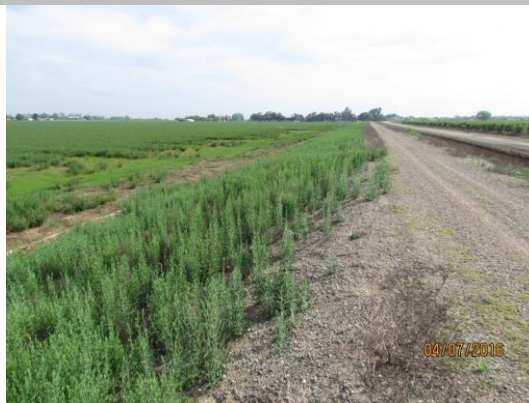
Photo 1 of 1 : SP_2016_RD1602_110_21_20160408_00095.jpg

LM Start	0.13	Rating **	M	Issue No.	21
LM End	0.56	Issue Type +	Ma	Location *	WS
Category	Earthen Levee			GPS Latitude/Longitude	
				Start	End
Item	Vegetation			37.477233 °	37.480269 °
				-121.081740 °	-121.075104 °
DWR ID	DWR_RD1602_01_f_2015_21				
Comment Code					
V1 : Control annual grass and weeds on the levee slopes and easements.					
Inspector Comment

View of the vegetation on the waterside of the levee.

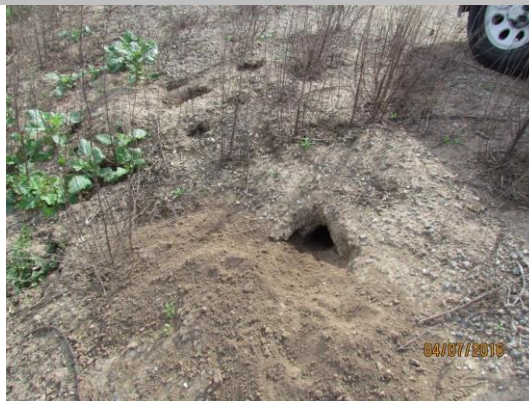
Photo 1 of 2 : SP_2016_RD1602_110_28_20160408_00094.jpg

Updated picture of the rodent hole on the waterside of the levee during spring 2016 inspection.

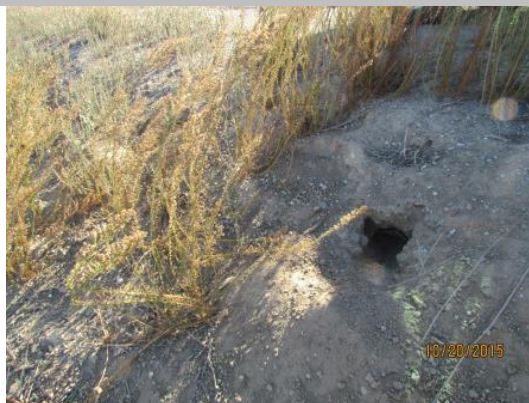
Photo 2 of 2 : SP_2016_RD1602_110_28_20160219_00009.jpg

A rodent hole was found on the waterside of the levee.

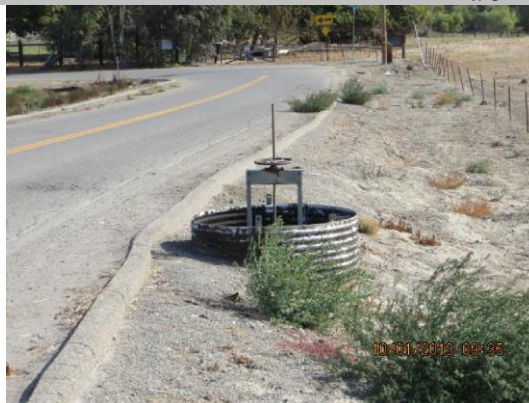
Photo 1 of 2 : UCIP_SP_2016_21623_36702.jpg

LM Start	0.58	Rating **	U	Issue No.	204
LM End	0.58	Issue Type +	En	Location *	WS
Category	Supplemental			GPS Latitude/Longitude	
				Start	End
Item	DWR UCIP Field Study			37.480182 °	37.480182 °
				-121.074765 °	-121.074765 °
DWR ID					
Comment Code					
Inspector Comment					
FS_ID:21623 DS_ID:20215 EP_NO: N/A Repair Type: Urgent Crossing Status: Found UCIP Comments: Open 60-inch CMP riser on WS needs lid as it's depth may be a hazard to the public. FIELD_STRUCT_DESC: 16-inch pipe through levee 11.3 feet below crown. Slide gate in 60-inch corrugated metal pipe riser on the waterward side. Concrete inlet 110-feet west of the levee crown. Originally included in 1964 O&M manual. FS Date: 10/1/2013 7:57:22 AM

60-inch CMP riser on WS shoulder.

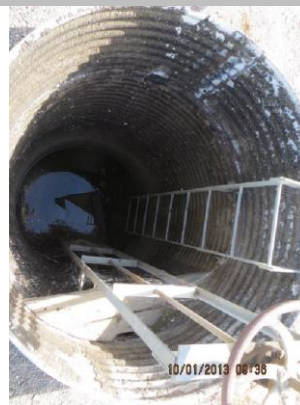
Photo 2 of 2 : UCIP_SP_2016_21623_36701.jpg

CMP riser with slide gate on WS shoulder.

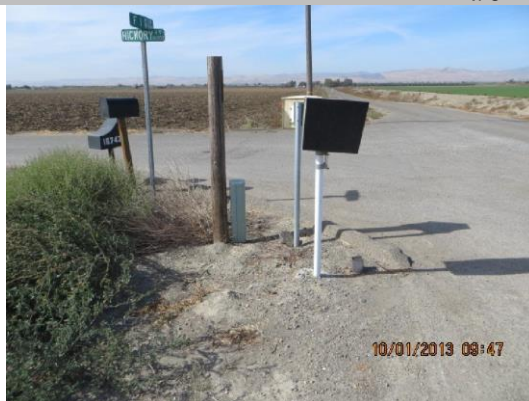
Photo 1 of 2 : UCIP_SP_2016_22937_39050.jpg

LM Start	0.58	Rating **	M	Issue No.	208
LM End	0.58	Issue Type +	En	Location *	WS
Category	Supplemental			GPS Latitude/Longitude	
				Start	End
Item	DWR UCIP Field Study			37.480176 °	37.480176 °
				-121.074736 °	-121.074736 °
DWR ID					
Comment Code					
Inspector Comment					
FS_ID:22937					
DS_ID:24681					
EP_NO: N/A					
Repair Type: Non-Urgent					
Crossing Status: Found					
UCIP Comments: No permit identified for this crossing.					
FIELD_STRUCT_DESC: Communication line through the levee at an unknown depth.					
FS Date: 10/1/2013

Communication line access box on LS shoulder.

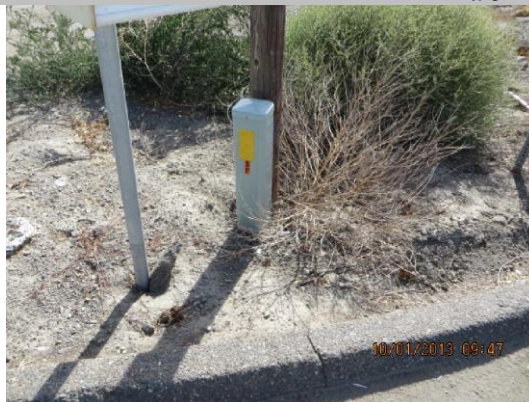
Photo 2 of 2 : UCIP_SP_2016_22937_39049.jpg

Communication line access box on LS shoulder.

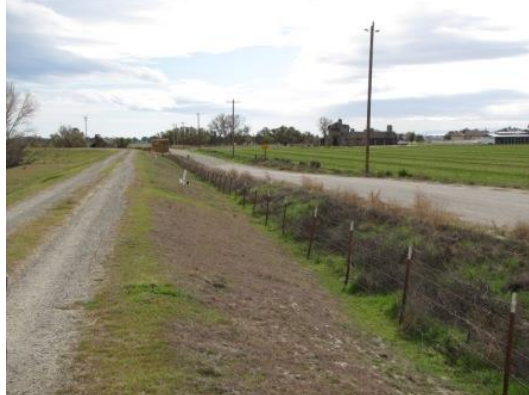
Photo 1 of 1 : SP_2016_RD1602_110_70_20160219_00042.jpg

View of barbed wire fence at landward toe looking upstream.

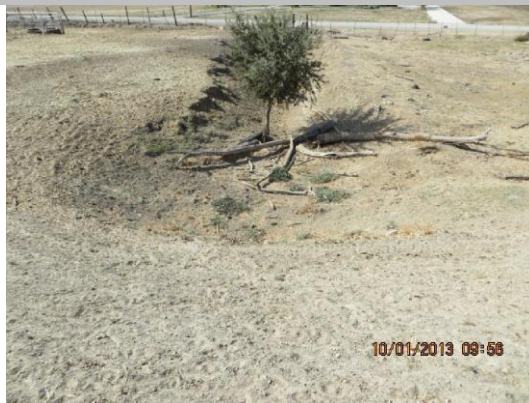
Photo 1 of 2 : UCIP_SP_2016_43084_36723.jpg

LM Start	0.77	Rating **	U	Issue No.	211
LM End	0.77	Issue Type +	En	Location *	WS
Category	Supplemental			GPS Latitude/Longitude	
				Start	End
Item	DWR UCIP Field Study			37.477993 °	37.477993 °
				-121.072645 °	-121.072645 °
DWR ID					
Comment Code					
Inspector Comment					
FS_ID:43084 DS_ID:20216 EP_NO: N/A Repair Type: Urgent Crossing Status: Found UCIP Comments: Flap gate blocked from functioning by soil buildup on WS toe. Soil should be cleared. FIELD_STRUCT_DESC: 30-inch square reinforced concrete box culvert through levee 14.4 feet below crown. Concrete "U" headwall on both ends. Slide gate in 6'X7' concrete surge box on the waterward shoulder. Flap gate on the waterward end. Originally included in 1964 O&M manual. FS Date: 10/1/2013

Inlet on LS toe.

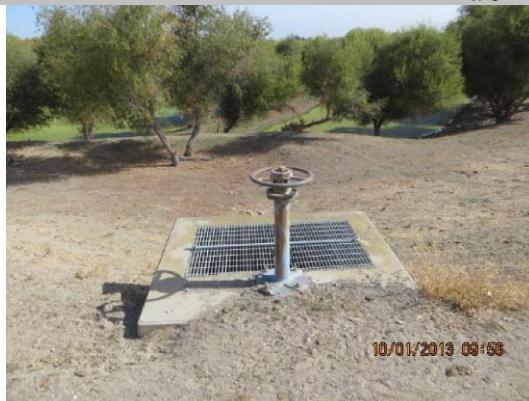
Photo 2 of 2 : UCIP_SP_2016_43084_36722.jpg

LM Start	0.77	Rating **	U	Issue No.	211 (cont)	
LM End	0.77	Issue Type +	En	Location *	WS	
Category	Supplemental			GPS Latitude/Longitude		
				Start		End
Item	DWR UCIP Field Study			37.477993 °	37.477993 °	
				-121.072645 °	-121.072645 °	
DWR ID						
Comment Code						
Inspector Comment						
FS_ID:43084 DS_ID:20216 EP_NO: N/A Repair Type: Urgent Crossing Status: Found UCIP Comments: Flap gate blocked from functioning by soil buildup on WS toe. Soil should be cleared. FIELD_STRUCT_DESC: 30-inch square reinforced concrete box culvert through levee 14.4 feet below crown. Concrete "U" headwall on both ends. Slide gate in 6'X7' concrete surge box on the waterward shoulder. Flap gate on the waterward end. Originally included in 1964 O&M manual. FS Date: 10/1/2013

Slide gate in concrete box on WS shoulder.

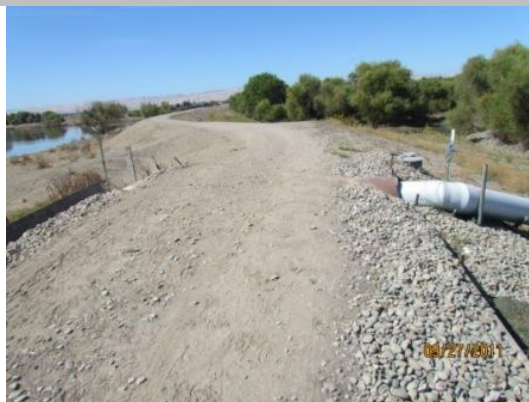
Photo 1 of 1 : SP_2016_RD1602_110_36_20160219_00012.jpg

LM Start	1.00	Rating **	M	Issue No.	36
LM End	1.00	Issue Type +	En	Location *	WS
Category	Earthen Levee			GPS Latitude/Longitude	
				Start	End
Item	Encroachments			37.478810 °	37.478810 °
				-121.068738 °	-121.068738 °
DWR ID	DWR_RD1602_01_s_2012_36				
Comment Code					
RA : Ramp					
Inspector Comment

View of the ramp on the crown. The picture was taken from crown looking downstream.

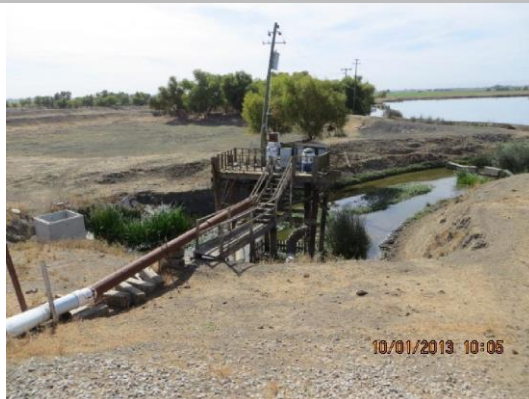
Photo 1 of 2 : UCIP_SP_2016_21639_36758.jpg

LM Start	1.00	Rating **	U	Issue No.	205
LM End	1.00	Issue Type +	En	Location *	WS
Category	Supplemental			GPS Latitude/Longitude	
				Start	End
Item	DWR UCIP Field Study			37.478816 °	37.478816 °
				-121.068780 °	-121.068780 °
DWR ID					
Comment Code					
Inspector Comment					
FS_ID:21639 DS_ID:20217 EP_NO: N/A Repair Type: Urgent Crossing Status: Found UCIP Comments: Appears abandoned and if so should be done so properly. Flapgate missing. FIELD_STRUCT_DESC: 1 of 2: 16-inch pipe through levee 17.0 feet below crown. Pumps on pump platform on the landward side. Siphon breaker in 24-inch CMP risers on the waterward shoulder. Concrete "U" headwall and flap gate on the waterward end. Originally included in 1964 O&M manual. FS Date: 10/1/2013

Pumping plant on LS toe. Pipe visible under walkway.

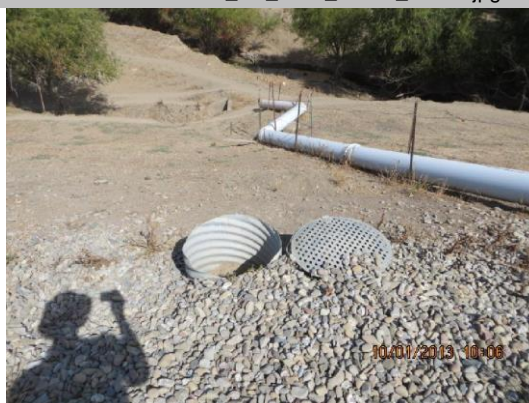
Photo 2 of 2 : UCIP_SP_2016_21639_36757.jpg

Siphon breaker in 24-inch CMP riser on WS shoulder.

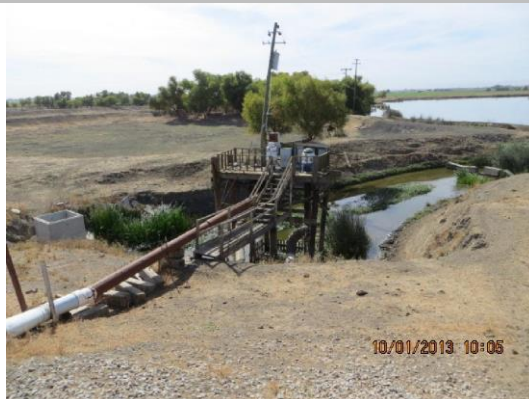
Photo 1 of 2 : UCIP_SP_2016_21642_36772.jpg

LM Start	1.00	Rating **	U	Issue No.	206
LM End	1.00	Issue Type +	En	Location *	WS
Category	Supplemental			GPS Latitude/Longitude	
				Start	End
Item	DWR UCIP Field Study			37.478817 °	37.478817 °
				-121.068773 °	-121.068773 °
DWR ID					
Comment Code					
Inspector Comment					
FS_ID:21642 DS_ID:20219 EP_NO: N/A Repair Type: Urgent Crossing Status: Found UCIP Comments: Appears abandoned siphon breakers covered in soil and flapgate missing. FIELD_STRUCT_DESC: 2 of 2: 16-inch pipe through levee 17.0 feet below crown. Pumps on pump platform on the landward side. Siphon breakers in 24-inch risers on the waterward shoulder. Concrete "U" headwall and flap gate on the waterward end. Originally included in 1964 O&M manual. FS Date: 10/1/2013

Pipe visible under walkway at pumping plant on LS toe.

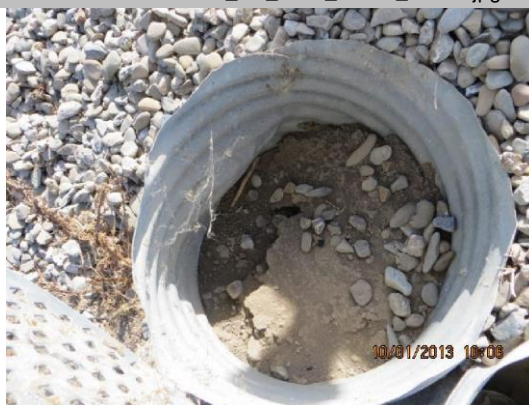
Photo 2 of 2 : UCIP_SP_2016_21642_36771.jpg

Siphon breaker covered in soil at CMP riser on WS shoulder.

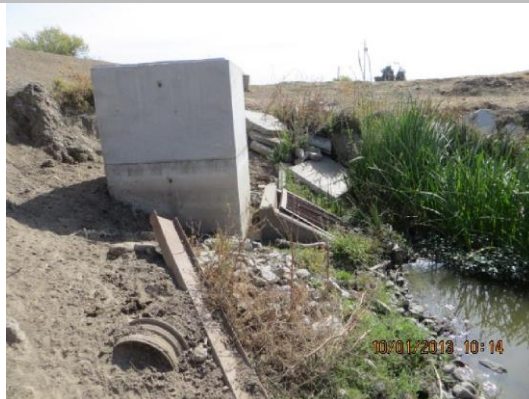
Photo 1 of 2 : UCIP_SP_2016_41771_36786.jpg

FS_ID:41771
DS_ID:20218
EP_NO: N/A
Repair Type: Urgent
Crossing Status: Found
UCIP Comments: Headwall on WS toe seperated from pipe. Erosion around concrete headwall and undermined at WS toe. Flapgate missing from WS toe headwall.
FIELD_STRUCT_DESC: 30-inch square reinforced concrete box culvert through levee 25.4 feet below crown. Concrete "U" headwalls on both ends. Slide gate in concrete surge box on the waterward slope. 5'X5' concrete box on LS toe. Flap gate on the waterward end. Originally included in 1964 O&M manual.
FS Date: 10/1/2013

Grated inlet and 5'X5' concrete box on LS toe.

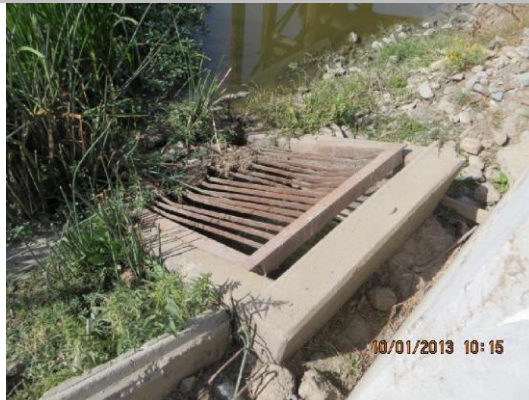
Photo 2 of 2 : UCIP_SP_2016_41771_36785.jpg

Grated inlet at LS toe.

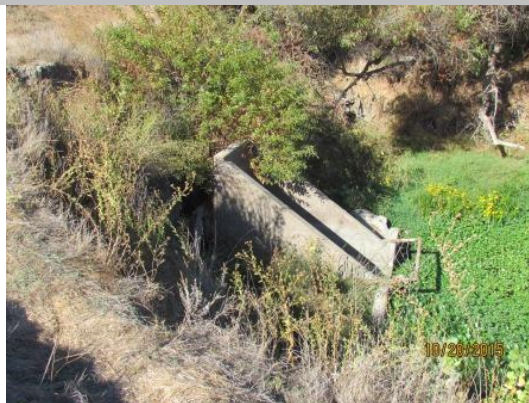
Photo 1 of 3 : SP_2016_RD1602_110_55_20160219_00027.jpg

LM Start	1.02	Rating **	U	Issue No.	55
LM End	1.02	Issue Type +	Ma	Location *	WS
Category	Interior Drainage & Piping Systems			GPS Latitude/Longitude	
				Start	End
Item	Concrete Tilting / Settlement			37.478772 °	37.478772 °
				-121.068454 °	-121.068454 °
DWR ID	DWR_RD1602_01_s_2012_55				
Comment Code					
Inspector Comment					
The outlet headwall is tilting away from the pipe rendering the existing flap gate ineffective. The LMA is planning to repair gap between pipe and headwall and stabilize headwall to prevent further damage.

View of the broken headwall on the waterside of the levee during fall 2015 inspection.

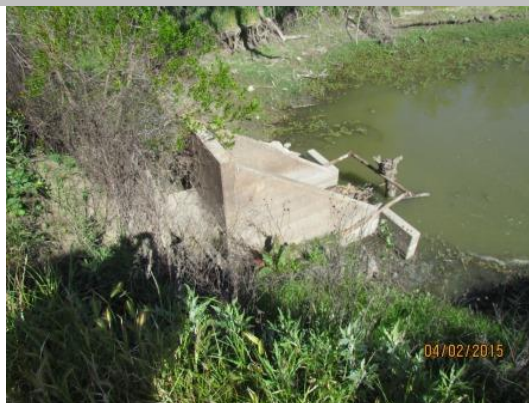
Photo 2 of 3 : SP_2016_RD1602_110_55_20160219_00028.jpg

View of the broken headwall on the waterside of the levee during spring 2015 inspection.

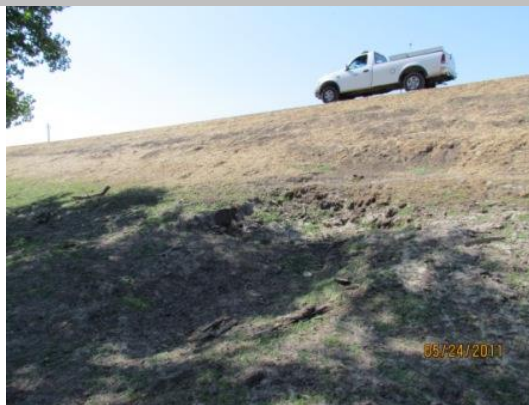
Photo 2 of 2 : SP_2016_RD1602_110_37_20160219_00014.jpg

Depression at the waterside slope of the levee during Spring 2011 inspection.

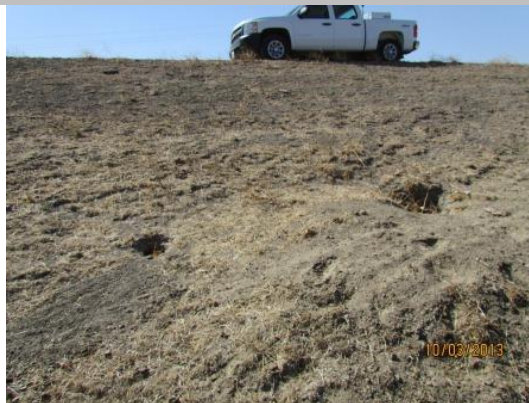
Photo 1 of 2 : SP_2016_RD1602_110_11_20160219_00002.jpg

Rodent holes were found on the waterside slope of the levee looking downstream.

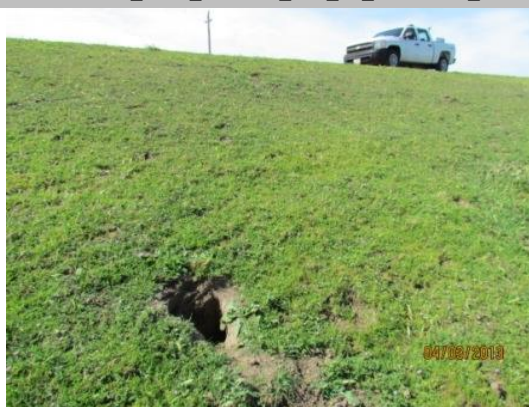
Photo 2 of 2 : SP_2016_RD1602_110_11_20160219_00003.jpg

A rodent hole was found on the waterside toe of the levee looking downstream.

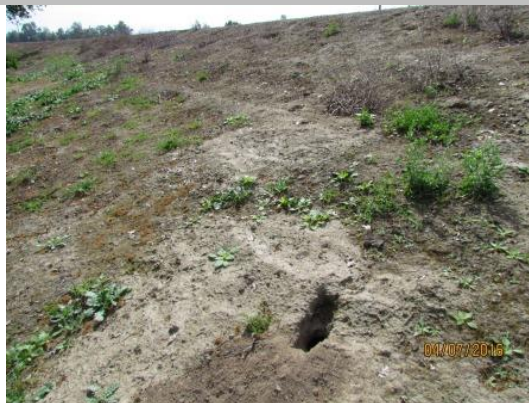
Photo 1 of 2 : SP_2016_RD1602_110_65_20160411_00096.jpg

Updated picture of the rodent hole on waterside of the levee during spring 2016 inspection.

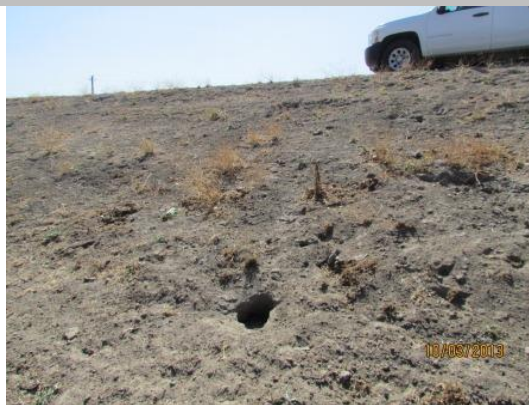
Photo 2 of 2 : SP_2016_RD1602_110_65_20160219_00037.jpg

View of rodent hole on the waterside slope of the levee looking upstream during fall 2013 inspection.

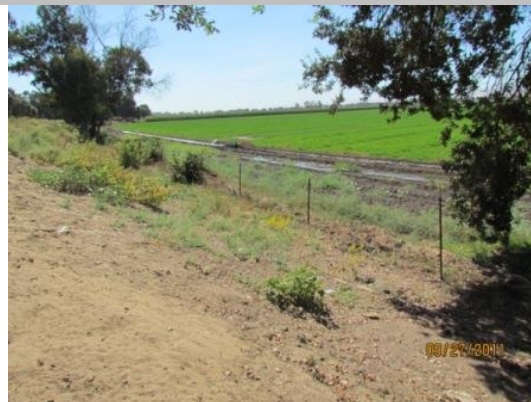
Photo 1 of 1 : SP_2016_RD1602_110_43_20160219_00017.jpg

View of the fence on the landside toe of the levee. The picture was taken from crown looking upstream.

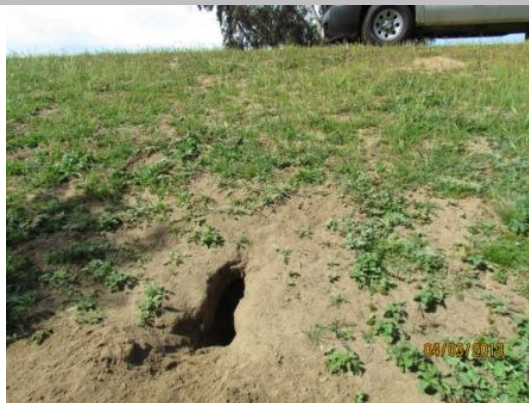
Photo 1 of 1 : SP_2016_RD1602_110_18_20160219_00004.jpg

A rodent hole was found on the waterside toe of the levee looking downstream.

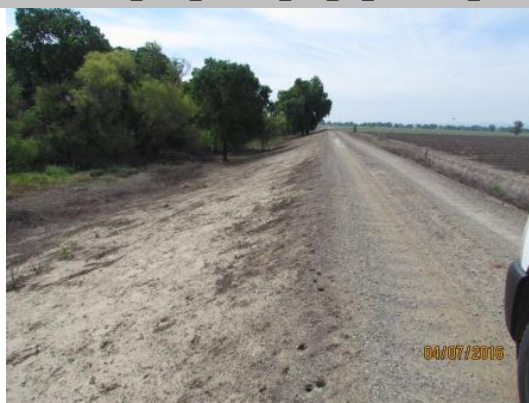
Photo 1 of 1 : SP_2016_RD1602_110_16_20160411_00097.jpg

View of an acceptable vegetation on the waterside slope of the levee.

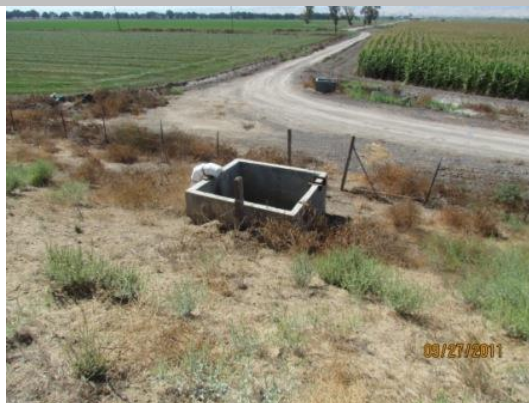
Photo 1 of 1 : SP_2016_RD1602_110_45_20160219_00019.jpg

A well is located at the landside toe of the levee. The picture was taken from the crown looking toward the landside of the levee.

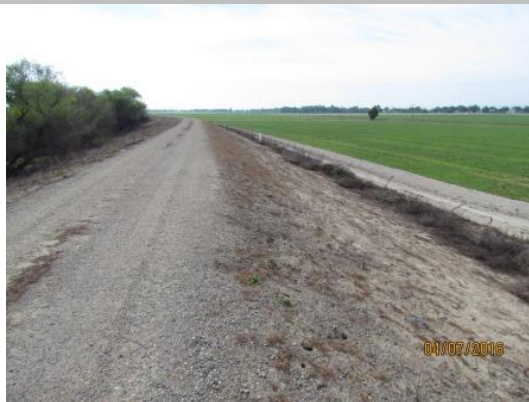
Photo 1 of 1 : SP_2016_RD1602_110_17_20160411_00098.jpg

View of an acceptable vegetation on the landside slope of the levee.

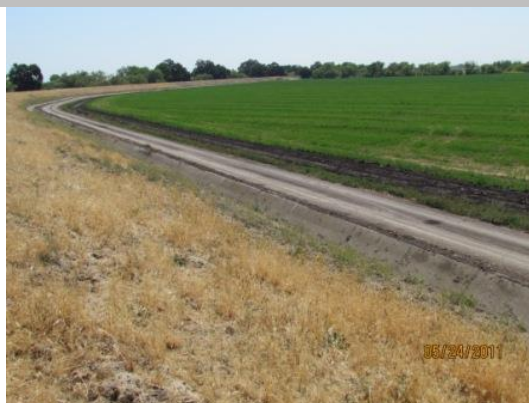
Photo 1 of 1 : SP_2016_RD1602_110_59_20160219_00031.jpg

Concrete drain was built at the toe of the levee. The picture was taken from the crown looking upstream.

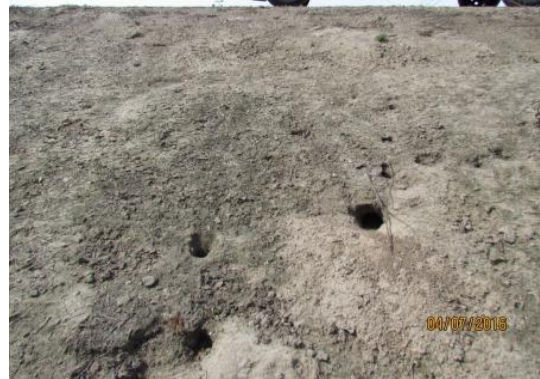
Photo 1 of 1 : SP_2016_RD1602_110_19_20160411_00099.jpg

View of rodent holes on the waterside of the levee.

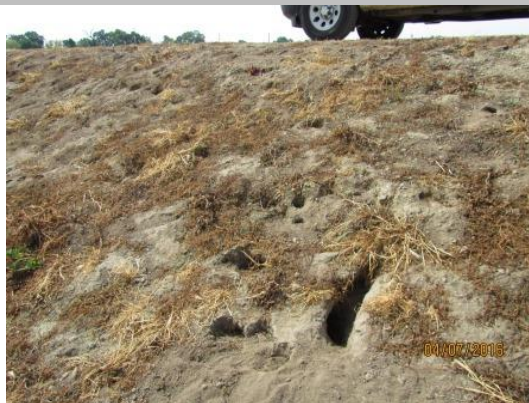
Photo 1 of 1 : SP_2016_RD1602_110_24_20160411_00100.jpg

View of rodent holes on the waterside of the levee looking upstream.

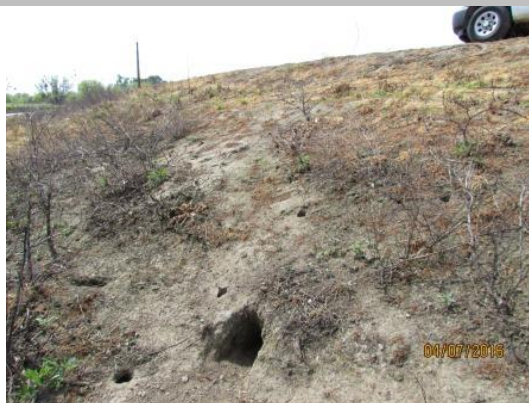
Photo 1 of 1 : SP_2016_RD1602_110_25_20160411_00101.jpg

View of rodent holes on the waterside toe of the levee looking upstream.

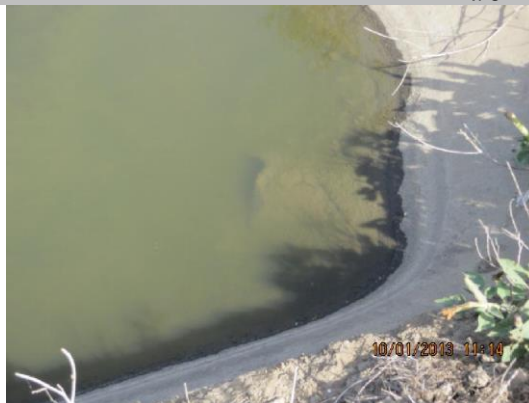
Photo 1 of 2 : UCIP_SP_2016_21652_36805.jpg

LM Start	3.27	Rating **	U	Issue No.	207
LM End	3.27	Issue Type +	En	Location *	WS
Category	Supplemental			GPS Latitude/Longitude	
				Start	End
Item	DWR UCIP Field Study			37.461507 °	37.461507 °
				-121.041609 °	-121.041609 °
DWR ID					
Comment Code					
Inspector Comment					
FS_ID:21652 DS_ID:20204 EP_NO: 8193 Repair Type: Urgent Crossing Status: Found UCIP Comments: Appears abandoned, and if so should be done so properly. No handle on slide gate, no cover on CMP standpipe on WS shoulder. FIELD_STRUCT_DESC: 16-inch pipe through levee 11.5 feet below crown. Slide gate in 60-inch corrugated metal pipe riser on the waterward slope. Discharge into concrete-lined ditch on the landward side (Permit No. 8193, 1964). Originally included in 1964 O&M manual. FS Date: 10/1/2013

Pipe visible in concrete channel on LS toe.

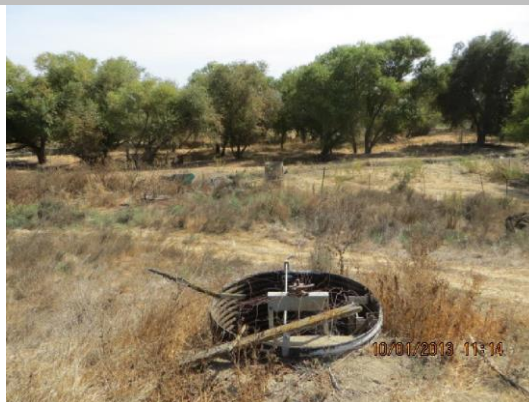
Photo 2 of 2 : UCIP_SP_2016_21652_36804.jpg

Slide gate in 60-inch CMP riser on WS shoulder.

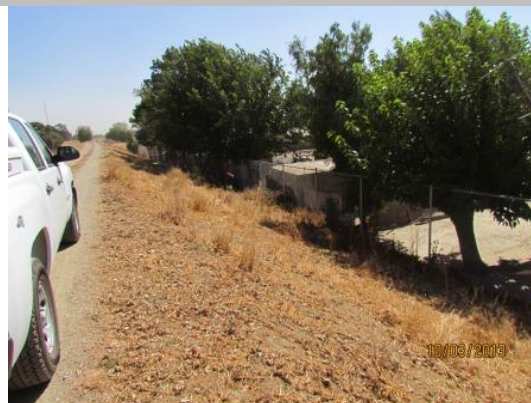
Photo 1 of 1 : SP_2016_RD1602_110_66_20160219_00039.jpg

LM Start	3.86	Rating **	U	Issue No.	201
LM End	3.86	Issue Type +	En	Location *	LS
Category	Supplemental			GPS Latitude/Longitude	
				Start	End
Item	DWR UCIP Field Study			37.454080 °	37.454080 °
				-121.042758 °	-121.042758 °
DWR ID					
Comment Code					
Inspector Comment					
FS_ID:21656 DS_ID:20206 EP_NO: 7796 Repair Type: Urgent Crossing Status: Indicator Found UCIP Comments: Gasline needs sign markers at levee. FIELD_STRUCT_DESC: 12.75-inch gas line crossing through levee 3.0 feet below crown (Permit No. 7796, 1972). Originally included in the 1964 O&M manual. FS Date: 10/1/2013

Fences were found on the landside toe of the levee looking upstream.

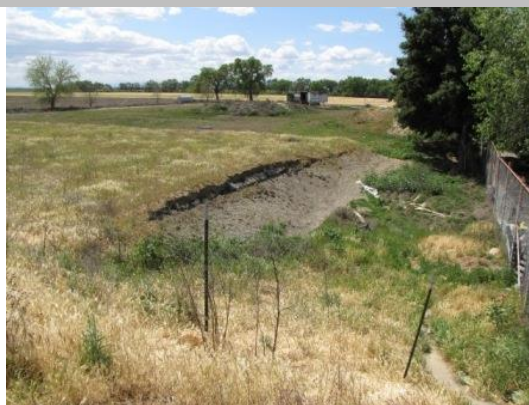
Photo 1 of 1 : SP_2016_RD1602_110_62_20160219_00034.jpg

LM Start	3.93	Rating **	M	Issue No.	62
LM End	3.93	Issue Type +	Ma	Location *	LS
Category	Earthen Levee			GPS Latitude/Longitude	
				Start	End
Item	Slope Stability			37.453216 °	37.453216 °
				-121.042127 °	-121.042127 °
DWR ID	DWR_RD1602_01_s _ 2012_62				
Comment Code					
S3 : Repair the levee slope damaged by vehicle traffic and prevent access where possible.					
Inspector Comment					
Significant damage to USACE constructed seepage berm due to human activity.

Repair damage to USACE constructed seepage berm by pedestrian and cycle traffic.

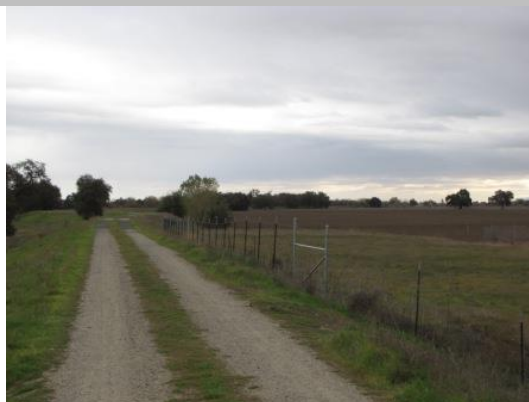
Photo 1 of 1 : SP_2016_RD1602_110_63_20160219_00035.jpg

View of a barbed wire fence on the landward slope looking upstream.

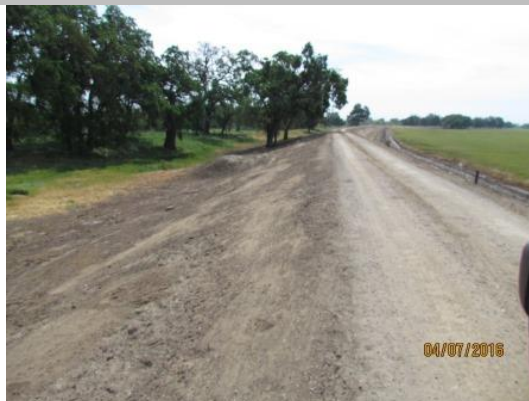
Photo 1 of 1 : SP_2016_RD1602_110_27_20160411_00102.jpg

View of an acceptable vegetation on the waterside of the levee looking upstream.

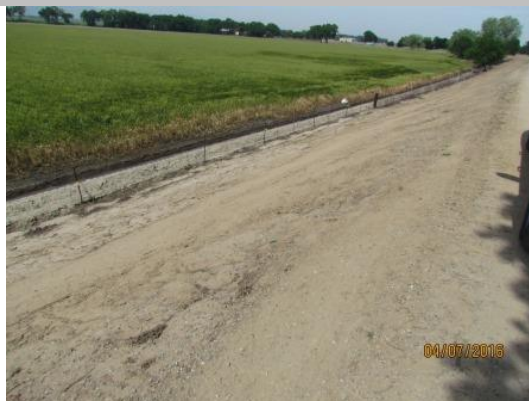
Photo 1 of 1 : SP_2016_RD1602_110_30_20160411_00103.jpg

LMA has repaired multiple rodent holes on the landside slope of the levee looking downstream.

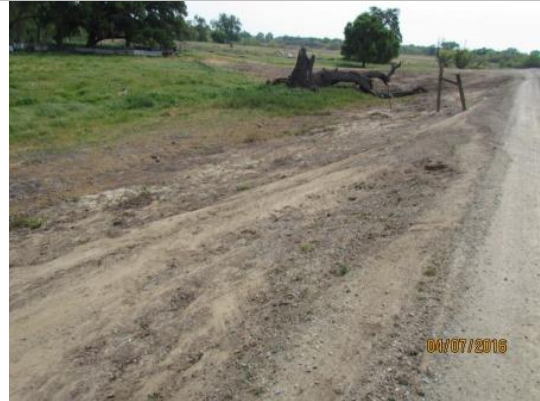
Photo 1 of 1 : SP_2016_RD1602_110_32_20160411_00104.jpg

LMA has repaired the rodent holes on the waterside slope of the levee during spring 2016 inspection.

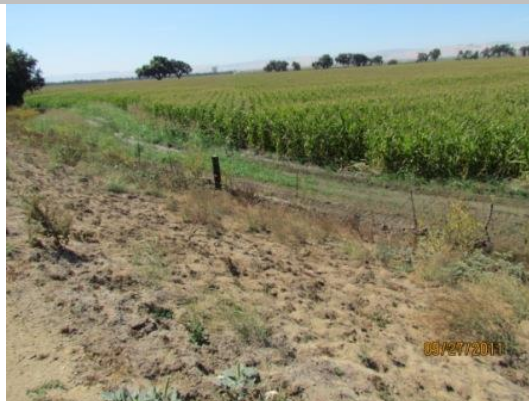
Photo 1 of 1 : SP_2016_RD1602_110_67_20160219_00040.jpg

View of the fence on the landside toe of the levee. The picture was taken from the crown looking upstream.

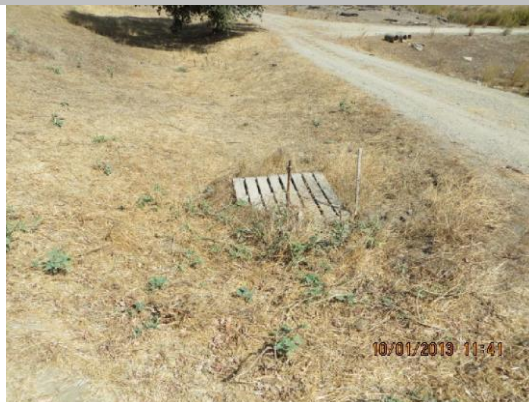
Photo 1 of 2 : UCIP_SP_2016_21657_36819.jpg

Slide gate in CMP riser on WS slope.

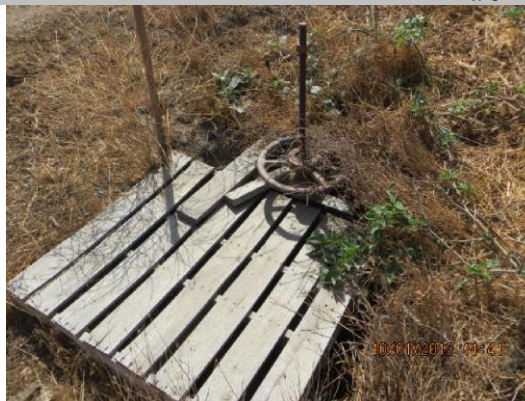
Photo 2 of 2 : UCIP_SP_2016_21657_36818.jpg

Slide gate in CMP riser on WS slope.

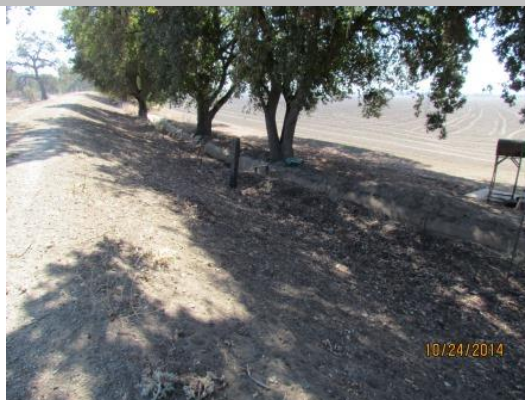
Photo 1 of 1 : SP_2016_RD1602_110_64_20160219_00036.jpg

View of a ditch on the landside toe of the levee looking upstream.

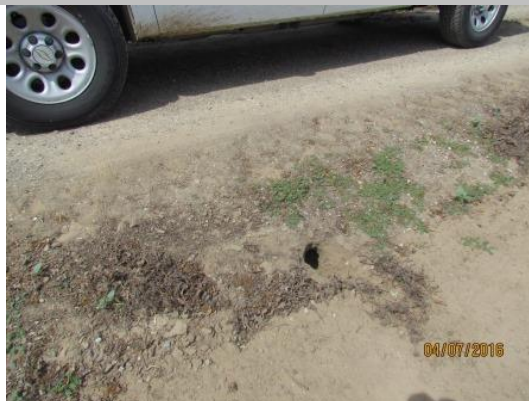
Photo 1 of 1 : SP_2016_RD1602_110_35_20160411_00105.jpg

View of an animal hole on the waterside shoulder of the levee looking downstream.

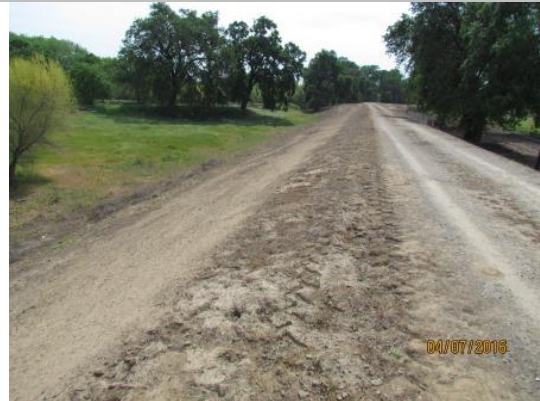
Photo 1 of 1 : SP_2016_RD1602_110_40_20160411_00106.jpg

View of an acceptable vegetation on the waterside slope of the levee looking upstream.

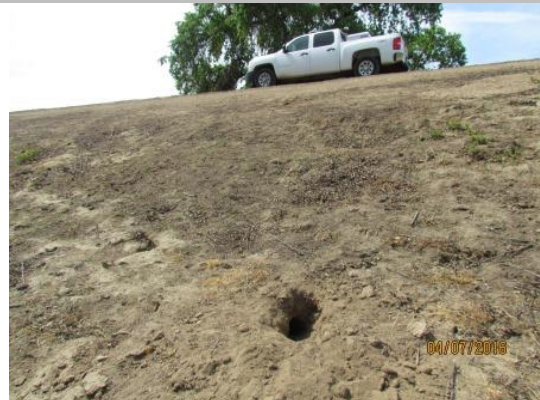
Photo 1 of 1 : SP_2016_RD1602_110_74_20160411_00107.jpg

View of a rodent hole on the waterside toe of the levee.

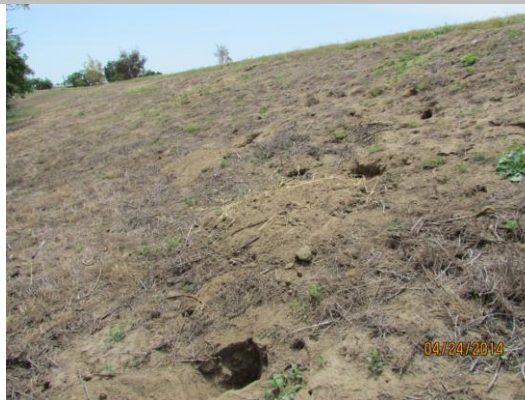
Photo 1 of 1 : SP_2016_RD1602_110_199_20160219_00060.jpg

Rodent holes were found on the waterside toe of the levee looking upstream.

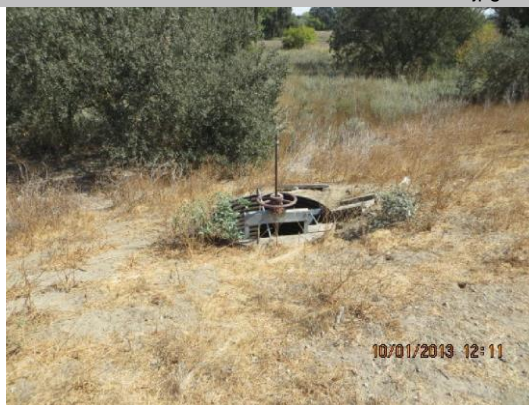
Photo 1 of 2 : UCIP_SP_2016_42983_36822.jpg

Slide gate in CMP riser on WS slope. Outlet visible under tree in background.

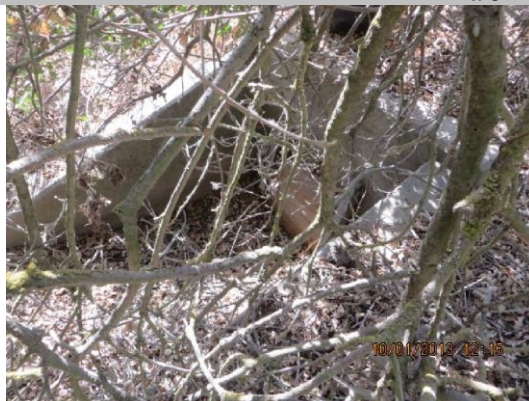
Photo 2 of 2 : UCIP_SP_2016_42983_36821.jpg

Flapgate in Concrete headwall on WS toe under tree.

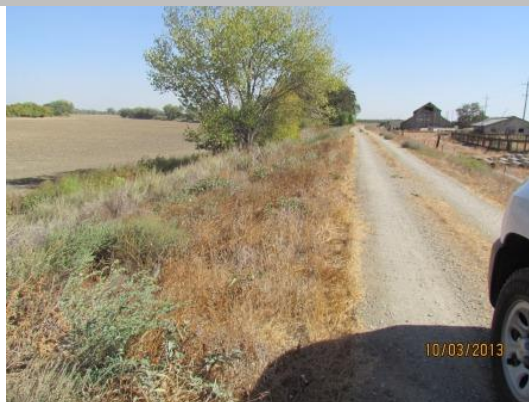
Photo 1 of 2 : SP_2016_RD1602_110_75_20160219_00045.jpg

Vegetation was found on the waterside slope of the levee looking upstream during fall 2013 inspection.

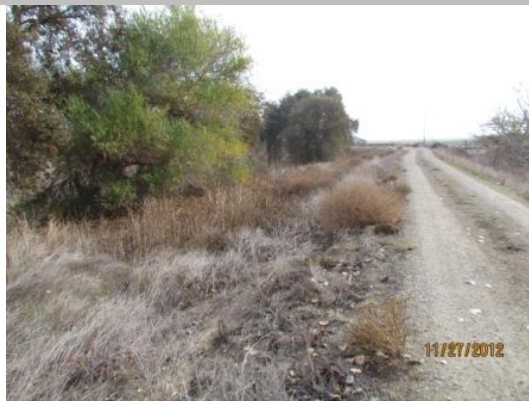
Photo 2 of 2 : SP_2016_RD1602_110_75_20160219_00046.jpg

Overgrown vegetation was found on the waterside slope of the levee looking upstream.

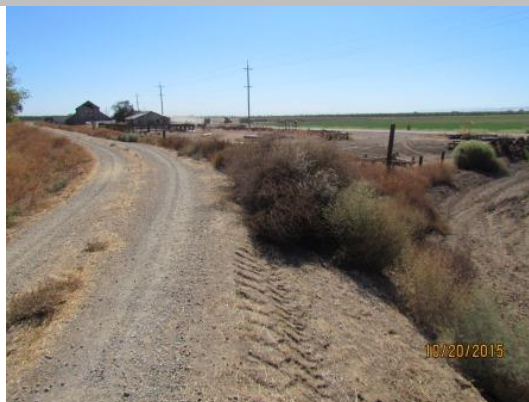
Photo 1 of 1 : SP_2016_RD1602_110_61_20160219_00033.jpg

Vegetation was obstructing the view of the landside of the levee.

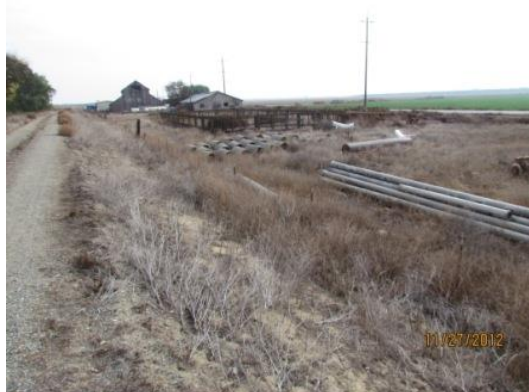
Photo 1 of 1 : SP_2016_RD1602_110_22_20160219_00007.jpg

A fence was found on the landside toe of the levee looking upstream.

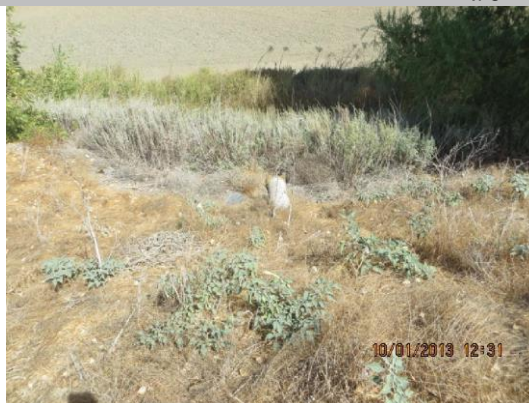
Photo 1 of 1 : UCIP_SP_2016_21674_36854.jpg

Pipe and flapgate visible on WS toe.

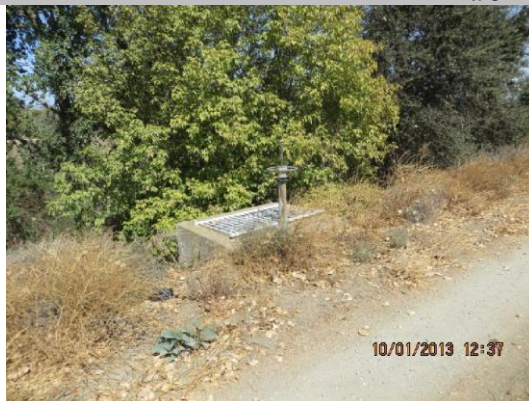
Photo 1 of 2 : UCIP_SP_2016_43100_36878.jpg

Slide gate in concrete riser on WS shoulder.

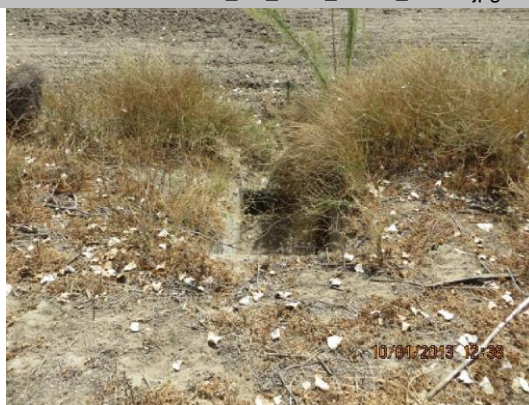
Photo 2 of 2 : UCIP_SP_2016_43100_36877.jpg

Concrete U-shaped headwall on LS toe.

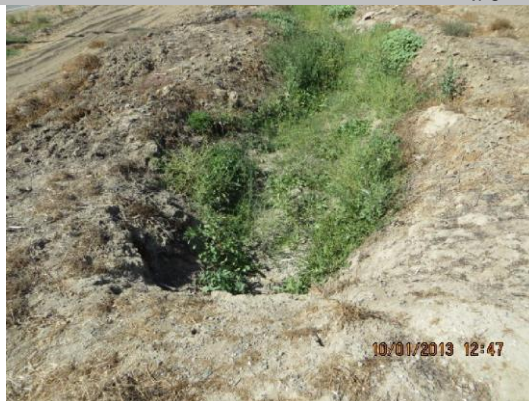
Photo 1 of 2 : UCIP_SP_2016_21683_36882.jpg

Drainage/irrigation canal on LS toe.

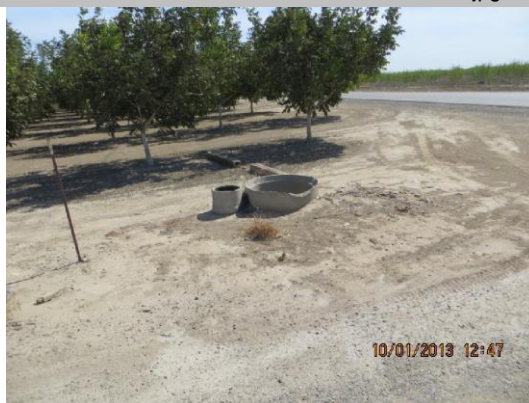
Photo 2 of 2 : UCIP_SP_2016_21683_36881.jpg

36-inch concrete standpipe on WS shoulder.
