**Flood Control Project Maintenance  
Levee Inspections**  
**LMA District Cover Sheet**  
**Spring 2017 Levee Inspection Results**

**Reclamation District No. 1602 Del Puerto**

Waterway			Bank	Unit Miles
Unit No. 01 San Joaquin River			Left	6.24
	Spring (March - May)	Summer (June - August)	(September - November) Fall	Winter (December - February)
Unit Maintenance Rating (Fall Only)				
Date of Inspection	4/6/2017 - 4/6/2017			
DWR Inspector	Pavel Kazi			
Accompanied By	Tony Martinez RD 1602

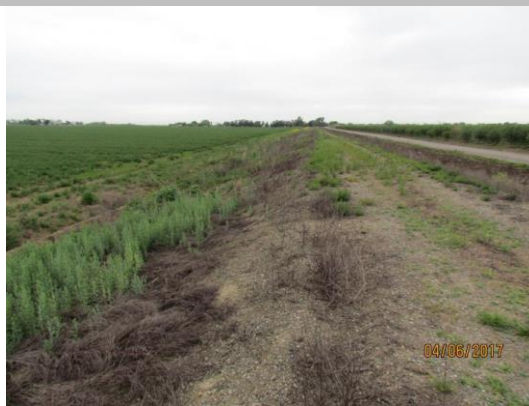
Photo 1 of 1 : SP\_2017\_RD1602\_110\_16\_20170410\_00091.jpg

LM Start	0.13	Rating **	M	Issue No.	16
LM End	0.60	Issue Type +	Ma	Location *	WS
Category	Earthen Levee			GPS Latitude/Longitude	
				Start	End
Item	Vegetation			37.477228 °	37.479964 °
				-121.081733 °	-121.074593 °
DWR ID	DWR_RD1602_01_f_2016_16				
Comment Code					
V1 : Control annual grass and weeds on the levee slopes and easements.					
Inspector Comment

View of the vegetation on the waterside of the levee. Spring 2017

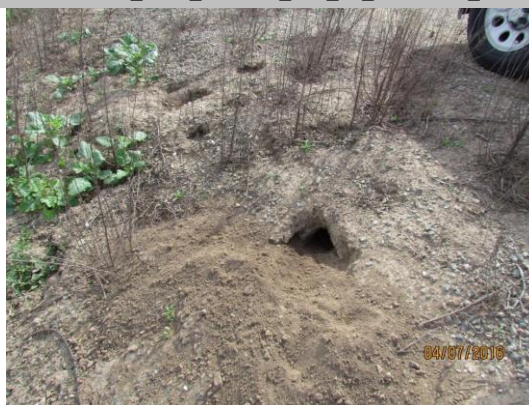
Photo 1 of 2 : SP\_2017\_RD1602\_110\_28\_20170327\_00013.jpg

Updated picture of the rodent hole on the waterside of the levee during spring 2016 inspection.

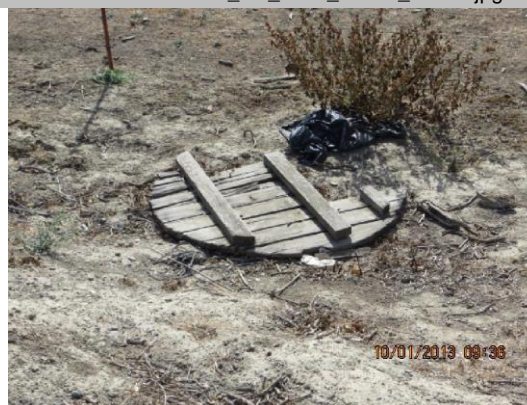
Photo 3 of 3 : UCIP\_SP\_2017\_51325\_36700.jpg

FS\_ID:51325  
DS\_ID:20215  
EP\_NO: N/A  
Repair Type: No Action Needed  
Crossing Status: Found  
UCIP Comments: 11/18/2016 Crossing has been downgraded from Urgent to No Action Needed a cover has been added to the CMP riser. (O. Magana - DWR UCIP)10/01/2013 Open 60-inch CMP riser on WS needs lid as it's depth may be a hazard to the public. (W. Wylie - DWR UCIP)  
FIELD\_STRUCT\_DESC: 16-inch steel drainage pipe through levee, 11.3 feet below crown. Slide gate in 60-inch corrugated metal pipe (CMP) riser located on the waterside (WS). Concrete inlet is approximately 110 feet west of the levee crown or 110 feet off landside (LS) toe next to roadway. [Additional Reference(s): DWR Levee Log, 1992. USACE San Joaquin River O&M Manual Unit 13, April 1964, (HLM 0.58), Drawing No. 7-4-1784].  
FS Date: 11/18/2016

Damaged Wooden lid on WS toe.

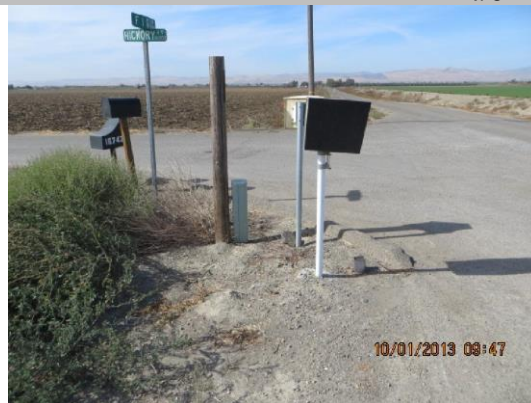
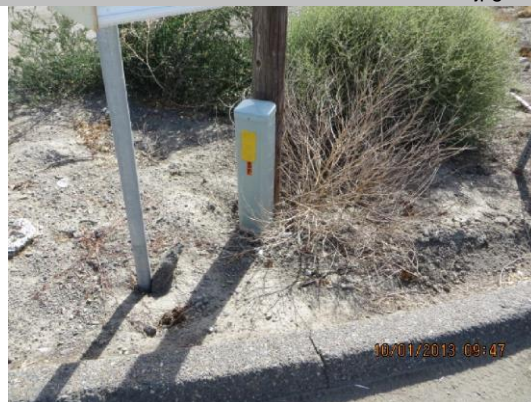
LM Start	0.58	Rating **	M	Issue No.	201
LM End	0.58	Issue Type +	En	Location *	WS
Category	Supplemental			GPS Latitude/Longitude	
				Start	End
Item	DWR UCIP Field Study			37.480176 °	37.480176 °
				-121.074736 °	-121.074736 °
DWR ID					
Comment Code					
Inspector Comment					
FS_ID:22937 DS_ID:24681 EP_NO: N/A Repair Type: Non-Urgent Crossing Status: Found UCIP Comments: No permit identified for this crossing. FIELD_STRUCT_DESC: Communication line through the levee at an unknown depth. FS Date: 10/1/2013

Communication line access box on LS shoulder.

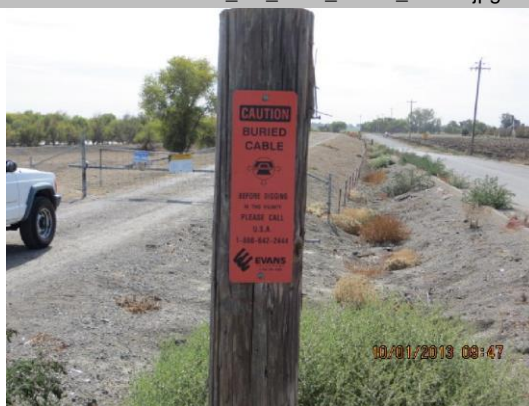
Photo 3 of 3 : UCIP\_SP\_2017\_22937\_39048.jpg

LM Start	0.58	Rating **	M	Issue No.	201 (cont)	
LM End	0.58	Issue Type +	En	Location *	WS	
Category	Supplemental			GPS Latitude/Longitude		
				Start		End
Item	DWR UCIP Field Study			37.480176 °	37.480176 °	
				-121.074736 °	-121.074736 °	
DWR ID						
Comment Code						
Inspector Comment						
FS_ID:22937 DS_ID:24681 EP_NO: N/A Repair Type: Non-Urgent Crossing Status: Found UCIP Comments: No permit identified for this crossing. FIELD_STRUCT_DESC: Communication line through the levee at an unknown depth. FS Date: 10/1/2013

Communication line marker on LS shoulder.

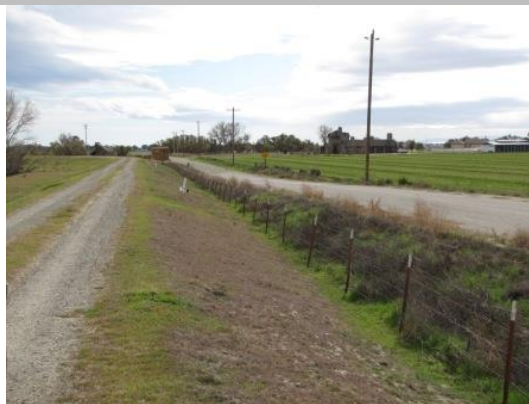
Photo 1 of 1 : SP\_2017\_RD1602\_110\_70\_20170327\_00042.jpg

LM Start	0.60	Rating **	M	Issue No.	70
LM End	0.71	Issue Type +	En	Location *	WS
Category	Earthen Levee			GPS Latitude/Longitude	
				Start	End
Item	Encroachments			37.479967 °	37.478514 °
				-121.074582 °	-121.073435 °
DWR ID	DWR_RD1602_01_s_2012_70				
Comment Code					
FE : Fence					
Inspector Comment					
Barbed wire fence along the landward toe.

View of barbed wire fence at landward toe looking upstream.

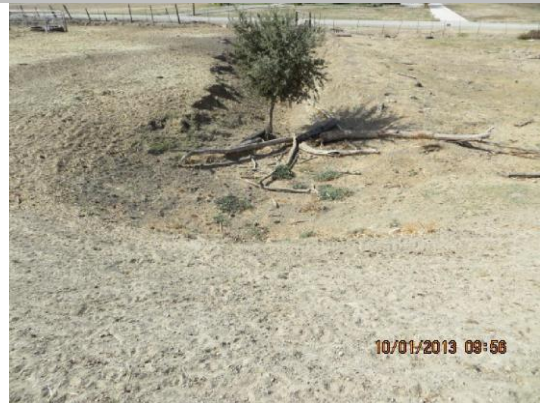
Photo 1 of 3 : UCIP\_SP\_2017\_51634\_36723.jpg

Comment Code					
Inspector Comment					
FS_ID:51634 DS_ID:20216 EP_NO: N/A Repair Type: No Action Needed Crossing Status: Found UCIP Comments: 11/18/2016 Crossing has been downgraded from Urgent to No Action Needed the debris blocking the outlet has been cleared. (O. Magana - DWR UCIP)10/01/2013 Flap gate blocked from functioning by soil buildup on WS toe. Soil should be cleared. (W. Wylie - DWR UCIP) FIELD_STRUCT_DESC: 30-inch square reinforced concrete box culvert through levee, 14.4 feet below crown. Concrete "U" headwall on the waterside (WS) and landside (LS) ends. Slide gate in 6-foot by 7-foot concrete surge box is located on the WS shoulder. Flap gate is located on the WS end. [Additional Reference(s): DWR Levee Log, 1992. USACE San Joaquin River O&M Manual Unit 13, April 1964, (HLM 0.78), Drawing No. 7-4-1784]. FS Date: 11/18/2016

Inlet on LS toe.

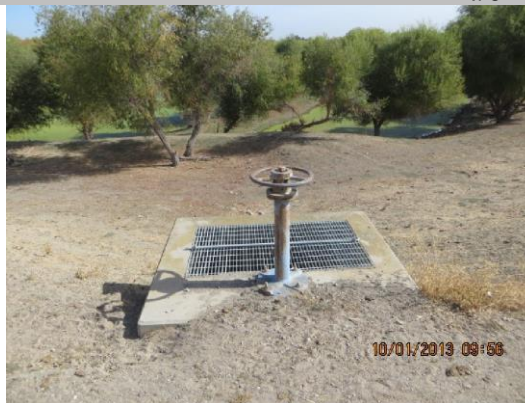
Photo 2 of 3 : UCIP\_SP\_2017\_51634\_36722.jpg

Comment Code					
Inspector Comment					
FS_ID:51634 DS_ID:20216 EP_NO: N/A Repair Type: No Action Needed Crossing Status: Found UCIP Comments: 11/18/2016 Crossing has been downgraded from Urgent to No Action Needed the debris blocking the outlet has been cleared. (O. Magana - DWR UCIP)10/01/2013 Flap gate blocked from functioning by soil buildup on WS toe. Soil should be cleared. (W. Wylie - DWR UCIP) FIELD_STRUCT_DESC: 30-inch square reinforced concrete box culvert through levee, 14.4 feet below crown. Concrete "U" headwall on the waterside (WS) and landside (LS) ends. Slide gate in 6-foot by 7-foot concrete surge box is located on the WS shoulder. Flap gate is located on the WS end. [Additional Reference(s): DWR Levee Log, 1992. USACE San Joaquin River O&M Manual Unit 13, April 1964, (HLM 0.78), Drawing No. 7-4-1784]. FS Date: 11/18/2016

Slide gate in concrete box on WS shoulder.

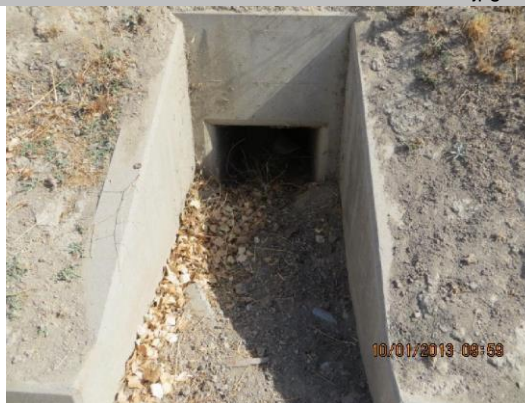
Photo 3 of 3 : UCIP\_SP\_2017\_51634\_36721.jpg

LM Start	<b>0.77</b>	Rating **	A/W	Issue No.	<b>202 (cont)</b>
LM End	<b>0.77</b>	Issue Type +	Ma	Location *	WS

Concrete inlet on LS toe.

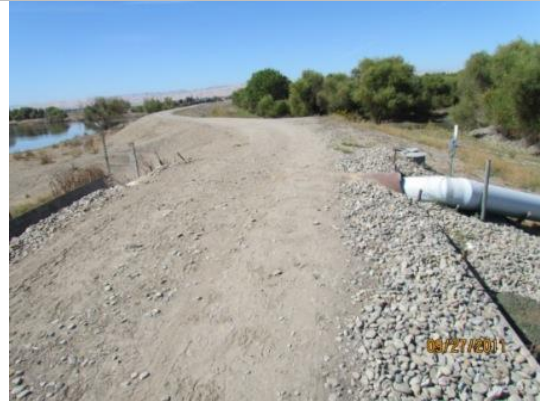
Photo 1 of 1 : SP\_2017\_RD1602\_110\_36\_20170327\_00018.jpg

View of the ramp on the crown. The picture was taken from crown looking downstream.

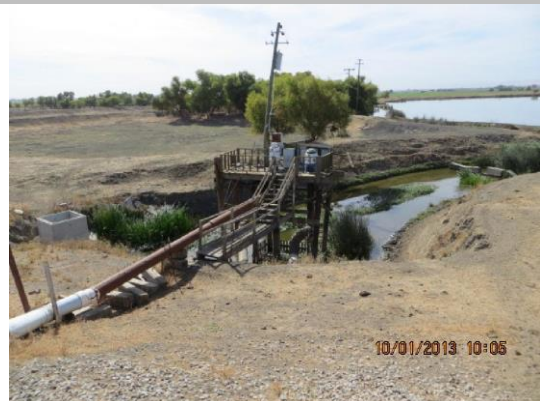
Photo 1 of 3 : UCIP\_SP\_2017\_51636\_36758.jpg

Comment Code					
Inspector Comment					
FS_ID:51636 DS_ID:20217 EP_NO: N/A Repair Type: Non-Urgent Crossing Status: Found UCIP Comments: 11/18/2016 Crossing has been downgraded from Urgent to Non-Urgent a flap gate has been added to the WS but pipe is currently not connected to pump. According to Tony Martinez, LMA representative, this crossing is currently not in use. Owner will need to coordinate with CVFPB to obtain permit. (O. Magana - DWR UCIP)10/01/2013 Appears abandoned and if so should be done so properly. Flapgate missing. (W. Wylie - DWR UCIP) FIELD_STRUCT_DESC: *ABANDONED* 1 of 2: 16-inch steel drainage pipe through levee, 17 feet below crown. Pumps on the pump platform are located on the landside (LS). Siphon breaker in 24-inch corrugated metal pipe (CMP) riser is located on the waterside (WS) shoulder. Concrete "U" headwall and flap gate are located on the WS end. [Additional Reference(s): DWR Levee Log, 1992. USACE San Joaquin River O&M Manual Unit 13, April 1964, (HLM 1.01), Drawing No. 7-4-1784]. FS Date: 11/18/2016

Pumping plant on LS toe. Pipe visible under walkway.

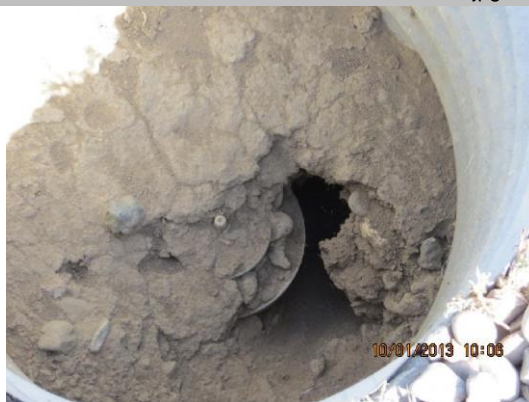
Photo 3 of 3 : UCIP\_SP\_2017\_51636\_36756.jpg

FS\_ID:51636  
DS\_ID:20217  
EP\_NO: N/A  
Repair Type: Non-Urgent  
Crossing Status: Found  
UCIP Comments: 11/18/2016 Crossing has been downgraded from Urgent to Non-Urgent a flap gate has been added to the WS but pipe is currently not connected to pump. According to Tony Martinez, LMA representative, this crossing is currently not in use. Owner will need to coordinate with CVFPB to obtain permit. (O. Magana - DWR UCIP)10/01/2013 Appears abandoned and if so should be done so properly. Flapgate missing. (W. Wylie - DWR UCIP)  
FIELD\_STRUCT\_DESC: \*ABANDONED\* 1 of 2: 16-inch steel drainage pipe through levee, 17 feet below crown. Pumps on the pump platform are located on the landside (LS). Siphon breaker in 24-inch corrugated metal pipe (CMP) riser is located on the waterside (WS) shoulder. Concrete "U" headwall and flap gate are located on the WS end.  
[Additional Reference(s): DWR Levee Log, 1992. USACE San Joaquin River O&M Manual Unit 13, April 1964, (HLM 1.01), Drawing No. 7-4-1784].

Siphon breaker in 24-inch CMP riser on WS shoulder.

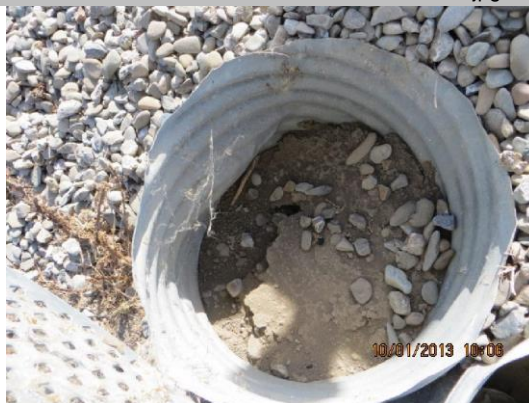
Photo 2 of 3 : UCIP\_SP\_2017\_51637\_36771.jpg

FS\_ID:51637  
DS\_ID:20219  
EP\_NO: N/A  
Repair Type: Non-Urgent  
Crossing Status: Found  
UCIP Comments: 11/18/2016 Crossing has been downgraded from Urgent to Non-Urgent a flap gate has been added to the WS. According to Tony Martinez, LMA representative, this crossing is currently not in use. Owner will need to coordinate with CVFPB to obtain permit. (O. Magana - DWR UCIP)10/01/2013 Appears abandoned siphon breakers covered in soil and flapgate missing. (W. Wylie - DWR UCIP) FIELD\_STRUCT\_DESC: \*ABANDONED\* 2 of 2: 16-inch steel drainage pipe through levee, 17 feet below crown. Pump on pump platform located on the landside (LS). Siphon breaker in 24-inch riser located on the waterside (WS) shoulder. Concrete "U" headwall and flap gate are located on the WS end. [Additional Reference(s): DWR Levee Log, 1992. USACE San Joaquin River O&M Manual Unit 13, April 1964, (HLM 1.01), Drawing No. 7-4-1784].

Siphon breaker covered in soil at CMP riser on WS shoulder.

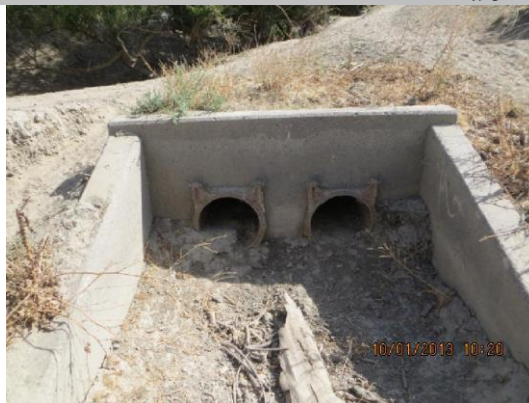
Photo 3 of 3 : UCIP\_SP\_2017\_51637\_36770.jpg

Item	DWR UCIP LMA Responsibility			37.478817 °	37.478817 °	
				-121.068773 °	-121.068773 °	
DWR ID						
Comment Code						
Inspector Comment						
FS_ID:51637						
DS_ID:20219						
EP_NO: N/A						
Repair Type: Non-Urgent						
Crossing Status: Found						
UCIP Comments: 11/18/2016 Crossing has been downgraded from Urgent to Non-Urgent a flap gate has been added to the WS. According to Tony Martinez, LMA representative, this crossing is currently not in use. Owner will need to coordinate with CVFPB to obtain permit. (O. Magana - DWR UCIP)10/01/2013 Appears abandoned siphon breakers covered in soil and flapgate missing. (W. Wylie - DWR UCIP) FIELD_STRUCT_DESC: *ABANDONED* 2 of 2: 16-inch steel drainage pipe through levee, 17 feet below crown. Pump on pump platform located on the landside (LS). Siphon breaker in 24-inch riser located on the waterside (WS) shoulder. Concrete "U" headwall and flap gate are located on the WS end. [Additional Reference(s): DWR Levee Log, 1992. USACE San Joaquin River O&M Manual Unit 13, April 1964, (HLM 1.01), Drawing No. 7-4-1784].

Concrete headwall on WS toe with missing flapgate.

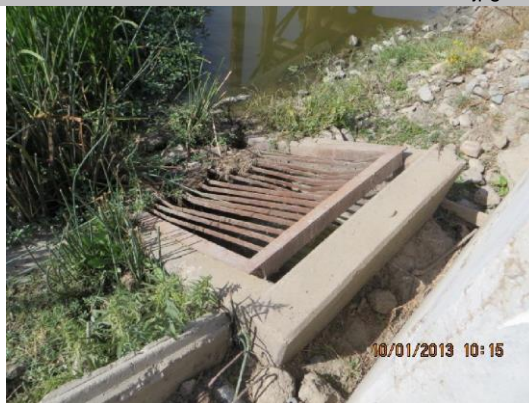
Photo 2 of 3 : UCIP\_SP\_2017\_51329\_36785.jpg

FS\_ID:51329  
DS\_ID:20218  
EP\_NO: N/A  
Repair Type: Urgent  
Crossing Status: Found  
UCIP Comments: 11/18/2016 Same as previous inspection headwall on the WS toe has separated from pipe and flap gate is still missing. Erosion around concrete headwall and undermined WS slope are visible from WS. The slope undermined appears to have progressed but no photos were taken due to the dense vegetation covering area. According to Tony Martinez, LMA representative, the WS concrete headwall has been detached since 2008/2009. LMA has been in contact with CVFPB, DWR, and USACE regarding this site. (O. Magana - DWR UCIP)10/01/2013 Headwall on WS toe separated from pipe. Erosion around concrete headwall and undermined at WS toe. Flap gate missing from WS toe headwall. (W. Wylie - DWR UCIP) FIELD\_STRUCT\_DESC: 30-inch square reinforced concrete box culvert through levee, 25.4 feet below crown. Concrete "U" headwalls on both waterside (WS) and landside (LS) ends. Slide gate in concrete surge box located on the WS slope. A 5-foot by 5-foot concrete box is located on LS toe. Flap gate is located on the WS end. [Additional Reference(s): DWR Levee Log, 1992. USACE San Joaquin River O&M Manual Unit 13, April 1964, (HLM 1.02), Drawing No. 7-4-1784]. FS Date: 11/18/2016

Grated inlet at LS toe.

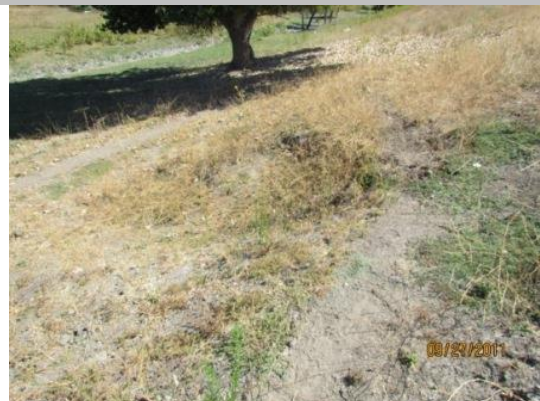
Photo 1 of 2 : SP\_2017\_RD1602\_110\_37\_20170327\_00019.jpg

LM Start	1.05	Rating **	M	Issue No.	37
LM End	1.05	Issue Type +	Ma	Location *	WS
Category	Earthen Levee			GPS Latitude/Longitude	
				Start	End
Item	Slope Stability			37.478567 °	37.478567 °
				-121.067847 °	-121.067847 °
DWR ID	DWR_RD1602_01_s_2012_37				
Comment Code					
S1 : Repair slope instability.					
Inspector Comment					
Small amount of slumping at waterside toe of the levee.

View of the depression at the waterside toe of the levee. The picture was taken from the crown of the levee looking upstream during fall 2011 inspection.

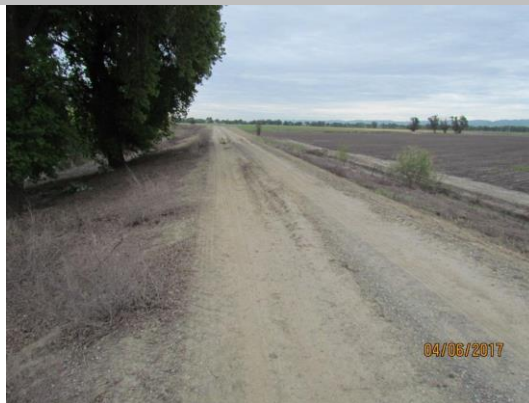
Photo 1 of 1 : SP\_2017\_RD1602\_110\_76\_20170410\_00094.jpg

LM Start	1.89	Rating **	M	Issue No.	76
LM End	1.89	Issue Type +	Ma	Location *	CR
Category	Earthen Levee			GPS Latitude/Longitude	
				Start	End
Item	Crown Surface / Depressions / Rutting			37.473718 °	37.473718 °
				-121.057926 °	-121.057926 °
DWR ID	DWR_RD1602_01_s_2017_76				
Comment Code					
C2 : Repair depressions or ruts in the crown or slope.					
Inspector Comment

View of crown depression on the levee looking upstream.

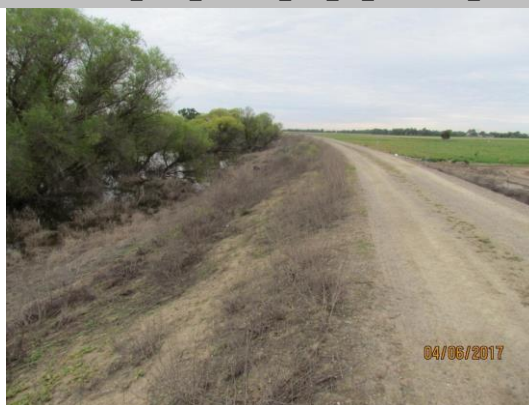
Photo 1 of 1 : SP\_2017\_RD1602\_110\_78\_20170410\_00095.jpg

View of the vegetation on the waterside of the levee.

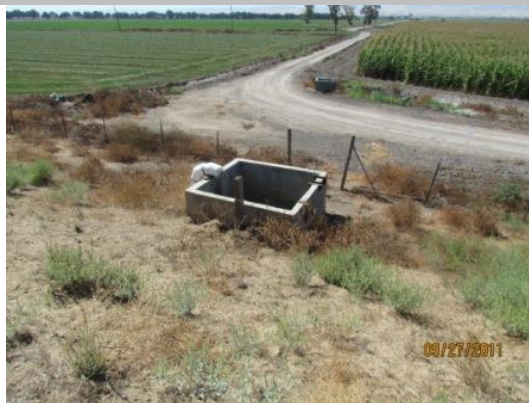
Photo 1 of 1 : SP\_2017\_RD1602\_110\_45\_20170327\_00025.jpg

A well is located at the landside toe of the levee. The picture was taken from the crown looking toward the landside of the levee.

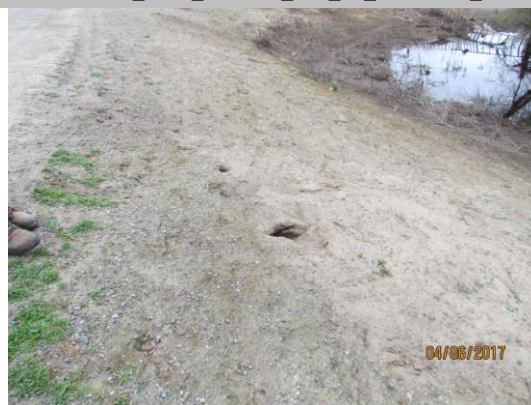
Photo 1 of 1 : SP\_2017\_RD1602\_110\_81\_20170410\_00096.jpg

View of a rodent hole on the waterside slope of the levee.

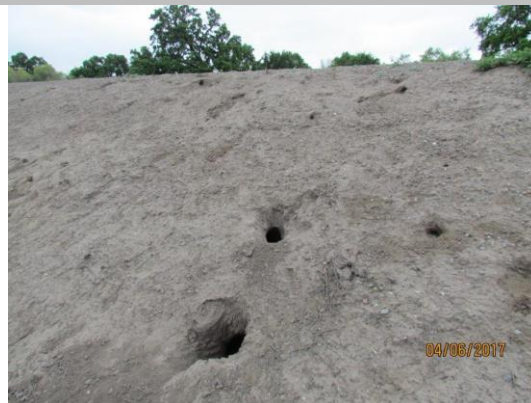
Photo 1 of 2 : SP\_2017\_RD1602\_110\_40\_20170410\_00097.jpg

Updated picture of the rodent holes on the landside of the levee during spring 2017 inspection.

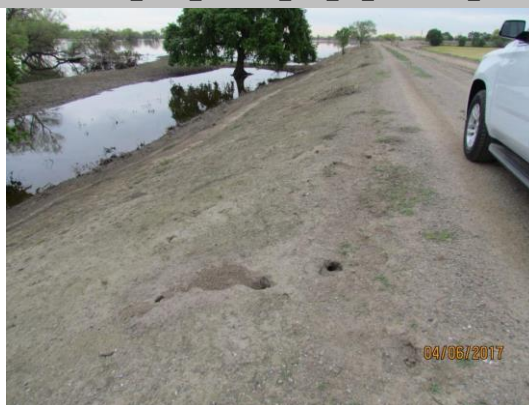
Photo 1 of 1 : SP\_2017\_RD1602\_110\_82\_20170410\_00098.jpg

View of rodent holes on the waterside slope of the levee. Spring 2017

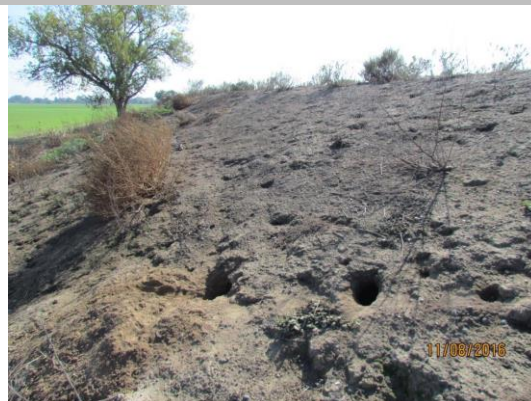
Photo 1 of 1 : SP\_2017\_RD1602\_110\_47\_20170327\_00026.jpg

View of rodent holes on the waterside of the levee. Fall 2016

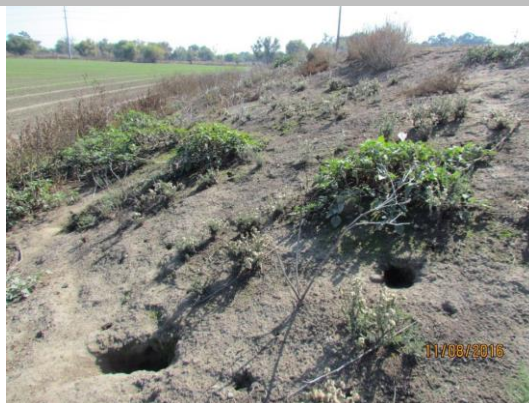
Photo 1 of 1 : SP\_2017\_RD1602\_110\_25\_20170327\_00011.jpg

View of rodent holes on the waterside toe of the levee looking upstream.  
Fall 2016

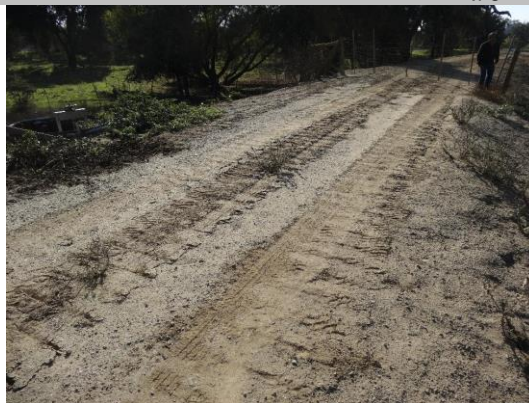
Photo 3 of 3 : UCIP\_SP\_2017\_51330\_76527.jpg

Overview of levee crown at pipe crossing.

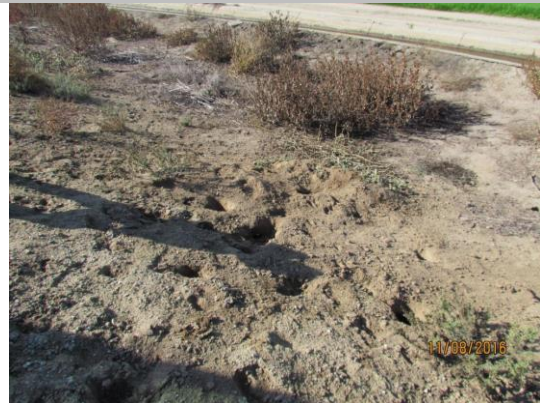
Photo 1 of 1 : SP\_2017\_RD1602\_110\_56\_20170327\_00031.jpg

View of rodent holes on the landside of the levee. Fall 2016

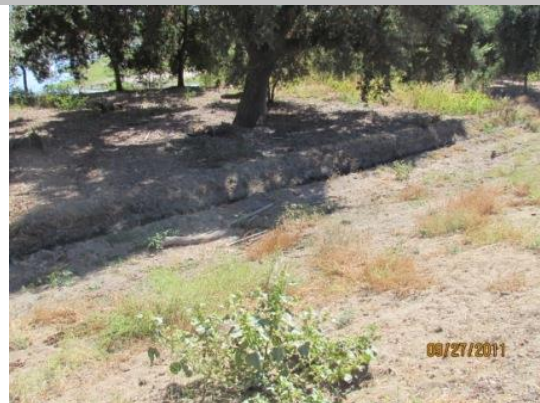
Photo 1 of 1 : SP\_2017\_RD1602\_110\_50\_20170327\_00028.jpg

A ditch was located on the waterside toe of the levee. The picture was taken from the crown looking upstream.

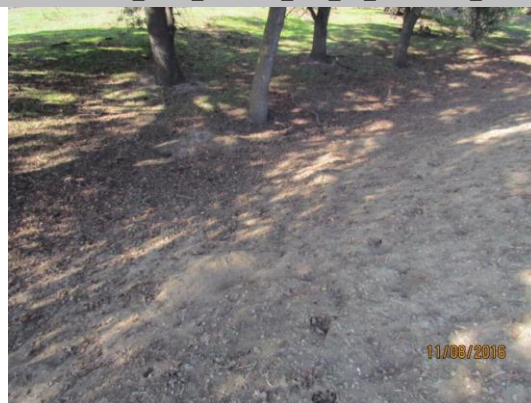
Photo 1 of 1 : SP\_2017\_RD1602\_110\_60\_20170327\_00033.jpg

View of rodent hole on the landside toe of the levee. Fall 2016

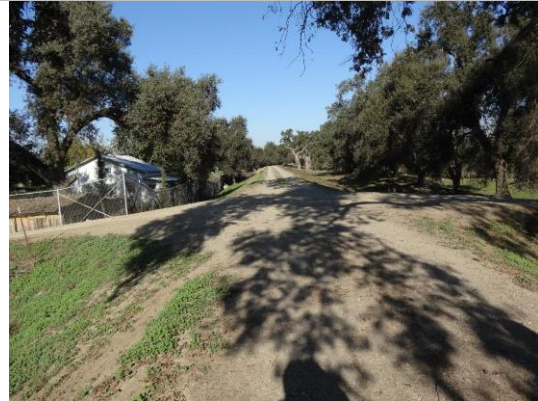
Photo 1 of 3 : UCIP\_SP\_2017\_51331\_76534.jpg

Overview of levee crown at pipe crossing.

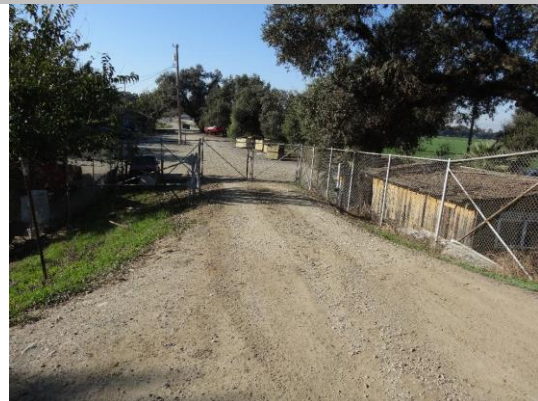
Photo 2 of 3 : UCIP\_SP\_2017\_51331\_76535.jpg

View of LS.

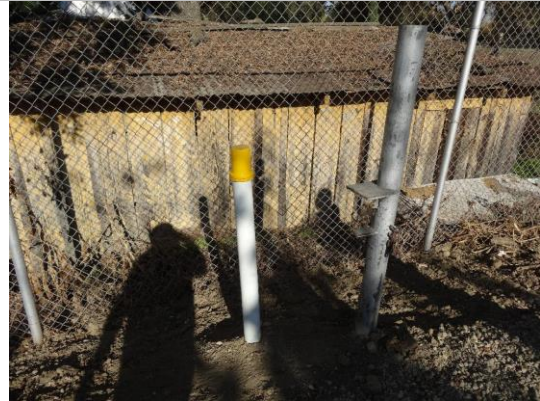
Photo 3 of 3 : UCIP\_SP\_2017\_51331\_76536.jpg

PVC riser with yellow cover located along fence on LS.

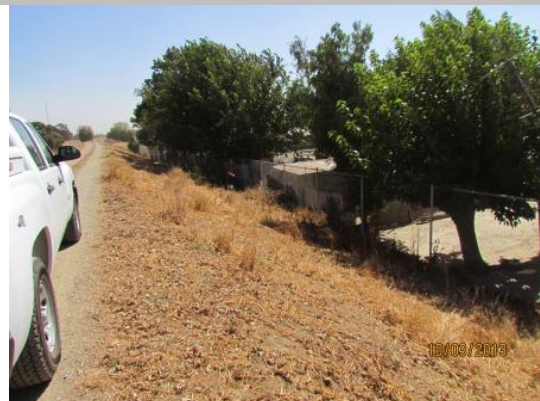
Photo 1 of 1 : SP\_2017\_RD1602\_110\_66\_20170327\_00040.jpg

Fences were found on the landside toe of the levee looking upstream.

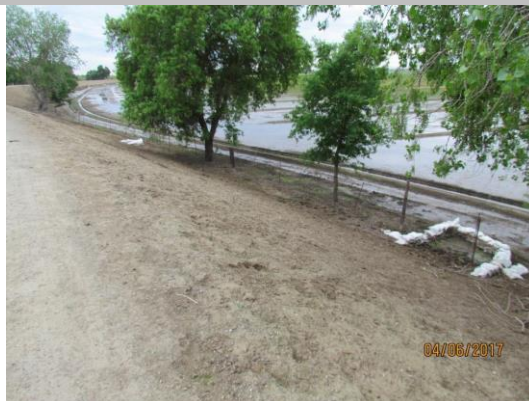
Photo 1 of 1 : SP\_2017\_RD1602\_110\_86\_20170410\_00101.jpg

View of sack rings on the landside toe of the levee. Spring 2017

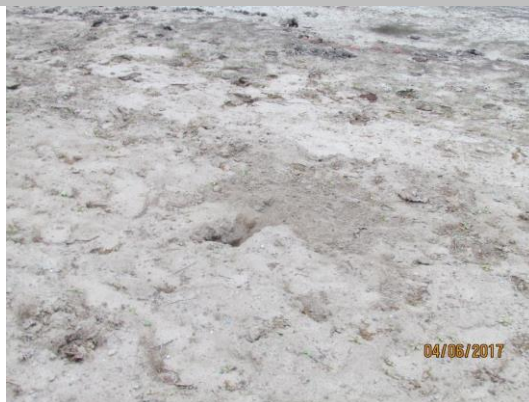
Photo 1 of 1 : SP\_2017\_RD1602\_110\_88\_20170410\_00103.jpg

View of a rodent hole on the waterside slope of the levee.

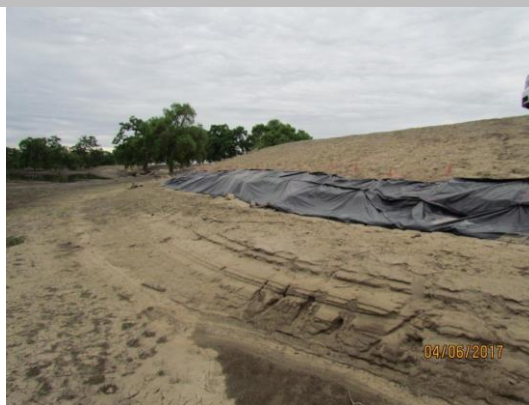
Photo 2 of 2 : SP\_2017\_RD1602\_110\_89\_20170410\_00105.jpg

Another view of wave wash installed by the LMA on the waterside toe of the levee. Spring 2017

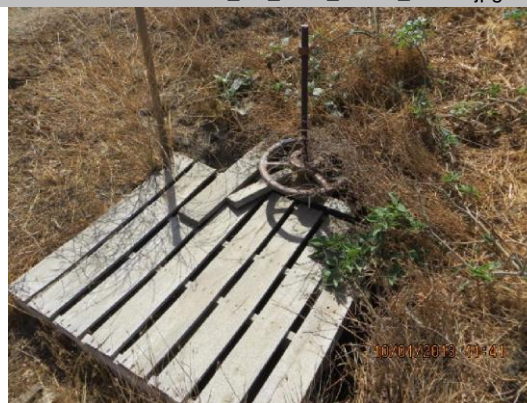
Photo 2 of 3 : UCIP\_SP\_2017\_51332\_36818.jpg

Slide gate in CMP riser on WS slope.

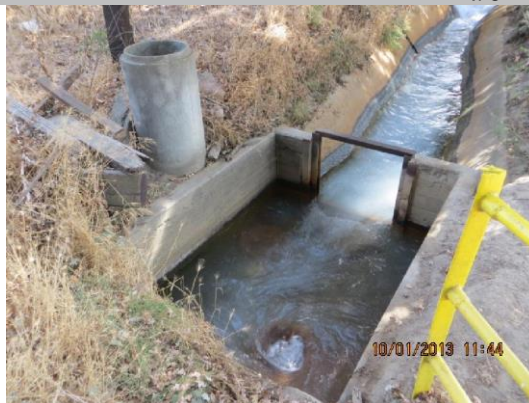
Photo 3 of 3 : UCIP\_SP\_2017\_51332\_36817.jpg

Concrete ditch at outlet from pipe on LS toe.

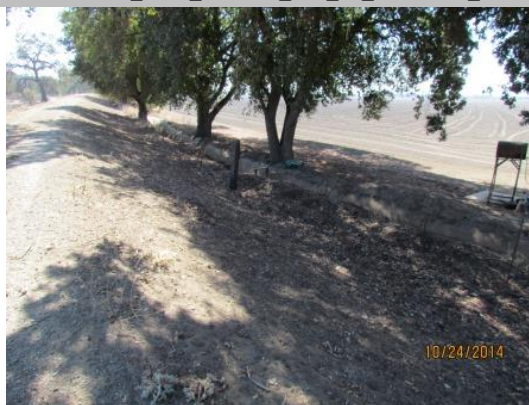
Photo 1 of 1 : SP\_2017\_RD1602\_110\_64\_20170327\_00037.jpg

View of a ditch on the landside toe of the levee looking upstream.

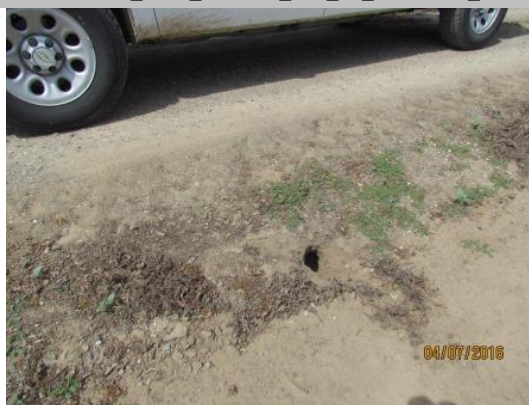
Photo 1 of 1 : SP\_2017\_RD1602\_110\_35\_20170327\_00017.jpg

View of an animal hole on the waterside shoulder of the levee looking downstream.

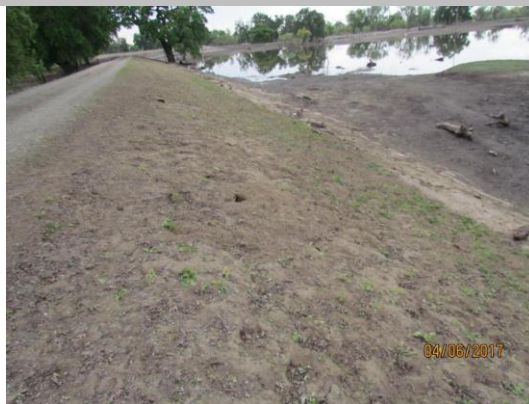
Photo 1 of 1 : SP\_2017\_RD1602\_110\_91\_20170410\_00106.jpg

View of rodent holes on the waterside of the levee looking downstream. Spring 2017

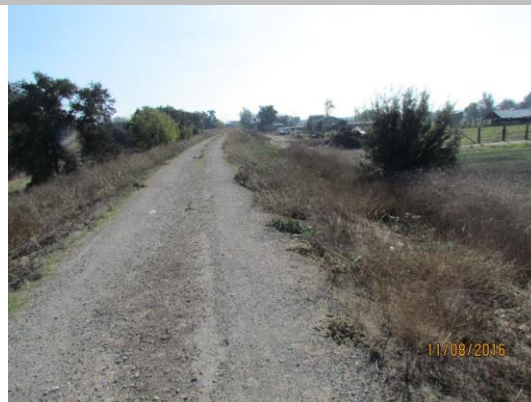
Photo 1 of 1 : SP\_2017\_RD1602\_110\_73\_20170327\_00043.jpg

View of vegetation on the landside slope of the levee. Fall 2016

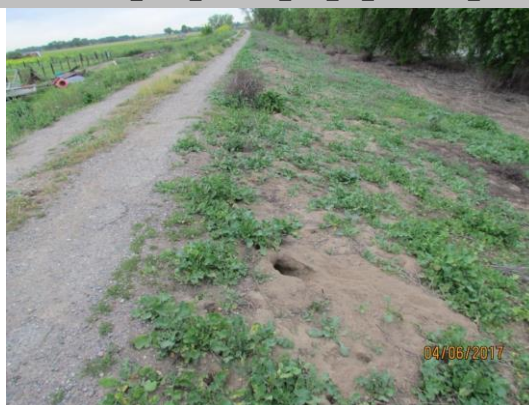
Photo 1 of 1 : SP\_2017\_RD1602\_110\_92\_20170410\_00107.jpg

View of a rodent hole on the waterside shoulder of the levee looking downstream.

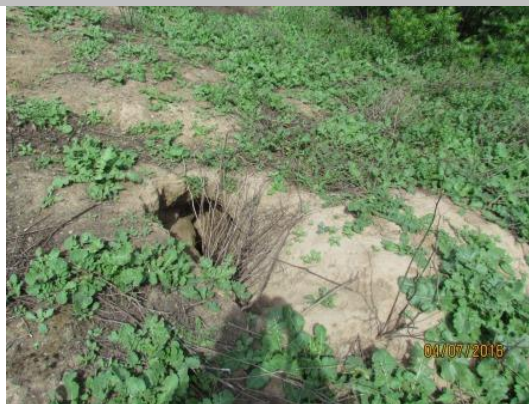
Photo 1 of 1 : SP\_2017\_RD1602\_110\_48\_20170327\_00027.jpg

View of rodent holes on the waterside of the levee looking downstream.

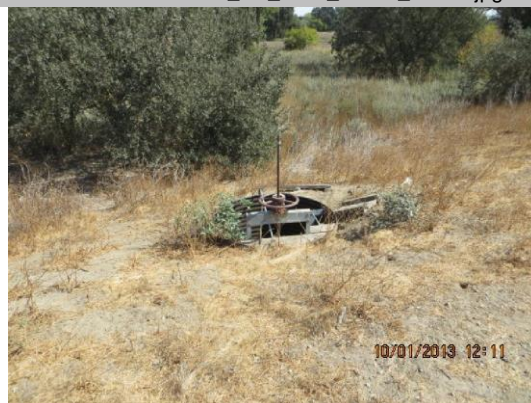
Photo 1 of 3 : UCIP\_SP\_2017\_51336\_36822.jpg

Slide gate in CMP riser on WS slope. Outlet visible under tree in background.

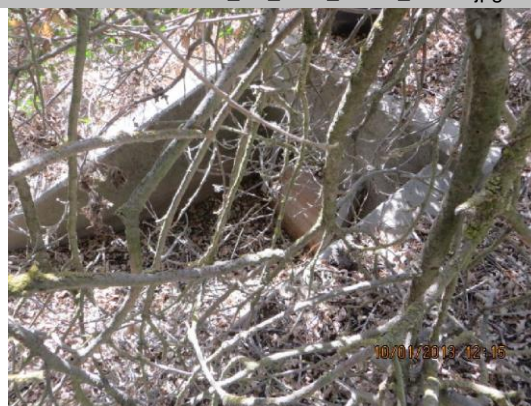
Photo 2 of 3 : UCIP\_SP\_2017\_51336\_36821.jpg

Flapgate in Concrete headwall on WS toe under tree.

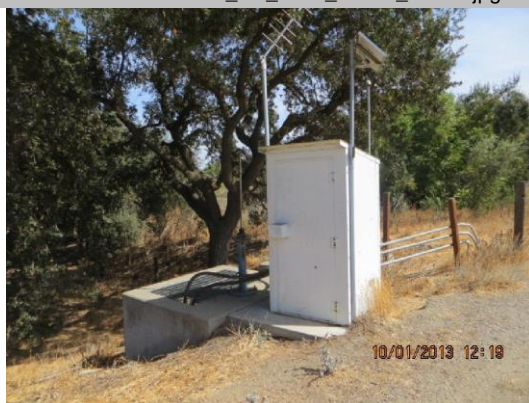
Photo 1 of 2 : UCIP\_SP\_2017\_21665\_36829.jpg

Shed with slide gate in Concrete riser on WS shoulder.

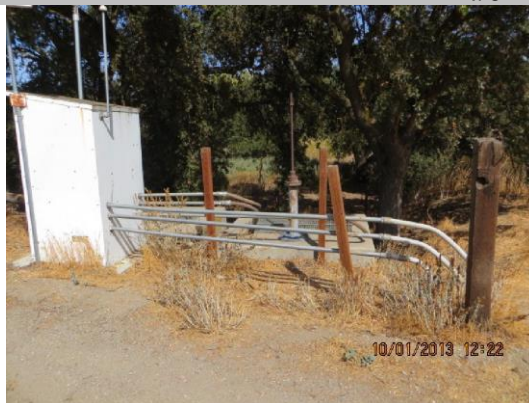
Photo 1 of 2 : UCIP\_SP\_2017\_21668\_36835.jpg

Slide gate in Concrete vault on WS shoulder.

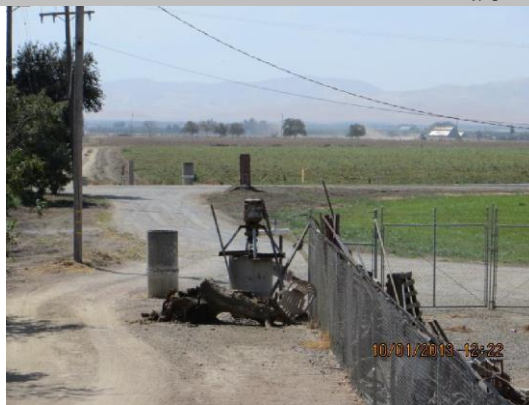
Photo 2 of 2 : UCIP\_SP\_2017\_21668\_36834.jpg

Possible concrete risers for pipe off LS toe.

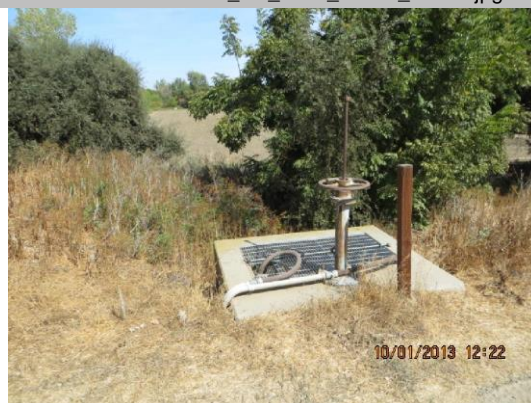
Photo 1 of 3 : UCIP\_SP\_2017\_21672\_36848.jpg

Slidegate in concrete riser on WS shoulder.

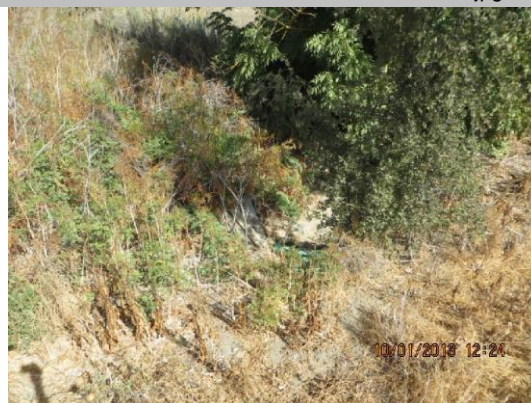
Photo 2 of 3 : UCIP\_SP\_2017\_21672\_36847.jpg

Concrete outlet on WS toe.

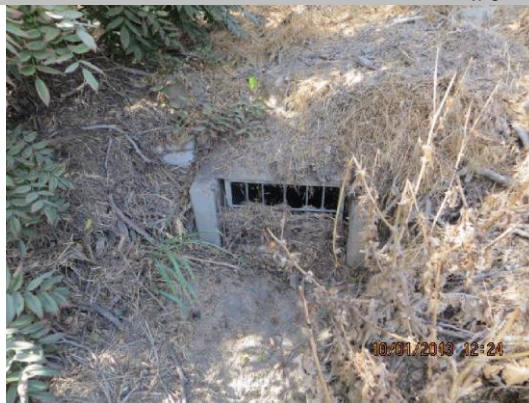
Photo 3 of 3 : UCIP\_SP\_2017\_21672\_36846.jpg

Concrete inlet on LS toe.

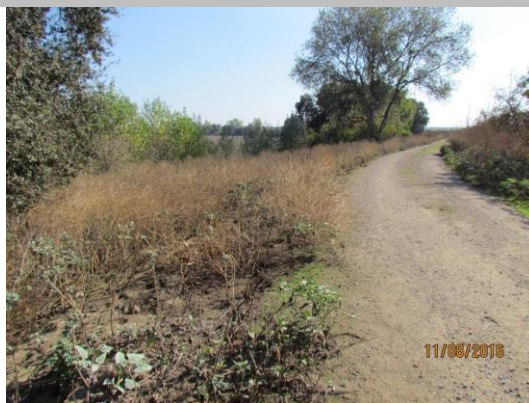
Photo 1 of 1 : SP\_2017\_RD1602\_110\_75\_20170327\_00045.jpg

Vegetation was found on the waterside slope of the levee looking upstream during fall 2016 inspection.

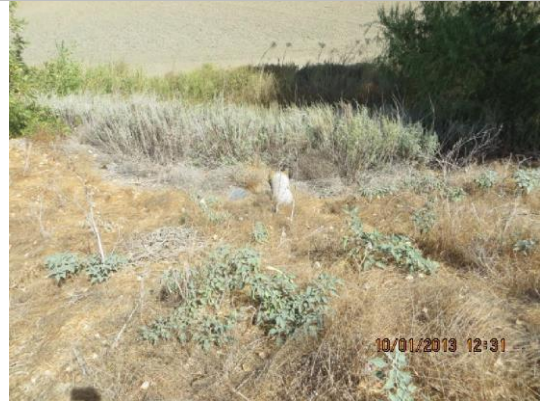
Photo 1 of 1 : UCIP\_SP\_2017\_21674\_36854.jpg

Pipe and flapgate visible on WS toe.

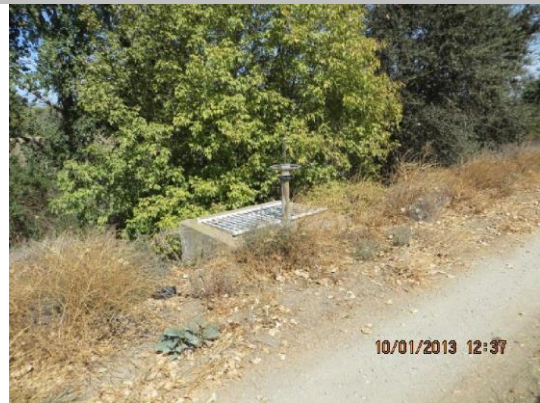
Photo 1 of 3 : UCIP\_SP\_2017\_51337\_36878.jpg

Slide gate in concrete riser on WS shoulder.

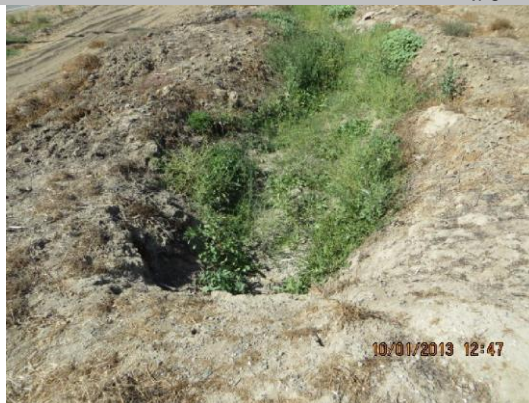
Photo 1 of 3 : UCIP\_SP\_2017\_21683\_36882.jpg

Drainage/irrigation canal on LS toe.

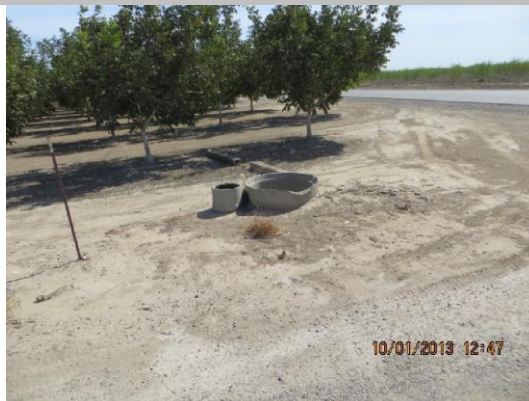
Photo 2 of 3 : UCIP\_SP\_2017\_21683\_36881.jpg

36-inch concrete standpipe on WS shoulder.

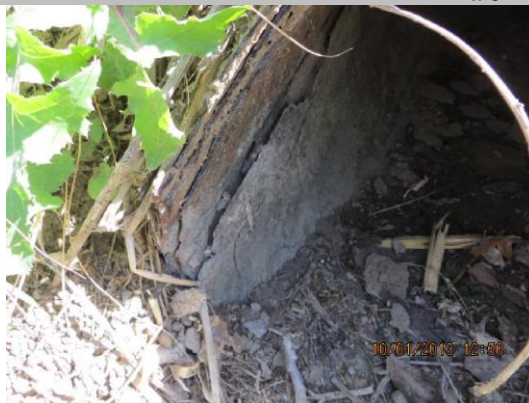
Photo 3 of 3 : UCIP\_SP\_2017\_21683\_36880.jpg

Pipe deteriorated on LS at outlet.
