**Flood Control Project Maintenance
Levee Inspections**
LMA District Cover Sheet
Spring 2018 Levee Inspection Results

Reclamation District No. 1602 Del Puerto

Spring 2018 Levee Inspection Results

Waterway			Bank	Unit Miles
Unit No. 01 San Joaquin River			Left	6.24
	Spring (March - May)	Summer (June - August)	(September - November) Fall	Winter (December - February)
Unit Maintenance Rating (Fall Only)				
Date of Inspection	3/13/2018 - 3/13/2018			
DWR Inspector	Richard Willoughby			
Accompanied By	Tony Martinez RD 1602

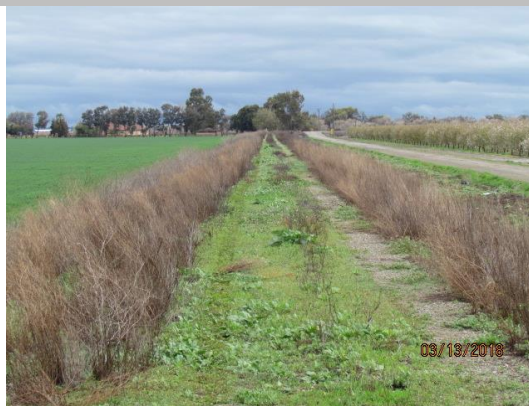
Photo 1 of 1 : SP_2018_RD1602_110_73_20180323_00101.jpg

LM Start	0.13	Rating **	M	Issue No.	73
LM End	6.23	Issue Type +	Ma	Location *	CR
Category	Earthen Levee			GPS Latitude/Longitude	
				Start	End
Item	Crown Surface / Depressions / Rutting			37.477229 °	37.429111 °
				-121.081894 °	-121.029755 °
DWR ID	DWR_RD1602_01_s_2018_73				
Comment Code					
C3 : Add appropriate gravel or road base. Grade and compact.					
Inspector Comment					
Need to control veg. on levee crown and add appropriate gravel

Looking upstream of levee crown.

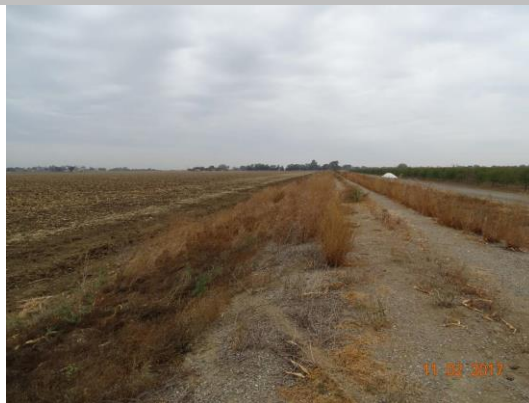
Photo 1 of 1 : SP_2018_RD1602_110_26_20180307_00009.jpg

LM Start	0.14	Rating **	M	Issue No.	26
LM End	1.63	Issue Type +	Ma	Location *	WS
Category	Earthen Levee			GPS Latitude/Longitude	
				Start	End
Item	Vegetation			37.477291 °	37.477498 °
				-121.081613 °	-121.058624 °
DWR ID	DWR_RD1602_01_f_2017_26				
Comment Code					
V1 : Control annual grass and weeds on the levee slopes and easements.					
Inspector Comment

View of the waterside vegetation. Fall 2017

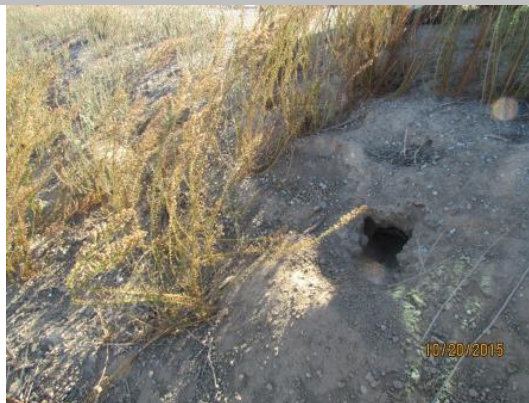
Photo 2 of 2 : SP_2018_RD1602_110_28_20180307_00012.jpg

A rodent hole was found on the waterside of the levee.

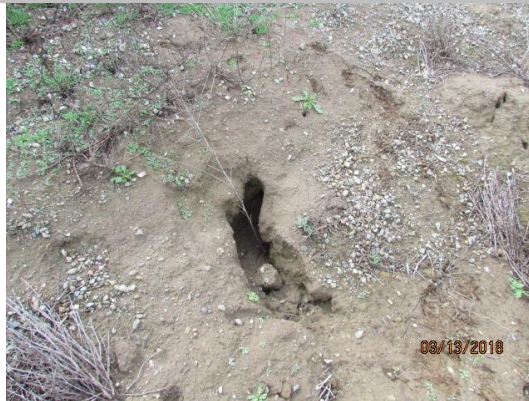
Photo 2 of 2 : SP_2018_RD1602_110_29_20180323_00102.jpg

LM Start	0.26	Rating **	M	Issue No.	29
LM End	0.26	Issue Type +	Ma	Location *	WS
Category	Earthen Levee			GPS Latitude/Longitude	
				Start	End
Item	Animal Control			37.478138 °	37.478138 °
				-121.079810 °	-121.079810 °
DWR ID	DWR_RD1602_01_f_2017_29				
Comment Code					
A3 : No rodents visible, but rodent burrows visible; need to backfill and compact or grout burrows.					
Inspector Comment

Looking at typical rodent holes on waterward slope. (Spring 2018)

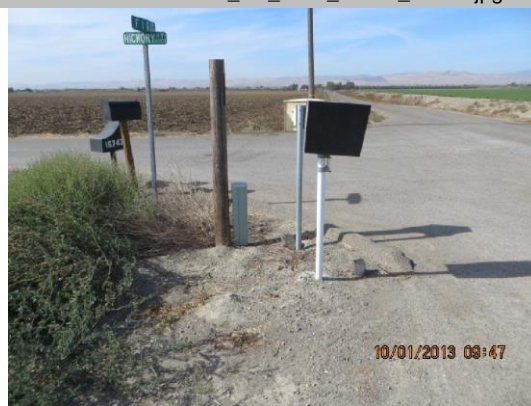
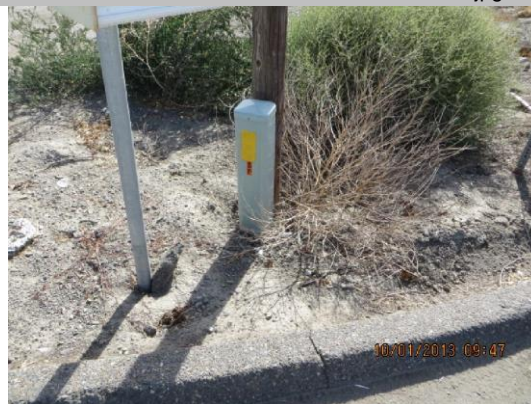
LM Start	0.58	Rating **	M	Issue No.	201
LM End	0.58	Issue Type +	En	Location *	
Category	Supplemental			GPS Latitude/Longitude	
				Start	End
Item	DWR UCIP Field Study			37.480176 °	37.480176 °
				-121.074736 °	-121.074736 °
DWR ID					
Comment Code					
Inspector Comment					
FS_ID:22937 DS_ID:24681 EP_NO: N/A Repair Type: Non-Urgent Crossing Status: Found UCIP Comments: No permit identified for this crossing. FIELD_STRUCT_DESC: Communications line of an unknown size or material through the levee, at an unknown depth. FS Date: 10/1/2013

Communication line access box on LS shoulder.

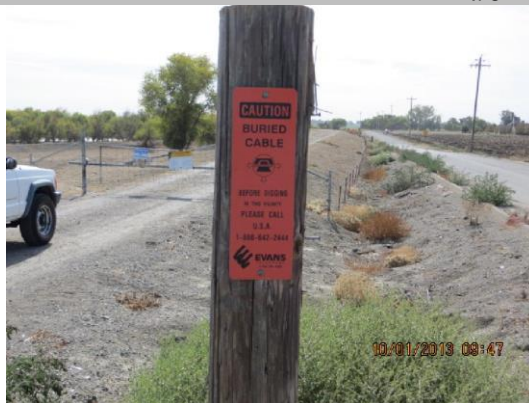
Photo 3 of 3 : UCIP_SP_2018_22937_39048.jpg

LM Start	0.58	Rating **	M	Issue No.	201 (cont)	
LM End	0.58	Issue Type +	En	Location *		
Category	Supplemental			GPS Latitude/Longitude		
				Start	End	
Item	DWR UCIP Field Study			37.480176 °	37.480176 °	
				-121.074736 °	-121.074736 °	
DWR ID						
Comment Code						
Inspector Comment						
FS_ID:22937 DS_ID:24681 EP_NO: N/A Repair Type: Non-Urgent Crossing Status: Found UCIP Comments: No permit identified for this crossing. FIELD_STRUCT_DESC: Communications line of an unknown size or material through the levee, at an unknown depth. FS Date: 10/1/2013

Communication line marker on LS shoulder.

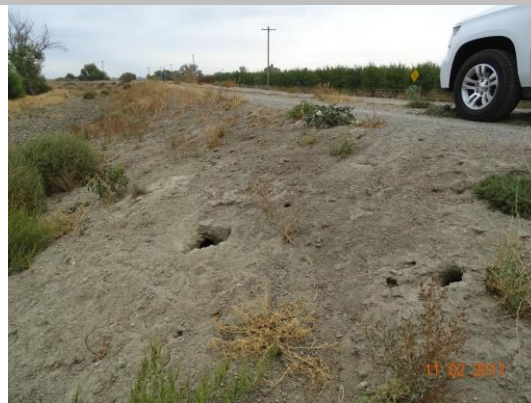
Photo 1 of 1 : SP_2018_RD1602_110_30_20180307_00014.jpg

View of rodent holes on the waterside slope of the levee. Fall 2017

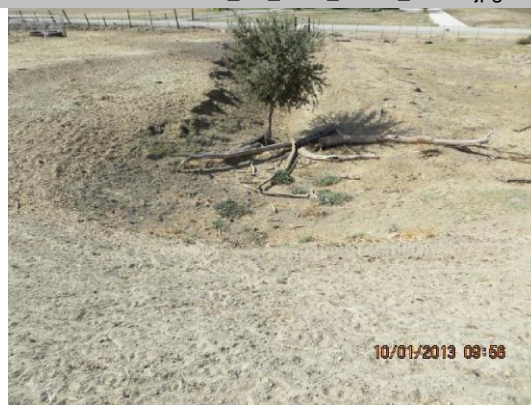
Photo 1 of 3 : UCIP_SP_2018_51634_36723.jpg

Comment Code					
Inspector Comment					
FS_ID:51634 DS_ID:20216 EP_NO: N/A Repair Type: No Action Needed Crossing Status: Found UCIP Comments: 11/18/2016 Crossing has been downgraded from Urgent to No Action Needed the debris blocking the outlet has been cleared. (O. Magana - DWR UCIP)10/01/2013 Flap gate blocked from functioning by soil buildup on WS toe. Soil should be cleared. (W. Wylie - DWR UCIP) FIELD_STRUCT_DESC: 30-inch square reinforced concrete box culvert through levee, 14.4 feet below crown. Concrete "U" headwall on the waterside (WS) and landside (LS) ends. Slide gate in 6-foot by 7-foot concrete surge box is located on the WS shoulder. Flap gate is located on the WS end. [Additional Reference(s): DWR Levee Log, 1992. USACE San Joaquin River O&M Manual Unit 13, April 1964, (HLM 0.78), Drawing No. 7-4-1784]. FS Date: 11/18/2016

Inlet on LS toe.

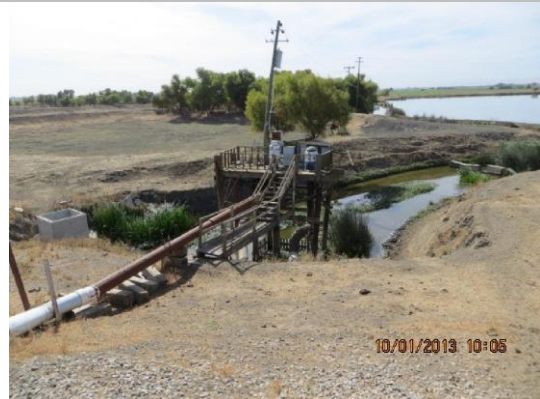
Photo 1 of 3 : UCIP_SP_2018_51636_36758.jpg

Comment Code					
Inspector Comment					
FS_ID:51636 DS_ID:20217 EP_NO: N/A Repair Type: Non-Urgent Crossing Status: Found UCIP Comments: 11/18/2016 Crossing has been downgraded from Urgent to Non-Urgent a flap gate has been added to the WS but pipe is currently not connected to pump. According to Tony Martinez, LMA representative, this crossing is currently not in use. Owner will need to coordinate with CVFPB to obtain permit. (O. Magana - DWR UCIP)10/01/2013 Appears abandoned and if so should be done so properly. Flapgate missing. (W. Wylie - DWR UCIP) FIELD_STRUCT_DESC: *ABANDONED* 1 of 2: 16-inch steel drainage pipe through levee, 17 feet below crown. Pumps on the pump platform are located on the landside (LS). Siphon breaker in 24-inch corrugated metal pipe (CMP) riser is located on the waterside (WS) shoulder. Concrete "U" headwall and flap gate are located on the WS end. [Additional Reference(s): DWR Levee Log, 1992. USACE San Joaquin River O&M Manual Unit 13, April 1964, (HLM 1.01), Drawing No. 7-4-1784]. FS Date: 11/18/2016

Pumping plant on LS toe. Pipe visible under walkway.

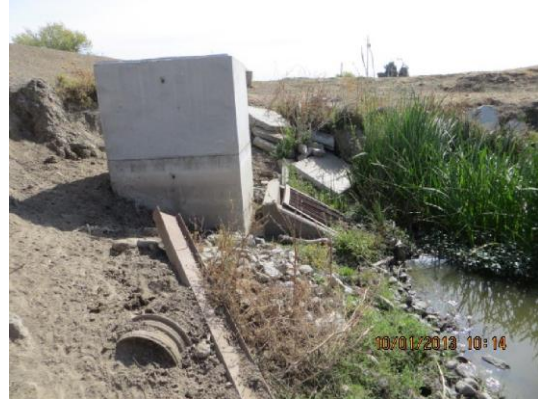
Photo 1 of 3 : UCIP_SP_2018_51329_36786.jpg

FS_ID:51329
DS_ID:20218
EP_NO: N/A
Repair Type: Urgent
Crossing Status: Found
UCIP Comments: 11/18/2016 Same as previous inspection headwall on the WS toe has separated from pipe and flap gate is still missing. Erosion around concrete headwall and undermined WS slope are visible from WS. The slope undermined appears to have progressed but no photos were taken due to the dense vegetation covering area. According to Tony Martinez, LMA representative, the WS concrete headwall has been detached since 2008/2009. LMA has been in contact with CVFPB, DWR, and USACE regarding this site. (O. Magana - DWR UCIP)10/01/2013 Headwall on WS toe separated from pipe. Erosion around concrete headwall and undermined at WS toe. Flap gate missing from WS toe headwall. (W. Wylie - DWR UCIP) FIELD_STRUCT_DESC: 30-inch square reinforced concrete box culvert through levee, 25.4 feet below crown. Concrete "U" headwalls on both waterside (WS) and landside (LS) ends. Slide gate in concrete surge box located on the WS slope. A 5-foot by 5-foot concrete box is located on LS toe. Flap gate is located on the WS end. [Additional Reference(s): DWR Levee Log, 1992. USACE San Joaquin River O&M Manual Unit 13, April 1964, (HLM 1.02), Drawing No. 7-4-1784]. FS Date: 11/18/2016

Grated inlet and 5'X5' concrete box on LS toe.

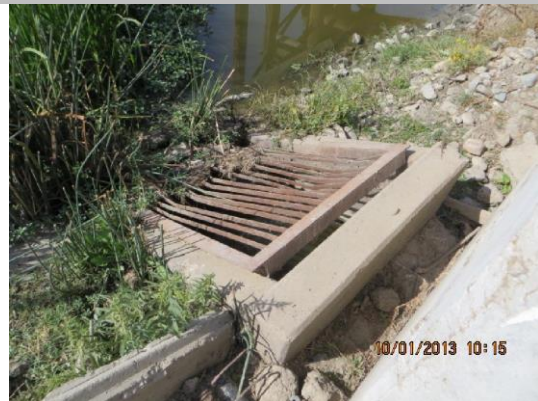
Photo 2 of 3 : UCIP_SP_2018_51329_36785.jpg

Grated inlet at LS toe.

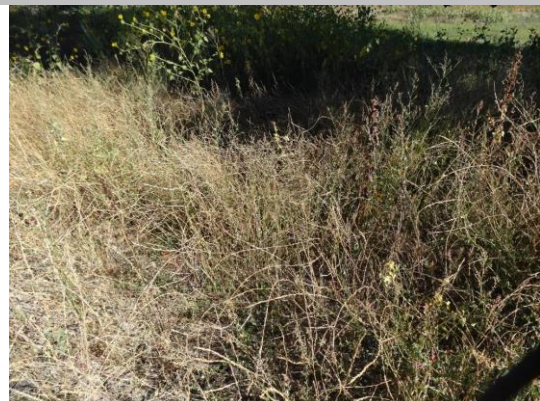
Photo 1 of 4 : SP_2018_RD1602_110_2_20180307_00002.jpg

Close view of the erosion. The erosion is covered by dense vegetation at the site.

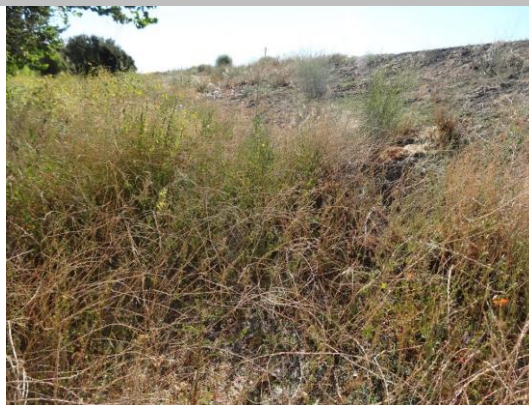
Photo 3 of 4 : SP_2018_RD1602_110_2_20180307_00004.jpg

Looking up at the erosion from the levee toe.

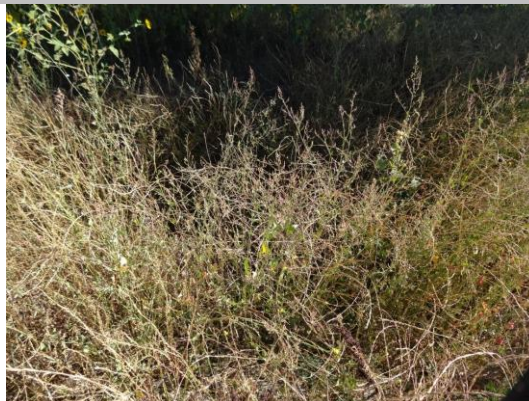
Photo 4 of 4 : SP_2018_RD1602_110_2_20180307_00005.jpg

Close view of the erosion.

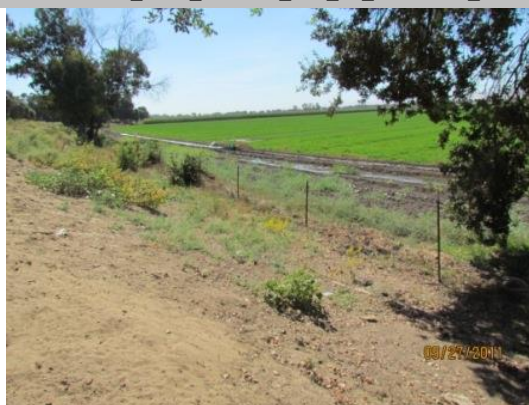
Photo 1 of 1 : SP_2018_RD1602_110_43_20180307_00024.jpg

View of the fence on the landside toe of the levee. The picture was taken from crown looking upstream.

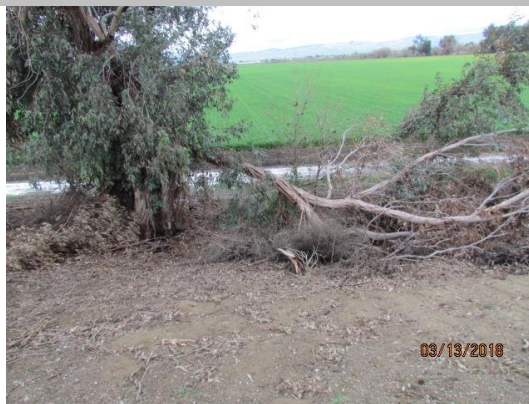
Photo 1 of 2 : SP_2018_RD1602_110_80_20180323_00103.jpg

LM Start	1.65	Rating **	U	Issue No.	80
LM End	1.65	Issue Type +	En	Location *	LS
Category	Earthen Levee			GPS Latitude/Longitude	
				Start	End
Item	Encroachments			37.477218 °	37.477218 °
				-121.058505 °	-121.058505 °
DWR ID	DWR_RD1602_01_s_2018_80				
Comment Code					
TR : Tree or limb					
Inspector Comment					
Broken tree branch on landward slope and toe.

Looking at broken branch on landward slope and toe.

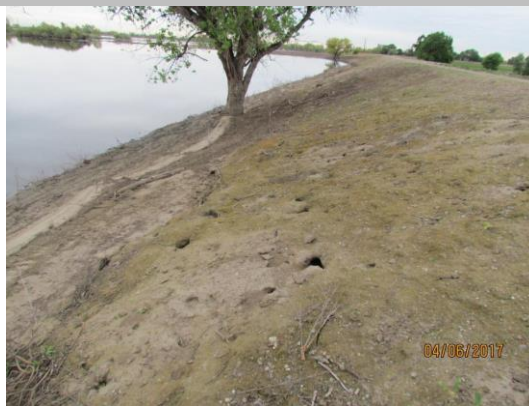
Photo 1 of 1 : SP_2018_RD1602_110_49_20180307_00029.jpg

View of rodent holes on the waterside slope of the levee. Spring 2017

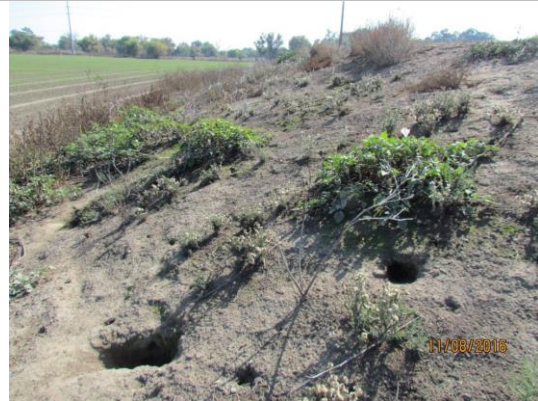
Photo 1 of 1 : SP_2018_RD1602_110_25_20180307_00008.jpg

View of rodent holes on the waterside toe of the levee looking upstream.
Fall 2016

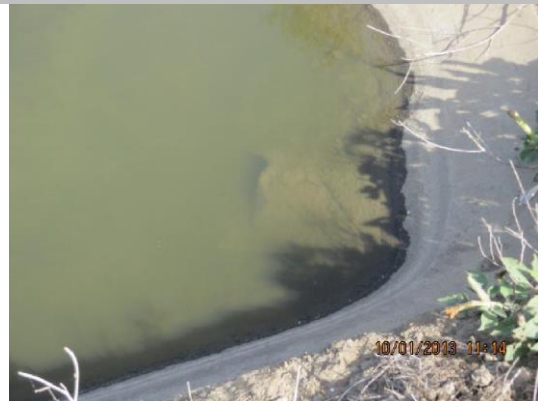
Photo 1 of 3 : UCIP_SP_2018_51330_36805.jpg

Comment Code					
Inspector Comment					
FS_ID:51330 DS_ID:20204 EP_NO: 8193 Repair Type: Urgent Crossing Status: Found UCIP Comments: 11/18/2016 Same as previous inspection riser cover and handle on slide gate are still missing. Crossing remains Urgent due to the pubic safety issue of the 60-inch CMP cover still missing. According to Tony Martinez, LMA representative, the condition and future use of this crossing is being evaluated. Owner will need to coordinate with CVFPB for future use requirements or proper abandonment/removal. (O. Magana - DWR UCIP)10/01/2013 Appears abandoned, and if so should be done so properly. No handle on slide gate, no cover on CMP standpipe on WS shoulder. (W. Wylie - DWR UCIP) FIELD_STRUCT_DESC: 16-inch steel irrigation pipe through levee, 11.5 feet below crown. Slide gate in 60-inch corrugated metal pipe riser is located on the waterside (WS) slope. Pipe discharges into concrete-lined ditch on the landside (LS) (Permit No. 8193, 1964 - Sabatte). [Additional Reference(s): DWR Levee Log, 1992. USACE San Joaquin River O&M Manual Unit 13, April 1964, (HLM 0.58), Drawing No. 7-4-1784]. FS Date: 11/18/2016

Pipe visible in concrete channel on LS toe.

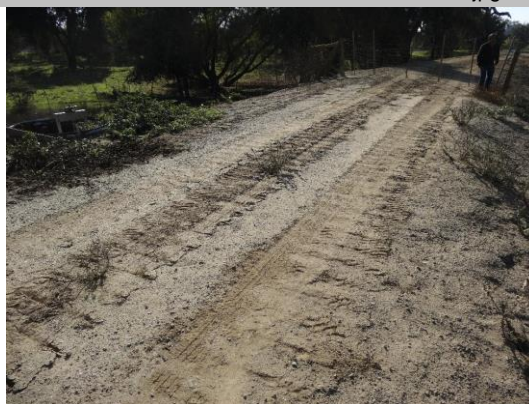
Photo 3 of 3 : UCIP_SP_2018_51330_76527.jpg

Comment Code						
Inspector Comment						
FS_ID:51330 DS_ID:20204 EP_NO: 8193 Repair Type: Urgent Crossing Status: Found UCIP Comments: 11/18/2016 Same as previous inspection riser cover and handle on slide gate are still missing. Crossing remains Urgent due to the pubic safety issue of the 60-inch CMP cover still missing. According to Tony Martinez, LMA representative, the condition and future use of this crossing is being evaluated. Owner will need to coordinate with CVFPB for future use requirements or proper abandonment/removal. (O. Magana - DWR UCIP)10/01/2013 Appears abandoned, and if so should be done so properly. No handle on slide gate, no cover on CMP standpipe on WS shoulder. (W. Wylie - DWR UCIP) FIELD_STRUCT_DESC: 16-inch steel irrigation pipe through levee, 11.5 feet below crown. Slide gate in 60-inch corrugated metal pipe riser is located on the waterside (WS) slope. Pipe discharges into concrete-lined ditch on the landside (LS) (Permit No. 8193, 1964 - Sabatte). [Additional Reference(s): DWR Levee Log, 1992. USACE San Joaquin River O&M Manual Unit 13, April 1964, (HLM 0.58), Drawing No. 7-4-1784]. FS Date: 11/18/2016

Overview of levee crown at pipe crossing.

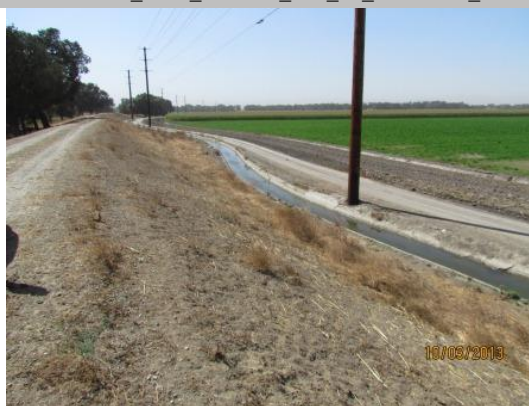
Photo 1 of 1 : SP_2018_RD1602_110_54_20180307_00032.jpg

A concrete lined ditch was found on the landside toe of the levee looking upstream.

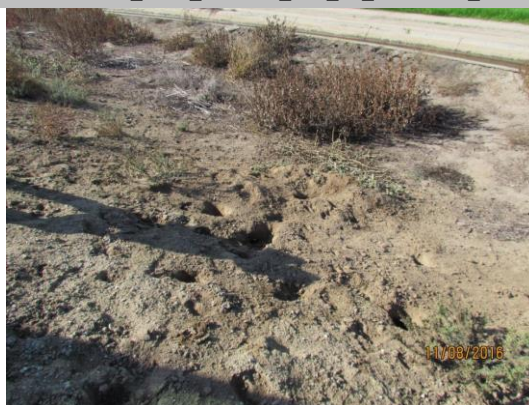
Photo 1 of 1 : SP_2018_RD1602_110_56_20180307_00033.jpg

View of rodent holes on the landside of the levee. Fall 2016

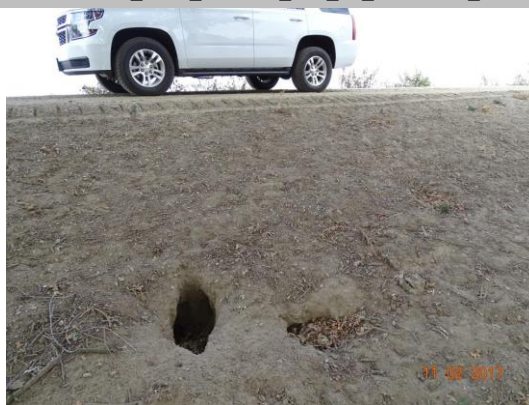
Photo 1 of 1 : SP_2018_RD1602_110_57_20180307_00034.jpg

View of a rodent hole on the waterside of the levee.

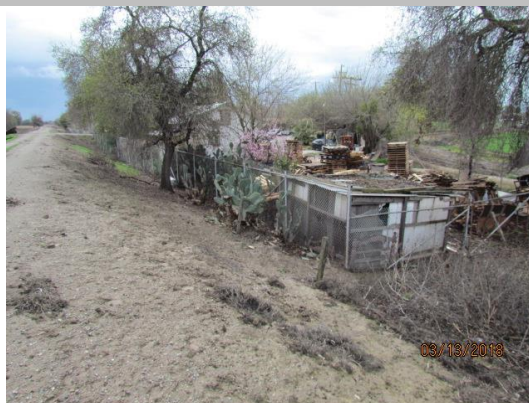
Photo 2 of 3 : SP_2018_RD1602_110_66_20180323_00105.jpg

Looking southwest at animal pens and other encroachments on landward toe. (Spring 2018)

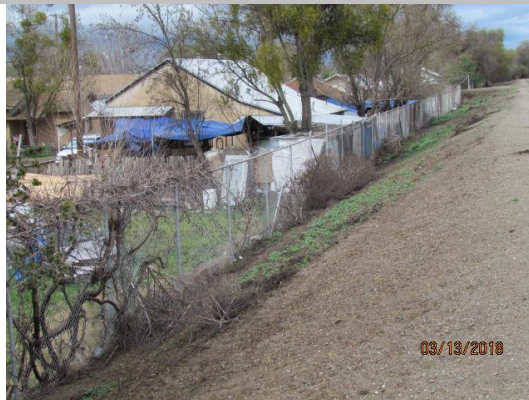
Photo 3 of 3 : SP_2018_RD1602_110_66_20180323_00106.jpg

Looking northwest at fence at landward toe. (Spring 2018)

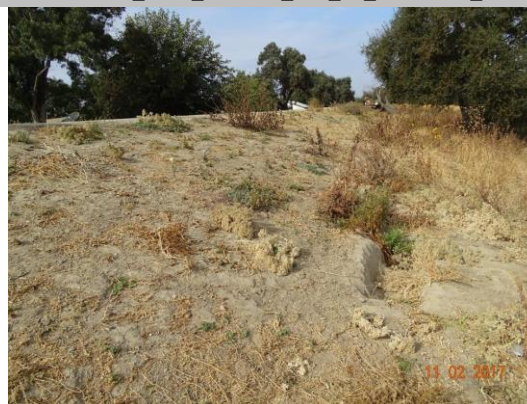
Photo 1 of 1 : SP_2018_RD1602_110_84_20180307_00049.jpg

View of rodent holes on the waterside of the levee.

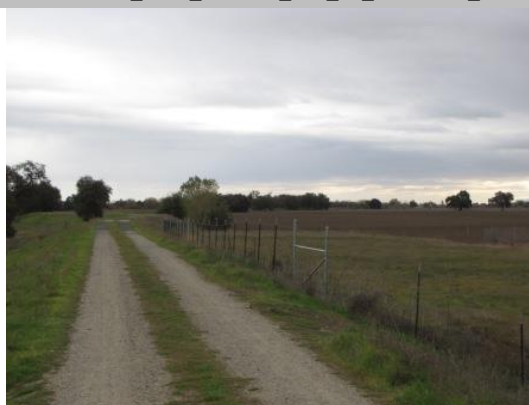
Photo 1 of 2 : SP_2018_RD1602_110_63_20180307_00039.jpg

View of a barbed wire fence on the landward slope looking upstream.

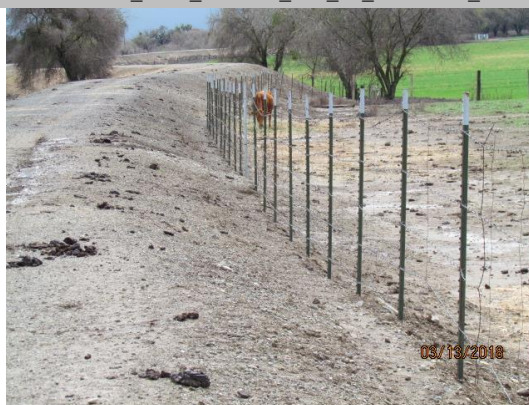
Photo 2 of 2 : SP_2018_RD1602_110_63_20180323_00107.jpg

Looking upstream at new fence on landward slope. (Spring 2018)

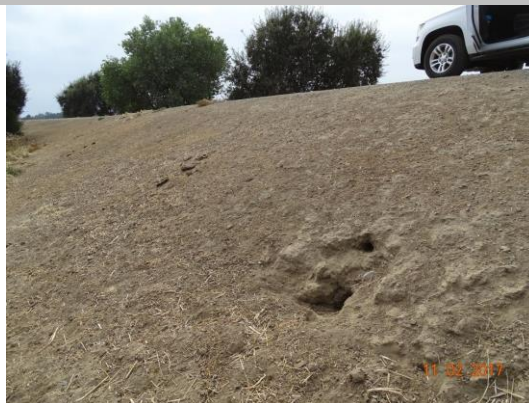
Photo 1 of 1 : SP_2018_RD1602_110_58_20180307_00035.jpg

View of rodent holes on the waterside of the levee.

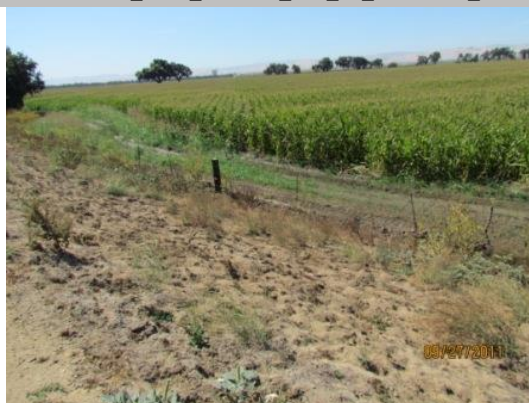
Photo 1 of 1 : SP_2018_RD1602_110_67_20180307_00043.jpg

View of the fence on the landside toe of the levee. The picture was taken from the crown looking upstream.

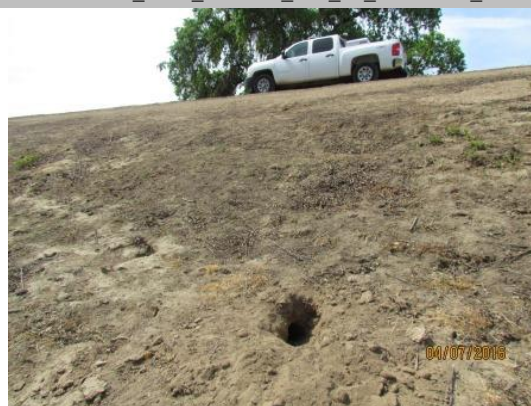
Photo 1 of 1 : SP_2018_RD1602_110_74_20180307_00045.jpg

View of a rodent hole on the waterside toe of the levee.

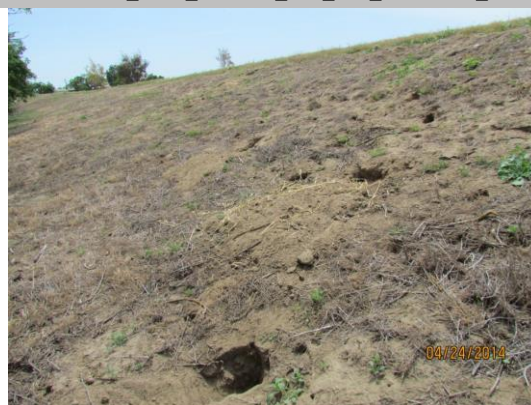
Photo 1 of 1 : SP_2018_RD1602_110_199_20180307_00053.jpg

Rodent holes were found on the waterside toe of the levee looking upstream.

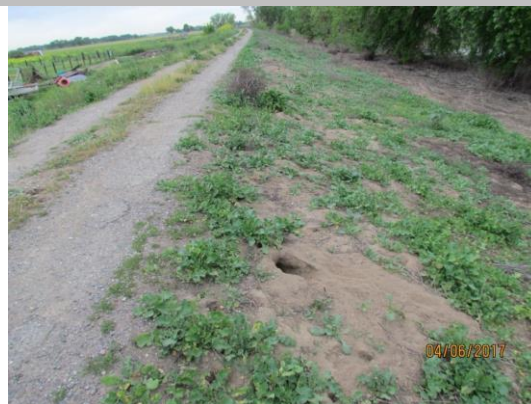
Photo 1 of 1 : SP_2018_RD1602_110_92_20180307_00052.jpg

View of a rodent hole on the waterside shoulder of the levee looking downstream.

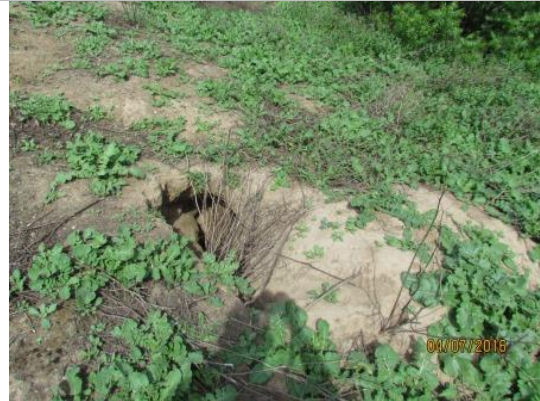
Photo 1 of 1 : SP_2018_RD1602_110_48_20180307_00028.jpg

View of rodent holes on the waterside of the levee looking downstream.

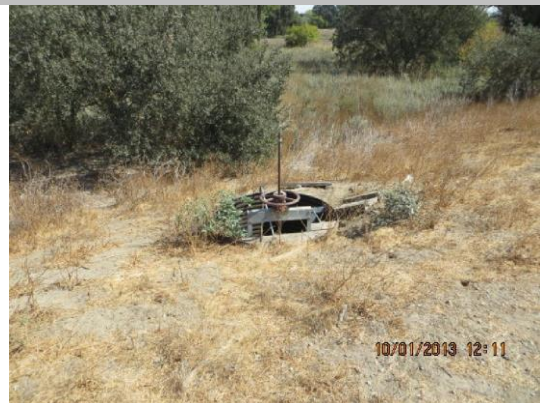
Photo 1 of 3 : UCIP_SP_2018_51336_36822.jpg

Slide gate in CMP riser on WS slope. Outlet visible under tree in background.

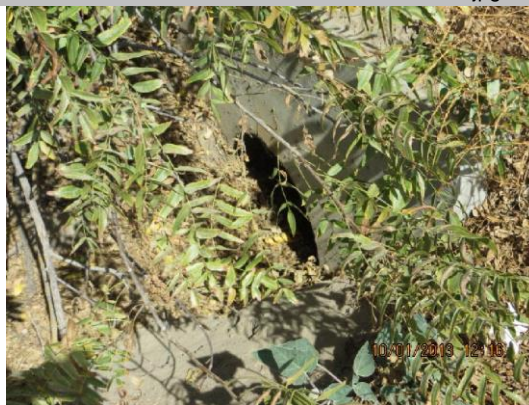
Photo 3 of 3 : UCIP_SP_2018_51336_36820.jpg

Concrete headwall at inlet on LS toe.

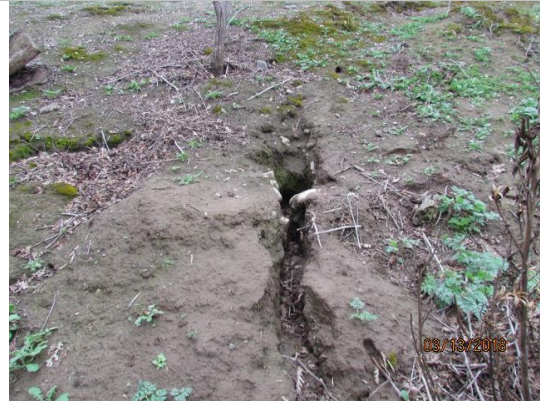
Photo 1 of 1 : SP_2018_RD1602_110_52_20180323_00108.jpg

Looking at rodent hole and erosion around rodent hole on waterward slope.

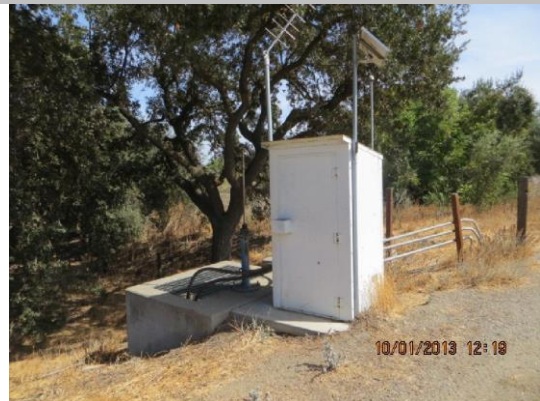
Photo 1 of 2 : UCIP_SP_2018_21665_36829.jpg

Shed with slide gate in Concrete riser on WS shoulder.

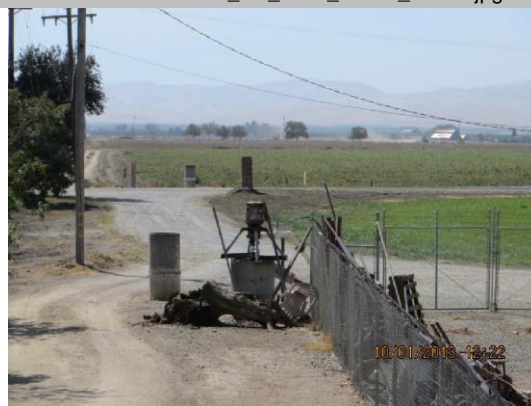
Photo 2 of 2 : UCIP_SP_2018_21665_36828.jpg

Likely risers for pipe off LS toe.

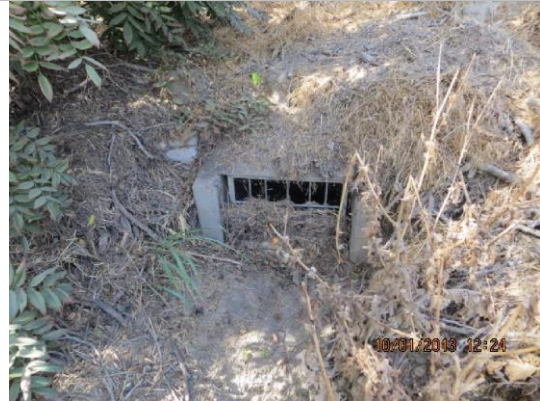
Photo 3 of 3 : UCIP_SP_2018_21672_36846.jpg

Concrete inlet on LS toe.

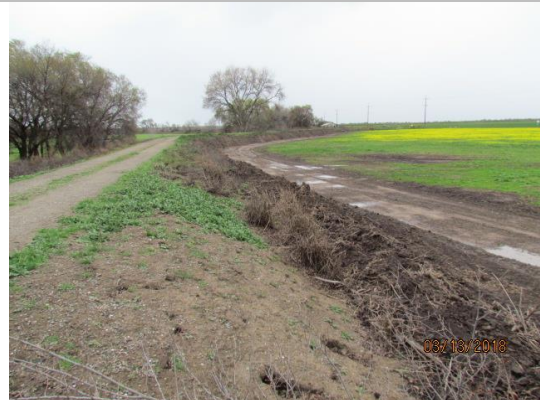
Photo 1 of 3 : SP_2018_RD1602_110_82_20180323_00109.jpg

Looking southwest at earthen material pile on landward toe.

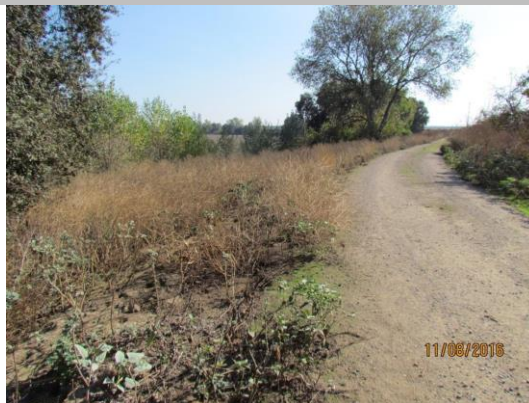
Photo 1 of 2 : SP_2018_RD1602_110_75_20180307_00046.jpg

Vegetation was found on the waterside slope of the levee looking upstream during fall 2016 inspection.

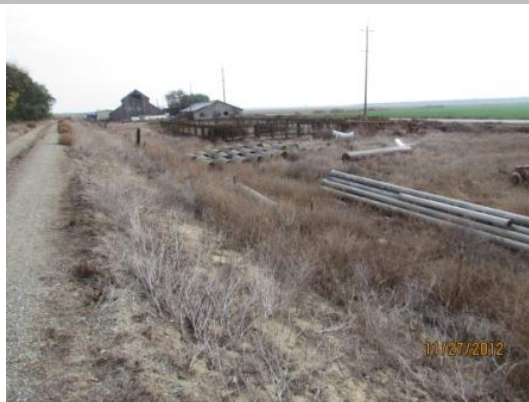
Photo 1 of 1 : SP_2018_RD1602_110_22_20180307_00007.jpg

A fence was found on the landside toe of the levee looking upstream.

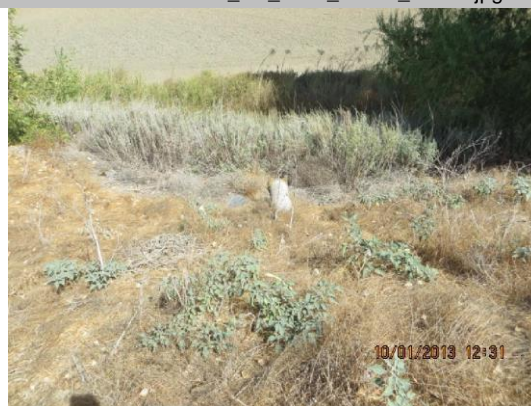
Photo 1 of 1 : UCIP_SP_2018_21674_36854.jpg

Pipe and flapgate visible on WS toe.

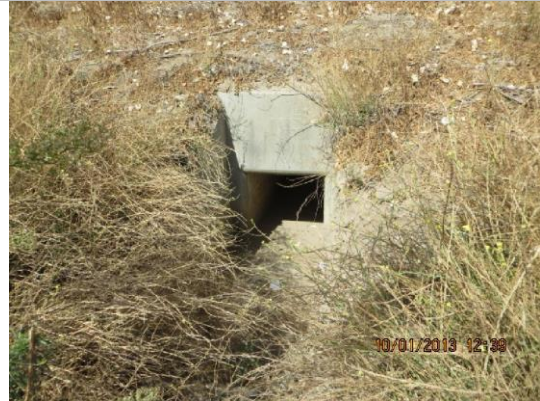
Photo 3 of 3 : UCIP_SP_2018_51337_36876.jpg

Concrete U-shaped headwall on LS toe.

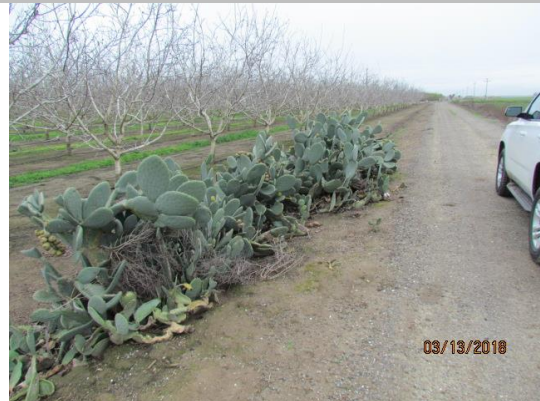
Photo 1 of 1 : SP_2018_RD1602_110_86_20180323_00113.jpg

Looking south at dense cactus on waterward slope.

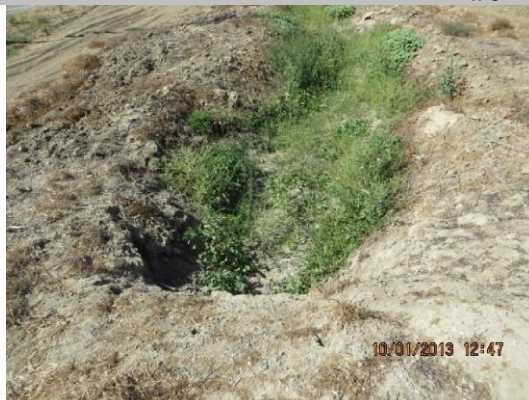
Photo 1 of 3 : UCIP_SP_2018_21683_36882.jpg

Drainage/irrigation canal on LS toe.

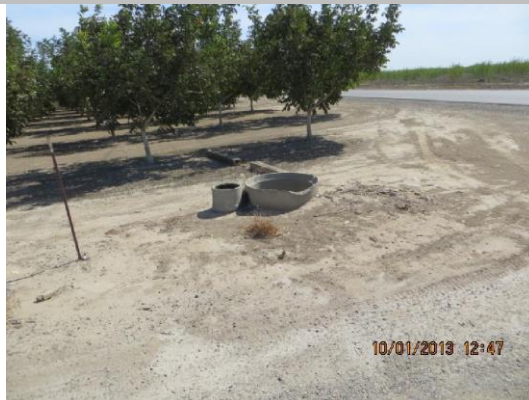
Photo 2 of 3 : UCIP_SP_2018_21683_36881.jpg

36-inch concrete standpipe on WS shoulder.
