**Flood Control Project Maintenance
Levee Inspections**
LMA District Cover Sheet
Spring 2019 Levee Inspection Results

Reclamation District No. 1602 Del Puerto

Spring 2019 Levee Inspection Results

Waterway			Bank	Unit Miles
Unit No. 01 San Joaquin River			Left	6.24
	Spring (March - May)	Summer (June - August)	(September - November) Fall	Winter (December - February)
Unit Maintenance Rating (Fall Only)				
Date of Inspection	4/16/2019 - 4/16/2019			
DWR Inspector	Corey Fujitani			
Accompanied By	Tony Martinez RD 1602

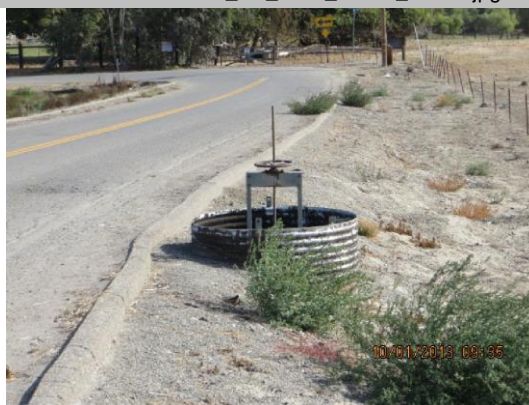
Photo 1 of 3 : UCIP_SP_2019_51325_36702.jpg

Comment Code					
Inspector Comment					
FS_ID:51325 DS_ID:20215 EP_NO: N/A Repair Type: No Action Needed Crossing Status: Found UCIP Comments: 11/18/2016 Crossing has been downgraded from Urgent to No Action Needed a cover has been added to the CMP riser. (O. Magana - DWR UCIP)10/01/2013 Open 60-inch CMP riser on WS needs lid as it's depth may be a hazard to the public. (W. Wylie - DWR UCIP) FIELD_STRUCT_DESC: 16-inch steel drainage pipe through levee, 11.3 feet below crown. Slide gate in 60-inch corrugated metal pipe (CMP) riser located on the waterside (WS). Concrete inlet is approximately 110 feet west of the levee crown or 110 feet off landside (LS) toe next to roadway. [Additional Reference(s): DWR Levee Log, 1992. USACE San Joaquin River O&M Manual Unit 13, April 1964, (HLM 0.58), Drawing No. 7-4-1784]. FS Date: 11/18/2016

60-inch CMP riser on WS shoulder.

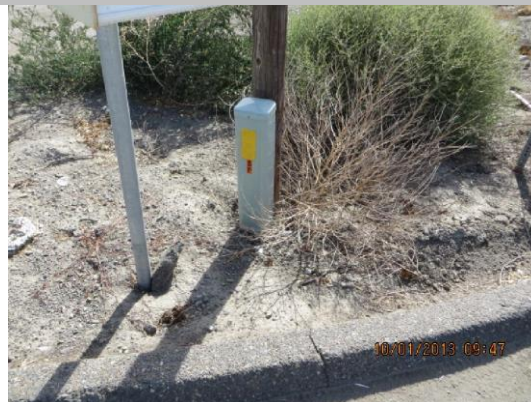
Photo 2 of 3 : UCIP_SP_2019_22937_39049.jpg

Communication line access box on LS shoulder.

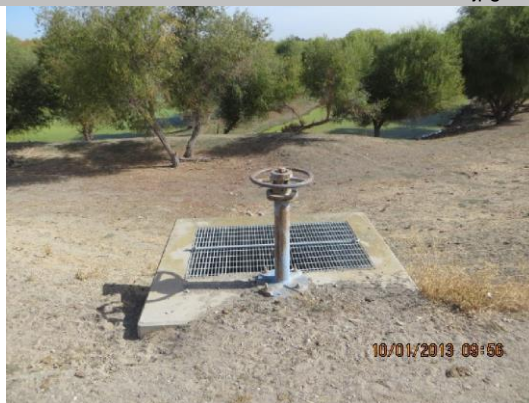
Photo 2 of 3 : UCIP_SP_2019_51634_36722.jpg

Comment Code					
Inspector Comment					
FS_ID:51634 DS_ID:20216 EP_NO: N/A Repair Type: No Action Needed Crossing Status: Found UCIP Comments: 11/18/2016 Crossing has been downgraded from Urgent to No Action Needed the debris blocking the outlet has been cleared. (O. Magana - DWR UCIP)10/01/2013 Flap gate blocked from functioning by soil buildup on WS toe. Soil should be cleared. (W. Wylie - DWR UCIP) FIELD_STRUCT_DESC: 30-inch square reinforced concrete box culvert through levee, 14.4 feet below crown. Concrete "U" headwall on the waterside (WS) and landside (LS) ends. Slide gate in 6-foot by 7-foot concrete surge box is located on the WS shoulder. Flap gate is located on the WS end. [Additional Reference(s): DWR Levee Log, 1992. USACE San Joaquin River O&M Manual Unit 13, April 1964, (HLM 0.78), Drawing No. 7-4-1784]. FS Date: 11/18/2016

Slide gate in concrete box on WS shoulder.

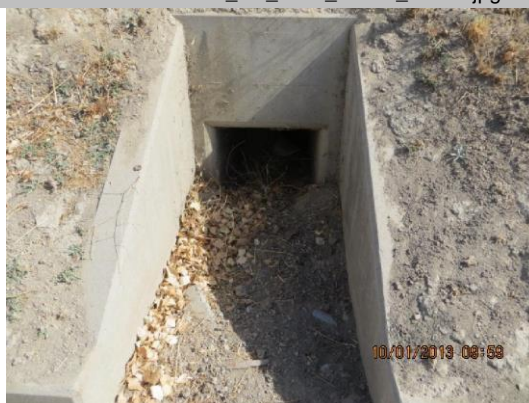
Photo 3 of 3 : UCIP_SP_2019_51634_36721.jpg

Comment Code					
Inspector Comment					
FS_ID:51634 DS_ID:20216 EP_NO: N/A Repair Type: No Action Needed Crossing Status: Found UCIP Comments: 11/18/2016 Crossing has been downgraded from Urgent to No Action Needed the debris blocking the outlet has been cleared. (O. Magana - DWR UCIP)10/01/2013 Flap gate blocked from functioning by soil buildup on WS toe. Soil should be cleared. (W. Wylie - DWR UCIP) FIELD_STRUCT_DESC: 30-inch square reinforced concrete box culvert through levee, 14.4 feet below crown. Concrete "U" headwall on the waterside (WS) and landside (LS) ends. Slide gate in 6-foot by 7-foot concrete surge box is located on the WS shoulder. Flap gate is located on the WS end. [Additional Reference(s): DWR Levee Log, 1992. USACE San Joaquin River O&M Manual Unit 13, April 1964, (HLM 0.78), Drawing No. 7-4-1784]. FS Date: 11/18/2016

Concrete inlet on LS toe.

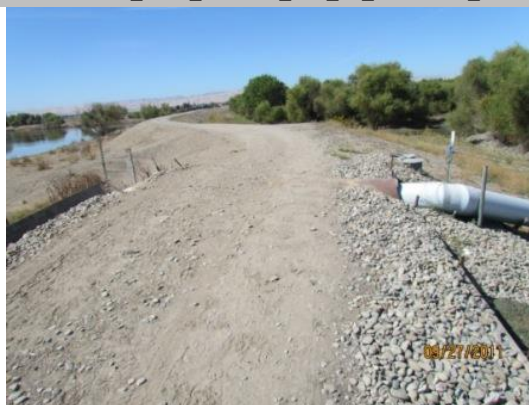
Photo 1 of 1 : SP_2019_RD1602_110_36_20190307_00014.jpg

LM Start	1.00	Rating **	M	Issue No.	36
LM End	1.00	Issue Type +	En	Location *	WS
Category	Earthen Levee			GPS Latitude/Longitude	
				Start	End
Item	Encroachments			37.478810 °	37.478810 °
				-121.068738 °	-121.068738 °
DWR ID	DWR_RD1602_01_s_2012_36				
Comment Code					
RA : Ramp					
Inspector Comment

View of the ramp on the crown. The picture was taken from crown looking downstream.

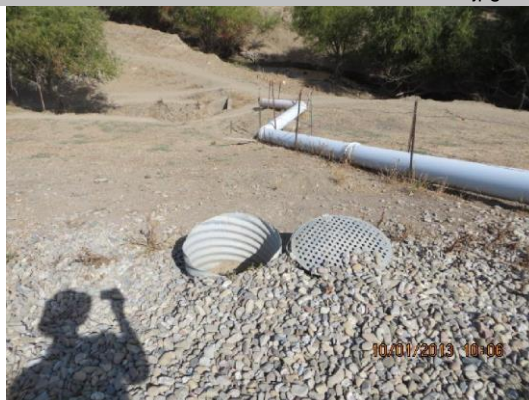
Photo 2 of 3 : UCIP_SP_2019_51636_36757.jpg

Comment Code					
Inspector Comment					
FS_ID:51636 DS_ID:20217 EP_NO: N/A Repair Type: Non-Urgent Crossing Status: Found UCIP Comments: 11/18/2016 Crossing has been downgraded from Urgent to Non-Urgent a flap gate has been added to the WS but pipe is currently not connected to pump. According to Tony Martinez, LMA representative, this crossing is currently not in use. Owner will need to coordinate with CVFPB to obtain permit. (O. Magana - DWR UCIP)10/01/2013 Appears abandoned and if so should be done so properly. Flapgate missing. (W. Wylie - DWR UCIP) FIELD_STRUCT_DESC: *ABANDONED* 1 of 2: 16-inch steel drainage pipe through levee, 17 feet below crown. Pumps on the pump platform are located on the landside (LS). Siphon breaker in 24-inch corrugated metal pipe (CMP) riser is located on the waterside (WS) shoulder. Concrete "U" headwall and flap gate are located on the WS end. [Additional Reference(s): DWR Levee Log, 1992. USACE San Joaquin River O&M Manual Unit 13, April 1964, (HLM 1.01), Drawing No. 7-4-1784]. FS Date: 11/18/2016

Siphon breaker in 24-inch CMP riser on WS shoulder.

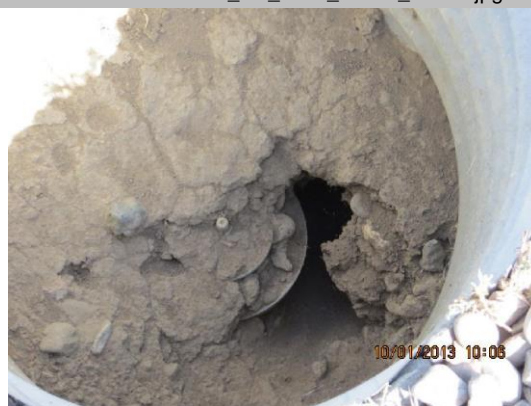
Photo 3 of 3 : UCIP_SP_2019_51636_36756.jpg

Comment Code						
Inspector Comment						
FS_ID:51636 DS_ID:20217 EP_NO: N/A Repair Type: Non-Urgent Crossing Status: Found UCIP Comments: 11/18/2016 Crossing has been downgraded from Urgent to Non-Urgent a flap gate has been added to the WS but pipe is currently not connected to pump. According to Tony Martinez, LMA representative, this crossing is currently not in use. Owner will need to coordinate with CVFPB to obtain permit. (O. Magana - DWR UCIP)10/01/2013 Appears abandoned and if so should be done so properly. Flapgate missing. (W. Wylie - DWR UCIP) FIELD_STRUCT_DESC: *ABANDONED* 1 of 2: 16-inch steel drainage pipe through levee, 17 feet below crown. Pumps on the pump platform are located on the landside (LS). Siphon breaker in 24-inch corrugated metal pipe (CMP) riser is located on the waterside (WS) shoulder. Concrete "U" headwall and flap gate are located on the WS end. [Additional Reference(s): DWR Levee Log, 1992. USACE San Joaquin River O&M Manual Unit 13, April 1964, (HLM 1.01), Drawing No. 7-4-1784]. FS Date: 11/18/2016

Siphon breaker in 24-inch CMP riser on WS shoulder.

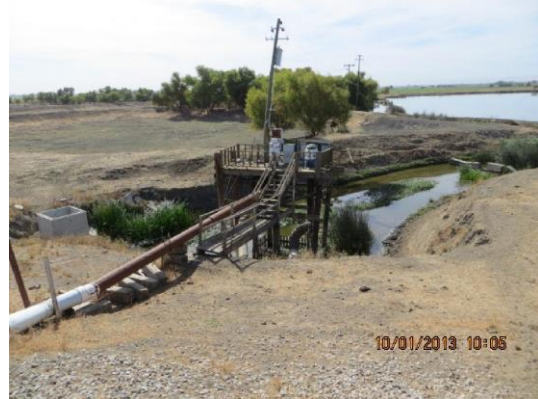
Photo 1 of 3 : UCIP_SP_2019_51637_36772.jpg

FS_ID:51637
DS_ID:20219
EP_NO: N/A
Repair Type: Non-Urgent
Crossing Status: Found
UCIP Comments: 11/18/2016 Crossing has been downgraded from Urgent to Non-Urgent a flap gate has been added to the WS. According to Tony Martinez, LMA representative, this crossing is currently not in use. Owner will need to coordinate with CVFPB to obtain permit. (O. Magana - DWR UCIP)10/01/2013 Appears abandoned siphon breakers covered in soil and flapgate missing. (W. Wylie - DWR UCIP) FIELD_STRUCT_DESC: *ABANDONED* 2 of 2: 16-inch steel drainage pipe through levee, 17 feet below crown. Pump on pump platform located on the landside (LS). Siphon breaker in 24-inch riser located on the waterside (WS) shoulder. Concrete "U" headwall and flap gate are located on the WS end. [Additional Reference(s): DWR Levee Log, 1992. USACE San Joaquin River O&M Manual Unit 13, April 1964, (HLM 1.01), Drawing No. 7-4-1784].
FS Date: 11/18/2016

Pipe visible under walkway at puming plant on LS toe.

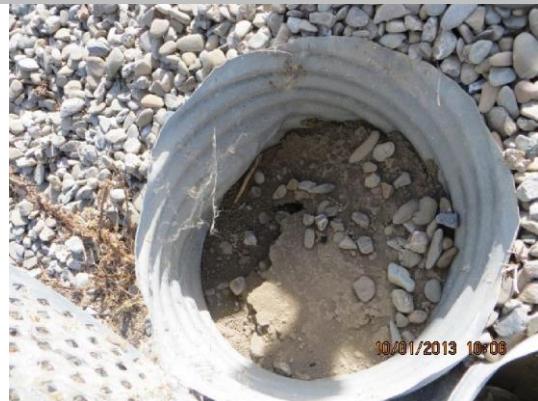
Photo 2 of 3 : UCIP_SP_2019_51637_36771.jpg

Siphon breaker covered in soil at CMP riser on WS shoulder.

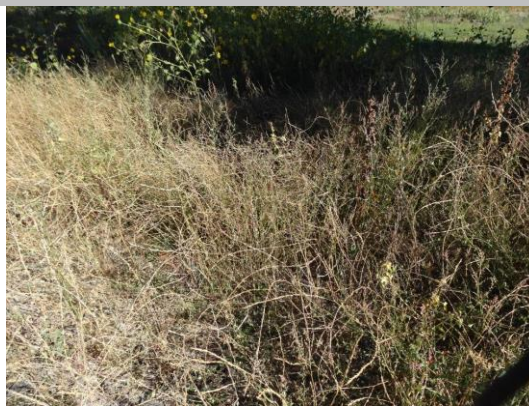
Photo 1 of 4 : SP_2019_RD1602_110_2_20190307_00001.jpg

Close view of the erosion. The erosion is covered by dense vegetation at the site.

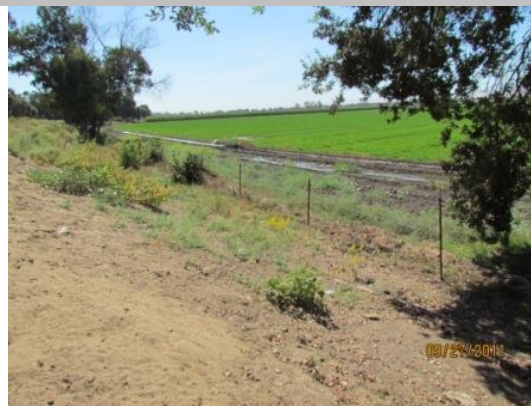
Photo 1 of 1 : SP_2019_RD1602_110_43_20190307_00020.jpg

View of the fence on the landside toe of the levee. The picture was taken from crown looking upstream.

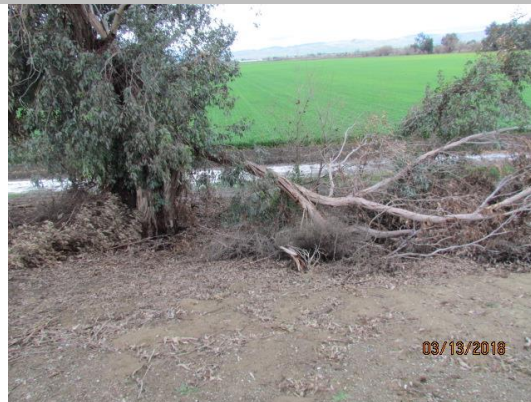
Photo 1 of 2 : SP_2019_RD1602_110_80_20190307_00047.jpg

LM Start	1.65	Rating **	U	Issue No.	80
LM End	1.65	Issue Type +	En	Location *	LS
Category	Earthen Levee			GPS Latitude/Longitude	
				Start	End
Item	Encroachments			37.477218 °	37.477218 °
				-121.058505 °	-121.058505 °
DWR ID	DWR_RD1602_01_s_2018_80				
Comment Code					
TR : Tree or limb					
Inspector Comment					
Broken tree branch on landward slope and toe.

Looking at broken branch on landward slope and toe.

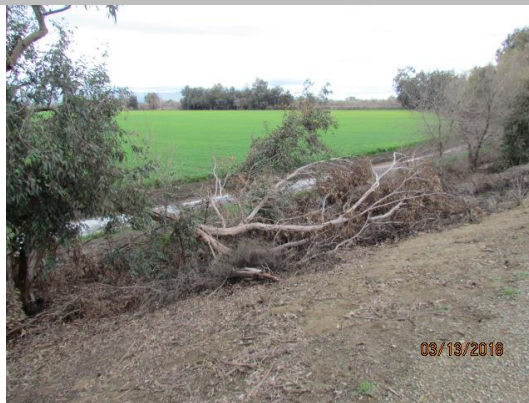
Photo 2 of 2 : SP_2019_RD1602_110_80_20190307_00048.jpg

LM Start	1.65	Rating **	U	Issue No.	80 (cont)	
LM End	1.65	Issue Type +	En	Location *	LS	
Category	Earthen Levee			GPS Latitude/Longitude		
				Start		End
Item	Encroachments			37.477218 °		37.477218 °
				-121.058505 °		-121.058505 °
DWR ID	DWR_RD1602_01_s_2018_80					
Comment Code						
TR : Tree or limb						
Inspector Comment						
Broken tree branch on landward slope and toe.

Looking downstream at broke branch on landward slope and toe.

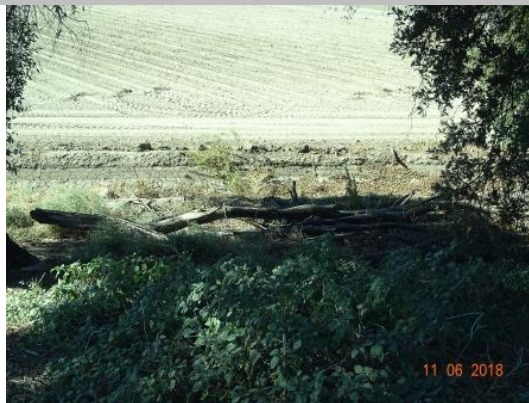
Photo 1 of 1 : SP_2019_RD1602_110_104_20190307_00066.jpg

tree limbs on landside toe. (Fall 2018)

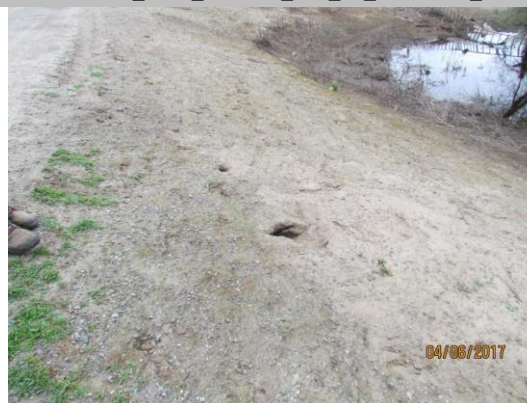
Photo 1 of 1 : SP_2019_RD1602_110_81_20190307_00049.jpg

View of a rodent hole on the waterside slope of the levee.

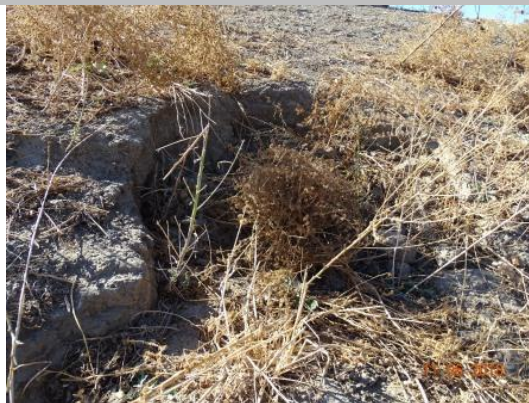
Photo 2 of 2 : SP_2019_RD1602_110_98_20190307_00062.jpg

close up view of erosion at toe. (Fall 2018)

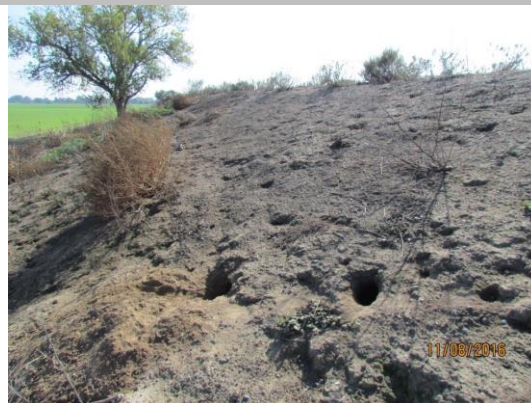
Photo 1 of 1 : SP_2019_RD1602_110_47_20190307_00023.jpg

View of rodent holes on the waterside of the levee. Fall 2016

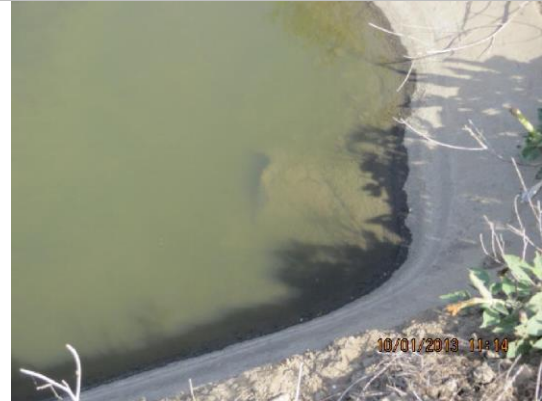
Photo 1 of 3 : UCIP_SP_2019_53522_36805.jpg

Pipe visible in concrete channel on LS toe.

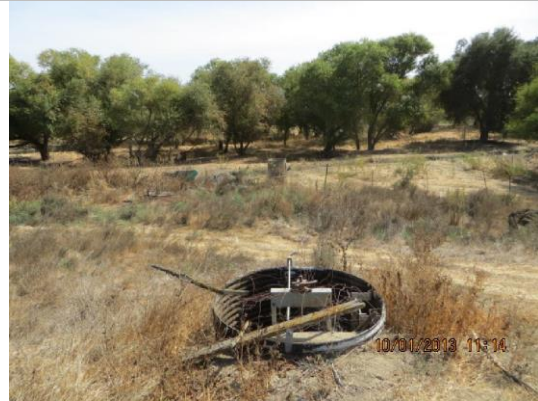
Photo 2 of 3 : UCIP_SP_2019_53522_36804.jpg

Slide gate in 60-inch CMP riser on WS shoulder.

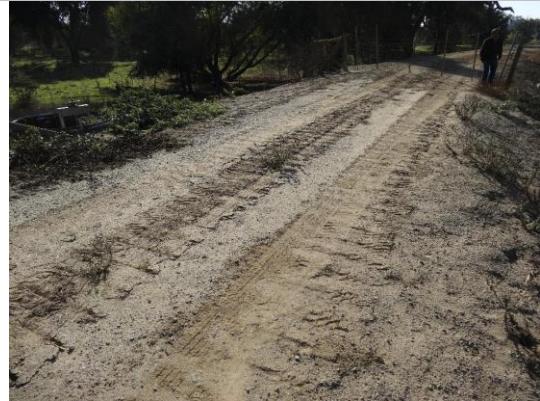
Photo 3 of 3 : UCIP_SP_2019_53522_76527.jpg

Overview of levee crown at pipe crossing.

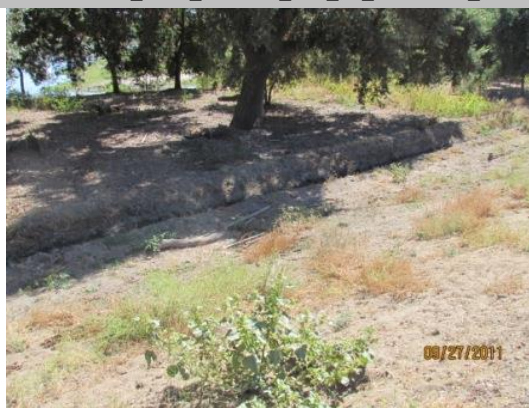
Photo 1 of 1 : SP_2019_RD1602_110_50_20190307_00026.jpg

A ditch was located on the waterside toe of the levee. The picture was taken from the crown looking upstream.

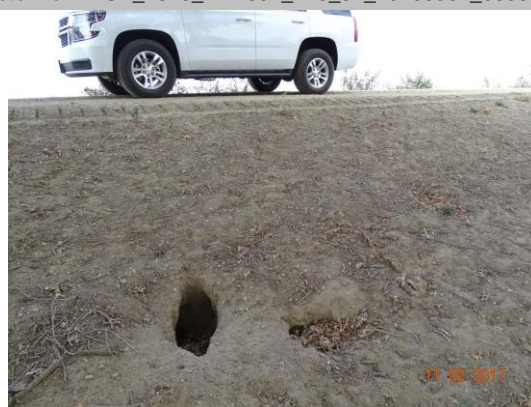
Photo 1 of 1 : SP_2019_RD1602_110_57_20190307_00031.jpg

View of a rodent hole on the waterside of the levee.

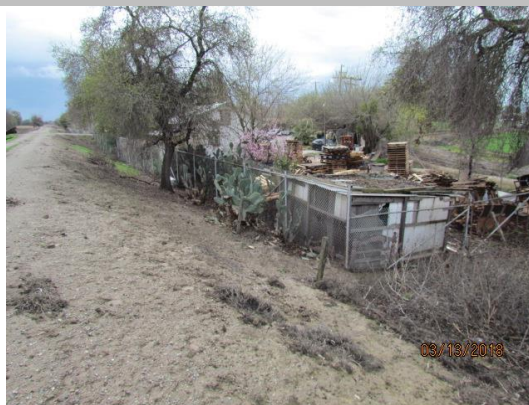
Photo 2 of 3 : SP_2019_RD1602_110_66_20190307_00041.jpg

Looking southwest at animal pens and other encroachments on landward toe. (Spring 2018)

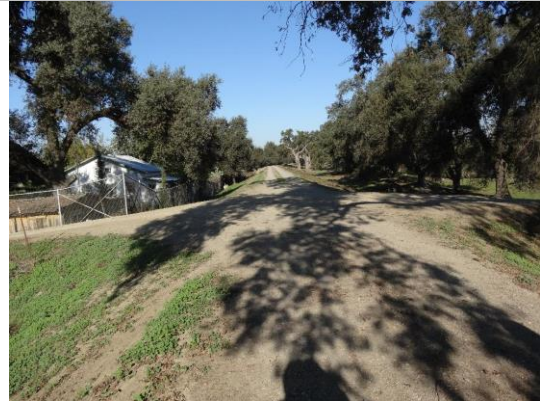
Photo 1 of 3 : UCIP_SP_2019_53523_76534.jpg

Overview of levee crown at pipe crossing.

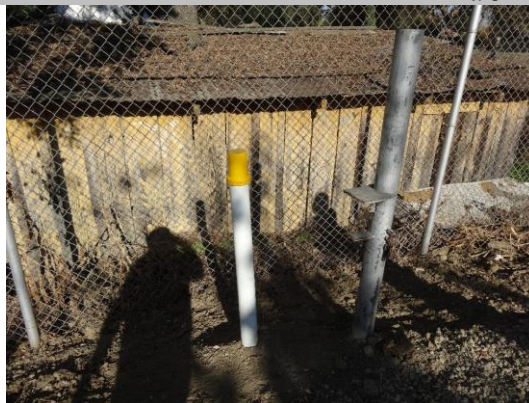
Photo 3 of 3 : UCIP_SP_2019_53523_76536.jpg

PVC riser with yellow cover located along fence on LS.

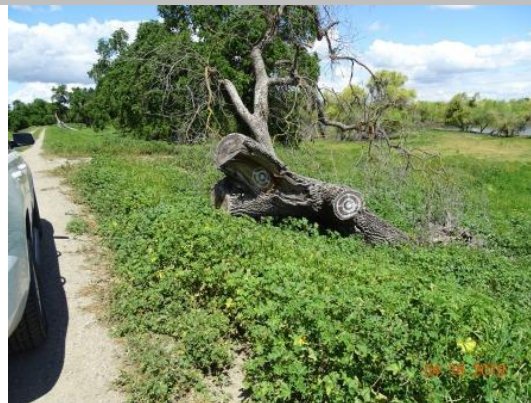
Photo 1 of 1 : SP_2019_RD1602_110_90_20190424_00114.jpg

Fallen tree trunk on waterside slope. (Spring 2019)

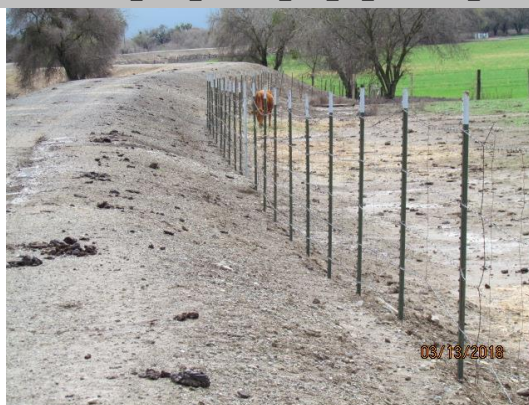
Photo 2 of 2 : SP_2019_RD1602_110_63_20190307_00038.jpg

Looking upstream at new fence on landward slope. (Spring 2018)

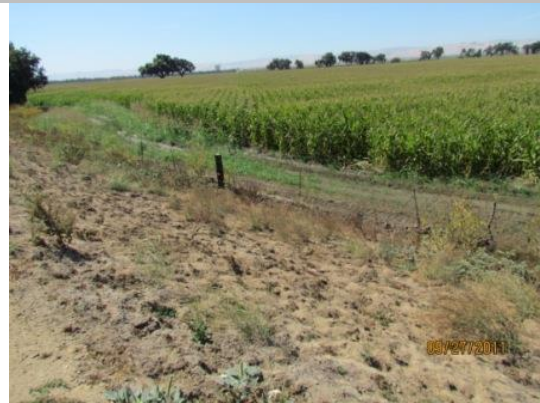
Photo 1 of 1 : SP_2019_RD1602_110_67_20190307_00043.jpg

View of the fence on the landside toe of the levee. The picture was taken from the crown looking upstream.

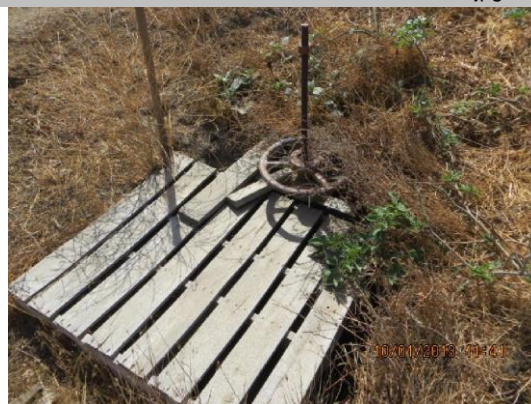
Photo 2 of 3 : UCIP_SP_2019_51332_36818.jpg

Slide gate in CMP riser on WS slope.

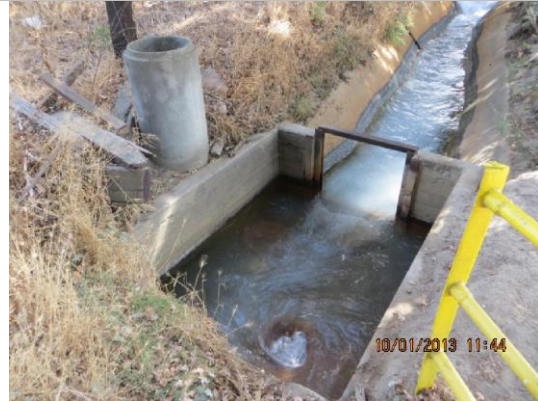
Photo 3 of 3 : UCIP_SP_2019_51332_36817.jpg

Concrete ditch at outlet from pipe on LS toe.

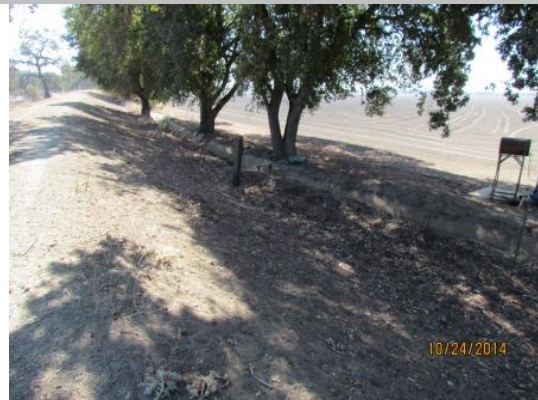
Photo 1 of 1 : SP_2019_RD1602_110_64_20190307_00039.jpg

View of a ditch on the landside toe of the levee looking upstream.

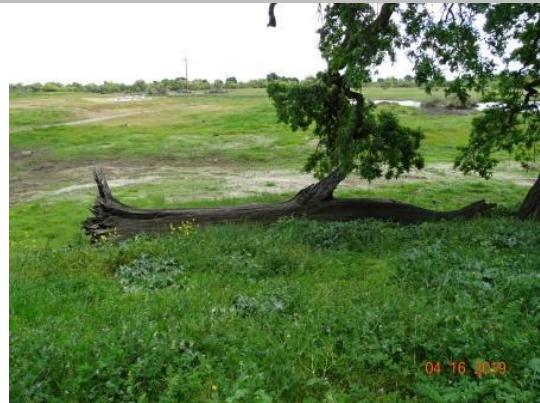
Photo 1 of 1 : SP_2019_RD1602_110_69_20190515_00119.jpg

View of fallen tree trunk on waterside slope. (Spring 2019)

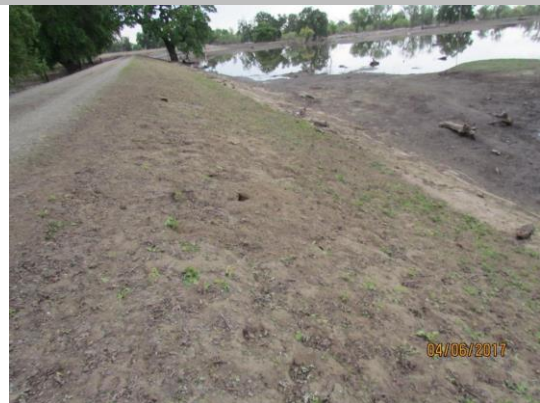
Photo 1 of 1 : SP_2019_RD1602_110_91_20190307_00058.jpg

View of rodent holes on the waterside of the levee looking downstream. Spring 2017

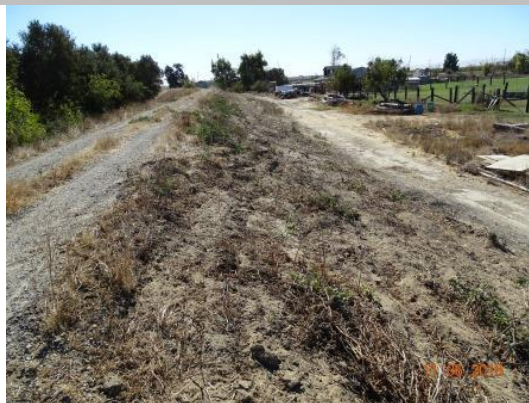
Photo 1 of 2 : SP_2019_RD1602_110_89_20190307_00056.jpg

View along landside slope looking upstream. (Fall 2018)

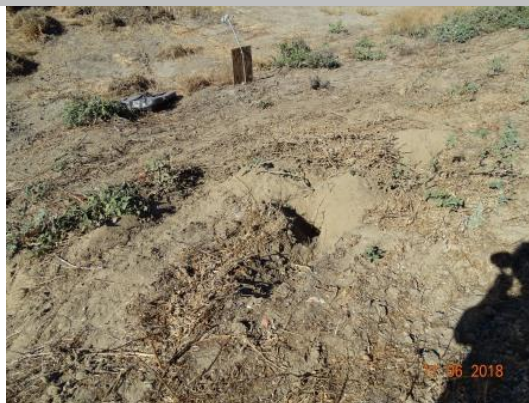
Photo 2 of 2 : SP_2019_RD1602_110_89_20190307_00057.jpg

Upclose view of some of the damage to slope. (Fall 2018)

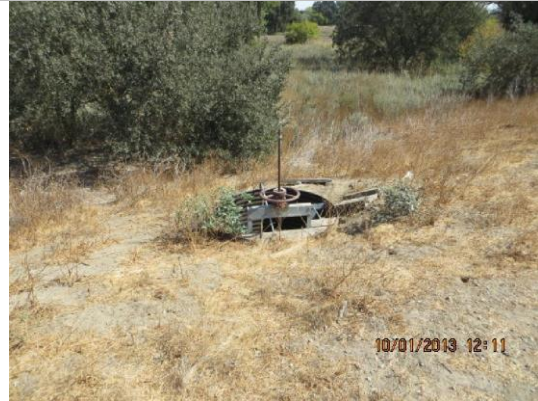
Photo 1 of 3 : UCIP_SP_2019_51336_36822.jpg

Slide gate in CMP riser on WS slope. Outlet visible under tree in background.

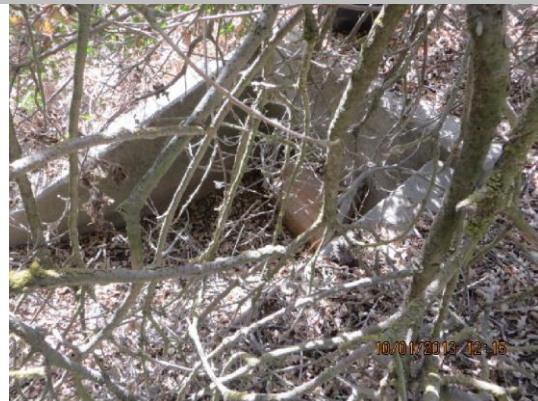
Photo 2 of 3 : UCIP_SP_2019_51336_36821.jpg

Flapgate in Concrete headwall on WS toe under tree.

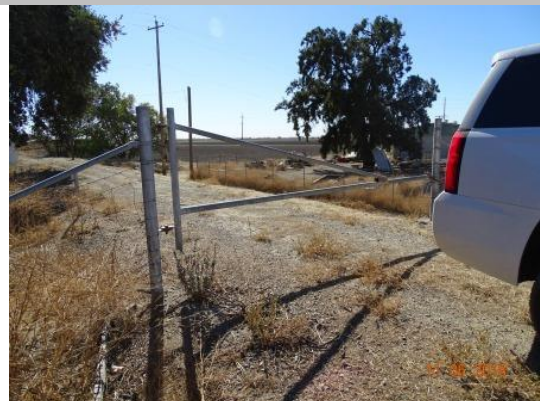
Photo 1 of 1 : SP_2019_RD1602_110_40_20190307_00018.jpg

DWR and LMA do not have keys for locks on gate. (Fall 2018)

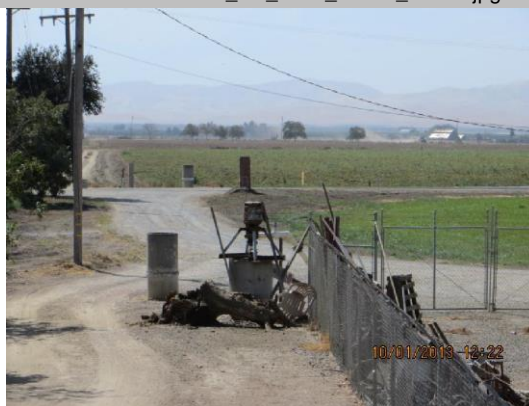
Photo 2 of 2 : UCIP_SP_2019_21665_36828.jpg

Likely risers for pipe off LS toe.

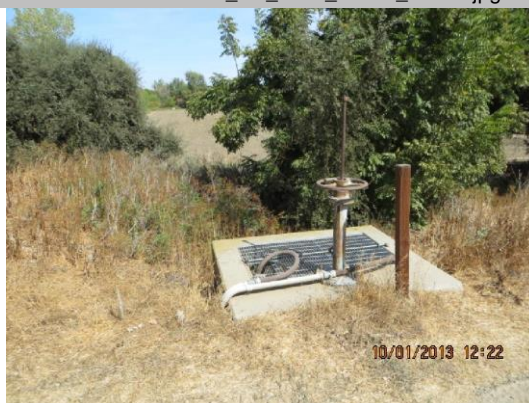
Photo 1 of 3 : UCIP_SP_2019_21672_36848.jpg

Slidegate in concrete riser on WS shoulder.

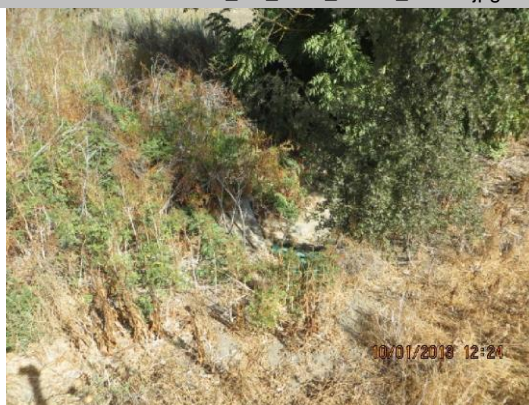
Photo 2 of 3 : UCIP_SP_2019_21672_36847.jpg

Concrete outlet on WS toe.

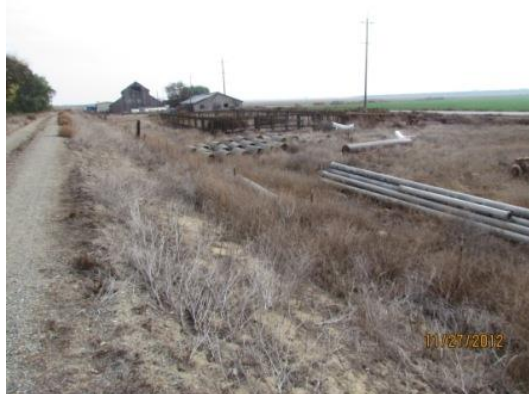
Photo 1 of 1 : SP_2019_RD1602_110_22_20190307_00005.jpg

A fence was found on the landside toe of the levee looking upstream.

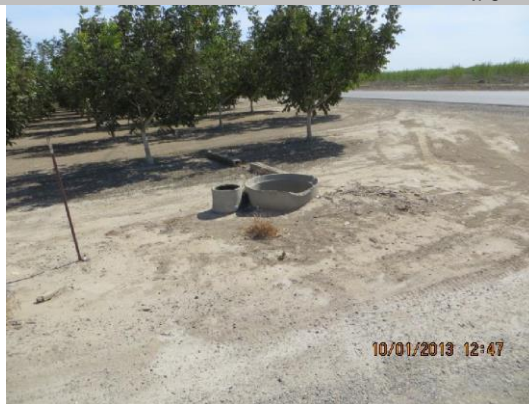
Photo 2 of 3 : UCIP_SP_2019_21683_36881.jpg

36-inch concrete standpipe on WS shoulder.
