**Flood Control Project Maintenance
Levee Inspections**
LMA District Cover Sheet
Spring 2020 Levee Inspection Results

Reclamation District No. 1602 Del Puerto

Spring 2020 Levee Inspection Results

Waterway			Bank	Unit Miles
Unit No. 01 San Joaquin River			Left	6.24
	Spring (March - May)	Summer (June - August)	(September - November) Fall	Winter (December - February)
Unit Maintenance Rating (Fall Only)				
Date of Inspection	4/2/2020 - 4/2/2020			
DWR Inspector	Corey Fujitani			
Accompanied By	Tony Martinez RD 1602

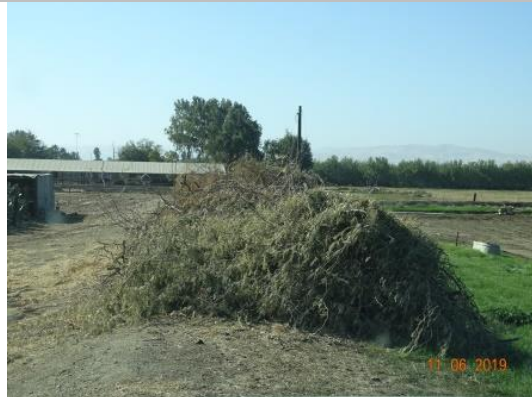
Photo 1 of 1 : SP_2020_RD1602_110_132_20200225_00077.jpg

View of burn pile on levee crown. (Fall 2019)

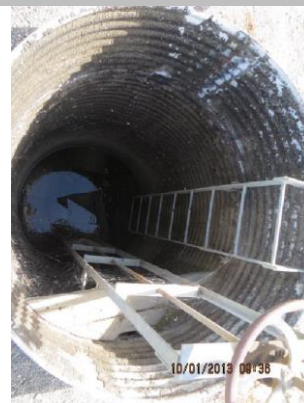
Photo 2 of 3 : UCIP_SP_2020_51325_36701.jpg

CMP riser with slide gate on WS shoulder.

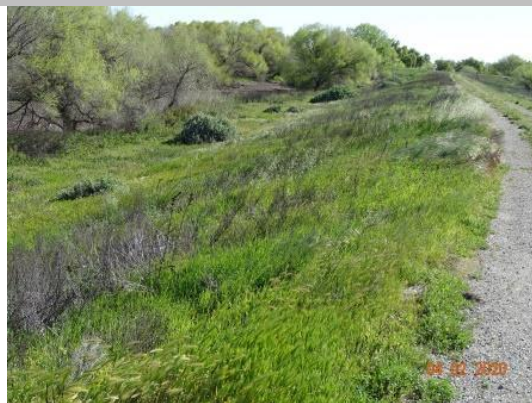
Photo 1 of 1 : SP_2020_RD1602_110_25_20200403_00126.jpg

LM Start	0.80	Rating **	M	Issue No.	25
LM End	1.34	Issue Type +	Ma	Location *	WS
Category	Earthen Levee			GPS Latitude/Longitude	
				Start	End
Item	Vegetation			37.477830 °	37.479293 °
				-121.072226 °	-121.063091 °
DWR ID	DWR_RD1602_01_s_2020_25				
Comment Code					
V1 : Control annual grass and weeds on the levee slopes and easements.					
Inspector Comment

View of the waterside slope looking upstream. (Spring 2020)

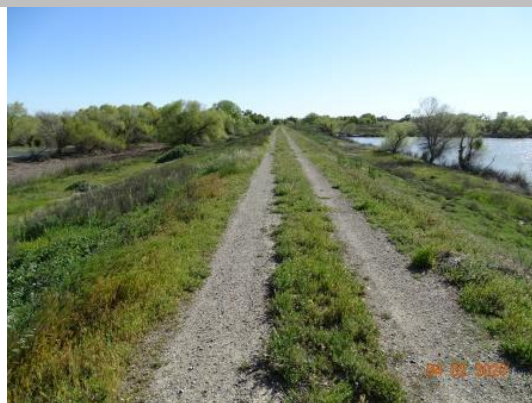
Photo 1 of 1 : SP_2020_RD1602_110_40_20200403_00127.jpg

LM Start	0.81	Rating **	M	Issue No.	40
LM End	1.63	Issue Type +	Ma	Location *	CR
Category	Earthen Levee			GPS Latitude/Longitude	
				Start	End
Item	Vegetation			37.477849 °	37.477455 °
				-121.071953 °	-121.058627 °
DWR ID	DWR_RD1602_01_s_2020_40				
Comment Code					
V9 : Keep the crown roadway free of vegetation.					
Inspector Comment

View of vegetation growing along the crown. (Spring 2020)

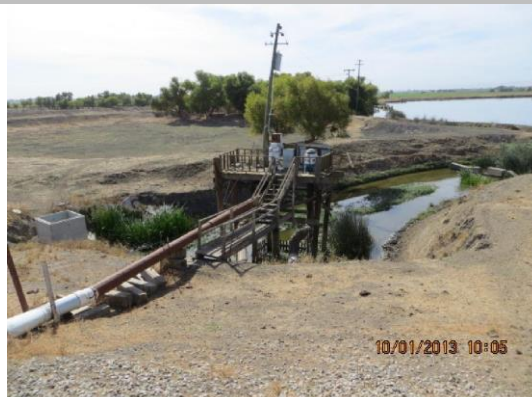
Photo 1 of 3 : UCIP_SP_2020_51636_36758.jpg

Comment Code						
Inspector Comment						
DS_ID:20217 FS_ID:51636 EP_NO: N/A Repair Type: Non-Urgent Crossing Status: Found UCIP Comments: 11/18/2016 Crossing has been downgraded from Urgent to Non-Urgent a flap gate has been added to the WS but pipe is currently not connected to pump. According to Tony Martinez, LMA representative, this crossing is currently not in use. Owner will need to coordinate with CVFPB to obtain permit. (O. Magana - DWR UCIP)10/01/2013 Appears abandoned and if so should be done so properly. Flapgate missing. (W. Wylie - DWR UCIP) FIELD_STRUCT_DESC: *ABANDONED* 1 of 2: 16-inch steel drainage pipe through levee, 17 feet below crown. Pumps on the pump platform are located on the landside (LS). Siphon breaker in 24-inch corrugated metal pipe (CMP) riser is located on the waterside (WS) shoulder. Concrete "U" headwall and flap gate are located on the WS end. [Additional Reference(s): DWR Levee Log, 1992. USACE San Joaquin River O&M Manual Unit 13, April 1964, (HLM 1.01), Drawing No. 7-4-1784]. FS Date: 11/18/2016

Pumping plant on LS toe. Pipe visible under walkway.

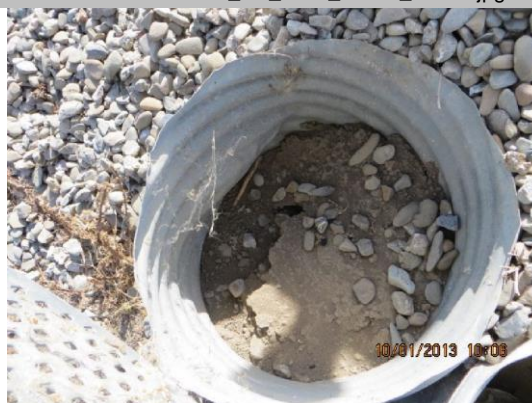
Photo 2 of 3 : UCIP_SP_2020_51637_36771.jpg

Siphon breaker covered in soil at CMP riser on WS shoulder.

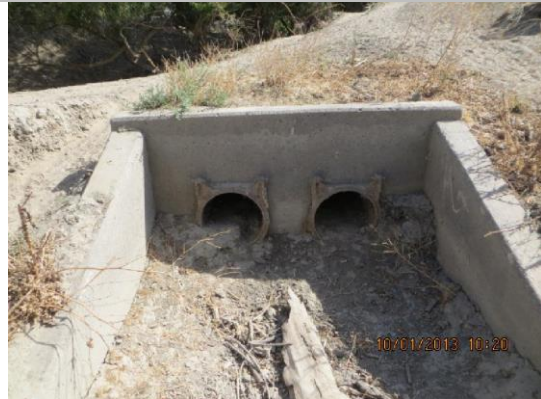
Photo 3 of 3 : UCIP_SP_2020_51637_36770.jpg

Concrete headwall on WS toe with missing flapgate.

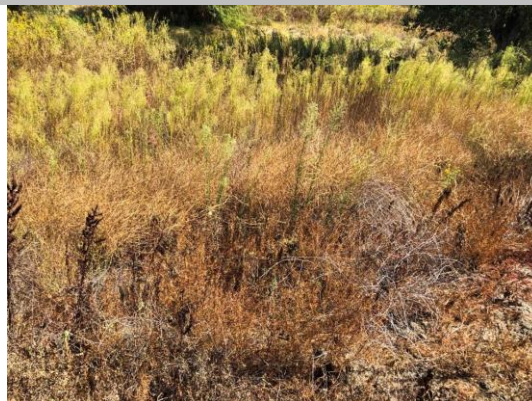
Photo 1 of 3 : SP_2020_RD1602_110_2_20200225_00001.jpg

Site ID: RD1602U01RM97.68
 09/17/2019: No significant change observed. Signs of animal activities at the site.
 09/20/2017: The erosion was discovered during the spring levee inspection. The size of the erosion is roughly estimated due to dense vegetation at the site.

Close-up view of the erosion. The erosion is covered by dense vegetation at the site.

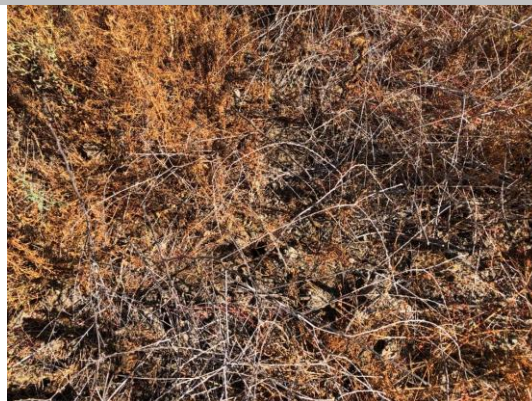
Photo 3 of 3 : SP_2020_RD1602_110_2_20200225_00003.jpg

Close-up view at the erosion. Signs of squirrel activities.

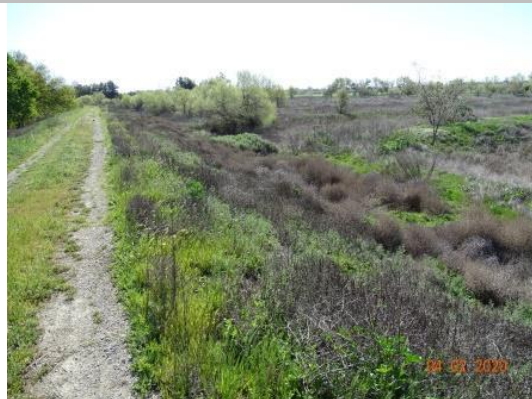
Photo 1 of 1 : SP_2020_RD1602_110_61_20200403_00128.jpg

Looking upstream at vegetation growing on the landside slope and toe.
(Spring 2020)

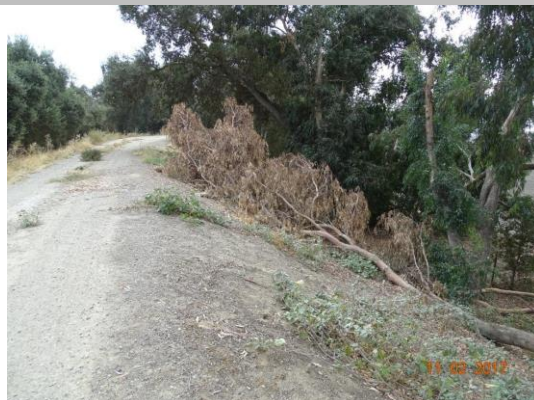
Photo 1 of 1 : SP_2020_RD1602_110_33_20200225_00015.jpg

View of prunings on the landside of the levee.

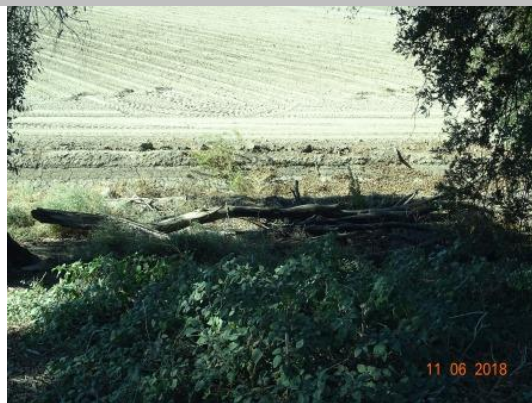
Photo 1 of 1 : SP_2020_RD1602_110_104_20200225_00064.jpg

tree limbs on landside toe. (Fall 2018)

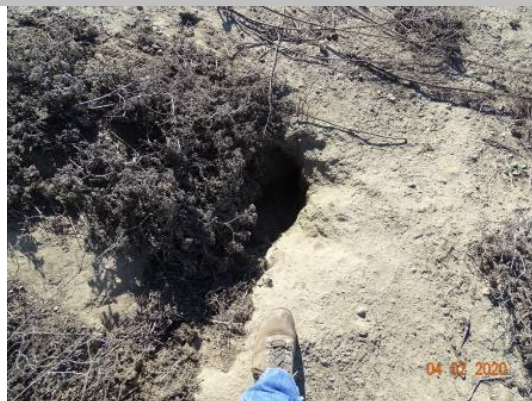
Photo 2 of 2 : SP_2020_RD1602_110_93_20200403_00131.jpg

Representative view of rodent burrow in landside slope. (Spring 2020)

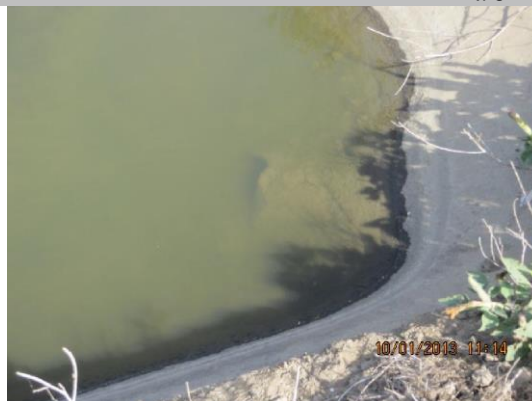
Photo 1 of 3 : UCIP_SP_2020_53522_36805.jpg

DS_ID:20204
FS_ID:53522
EP_NO: 8193
Repair Type: Urgent
Crossing Status: Found
UCIP Comments: 10/19/2018 Pipe is deteriorated on the LS toe (pipe section missing at inlet). This crossing remains Urgent due to the wall deterioration at the inlet. If wall is rusted out at the inlet, need to determine the condition of the pipe section through the levee. According to the LMA representative, this crossing is no longer in use (crossing is abandoned). LMA is interested in abandoning crossing in place. LMA was referred to the CVFPB staff for direction regarding proper action under Title 23 for this crossing. (O. Magana - DWR UCIP)11/18/2016 Same as previous inspection riser cover and handle on slide gate are still missing. Crossing remains Urgent due to the public safety issue of the 60-inch CMP cover still missing. According to Tony Martinez, LMA representative, the condition and future use of this crossing is being evaluated. Owner will need to coordinate with CVFPB for future use requirements or proper abandonment/removal. (O. Magana - DWR UCIP)10/01/2013 Appears abandoned, and if so should be done so properly. No handle on slide gate, no cover on CMP standpipe on WS shoulder. (W. Wylie - DWR UCIP)

Pipe visible in concrete channel on LS toe.

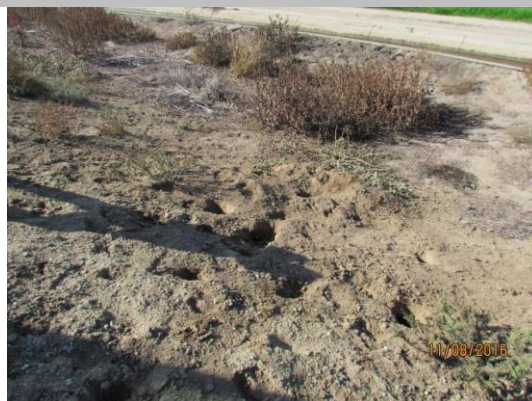
Photo 1 of 1 : SP_2020_RD1602_110_56_20200225_00031.jpg

View of rodent holes on the landside of the levee. Fall 2016

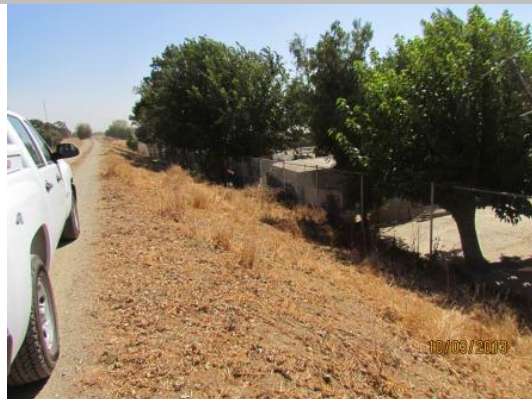
Photo 1 of 2 : SP_2020_RD1602_110_66_20200225_00038.jpg

Fences were found on the landside toe of the levee looking upstream.

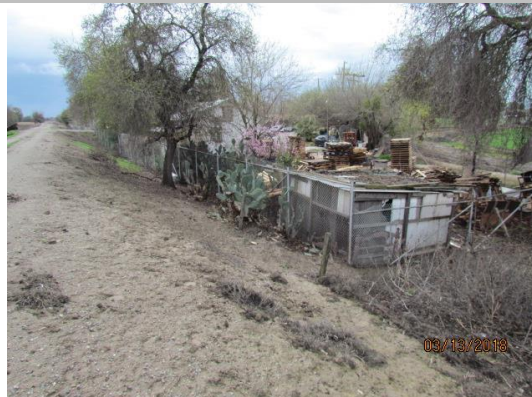
Photo 2 of 2 : SP_2020_RD1602_110_66_20200225_00039.jpg

Looking southwest at animal pens and other encroachments on landward toe. (Spring 2018)

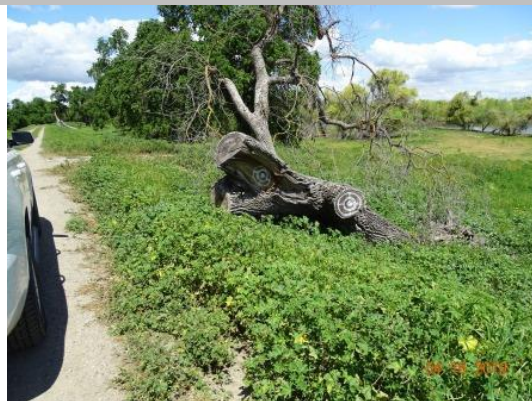
Photo 1 of 1 : SP_2020_RD1602_110_90_20200225_00055.jpg

Fallen tree trunk on waterside slope. (Spring 2019)

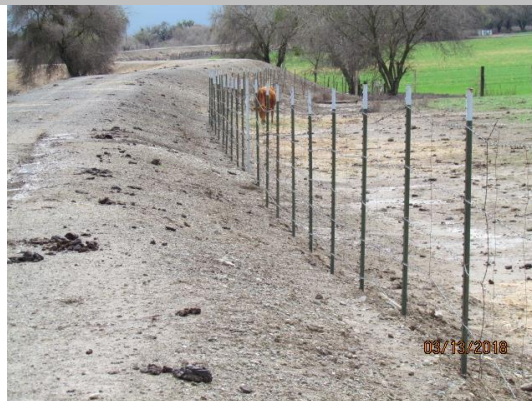
Photo 2 of 2 : SP_2020_RD1602_110_63_20200225_00037.jpg

Looking upstream at fence on landward slope. (Spring 2018)

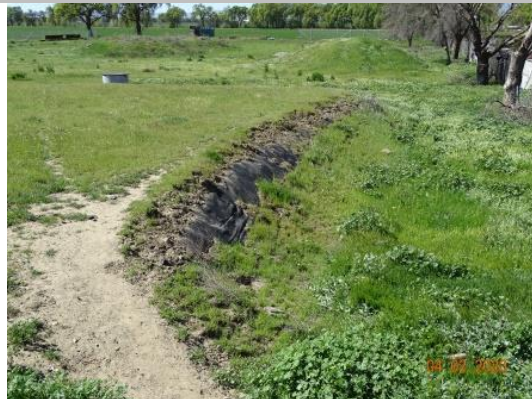
Photo 1 of 2 : SP_2020_RD1602_110_62_20200403_00142.jpg

View of damage on downstream side of seepage berm. (Spring 2020)

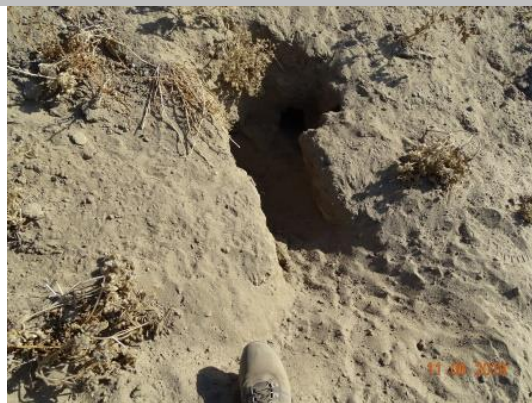
Photo 2 of 2 : SP_2020_RD1602_110_87_20200225_00052.jpg

Representative rodent burrow in the landside slope. (Fall 2019)

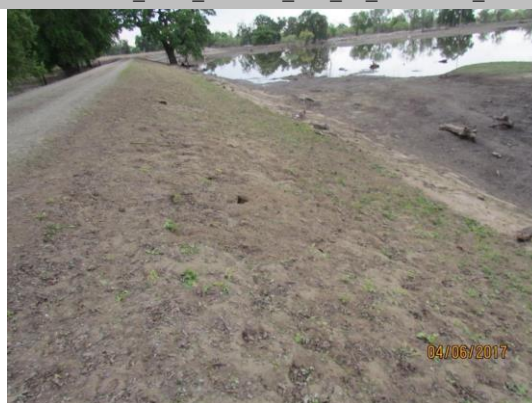
Photo 1 of 1 : SP_2020_RD1602_110_91_20200225_00056.jpg

View of rodent holes on the waterside of the levee looking downstream.
Spring 2017

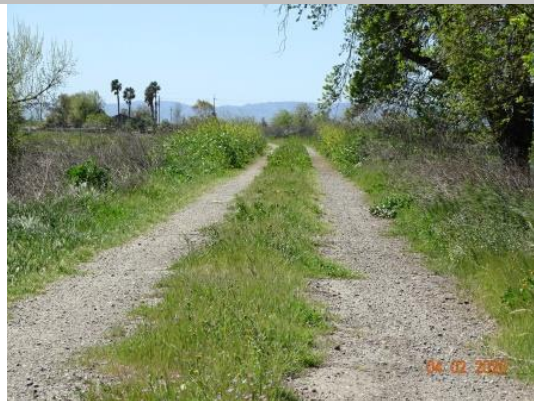
Photo 1 of 1 : SP_2020_RD1602_110_137_20200403_00149.jpg

View of vegetation growing along the levee crown. (Spring 2020)

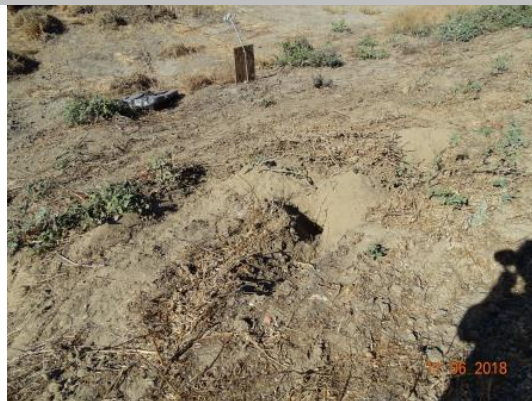
Photo 2 of 2 : SP_2020_RD1602_110_89_20200225_00054.jpg

Upclose view of some of the damage to slope. (Fall 2018)

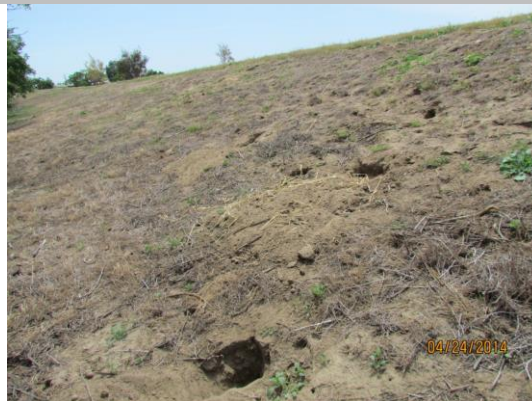
Photo 1 of 1 : SP_2020_RD1602_110_199_20200225_00078.jpg

Rodent holes were found on the waterside toe of the levee looking upstream.

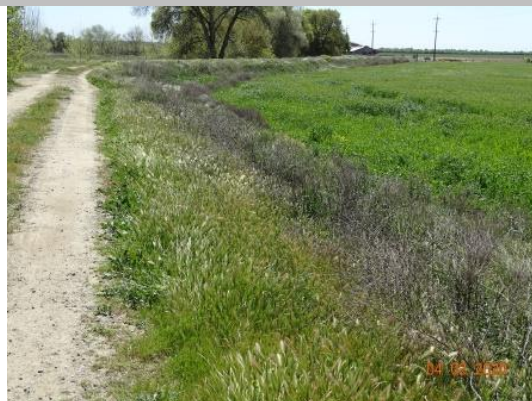
Photo 1 of 1 : SP_2020_RD1602_110_142_20200403_00151.jpg

View of vegetation along the landside slope looking upstream. (Spring 2020)

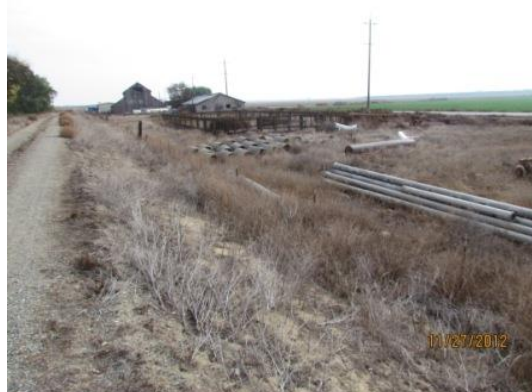
Photo 1 of 1 : SP_2020_RD1602_110_22_20200225_00007.jpg

A fence was found on the landside toe of the levee looking upstream.

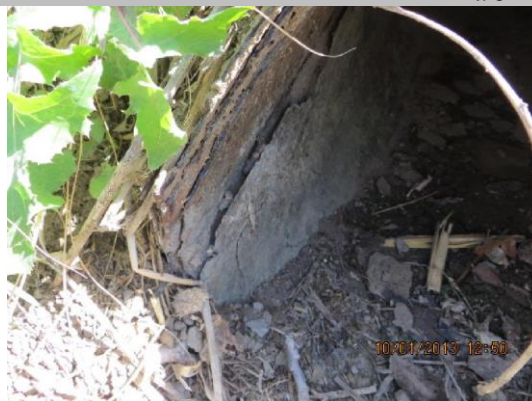
Photo 3 of 3 : UCIP_SP_2020_21683_36880.jpg

Pipe deteriorated on LS at outlet.
