**Flood Control Project Maintenance  
Levee Inspections  
LMA District Cover Sheet**

**Reclamation District No. 1602 Del Puerto**

**Flood Control Project Maintenance  
Levee Inspections**

**Levee Inspection Report By Mile - Spring 2021**

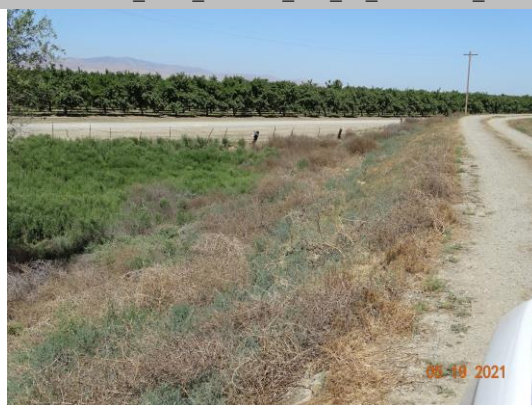
Photo 1 of 1 : SP\_2021\_RD1602\_110\_37\_20210521\_00099.jpg

View of the landside slope looking downstream. (Spring 2021)

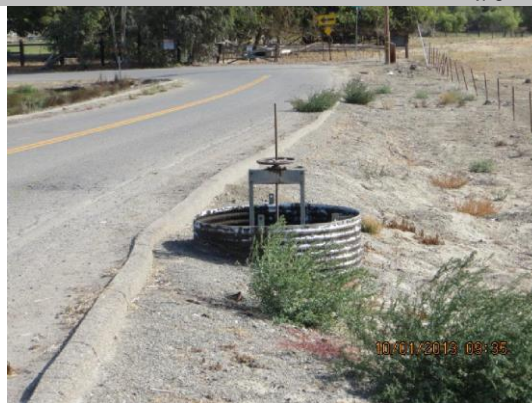
Photo 1 of 3 : UCIP\_SP\_2021\_51325\_36702.jpg

Comment Code						
Inspector Comment						
FS_ID:51325 DS_ID:20215 EP_NO: N/A Repair Type: No Action Needed Crossing Status: Found UCIP Comments: 11/18/2016 Crossing has been downgraded from Urgent to No Action Needed a cover has been added to the CMP riser. (O. Magana - DWR UCIP)10/01/2013 Open 60-inch CMP riser on WS needs lid as it's depth may be a hazard to the public. (W. Wylie - DWR UCIP) FIELD_STRUCT_DESC: 16-inch steel drainage pipe through levee, 11.3 feet below crown. Slide gate in 60-inch corrugated metal pipe (CMP) riser located on the waterside (WS). Concrete inlet is approximately 110 feet west of the levee crown or 110 feet off landside (LS) toe next to roadway. [Additional Reference(s): DWR Levee Log, 1992. USACE San Joaquin River O&M Manual Unit 13, April 1964, (HLM 0.58), Drawing No. 7-4-1784]. FS Date: 11/18/2016

60-inch CMP riser on WS shoulder.

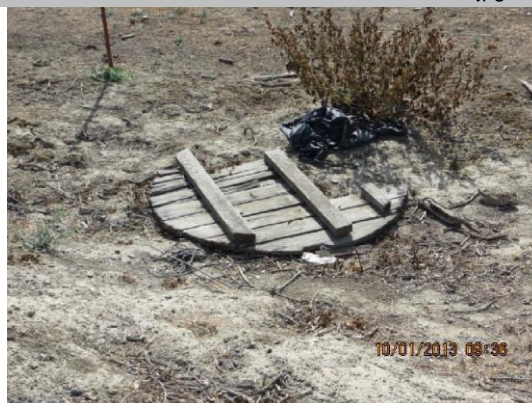
Photo 3 of 3 : UCIP\_SP\_2021\_51325\_36700.jpg

Damaged Wooden lid on WS toe.

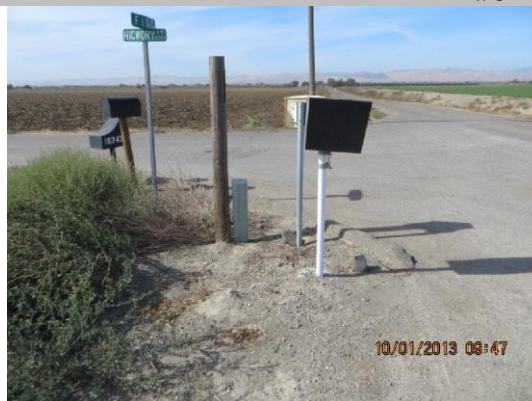
Photo 1 of 3 : UCIP\_SP\_2021\_22937\_39050.jpg

LM Start	0.58	Rating **	M	Issue No.	2
LM End	0.58	Issue Type +	En	Location *	
Category	Supplemental			GPS Latitude/Longitude	
				Start	End
Item	DWR UCIP Field Study			37.480176 °	37.480176 °
				-121.074736 °	-121.074736 °
DWR ID	24681				
Comment Code					
Inspector Comment					
FS_ID:22937 DS_ID:24681 EP_NO: N/A Repair Type: Non-Urgent Crossing Status: Found UCIP Comments: 10/01/2013 No permit identified for this crossing. (W. Wylie - DWR UCIP) FIELD_STRUCT_DESC: Communications line of an unknown size or material through the levee, at an unknown depth. FS Date: 10/1/2013

Communication line access box on LS shoulder.

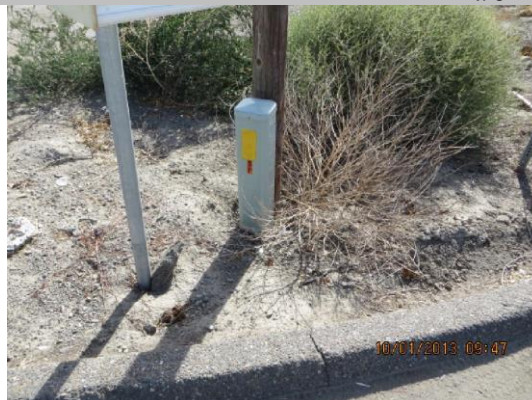
Photo 2 of 3 : UCIP\_SP\_2021\_22937\_39049.jpg

Communication line access box on LS shoulder.

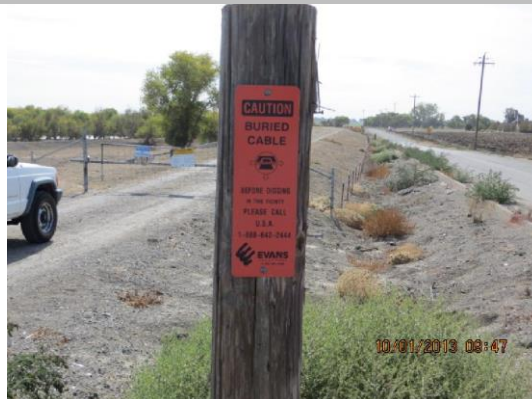
Photo 3 of 3 : UCIP\_SP\_2021\_22937\_39048.jpg

Communication line marker on LS shoulder.

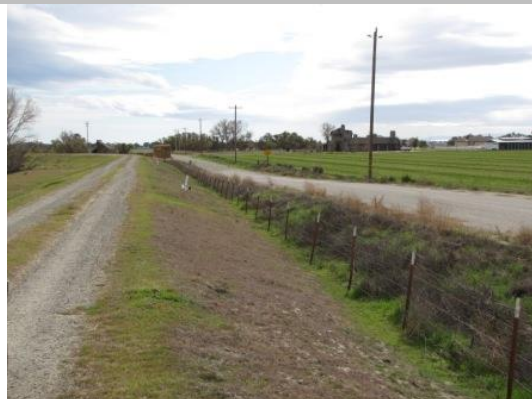
Photo 1 of 1 : SP\_2021\_RD1602\_110\_70\_20210308\_00031.jpg

LM Start	0.60	Rating **	M	Issue No.	70
LM End	0.71	Issue Type +	En	Location *	LS
Category	Earthen Levee			GPS Latitude/Longitude	
				Start	End
Item	Encroachments			37.479967 °	37.478514 °
				-121.074582 °	-121.073435 °
DWR ID	DWR_RD1602_01_s_2012_70				
Comment Code					
FE : Fence					
Inspector Comment					
Barbed wire fence along the landward toe.

View of barbed wire fence at landward toe looking upstream.

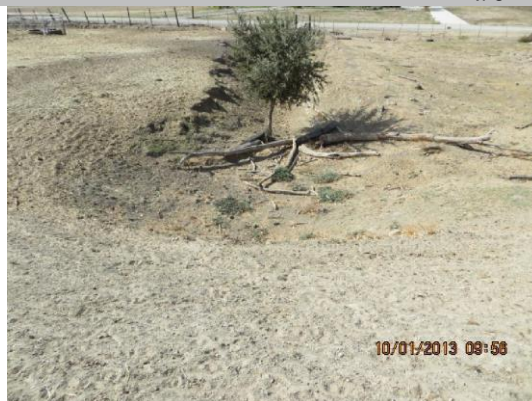
Photo 1 of 3 : UCIP\_SP\_2021\_51634\_36723.jpg

Comment Code						
Inspector Comment						
FS_ID:51634 DS_ID:20216 EP_NO: N/A Repair Type: No Action Needed Crossing Status: Found UCIP Comments: 11/18/2016 Crossing has been downgraded from Urgent to No Action Needed the debris blocking the outlet has been cleared. (O. Magana - DWR UCIP)10/01/2013 Flap gate blocked from functioning by soil buildup on WS toe. Soil should be cleared. (W. Wylie - DWR UCIP) FIELD_STRUCT_DESC: 30-inch square reinforced concrete box culvert through levee, 14.4 feet below crown. Concrete "U" headwall on the waterside (WS) and landside (LS) ends. Slide gate in 6-foot by 7-foot concrete surge box is located on the WS shoulder. Flap gate is located on the WS end. [Additional Reference(s): DWR Levee Log, 1992. USACE San Joaquin River O&M Manual Unit 13, April 1964, (HLM 0.78), Drawing No. 7-4-1784]. FS Date: 11/18/2016

Inlet on LS toe.

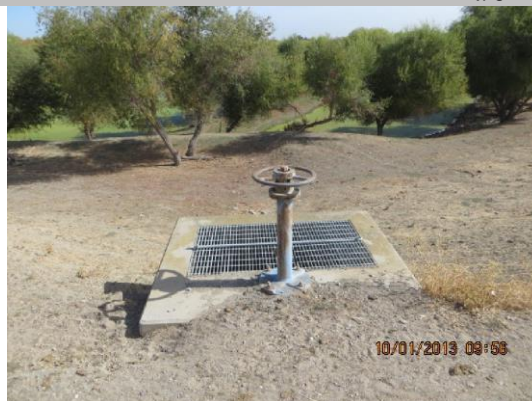
Photo 2 of 3 : UCIP\_SP\_2021\_51634\_36722.jpg

Slide gate in concrete box on WS shoulder.

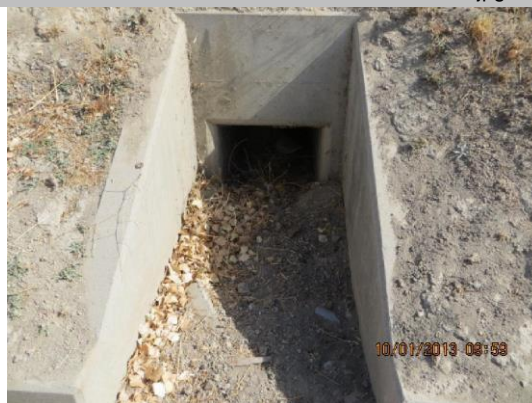
Photo 3 of 3 : UCIP\_SP\_2021\_51634\_36721.jpg

Concrete inlet on LS toe.

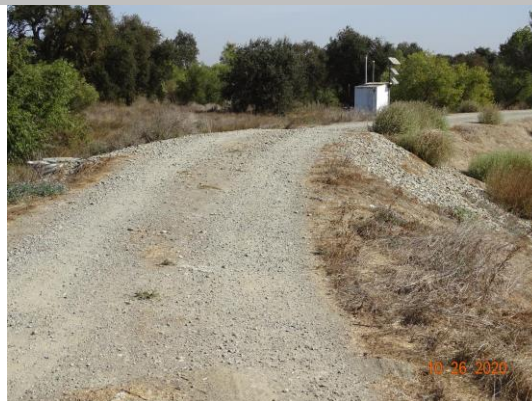
Photo 1 of 1 : SP\_2021\_RD1602\_110\_36\_20210308\_00007.jpg

LM Start	1.00	Rating **	A/W	Issue No.	36
LM End	1.00	Issue Type +	En	Location *	WS
Category	Earthen Levee			GPS Latitude/Longitude	
				Start	End
Item	Encroachments			37.478810 °	37.478810 °
				-121.068738 °	-121.068738 °
DWR ID	DWR_RD1602_01_s_2012_36				
Comment Code					
RA : Ramp					
Inspector Comment					
Pipe owner placed fill over pipe above crown of levee to build ramp over pipe.

View of ramp built up on levee crown. (Fall 2020)

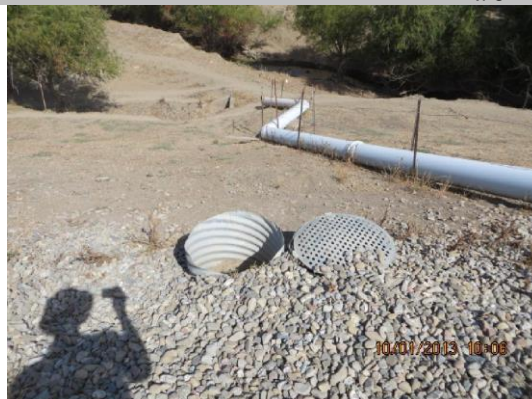
Photo 2 of 3 : UCIP\_SP\_2021\_51636\_36757.jpg

Comment Code						
Inspector Comment						
FS_ID:51636 DS_ID:20217 EP_NO: N/A Repair Type: Non-Urgent Crossing Status: Found UCIP Comments: 11/18/2016 Crossing has been downgraded from Urgent to Non-Urgent a flap gate has been added to the WS but pipe is currently not connected to pump. According to Tony Martinez, LMA representative, this crossing is currently not in use. Owner will need to coordinate with CVFPB to obtain permit. (O. Magana - DWR UCIP)10/01/2013 Appears abandoned and if so should be done so properly. Flapgate missing. (W. Wylie - DWR UCIP) FIELD_STRUCT_DESC: *ABANDONED* 1 of 2: 16-inch steel drainage pipe through levee, 17 feet below crown. Pumps on the pump platform are located on the landside (LS). Siphon breaker in 24-inch corrugated metal pipe (CMP) riser is located on the waterside (WS) shoulder. Concrete "U" headwall and flap gate are located on the WS end. [Additional Reference(s): DWR Levee Log, 1992. USACE San Joaquin River O&M Manual Unit 13, April 1964, (HLM 1.01), Drawing No. 7-4-1784]. FS Date: 11/18/2016

Siphon breaker in 24-inch CMP riser on WS shoulder.

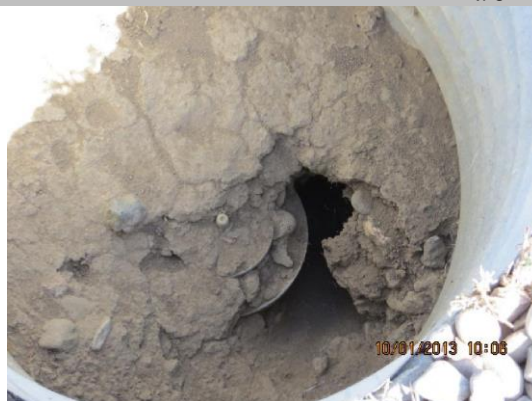
Photo 3 of 3 : UCIP\_SP\_2021\_51636\_36756.jpg

Siphon breaker in 24-inch CMP riser on WS shoulder.

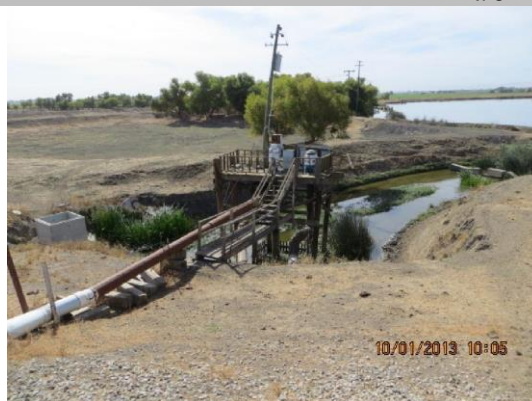
Photo 1 of 3 : UCIP\_SP\_2021\_51637\_36772.jpg

FS\_ID:51637  
DS\_ID:20219  
EP\_NO: N/A  
Repair Type: Non-Urgent  
Crossing Status: Found  
UCIP Comments: 11/18/2016 Crossing has been downgraded from Urgent to Non-Urgent a flap gate has been added to the WS. According to Tony Martinez, LMA representative, this crossing is currently not in use. Owner will need to coordinate with CVFPB to obtain permit. (O. Magana - DWR UCIP)10/01/2013 Appears abandoned siphon breakers covered in soil and flapgate missing. (W. Wylie - DWR UCIP) FIELD\_STRUCT\_DESC: \*ABANDONED\* 2 of 2: 16-inch steel drainage pipe through levee, 17 feet below crown. Pump on pump platform located on the landside (LS). Siphon breaker in 24-inch riser located on the waterside (WS) shoulder. Concrete "U" headwall and flap gate are located on the WS end. [Additional Reference(s): DWR Levee Log, 1992. USACE San Joaquin River O&M Manual Unit 13, April 1964, (HLM 1.01), Drawing No. 7-4-1784].

Pipe visible under walkway at puming plant on LS toe.

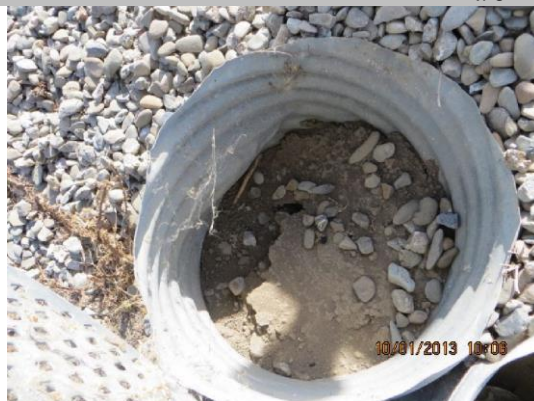
Photo 2 of 3 : UCIP\_SP\_2021\_51637\_36771.jpg

Siphon breaker covered in soil at CMP riser on WS shoulder.

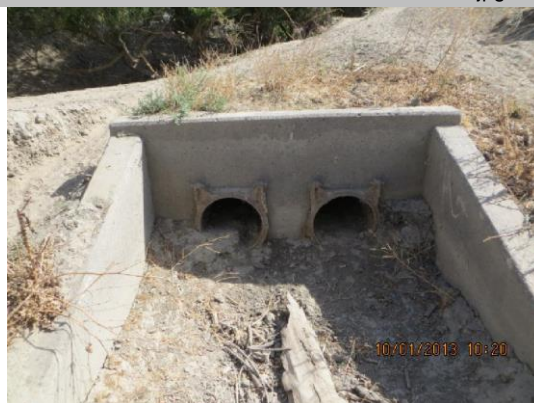
Photo 3 of 3 : UCIP\_SP\_2021\_51637\_36770.jpg

Concrete headwall on WS toe with missing flapgate.

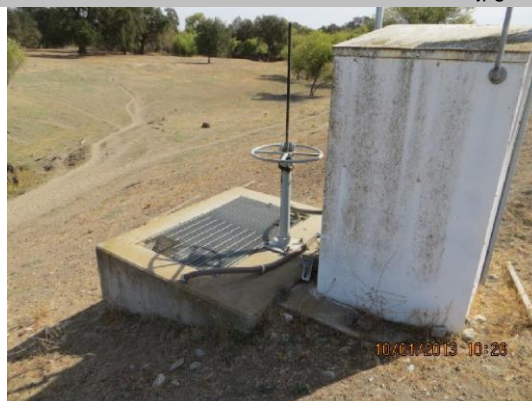
Photo 3 of 3 : UCIP\_SP\_2021\_53521\_36789.jpg

Slide gate in concrete riser next to shed on WS shoulder.

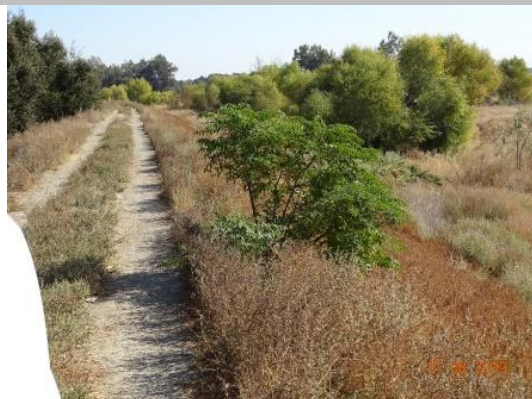
Photo 1 of 1 : SP\_2021\_RD1602\_110\_127\_20210308\_00051.jpg

Young tree growing on the landside shoulder should be removed. (Fall 2019)

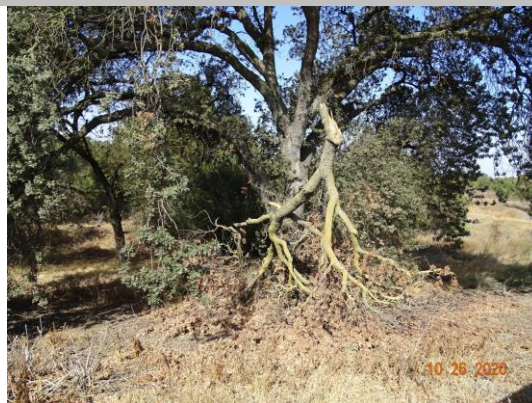
Photo 1 of 1 : SP\_2021\_RD1602\_110\_72\_20210308\_00032.jpg

Tree limb hanging on the waterside slope. (Fall 2020)

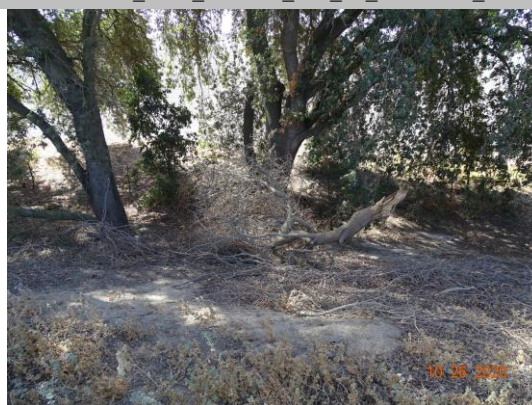
Photo 1 of 1 : SP\_2021\_RD1602\_110\_40\_20210308\_00010.jpg

Broken tree limb left on the landside toe. (Fall 2020)

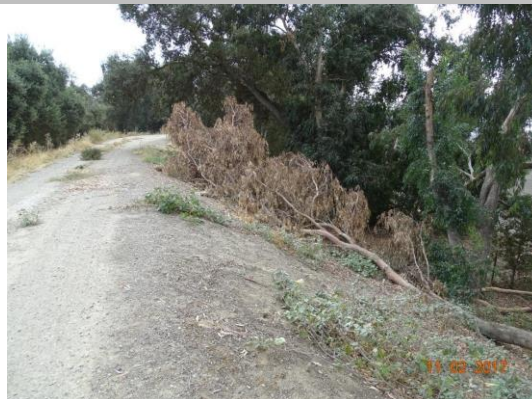
Photo 1 of 1 : SP\_2021\_RD1602\_110\_33\_20210308\_00005.jpg

View of prunings on the landside of the levee.

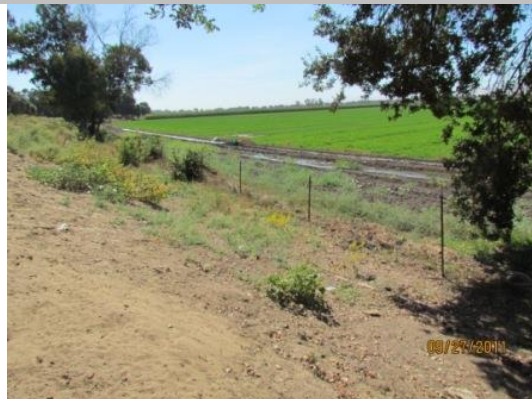
Photo 1 of 1 : SP\_2021\_RD1602\_110\_43\_20210308\_00012.jpg

View of the fence on the landside toe of the levee. The picture was taken from crown looking upstream.

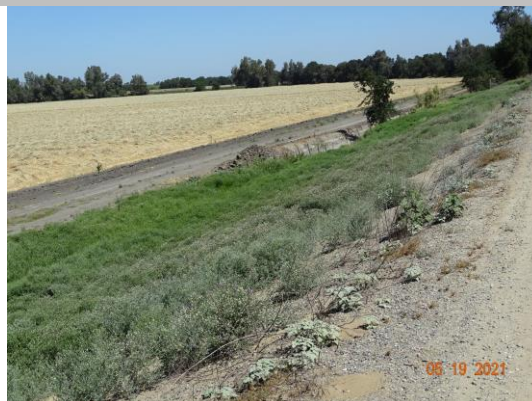
Photo 1 of 1 : SP\_2021\_RD1602\_110\_28\_20210521\_00100.jpg

View of vegetation on the landside slope looking downstream. (Spring 2021)

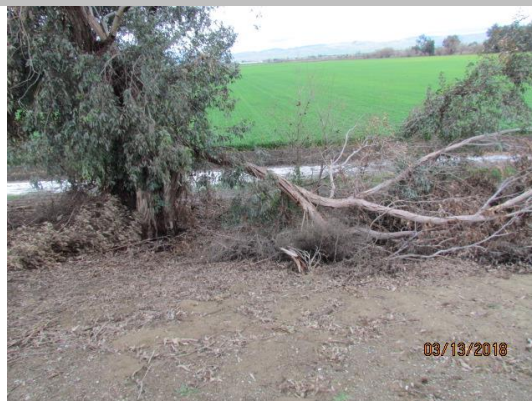
Photo 1 of 1 : SP\_2021\_RD1602\_110\_80\_20210308\_00036.jpg

Looking at fallen branch on landward slope and toe.

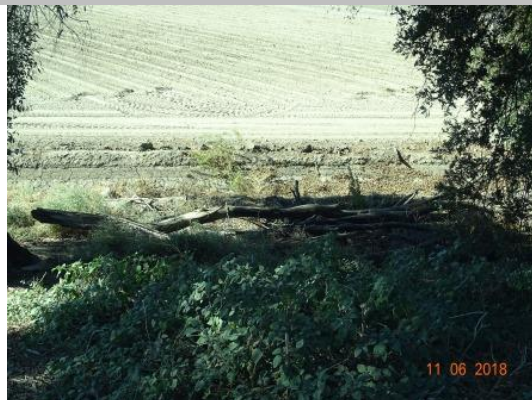
Photo 1 of 1 : SP\_2021\_RD1602\_110\_104\_20210308\_00049.jpg

View of tree limbs on the landside toe. (Fall 2018)

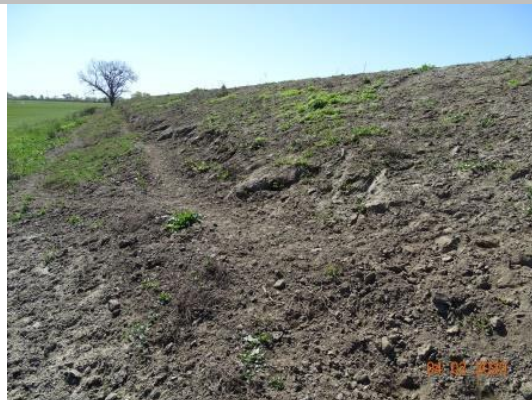
Photo 1 of 1 : SP\_2021\_RD1602\_110\_119\_20210308\_00050.jpg

LM Start	2.81	Rating **	M	Issue No.	119
LM End	3.01	Issue Type +	Ma	Location *	WS
Category	Earthen Levee			GPS Latitude/Longitude	
				Start	End
Item	Animal Control			37.466673 °	37.464528 °
				-121.046185 °	-121.044012 °
DWR ID	DWR_RD1602_01_s_2020_119				
Comment Code					
A2 : Repair the levee slope damaged by livestock and prevent large animal access.					
Inspector Comment					
Cattle trail beginning to cut in to the waterside slope.

Looking upstream along the waterside slope at cattle trail. (Spring 2020)

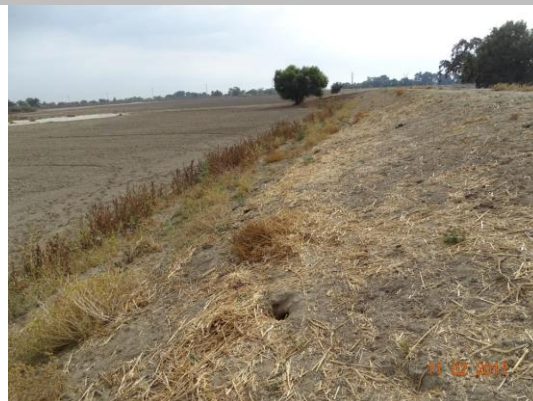
Photo 1 of 1 : SP\_2021\_RD1602\_110\_51\_20210308\_00019.jpg

View of a rodent hole on the waterside of the levee.

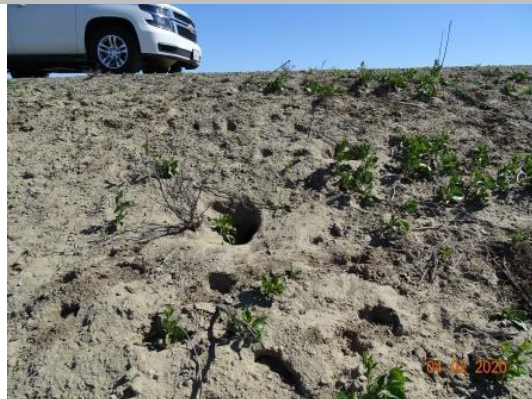
Photo 1 of 1 : SP\_2021\_RD1602\_110\_95\_20210308\_00046.jpg

View of the landside slope from the toe of the levee. (Spring 2020)

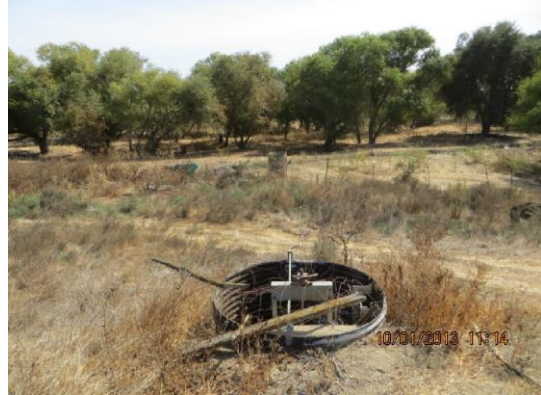
Photo 2 of 3 : UCIP\_SP\_2021\_53522\_36804.jpg

Slide gate in 60-inch CMP riser on WS shoulder.

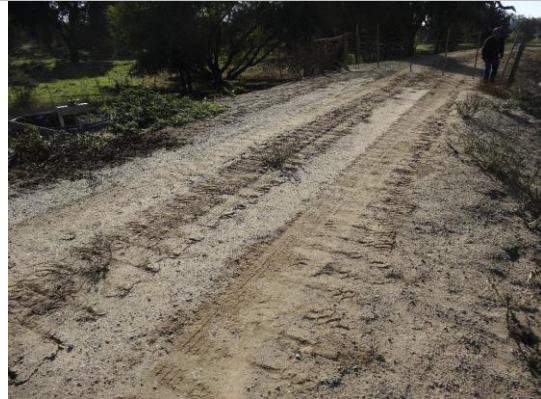
Photo 3 of 3 : UCIP\_SP\_2021\_53522\_76527.jpg

Overview of levee crown at pipe crossing.

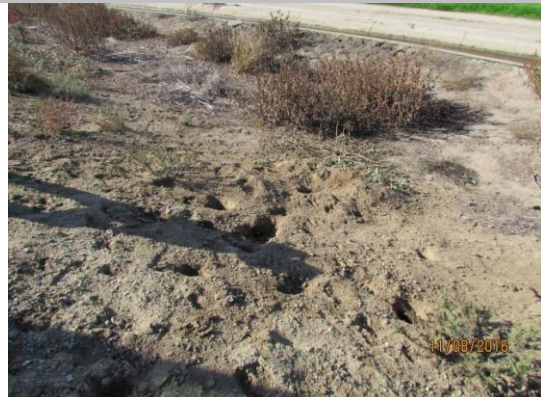
Photo 1 of 1 : SP\_2021\_RD1602\_110\_56\_20210308\_00023.jpg

View of rodent holes on the landside of the levee. Fall 2016

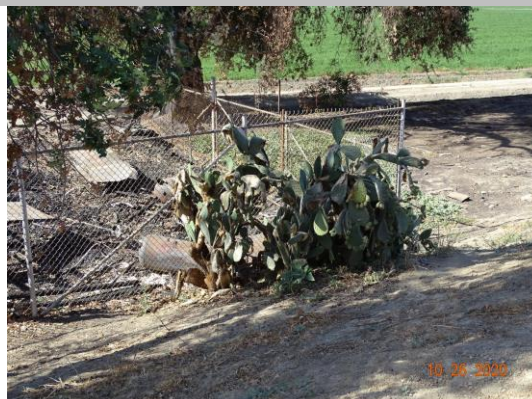
Photo 1 of 1 : SP\_2021\_RD1602\_110\_42\_20210308\_00011.jpg

Cactus growing on the landside slope. (Fall 2020)

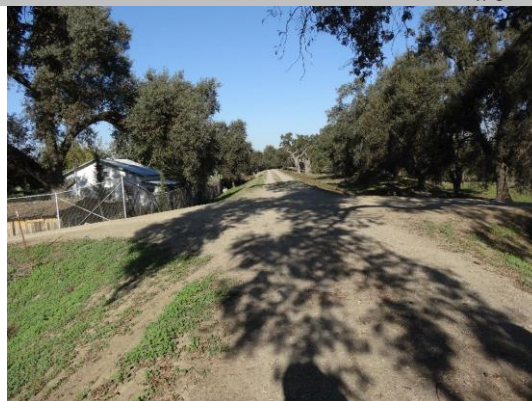
Photo 1 of 3 : UCIP\_SP\_2021\_53523\_76534.jpg

FS\_ID:53523  
DS\_ID:20206  
EP\_NO: 7796  
Repair Type: Non-Urgent  
Crossing Status: Indicator Found  
UCIP Comments: 10/19/2018 Pipe section through the WS ramp was exposed during the 2017 storms. According to LMA representative, adjacent property owner has backfilled the pipe with soil to avoid damage to line. Contacted Mr. Chris Williams with PG&E and Mr. Williams mentioned that PG&E is planning to abandon the line and install a new line. The new line will be bored through the levee. Mr. Williams also mentioned that the line was inspected in 2016-17 and was found to be functional. However, due to the pipe exposure in 2017 PG&E has decided to abandon the current line. PG&E is working with the CVFPB to obtain the proper permits and complete the final design for the new line. This crossing has been downgraded from Urgent to Non-Urgent due to the updated UCIP reclassification evaluations. Pending action for this crossing includes line abandonment documentation from CVFPB and closeout files for this crossing. Primary PG&E contact for this crossing is Carlos Carbrera, Stanislaus and San Joaquin PG&E Local Engineer. He can be reached at 1-925-789-0509 or by email at c4ch@pge.com. (O. Magana - DWR UCIP)11/18/2016 Same as previous inspection crossing is missing markers visible from levee crown. PG&E completed some construction work on this line from September - November 3rd, 2016 and installed a marker on WS approximately 341 feet from levee crown. UCIP inspector will need to contact Mr. Chris Williams, Associate Construction Specialist, Gas Construction Management Central Valley Region with PG&E at 1-209-272-2811 to determine extent of inspection through levee. (O. Magana - DWR UCIP)10/01/2013 Gasline needs sign markers at levee. (W. Wylie - DWR UCIP)

Overview of levee crown at pipe crossing.

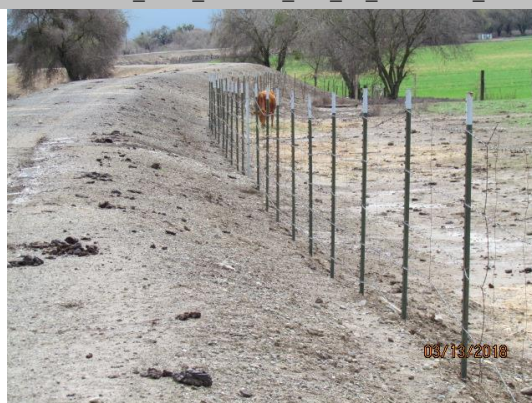
Photo 1 of 1 : SP\_2021\_RD1602\_110\_63\_20210308\_00027.jpg

Looking upstream at fence on landward slope. (Spring 2018)

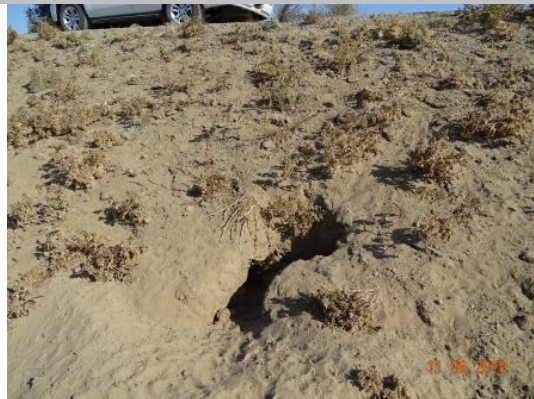
Photo 1 of 1 : SP\_2021\_RD1602\_110\_87\_20210308\_00041.jpg

View of rodent burrows in the landside slope. (Fall 2019)

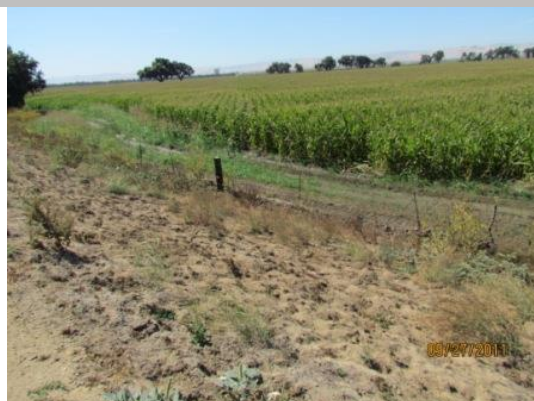
Photo 1 of 1 : SP\_2021\_RD1602\_110\_67\_20210308\_00029.jpg

View of the fence on the landside toe of the levee. The picture was taken from the crown looking upstream.

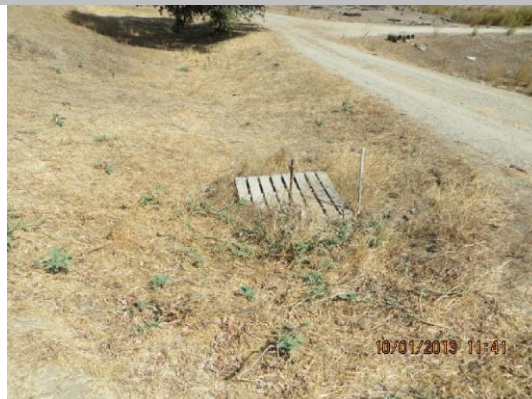
Photo 1 of 3 : UCIP\_SP\_2021\_51332\_36819.jpg

Slide gate in CMP riser on WS slope.

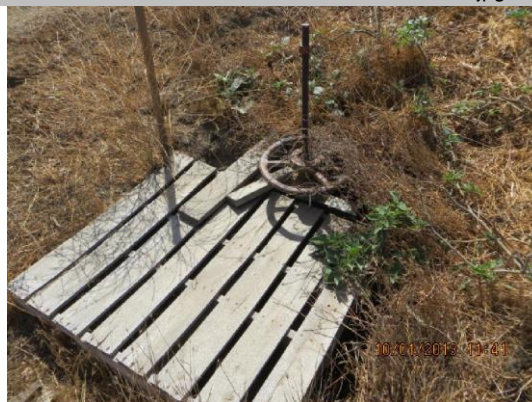
Photo 2 of 3 : UCIP\_SP\_2021\_51332\_36818.jpg

Slide gate in CMP riser on WS slope.

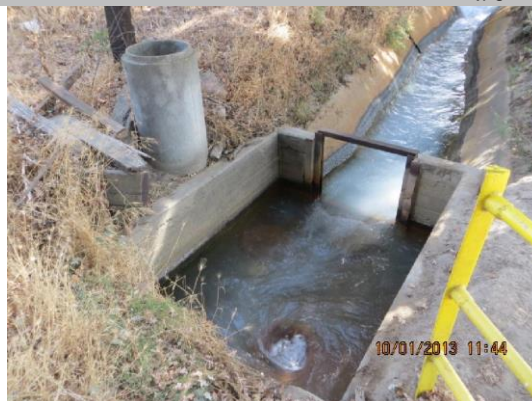
Photo 3 of 3 : UCIP\_SP\_2021\_51332\_36817.jpg

Concrete ditch at outlet from pipe on LS toe.

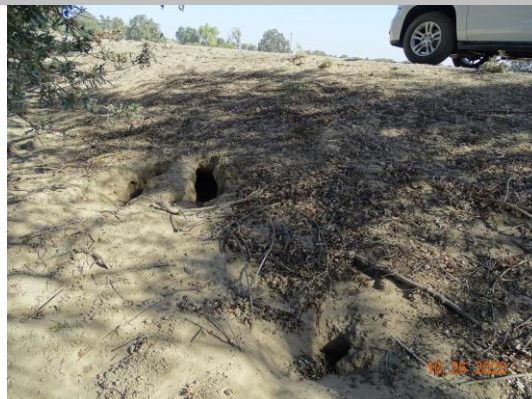
Photo 1 of 1 : SP\_2021\_RD1602\_110\_55\_20210308\_00022.jpg

Large animal burrows in the landside slope. (Fall 2020)

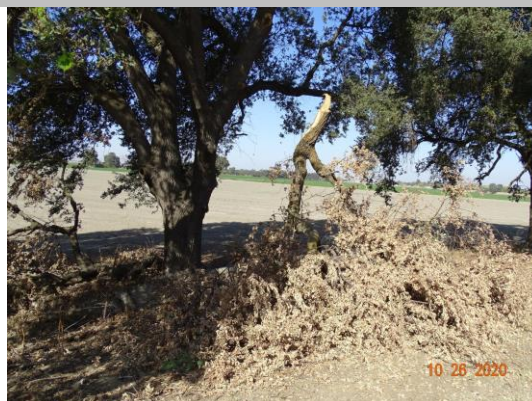
Photo 1 of 1 : SP\_2021\_RD1602\_110\_54\_20210308\_00021.jpg

View of broken tree branch that has fallen on the landside slope. (Fall 2020)

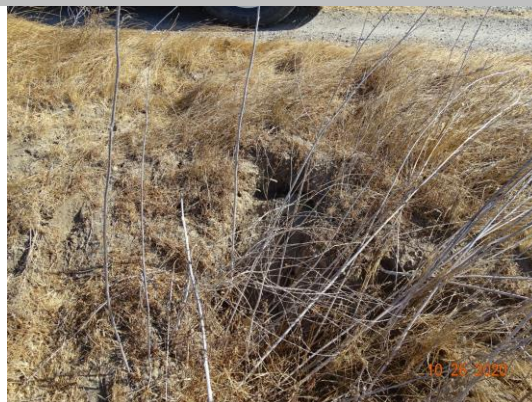
Photo 1 of 1 : SP\_2021\_RD1602\_110\_44\_20210308\_00013.jpg

Several rodent holes noted at this location. (Fall 2020)

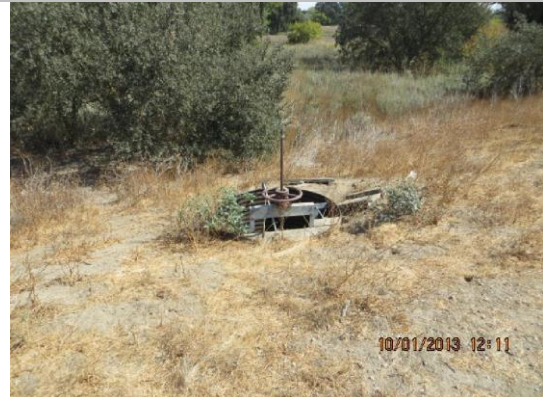
Photo 1 of 3 : UCIP\_SP\_2021\_51336\_36822.jpg

Slide gate in CMP riser on WS slope. Outlet visible under tree in background.

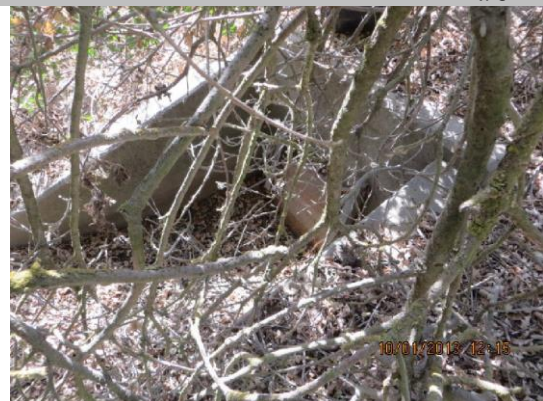
Photo 2 of 3 : UCIP\_SP\_2021\_51336\_36821.jpg

Flapgate in Concrete headwall on WS toe under tree.

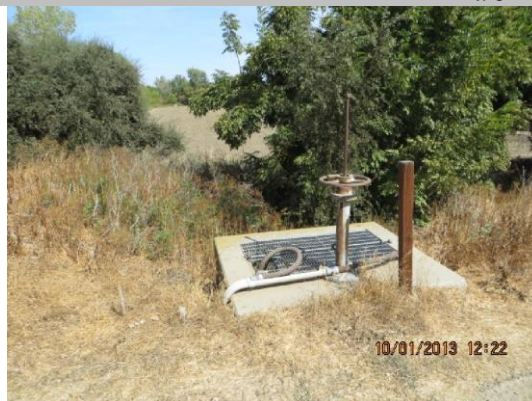
Photo 1 of 3 : UCIP\_SP\_2021\_21672\_36848.jpg

Slidegate in concrete riser on WS shoulder.

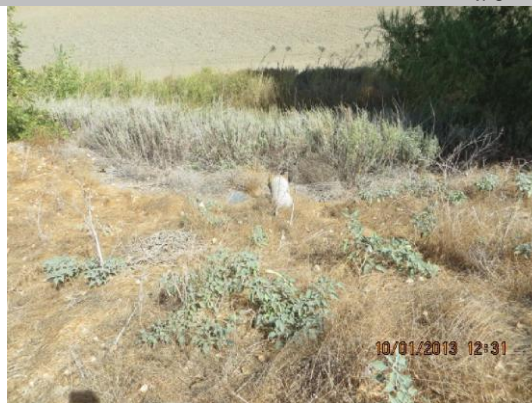
Photo 1 of 1 : UCIP\_SP\_2021\_21674\_36854.jpg

Pipe and flapgate visible on WS toe.

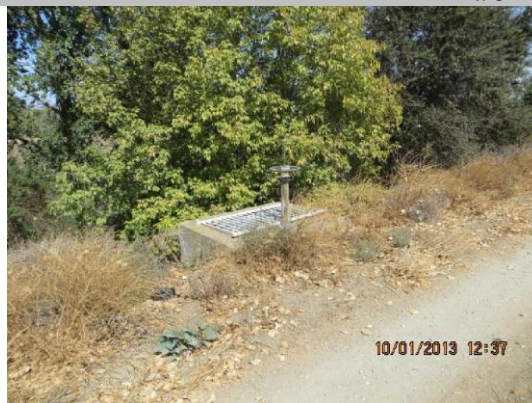
Photo 1 of 3 : UCIP\_SP\_2021\_51337\_36878.jpg

Slide gate in concrete riser on WS shoulder.

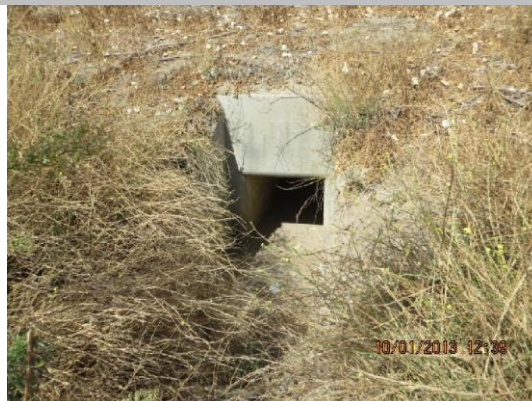
Photo 3 of 3 : UCIP\_SP\_2021\_51337\_36876.jpg

Concrete U-shaped headwall on LS toe.

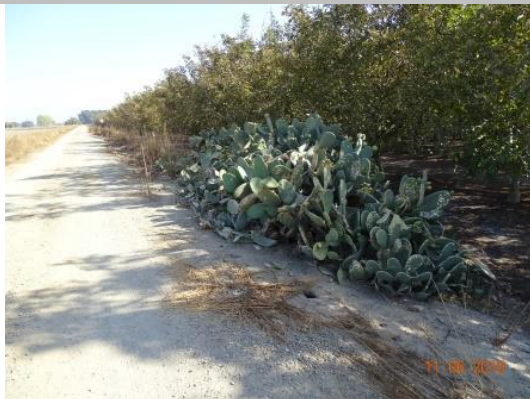
Photo 1 of 1 : SP\_2021\_RD1602\_110\_86\_20210308\_00040.jpg

Looking at dense cactus growth on the waterside slope. (Fall 2019)

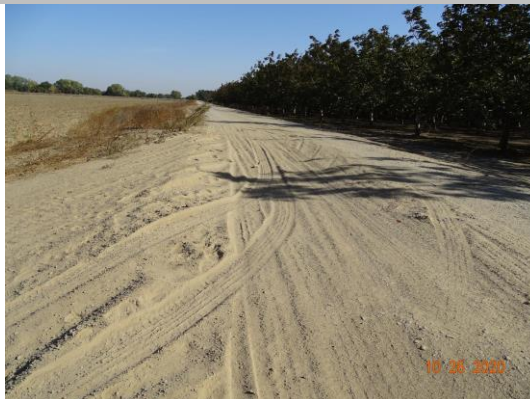
Photo 1 of 1 : SP\_2021\_RD1602\_110\_24\_20210308\_00002.jpg

Depression in levee crown from vehicle traffic. (Fall 2020)

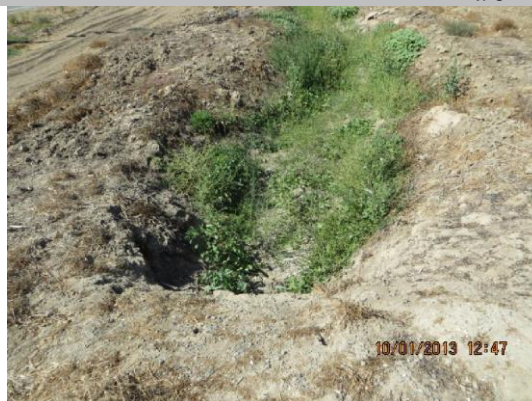
Photo 1 of 3 : UCIP\_SP\_2021\_21683\_36882.jpg

Drainage/irrigation canal on LS toe.

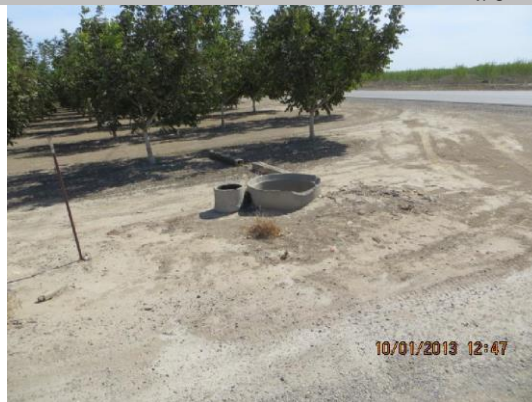
Photo 2 of 3 : UCIP\_SP\_2021\_21683\_36881.jpg

36-inch concrete standpipe on WS shoulder.

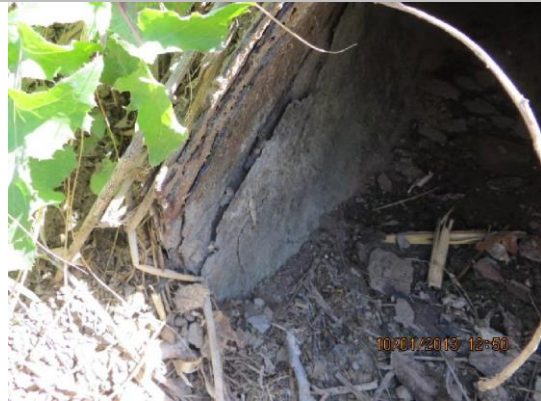
Photo 3 of 3 : UCIP\_SP\_2021\_21683\_36880.jpg

Pipe deteriorated on LS at outlet.
