**Flood Control Project Maintenance
Levee Inspections
LMA District Cover Sheet**

Reclamation District No. 1602 Del Puerto

**Flood Control Project Maintenance
Levee Inspections**

Levee Inspection Report By Mile - Spring 2022

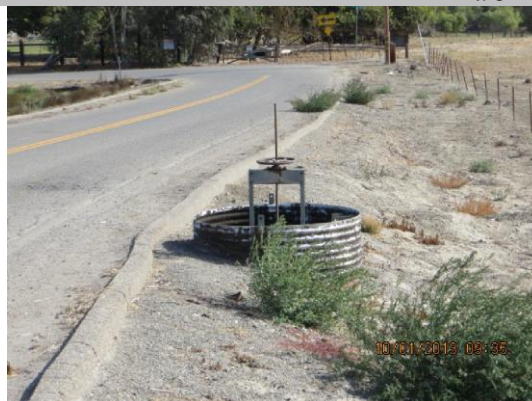
Photo 1 of 3 : UCIP_SP_2022_51325_36702.jpg

FS_ID:51325
DS_ID:20215
EP_NO: N/A
Repair Type: Urgent
Crossing Status: Found
UCIP Comments: 11/18/2016 Crossing has been downgraded from Urgent to No Action Needed a cover has been added to the CMP riser. (O. Magana - DWR UCIP)10/01/2013 Open 60-inch CMP riser on WS needs lid as it's depth may be a hazard to the public. (W. Wylie - DWR UCIP)
FIELD_STRUCT_DESC: 16-inch steel drainage pipe through levee, 11.3 feet below crown. Slide gate in 60-inch corrugated metal pipe (CMP) riser located on the waterside (WS). Concrete inlet is approximately 110 feet west of the levee crown or 110 feet off landside (LS) toe next to roadway. [Additional Reference(s): DWR Levee Log, 1992. USACE San Joaquin River O&M Manual Unit 13, April 1964, (HLM 0.58), Drawing No. 7-4-1784].
FS Date: 11/18/2016

60-inch CMP riser on WS shoulder.

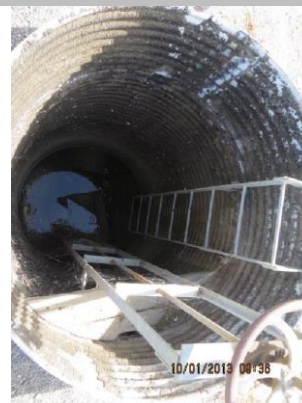
Photo 2 of 3 : UCIP_SP_2022_51325_36701.jpg

CMP riser with slide gate on WS shoulder.

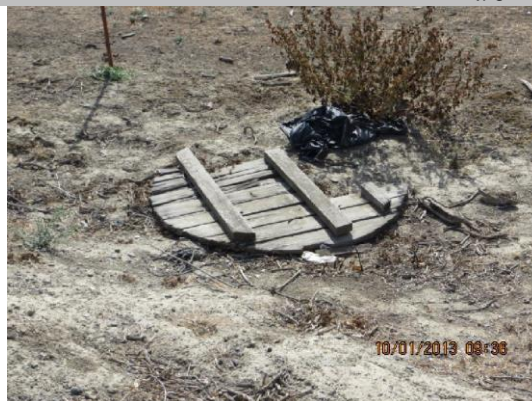
Photo 3 of 3 : UCIP_SP_2022_51325_36700.jpg

Damaged Wooden lid on WS toe.

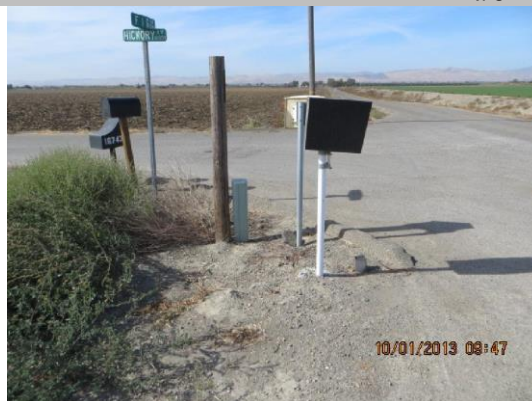
Photo 1 of 3 : UCIP_SP_2022_22937_39050.jpg

FS_ID:22937
 DS_ID:24681
 EP_NO: N/A
 Repair Type: Non-Urgent
 Crossing Status: Found
 UCIP Comments: 10/01/2013 No permit identified for this crossing. (W. Wylie - DWR UCIP)
 FIELD_STRUCT_DESC: Communications line of an unknown size or material through the levee, at an unknown depth.
 FS Date: 10/1/2013

Communication line access box on LS shoulder.

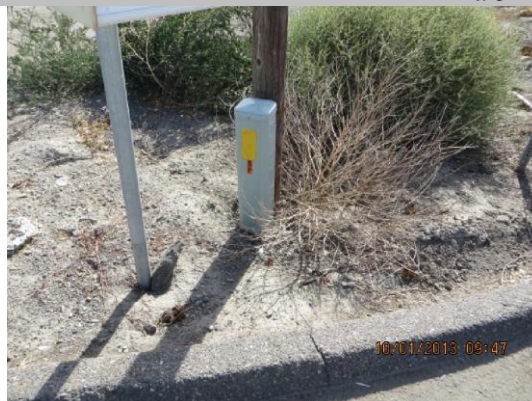
Photo 2 of 3 : UCIP_SP_2022_22937_39049.jpg

Communication line access box on LS shoulder.

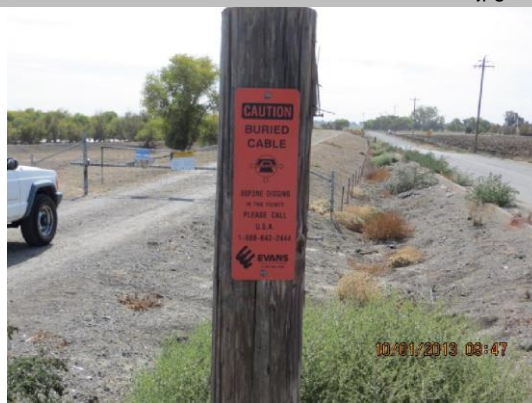
Photo 3 of 3 : UCIP_SP_2022_22937_39048.jpg

Communication line marker on LS shoulder.

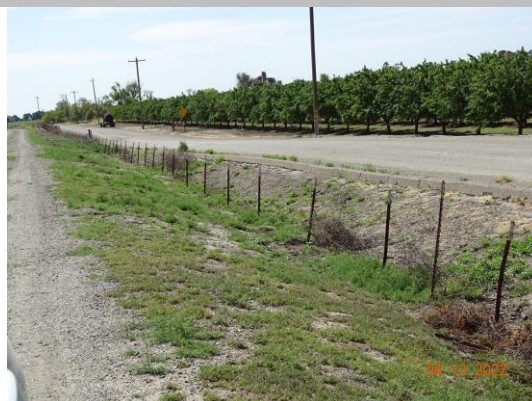
Photo 1 of 1 : SP_2022_RD1602_110_70_20220425_00089.jpg

LM Start	0.60	Rating **	M	Issue No.	70
LM End	0.71	Issue Type +	En	Location *	LS
Category	Earthen Levee			GPS Latitude/Longitude	
				Start	End
Item	Encroachments			37.479967 °	37.478514 °
				-121.074582 °	-121.073435 °
DWR ID	DWR_RD1602_01_s_2012_70				
Comment Code					
FE : Fence					
Inspector Comment					
Barbed wire fence along the landward toe.

View of barbed wire fence at landward toe looking upstream. (Spring 2022)

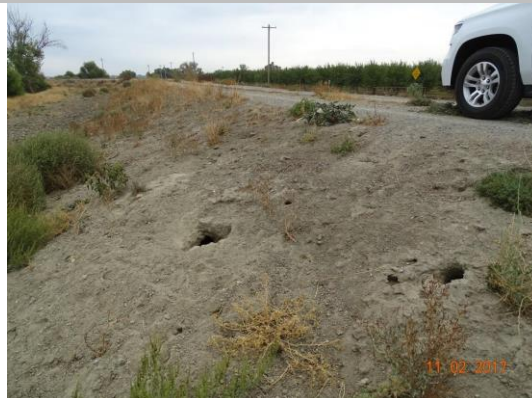
Photo 1 of 1 : SP_2022_RD1602_110_30_20220308_00008.jpg

View of rodent holes on the waterside slope of the levee. Fall 2017

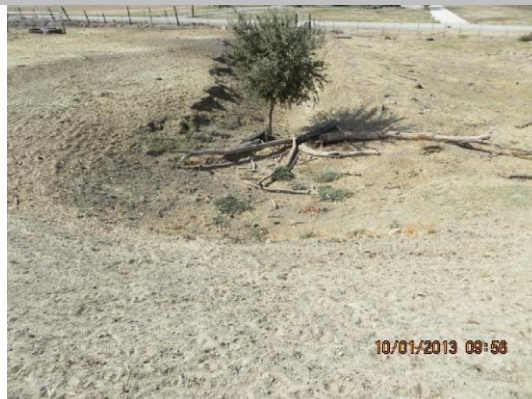
Photo 1 of 3 : UCIP_SP_2022_51634_36723.jpg

Comment Code						
Inspector Comment						
FS_ID:51634 DS_ID:20216 EP_NO: N/A Repair Type: No Action Needed Crossing Status: Found UCIP Comments: 11/18/2016 Crossing has been downgraded from Urgent to No Action Needed the debris blocking the outlet has been cleared. (O. Magana - DWR UCIP)10/01/2013 Flap gate blocked from functioning by soil buildup on WS toe. Soil should be cleared. (W. Wylie - DWR UCIP) FIELD_STRUCT_DESC: 30-inch square reinforced concrete box culvert through levee, 14.4 feet below crown. Concrete "U" headwall on the waterside (WS) and landside (LS) ends. Slide gate in 6-foot by 7-foot concrete surge box is located on the WS shoulder. Flap gate is located on the WS end. [Additional Reference(s): DWR Levee Log, 1992. USACE San Joaquin River O&M Manual Unit 13, April 1964, (HLM 0.78), Drawing No. 7-4-1784]. FS Date: 11/18/2016

Inlet on LS toe.

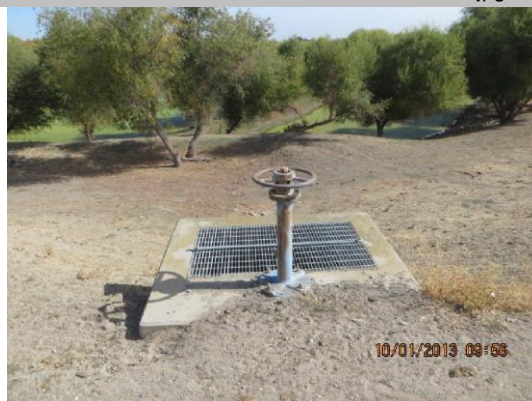
Photo 2 of 3 : UCIP_SP_2022_51634_36722.jpg

Slide gate in concrete box on WS shoulder.

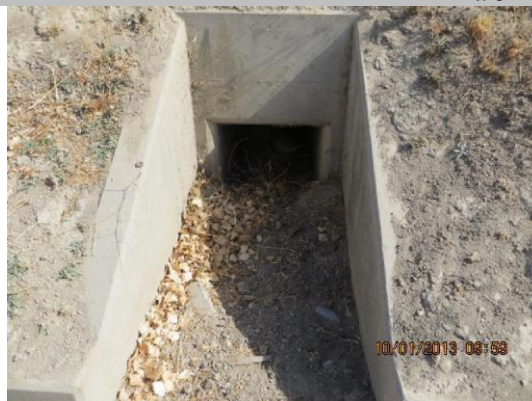
Photo 3 of 3 : UCIP_SP_2022_51634_36721.jpg

Concrete inlet on LS toe.

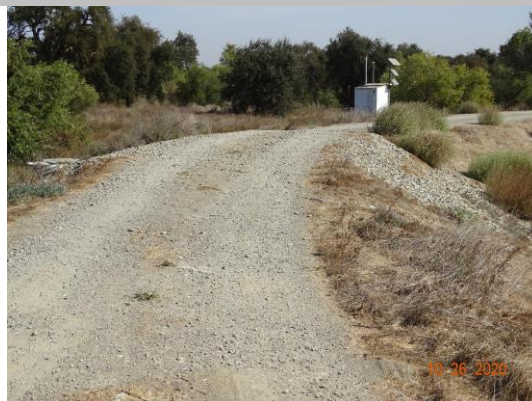
Photo 1 of 1 : SP_2022_RD1602_110_36_20220308_00010.jpg

LM Start	1.00	Rating **	A/W	Issue No.	36
LM End	1.00	Issue Type +	En	Location *	WS
Category	Earthen Levee			GPS Latitude/Longitude	
				Start	End
Item	Encroachments			37.478810 °	37.478810 °
				-121.068738 °	-121.068738 °
DWR ID	DWR_RD1602_01_s_2012_36				
Comment Code					
RA : Ramp					
Inspector Comment					
Pipe owner placed fill over pipe above crown of levee to build ramp over pipe.

View of ramp built up on levee crown. (Fall 2020)

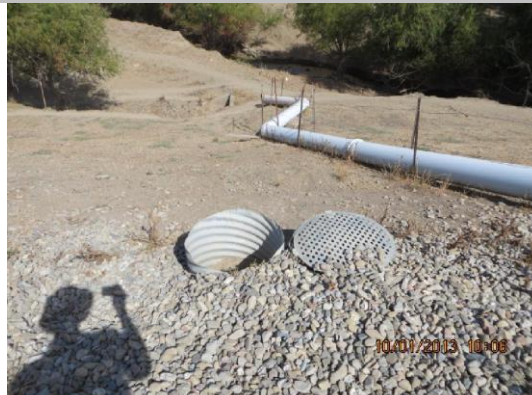
Photo 2 of 3 : UCIP SP 2022 51636 36757.jpg

Siphon breaker in 24-inch CMP riser on WS shoulder.

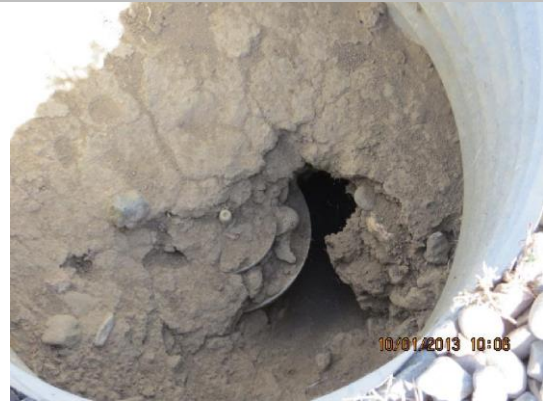
Photo 3 of 3 : UCIP_SP_2022_51636_36756.jpg

Siphon breaker in 24-inch CMP riser on WS shoulder.

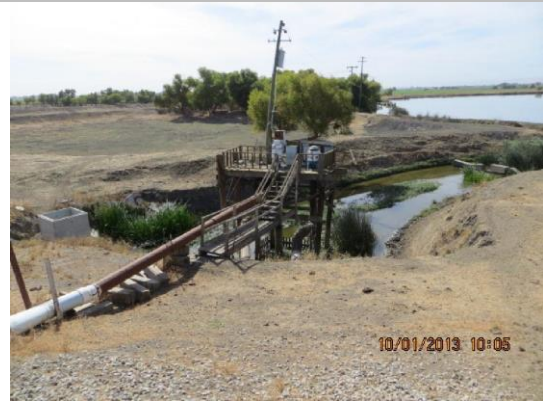
Photo 1 of 3 : UCIP_SP_2022_51637_36772.jpg

FS_ID:51637
DS_ID:20219
EP_NO: N/A
Repair Type: Non-Urgent
Crossing Status: Found
UCIP Comments: 11/18/2016 Crossing has been downgraded from Urgent to Non-Urgent a flap gate has been added to the WS. According to Tony Martinez, LMA representative, this crossing is currently not in use. Owner will need to coordinate with CVFPB to obtain permit. (O. Magana - DWR UCIP)10/01/2013 Appears abandoned siphon breakers covered in soil and flapgate missing. (W. Wylie - DWR UCIP) FIELD_STRUCT_DESC: *ABANDONED* 2 of 2: 16-inch steel drainage pipe through levee, 17 feet below crown. Pump on pump platform located on the landside (LS). Siphon breaker in 24-inch riser located on the waterside (WS) shoulder. Concrete "U" headwall and flap gate are located on the WS end. [Additional Reference(s): DWR Levee Log, 1992. USACE San Joaquin River O&M Manual Unit 13, April 1964, (HLM 1.01), Drawing No. 7-4-1784].
FS Date: 11/18/2016

Pipe visible under walkway at puming plant on LS toe.

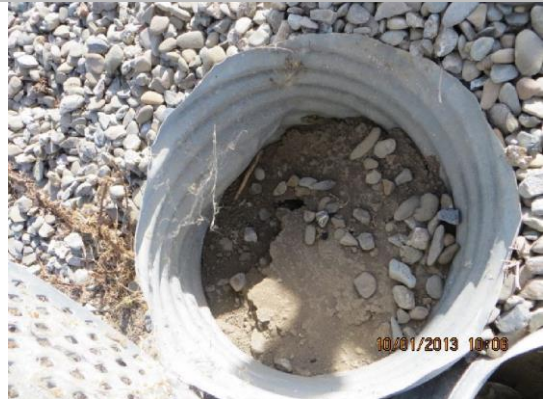
Photo 2 of 3 : UCIP_SP_2022_51637_36771.jpg

Siphon breaker covered in soil at CMP riser on WS shoulder.

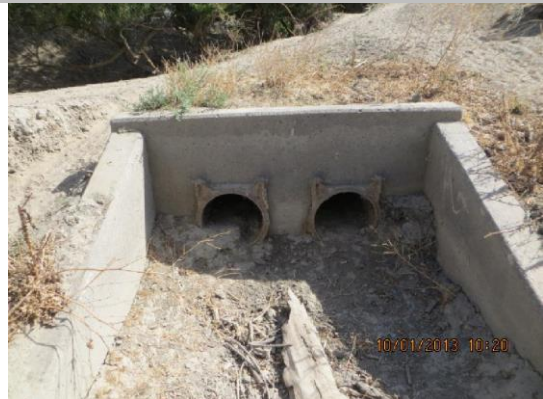
Photo 3 of 3 : UCIP_SP_2022_51637_36770.jpg

Concrete headwall on WS toe with missing flapgate.

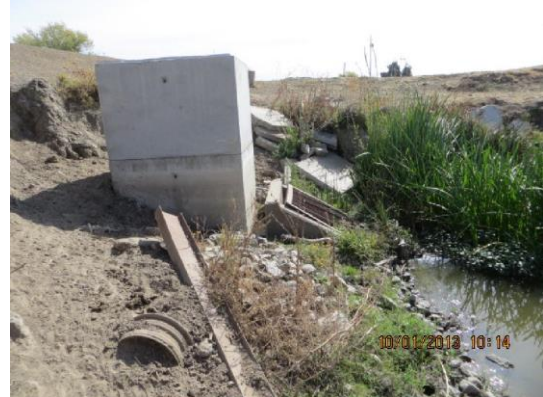
Photo 1 of 3 : UCIP_SP_2022_53521_36786.jpg

Comment Code					
Inspector Comment					
FS_ID:53521 DS_ID:20218 EP_NO: N/A Repair Type: Urgent Crossing Status: Found UCIP Comments: 10/19/2018 Pipe remains the same. WS concrete headwall is still detached with vertical erosion on the WS slope. Dense vegetation along pipe alignment made it difficult to inspect levee slopes and identify any potential issues present at this site. Recommend clearing vegetation along pipe alignment to be able to conduct a proper UCIP inspection. This crossing is part of DWR's Flood System Repair Project (FSRP) and Deferred Maintenance Project (DMP). Crossing will be monitored to identify progress of erosion on the WS slope. Crossing remains Urgent due to the detachment of the concrete wall and vertical cut on the WS. (O. Magana - DWR UCIP)11/18/2016 Same as previous inspection headwall on the WS toe has separated from pipe and flap gate is still missing. Erosion around concrete headwall and undermined WS slope are visible from WS. The slope undermined appears to have progressed but no photos were taken due to the dense vegetation covering area. According to Tony Martinez, LMA representative, the WS concrete headwall has been detached since 2008/2009. LMA has been in contact with CVFPB, DWR, and USACE regarding this site. (O. Magana - DWR UCIP)10/01/2013 Headwall on WS toe separated from pipe. Erosion around concrete headwall and undermined at WS toe. Flap gate missing from WS toe headwall. (W. Wylie - DWR UCIP) FIELD_STRUCT_DESC: 30-inch square reinforced concrete box culvert through levee, 25.4 feet below crown. Concrete "U" headwalls on both waterside (WS) and landside (LS) ends. Slide gate in concrete surge box located on the WS slope. A 5-foot by 5-foot concrete box is located on LS toe. Flap gate is located on the WS end. [Additional Reference(s): DWR Levee Log, 1992. USACE San Joaquin River O&M Manual Unit 13, April 1964, (HLM 1.02), Drawing No. 7-4-1784]. FS Date: 10/19/2018 10:23:00 AM

Grated inlet and 5'X5' concrete box on LS toe.

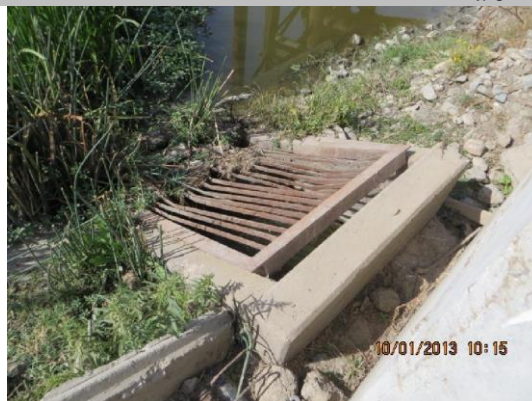
Photo 2 of 3 : UCIP_SP_2022_53521_36785.jpg

Grated inlet at LS toe.

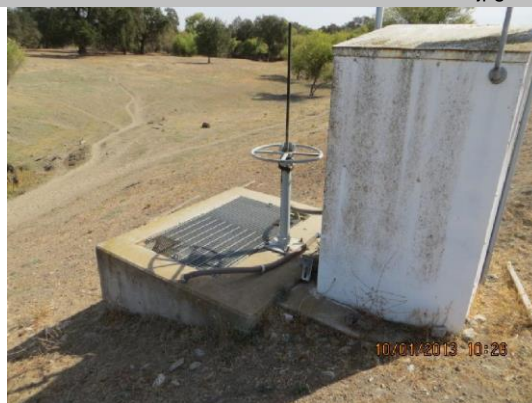
Photo 3 of 3 : UCIP_SP_2022_53521_36789.jpg

Slide gate in concrete riser next to shed on WS shoulder.

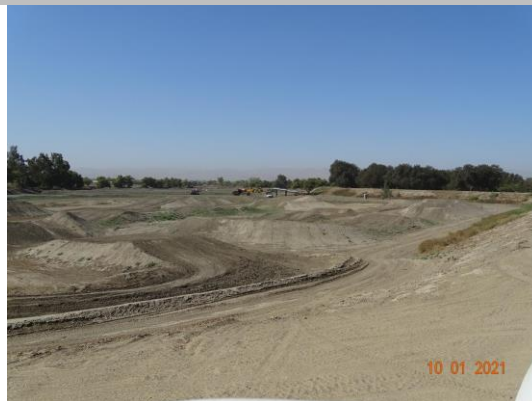
Photo 1 of 1 : SP_2022_RD1602_110_28_20220308_00006.jpg

Landowner is constructing a BMX track on the landside toe. (Fall 2021)

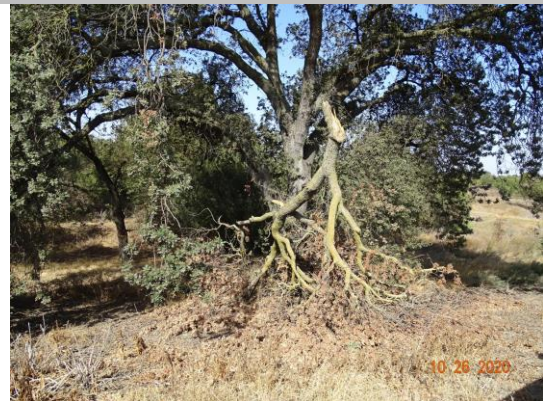
Photo 1 of 1 : SP_2022_RD1602_110_72_20220308_00029.jpg

Tree limb hanging on the waterside slope. (Fall 2020)

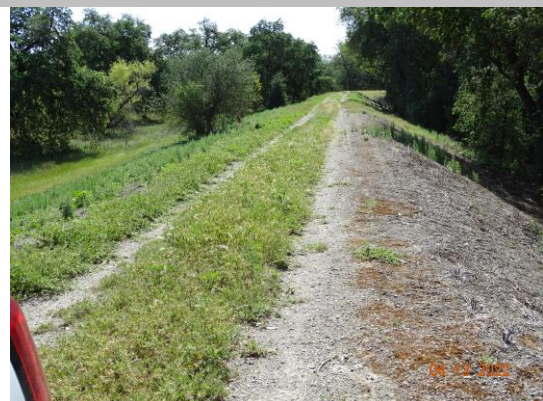
Photo 1 of 1 : SP_2022_RD1602_110_34_20220425_00090.jpg

View of vegetation on the levee crown looking upstream. (Spring 2022)

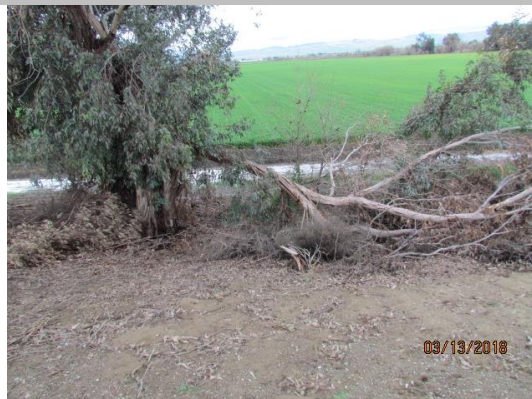
Photo 1 of 1 : SP_2022_RD1602_110_80_20220308_00032.jpg

Looking at fallen branch on landward slope and toe.

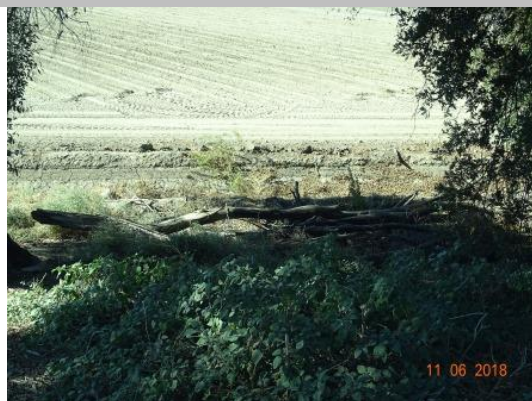
Photo 1 of 1 : SP_2022_RD1602_110_104_20220308_00041.jpg

View of tree limbs on the landside toe. (Fall 2018)

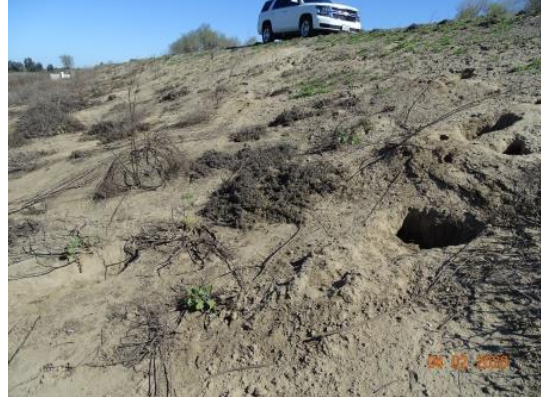
Photo 1 of 1 : SP_2022_RD1602_110_93_20220308_00039.jpg

View of rodent burrows on the landside slope. (Spring 2020)

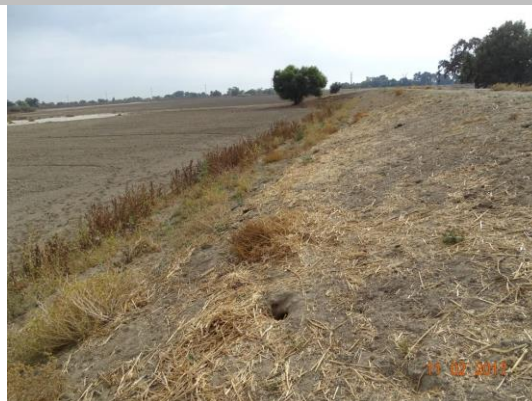
Photo 1 of 1 : SP_2022_RD1602_110_51_20220308_00018.jpg

View of a rodent hole on the waterside of the levee.

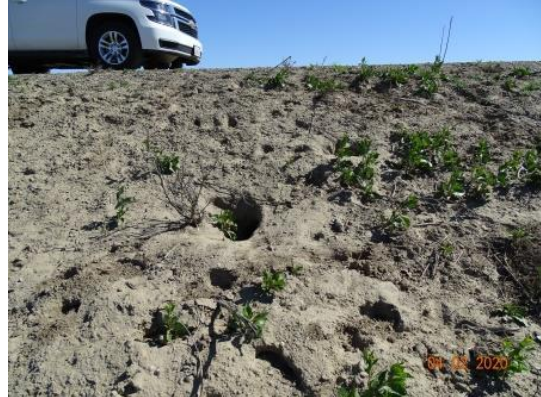
Photo 1 of 1 : SP_2022_RD1602_110_95_20220308_00040.jpg

View of the landside slope from the toe of the levee. (Spring 2020)

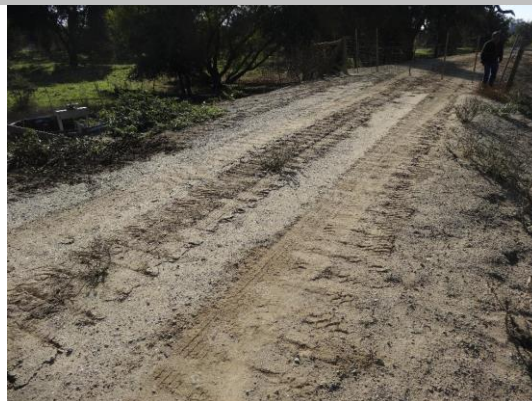
Photo 3 of 3 : UCIP_SP_2022_53522_76527.jpg

Overview of levee crown at pipe crossing.

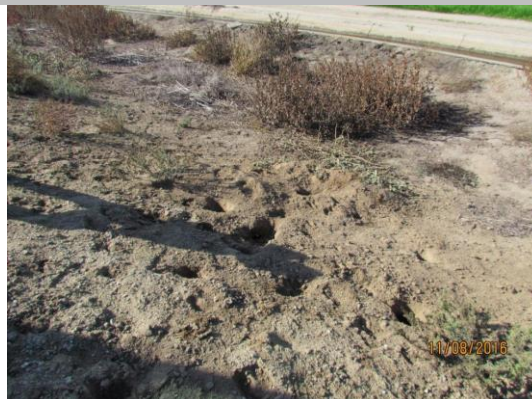
Photo 1 of 1 : SP_2022_RD1602_110_56_20220308_00022.jpg

View of rodent holes on the landside of the levee. Fall 2016

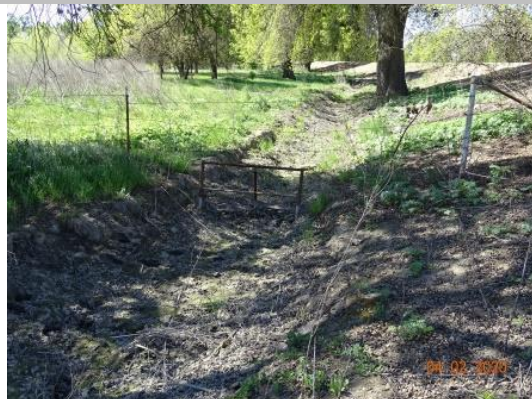
Photo 1 of 1 : SP_2022_RD1602_110_50_20220308_00017.jpg

Looking upstream along the waterside toe. (Spring 2020)

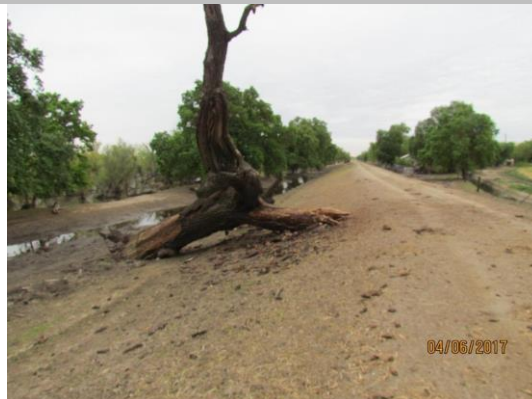
Photo 1 of 1 : SP_2022_RD1602_110_83_20220308_00033.jpg

View of a tree trunk on the waterside slope of the levee.

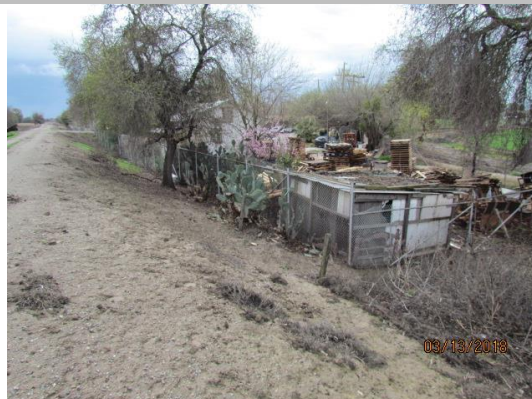
Photo 1 of 1 : SP_2022_RD1602_110_66_20220308_00025.jpg

Looking southwest at animal pens and other encroachments on landward toe. (Spring 2018)

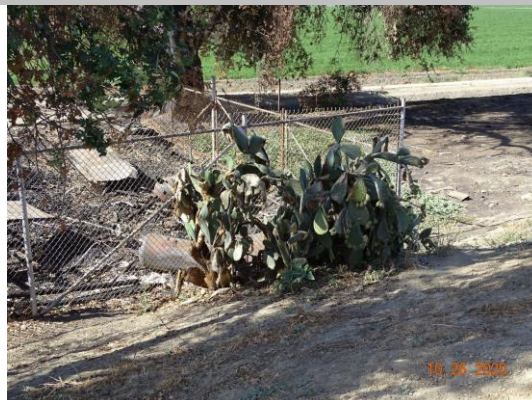
Photo 1 of 1 : SP_2022_RD1602_110_42_20220308_00012.jpg

Cactus growing on the landside slope. (Fall 2020)

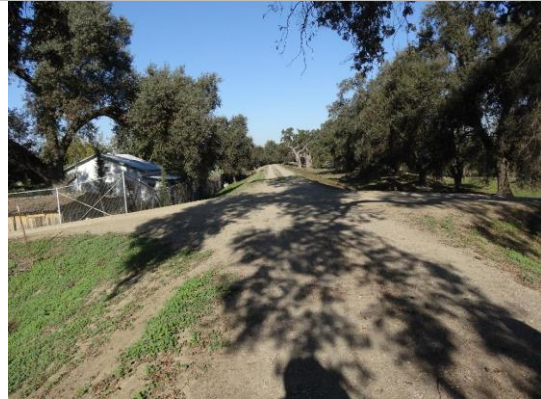
Photo 1 of 3 : UCIP_SP_2022_53523_76534.jpg

FS_ID:53523
DS_ID:20206
EP_NO: 7796
Repair Type: Non-Urgent
Crossing Status: Indicator Found
UCIP Comments: 10/19/2018 Pipe section through the WS ramp was exposed during the 2017 storms. According to LMA representative, adjacent property owner has backfilled the pipe with soil to avoid damage to line. Contacted Mr. Chris Williams with PG&E and Mr. Williams mentioned that PG&E is planning to abandon the line and install a new line. The new line will be bored through the levee. Mr. Williams also mentioned that the line was inspected in 2016-17 and was found to be functional. However, due to the pipe exposure in 2017 PG&E has decided to abandon the current line. PG&E is working with the CVFPB to obtain the proper permits and complete the final design for the new line. This crossing has been downgraded from Urgent to Non-Urgent due to the updated UCIP reclassification evaluations. Pending action for this crossing includes line abandonment documentation from CVFPB and closeout files for this crossing. Primary PG&E contact for this crossing is Carlos Carbrera, Stanislaus and San Joaquin PG&E Local Engineer. He can be reached at 1-925-789-0509 or by email at c4ch@pge.com. (O. Magana - DWR UCIP)11/18/2016 Same as previous inspection crossing is missing markers visible from levee crown. PG&E completed some construction work on this line from September - November 3rd, 2016 and installed a marker on WS approximately 341 feet from levee crown. UCIP inspector will need to contact Mr. Chris Williams, Associate Construction Specialist, Gas Construction Management Central Valley Region with PG&E at 1-209-272-2811 to determine extent of inspection through levee. (O. Magana - DWR UCIP)10/01/2013 Gasline needs sign markers at levee. (W. Wylie - DWR UCIP)

Overview of levee crown at pipe crossing.

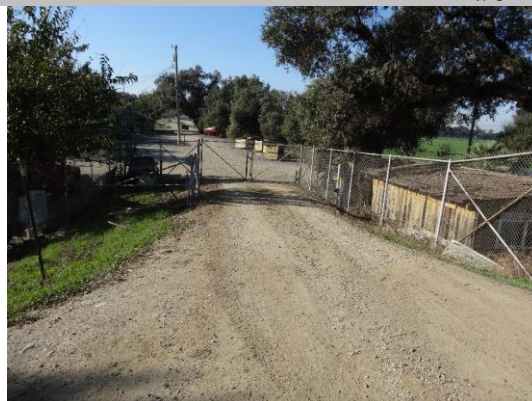
Photo 2 of 3 : UCIP_SP_2022_53523_76535.jpg

View of LS.

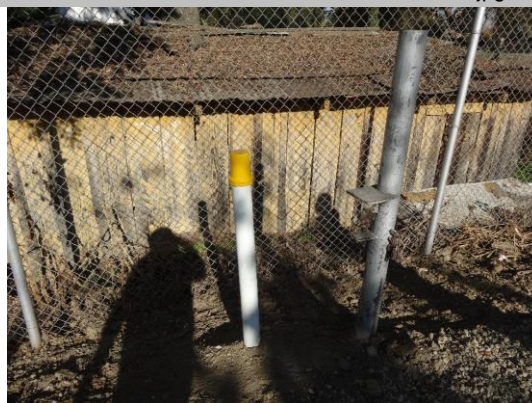
Photo 3 of 3 : UCIP_SP_2022_53523_76536.jpg

PVC riser with yellow cover located along fence on LS.

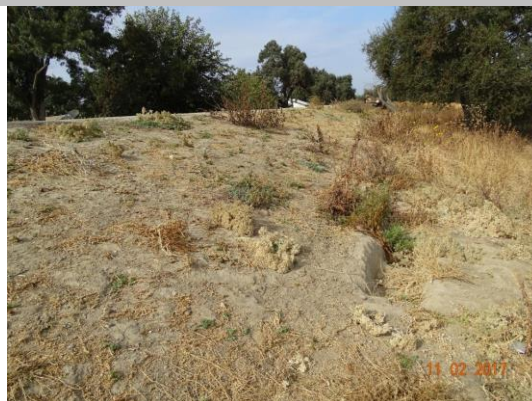
Photo 1 of 1 : SP_2022_RD1602_110_84_20220308_00034.jpg

View of rodent holes on the waterside of the levee.

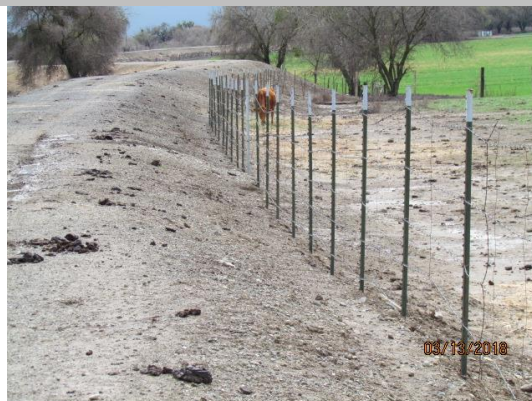
Photo 1 of 1 : SP_2022_RD1602_110_63_20220308_00024.jpg

Looking upstream at fence on landward slope. (Spring 2018)

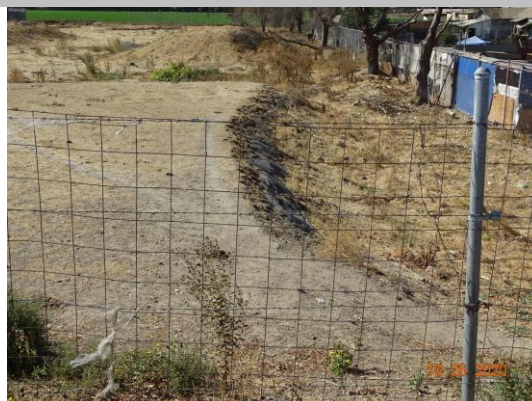
Photo 1 of 1 : SP_2022_RD1602_110_62_20220308_00023.jpg

LM Start	3.93	Rating **	M	Issue No.	62
LM End	3.93	Issue Type +	Ma	Location *	LS
Category	Earthen Levee			GPS Latitude/Longitude	
				Start	End
Item	Erosion / Foot Traffic			37.453216 °	37.453216 °
				-121.042127 °	-121.042127 °
DWR ID	DWR_RD1602_01_s_2012_62				
Comment Code					
E3 : Repair the levee slope damaged by foot traffic and prevent access where possible.					
Inspector Comment					
Significant damage to USACE constructed seepage berm due to human activity.

View of damage to seepage berm constructed on the landside toe. (Fall 2020)

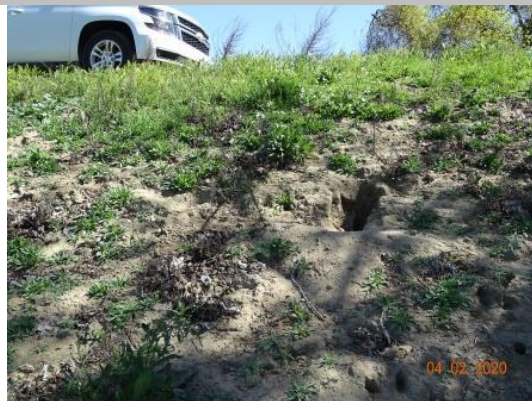
Photo 1 of 1 : SP_2022_RD1602_110_74_20220308_00031.jpg

Looking at the landside slope from the levee toe. (Spring 2020)

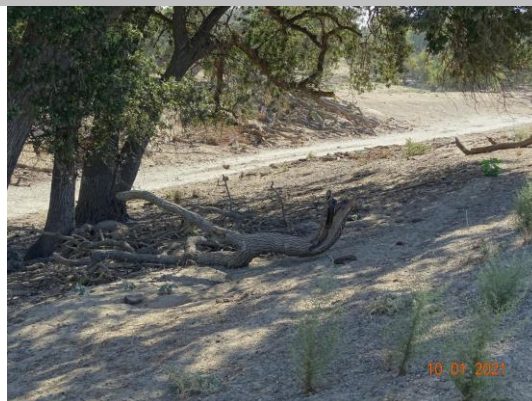
Photo 1 of 1 : SP_2022_RD1602_110_73_20220308_00030.jpg

Branches should be removed from the waterside slope. (Fall 2021)

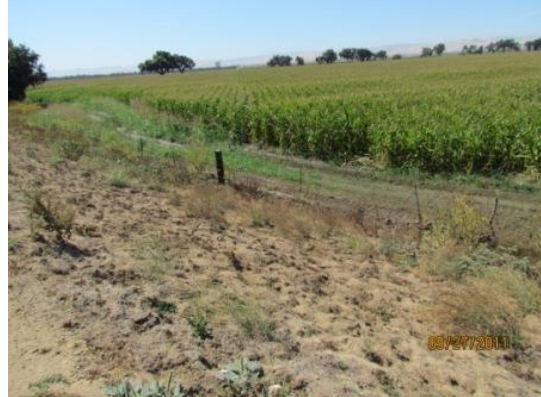
Photo 1 of 1 : SP_2022_RD1602_110_67_20220308_00026.jpg

View of the fence on the landside toe of the levee. The picture was taken from the crown looking upstream.

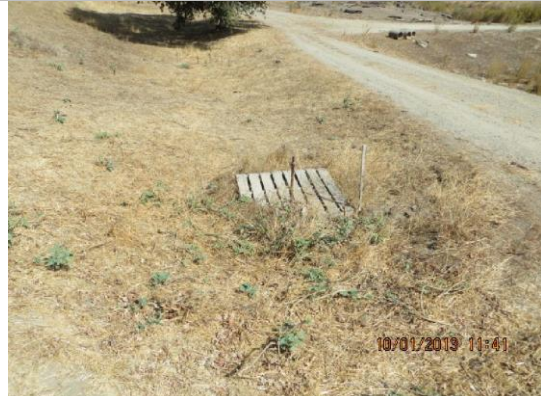
Photo 1 of 3 : UCIP_SP_2022_51332_36819.jpg

FS_ID:51332
DS_ID:20207
EP_NO: 8195
Repair Type: Non-Urgent
Crossing Status: Found
UCIP Comments: 11/18/2016 60-inch riser has a temporary cover therefore crossing has been downgraded from Urgent to Non-Urgent. (O. Magana - DWR UCIP) 10/01/2013 Lid missing from 60-inch CMP riser, may be an attractive nuisance or hazard to public. (W. Wylie - DWR UCIP)
FIELD_STRUCT_DESC: 18-inch steel pipe through levee, 10 feet below crown. Slide gate in 60-inch corrugated metal pipe riser located on the waterside (WS) slope. Concrete discharge box is located on landside (LS) end. Pipe is buried across WS berm to pump located on the riverbank approximately 1,000 feet from the levee. (18-inch pipe authorized under Automatic Board Order (ABO) issued as Permit No. 8195, 1972 - Larry Buehner). [Additional Reference(s): DWR Levee Log, 1992. USACE San Joaquin River O&M Manual Unit 13, April 1964, (HLM 4.51), Drawing No. 7-4-1784].

Slide gate in CMP riser on WS slope.

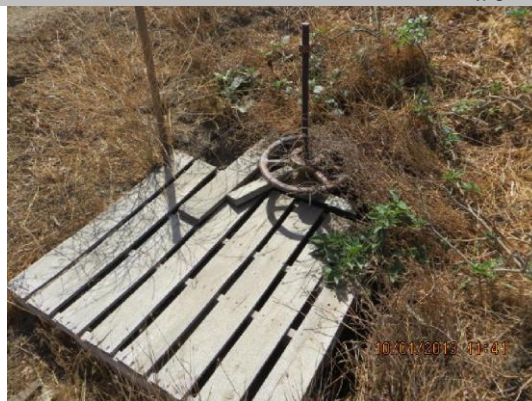
Photo 2 of 3 : UCIP_SP_2022_51332_36818.jpg

Slide gate in CMP riser on WS slope.

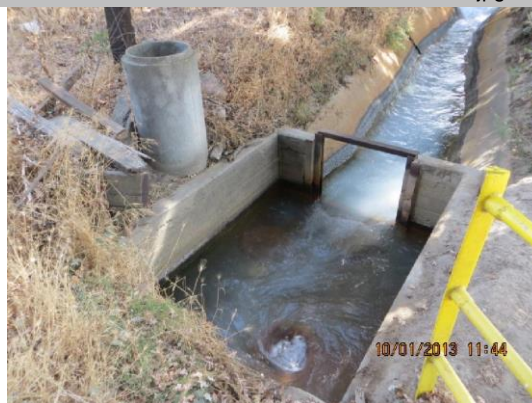
Photo 3 of 3 : UCIP_SP_2022_51332_36817.jpg

Concrete ditch at outlet from pipe on LS toe.

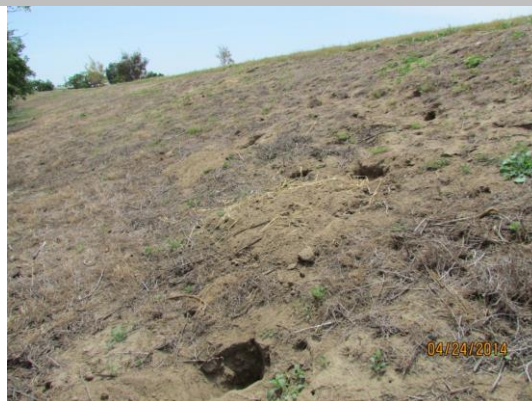
Photo 1 of 1 : SP_2022_RD1602_110_199_20220308_00044.jpg

Rodent holes were found on the waterside toe of the levee looking upstream.

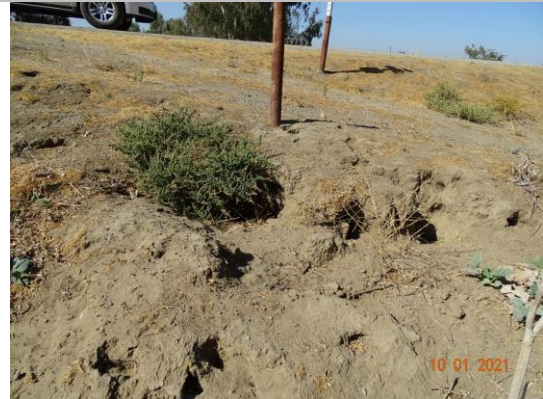
Photo 1 of 1 : SP_2022_RD1602_110_48_20220308_00016.jpg

View of rodent holes on the waterside of the levee looking downstream.
(Fall 2021)

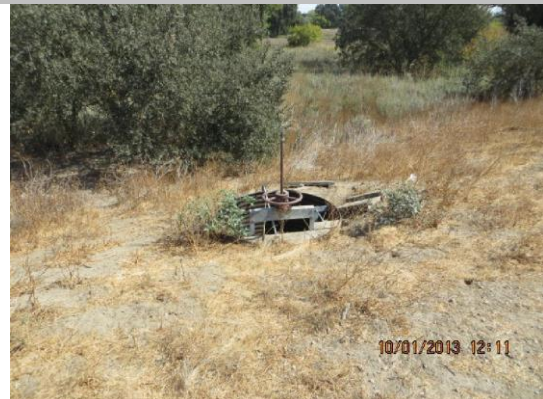
Photo 1 of 3 : UCIP_SP_2022_51336_36822.jpg

Slide gate in CMP riser on WS slope. Outlet visible under tree in background.

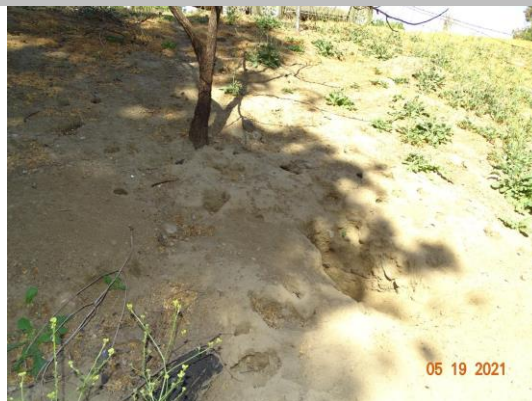
Photo 1 of 1 : SP_2022_RD1602_110_52_20220308_00019.jpg

View of large rodent burrow on the waterside slope. (Spring 2021)

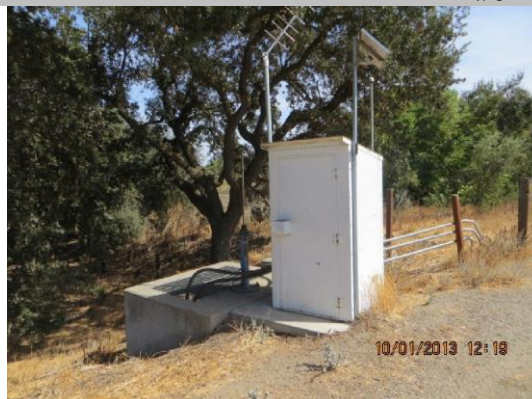
Photo 1 of 2 : UCIP_SP_2022_21665_36829.jpg

Shed with slide gate in Concrete riser on WS shoulder.

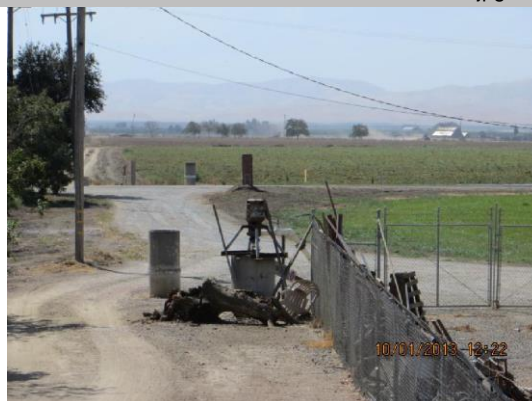
Photo 2 of 2 : UCIP_SP_2022_21665_36828.jpg

Likely risers for pipe off LS toe.

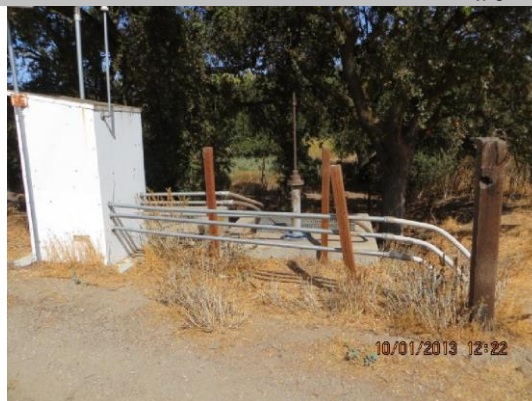
Photo 1 of 2 : UCIP_SP_2022_21668_36835.jpg

Slide gate in Concrete vault on WS shoulder.

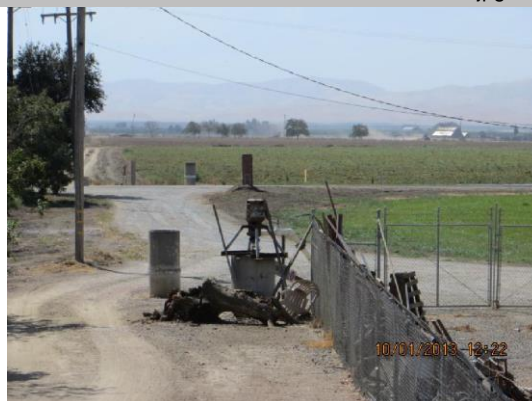
Photo 2 of 2 : UCIP_SP_2022_21668_36834.jpg

Possible concrete risers for pipe off LS toe.

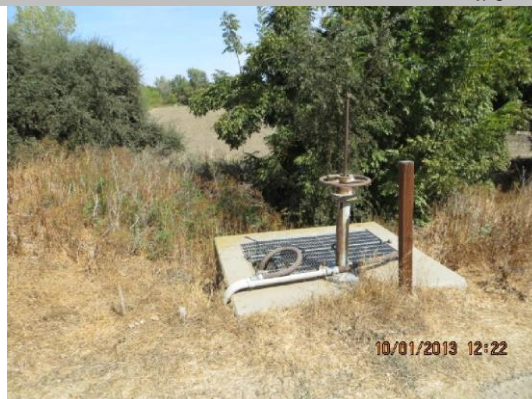
Photo 1 of 3 : UCIP_SP_2022_21672_36848.jpg

Slidegate in concrete riser on WS shoulder.

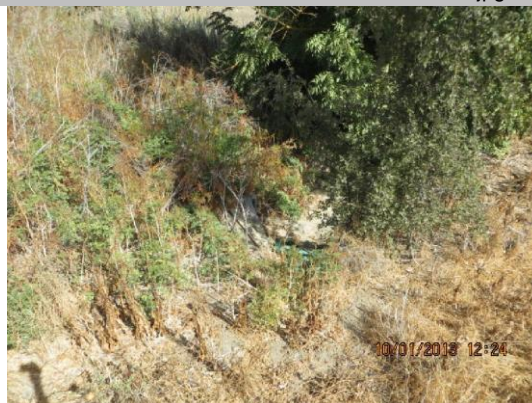
Photo 2 of 3 : UCIP_SP_2022_21672_36847.jpg

Concrete outlet on WS toe.

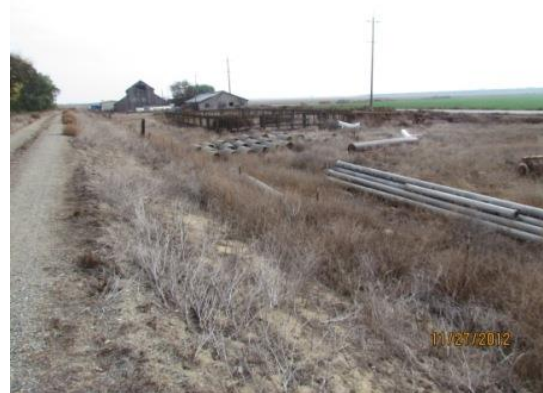
Photo 1 of 1 : SP_2022_RD1602_110_22_20220308_00002.jpg

A fence was found on the landside toe of the levee looking upstream.

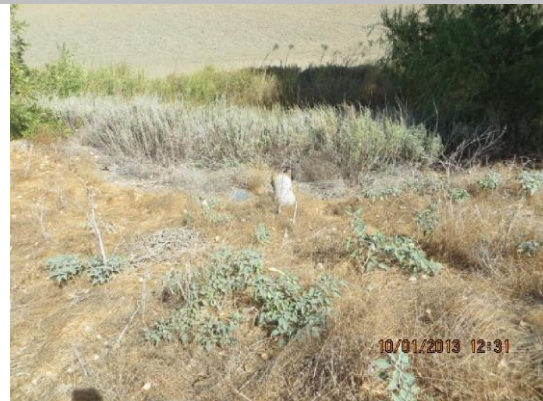
Photo 1 of 1 : UCIP_SP_2022_21674_36854.jpg

Pipe and flapgate visible on WS toe.

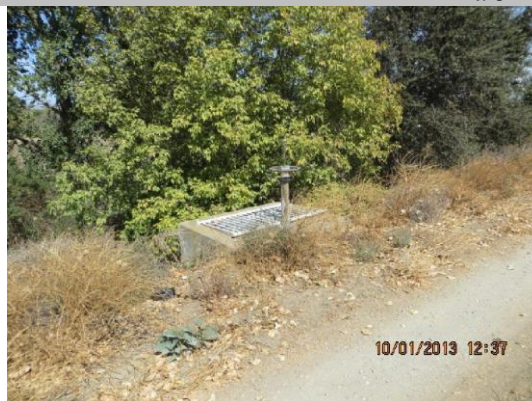
Photo 1 of 3 : UCIP_SP_2022_51337_36878.jpg

Slide gate in concrete riser on WS shoulder.

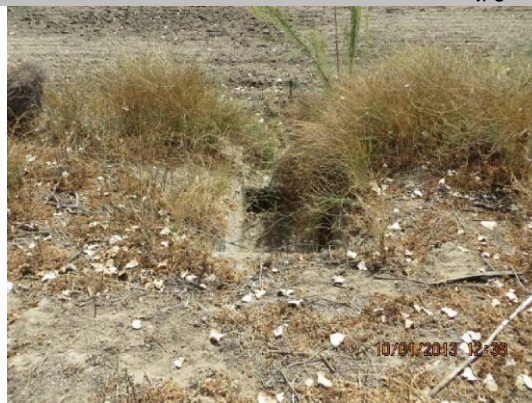
Photo 2 of 3 : UCIP_SP_2022_51337_36877.jpg

Concrete U-shaped headwall on LS toe.

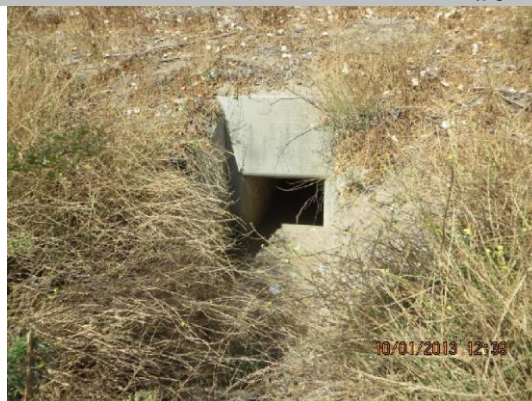
Photo 3 of 3 : UCIP_SP_2022_51337_36876.jpg

Concrete U-shaped headwall on LS toe.

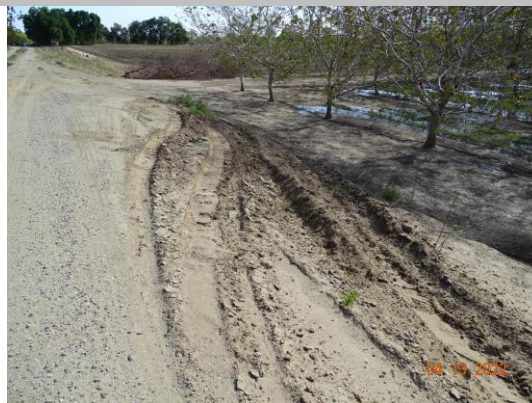
Photo 1 of 1 : SP_2022_RD1602_110_17_20220425_00092.jpg

View of damage to the levee slope from vehicle traffic. (Spring 2022)

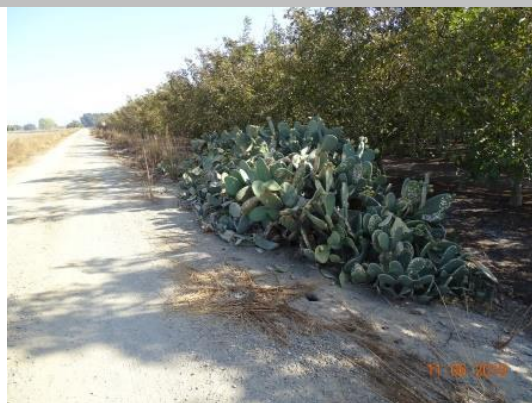
Photo 1 of 1 : SP_2022_RD1602_110_86_20220308_00035.jpg

Looking at dense cactus growth on the waterside slope. (Fall 2019)

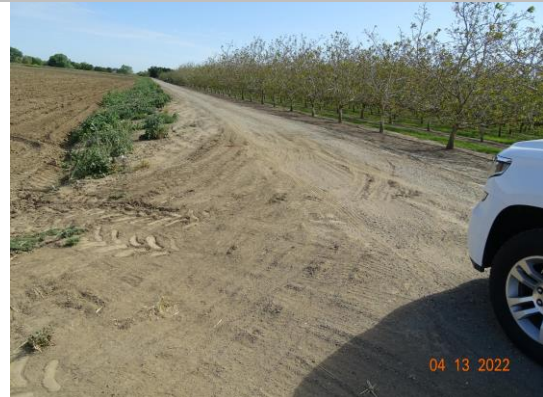
Photo 1 of 1 : SP_2022_RD1602_110_24_20220425_00093.jpg

Depression in levee crown from vehicle traffic. (Spring 2022)

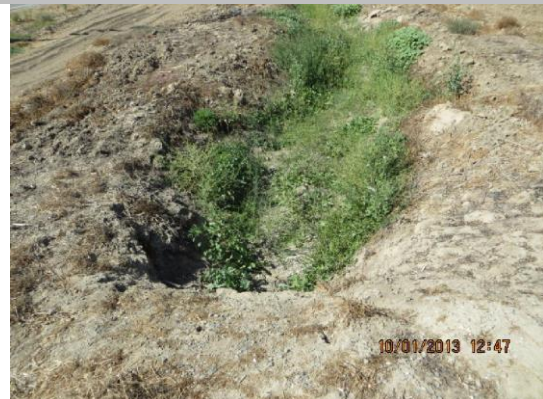
Photo 1 of 3 : UCIP_SP_2022_21683_36882.jpg

Drainage/irrigation canal on LS toe.

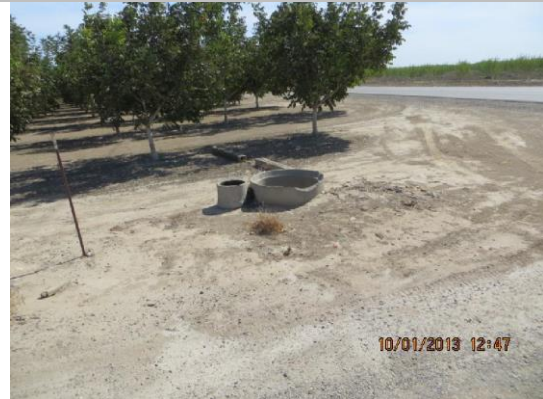
Photo 2 of 3 : UCIP_SP_2022_21683_36881.jpg

36-inch concrete standpipe on WS shoulder.

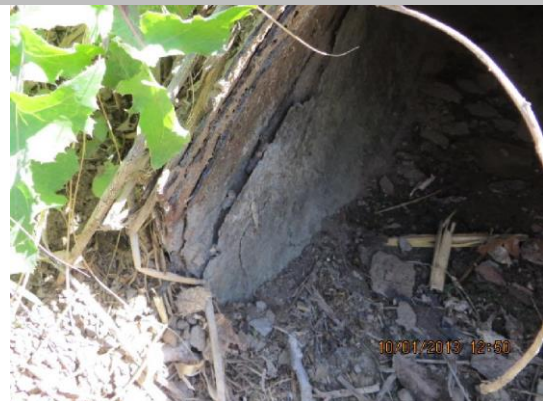
Photo 3 of 3 : UCIP_SP_2022_21683_36880.jpg

Pipe deteriorated on LS at outlet.
