Flood Control Project Maintenance
Levee Inspections
LMA District Cover Sheet

Reclamation District No. 1602 Del Puerto

Waterway			Bank	Unit Miles
Unit No. 01 San Joaquin River			Left	6.24
	Spring (March - May)	Summer (June - August)	(September - November) Fall	Winter (December - February)
Unit Maintenance Rating (Fall Only)				
Date of Inspection	3/27/2024 - 3/27/2024			
DWR Inspector	Nate Hicks			
Accompanied By	Nick Short RD1602

Levee Inspection Report By Mile - Spring 2024

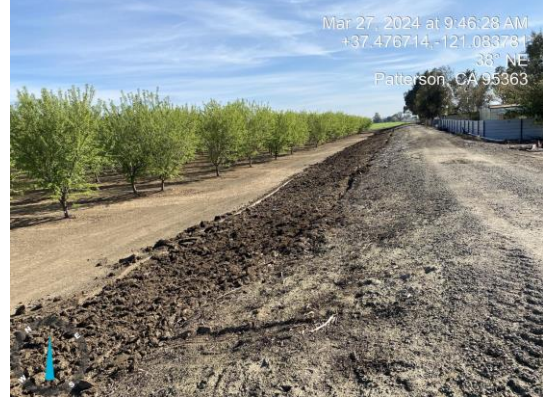
Photo 1 of 1 : SP_2024_RD1602_110_34_20240402_00084.jpg

View of tilling along the waterside slope (Spring 2024).

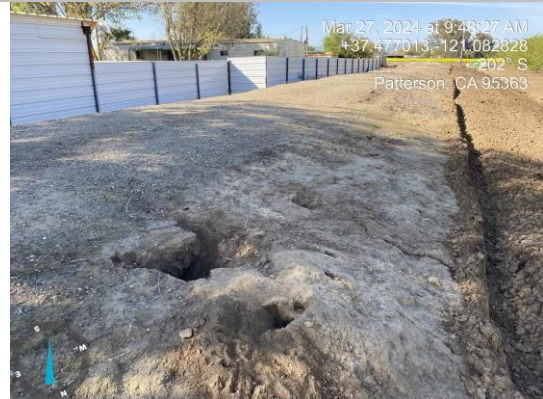
Photo 1 of 1 : SP_2024_RD1602_110_28_20240402_00085.jpg

LM Start	0.00	Rating **	U	Issue No.	28
LM End	0.12	Issue Type +	Ma	Location *	WS
Category	Earthen Levee			GPS Latitude/Longitude	
				Start	End
Item	Animal Control			37.476578°	37.477248°
				-121.083898°	-121.081971°
DWR ID	DWR_RD1602_01_s_2024_28				
Comment Code					
A1 : Exterminate rodents and backfill and compact or grout burrows.					
Inspector Comment					
Rodent burrows in the crown and waterside shoulder should be backfilled and compacted.

View of animal holes along the waterside slope (Spring 2024).

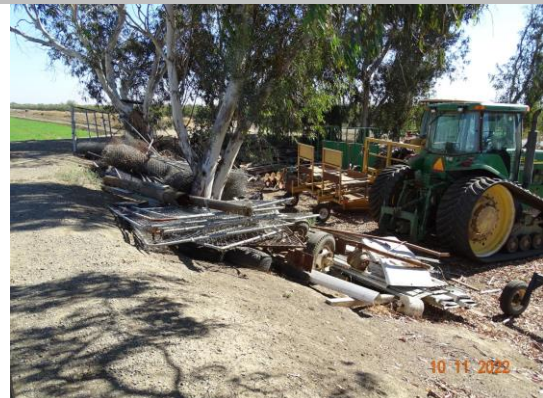
Photo 1 of 1 : SP_2024_RD1602_110_60_20240308_00024.jpg

LM Start	0.11	Rating **	M	Issue No.	60
LM End	0.11	Issue Type +	En	Location *	LS
Category	Earthen Levee			GPS Latitude/Longitude	
				Start	End
Item	Encroachments			37.477289°	37.477289°
				-121.082183°	-121.082183°
DWR ID	DWR_RD1602_01_f_2022_60				
Comment Code					
EQ : Equipment					
Inspector Comment					
Farming equipment should be moved off of the landside slope and toe.

Equipment should be moved off of the landside slope and toe. (Fall 2022)

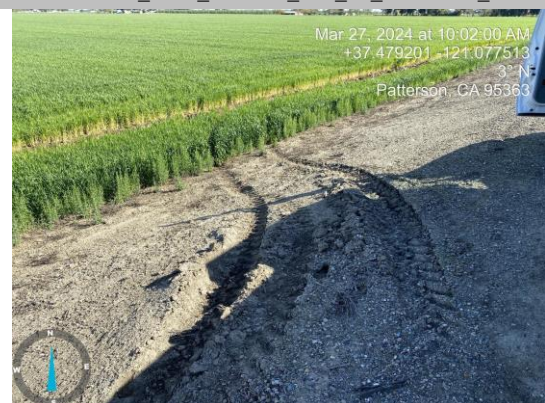
Photo 1 of 1 : SP_2024_RD1602_110_73_20240402_00086.jpg

LM Start	0.40	Rating **	M	Issue No.	73
LM End	0.40	Issue Type +	Ma	Location *	WS
Category	Earthen Levee			GPS Latitude/Longitude	
				Start	End
Item	Erosion / Vehicle Traffic			37.479172°	37.479172°
				-121.077494°	-121.077494°
DWR ID	DWR_RD1602_01_s_2024_73				
Comment Code					
E6 : Repair the levee slope damaged by vehicle traffic and prevent access where possible.					
Inspector Comment

View of vehicle traffic that has cut ruts into the waterside slope (Spring 2024).

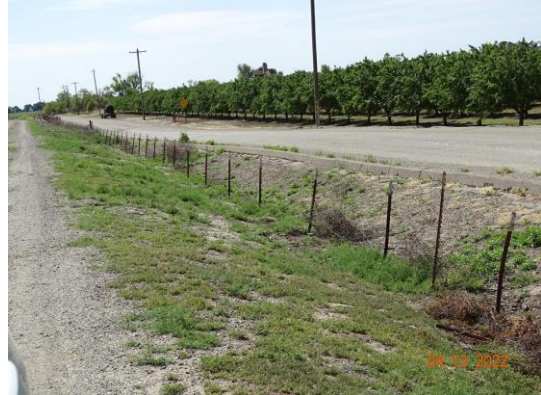
Photo 1 of 1 : SP_2024_RD1602_110_70_20240308_00032.jpg

View of barbed wire fence at landward toe looking upstream. (Spring 2022)

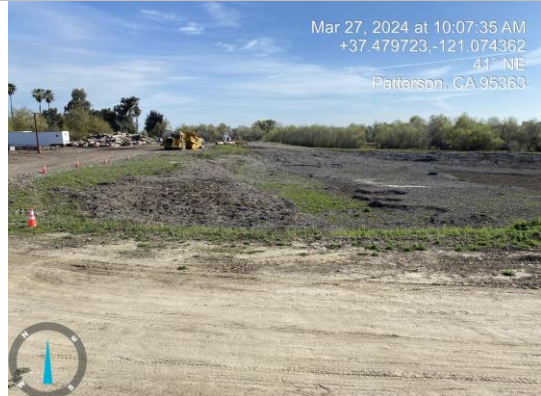
Photo 1 of 1 : SP_2024_RD1602_110_29_20240402_00087.jpg

LM Start	0.61	Rating **	U	Issue No.	29
LM End	0.73	Issue Type +	En	Location *	WS
Category	Rivers, Channels & Designated Floodways			GPS Latitude/Longitude	
				Start	End
Item	Encroachments			37.479815°	37.478415°
				-121.074479°	-121.073284°
DWR ID	DWR_RD1602_01_f_ 2021_29				
Comment Code					
Inspector Comment					
Material piled within the channel and excavation. Was initially reported by the RD as a BMX course.

Haul road constructed by an adjacent landowner and material piled in the channel (Spring 2024).

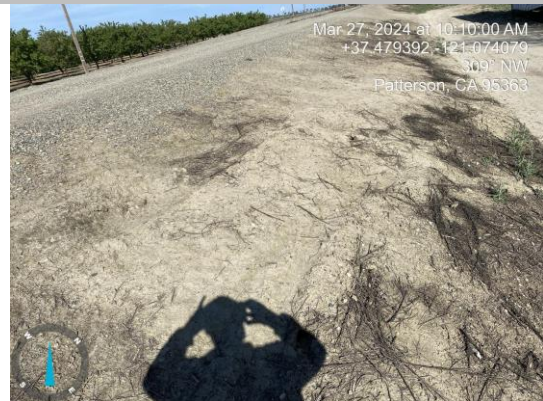
Photo 1 of 1 : SP_2024_RD1602_110_30_20240402_00088.jpg

View of collapsed rodent holes that need to be backfilled and compacted properly (Spring 2024).

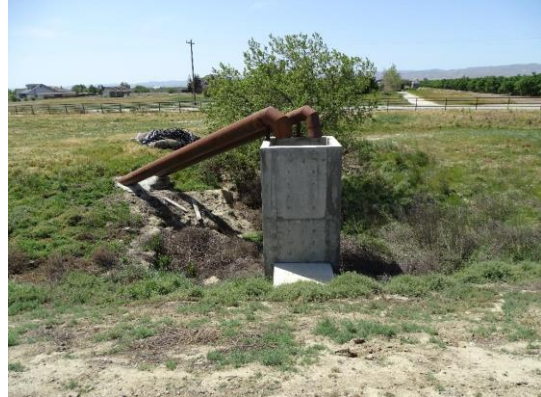
Photo 1 of 1 : UCIP_SP_2024_75648_111281.jpg

Comment Code					
Inspector Comment					
DS_ID:20216 FS_ID:75648 EP_NO: N/A Repair Type: Non-Urgent EVAL Issue: 10, Unauthorized Modification or Non-Compliant Permit Crossing Status: Found UCIP Comments: 04/05/2022 Record updated from No Action Needed to Non-Urgent. A new concrete discharge box was installed on the LS toe since the last inspection; unable to find a permit for modification. (M. Thao - DWR UCIP) 11/18/2016 Crossing has been downgraded from Urgent to No Action Needed the debris blocking the outlet has been cleared. (O. Magana - DWR UCIP)10/01/2013 Flap gate blocked from functioning by soil buildup on WS toe. Soil should be cleared. (W. Wylie - DWR UCIP) FIELD_STRUCT_DESC: 30-inch square reinforced concrete box drainage culvert through levee, 14.4 feet below crown. Concrete "U" headwall on the waterside (WS) and landside (LS) ends. Slide gate in 6-foot by 7-foot concrete surge box is located on the WS shoulder. Flap gate is located on the WS end. [Additional Reference(s): DWR Levee Log, 1992 (HLM 0.78). USACE San Joaquin River O&M Manual Unit 13, April 1964, (HLM 0.78), Station 279+60, listed as 30-inch pipe, Drawing No. 7-4-1784]. FS Date: 4/5/2022

LS view: Looking from crown; new concrete drainage box on toe.

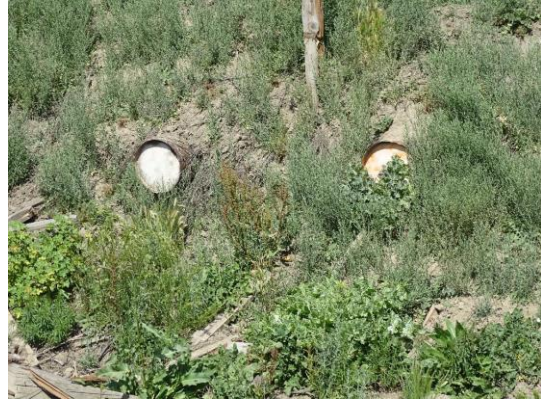
Photo 1 of 2 : UCIP_SP_2024_74539_111263.jpg

Comment Code						
Inspector Comment						
DS_ID:20217 FS_ID:74539 EP_NO: N/A Repair Type: Non-Urgent EVAL Issue: 4b, Safety Issue Crossing Status: Found UCIP Comments: 04/05/2022 Record remains Non-Urgent. Pump and platform on LS has been removed. The crossing has been capped and exposed on the LS toe. Unable to find a permit for modification. Crossing appears abandoned. Unable to locate a permit and confirm proper pipe abandonment. Recommend owner to contact CVFPB to abandon or remove pipe from levee. Cover missing on CMP riser causing a safety hazard. (M. Thao - DWR UCIP) 11/18/2016 Crossing has been downgraded from Urgent to Non-Urgent a flap gate has been added to the WS but pipe is currently not connected to pump. According to Tony Martinez, LMA representative, this crossing is currently not in use. Owner will need to coordinate with CVFPB to obtain permit. (O. Magana - DWR UCIP)10/01/2013 Appears abandoned and if so should be done so properly. Flapgate missing. (W. Wylie - DWR UCIP) FIELD_STRUCT_DESC: 1 of 2: 16-inch steel drainage pipe through levee, 17 feet below crown. Pipe is capped on the landside (LS) end. Pumps on the pump platform are located on LS. Siphon breaker in 24-inch corrugated metal pipe (CMP) riser is located on the waterside (WS) shoulder. Concrete "U" headwall and flap gate are located on the WS end. [Additional Reference(s): DWR Levee Log, 1992 (HLM 1.01). USACE San Joaquin River O&M Manual Unit 13, April 1964, (HLM 1.01), Station 266+68, listed as 16-inch pipe, Drawing No. 7-4-1784]. FS Date: 4/5/2022

LS view: Close-up view of pipe inlet capped.

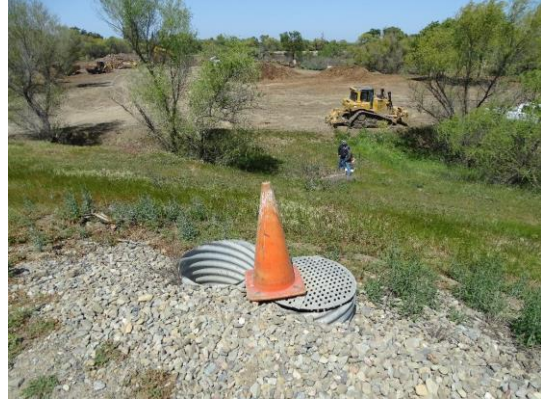
Photo 2 of 2 : UCIP_SP_2024_74539_111264.jpg

WS view: Siphon breaker in CMP riser on shoulder; missing cover on riser. Concrete headwall on toe in background.

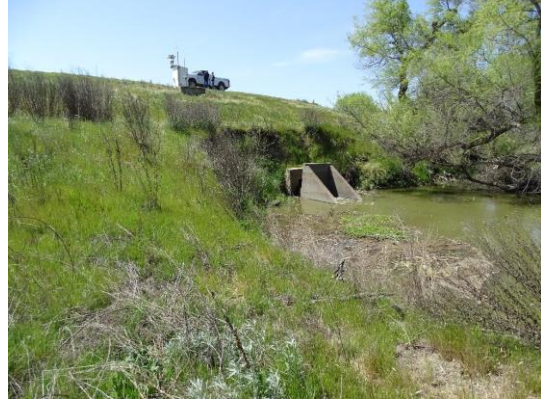
Photo 1 of 2 : UCIP_SP_2024_75649_111240.jpg

DS_ID:20218
FS_ID:75649
EP_NO: N/A
Repair Type: Urgent
EVAL Issue: 2b, Levee Integrity
Crossing Status: Found
UCIP Comments: 04/05/2022 Record remains Urgent. WS concrete headwall is still detached with vertical erosion behind the headwall on the WS slope. Was not able to inspect the flap gate due to water on present on WS. Modification was made on the LS to move the grated inlet at the toe landward approximately 100 feet; unable to find a permit for modification. (M. Thao - DWR UCIP)
10/19/2018 Pipe remains the same. WS concrete headwall is still detached with vertical erosion on the WS slope. Dense vegetation along pipe alignment made it difficult to inspect levee slopes and identify any potential issues present at this site. Recommend clearing vegetation along pipe alignment to be able to conduct a proper UCIP inspection. This crossing is part of DWR's Flood System Repair Project (FSRP) and Deferred Maintenance Project (DMP). Crossing will be monitored to identify progress of erosion on the WS slope. Crossing remains Urgent due to the detachment of the concrete wall and vertical cut on the WS. (O. Magana - DWR UCIP)

11/18/2016 Same as previous inspection headwall on the WS toe has seperated from pipe and flap gate is still missing. Erosion around concrete headwall and undermined WS slope are visible from WS. The slope undermined appears to have progressed but no photos were taken due to the dense vegetation covering area. According to Tony Martinez, LMA representative, the WS concrete headwall has been detached since 2008/2009. LMA has been in contact with CVFPB, DWR, and USACE regarding this site. (O. Magana - DWR UCIP)
10/01/2013 Headwall on WS toe seperated from pipe. Erosion around concrete headwall and undermined at WS toe. Flap gate missing from WS toe headwall. (W. Wylie - DWR UCIP)
FIELD_STRUCT_DESC: 30-inch square reinforced concrete box culvert through levee, 25.4 feet below crown. Concrete "U" headwalls on both waterside (WS) and landside (LS) ends. Slide gate in concrete surge box located on the WS slope. A 5-foot by 5-foot concrete box is located on LS toe. Flap gate is located on the WS end. [Additional Reference(s): DWR Levee Log, 1992 (HLM 1.03). USACE San Joaquin River O&M Manual Unit 13, April 1964, (HLM 1.02), Station 266+29, listed as 30-inch pipe, Drawing No. 7-4-1784].

WS view: Looking toward levee; concrete headwall on toe with erosion.

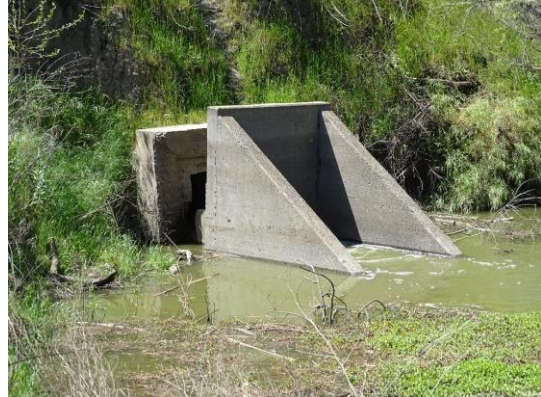
Photo 2 of 2 : UCIP_SP_2024_75649_111241.jpg

WS view: Close-up view of detached concrete headwall on toe.

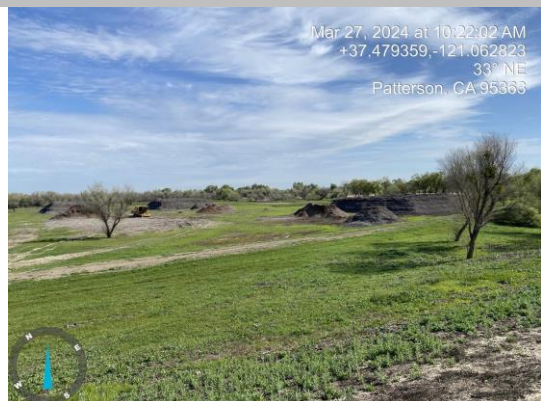
Photo 1 of 1 : SP_2024_RD1602_110_78_20240402_00089.jpg

View of wood chippings within the channel (Spring 2024).

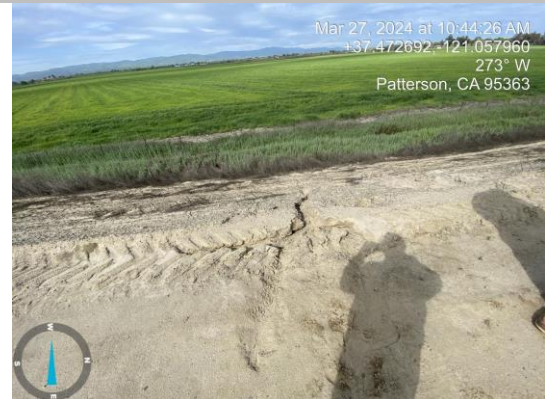
Photo 1 of 1 : SP_2024_RD1602_110_85_20240402_00092.jpg

LM Start	1.96	Rating **	M	Issue No.	85
LM End	1.96	Issue Type +	Ma	Location *	LS
Category	Earthen Levee			GPS Latitude/Longitude	
				Start	End
Item	Erosion / Rills			37.472737°	37.472737°
				-121.057939°	-121.057939°
DWR ID	DWR_RD1602_01_s_2024_85				
Comment Code					
E5 : Schedule repair of rills prior to the next inspection.					
Inspector Comment

View of erosion/rills along the landside slope (Spring 2024).

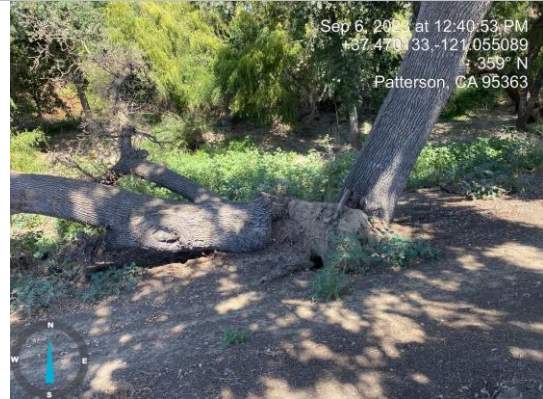
Photo 1 of 1 : SP_2024_RD1602_110_41_20240308_00012.jpg

View of downed tree with root ball exposed on waterside slope (Fall 2023).

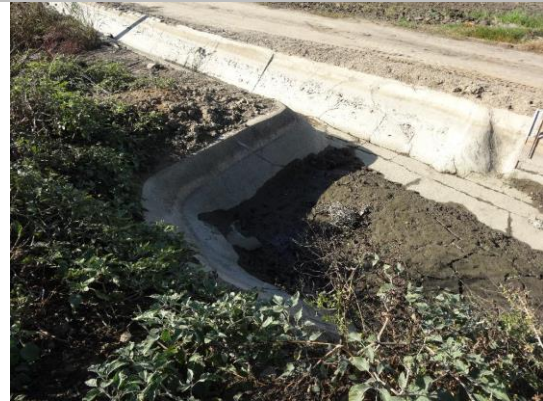
Photo 1 of 3 : UCIP_SP_2024_74530_76528.jpg

Comment Code					
Inspector Comment					
DS_ID:20204 FS_ID:74530 EP_NO: 8193 Repair Type: Urgent EVAL Issue: 1, Pipe Integrity Crossing Status: Found UCIP Comments: 04/05/2022 Record remains Urgent. Pipe inlet within CMP riser is deteriorated. CMP riser cover has broken and fallen into the riser; no cover on the riser causing a safety hazard. Crossing appears abandoned. Recommend owner to contact CVFPB to abandon or remove pipe from levee. (M. Thao - DWR UCIP) 10/19/2018 Pipe is deteriorated on the LS toe (pipe section missing at inlet). This crossing remains Urgent due to the wall deterioration at the inlet. If wall is rusted out at the inlet, need to determine the condition of the pipe section through the levee. According to the LMA representative, this crossing is no longer in use (crossing is abandoned). LMA is interested in abandoning crossing in place. LMA was referred to the CVFPB staff for direction regarding proper action under Title 23 for this crossing. (O. Magana - DWR UCIP) 11/18/2016 Same as previous inspection riser cover and handle on slide gate are still missing. Crossing remains Urgent due to the public safety issue of the 60-inch CMP cover still missing. According to Tony Martinez, LMA representative, the condition and future use of this crossing is being evaluated. Owner will need to coordinate with CVFPB for future use requirements or proper abandonment/removal. (O. Magana - DWR UCIP) 10/01/2013 Appears abandoned, and if so should be done so properly. No handle on slide gate, no cover on CMP standpipe on WS shoulder. (W. Wylie - DWR UCIP) FIELD_STRUCT_DESC: 16-inch steel irrigation pipe through levee, 11.5 feet below crown. Slide gate in 60-inch corrugated metal pipe riser is located on the waterside (WS) slope. Pipe discharges into concrete-lined ditch on the landside (LS) (irrigation pipe was authorized under Automatic Board Order (ABO) issued as Permit No. 8193, 1964 - Sabatte). [Additional Reference(s): DWR Levee Log, 1992 (HLM 3.30). USACE San Joaquin River O&M Manual Unit 13, April 1964, (HLM 3.30), Station 146+62, listed as 16-inch pipe, Drawing No. 7-4-1784]. FS Date: 4/5/2022

Concrete drain channel located on LS toe.

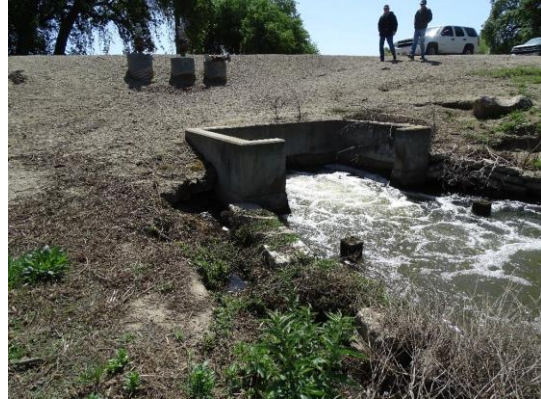
Photo 1 of 2 : UCIP_SP_2024_74520_111227.jpg

Comment Code					
Inspector Comment					
DS_ID:20221 FS_ID:74520 EP_NO: 8191 Repair Type: Non-Urgent EVAL Issue: 6, Levee Damage or Threat for Levee Damage Crossing Status: Found UCIP Comments: 04/05/2022 Record updated from No Action Needed to Non-Urgent. Minor erosion was present around the downstream sides of the concrete distribution box on the LS toe. (M. Thao - DWR UCIP) FIELD_STRUCT_DESC: 1 of 3: 20-inch steel irrigation pipe through the levee, 3.7 feet below the crown. Pump on pump platform on the waterside (WS) bank. Siphon breaker in a 24-inch riser on the landside (LS) shoulder. Concrete discharge box on the LS end. (two 18-inch and one 20-inch pipes were authorized under Automatic Board Order (ABO) issued as Permit No. 8191, 1972 - Twin Oaks Irrigation District c/o Mr. V. R. Peterson). [Additional Reference(s): DWR Levee Log, 1992 (HLM 3.57). USACE San Joaquin O&M Manual 13, April 1964, (HLM 3.57), Station 132+32, listed as 20-inch pipe, Drawing No. 7-4-1784]. FS Date: 4/5/2022

LS view: Concrete discharge box on toe; erosion around downstream sides.

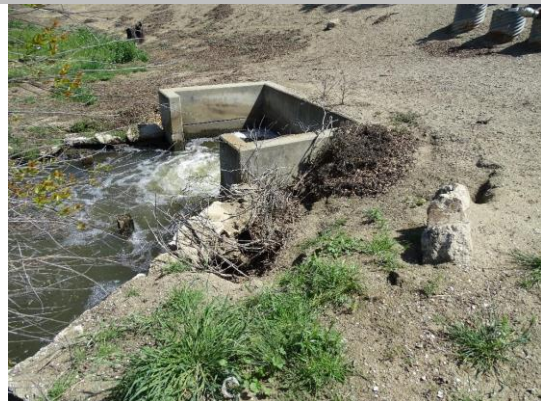
Photo 2 of 2 : UCIP_SP_2024_74520_111228.jpg

LS view: Concrete discharge box on toe; erosion around downstream sides.

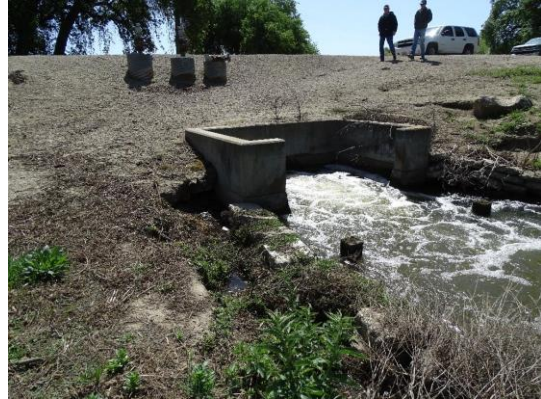
Photo 1 of 2 : UCIP_SP_2024_74519_111221.jpg

LS view: Concrete discharge box on toe; erosion around downstream sides.

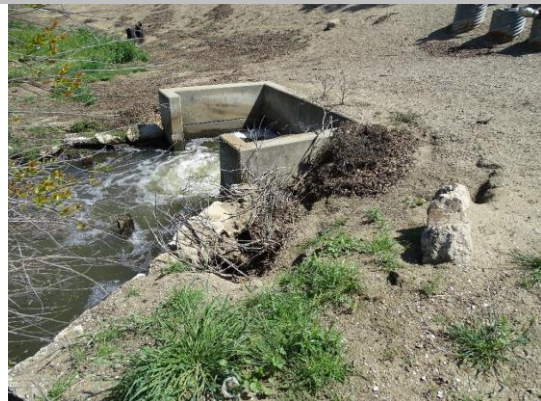
Photo 2 of 2 : UCIP_SP_2024_74519_111222.jpg

LS view: Concrete discharge box on toe; erosion around downstream sides.

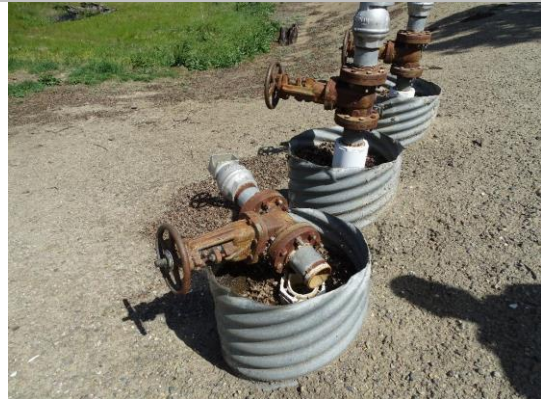
Photo 1 of 3 : UCIP_SP_2024_74503_111215.jpg

LS view: Close-up view of broken siphon breaker.

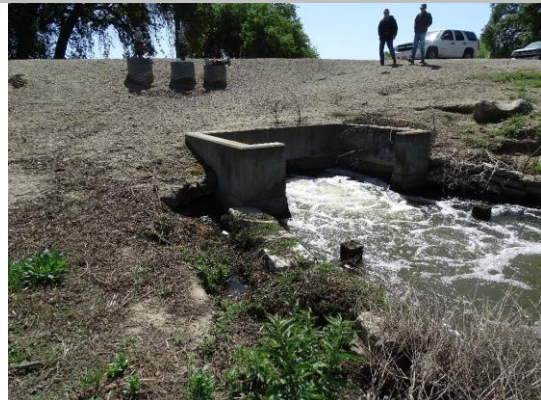
Photo 2 of 3 : UCIP_SP_2024_74503_111216.jpg

LS view: Concrete discharge box on toe; erosion around downstream sides.

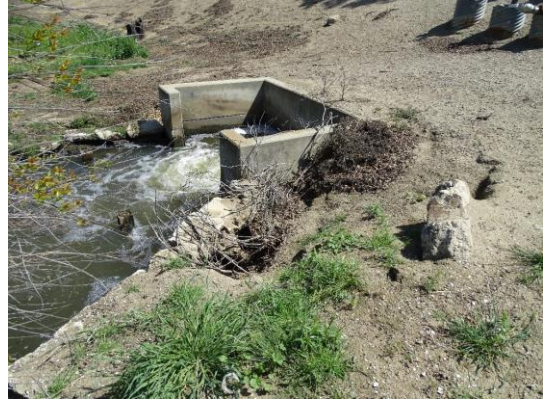
Photo 3 of 3 : UCIP_SP_2024_74503_111217.jpg

LS view: Concrete discharge box on toe; erosion around downstream sides.

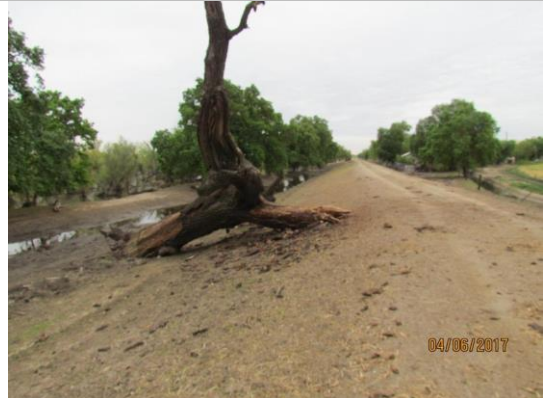
Photo 1 of 1 : SP_2024_RD1602_110_83_20240308_00037.jpg

View of a tree trunk on the waterside slope of the levee.

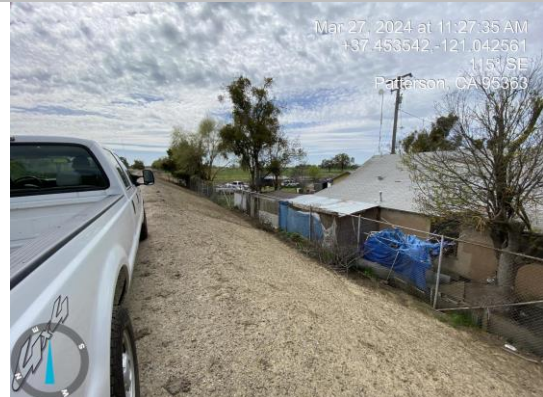
Photo 1 of 1 : SP_2024_RD1602_110_66_20240403_00095.jpg

Looking southwest at fence and other encroachments on landward toe (Spring 2024).

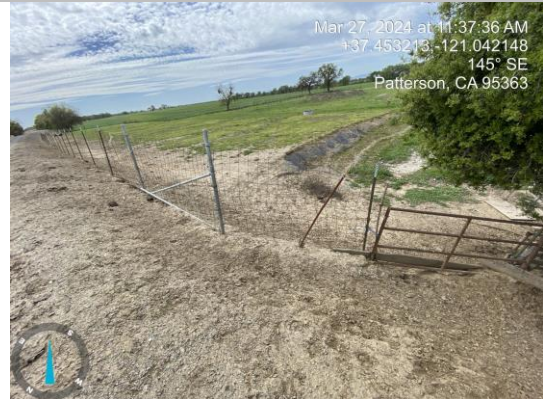
Photo 1 of 1 : SP_2024_RD1602_110_62_20240403_00098.jpg

View of damage to USACE seepage berm that appears to be caused by foot traffic (Spring 2024).

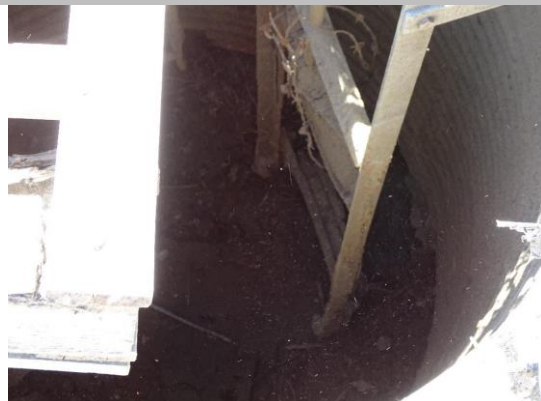
Photo 2 of 2 : UCIP_SP_2024_74531_111174.jpg

WS view: Looking into CMP riser; inlet of pipe through levee is deteriorating.

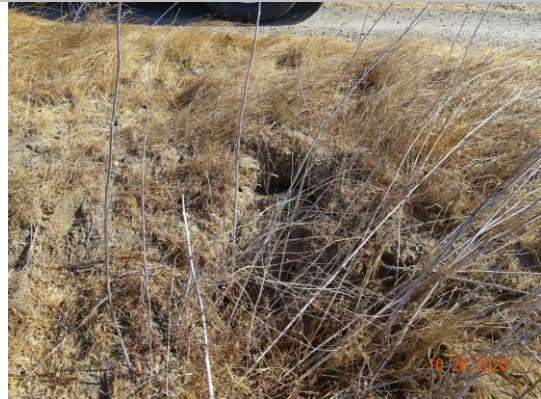
Photo 1 of 1 : SP_2024_RD1602_110_44_20240308_00015.jpg

Several rodent holes noted at this location. (Fall 2020)

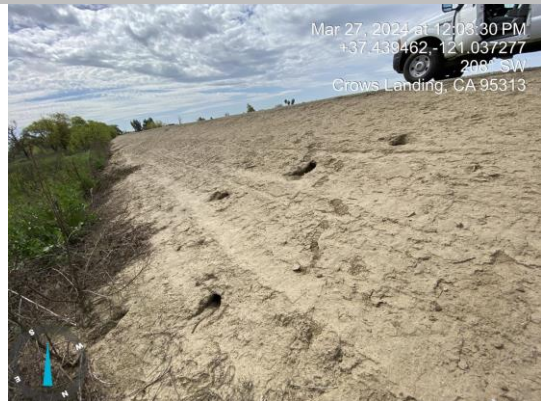
Photo 1 of 1 : SP_2024_RD1602_110_95_20240403_00100.jpg

View of rodent holes along the waterside slope (Spring 2024).

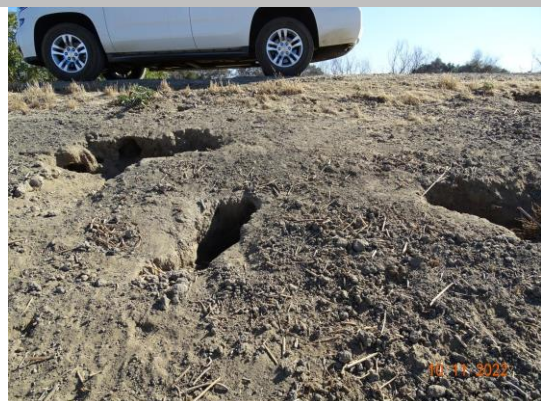
Photo 1 of 1 : SP_2024_RD1602_110_53_20240308_00021.jpg

Several large animal burrows were observed at this location. (Fall 2022)

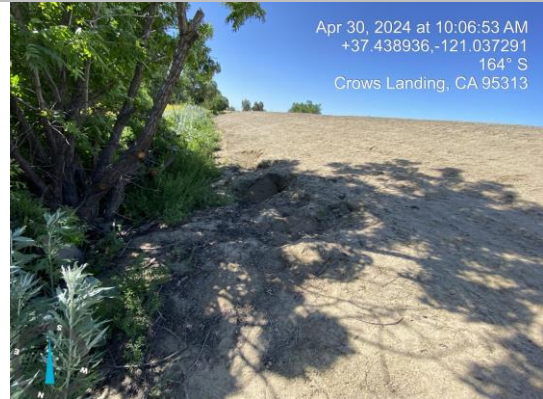
Photo 1 of 1 : SP_2024_RD1602_110_33_20240503_00105.jpg

View of erosion pocket on the waterside slope near the toe (Spring 2024).

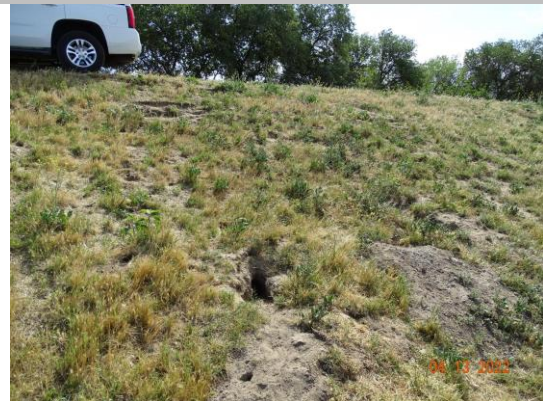
Photo 1 of 1 : SP_2024_RD1602_110_25_20240308_00004.jpg

View of rodent burrows in the landside slope. (Spring 2022)

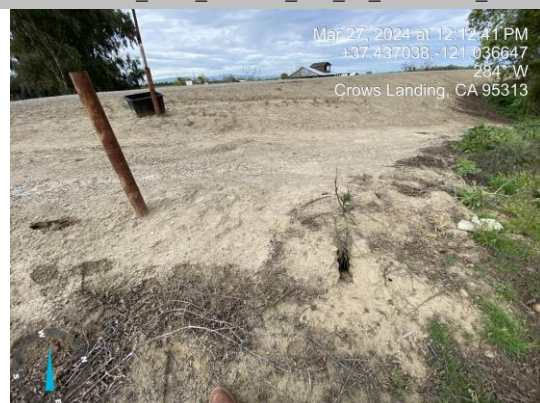
Photo 1 of 1 : SP_2024_RD1602_110_48_20240403_00101.jpg

View of animal burrows along the waterside slope near the gate (Spring 2024).

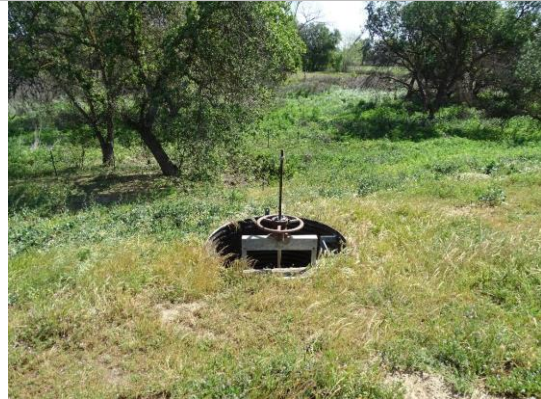
Photo 1 of 2 : UCIP_SP_2024_74358_111160.jpg

WS view: Looking from crown; CMP riser with no cover on slope.

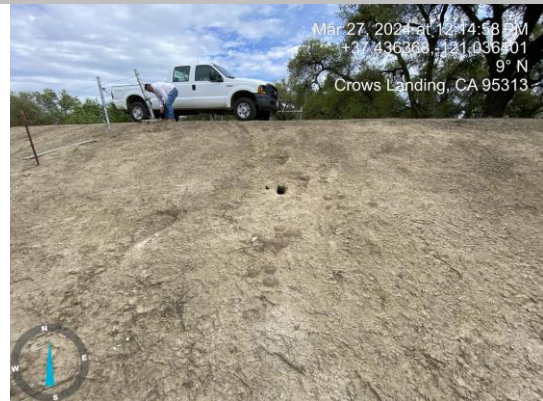
Photo 1 of 1 : SP_2024_RD1602_110_27_20240403_00102.jpg

View of animal burrow along the landside slope (Spring 2024).

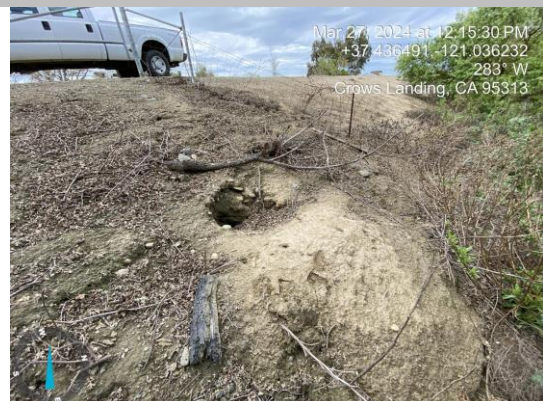
Photo 1 of 1 : SP_2024_RD1602_110_52_20240403_00103.jpg

View of animal burrow on the waterside slope (Spring 2024).

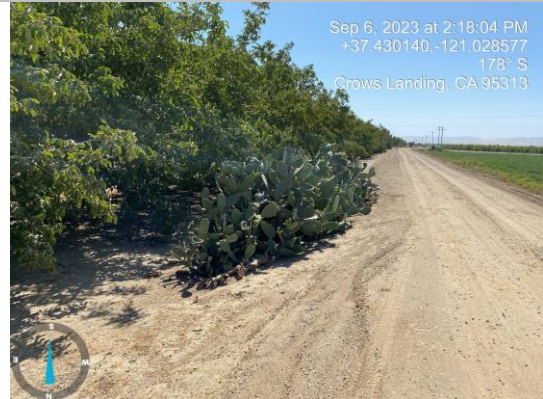
Photo 1 of 1 : SP_2024_RD1602_110_86_20240308_00039.jpg

Looking at dense cactus growth on the waterside slope (Fall 2023).

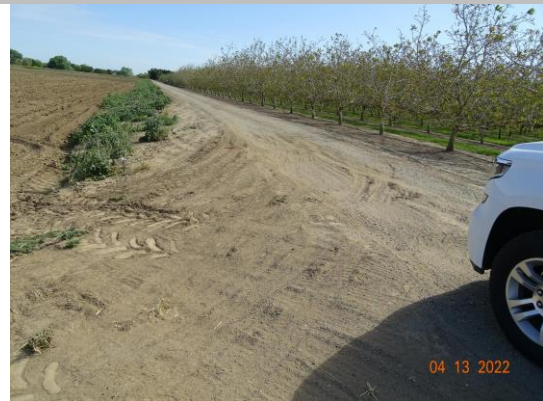
Photo 1 of 1 : SP_2024_RD1602_110_24_20240308_00003.jpg

Depression in levee crown from vehicle traffic. (Spring 2022)

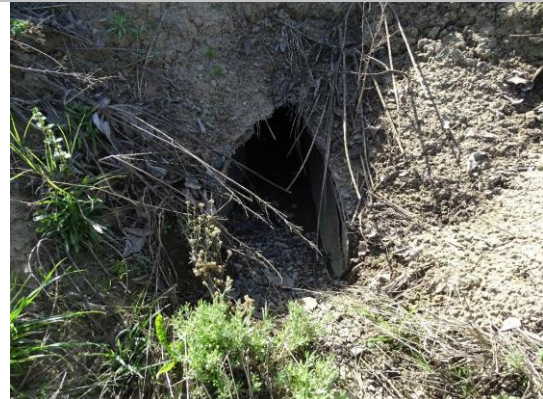
Photo 1 of 2 : UCIP_SP_2024_77638_111103.jpg

LS view: Outlet of irrigation pipe is deteriorated.
