**Flood Control Project Maintenance
Levee Inspections**

Maintenance Issue Types Only, Levee Inspection Report By Mile - Fall 2014

Reclamation District No. 1602 Del Puerto

Waterway	Bank	Unit Miles	Inspection Start/End	Inspector
Unit No. 01 San Joaquin River	Left	6.24	10/24/2014 10/24/2014	Pavel Kazi

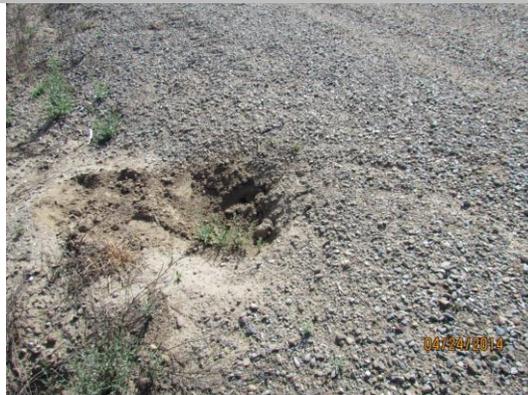
Photo 1 of 1 : FA_2014_RD1602_110_172_20141021_00087.jpg

LM Start	0.32	Rating **	A	Issue No.	172
LM End	0.32	Issue Type +	Ma	Location *	WS
Category	Earthen Levee		GPS Latitude/Longitude		
			Start	End	
Item	Animal Control		37.478581 °	37.478581 °	
			-121.078811 °	-121.078811 °	
DWR ID	DWR_RD1602_01_s_2014_172				
Action/Comments					
No rodents visible, but rodent burrows visible; need to backfill and compact or grout burrows. Inspector Comments: LMA repaired the rodent hole.

The rodent hole was filled with material on the waterside shoulder of the levee looking downstream.

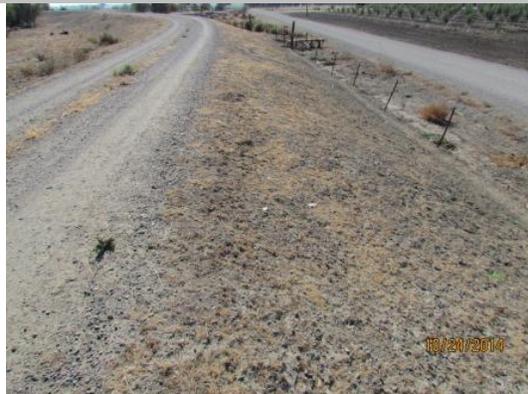
Photo 1 of 2 : FA_2014_RD1602_110_173_20141027_00116.jpg

View of the landside shoulder of the levee looking upstream during fall 2014 inspection.

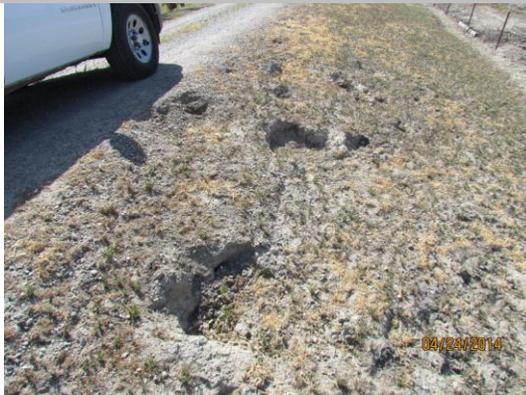
Photo 2 of 2 : FA_2014_RD1602_110_173_20141021_00088.jpg

The rodent holes were filled with material on the landside shoulder of the levee looking upstream.

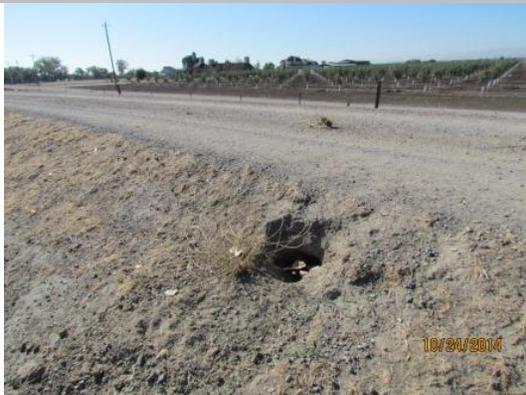
Photo 1 of 2 : FA_2014_RD1602_110_26_20141027_00117.jpg

LM Start	0.69	Rating **	M	Issue No.	26
LM End	0.69	Issue Type +	Ma	Location *	WS
Category	Earthen Levee		GPS Latitude/Longitude		
			Start	End	
Item	Animal Control		37.478792 °	37.478792 °	
			-121.073740 °	-121.073740 °	
DWR ID	DWR_RD1602_01_f_2013_26				
Action/Comments					
No rodents visible, but rodent burrows visible; need to backfill and compact or grout burrows.

Updated picture of the rodent hole on the waterside shoulder of the levee looking upstream during fall 2014 inspection.

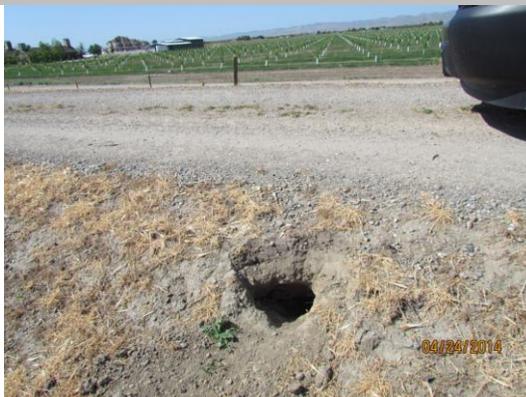
Photo 2 of 2 : FA_2014_RD1602_110_26_20141021_00020.jpg

View of the rodent hole on the waterside shoulder of the levee during spring 2014 inspection.

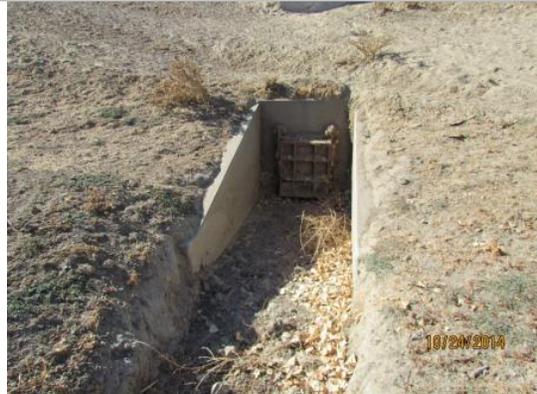
Photo 1 of 4 : FA_2014_RD1602_110_72_20141027_00118.jpg

View of the flap gate on the waterside of the levee during fall 2014 inspection.

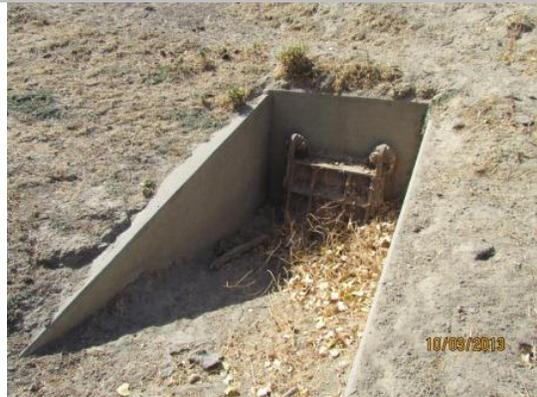
Photo 2 of 4 : FA_2014_RD1602_110_72_20141021_00056.jpg

Debris were obstructing the flap gate from closing completely. The picture was taken from toe of waterside of the levee during the fall 2013 inspection.

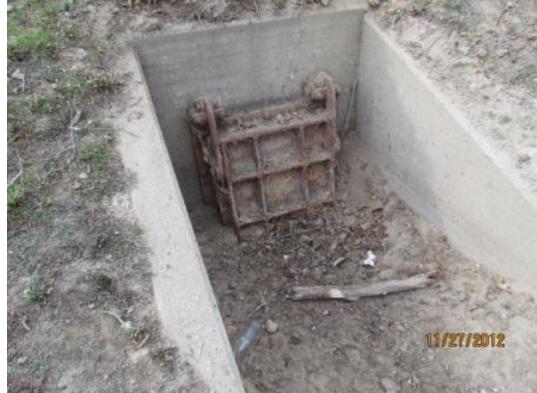
Photo 3 of 4 : FA_2014_RD1602_110_72_20141021_00057.jpg

Debris and sediments were obstructing the flap gate from closing completely. The picture was taken from toe of waterside of the levee during the fall 2012 inspection.

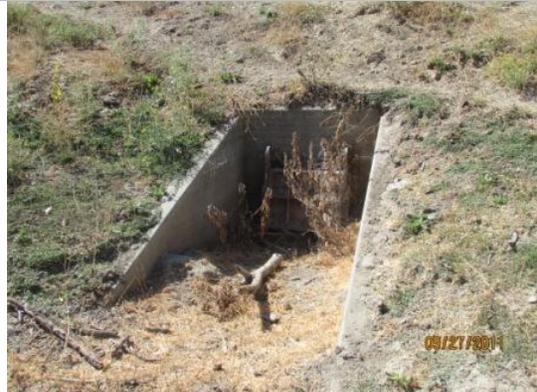
Photo 4 of 4 : FA_2014_RD1602_110_72_20141021_00058.jpg

Debris and sediments were obstructing the flap gate. The picture was taken from toe of waterside of the levee looking towards the crown. This picture was taken during the fall 2011 inspection.

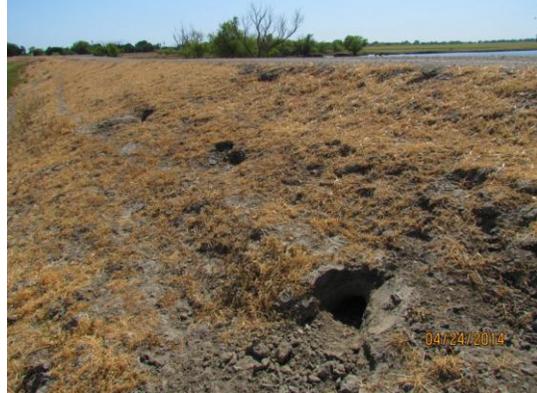
Photo 1 of 3 : FA_2014_RD1602_110_76_20141021_00061.jpg

Updated picture of the rodent holes on the waterside of the levee looking upstream during spring 2014 inspection.

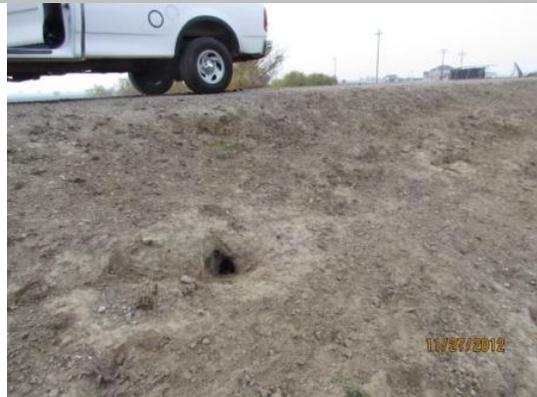
Photo 2 of 3 : FA_2014_RD1602_110_76_20141021_00062.jpg

Updated picture of the rodent hole on the waterside slope of the levee looking downstream.

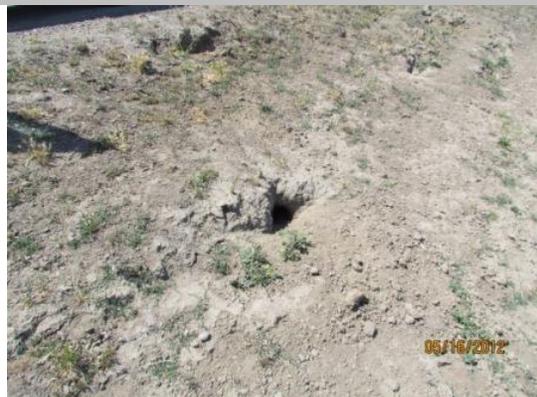
Photo 3 of 3 : FA_2014_RD1602_110_76_20141021_00063.jpg

A rodent hole was found on the waterside of the levee looking downstream.

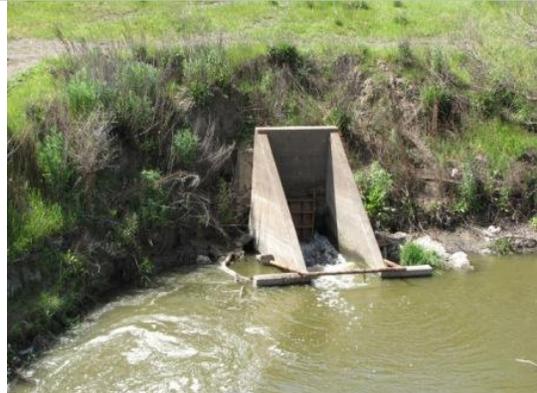
Photo 1 of 2 : FA_2014_RD1602_110_55_20141021_00039.jpg

LM Start	1.04	Rating **	M	Issue No.	55
LM End	1.04	Issue Type +	Ma	Location *	WS
Category	Interior Drainage & Piping Systems		GPS Latitude/Longitude		
			Start	End	
Item	Concrete Tilting / Settlement		37.478678 °	37.478678 °	
			-121.068305 °	-121.068305 °	
DWR ID	DWR_RD1602_01_s_2012_55				
Action/Comments					
Inspector Comments: The outlet headwall is tilting away from the pipe rendering the existing flap gate ineffective. Repair gap between pipe and headwall and stabilize headwall to prevent further damage.

Additional view of outfall structure at LM 1.04.

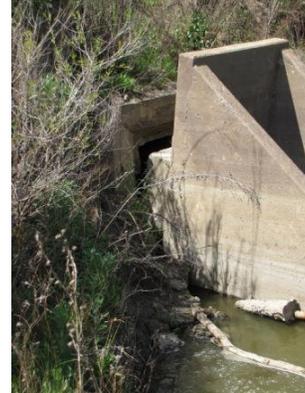
Photo 2 of 2 : FA_2014_RD1602_110_55_20141021_00040.jpg

LM Start	1.04	Rating **	M	Issue No.	55 (cont)
LM End	1.04	Issue Type +	Ma	Location *	WS
Category	Interior Drainage & Piping Systems			GPS Latitude/Longitude	
				Start	End
Item	Concrete Tilting / Settlement			37.478678 °	37.478678 °
				-121.068305 °	-121.068305 °
DWR ID	DWR_RD1602_01_s_2012_55				
Action/Comments					
Inspector Comments: The outlet headwall is tilting away from the pipe rendering the existing flap gate ineffective. Repair gap between pipe and headwall and stabilize headwall to prevent further damage.

Separation of outfall structure from the outlet pipe at LM 1.04.

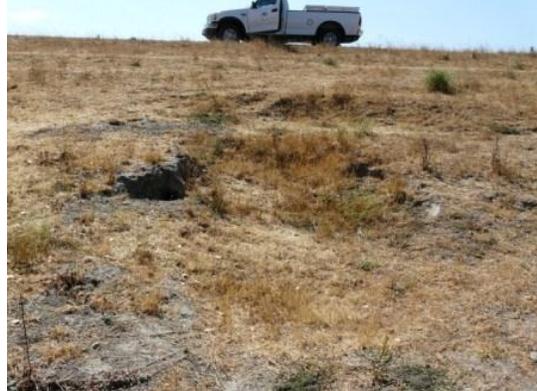
Photo 1 of 3 : FA_2014_RD1602_110_37_20141021_00026.jpg

LM Start	1.07	Rating **	M	Issue No.	37
LM End	1.07	Issue Type +	Ma	Location *	WS
Category	Earthen Levee		GPS Latitude/Longitude		
			Start	End	
Item	Slope Stability		37.478567 °	37.478567 °	
			-121.067847 °	-121.067847 °	
DWR ID	DWR_RD1602_01_s_2012_37				
Action/Comments					
Repair slope instability. Inspector Comments: Small amount of slumping at waterside toe of the levee.

Small amount of slumping at water toe.

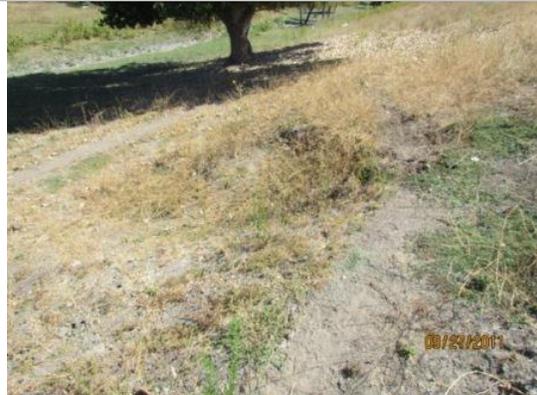
Photo 2 of 3 : FA_2014_RD1602_110_37_20141021_00027.jpg

Updated picture of the depression at the waterside toe of the levee. The picture was taken from the crown of the levee looking upstream.

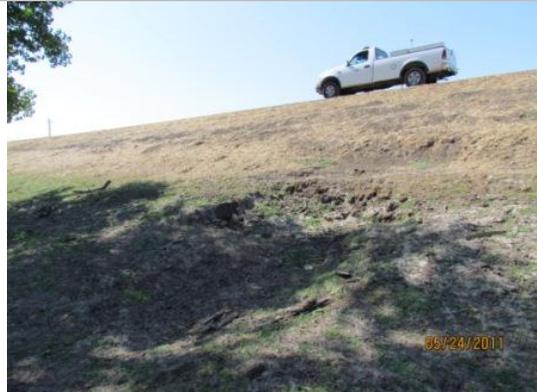
Photo 3 of 3 : FA_2014_RD1602_110_37_20141021_00028.jpg

Depression at the waterside slope of the levee during Spring 2011 inspection.

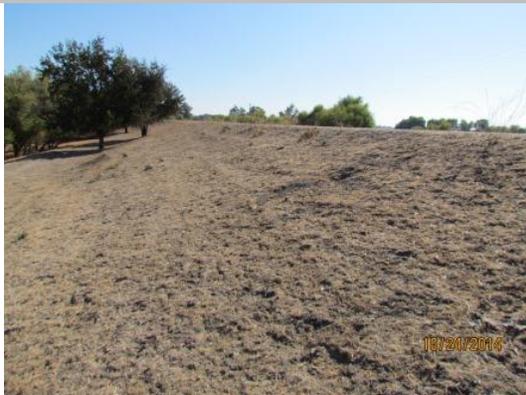
Photo 1 of 2 : FA_2014_RD1602_110_8_20141027_00119.jpg

LMA grouted the rodent holes on the waterside slope of the levee looking upstream. The picture was taken during fall 2014 inspection.

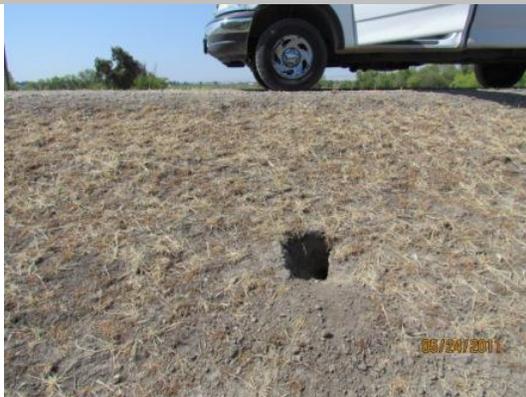
Photo 2 of 2 : FA_2014_RD1602_110_8_20141021_00005.jpg

Rodent hole was found on the waterside of the levee. The picture was taken from waterside looking upstream.

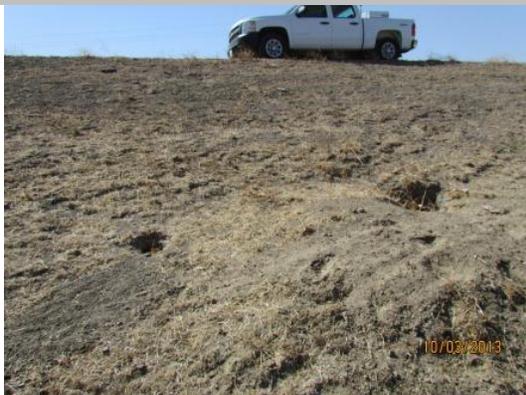
Photo 1 of 2 : FA_2014_RD1602_110_11_20141021_00006.jpg

Rodent holes were found on the waterside slope of the levee looking downstream.

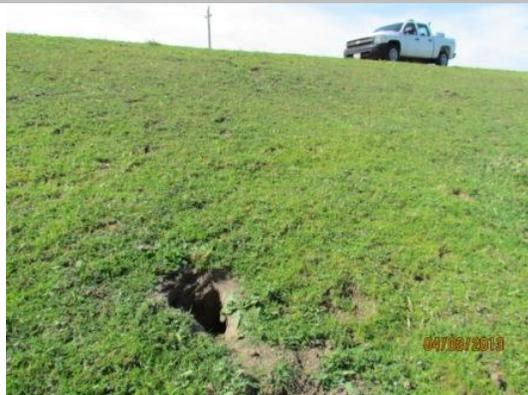
Photo 2 of 2 : FA_2014_RD1602_110_11_20141021_00007.jpg

A rodent hole was found on the waterside toe of the levee looking downstream.

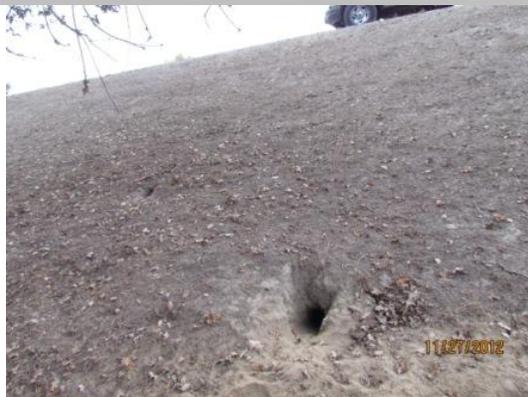
Photo 1 of 1 : FA_2014_RD1602_110_56_20141021_00041.jpg

A rodent hole was found on the waterside toe of the levee looking upstream.

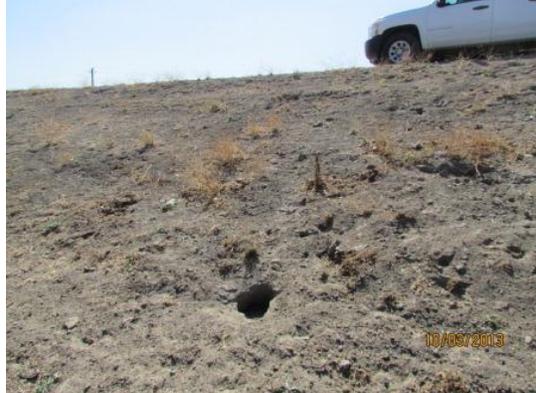
Photo 1 of 2 : FA_2014_RD1602_110_65_20141021_00049.jpg

Updated picture of rodent hole on the waterside slope of the levee looking upstream during fall 2013 inspection.

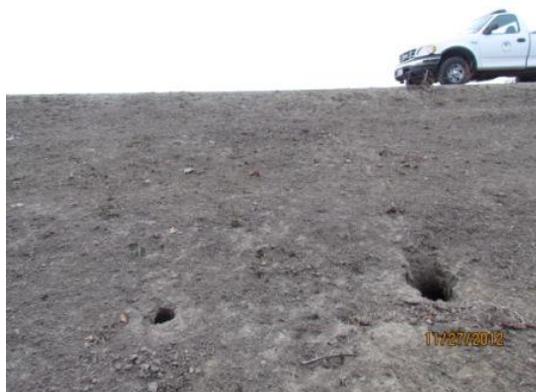
Photo 2 of 2 : FA_2014_RD1602_110_65_20141021_00050.jpg

Rodent holes were found on the waterside toe of the levee. The picture was taken from toe of the levee looking towards the crown.

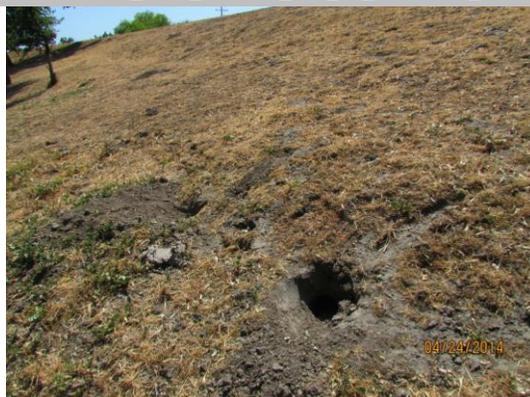
Photo 1 of 2 : FA_2014_RD1602_110_79_20141021_00065.jpg

Updated picture of the rodent holes on the waterside toe of the levee during spring 2014 inspection.

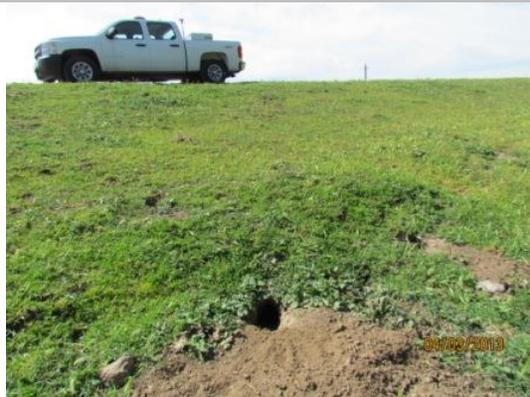
Photo 2 of 2 : FA_2014_RD1602_110_79_20141021_00066.jpg

A rodent hole was found on the waterside toe of the levee looking downstream.

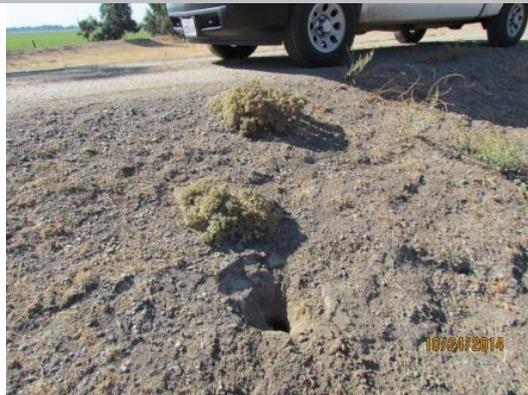
Photo 1 of 1 : FA_2014_RD1602_110_31_20141027_00120.jpg

View of the rodent hole on the waterside slope of the levee looking downstream.

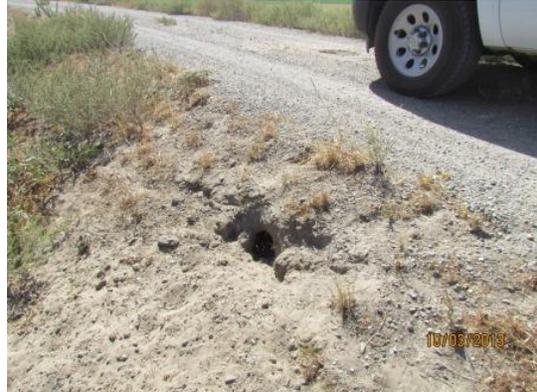
Photo 1 of 2 : FA_2014_RD1602_110_85_20141021_00070.jpg

Updated picture of a rodent hole on the waterside shoulder of the levee looking upstream during fall 2013 inspection.

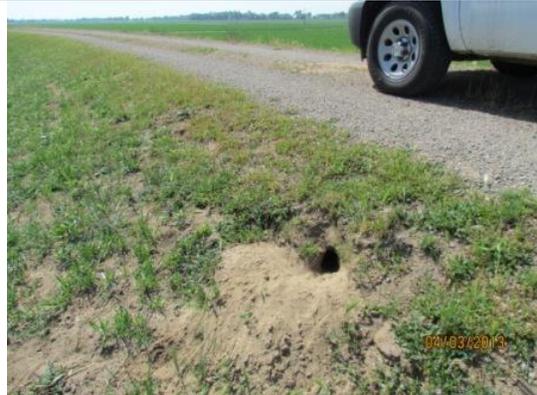
Photo 2 of 2 : FA_2014_RD1602_110_85_20141021_00071.jpg

A rodent hole was found on the waterside shoulder of the levee looking upstream.

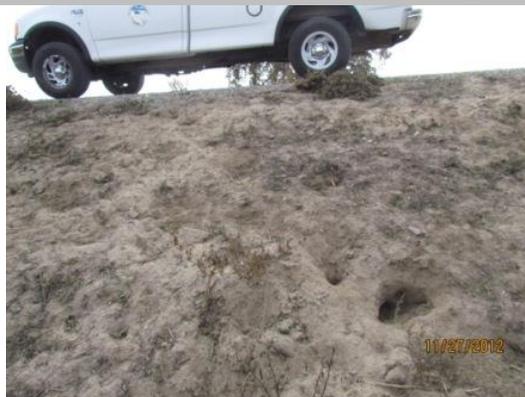
Photo 1 of 1 : FA_2014_RD1602_110_86_20141021_00072.jpg

Rodent holes were found on the waterside toe of the levee looking upstream.

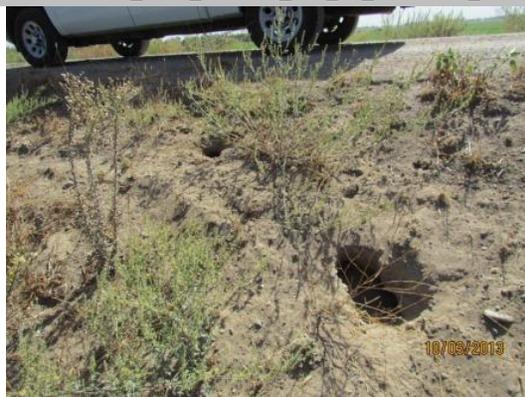
Photo 1 of 1 : FA_2014_RD1602_110_35_20141021_00024.jpg

Animal holes were found on the waterside shoulder of the levee looking upstream.

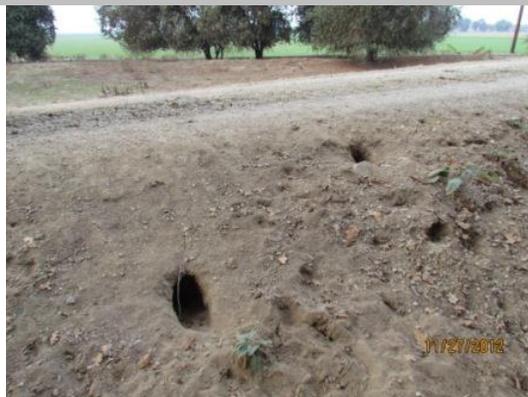
Photo 1 of 1 : FA_2014_RD1602_110_106_20141021_00081.jpg

Rodent holes were found on the waterside slope of the levee looking downstream.

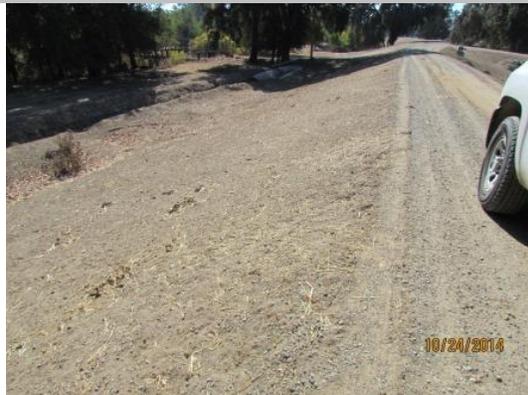
Photo 1 of 3 : FA_2014_RD1602_110_107_20141027_00122.jpg

LMA repaired the rodent holes on the waterside slope of the levee looking upstream during fall 2014 inspection.

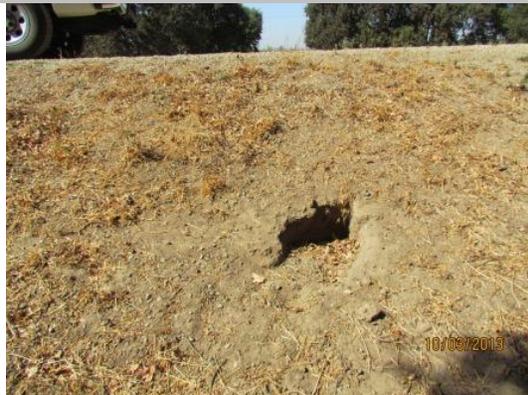
Photo 2 of 3 : FA_2014_RD1602_110_107_20141021_00082.jpg

Updated picture of rodent hole on the waterside shoulder of the levee looking upstream.

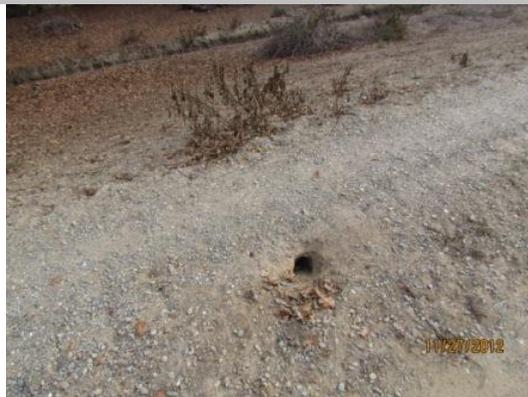
Photo 3 of 3 : FA_2014_RD1602_110_107_20141021_00083.jpg

A rodent hole was found on the waterside shoulder of the levee looking upstream.

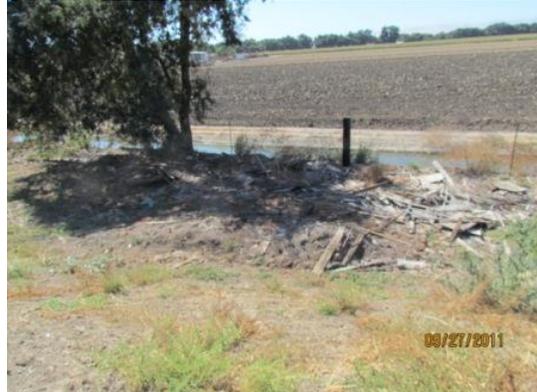
Photo 1 of 2 : FA_2014_RD1602_110_15_20141021_00010.jpg

Debris was located on the landside of the levee. The picture was taken from the crown looking upstream.

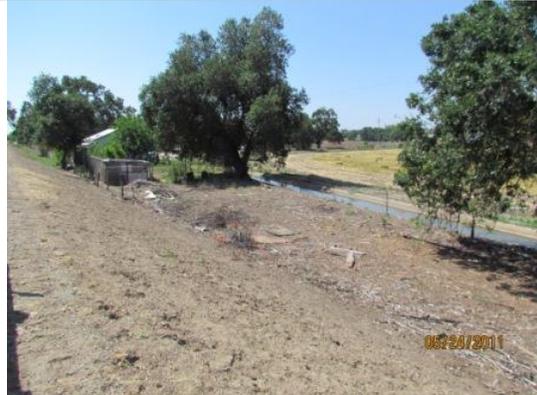
Photo 2 of 2 : FA_2014_RD1602_110_15_20141021_00011.jpg

Garbage was found on the landside of the levee. The picture was taken from the crown looking upstream.

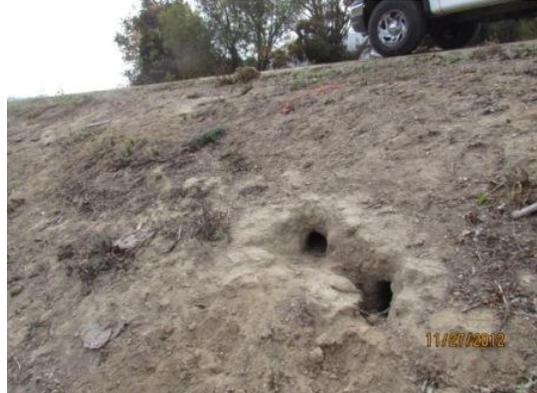
Photo 1 of 1 : FA_2014_RD1602_110_94_20141021_00075.jpg

Rodent holes were found on the waterside toe of the levee looking upstream.

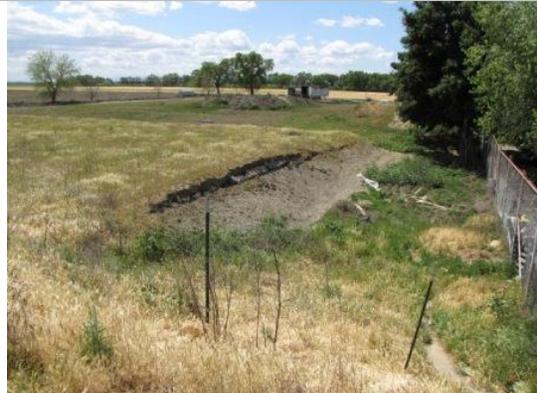
Photo 1 of 1 : FA_2014_RD1602_110_62_20141021_00047.jpg

LM Start	3.96	Rating **	M	Issue No.	62
LM End	3.96	Issue Type +	Ma	Location *	LS
Category	Earthen Levee		GPS Latitude/Longitude		
			Start	End	
Item	Slope Stability		37.453216 °	37.453216 °	
			-121.042127 °	-121.042127 °	
DWR ID	DWR_RD1602_01_s_2012_62				
Action/Comments					
Repair the levee slope damaged by vehicle traffic and prevent access where possible. Inspector Comments: Significant damage to USACE constructed seepage berm due to human activity.

Repair damage to USACE constructed seepage berm by pedestrian and cycle traffic at LM 3.96.

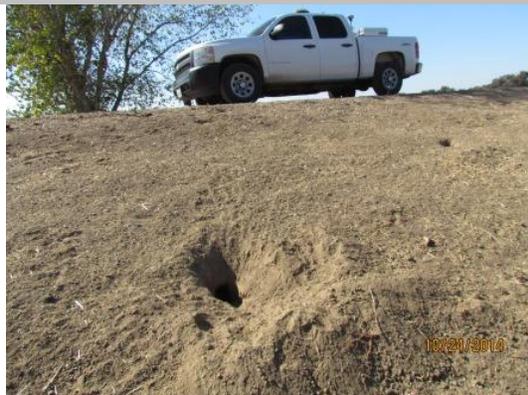
Photo 1 of 1 : FA_2014_RD1602_110_41_20141027_00123.jpg

View of a rodent hole on the waterside toe of the levee during fall 2014 inspection.

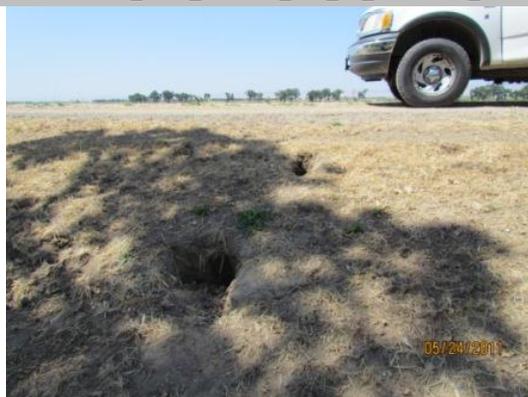
Photo 1 of 1 : FA_2014_RD1602_110_17_20141021_00015.jpg

Rodent hole was found on the waterside of the levee. The picture was taken from the crown looking upstream.

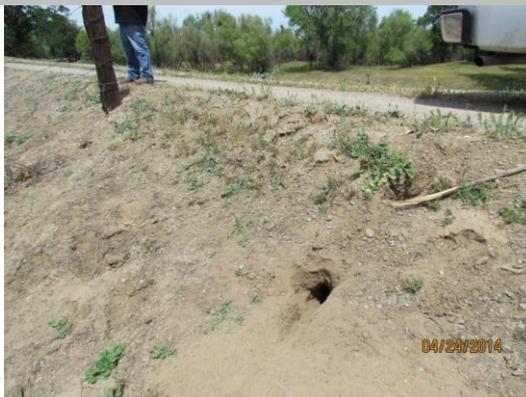
Photo 1 of 1 : FA_2014_RD1602_110_190_20141021_00098.jpg

A rodent hole was found on the waterside shoulder of the levee looking upstream.

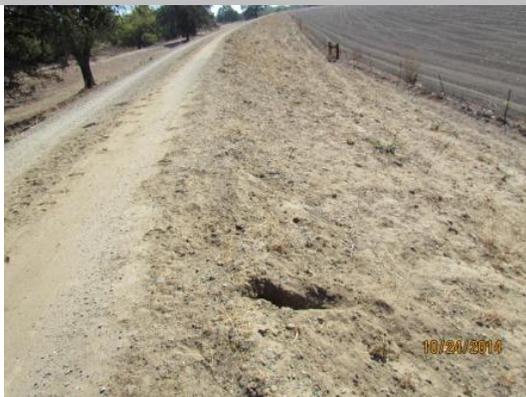
Photo 1 of 1 : FA_2014_RD1602_110_44_20141027_00124.jpg

A rodent hole was found on the landside shoulder of the levee looking upstream.

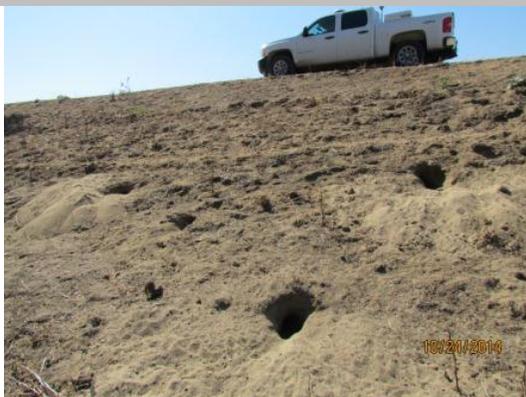
Photo 1 of 1 : FA_2014_RD1602_110_46_20141027_00125.jpg

View of the rodent holes on the waterside slope of the levee. The picture was taken from the toe of the levee during fall 2014 inspection.

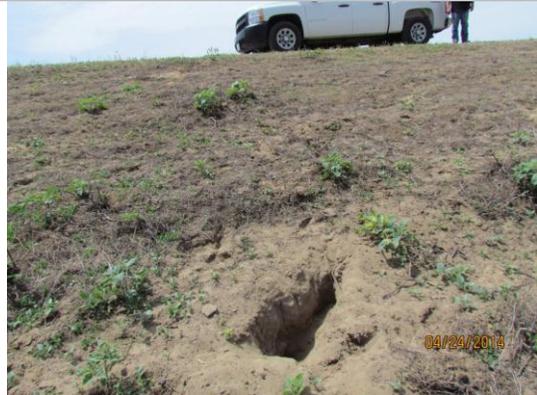
Photo 1 of 1 : FA_2014_RD1602_110_191_20141021_00099.jpg

A rodent hole was found on the waterside toe of the levee looking downstream.

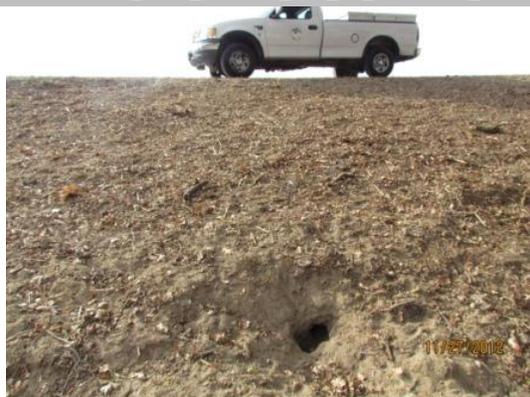
Photo 1 of 1 : FA_2014_RD1602_110_52_20141021_00036.jpg

A rodent hole was found on the waterside toe of the levee looking downstream.

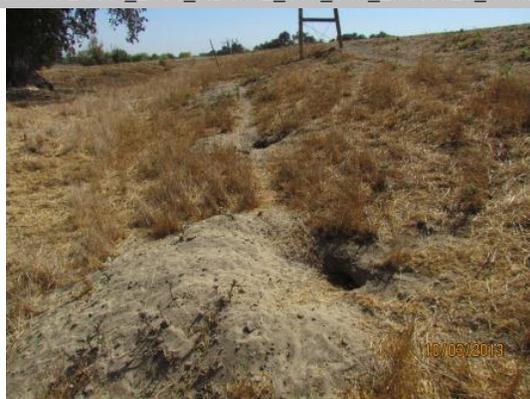
Photo 1 of 2 : FA_2014_RD1602_110_109_20141021_00085.jpg

Updated pictures of rodent holes were found on the waterside toe of the levee looking upstream.

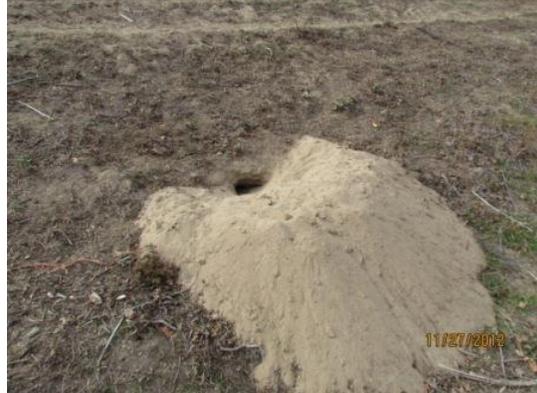
Photo 2 of 2 : FA_2014_RD1602_110_109_20141021_00086.jpg

A rodent hole was found on the waterside toe of the levee looking downstream.

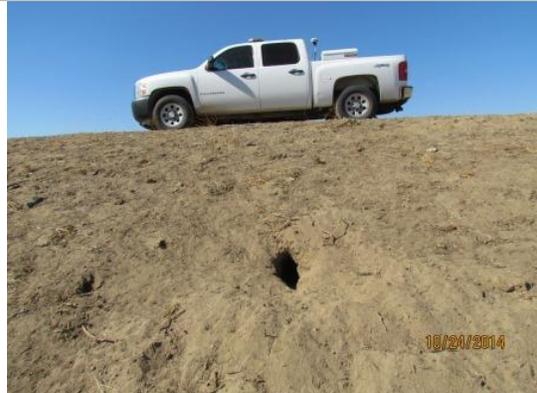
Photo 1 of 1 : FA_2014_RD1602_110_48_20141027_00126.jpg

View of a rodent hole on the waterside slope of the levee looking from the toe.

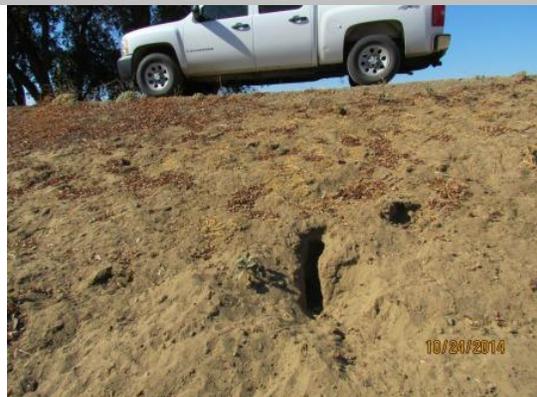
Photo 1 of 1 : FA_2014_RD1602_110_196_20141027_00128.jpg

Rodent holes were found on the waterside slope of the levee.

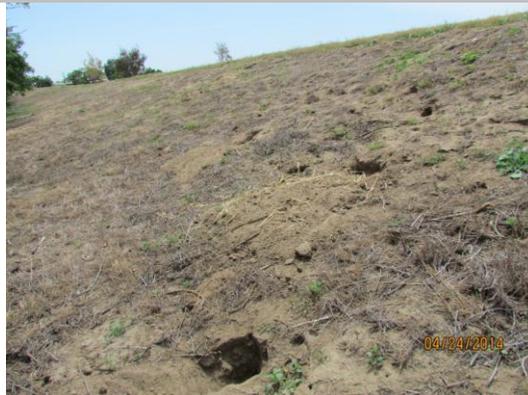
Photo 1 of 1 : FA_2014_RD1602_110_199_20141021_00102.jpg

Few rodent holes were found on the waterside toe of the levee looking upstream.

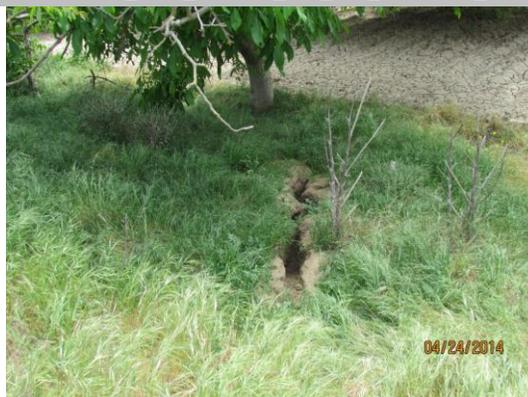
Photo 1 of 1 : FA_2014_RD1602_110_202_20141021_00103.jpg

Erosion was found on the landside slope of the levee looking upstream.

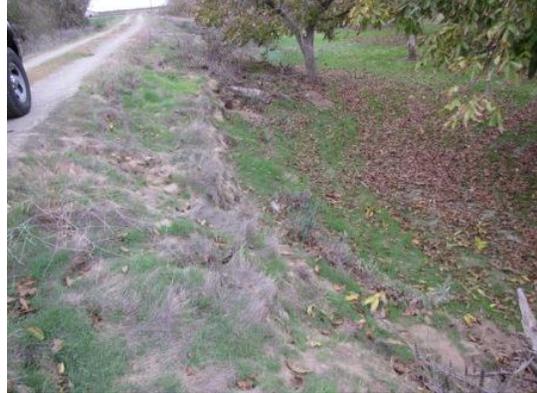
Photo 1 of 1 : FA_2014_RD1602_110_102_20141021_00078.jpg

View of significant damage and erosion to the landward slope looking upstream.

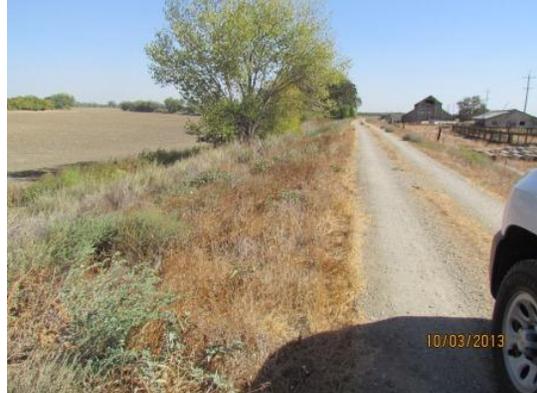
Photo 1 of 2 : FA_2014_RD1602_110_75_20141021_00059.jpg

Vegetation was found on the waterside slope of the levee looking upstream during fall 2013 inspection.

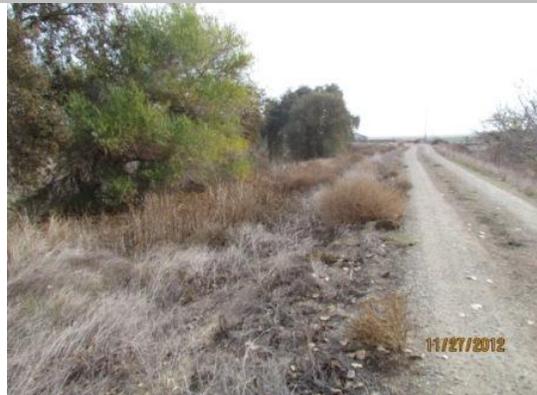
Photo 2 of 2 : FA_2014_RD1602_110_75_20141021_00060.jpg

Overgrown vegetation was found on the waterside slope of the levee looking upstream.

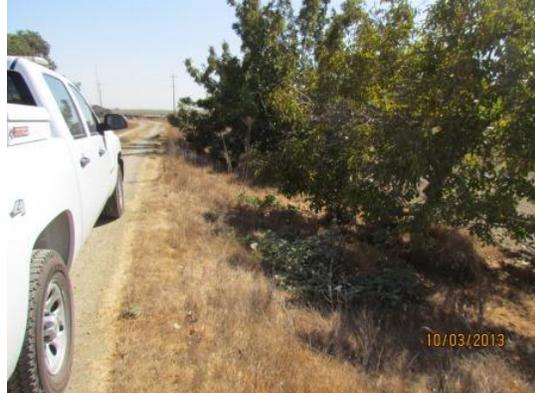
Photo 1 of 2 : FA_2014_RD1602_110_61_20141021_00045.jpg

Updated picture of vegetation on the landside of the levee. The picture was taken from the crown looking upstream during fall 2013 inspection.

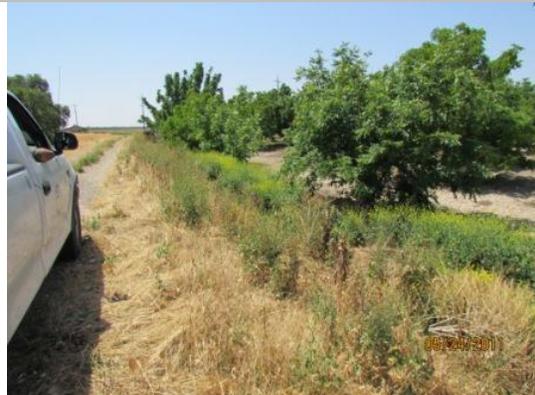
Photo 2 of 2 : FA_2014_RD1602_110_61_20141021_00046.jpg

Vegetation was obstructing the view of the landside of the levee. The picture was taken from the crown looking upstream.

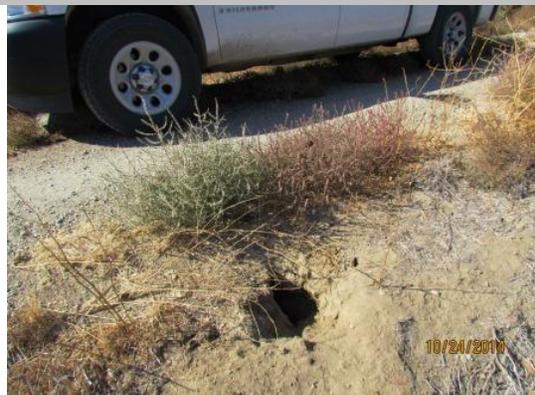
Photo 1 of 1 : FA_2014_RD1602_110_204_20141027_00129.jpg

An animal hole was found on the waterside shoulder of the levee looking downstream.
