**Flood Control Project Maintenance
Levee Inspections
LMA District Cover Sheet
Spring 2013 Levee Inspection Results**

Reclamation District No. 1660 Tisdale

Levee Inspection Report By Mile - Spring 2013

Waterway		Bank	Unit Miles	Inspection Start/End	Inspector
Unit No. 01 Sacramento River		Left	3.00	03/05/2013 03/05/2013	Bob Duffey

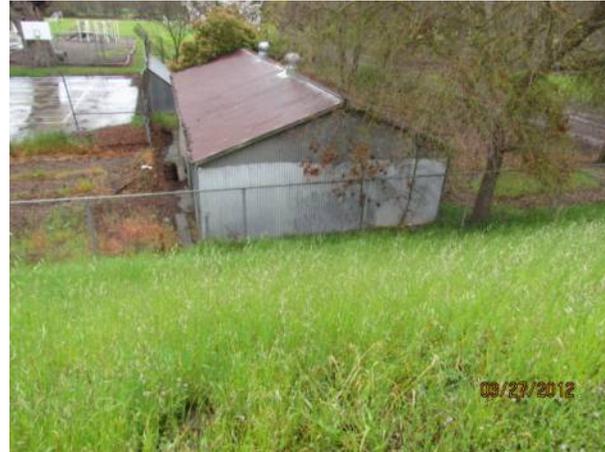
Levee Mile Report Line	4
Start Levee Mile	0.05
End Levee Mile	0.05
Location	Land Side
Category	
Item	Encroachments
View of the building and fence at the landside toe.	
rduffey_s_20130225_244.jpg

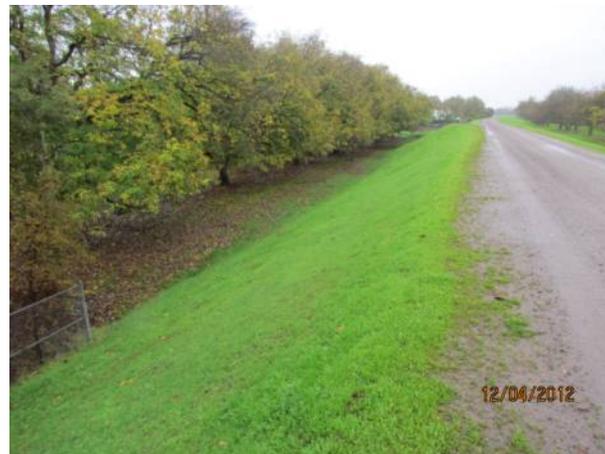
Levee Mile Report Line	5
Start Levee Mile	0.08
End Levee Mile	0.10
Location	Land Side
Category	
Item	Animal Control
View of the repaired rodent holes along the landside slope of the levee.	
rduffey_s_20130225_238.JPG

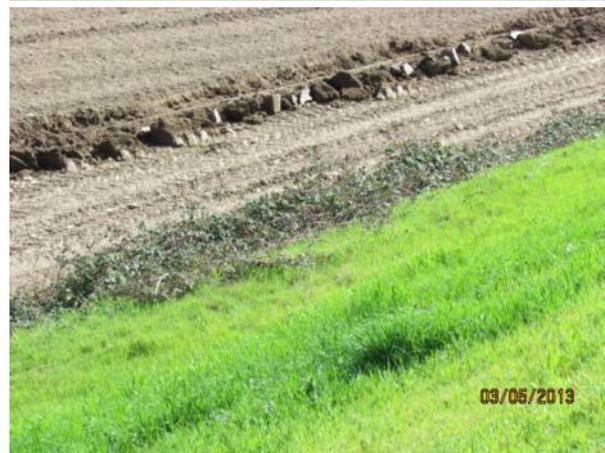
Levee Mile Report Line	6
Start Levee Mile	0.97
End Levee Mile	0.97
Location	Land Side
Category	
Item	Vegetation
View of the berry vines along the landside slope.	
rduffey_s_20130312_309.JPG

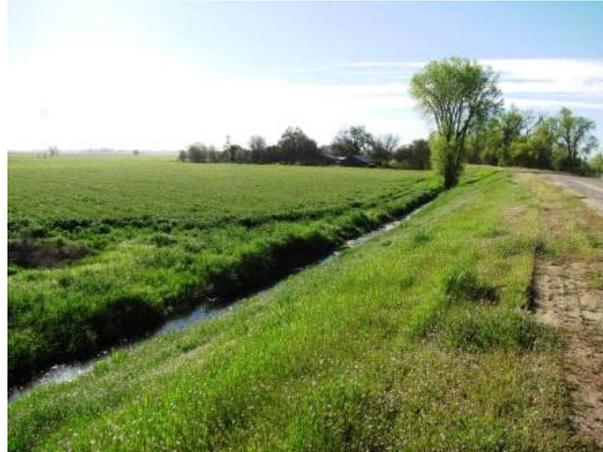
DWR ID: DWR_RD1660_01_s_2013_13		
7	1.12	1.43		Encroachments	LS	M En	DT : Ditch	39.047610 ° -121.838802 °	39.043622 ° -121.836445 °	9 Y
								DWR ID: DWR_RD1660_01_s_2012_9		
8	1.32	1.35	Supplemental	USACE Erosion Survey	WS	M Ma	Inspector Comments: 2009 - Erosion on levee toe where an old cobble site is failing. 2011 - Some new minor erosion. 2012: Site extended downstream, bank is negatively being impacted from the weight of the trees. [2012 Site ID: SAC_120-6_L]	39.044361 ° -121.837654 °	39.043916 ° -121.837305 °	11 Y
								DWR ID: DWR_RD1660_01_s_2013_11		
9	2.04	2.38		Encroachments	LS	M En	DT : Ditch	39.037640 ° -121.828421 °	39.034416 ° -121.825698 °	1 Y
								DWR ID: DWR_RD1660_01_s_2012_1		
10	2.42	2.42		Slope Stability	LS	M Ma	S1 : Repair slope instability.	39.034107 ° -121.825152 °	39.034107 ° -121.825152 °	2 Y
								DWR ID: DWR_RD1660_01_s_2012_2		
11	2.44	2.44		Slope Stability	LS	M Ma	S1 : Repair slope instability.	39.033858 ° -121.824985 °	39.033858 ° -121.824985 °	4 Y

Levee Mile Report Line	7
Start Levee Mile	1.12
End Levee Mile	1.43
Location	Land Side
Category	
Item	Encroachments
View of the ag ditch along the L/S toe.	
rduffey_s_20130225_239.jpg

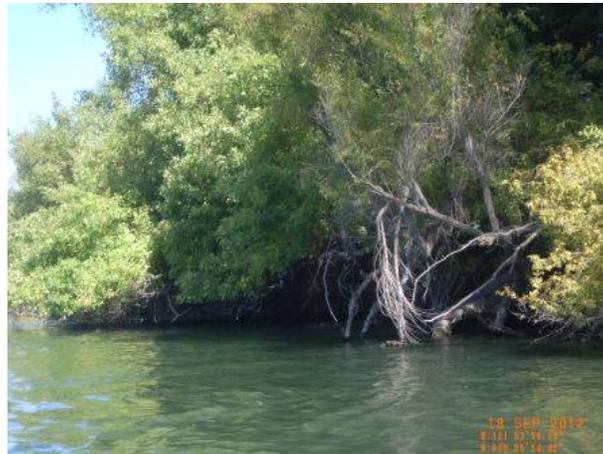
Levee Mile Report Line	8
Start Levee Mile	1.32
End Levee Mile	1.35
Location	Water Side
Category	Supplemental
Item	USACE Erosion Survey
USACE 2012 Photo #1	
rduffey_s_20130225_241.jpg

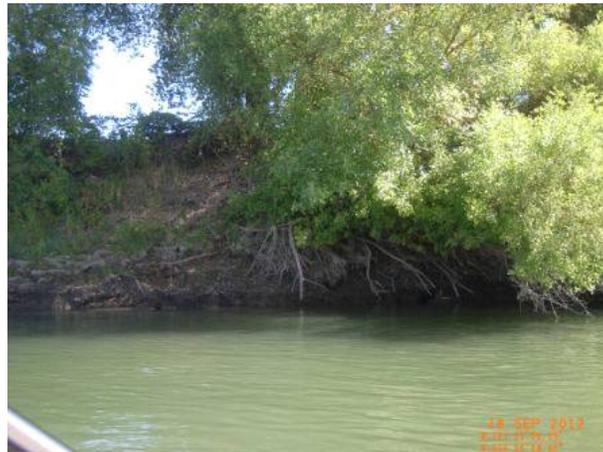
Levee Mile Report Line	8
Start Levee Mile	1.32
End Levee Mile	1.35
Location	Water Side
Category	Supplemental
Item	USACE Erosion Survey
USACE 2012 Photo #2	
rduffey_s_20130225_242.jpg

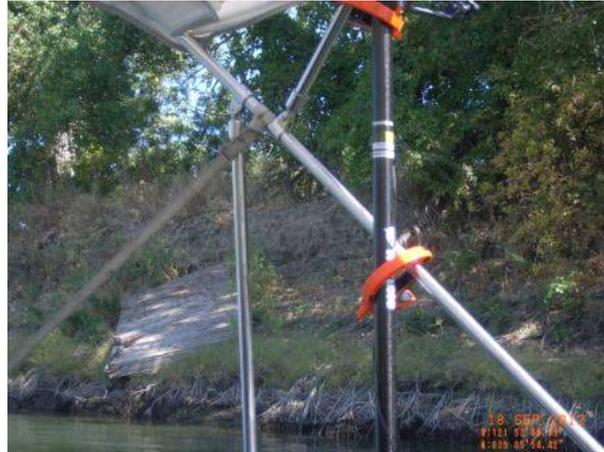
Levee Mile Report Line	8
Start Levee Mile	1.32
End Levee Mile	1.35
Location	Water Side
Category	Supplemental
Item	USACE Erosion Survey
USACE 2012 Photo #3	
rduffey_s_20130225_243.jpg

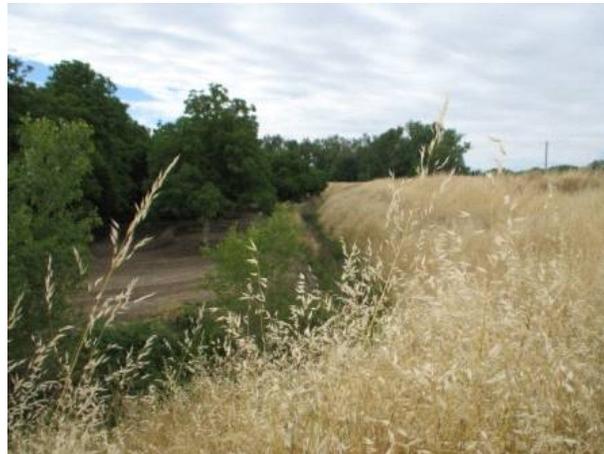
Levee Mile Report Line	9
Start Levee Mile	2.04
End Levee Mile	2.38
Location	Land Side
Category	
Item	Encroachments
View of the large ditch along the landside toe.	
rduffey_s_20130225_236.jpg

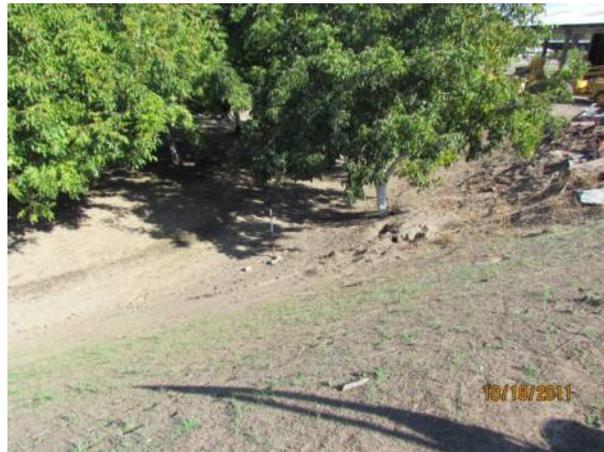
DWR ID: DWR_RD1660_01_s_2012_4		
12	2.62	2.62		Animal Control	LS	A/W Ma	A3 : No rodents visible, but rodent burrows visible; need to backfill and compact or grout burrows.	39.031520 ° -121.823420 °	39.031520 ° -121.823420 °	10 Y
								DWR ID: DWR_RD1660_01_s_2012_10		
13	2.63	2.63		Encroachments	LS	M Ma	EQ : Equipment	39.031405 ° -121.823403 °	39.031405 ° -121.823403 °	3 Y
								DWR ID: DWR_RD1660_01_s_2012_3		
14	2.68	2.71		Slope Stability	LS	M Ma	S1 : Repair slope instability.	39.030891 ° -121.822956 °	39.030436 ° -121.822617 °	5 Y
								DWR ID: DWR_RD1660_01_s_2012_5

Levee Mile Report Line	12
Start Levee Mile	2.62
End Levee Mile	2.62
Location	Land Side
Category	
Item	Animal Control
View of rodent holes along the L/S slope.	
rduffey_s_20130225_240.jpg

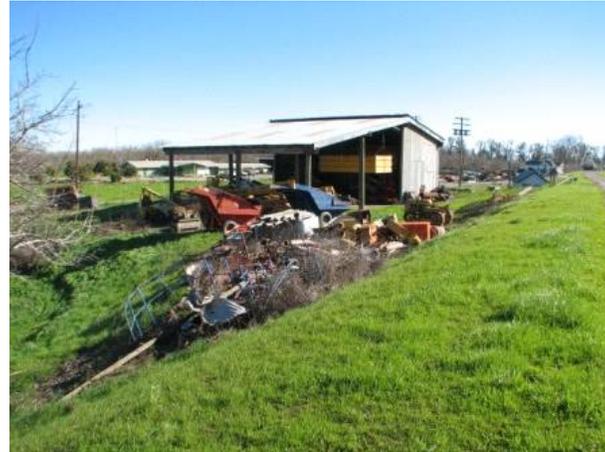
Levee Mile Report Line	13
Start Levee Mile	2.63
End Levee Mile	2.63
Location	Land Side
Category	
Item	Encroachments
View of equipment along the slope.	
rduffey_s_20130225_237.jpg

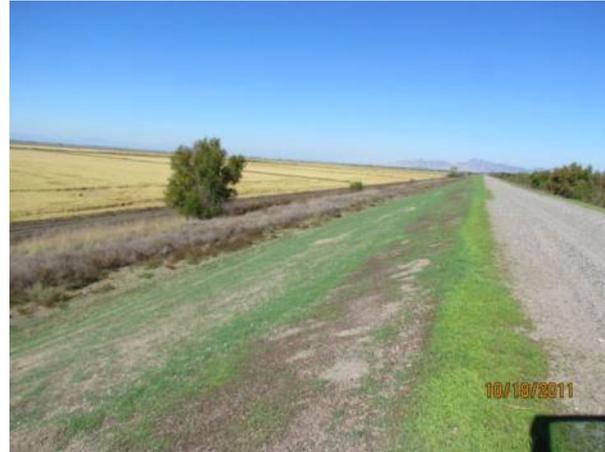
LMIR No.	Levee Mile		Category	Item	Location * + Rating	Action/Comment	GPS Latitude/Longitude		Issue No. Photo
	Start	End					Start	End	
1	0.93	0.97	Animal Control	LS A/W Ma	A3 : No rodents visible, but rodent burrows visible; need to backfill and compact or grout burrows.	39.045810 ° -121.748792 °	39.046332 ° -121.749000 °	3 Y	
						DWR ID: DWR_RD1660_02_s_2012_3			
2	1.55	1.55	Animal Control	WSA/W Ma	A1 : Exterminate rodents and backfill and compact or grout burrows. Inspector Comments: Beaver holes were repaired by District.	39.054290 ° -121.752319 °	39.054290 ° -121.752319 °	7 Y	
						DWR ID: DWR_RD1660_02_s_2012_7			
3	1.57	1.61	Animal Control	LS A/W Ma	A1 : Exterminate rodents and backfill and compact or grout burrows.	39.054595 ° -121.752460 °	39.055170 ° -121.752698 °	4 Y	
						DWR ID: DWR_RD1660_02_s_2012_4			
4	3.80	3.80	Encroachments	WS M En	TR : Tree or limb	39.085233 ° -121.765229 °	39.085233 ° -121.765229 °	5 Y

Levee Mile Report Line	1
Start Levee Mile	0.93
End Levee Mile	0.97
Location	Land Side
Category	
Item	Animal Control
View of rodent holes along the L/S slope.	
rduffey_s_20130225_245.jpg

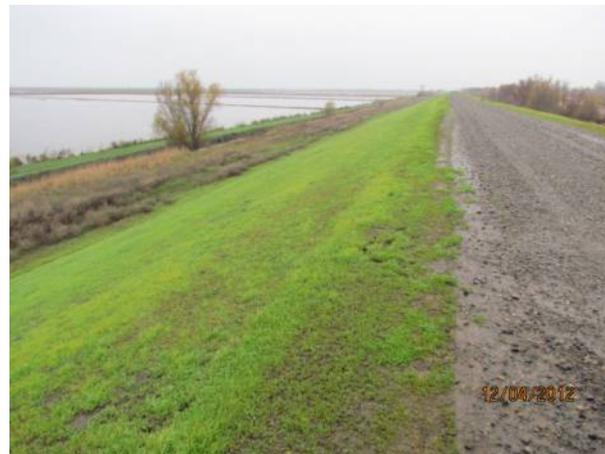
Levee Mile Report Line	1
Start Levee Mile	0.93
End Levee Mile	0.97
Location	Land Side
Category	
Item	Animal Control
View of the repaired rodent holes on the landside slope.	
rduffey_s_20130225_246.JPG

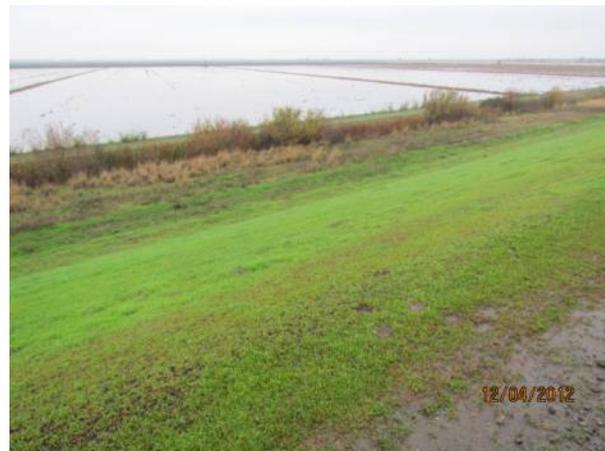
Levee Mile Report Line	2
Start Levee Mile	1.55
End Levee Mile	1.55
Location	Water Side
Category	
Item	Animal Control
View of the repaired rodent holes on the landside slope of the levee.	
rduffey_s_20130225_249.JPG

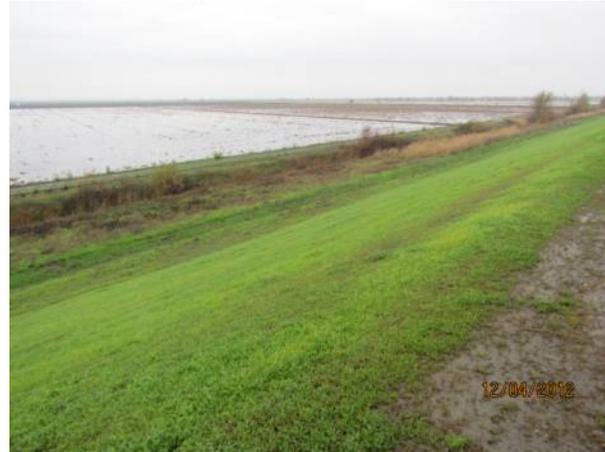
Levee Mile Report Line	3
Start Levee Mile	1.57
End Levee Mile	1.61
Location	Land Side
Category	
Item	Animal Control
View of the repaired rodent holes on the landside slope of the levee.	
rduffey_s_20130225_247.JPG

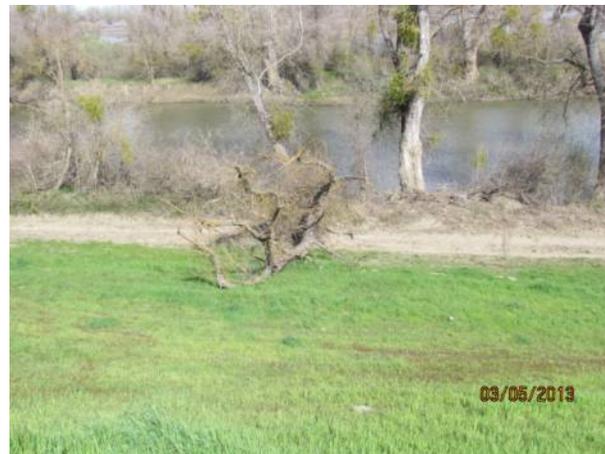
Levee Mile Report Line	4
Start Levee Mile	3.80
End Levee Mile	3.80
Location	Water Side
Category	
Item	Encroachments
View of the downed tree on the land water slope.	
rduffey_s_20130312_313.JPG

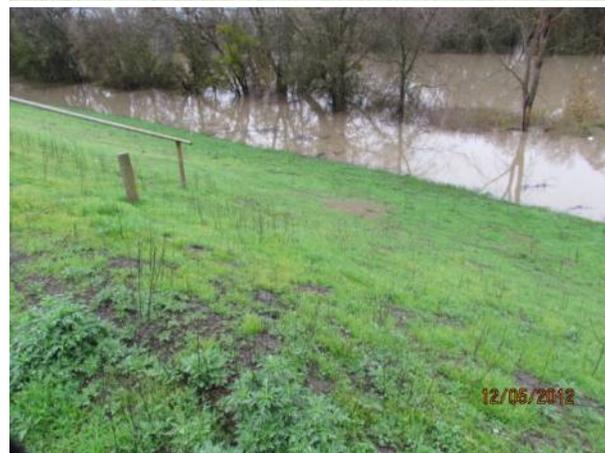
DWR ID: DWR_RD1660_02_s_2013_5			
5	5.07	5.07	Animal Control	WSA/W Ma	A3 : No rodents visible, but rodent burrows visible; need to backfill and compact or grout burrows.	39.102052 ° -121.774477 °	39.102052 ° -121.774477 °	6 Y	
						DWR ID: DWR_RD1660_02_s_2012_6			
6	6.48	6.48	Encroachments	WS M En	TR : Tree or limb	39.114934 ° -121.794431 °	39.114934 ° -121.794431 °	8 Y	
						DWR ID: DWR_RD1660_02_s_2013_8

Levee Mile Report Line	5
Start Levee Mile	5.07
End Levee Mile	5.07
Location	Water Side
Category	
Item	Animal Control
View of the repaired rodent hole on the waterside slope.	
rduffey_s_20130225_248.JPG

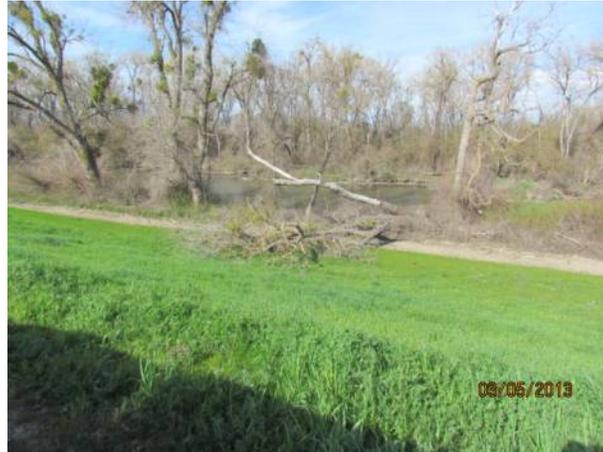
Levee Mile Report Line	6
Start Levee Mile	6.48
End Levee Mile	6.48
Location	Water Side
Category	
Item	Encroachments
View of the downed tree on the water side slope.	
rduffey_s_20130312_314.JPG
