**Flood Control Project Maintenance
Levee Inspections**
LMA District Cover Sheet
Spring 2015 Levee Inspection Results

Reclamation District No. 1660 Tisdale

Levee Inspection Report By Mile - Spring 2015

Waterway	Bank	Unit Miles	Inspection Start/End	Inspector
Unit No. 01 Sacramento River	Left	2.94	03/16/2015 03/16/2015	Bob Duffey

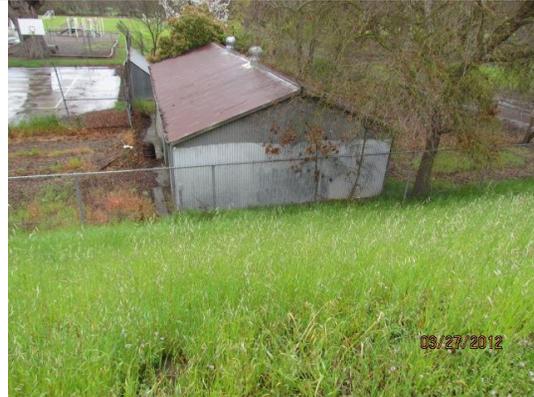
Photo 1 of 1 : SP_2015_RD1660_8_12_20150310_00005.jpg

LM Start	0.05	Rating **	M	Issue No.	12
LM End	0.05	Issue Type +	En	Location *	LS
Category	Earthen Levee			GPS Latitude/Longitude	
				Start	End
Item	Encroachments			39.062643 °	39.062643 °
				-121.837857 °	-121.837857 °
DWR ID	DWR_RD1660_01_s_2012_12				
Action/Comments					
Building

View of the building and fence at the landside toe.

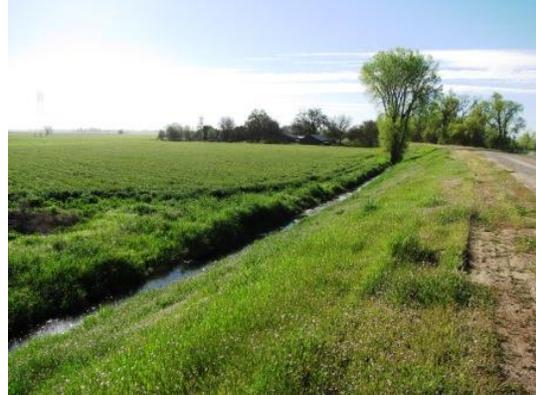
Photo 1 of 1 : SP_2015_RD1660_8_9_20150310_00004.jpg

LM Start	1.10	Rating **	M	Issue No.	9
LM End	1.40	Issue Type +	En	Location *	LS
Category	Earthen Levee			GPS Latitude/Longitude	
				Start	End
Item	Encroachments			39.047610 °	39.043622 °
				-121.838802 °	-121.836445 °
DWR ID	DWR_RD1660_01_s_2012_9				
Action/Comments					
Ditch

View of the ag ditch along the L/S toe.

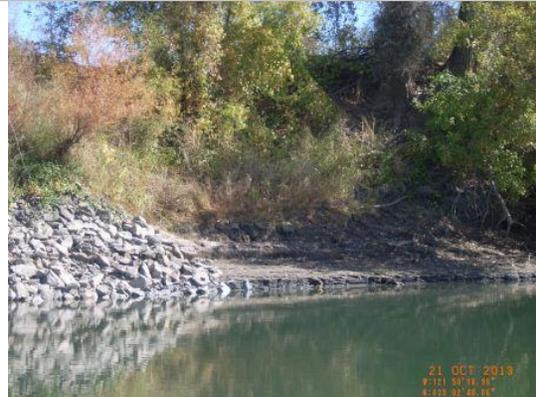
Photo 1 of 1 : SP_2015_RD1660_8_8_20150310_00003.jpg

LM Start	1.33	Rating **	M	Issue No.	8
LM End	1.36	Issue Type +	Ma	Location *	WS
Category	Supplemental			GPS Latitude/Longitude	
				Start	End
Item	USACE Erosion Survey			39.044361 °	39.043916 °
				-121.837654 °	-121.837305 °
DWR ID	DWR_RD1660_01_f_2014_8				
Action/Comments					
Inspector Comments: 2009 - Erosion on levee toe where an old cobble site is failing. 2011 - Some new minor erosion. 2012 - Site extended downstream, bank is being impacted from the weight of the trees. 2013: Minor new erosion at the toe. [2013 Site ID: SAC_120-6_L]

USACE 2013 Photo #1

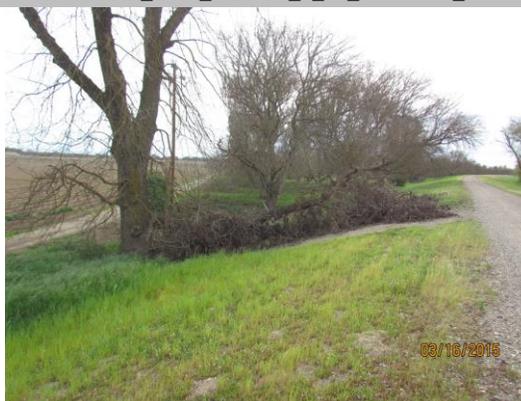
Photo 1 of 1 : SP_2015_RD1660_8_17_20150406_00010.jpg

LM Start	1.64	Rating **	M	Issue No.	17
LM End	1.64	Issue Type +	En	Location *	LS
Category	Earthen Levee			GPS Latitude/Longitude	
				Start	End
Item	Encroachments			39.041310 °	39.041310 °
				-121.833230 °	-121.833230 °
DWR ID	DWR_RD1660_01_s_2015_17				
Action/Comments					
Tree or limb Inspector Comments: Remove the tree from the landside slope.

View of the tree along the landside slope.

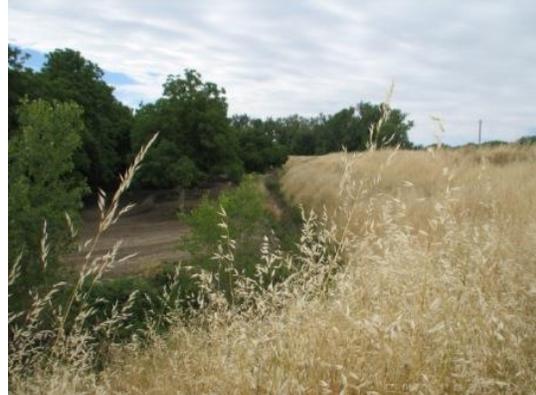
Photo 1 of 1 : SP_2015_RD1660_8_1_20150310_00001.jpg

LM Start	2.01	Rating **	M	Issue No.	1
LM End	2.34	Issue Type +	En	Location *	LS
Category	Earthen Levee		GPS Latitude/Longitude		
			Start	End	
Item	Encroachments		39.037640 °	39.034416 °	
			-121.828421 °	-121.825698 °	
DWR ID	DWR_RD1660_01_s_2012_1				
Action/Comments					
Ditch

View of the large ditch along the landside toe.

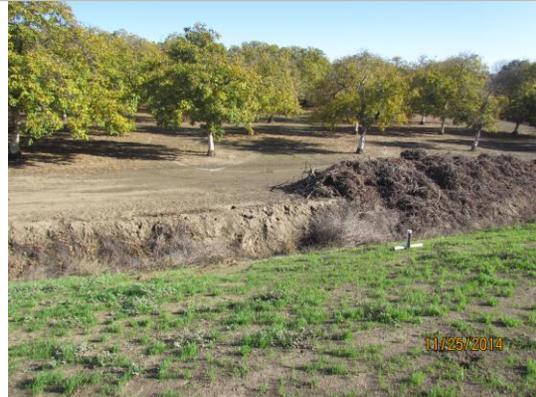
Photo 1 of 1 : SP_2015_RD1660_8_19_20150310_00006.jpg

LM Start	2.16	Rating **	A/W	Issue No.	19
LM End	2.16	Issue Type +	Ma	Location *	LS
Category	Earthen Levee		GPS Latitude/Longitude		
			Start	End	
Item	Animal Control		39.035420 °	39.035420 °	
			-121.828530 °	-121.828530 °	
DWR ID	DWR_RD1660_01_f_2014_19				
Action/Comments					
No rodents visible, but rodent burrows visible; need to backfill and compact or grout burrows.

View of the rodent holes and bait station.

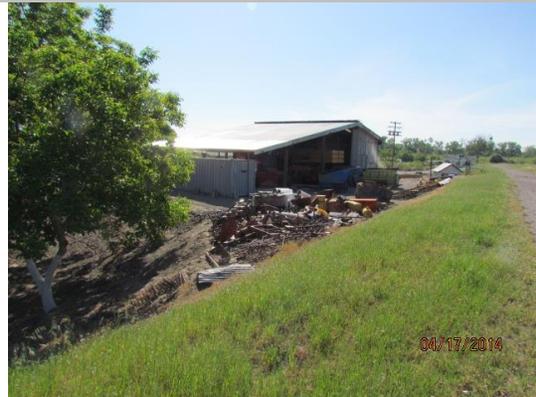
Photo 1 of 1 : SP_2015_RD1660_8_3_20150310_00002.jpg

LM Start	2.58	Rating **	M	Issue No.	3
LM End	2.58	Issue Type +	Ma	Location *	LS
Category	Earthen Levee		GPS Latitude/Longitude		
			Start	End	
Item	Encroachments		39.031405 °	39.031405 °	
			-121.823403 °	-121.823403 °	
DWR ID	DWR_RD1660_01_s_2012_3				
Action/Comments					
Equipment

View of equipment along the landside slope.

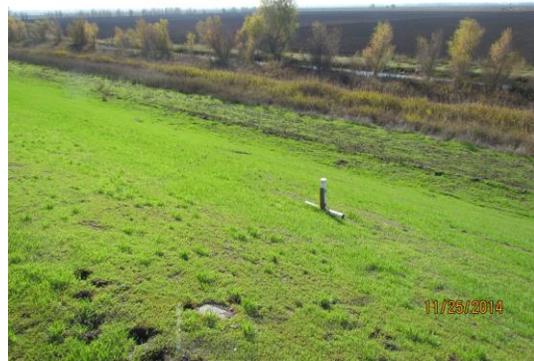
Photo 1 of 1 : SP_2015_RD1660_9_4_20150310_00001.jpg

LM Start	2.59	Rating **	A/W	Issue No.	4
LM End	2.59	Issue Type +	Ma	Location *	LS
Category	Earthen Levee			GPS Latitude/Longitude	
				Start	End
Item	Animal Control			39.068627 °	39.068627 °
				-121.758247 °	-121.758247 °
DWR ID	DWR_RD1660_02_f_2014_4				
Action/Comments					
No rodents visible, but rodent burrows visible; need to backfill and compact or grout burrows.

View of the rodent holes and bait station along the landside slope.

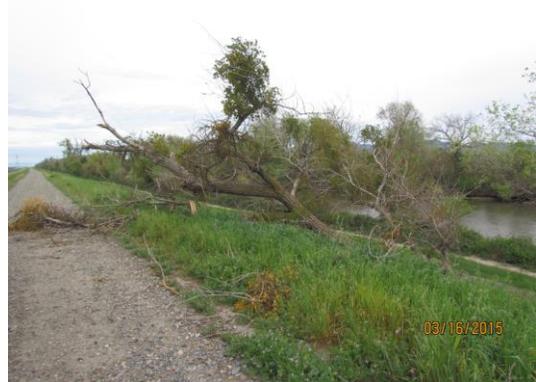
Photo 1 of 1 : SP_2015_RD1660_9_5_20150406_00003.jpg

LM Start	6.01	Rating **	M	Issue No.	5
LM End	6.01	Issue Type +	En	Location *	WS
Category	Earthen Levee		GPS Latitude/Longitude		
			Start	End	
Item	Encroachments		39.111145 °	39.111145 °	
			-121.787588 °	-121.787588 °	
DWR ID	DWR_RD1660_02_s_2015_5				
Action/Comments					
Tree or limb Inspector Comments: Remove the tree from the waterside slope.

View of the tree along the waterside slope.

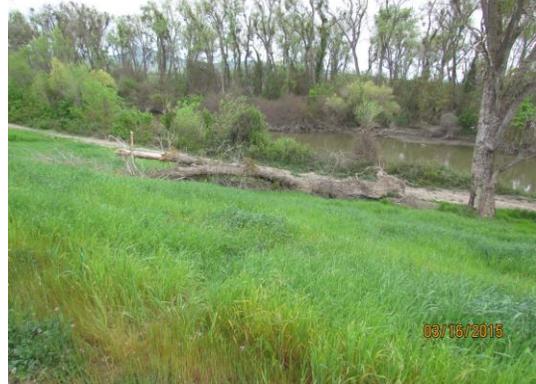
Photo 1 of 1 : SP_2015_RD1660_9_6_20150406_00004.jpg

LM Start	6.54	Rating **	M	Issue No.	6
LM End	6.54	Issue Type +	En	Location *	WS
Category	Earthen Levee		GPS Latitude/Longitude		
			Start	End	
Item	Encroachments		39.115590 °	39.115590 °	
			-121.795577 °	-121.795577 °	
DWR ID	DWR_RD1660_02_s_2015_6				
Action/Comments					
Tree or limb Inspector Comments: Remove the tree from the waterside slope.

View of the tree on the waterside slope.

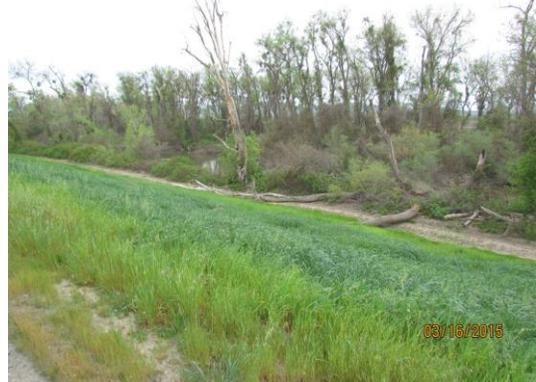
Photo 1 of 1 : SP_2015_RD1660_9_7_20150406_00005.jpg

LM Start	6.78	Rating **	M	Issue No.	7
LM End	6.78	Issue Type +	En	Location *	WS
Category	Earthen Levee		GPS Latitude/Longitude		
			Start	End	
Item	Encroachments		39.117640 °	39.117640 °	
			-121.799242 °	-121.799242 °	
DWR ID	DWR_RD1660_02_s_2015_7				
Action/Comments					
Tree or limb Inspector Comments: Remove the tree from the waterside slope.

View of the tree on the waterside slope.
