**Flood Control Project Maintenance
Levee Inspections**

Maintenance Issue Types Only, Levee Inspection Report By Mile - Spring 2015

Reclamation District No. 1660 Tisdale

Waterway	Bank	Unit Miles	Inspection Start/End	Inspector
Unit No. 01 Sacramento River	Left	2.94	03/16/2015 03/16/2015	Bob Duffey

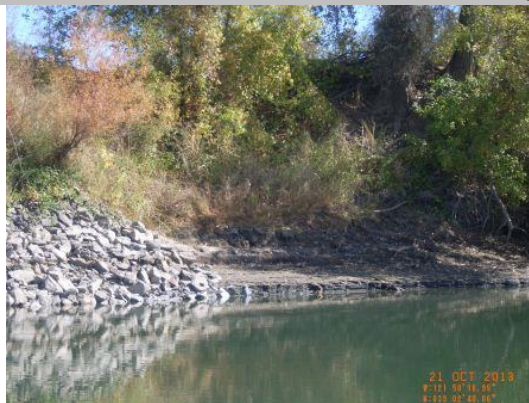
Photo 1 of 1 : SP_2015_RD1660_8_8_20150310_00003.jpg

LM Start	1.33	Rating **	M	Issue No.	8
LM End	1.36	Issue Type +	Ma	Location *	WS
Category	Supplemental			GPS Latitude/Longitude	
				Start	End
Item	USACE Erosion Survey			39.044361 °	39.043916 °
				-121.837654 °	-121.837305 °
DWR ID	DWR_RD1660_01_f_2014_8				
Action/Comments					
Inspector Comments: 2009 - Erosion on levee toe where an old cobble site is failing. 2011 - Some new minor erosion. 2012 - Site extended downstream, bank is being impacted from the weight of the trees. 2013: Minor new erosion at the toe. [2013 Site ID: SAC_120-6_L]

USACE 2013 Photo #1

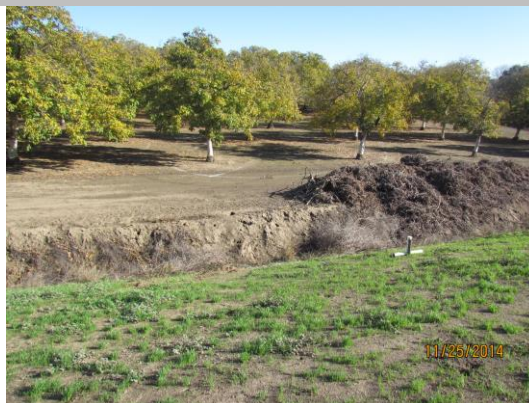
Photo 1 of 1 : SP_2015_RD1660_8_19_20150310_00006.jpg

LM Start	2.16	Rating **	A/W	Issue No.	19
LM End	2.16	Issue Type +	Ma	Location *	LS
Category	Earthen Levee			GPS Latitude/Longitude	
				Start	End
Item	Animal Control			39.035420 °	39.035420 °
				-121.828530 °	-121.828530 °
DWR ID	DWR_RD1660_01_f_2014_19				
Action/Comments					
No rodents visible, but rodent burrows visible; need to backfill and compact or grout burrows.

View of the rodent holes and bait station.

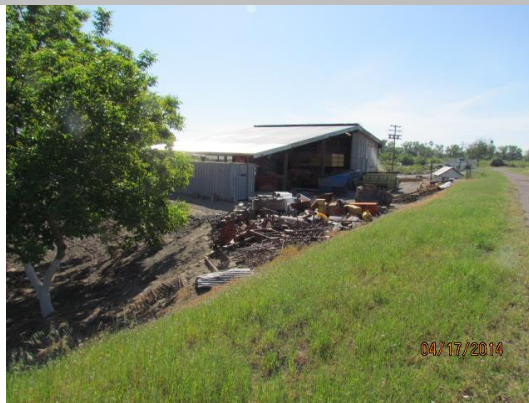
Photo 1 of 1 : SP_2015_RD1660_8_3_20150310_00002.jpg

LM Start	2.58	Rating **	M	Issue No.	3
LM End	2.58	Issue Type +	Ma	Location *	LS
Category	Earthen Levee			GPS Latitude/Longitude	
				Start	End
Item	Encroachments			39.031405 °	39.031405 °
				-121.823403 °	-121.823403 °
DWR ID	DWR_RD1660_01_s _ 2012_3				
Action/Comments					
Equipment

View of equipment along the landside slope.

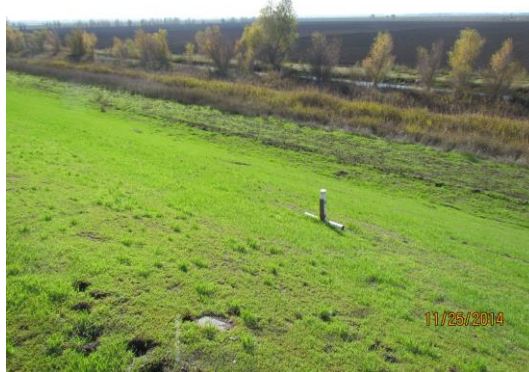
Photo 1 of 1 : SP_2015_RD1660_9_4_20150310_00001.jpg

LM Start	2.59	Rating **	A/W	Issue No.	4
LM End	2.59	Issue Type +	Ma	Location *	LS
Category	Earthen Levee			GPS Latitude/Longitude	
				Start	End
Item	Animal Control			39.068627 °	39.068627 °
				-121.758247 °	-121.758247 °
DWR ID	DWR_RD1660_02_f_2014_4				
Action/Comments					
No rodents visible, but rodent burrows visible; need to backfill and compact or grout burrows.

View of the rodent holes and bait station along the landside slope.
