**Flood Control Project Maintenance
Levee Inspections**

Maintenance Issue Types Only, Levee Inspection Report By Mile - Spring 2016

Reclamation District No. 1660 Tisdale

Waterway	Bank	Unit Miles	Inspection Start/End	Inspector
Unit No. 01 Sacramento River	Left	2.94	03/29/2016 03/29/2016	Keith Millard

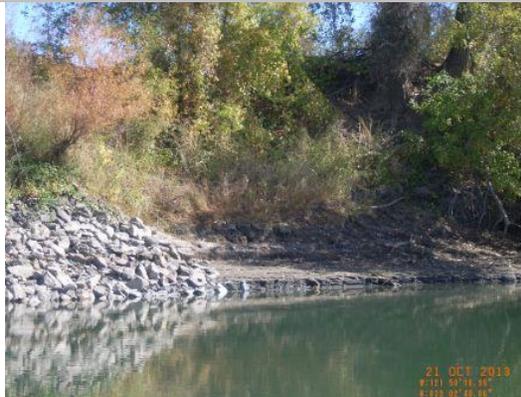
Photo 1 of 1 : SP_2016_RD1660_8_8_20160316_00003.jpg

LM Start	1.33	Rating **	M	Issue No.	8
LM End	1.36	Issue Type +	Ma	Location *	WS
Category	Supplemental			GPS Latitude/Longitude	
				Start	End
Item	2015 USACE Erosion Survey, DRAFT			39.044361 °	39.043916 °
				-121.837654 °	-121.837305 °
DWR ID	DWR_RD1660_01_s_2016_8				
Comment Code					
Inspector Comment					
2009 - Erosion on levee toe where an old cobble site is failing. 2011 - Some new minor erosion. 2012 - Site extended downstream, bank is being impacted from the weight of the trees. 2013 - Minor new erosion at the toe. 2015: Minor new erosion at the toe. [2015 Site ID: SAC_120-6_L]

USACE 2013 Photo #1

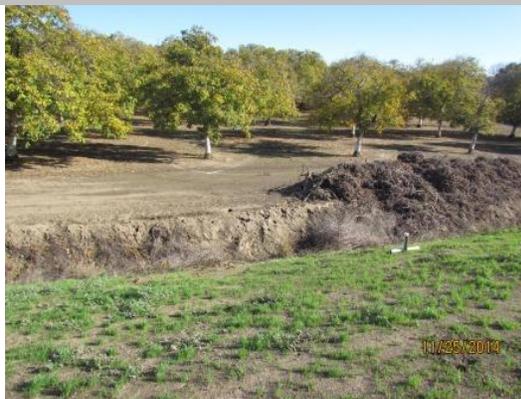
Photo 1 of 1 : SP_2016_RD1660_8_19_20160316_00006.jpg

LM Start	2.16	Rating **	M	Issue No.	19
LM End	2.16	Issue Type +	Ma	Location *	LS
Category	Earthen Levee			GPS Latitude/Longitude	
				Start	End
Item	Animal Control			39.035420 °	39.035420 °
				-121.828530 °	-121.828530 °
DWR ID	DWR_RD1660_01_f_2014_19				
Comment Code					
A3 : No rodents visible, but rodent burrows visible; need to backfill and compact or grout burrows.					
Inspector Comment					
Repair the rodent holes on the landside slope.

View of the rodent holes and bait station.

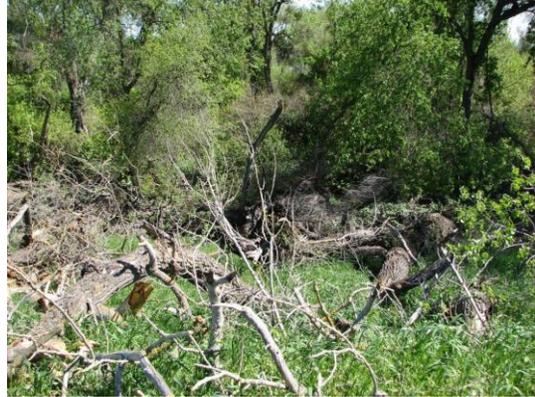
Photo 1 of 1 : SP_2016_RD1660_9_4_20160405_00004.jpg

LM Start	4.53	Rating **	U	Issue No.	4
LM End	4.53	Issue Type +	Ma	Location *	WS
Category	Earthen Levee		GPS Latitude/Longitude		
			Start	End	
Item	Vegetation		39.095324 °	39.095324 °	
			-121.769581 °	-121.769581 °	
DWR ID	DWR_RD1660_02_s_2016_4				
Comment Code					
V7 : Trees / Woody Vegetation					
Inspector Comment					
Remove two large fallen Cottonwood trees on w/s slope from toe to crown.

Downed trees obstructing access
