**Flood Control Project Maintenance  
Levee Inspections**

## Maintenance Issue Types Only, Levee Inspection Report By Mile - Spring 2017

### Reclamation District No. 1660 Tisdale

Waterway	Bank	Unit Miles	Inspection Start/End	Inspector
Unit No. 01 Sacramento River	Left	2.94	04/06/2017 04/06/2017	Bob Duffey

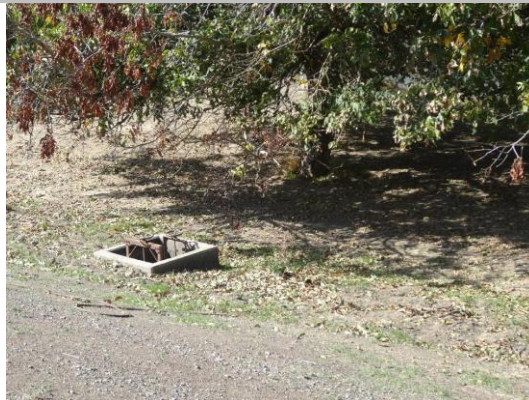
Photo 1 of 3 : UCIP\_SP\_2017\_46670\_38107.jpg

LM Start	0.14	Rating **	M	Issue No.	21
LM End	0.14	Issue Type +	Ma	Location *	LS
Category	Supplemental		GPS Latitude/Longitude		
			Start	End	
Item	DWR UCIP LMA Responsibility		39.061322 °	39.061322 °	
			-121.837993 °	-121.837993 °	
DWR ID					
Comment Code					
Inspector Comment					
FS_ID:46670 DS_ID:22489 EP_NO: N/A Repair Type: Non-Urgent Crossing Status: Found UCIP Comments: - needs proper abandonment.- opening of landside pipe almost buried. FIELD_STRUCT_DESC: *ABANDONED* 24-inch pipe thru levee, 16.4 FBC. Slide gate in concrete well at toe of WW slope. (IV A-Winship). USACE bench mark on top of headwall at LS toe. O&M Manual SAC 133, August 1955. FS Date: 10/10/2013

WS view: concrete box on levee slope. No pipe found on berm and river bank.

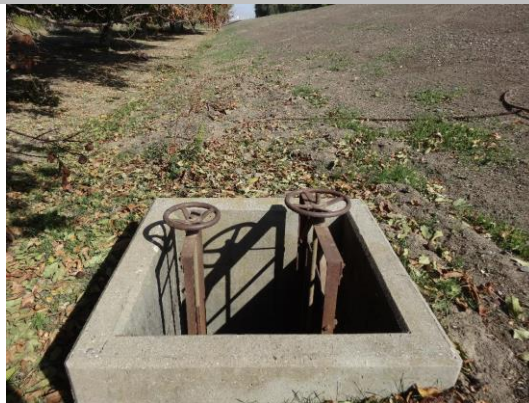
Photo 2 of 3 : UCIP\_SP\_2017\_46670\_38106.jpg

LM Start	0.14	Rating **	M	Issue No.	21 (cont)	
LM End	0.14	Issue Type +	Ma	Location *	LS	
Category	Supplemental			GPS Latitude/Longitude		
				Start	End	
Item	DWR UCIP LMA Responsibility			39.061322 °	39.061322 °	
				-121.837993 °	-121.837993 °	
DWR ID						
Comment Code						
Inspector Comment						
FS_ID:46670						
DS_ID:22489						
EP_NO: N/A						
Repair Type: Non-Urgent						
Crossing Status: Found						
UCIP Comments: - needs proper abandonment.- opening of landside pipe almost burried.						
FIELD_STRUCT_DESC: *ABANDONED* 24-inch pipe thru levee, 16.4						
FBC. Slide gate in concrete well at toe of WW slope. (IV A-Winship).						
USACE bench mark on top of headwall at LS toe. O&M Manual SAC						
133, August 1955.						
FS Date: 10/10/2013

WS view: two slide gates in concrete box on levee slope.

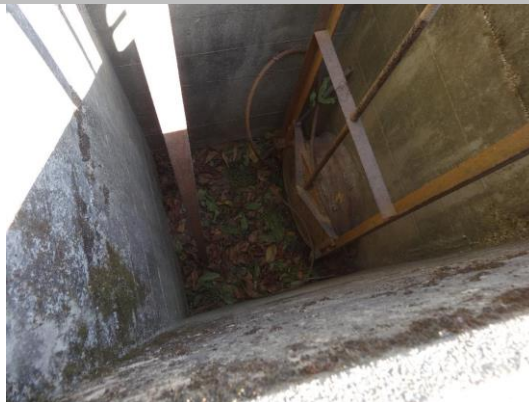
Photo 3 of 3 : UCIP\_SP\_2017\_46670\_38105.jpg

WS view: closer view of two slide gates in concrete box on levee slope.

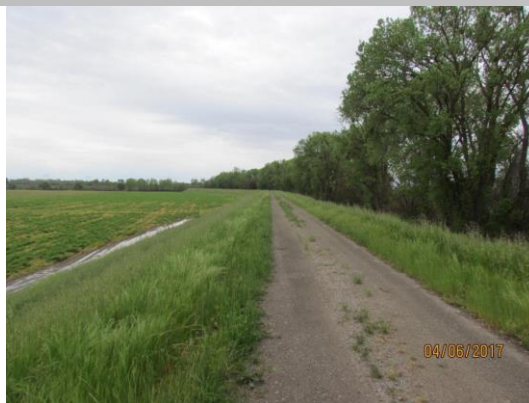
Photo 1 of 1 : SP\_2017\_RD1660\_8\_19\_20170410\_00017.jpg

LM Start	0.61	Rating **	A	Issue No.	19
LM End	0.61	Issue Type +	Ma	Location *	LS
Category	Earthen Levee			GPS Latitude/Longitude	
				Start	End
Item	Vegetation			39.054537 °	39.054537 °
				-121.839288 °	-121.839288 °
DWR ID	DWR_RD1660_01_s_2017_19				
Comment Code					
V1 : Control annual grass and weeds on the levee slopes and easements.					
Inspector Comment					
There are native grasses on both slopes.

View of the native grasses on both slopes.

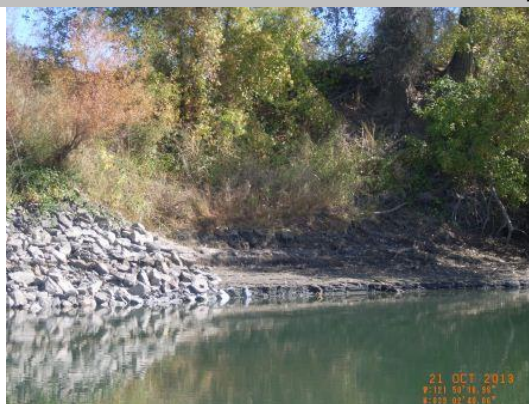
Photo 1 of 1 : SP\_2017\_RD1660\_8\_8\_20170315\_00004.jpg

LM Start	1.33	Rating **	M	Issue No.	8
LM End	1.36	Issue Type +	Ma	Location *	WS
Category	Supplemental			GPS Latitude/Longitude	
				Start	End
Item	2015 USACE Erosion Survey, DRAFT			39.044361 °	39.043916 °
				-121.837654 °	-121.837305 °
DWR ID	DWR_RD1660_01_s_2016_8				
Comment Code					
Inspector Comment					
2009 - Erosion on levee toe where an old cobble site is failing. 2011 - Some new minor erosion. 2012 - Site extended downstream, bank is being impacted from the weight of the trees. 2013 - Minor new erosion at the toe. 2015: Minor new erosion at the toe. [2015 Site ID: SAC_120-6_L]

USACE 2013 Photo #1

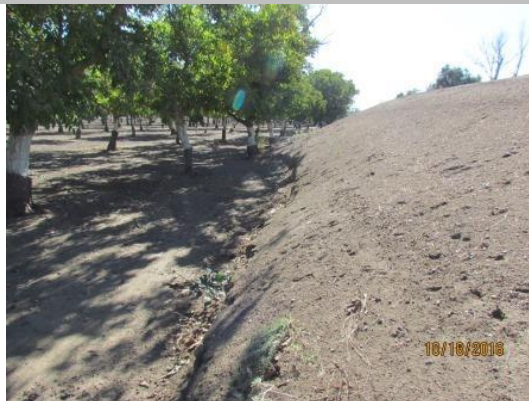
Photo 1 of 1 : SP\_2017\_RD1660\_8\_2\_20170315\_00002.jpg

LM Start	2.37	Rating **	M	Issue No.	2
LM End	2.37	Issue Type +	Ma	Location *	LS
Category	Earthen Levee			GPS Latitude/Longitude	
				Start	End
Item	Slope Stability			39.034107 °	39.034107 °
				-121.825152 °	-121.825152 °
DWR ID	DWR_RD1660_01_s_2012_2				
Comment Code					
S1 : Repair slope instability.					
Inspector Comment

View of the toe cut by the farmer on the landside.

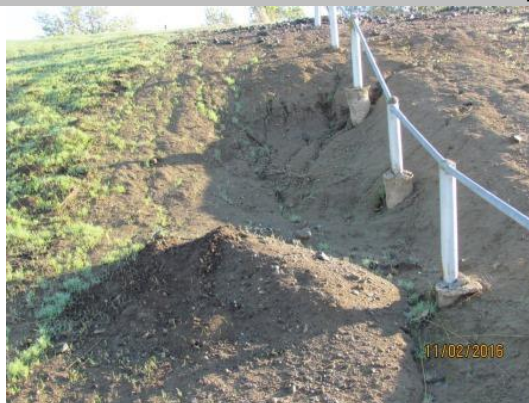
Photo 1 of 2 : SP\_2017\_RD1660\_9\_6\_20170315\_00002.jpg

LM Start	0.00	Rating **	M	Issue No.	6
LM End	0.00	Issue Type +	Ma	Location *	LS
Category	Earthen Levee			GPS Latitude/Longitude	
				Start	End
Item	Slope Stability			39.032910 °	39.032910 °
				-121.743665 °	-121.743665 °
DWR ID	DWR_RD1660_02_f_2016_6				
Comment Code					
S1 : Repair slope instability.					
Inspector Comment

View of the slope instability looking from the landside toe.

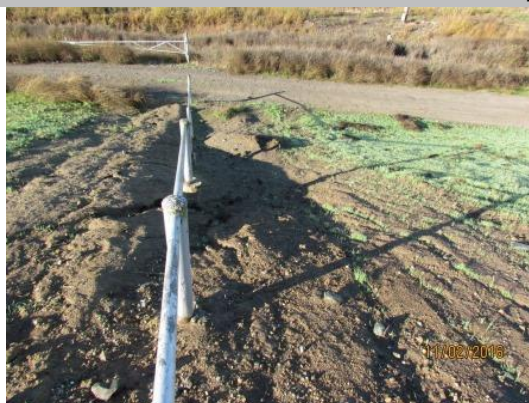
Photo 2 of 2 : SP\_2017\_RD1660\_9\_6\_20170315\_00003.jpg

Another view of the slope instability looking from the levee crown.

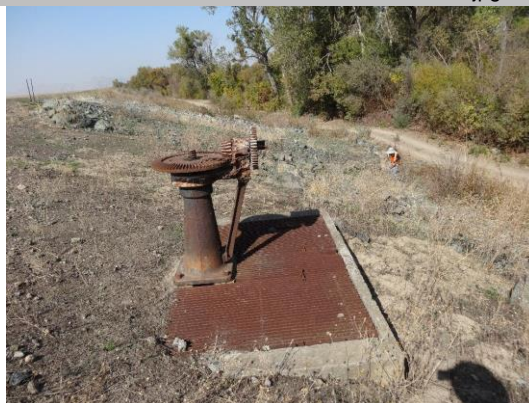
Photo 1 of 3 : UCIP\_SP\_2017\_22663\_38248.jpg

FS\_ID:22663  
DS\_ID:22495  
EP\_NO: 10020  
Repair Type: No Action Needed  
Crossing Status: Found  
UCIP Comments: - pipe/opening not visible as it was submerged into water on both sides.- it seems that 36-inch concrete pipe through the levee. It needs confirmation from LMA/DWR Inspector.- USED bench mark on landside concrete vault.  
FIELD\_STRUCT\_DESC: 4 by 7 foot concrete outfall structure through levee, 34 feet below crown. Slide gate in 4 ft. by 8 ft. concrete riser on waterside slope. (App. 10020-Bandoni). O&M Manual SAC 133, August 1955.  
FS Date: 10/10/2013

WS view: 4 ft. by 8 ft. concrete box with slide gate on levee slope. USED bench mark on top of the box.

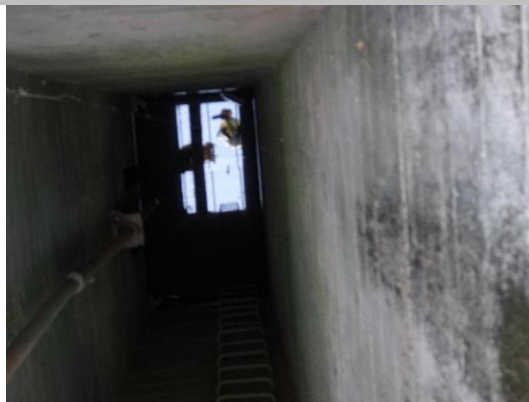
Photo 2 of 3 : UCIP\_SP\_2017\_22663\_38247.jpg

WS view: inside view of concrete box on levee slope. Slide gate in concrete box.

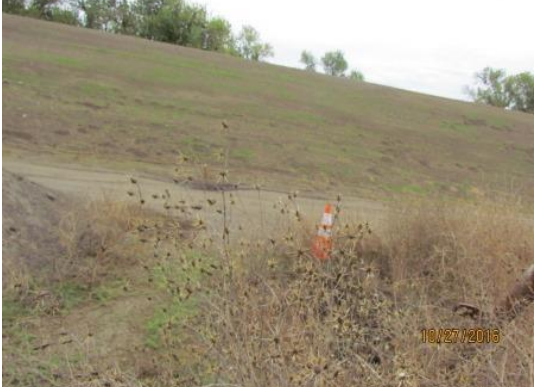
Photo 1 of 2 : SP\_2017\_RD1660\_9\_8\_20170315\_00004.jpg

View of the levee from the landside toe. Beaver hole is where the reflective traffic cone is.

LM Start	0.04	Rating **	A/W	Issue No.	8 (cont)	
LM End	0.04	Issue Type +	Ma	Location *	LS	
Category	Earthen Levee			GPS Latitude/Longitude		
				Start		End
Item	Slope Stability			39.033502 °		39.033502 °
				-121.743665 °		-121.743665 °
DWR ID	DWR_RD1660_02_f_2016_8					
Comment Code						
S1 : Repair slope instability.						
Inspector Comment						
Repair the site before flood season.

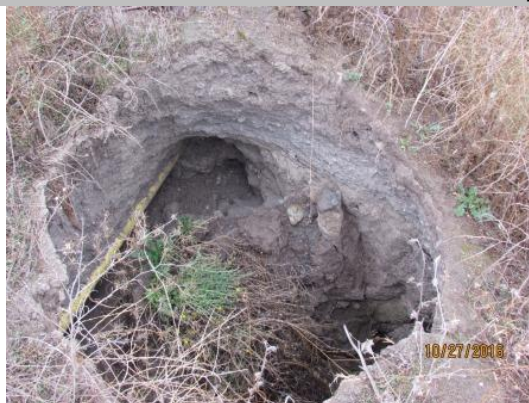
Photo 2 of 2 : SP\_2017\_RD1660\_9\_8\_20170315\_00005.jpg

View of a beaver hole along the toe road outside of the levee easement.

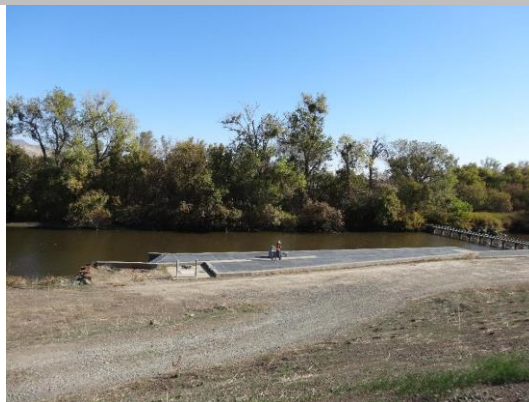
Photo 1 of 3 : UCIP\_SP\_2017\_22708\_38406.jpg

LM Start	9.07	Rating **	A/W	Issue No.	22
LM End	9.07	Issue Type +	Ma	Location *	LS
Category	Supplemental			GPS Latitude/Longitude	
				Start	End
Item	DWR UCIP LMA Responsibility			39.136861 °	39.136861 °
				-121.833974 °	-121.833974 °
DWR ID					
Comment Code					
Inspector Comment					
FS_ID:22708					
DS_ID:22505					
EP_NO: N/A					
Repair Type: No Action Needed					
Crossing Status: Found					
UCIP Comments: - inlet structure 160 ft off the levee center on landside drainage ditch.					
FIELD_STRUCT_DESC: 48-inch steel pipe through the levee, 29.0 feet below the crown. Slide gate and concrete bulkhead on channel bank.					
Staff gage on the waterward berm. ABO# 10021. O&M Manual SAC 133, August 1955.					
FS Date: 10/15/2013

WS view: overview of concrete box on channel bank. It looks like a fish ladder. Pipe discharges into this box.

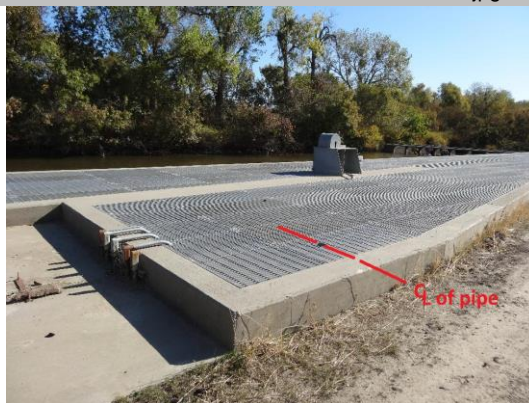
Photo 2 of 3 : UCIP\_SP\_2017\_22708\_38405.jpg

WS view: concrete box on channel bank. Pipe end with slide gate. Pipe discharges into this box.

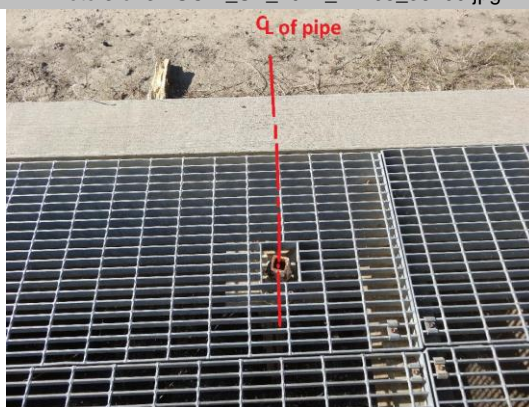
Photo 3 of 3 : UCIP\_SP\_2017\_22708\_38409.jpg

WS view: concrete box on channel bank. Pipe discharges into this box. A slide gate inside this box.
