**Flood Control Project Maintenance
Levee Inspections**

Maintenance Issue Types Only, Levee Inspection Report By Mile - Spring 2018

Reclamation District No. 1660 Tisdale

Waterway	Bank	Unit Miles	Inspection Start/End	Inspector
Unit No. 01 Sacramento River	Left	2.94	03/15/2018 03/15/2018	Bob Duffey

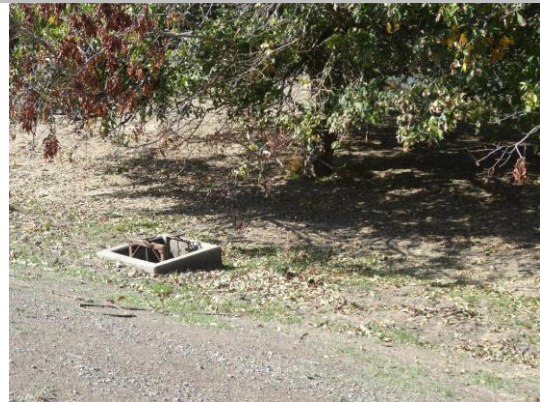
Photo 1 of 3 : UCIP_SP_2018_46670_38107.jpg

LM Start	0.14	Rating **	M	Issue No.	21
LM End	0.14	Issue Type +	Ma	Location *	
Category	Supplemental		GPS Latitude/Longitude		
			Start	End	
Item	DWR UCIP LMA Responsibility		39.061322 °	39.061322 °	
			-121.837993 °	-121.837993 °	
DWR ID					
Comment Code					
Inspector Comment					
FS_ID:46670 DS_ID:22489 EP_NO: N/A Repair Type: Non-Urgent Crossing Status: Found UCIP Comments: - needs proper abandonment.- opening of landside pipe almost buried. FIELD_STRUCT_DESC: *ABANDONED* 24-inch corrugated metal gravity drainage pipe through the levee, 16.4 feet below the crown. Two corrugated metal cutoff walls. Slide gate in a concrete well at the waterside (WS) toe. (IV A-Winship). USACE bench mark on the top of the headwall at the landside (LS) toe. [Additional Reference(s): DWR Levee Log, 2005. USACE Sacramento O&M Manual 133, August 1955, (Station 2+07.8)]. FS Date: 10/10/2013

WS view: concrete box on levee slope. No pipe found on berm and river bank.

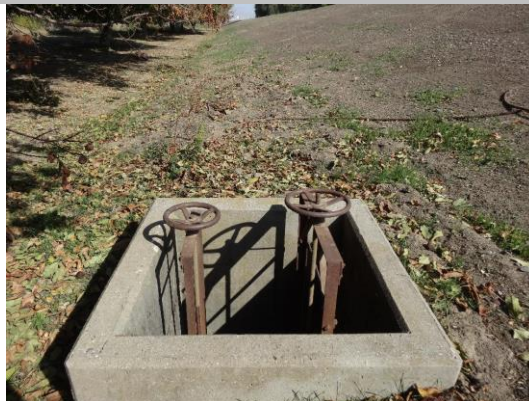
Photo 2 of 3 : UCIP_SP_2018_46670_38106.jpg

FS_ID:46670
DS_ID:22489
EP_NO: N/A
Repair Type: Non-Urgent
Crossing Status: Found
UCIP Comments: - needs proper abandonment.- opening of landside pipe almost buried.
FIELD_STRUCT_DESC: *ABANDONED* 24-inch corrugated metal gravity drainage pipe through the levee, 16.4 feet below the crown. Two corrugated metal cutoff walls. Slide gate in a concrete well at the waterside (WS) toe. (IV A-Winship). USACE bench mark on the top of the headwall at the landside (LS) toe. [Additional Reference(s): DWR Levee Log, 2005. USACE Sacramento O&M Manual 133, August 1955, (Station 2+07.8)].
FS Date: 10/10/2013

WS view: two slide gates in concrete box on levee slope.

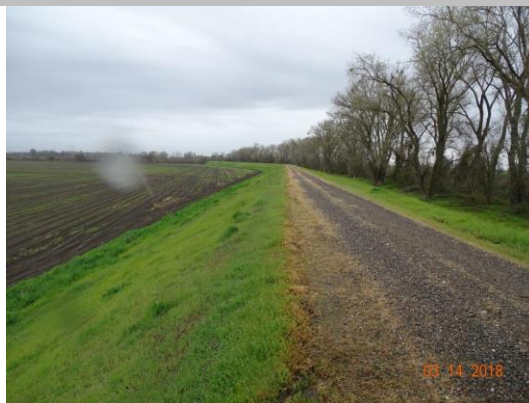
Photo 1 of 1 : SP_2018_RD1660_8_19_20180402_00017.jpg

LM Start	0.59	Rating **	A	Issue No.	19
LM End	0.59	Issue Type +	Ma	Location *	LS
Category	Earthen Levee			GPS Latitude/Longitude	
				Start	End
Item	Vegetation			39.054918 °	39.054918 °
				-121.839208 °	-121.839208 °
DWR ID	DWR_RD1660_01_s_2018_19				
Comment Code					
V1 : Control annual grass and weeds on the levee slopes and easements.					
Inspector Comment					
Native grasses on both slopes are adequately maintained.

View of the native grasses on both slopes.

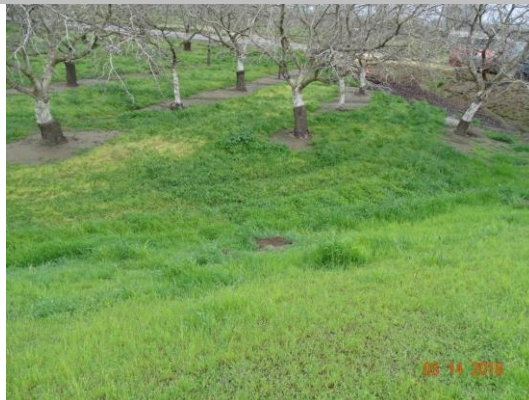
Photo 1 of 1 : SP_2018_RD1660_8_20_20180402_00018.jpg

LM Start	2.57	Rating **	M	Issue No.	20
LM End	2.57	Issue Type +	Ma	Location *	LS
Category	Earthen Levee			GPS Latitude/Longitude	
				Start	End
Item	Animal Control			39.031625 °	39.031625 °
				-121.823492 °	-121.823492 °
DWR ID	DWR_RD1660_01_s_2018_20				
Comment Code					
A3 : No rodents visible, but rodent burrows visible; need to backfill and compact or grout burrows.					
Inspector Comment					
Repair the rodent holes along the landside slope.

View of the rodent holes along the landside slope.

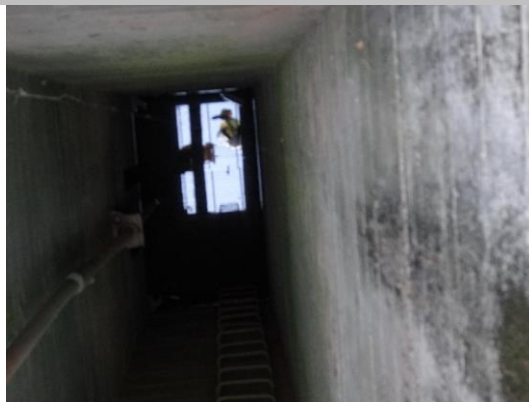
Photo 2 of 3 : UCIP_SP_2018_22663_38247.jpg

WS view: inside view of concrete box on levee slope. Slide gate in concrete box.

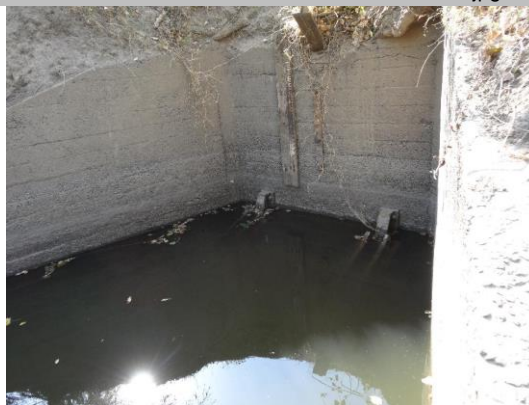
Photo 3 of 3 : UCIP_SP_2018_22663_38246.jpg

WS view: closer view of U shaped concrete headwall in bypass channel.
Pipe not visible.

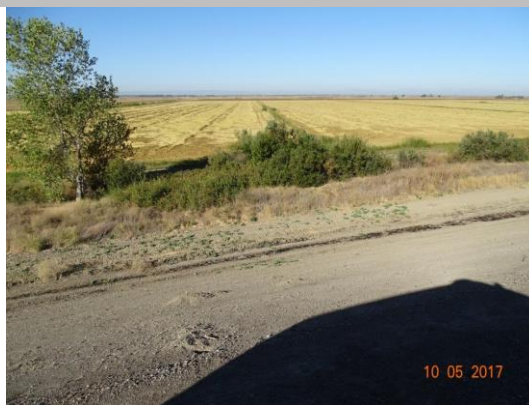
Photo 1 of 1 : SP_2018_RD1660_9_23_20180305_00011.jpg

LM Start	1.43	Rating **	M	Issue No.	23							
LM End	1.43	Issue Type +	Ma	Location *	LS							
Category	Earthen Levee		GPS Latitude/Longitude									
			Start	End								
Item	Animal Control		39.052687 °	39.052687 °								
			-121.751720 °	-121.751720 °								
DWR ID	DWR_RD1660_02_f_2017_23											
Comment Code												
A3 : No rodents visible, but rodent burrows visible; need to backfill and compact or grout burrows.												
Inspector Comment												
Repair the rodent holes on the landside slope.

View of the rodent holes along the landside slope.

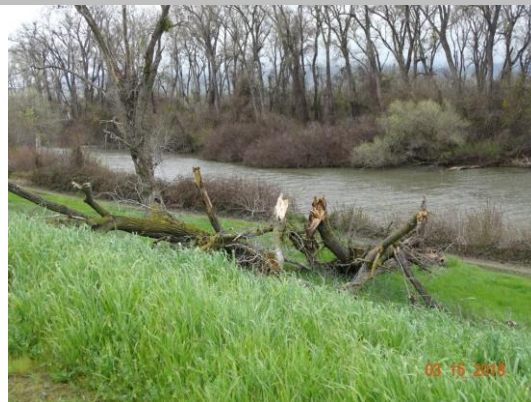
Photo 1 of 1 : SP_2018_RD1660_9_7_20180402_00024.jpg

LM Start	6.51	Rating **	M	Issue No.	7
LM End	6.51	Issue Type +	Ma	Location *	WS
Category	Earthen Levee			GPS Latitude/Longitude	
				Start	End
Item	Encroachments			39.115398°	39.115398°
				-121.795265°	-121.795265°
DWR ID	DWR_RD1660_02_s_2018_7				
Comment Code					
TR : Tree or limb					
Inspector Comment					
Remove the tree from the waterside toe.

View of the tree along the waterside toe.

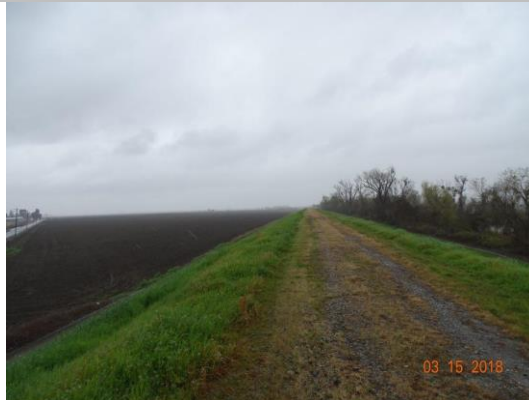
Photo 1 of 1 : SP_2018_RD1660_9_8_20180402_00026.jpg

LM Start	8.04	Rating **	A	Issue No.	8
LM End	8.04	Issue Type +	Ma	Location *	LS
Category	Earthen Levee			GPS Latitude/Longitude	
				Start	End
Item	Vegetation			39.128257 °	39.128257 °
				-121.818465 °	-121.818465 °
DWR ID	DWR_RD1660_02_s_2018_8				
Comment Code					
V1 : Control annual grass and weeds on the levee slopes and easements.					
Inspector Comment					
Native grasses on both slopes should continue to be managed.

View of the native grasses on both slopes.

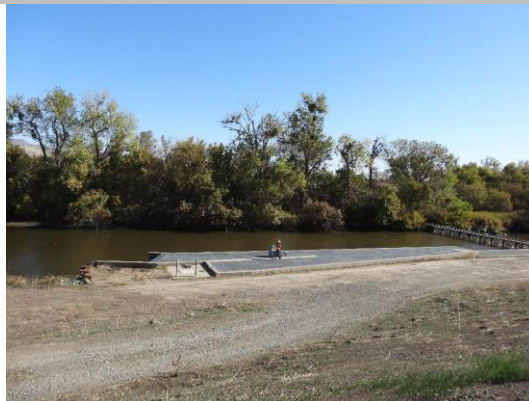
Photo 1 of 3 : UCIP_SP_2018_22708_38406.jpg

FS_ID:22708
DS_ID:22505
EP_NO: N/A
Repair Type: No Action Needed
Crossing Status: Found
UCIP Comments: - inlet structure 160 ft off the levee center on landside drainage ditch.
FIELD_STRUCT_DESC: 48-inch steel gravity drainage pipe through the levee, 29 feet below the crown. Slide gate and concrete bulkhead on the riverbank. Staff gage on the waterside (WS) berm. (Retention of a 48-inch corrugated metal pipe (CMP) through the levee, 29 feet below the crown, a slide gate, and a concrete bulkhead authorized under Automatic Board Order (ABO) No. 10021, 1974 - Butte Slough Irrigation Company, care of Tarke Warehouse). [Additional Reference(s): DWR Levee Log, 2005. USACE Sacramento O&M Manual 133, August 1955, (Station 433+43), 48-inch CMP referenced].
FS Date: 10/15/2013

WS view: overview of concrete box on channel bank. It looks like a fish ladder. Pipe discharges into this box.

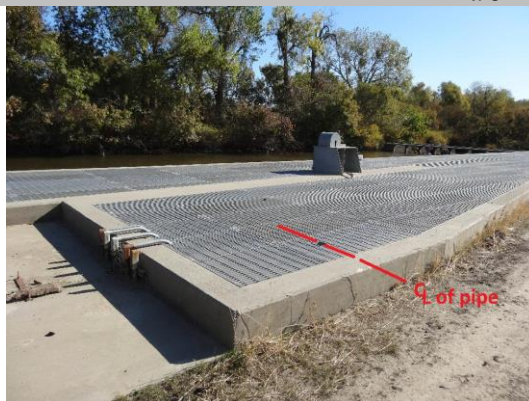
Photo 2 of 3 : UCIP_SP_2018_22708_38405.jpg

WS view: concrete box on channel bank. Pipe end with slide gate. Pipe discharges into this box.

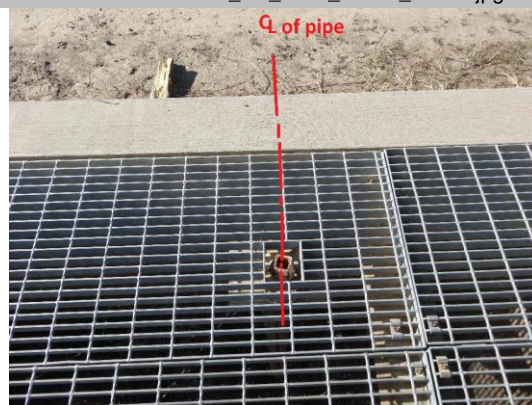
Photo 3 of 3 : UCIP_SP_2018_22708_38409.jpg

WS view: concrete box on channel bank. Pipe discharges into this box.
A slide gate inside this box.
