**Flood Control Project Maintenance
Levee Inspections**

Maintenance Issue Types Only, Levee Inspection Report By Mile - Spring 2019

Reclamation District No. 1660 Tisdale

Waterway	Bank	Unit Miles	Inspection Start/End	Inspector
Unit No. 01 Sacramento River	Left	2.94	04/03/2019 04/03/2019	Makar Sokol

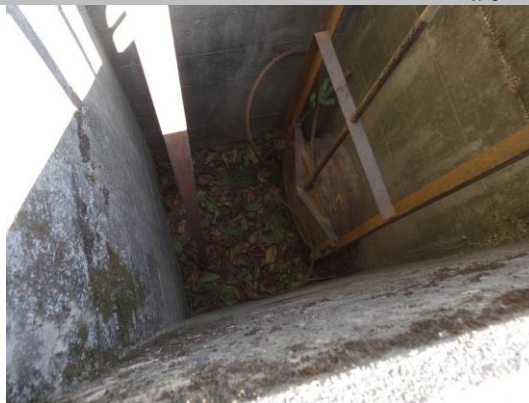
Photo 3 of 3 : UCIP_SP_2019_46670_38105.jpg

WS view: closer view of two slide gates in concrete box on levee slope.

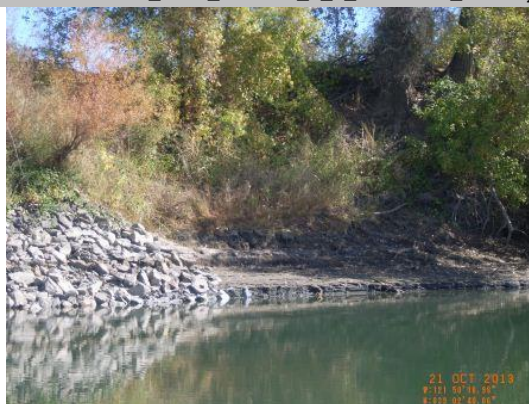
Photo 1 of 1 : SP_2019_RD1660_8_8_20190326_00004.jpg

LM Start	1.33	Rating **	M	Issue No.	8
LM End	1.36	Issue Type +	Ma	Location *	WS
Category	Supplemental			GPS Latitude/Longitude	
				Start	End
Item	2017 USACE Erosion Survey, DRAFT			39.044361 °	39.043916 °
				-121.837654 °	-121.837305 °
DWR ID	DWR_RD1660_01_f_2018_8				
Comment Code					
Inspector Comment					
2017 Site ID: SAC 120.6 L					
Status: Eroding					
2017 Field Notes: No observed change.					
Site History: 2009 - Erosion on levee toe where an old cobble site is failing. 2011 - Some new minor erosion. 2012 - Site extended downstream, bank is being impacted from the weight of the trees. 2013 - Minor new erosion at the toe. 2015 - Minor new erosion at toe.

USACE 2013 Photo #1

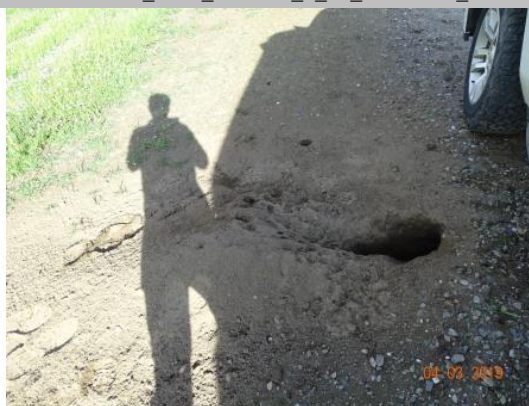
Photo 1 of 1 : SP_2019_RD1660_8_23_20190408_00020.jpg

LM Start	2.36	Rating **	U	Issue No.	23
LM End	2.36	Issue Type +	Ma	Location *	WS
Category	Earthen Levee			GPS Latitude/Longitude	
				Start	End
Item	Animal Control			39.034209 °	39.034209 °
				-121.825316 °	-121.825316 °
DWR ID	DWR_RD1660_01_s_2019_23				
Comment Code					
A3 : No rodents visible, but rodent burrows visible; need to backfill and compact or grout burrows.					
Inspector Comment

View of a large rodent burrow on the waterside shoulder. Spring 2019.

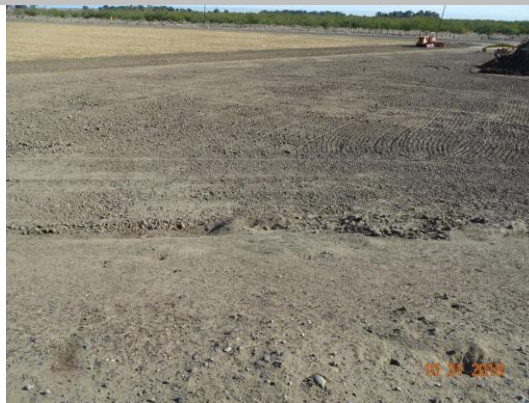
Photo 1 of 1 : SP_2019_RD1660_8_21_20190326_00009.jpg

LM Start	2.38	Rating **	U	Issue No.	21
LM End	2.38	Issue Type +	Ma	Location *	LS
Category	Earthen Levee			GPS Latitude/Longitude	
				Start	End
Item	Animal Control			39.034032 °	39.034032 °
				-121.825120 °	-121.825120 °
DWR ID	DWR_RD1660_01_f_2018_21				
Comment Code					
A3 : No rodents visible, but rodent burrows visible; need to backfill and compact or grout burrows.					
Inspector Comment

View of rodent holes along the landside slope.

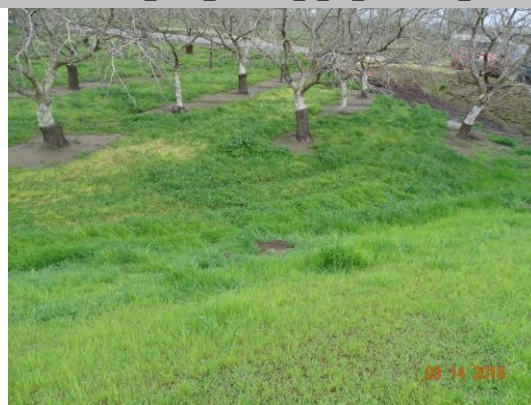
Photo 1 of 1 : SP_2019_RD1660_8_20_20190326_00008.jpg

LM Start	2.57	Rating **	M	Issue No.	20
LM End	2.57	Issue Type +	Ma	Location *	LS
Category	Earthen Levee			GPS Latitude/Longitude	
				Start	End
Item	Animal Control			39.031625 °	39.031625 °
				-121.823492 °	-121.823492 °
DWR ID	DWR_RD1660_01_s_2018_20				
Comment Code					
A3 : No rodents visible, but rodent burrows visible; need to backfill and compact or grout burrows.					
Inspector Comment

View of the rodent holes along the landside slope.

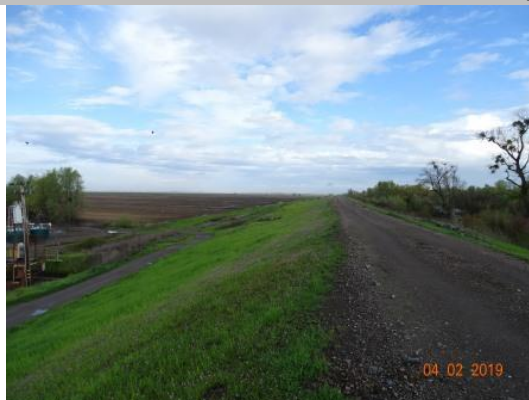
Photo 1 of 1 : SP_2019_RD1660_9_1_20190411_00016.jpg

LM Start	0.00	Rating **	A	Issue No.	1
LM End	2.38	Issue Type +	Ma	Location *	LS
Category	Earthen Levee			GPS Latitude/Longitude	
				Start	End
Item	Vegetation			39.033004 °	39.065780 °
				-121.743451 °	-121.757099 °
DWR ID	DWR_RD1660_02_s_2012_1				
Comment Code					
V1 : Control annual grass and weeds on the levee slopes and easements.					
Inspector Comment					
The vegetation is well maintained on the landside slope.

View of the vegetation on the landside slope. Spring 2019.

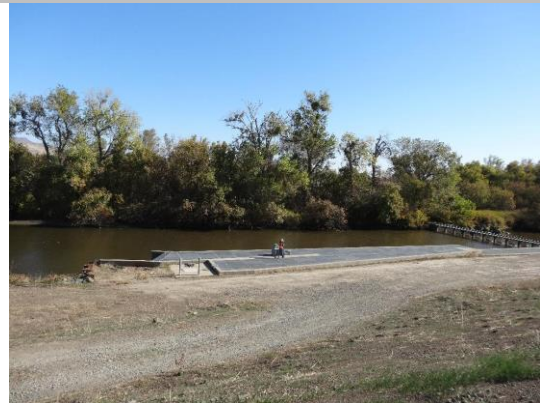
Photo 1 of 3 : UCIP_SP_2019_22708_38406.jpg

Comment Code					
Inspector Comment					
FS_ID:22708					
DS_ID:22505					
EP_NO: N/A					
Repair Type: No Action Needed					
Crossing Status: Found					
UCIP Comments: - inlet structure 160 ft off the levee center on landside drainage ditch.					
FIELD_STRUCT_DESC: 48-inch steel gravity drainage pipe through the levee, 29 feet below the crown. Slide gate and concrete bulkhead on the riverbank. Staff gage on the waterside (WS) berm. (Retention of a 48-inch corrugated metal pipe (CMP) through the levee, 29 feet below the crown, a slide gate, and a concrete bulkhead authorized under Automatic Board Order (ABO) No. 10021, 1974 - Butte Slough Irrigation Company, care of Tarke Warehouse). [Additional Reference(s): DWR Levee Log, 2005. USACE Sacramento O&M Manual 133, August 1955, (Station 433+43), 48-inch CMP referenced].					
FS Date: 10/15/2013

WS view: overview of concrete box on channel bank. It looks like a fish ladder. Pipe discharges into this box.

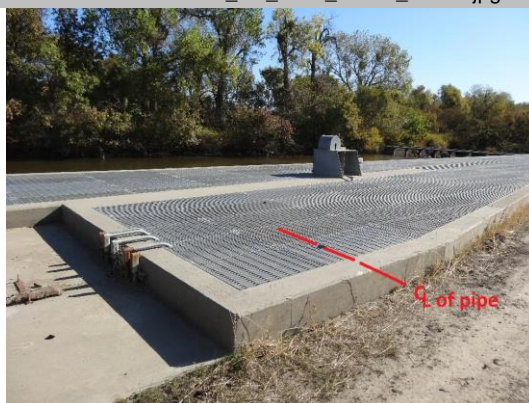
Photo 2 of 3 : UCIP_SP_2019_22708_38405.jpg

WS view: concrete box on channel bank. Pipe end with slide gate. Pipe discharges into this box.

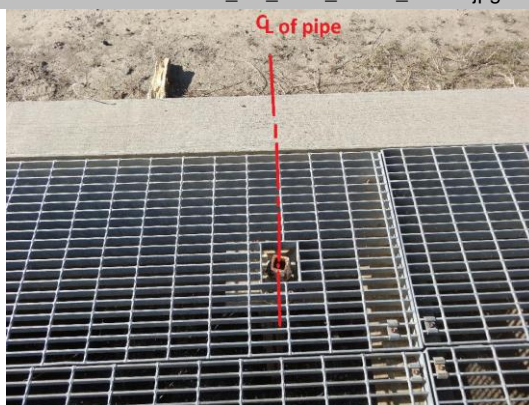
Photo 3 of 3 : UCIP_SP_2019_22708_38409.jpg

WS view: concrete box on channel bank. Pipe discharges into this box. A slide gate inside this box.
