**Flood Control Project Maintenance
Levee Inspections**

Maintenance Issue Types Only, Levee Inspection Report By Mile - Spring 2020

Reclamation District No. 1660 Tisdale

Waterway	Bank	Unit Miles	Inspection Start/End	Inspector
Unit No. 01 Sacramento River	Left	2.94	03/27/2020 03/27/2020	Makar Sokol

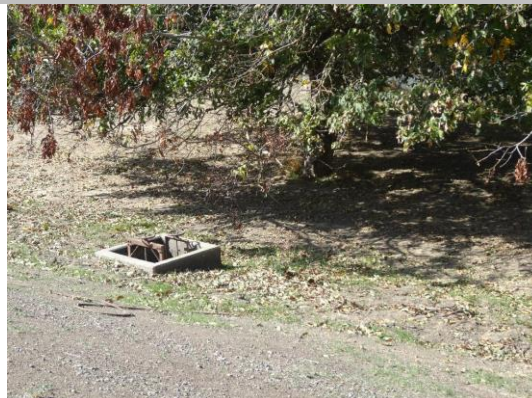
Photo 1 of 3 : UCIP_SP_2020_46670_38107.jpg

Comment Code						
Inspector Comment						
DS_ID:22489						
FS_ID:46670						
EP_NO: N/A						
Repair Type: Non-Urgent						
Crossing Status: Found						
UCIP Comments: - needs proper abandonment.- opening of landside pipe almost burried.						
FIELD_STRUCT_DESC: *ABANDONED* 24-inch corrugated metal gravity drainage pipe through the levee, 16.4 feet below the crown. Two corrugated metal cutoff walls. Slide gate in a concrete well at the waterside (WS) toe. (IV A-Winship). USACE bench mark on the top of the headwall at the landside (LS) toe. [Additional Reference(s): DWR Levee Log, 2005. USACE Sacramento O&M Manual 133, August 1955, (Station 2+07.8)].						
FS Date: 10/10/2013

WS view: concrete box on levee slope. No pipe found on berm and river bank.

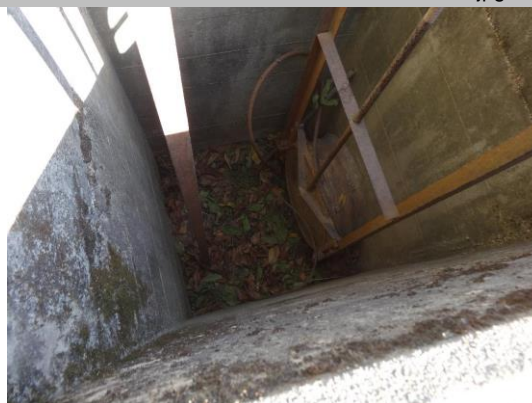
Photo 3 of 3 : UCIP_SP_2020_46670_38105.jpg

WS view: closer view of two slide gates in concrete box on levee slope.

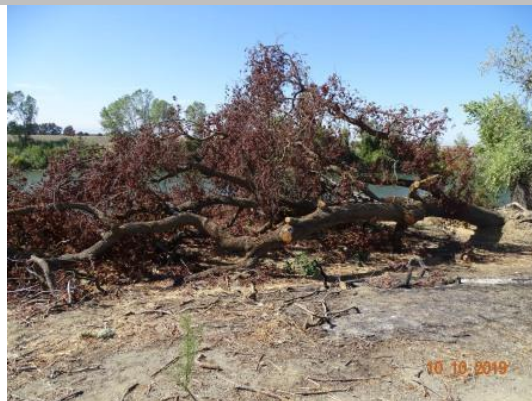
Photo 1 of 1 : SP_2020_RD1660_8_13_20200226_00007.jpg

LM Start	1.22	Rating **	U	Issue No.	13
LM End	1.22	Issue Type +	Ma	Location *	WS
Category	Earthen Levee			GPS Latitude/Longitude	
				Start	End
Item	Encroachments			39.045932 °	39.045932 °
				-121.838241 °	-121.838241 °
DWR ID	DWR_RD1660_01_f_2019_13				
Comment Code					
TR : Tree or limb					
Inspector Comment					
The large fallen tree should be removed from the waterside slope.

View of the large fallen tree on the waterside slope. Fall 2019.

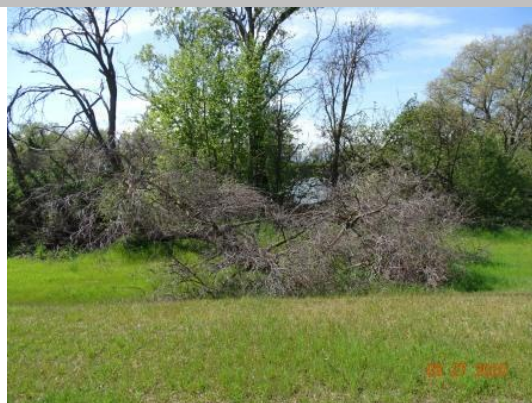
Photo 1 of 1 : SP_2020_RD1660_8_17_20200421_00019.jpg

LM Start	2.48	Rating **	M	Issue No.	17
LM End	2.48	Issue Type +	Ma	Location *	WS
Category	Earthen Levee			GPS Latitude/Longitude	
				Start	End
Item	Encroachments			39.032688 °	39.032688 °
				-121.824242 °	-121.824242 °
DWR ID	DWR_RD1660_01_s_2020_17				
Comment Code					
TR : Tree or limb					
Inspector Comment					
The fallen tree should be removed from the waterside slope.

View of the fallen tree at the waterside toe. Spring 2020.

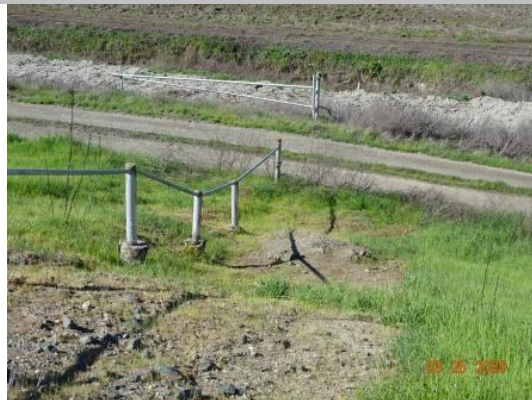
Photo 1 of 1 : SP_2020_RD1660_9_6_20200326_00015.jpg

LM Start	0.00	Rating **	M	Issue No.	6
LM End	0.00	Issue Type +	Ma	Location *	LS
Category	Earthen Levee			GPS Latitude/Longitude	
				Start	End
Item	Slope Stability			39.032910 °	39.032910 °
				-121.743665 °	-121.743665 °
DWR ID	DWR_RD1660_02_f_2016_6				
Comment Code					
S1 : Repair slope instability.					
Inspector Comment

View of the slope instability along the landside slope. Spring 2020.

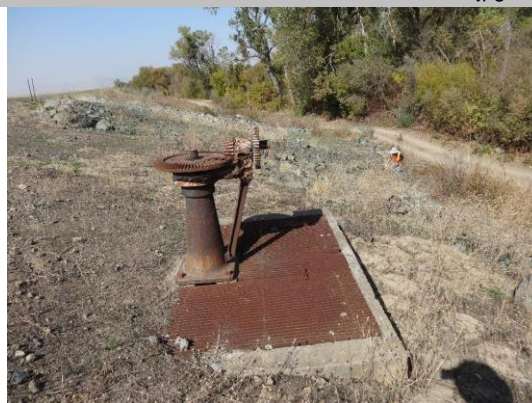
Photo 1 of 3 : UCIP_SP_2020_22663_38248.jpg

Comment Code					
Inspector Comment					
DS_ID:22495 FS_ID:22663 EP_NO: 10020 Repair Type: No Action Needed Crossing Status: Found UCIP Comments: - pipe/opening not visible as it was submerged into water on both sides.- it seems that 36-inch concrete pipe through the levee. It needs confirmation from LMA/DWR Inspector.- USED bench mark on landside concrete vault. FIELD_STRUCT_DESC: [Reclamation District No. 1660 (RD1660) Drainage Pump] 48-inch by 84-inch reinforced concrete outfall structure through the levee, 34 feet below the crown. Slide gate in a 4-foot by 8-foot concrete riser on the waterside (WS) slope. (Retention of a 4-foot by 7-foot concrete culvert outfall drain through the levee, 34 feet below the crown, and a slide gate in a concrete well authorized under Automatic Board Order (ABO) issued as Permit No. 10020, 1974 - Leo Bandoni, care of John Digardi). [Additional Reference(s): DWR Levee Log, 2005. USACE Sacramento O&M Manual 133, August 1955, (Station 1044+60), two 4-foot by 7-foot concrete tunnels referenced]. FS Date: 10/10/2013

WS view: 4 ft. by 8 ft. concrete box with slide gate on levee slope. USED bench mark on top of the box.

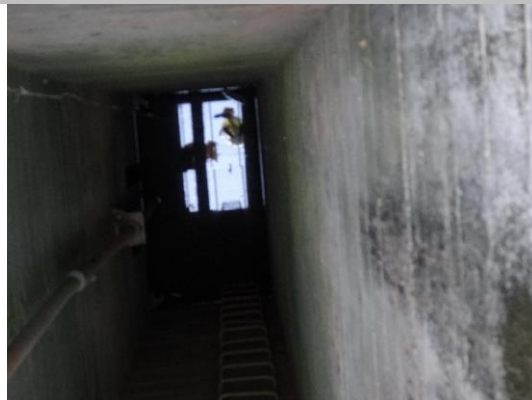
Photo 2 of 3 : UCIP_SP_2020_22663_38247.jpg

WS view: inside view of concrete box on levee slope. Slide gate in concrete box.

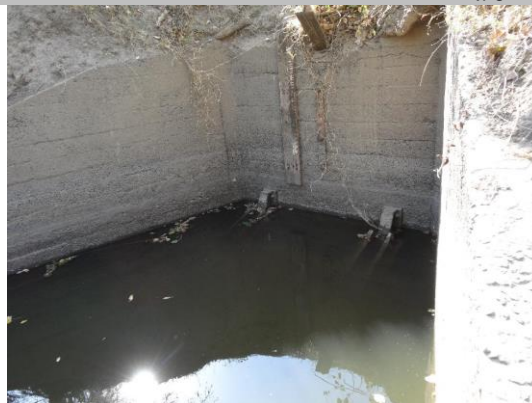
Photo 3 of 3 : UCIP_SP_2020_22663_38246.jpg

WS view: closer view of U shaped concrete headwall in bypass channel. Pipe not visible.

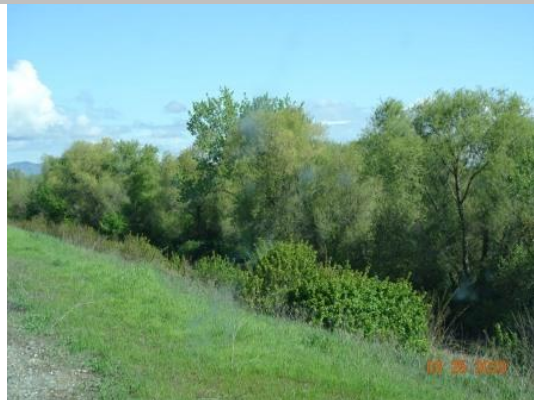
Photo 1 of 1 : SP_2020_RD1660_9_5_20200326_00016.jpg

LM Start	0.61	Rating **	M	Issue No.	5
LM End	0.61	Issue Type +	Ma	Location *	WS
Category	Earthen Levee			GPS Latitude/Longitude	
				Start	End
Item	Vegetation			39.041313 °	39.041313 °
				-121.746910 °	-121.746910 °
DWR ID	DWR_RD1660_02_s_2020_5				
Comment Code					
V2 : Remove the wild growth other than native grasses from the levee slopes.					
Inspector Comment

View of wild growth along the waterside slope. Spring 2020.

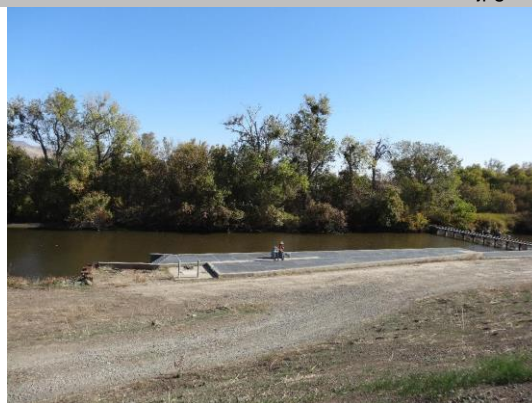
Photo 1 of 3 : UCIP_SP_2020_22708_38406.jpg

Comment Code					
Inspector Comment					
DS_ID:22505 FS_ID:22708 EP_NO: N/A Repair Type: No Action Needed Crossing Status: Found UCIP Comments: - inlet structure 160 ft off the levee center on landside drainage ditch. FIELD_STRUCT_DESC: 48-inch steel gravity drainage pipe through the levee, 29 feet below the crown. Slide gate and concrete bulkhead on the riverbank. Staff gage on the waterside (WS) berm. (Retention of a 48-inch corrugated metal pipe (CMP) through the levee, 29 feet below the crown, a slide gate, and a concrete bulkhead authorized under Automatic Board Order (ABO) No. 10021, 1974 - Butte Slough Irrigation Company, care of Tarke Warehouse). [Additional Reference(s): DWR Levee Log, 2005. USACE Sacramento O&M Manual 133, August 1955, (Station 433+43), 48-inch CMP referenced]. FS Date: 10/15/2013

WS view: overview of concrete box on channel bank. It looks like a fish ladder. Pipe discharges into this box.

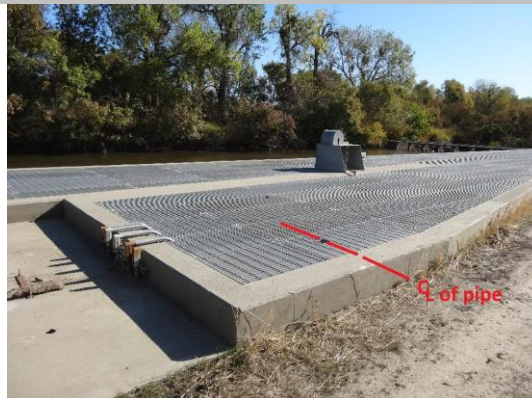
Photo 2 of 3 : UCIP_SP_2020_22708_38405.jpg

WS view: concrete box on channel bank. Pipe end with slide gate. Pipe discharges into this box.

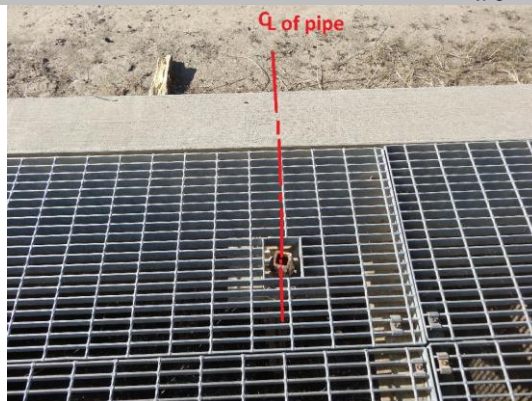
Photo 3 of 3 : UCIP_SP_2020_22708_38409.jpg

WS view: concrete box on channel bank. Pipe discharges into this box.
A slide gate inside this box.
