**Flood Control Project Maintenance  
Levee Inspections**

**Maintenance Issue Types Only, Levee Inspection Report By Mile - Spring 2021**

**Reclamation District No. 1660 Tisdale**

Waterway	Bank	Unit Miles	Inspection Start/End	Inspector
Unit No. 01 Sacramento River	Left	2.94	04/21/2021 04/14/2021	Makar Sokol

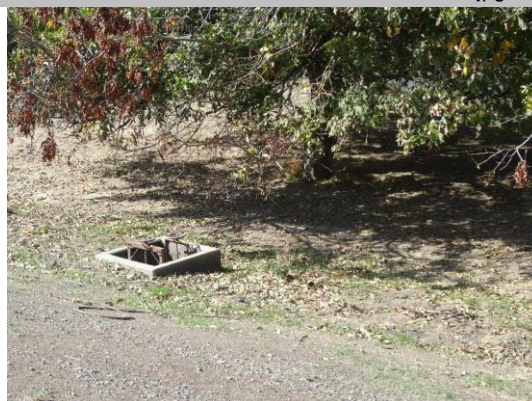
Photo 1 of 3 : UCIP\_SP\_2021\_46670\_38107.jpg

Comment Code						
Inspector Comment						
FS_ID:46670						
DS_ID:22489						
EP_NO: N/A						
Repair Type: Non-Urgent						
Crossing Status: Found						
UCIP Comments: - needs proper abandonment.- opening of landside pipe almost buried.						
FIELD_STRUCT_DESC: *ABANDONED* 24-inch corrugated metal gravity drainage pipe through the levee, 16.4 feet below the crown. Two corrugated metal cutoff walls. Slide gate in a concrete well at the waterside (WS) toe. (IV A-Winship). USACE bench mark on the top of the headwall at the landside (LS) toe. [Additional Reference(s): DWR Levee Log, 2005. USACE Sacramento O&M Manual 133, August 1955, (Station 2+07.8)].						
FS Date: 10/10/2013

WS view: concrete box on levee slope. No pipe found on berm and river bank.

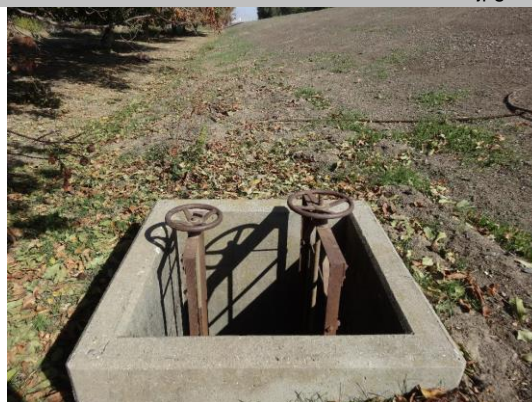
Photo 2 of 3 : UCIP\_SP\_2021\_46670\_38106.jpg

WS view: two slide gates in concrete box on levee slope.

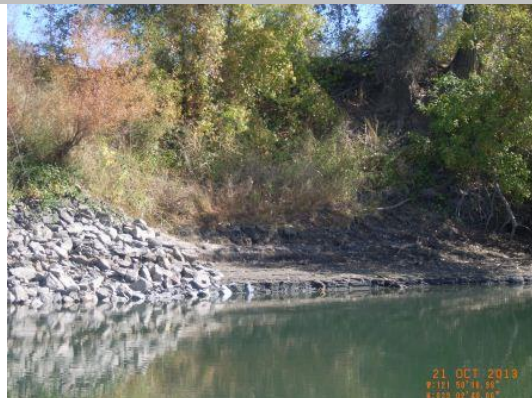
Photo 1 of 1 : SP\_2021\_RD1660\_8\_8\_20210224\_00003.jpg

LM Start	1.33	Rating **	A/W	Issue No.	8
LM End	1.36	Issue Type +	Ma	Location *	WS
Category	Supplemental			GPS Latitude/Longitude	
				Start	End
Item	2017 USACE Erosion Survey			39.044361 °	39.043916 °
				-121.837654 °	-121.837305 °
DWR ID	DWR_RD1660_01_f_2018_8				
Comment Code					
Inspector Comment					
2017 Site ID: SAC 120.6 L					
Status: Eroding					
2017 Field Notes: No observed change.					
Site History: 2009 - Erosion on levee toe where an old cobble site is failing. 2011 - Some new minor erosion. 2012 - Site extended downstream, bank is being impacted from the weight of the trees.					
2013 - Minor new erosion at the toe. 2015 - Minor new erosion at toe.

USACE 2013 Photo #1

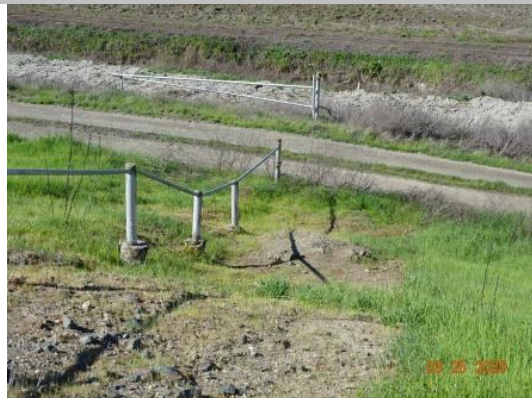
Photo 1 of 1 : SP\_2021\_RD1660\_9\_6\_20210224\_00001.jpg

View of the slope instability along the landside slope. Spring 2020.

LM Start	0.00	Rating **	M	Issue No.	6
LM End	0.00	Issue Type +	Ma	Location *	LS
Category	Earthen Levee			GPS Latitude/Longitude	
				Start	End
Item	Slope Stability			39.032910 °	39.032910 °
				-121.743665 °	-121.743665 °
DWR ID	DWR_RD1660_02_f_2016_6				
Comment Code					
S1 : Repair slope instability.					
Inspector Comment

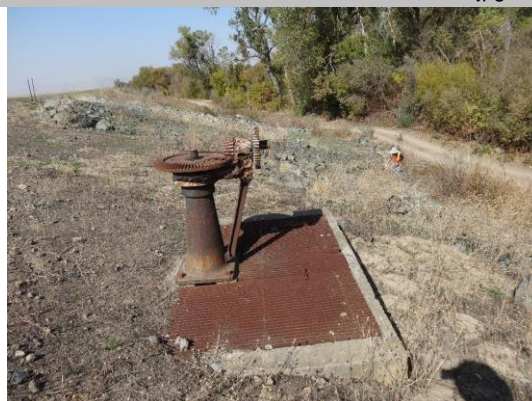
Photo 1 of 3 : UCIP\_SP\_2021\_22663\_38248.jpg

Comment Code						
Inspector Comment						
FS_ID:22663 DS_ID:22495 EP_NO: 10020 Repair Type: No Action Needed Crossing Status: Found UCIP Comments: - pipe/opening not visible as it was submerged into water on both sides.- it seems that 36-inch concrete pipe through the levee. It needs confirmation from LMA/DWR Inspector.- USED bench mark on landside concrete vault. FIELD_STRUCT_DESC: [Reclamation District No. 1660 (RD1660) Drainage Pump] 48-inch by 84-inch reinforced concrete outfall structure through the levee, 34 feet below the crown. Slide gate in a 4-foot by 8-foot concrete riser on the waterside (WS) slope. (Retention of a 4-foot by 7-foot concrete culvert outfall drain through the levee, 34 feet below the crown, and a slide gate in a concrete well authorized under Automatic Board Order (ABO) issued as Permit No. 10020, 1974 - Leo Bandoni, care of John Digardi). [Additional Reference(s): DWR Levee Log, 2005. USACE Sacramento O&M Manual 133, August 1955, (Station 1044+60), two 4-foot by 7-foot concrete tunnels referenced]. FS Date: 10/10/2013

WS view: 4 ft. by 8 ft. concrete box with slide gate on levee slope. USED bench mark on top of the box.

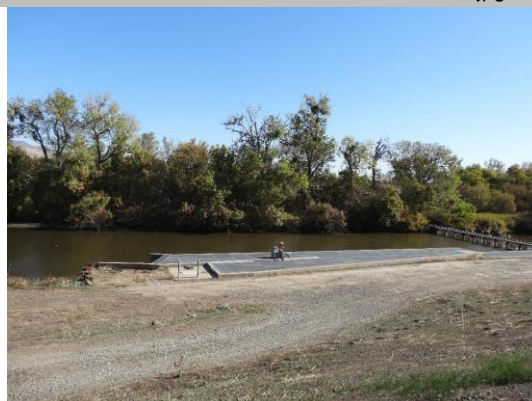
Photo 1 of 3 : UCIP\_SP\_2021\_22708\_38406.jpg

Comment Code						
Inspector Comment						
FS_ID:22708						
DS_ID:22505						
EP_NO: N/A						
Repair Type: No Action Needed						
Crossing Status: Found						
UCIP Comments: - inlet structure 160 ft off the levee center on landside drainage ditch.						
FIELD_STRUCT_DESC: 48-inch steel gravity drainage pipe through the levee, 29 feet below the crown. Slide gate and concrete bulkhead on the riverbank. Staff gage on the waterside (WS) berm. (Retention of a 48-inch corrugated metal pipe (CMP) through the levee, 29 feet below the crown, a slide gate, and a concrete bulkhead authorized under Automatic Board Order (ABO) No. 10021, 1974 - Butte Slough Irrigation Company, care of Tarke Warehouse). [Additional Reference(s): DWR Levee Log, 2005. USACE Sacramento O&M Manual 133, August 1955, (Station 433+43), 48-inch CMP referenced].						
FS Date: 10/15/2013

WS view: overview of concrete box on channel bank. It looks like a fish ladder. Pipe discharges into this box.

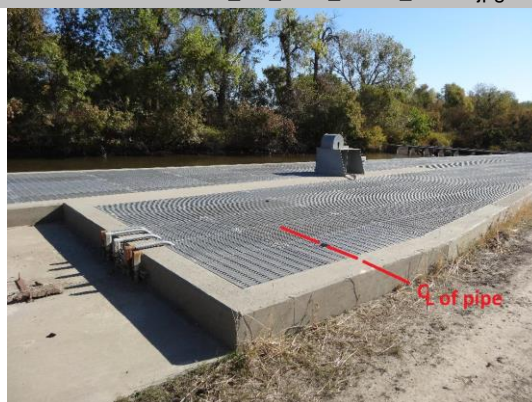
Photo 2 of 3 : UCIP\_SP\_2021\_22708\_38405.jpg

WS view: concrete box on channel bank. Pipe end with slide gate. Pipe discharges into this box.

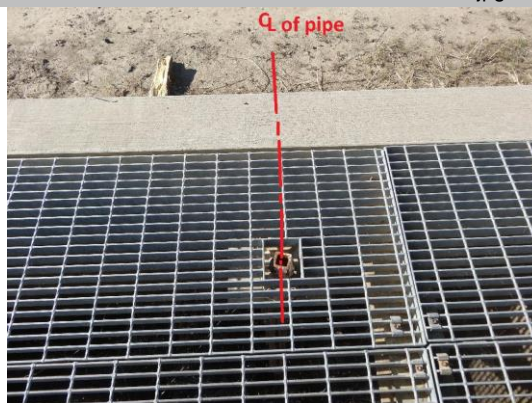
Photo 3 of 3 : UCIP\_SP\_2021\_22708\_38409.jpg

WS view: concrete box on channel bank. Pipe discharges into this box.  
A slide gate inside this box.
