**Flood Control Project Maintenance
Levee Inspections**

Maintenance Issue Types Only, Levee Inspection Report By Mile - Spring 2022

Reclamation District No. 1660 Tisdale

Waterway	Bank	Unit Miles	Inspection Start/End	Inspector
Unit No. 01 Sacramento River	Left	2.94	03/30/2022 03/30/2022	Makar Sokol

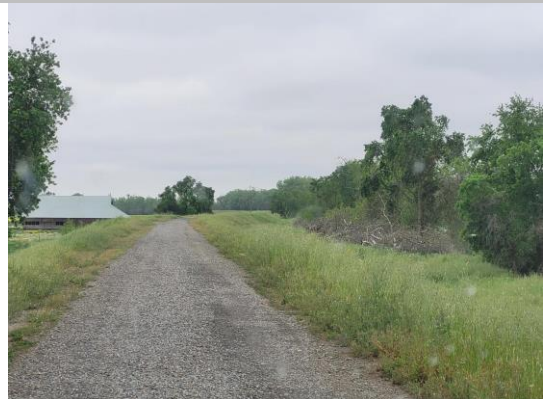
Photo 1 of 1 : SP_2022_RD1660_8_22_20220401_00045.jpg

LM Start	0.02	Rating **	M	Issue No.	22
LM End	1.36	Issue Type +	Ma	Location *	WS
Category	Earthen Levee			GPS Latitude/Longitude	
				Start	End
Item	Vegetation			39.063048 °	39.044163 °
				-121.837837 °	-121.837010 °
DWR ID	DWR_RD1660_01_s_2022_22				
Comment Code					
V1 : Control annual grass and weeds on the levee slopes and easements.					
Inspector Comment

View of the vegetation along the waterside slope. Spring 2022.

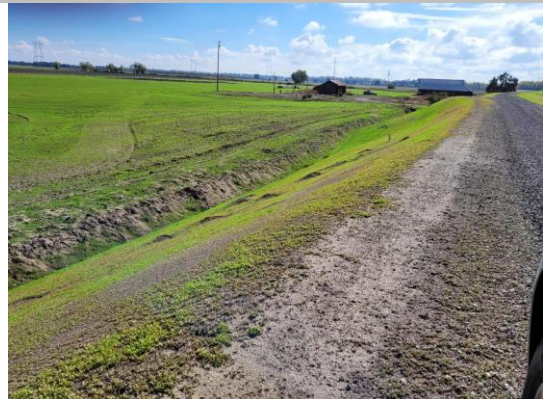
Photo 1 of 1 : SP_2022_RD1660_8_27_20220307_00008.jpg

LM Start	0.08	Rating **	M	Issue No.	27
LM End	0.08	Issue Type +	Ma	Location *	LS
Category	Earthen Levee			GPS Latitude/Longitude	
				Start	End
Item	Animal Control			39.062196 °	39.062196 °
				-121.837899 °	-121.837899 °
DWR ID	DWR_RD1660_01_f_2021_27				
Comment Code					
A3 : No rodents visible, but rodent burrows visible; need to backfill and compact or grout burrows.					
Inspector Comment

View of the rodent burrows along the landside slope. Fall 2021.

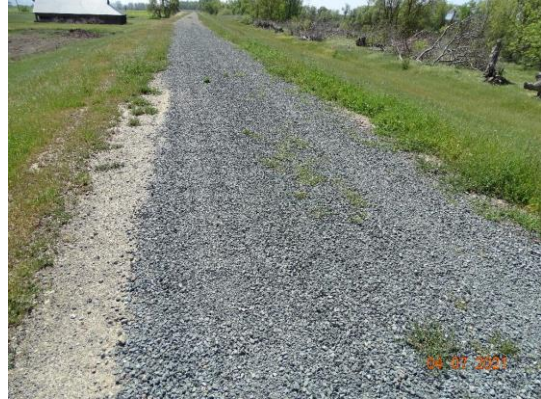
Photo 1 of 3 : UCIP_SP_2022_69282_103570.jpg

Comment Code					
Inspector Comment					
FS_ID:69282 DS_ID:22489 EP_NO: N/A Repair Type: Urgent Crossing Status: Found UCIP Comments: 04/07/2021 Record updated from Non-Urgent to Urgent. DMP internal video inspection has found pipe integrity issues. LOF of crossing is between 5 and 6. Crossing will be monitored until funding becomes available to address the issues. No permit has been identified authorizing pipe. (O.Yakimov - DWR UCIP) 10/10/2013 needs proper abandonment, opening of landside pipe almost buried. (P.Amatya - DWR UCIP) FIELD_STRUCT_DESC: 24-inch corrugated metal gravity drainage pipe through the levee, 16.4 feet below the crown. Two corrugated metal cutoff walls. Slide gate in a concrete well at the waterside (WS) toe. (IV A-Winship). USACE bench mark on the top of the headwall at the landside (LS) toe. [Additional Reference(s): DWR Levee Log, 2005 (HLM 0.14), listed as abandoned pipe. USACE Sacramento O&M Manual, Unit 133, August 1955, Revised 29 December 2016, (Station 2+07.8), listed as 24-inch pipe]. FS Date: 4/7/2021 7:30:38 AM

Top of Levee: View of levee crown looking downstream

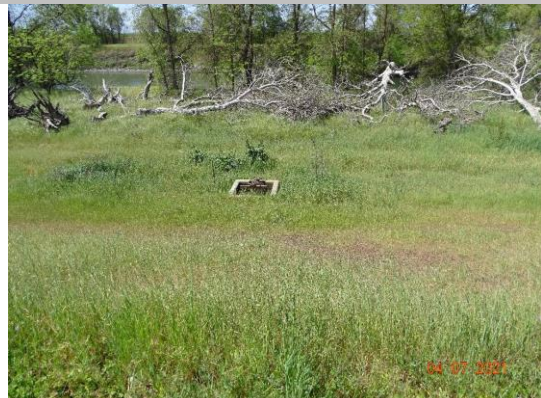
Photo 2 of 3 : UCIP_SP_2022_69282_103571.jpg

Water-Side: View of levee slope looking from crown, concrete box on levee berm

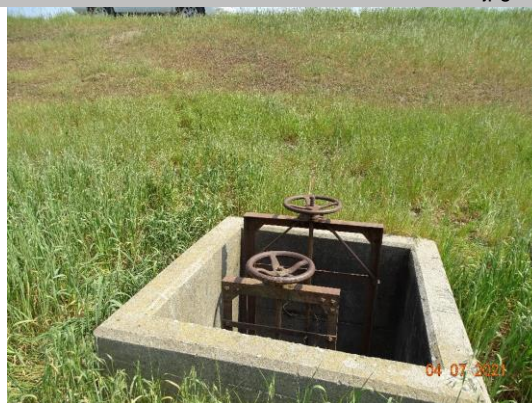
Photo 3 of 3 : UCIP_SP_2022_69282_103569.jpg

Water-Side: Overview of levee slope and concrete box with slide gates

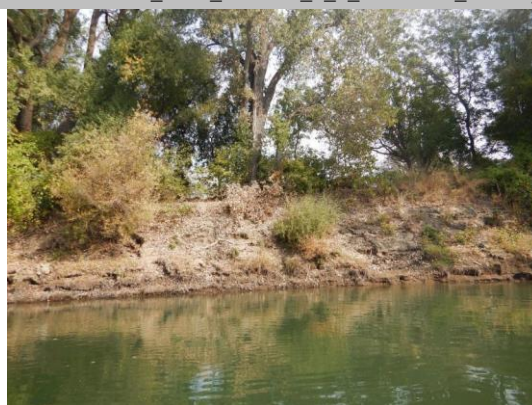
Photo 1 of 2 : SP_2022_RD1660_8_8_20220307_00003.jpg

2018 Site ID: SAC 120.6 L
 Status: Eroding
 2018 Field Notes: extended downstream
 Site History: 2009 - Erosion on levee toe where an old cobble site is failing. 2011 - Some new minor erosion. 2012 - Site extended downstream, bank is being impacted from the weight of the trees. 2013 - Minor new erosion at the toe. 2015 - Minor new erosion at toe.

USACE 2018 Erosion Photo #1

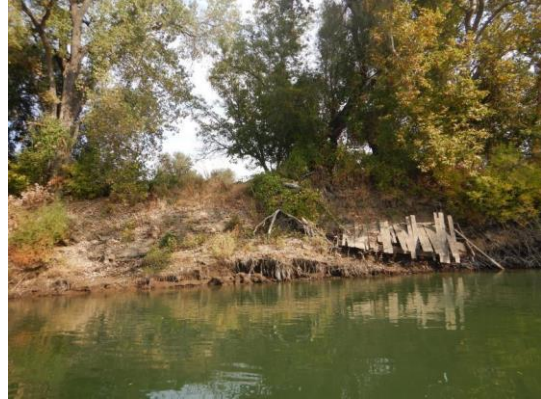
Photo 2 of 2 : SP_2022_RD1660_8_8_20220307_00004.jpg

USACE 2018 Erosion Photo #2

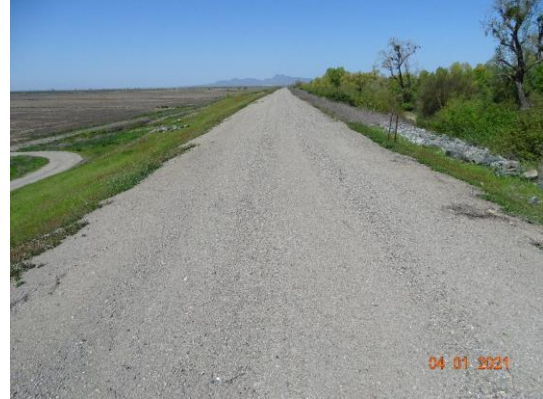
Photo 1 of 3 : UCIP_SP_2022_69307_103651.jpg

Comment Code						
Inspector Comment						
FS_ID:69307 DS_ID:22495 EP_NO: 10020 Repair Type: Non-Urgent Crossing Status: Found UCIP Comments: 04/01/2021 Record updated from No Action Needed to Non-Urgent. No permit has been identified authorizing pipe. Need to have CVFPB review ABO and determine current owner. DMP internal video inspection has not found pipe integrity issues. LOF of crossing is less or equal to 4. Recommend next video inspection in 5 years. (O.Yakimov - DWR UCIP) 10/10/2013 Pipe/opening not visible as it was submerged into water on both sides. It seems that 36-inch concrete pipe through the levee. It needs confirmation from LMA/DWR Inspector. USED bench mark on landside concrete vault. (P.Amatya - DWR UCIP) FIELD_STRUCT_DESC: [Reclamation District No. 1660 (RD1660) Drainage Pump] 48-inch by 84-inch reinforced concrete outfall structure through the levee, 34 feet below the crown. Slide gate in a 4-foot by 8-foot concrete riser on the waterside (WS) slope. (4-foot by 7-foot concrete culver outfall [HLM 0.03] authorized under Automatic Board Order (ABO) issued as Permit No. 10020, 1974 - Leo Bandoni, care of John Digardi). [Additional Reference(s): DWR Levee Log, 2005. USACE Sacramento O&M Manual, Unit 133, August 1955, Revised 29 December 2016, (Station 910+87), listed as 7.5 x 6 -feet concrete culvert. USACE As-Built Drawing No. 50-04-1814, Sheet 2, Station 910+87, June 1940, listed as 7.5 x 6 -foot concrete culvert]. FS Date: 4/1/2021 9:47:28 AM

Top of Levee: View of levee crown looking upstream

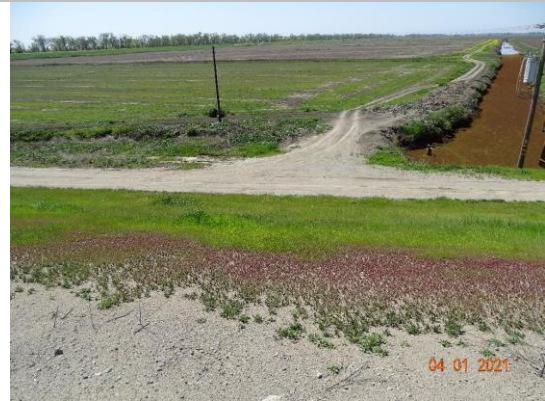
Photo 2 of 3 : UCIP_SP_2022_69307_103649.jpg

Land-Side: View of levee slope looking from crown, irrigation canal on landside

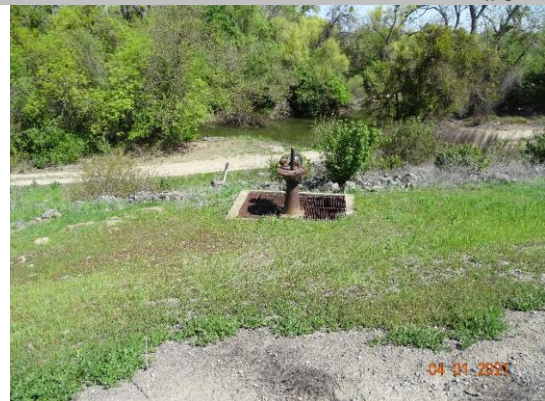
Photo 3 of 3 : UCIP_SP_2022_69307_103648.jpg

Water-Side: View of levee slope looking from crown, concrete box with slide gate on levee slope

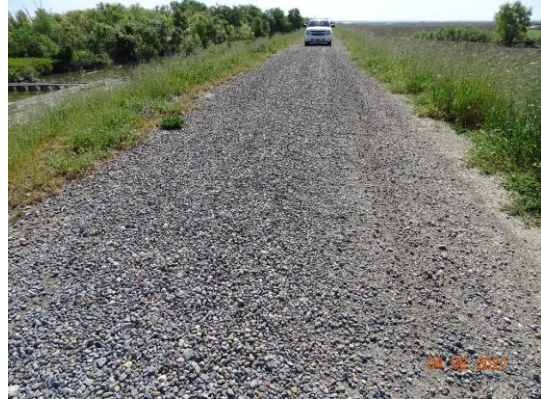
Photo 1 of 3 : UCIP_SP_2022_69337_103745.jpg

FS_ID:69337
DS_ID:22505
EP_NO: 10021
Repair Type: Non-Urgent
Crossing Status: Found
UCIP Comments: 04/08/2021 Record updated from No Action Needed to Non-Urgent. No permit has been identified authorizing pipe. Need to have CVFPB review ABO and determine current owner. DMP internal video inspection has not found pipe integrity issues. LOF of crossing is less or equal to 4. Recommend next video inspection in 5 years.
(O.Yakimov - DWR UCIP)
10/15/2013 Inlet structure 160 ft off the levee center on landside drainage ditch. (P.Amatya - DWR UCIP)
FIELD_STRUCT_DESC: 48-inch steel gravity drainage pipe through the levee, 29 feet below the crown. Concrete headwall and inlet pipe at bottom of drainage ditch on landside approximately 160 feet from levee. Slide gate and concrete bulkhead on the riverbank. Staff gage on the waterside (WS) berm. (48-inch pipe authorized under Permit No. 519, 1931 - McGrath Bros. et.al). (48-inch pipe [HLM 9.09] authorized under Automatic Board Order (ABO) issued as Permit No. 10021, 1974 - Butte Slough Irrigation Company, care of Tarke Warehouse).

Top of Levee: View of levee crown looking downstream

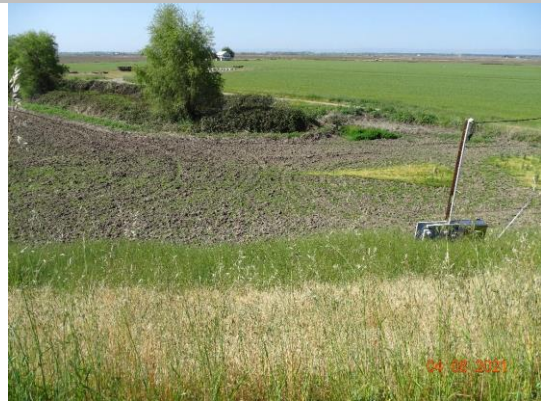
Photo 2 of 3 : UCIP_SP_2022_69337_103744.jpg

Land-Side: View of levee slope looking from crown. Drainage ditch on landside

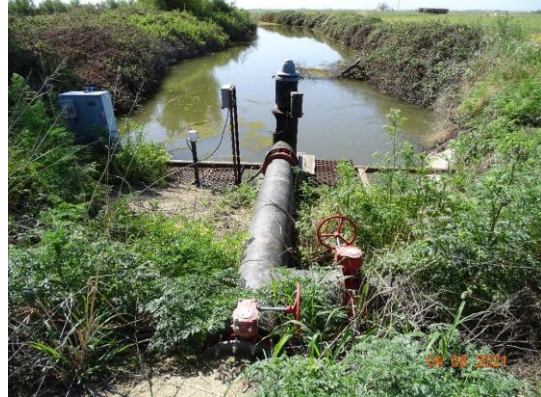
Photo 3 of 3 : UCIP_SP_2022_69337_103747.jpg

Land-Side: Vertical pump in drainage ditch. Doesn't seem to be relating to this crossing
