**Flood Control Project Maintenance
Levee Inspections**

Maintenance Issue Types Only, Levee Inspection Report By Mile - Spring 2023

Reclamation District No. 1660 Tisdale

Waterway	Bank	Unit Miles	Inspection Start/End	Inspector
Unit No. 01 Sacramento River	Left	2.94	04/19/2023 04/19/2023	Makar Sokol

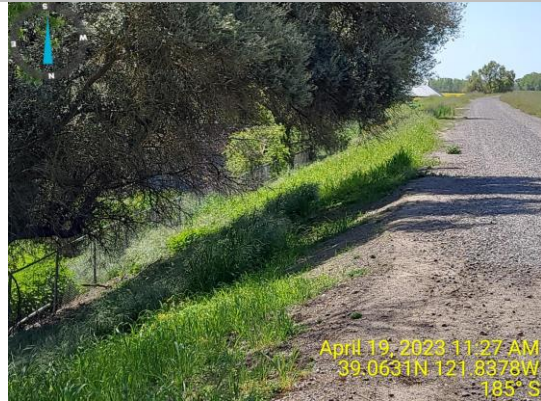
Photo 1 of 1 : SP_2023_RD1660_7_20230530_00021.jpg

LM Start	0.01	Rating **	U	Issue No.	7
LM End	2.92	Issue Type +	Ma	Location *	LS
Category	Earthen Levee			GPS Latitude/Longitude	
				Start	End
Item	Vegetation			39.063165°	39.026790°
				-121.837831°	-121.821963°
DWR ID	DWR_RD1660_01_s_2023_7				
Comment Code					
V1 : Control annual grass and weeds on the levee slopes and easements.					
Inspector Comment

View of the vegetation along the landside slope. Spring 2023.

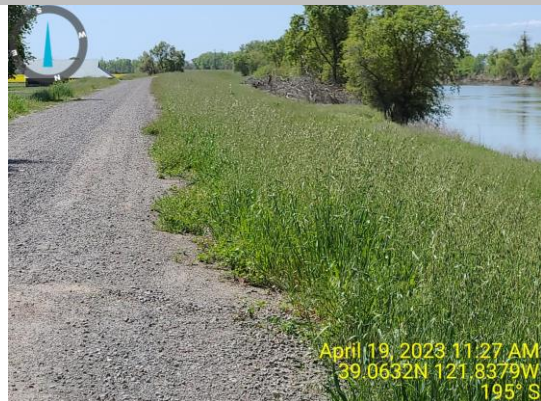
Photo 1 of 1 : SP_2023_RD1660_8_10_20230530_00022.jpg

LM Start	0.01	Rating **	U	Issue No.	10
LM End	2.92	Issue Type +	Ma	Location *	WS
Category	Earthen Levee			GPS Latitude/Longitude	
				Start	End
Item	Vegetation			39.063162°	39.026788°
				-121.837832°	-121.821959°
DWR ID	DWR_RD1660_01_s_2023_10				
Comment Code					
V1 : Control annual grass and weeds on the levee slopes and easements.					
Inspector Comment

View of the vegetation along the waterside slope. Spring 2023.

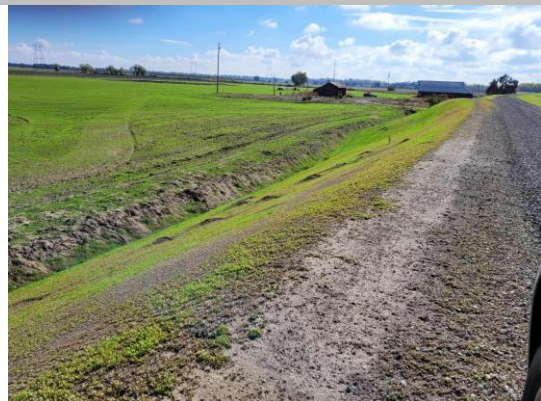
Photo 1 of 1 : SP_2023_RD1660_8_27_20230417_00008.jpg

LM Start	0.08	Rating **	M	Issue No.	27
LM End	0.08	Issue Type +	Ma	Location *	LS
Category	Earthen Levee			GPS Latitude/Longitude	
				Start	End
Item	Animal Control			39.062196°	39.062196°
				-121.837899°	-121.837899°
DWR ID	DWR_RD1660_01_f_2021_27				
Comment Code					
A3 : No rodents visible, but rodent burrows visible; need to backfill and compact or grout burrows.					
Inspector Comment

View of the rodent burrows along the landside slope. Fall 2021.

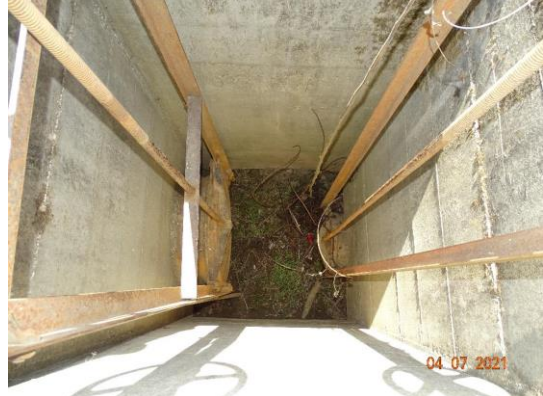
Photo 1 of 3 : UCIP_SP_2023_69282_103568.jpg

Comment Code					
Inspector Comment					
DS_ID:22489 FS_ID:69282 EP_NO: N/A Repair Type: Urgent EVAL Issue: 1, Pipe Integrity Crossing Status: Found UCIP Comments: 04/07/2021 Record updated from Non-Urgent to Urgent. DMP internal video inspection has found pipe integrity issues. LOF of crossing is between 5 and 6. Crossing will be monitored until funding becomes available to address the issues. No permit has been identified authorizing pipe. (O.Yakimov - DWR UCIP) 10/10/2013 needs proper abandonment, opening of landside pipe almost buried. (P.Amatya - DWR UCIP) FIELD_STRUCT_DESC: 24-inch corrugated metal gravity drainage pipe through the levee, 16.4 feet below the crown. Two corrugated metal cutoff walls. Slide gate in a concrete well at the waterside (WS) toe. (IV A-Winship). USACE bench mark on the top of the headwall at the landside (LS) toe. [Additional Reference(s): DWR Levee Log, 2005 (HLM 0.14), listed as abandoned pipe. USACE Sacramento O&M Manual, Unit 133, August 1955, Revised 29 December 2016, (Station 2+07.8), listed as 24-inch pipe]. FS Date: 4/7/2021 7:30:38 AM

Water-Side: Slide gates inside of concrete box on levee berm

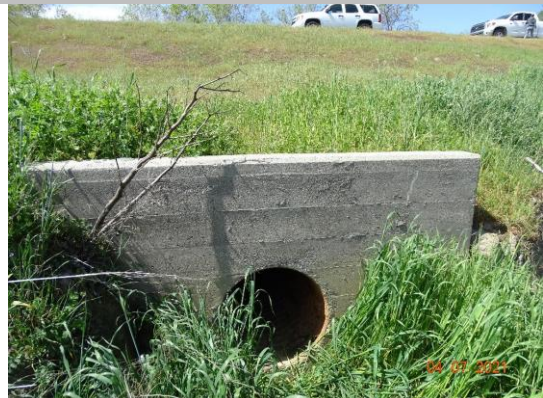
Photo 2 of 3 : UCIP_SP_2023_69282_103574.jpg

Land-Side: Headwall near levee toe

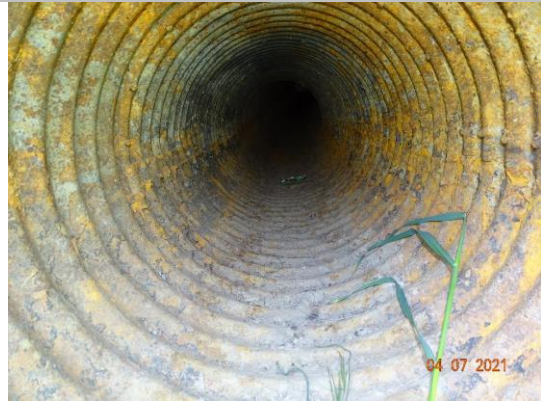
Photo 3 of 3 : UCIP_SP_2023_69282_103573.jpg

Land-Side: View inside of pipe at headwall

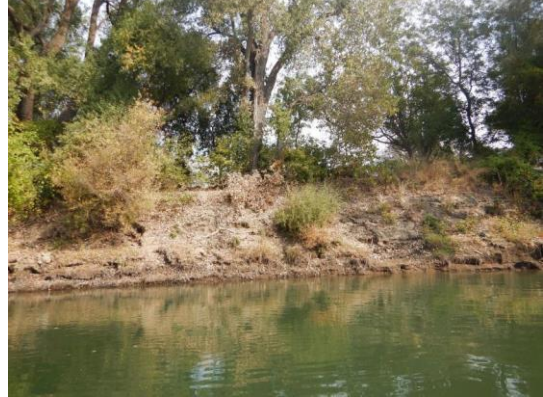
Photo 1 of 2 : SP_2023_RD1660_8_8_20230417_00003.jpg

LM Start	1.33	Rating **	A/W	Issue No.	8
LM End	1.36	Issue Type +	Ma	Location *	WS
Category	Supplemental			GPS Latitude/Longitude	
				Start	End
Item	2018 USACE Erosion Survey			39.044361°	39.043916°
				-121.837654°	-121.837305°
DWR ID	DWR_RD1660_01_s_2022_8				
Comment Code					
Inspector Comment					
2018 Site ID: SAC 120.6 L					
Status: Eroding					
2018 Field Notes: extended downstream					
Site History: 2009 - Erosion on levee toe where an old cobble site is failing. 2011 - Some new minor erosion. 2012 - Site extended downstream, bank is being impacted from the weight of the trees. 2013 - Minor new erosion at the toe. 2015 - Minor new erosion at toe.

USACE 2018 Erosion Photo #1

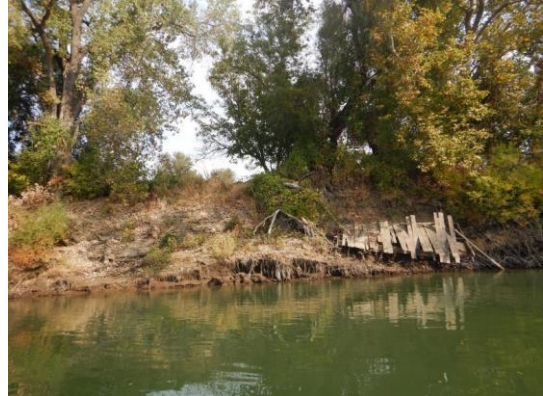
Photo 2 of 2 : SP_2023_RD1660_8_8_20230417_00004.jpg

USACE 2018 Erosion Photo #2

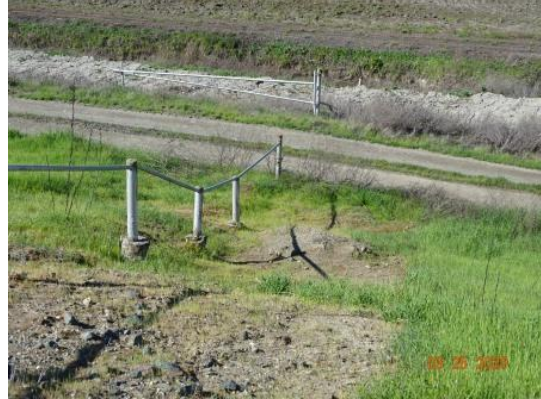
Photo 1 of 1 : SP_2023_RD1660_9_6_20230417_00001.jpg

LM Start	0.00	Rating **	M	Issue No.	6
LM End	0.00	Issue Type +	Ma	Location *	LS
Category	Earthen Levee			GPS Latitude/Longitude	
				Start	End
Item	Slope Stability			39.032910°	39.032910°
				-121.743665°	-121.743665°
DWR ID	DWR_RD1660_02_f_2016_6				
Comment Code					
S1 : Repair slope instability.					
Inspector Comment

View of the slope instability along the landside slope. Spring 2020.

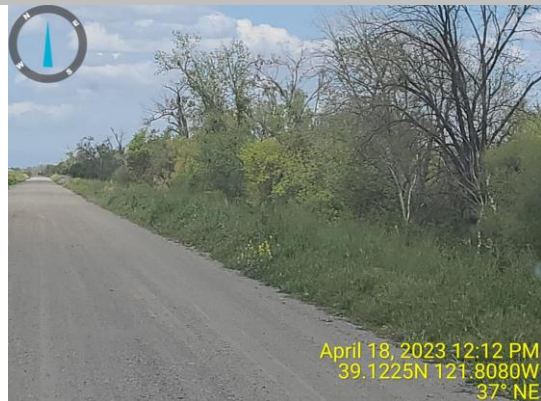
Photo 1 of 1 : SP_2023_RD1660_9_41_20230530_00018.jpg

LM Start	0.01	Rating **	U	Issue No.	41
LM End	9.08	Issue Type +	Ma	Location *	WS
Category	Earthen Levee			GPS Latitude/Longitude	
				Start	End
Item	Vegetation			39.033052°	39.136955°
				-121.743485°	-121.834179°
DWR ID	DWR_RD1660_02_f_2022_41				
Comment Code					
V1 : Control annual grass and weeds on the levee slopes and easements.					
Inspector Comment

View of the vegetation along the waterside slope. Spring 2023.

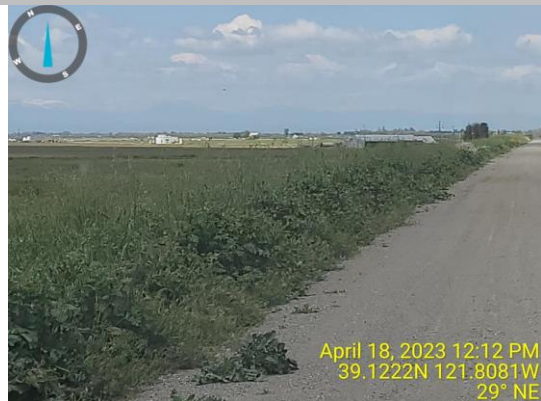
Photo 1 of 1 : SP_2023_RD1660_9_8_20230605_00021.jpg

LM Start	0.01	Rating **	U	Issue No.	8
LM End	9.08	Issue Type +	Ma	Location *	LS
Category	Earthen Levee			GPS Latitude/Longitude	
				Start	End
Item	Vegetation			39.033052°	39.136955°
				-121.743485°	-121.834179°
DWR ID	DWR_RD1660_02_s_2023_8				
Comment Code					
V1 : Control annual grass and weeds on the levee slopes and easements.					
Inspector Comment

View of the vegetation along the landside slope. Spring 2023.

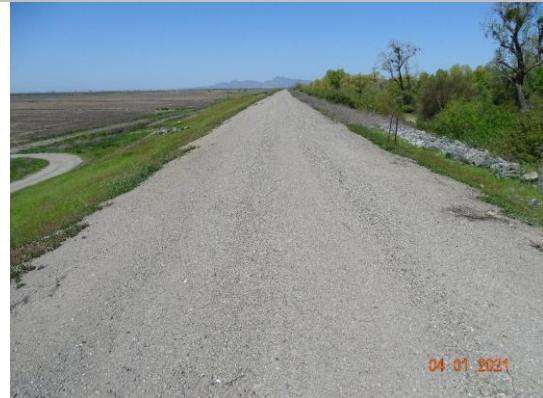
Photo 1 of 3 : UCIP_SP_2023_69307_103651.jpg

Comment Code						
Inspector Comment						
DS_ID:22495 FS_ID:69307 EP_NO: 10020 Repair Type: Non-Urgent EVAL Issue: Crossing Status: Found UCIP Comments: 04/01/2021 Record updated from No Action Needed to Non-Urgent. No permit has been identified authorizing pipe. Need to have CVFPB review ABO and determine current owner. DMP internal video inspection has not found pipe integrity issues. LOF of crossing is less or equal to 4. Recommend next video inspection in 5 years. (O.Yakimov - DWR UCIP) 10/10/2013 Pipe/opening not visible as it was submerged into water on both sides. It seems that 36-inch concrete pipe through the levee. It needs confirmation from LMA/DWR Inspector. USED bench mark on landside concrete vault. (P.Amatya - DWR UCIP) FIELD_STRUCT_DESC: [Reclamation District No. 1660 (RD1660) Drainage Pump] 48-inch by 84-inch reinforced concrete outfall structure through the levee, 34 feet below the crown. Slide gate in a 4-foot by 8-foot concrete riser on the waterside (WS) slope. (4-foot by 7-foot concrete culver outfall [HLM 0.03] authorized under Automatic Board Order (ABO) issued as Permit No. 10020, 1974 - Leo Bandoni, care of John Digardi). [Additional Reference(s): DWR Levee Log, 2005 (HLM 0.03). USACE Sacramento O&M Manual, Unit 133, August 1955, Revised 29 December 2016, (Station 910+87), listed as 7.5 x 6 -feet concrete culvert. USACE As-Built Drawing No. 50-04-1814, Sheet 2, Station 910+87, June 1940, listed as 7.5 x 6 -foot concrete culvert]. FS Date: 4/1/2021 9:47:28 AM

Top of Levee: View of levee crown looking upstream

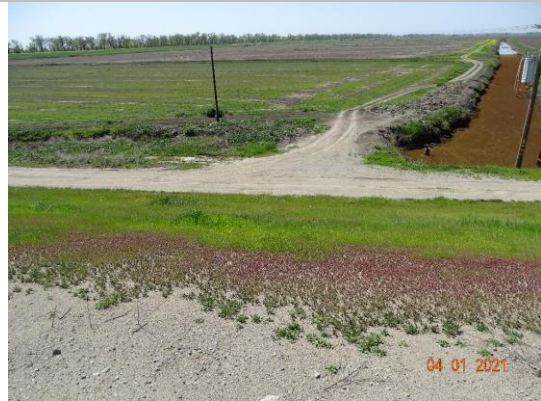
Photo 2 of 3 : UCIP_SP_2023_69307_103649.jpg

Land-Side: View of levee slope looking from crown, irrigation canal on landside

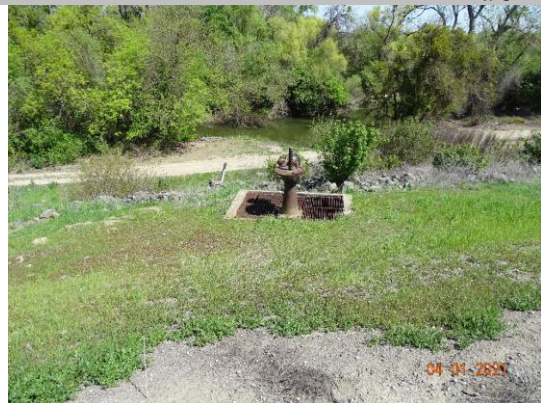
Photo 3 of 3 : UCIP_SP_2023_69307_103648.jpg

Water-Side: View of levee slope looking from crown, concrete box with slide gate on levee slope

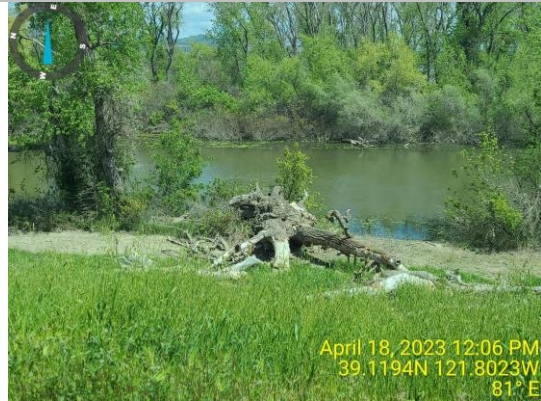
Photo 1 of 1 : SP_2023_RD1660_9_5_20230530_00019.jpg

LM Start	6.98	Rating **	M	Issue No.	5
LM End	6.98	Issue Type +	Ma	Location *	WS
Category	Earthen Levee			GPS Latitude/Longitude	
				Start	End
Item	Trim / Thin Trees			39.119289°	39.119289°
				-121.802284°	-121.802284°
DWR ID	DWR_RD1660_02_s_2023_5				
Comment Code					
T2 : Tree or limb.					
Inspector Comment

View of a fallen tree on the waterside slope and toe. Spring 2023.

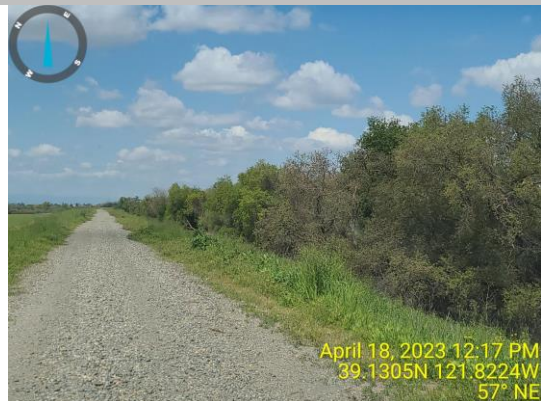
Photo 1 of 1 : SP_2023_RD1660_9_7_20230530_00020.jpg

LM Start	8.34	Rating **	M	Issue No.	7
LM End	8.34	Issue Type +	Ma	Location *	WS
Category	Earthen Levee			GPS Latitude/Longitude	
				Start	End
Item	Trim / Thin Trees			39.130712°	39.130712°
				-121.822868°	-121.822868°
DWR ID	DWR_RD1660_02_s_2023_7				
Comment Code					
T3 : Fallen tree with root ball.					
Inspector Comment

View of a fallen tree on the waterside slope and toe. Spring 2023.
