**Flood Control Project Maintenance
Levee Inspections**

Maintenance Issue Types Only, Levee Inspection Report By Mile - Spring 2024

Reclamation District No. 1660 Tisdale

Waterway	Bank	Unit Miles	Inspection Start/End	Inspector
Unit No. 01 Sacramento River	Left	2.94	04/23/2024 04/23/2024	Makar Sokol

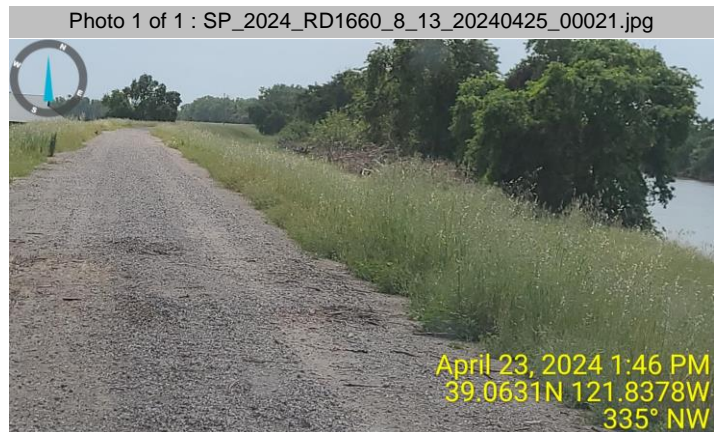
LM Start	0.02	Rating **	M	Issue No.	13
LM End	2.88	Issue Type +	Ma	Location *	WS
Category	Earthen Levee			GPS Latitude/Longitude	
				Start	End
Item	Vegetation			39.063056°	39.027464°
				-121.837846°	-121.821799°
DWR ID	DWR_RD1660_01_s_2024_13				
Comment Code					
V1 : Control annual grass and weeds on the levee slopes and easements.					
Inspector Comment

View of the vegetation along the waterside slope. Spring 2024.

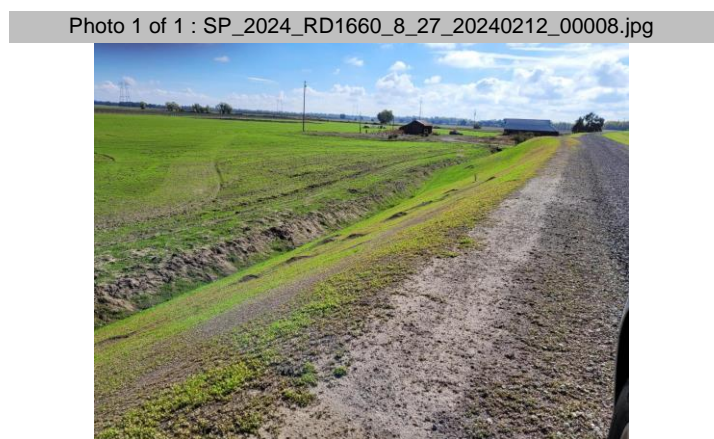
LM Start	0.08	Rating **	M	Issue No.	27
LM End	0.08	Issue Type +	Ma	Location *	LS
Category	Earthen Levee			GPS Latitude/Longitude	
				Start	End
Item	Animal Control			39.062196°	39.062196°
				-121.837899°	-121.837899°
DWR ID	DWR_RD1660_01_f_2021_27				
Comment Code					
A3 : No rodents visible, but rodent burrows visible; need to backfill and compact or grout burrows.					
Inspector Comment

View of the rodent burrows along the landside slope. Fall 2021.

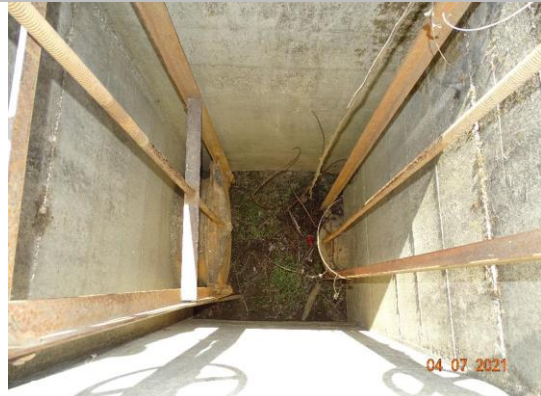
Photo 1 of 3 : UCIP_SP_2024_69282_103568.jpg

Comment Code					
Inspector Comment					
DS_ID:22489 FS_ID:69282 EP_NO: N/A Repair Type: Urgent EVAL Issue: 1, Pipe Integrity Crossing Status: Found UCIP Comments: 04/07/2021 Record updated from Non-Urgent to Urgent. DMP internal video inspection has found pipe integrity issues. LOF of crossing is between 5 and 6. Crossing will be monitored until funding becomes available to address the issues. No permit has been identified authorizing pipe. (O.Yakimov - DWR UCIP) 10/10/2013 needs proper abandonment, opening of landside pipe almost buried. (P.Amatya - DWR UCIP) FIELD_STRUCT_DESC: 24-inch corrugated metal gravity drainage pipe through the levee, 16.4 feet below the crown. Two corrugated metal cutoff walls. Slide gate in a concrete well at the waterside (WS) toe. (IV A-Winship). USACE bench mark on the top of the headwall at the landside (LS) toe. [Additional Reference(s): DWR Levee Log, 2005 (HLM 0.14), listed as abandoned pipe. USACE Sacramento O&M Manual, Unit 133, August 1955, Revised 29 December 2016, (Station 2+07.8), listed as 24-inch pipe]. FS Date: 4/7/2021 7:30:38 AM

Water-Side: Slide gates inside of concrete box on levee berm

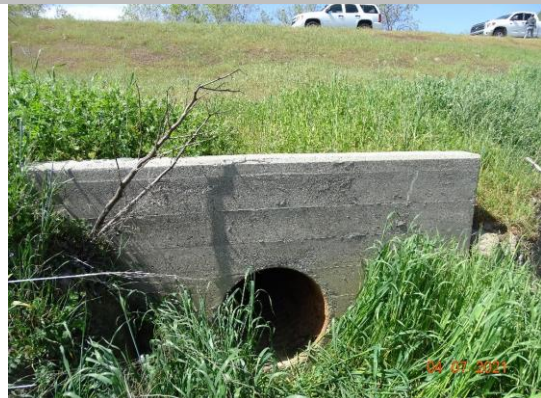
Photo 2 of 3 : UCIP_SP_2024_69282_103574.jpg

Land-Side: Headwall near levee toe

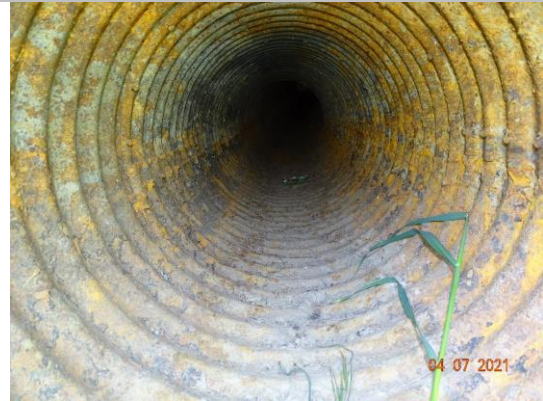
Photo 3 of 3 : UCIP_SP_2024_69282_103573.jpg

Land-Side: View inside of pipe at headwall

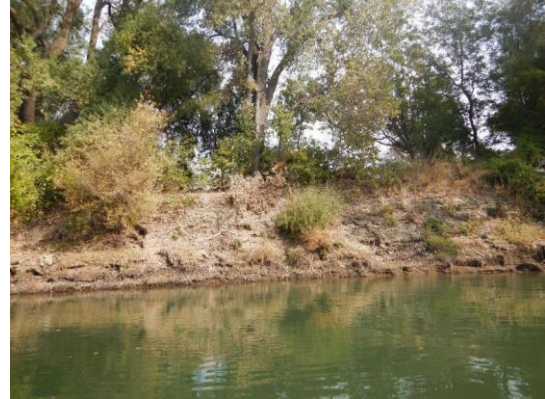
Photo 1 of 2 : SP_2024_RD1660_8_8_20240212_00003.jpg

LM Start	1.33	Rating **	A/W	Issue No.	8
LM End	1.36	Issue Type +	Ma	Location *	WS
Category	Supplemental			GPS Latitude/Longitude	
				Start	End
Item	2018 USACE Erosion Survey			39.044361°	39.043916°
				-121.837654°	-121.837305°
DWR ID	DWR_RD1660_01_s_2022_8				
Comment Code					
Inspector Comment					
2018 Site ID: SAC 120.6 L					
Status: Eroding					
2018 Field Notes: extended downstream					
Site History: 2009 - Erosion on levee toe where an old cobble site is					
failing. 2011 - Some new minor erosion. 2012 - Site extended					
downstream, bank is being impacted from the weight of the trees.					
2013 - Minor new erosion at the toe. 2015 - Minor new erosion at toe.

USACE 2018 Erosion Photo #1

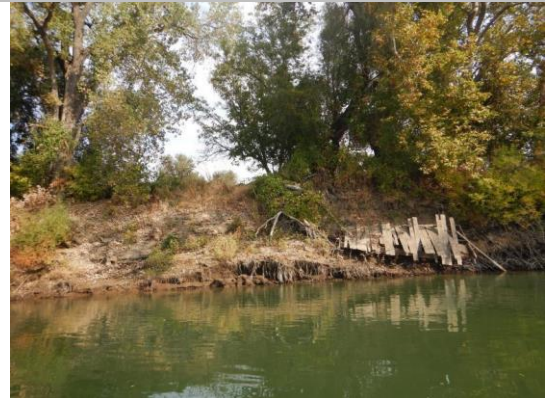
Photo 2 of 2 : SP_2024_RD1660_8_8_20240212_00004.jpg

USACE 2018 Erosion Photo #2

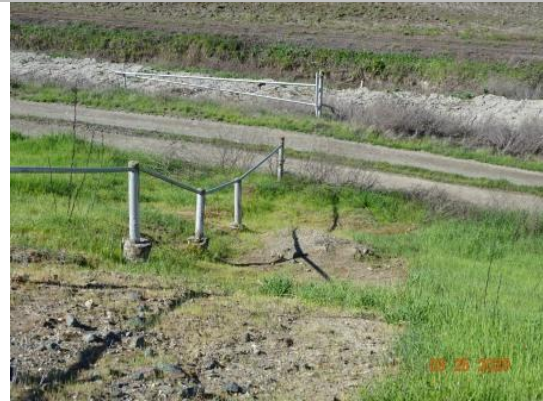
Photo 1 of 1 : SP_2024_RD1660_9_6_20240212_00002.jpg

LM Start	0.00	Rating **	M	Issue No.	6
LM End	0.00	Issue Type +	Ma	Location *	LS
Category	Earthen Levee			GPS Latitude/Longitude	
				Start	End
Item	Slope Stability			39.032910°	39.032910°
				-121.743665°	-121.743665°
DWR ID	DWR_RD1660_02_f_2016_6				
Comment Code					
S1 : Repair slope instability.					
Inspector Comment

View of the slope instability along the landside slope. Spring 2020.

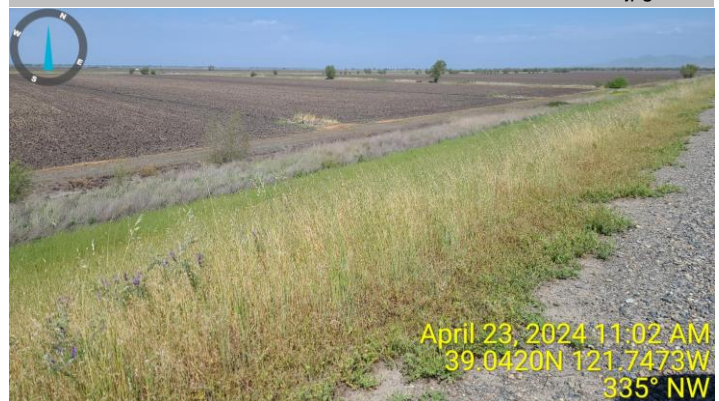
Photo 1 of 1 : SP_2024_RD1660_9_12_20240425_00016.jpg

LM Start	0.00	Rating **	M	Issue No.	12
LM End	9.09	Issue Type +	Ma	Location *	LS
Category	Earthen Levee			GPS Latitude/Longitude	
				Start	End
Item	Vegetation			39.032973°	39.137011°
				-121.743451°	-121.834287°
DWR ID	DWR_RD1660_02_s_2024_12				
Comment Code					
V1 : Control annual grass and weeds on the levee slopes and easements.					
Inspector Comment

View of the vegetation along the landside slope. Spring 2024.

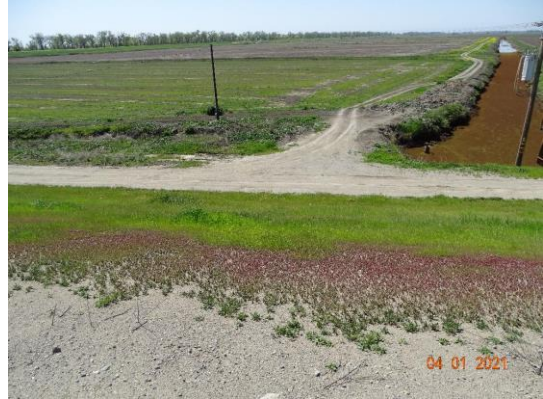
Photo 2 of 3 : UCIP_SP_2024_69307_103649.jpg

Land-Side: View of levee slope looking from crown, irrigation canal on landside

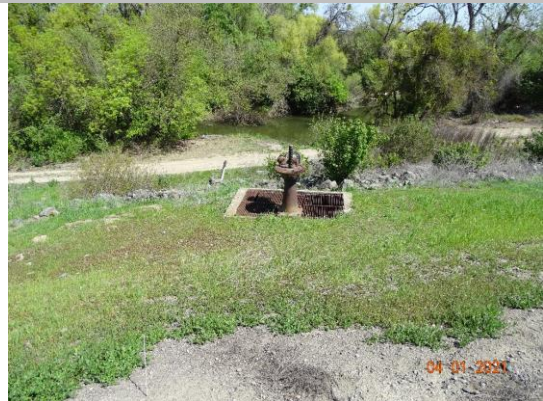
Photo 3 of 3 : UCIP_SP_2024_69307_103648.jpg

Water-Side: View of levee slope looking from crown, concrete box with slide gate on levee slope

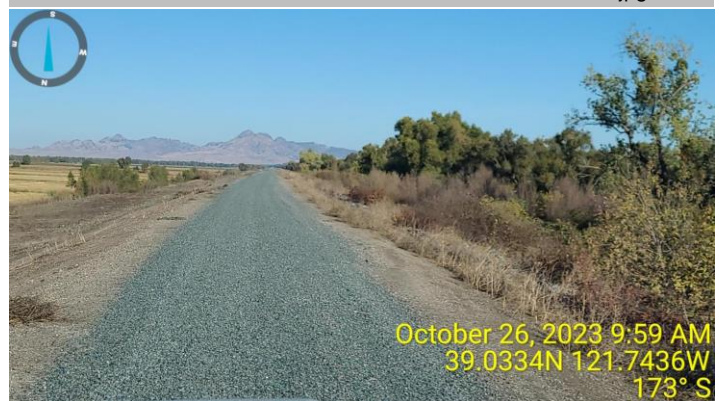
Photo 1 of 1 : SP_2024_RD1660_9_8_20240212_000004.jpg

LM Start	0.15	Rating **	M	Issue No.	8
LM End	1.17	Issue Type +	Ma	Location *	WS
Category	Earthen Levee			GPS Latitude/Longitude	
				Start	End
Item	Vegetation			39.035019°	39.049081°
				-121.744323°	-121.750172°
DWR ID	DWR_RD1660_02_f_2023_8				
Comment Code					
V2 : Remove the wild growth and woody vegetation other than native grasses from the levee slopes.					
Inspector Comment

View of the vegetation and wild growth along the waterside slope. Fall 2023.

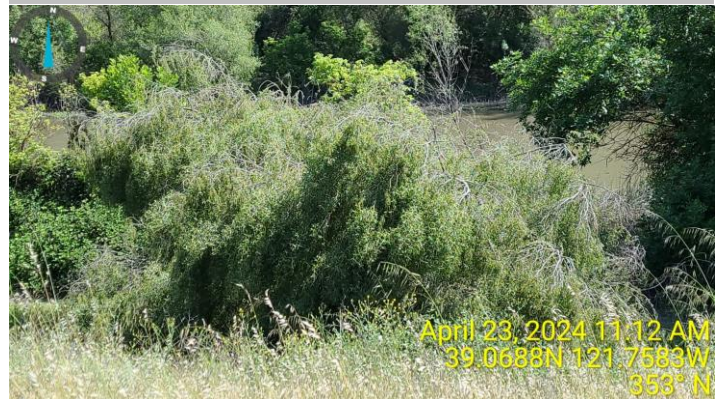
Photo 1 of 1 : SP_2024_RD1660_9_13_20240425_00017.jpg

LM Start	2.59	Rating **	M	Issue No.	13							
LM End	2.59	Issue Type +	Ma	Location *	WS							
Category	Earthen Levee		GPS Latitude/Longitude									
			Start	End								
Item	Trim / Thin Trees		39.068738°	39.068738°								
			-121.758340°	-121.758340°								
DWR ID	DWR_RD1660_02_s_2024_13											
Comment Code												
T2 : Tree or limb.												
Inspector Comment

View of a fallen tree on the waterside slope. Spring 2024.
