**Flood Control Project Maintenance  
Levee Inspections**

**Fall 2009 Levee Maintenance Deficiency Summary Report  
Overall LMA & Unit Ratings, including DWR Erosion Survey**

**Reclamation District No. 2031 Elliot**

**Levee Inspection Report By Mile - Fall 2009**

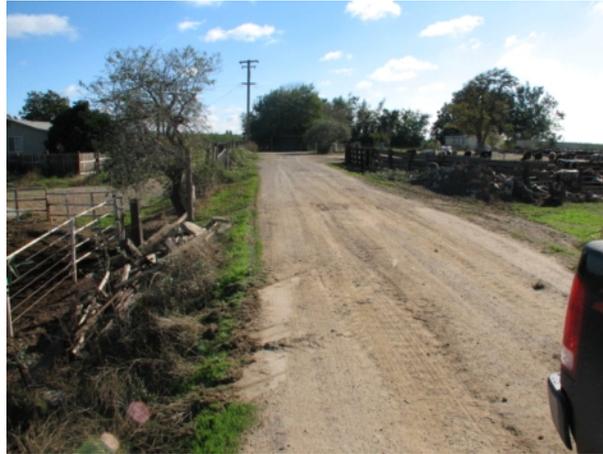
Levee Mile Report Line	1
Start Levee Mile	0.00
End Levee Mile	0.07
Location	Water Side
Category	Earthen Levee
Item	Encroachments
Photo looking upstream at beginning of unit 1. Water side to the left.	
jpaasch_20091026_60.jpg

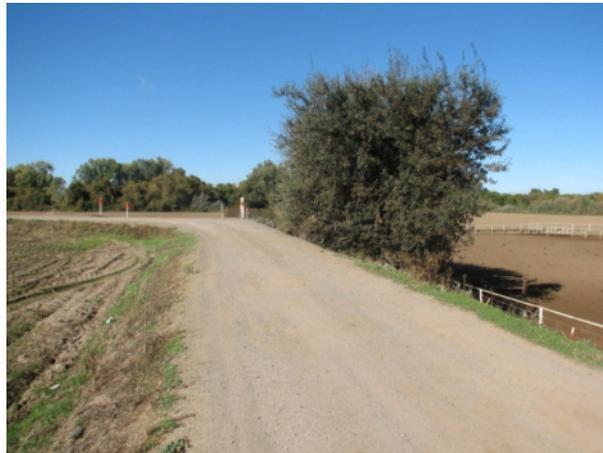
Levee Mile Report Line	2
Start Levee Mile	0.07
End Levee Mile	0.07
Location	Water Side
Category	Earthen Levee
Item	Vegetation
Photo of vegetation on water side slope.	
jpaasch_20091026_61.jpg

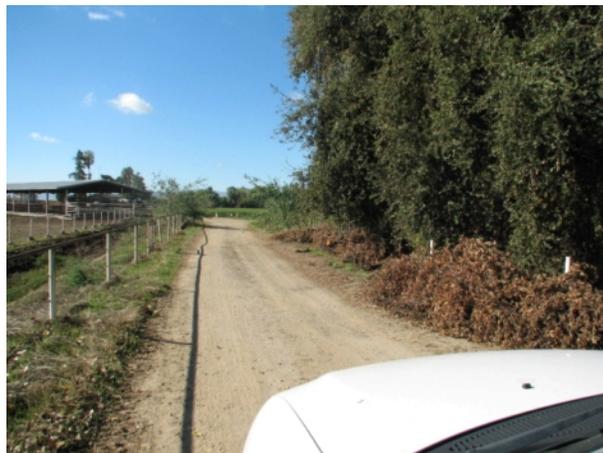
5	0.51	0.51	Earthen Levee	Encroachments	WS	M	Tree or limb Inspector Comments: Downed tree limbs should be removed.	37.704136 ° -121.159462 °	37.704136 ° -121.159462 °	967 Y
6	0.51	0.51	Earthen Levee	Vegetation	CR	M	Remove the wild growth other than native grasses from the levee slopes. Inspector Comments: tobacco leaf	37.704136 ° -121.159462 °	37.704136 ° -121.159462 °	968
7	0.55	0.65	Earthen Levee	Encroachments	LS	CO	Buildings Inspector Comments: Corrals and house	37.703626 ° -121.159714 °	37.702648 ° -121.160700 °	969 Y
8	0.64	0.64	Earthen Levee	Crown Surface / Depressions / Rutting	CR	M	Regrade the crown roadway for proper drainage.	37.702766 ° -121.160598 °	37.702766 ° -121.160598 °	970
9	0.70	0.75	Earthen Levee	Animal Control	WS	M	Exterminate rodents and backfill and compact or grout burrows.	37.702138 ° -121.161329 °	37.701566 ° -121.161852 °	971
10	0.75	0.78	Earthen Levee	Encroachments	LS	PO	Agricultural Ditch	37.701566 ° -121.161852 °	37.701178 ° -121.162086 °	972

Levee Mile Report Line	5
Start Levee Mile	0.51
End Levee Mile	0.51
Location	Water Side
Category	Earthen Levee
Item	Encroachments
Trees and limbs on water side slope limit access and visibility.	
jpaasch_20091026_63.jpg

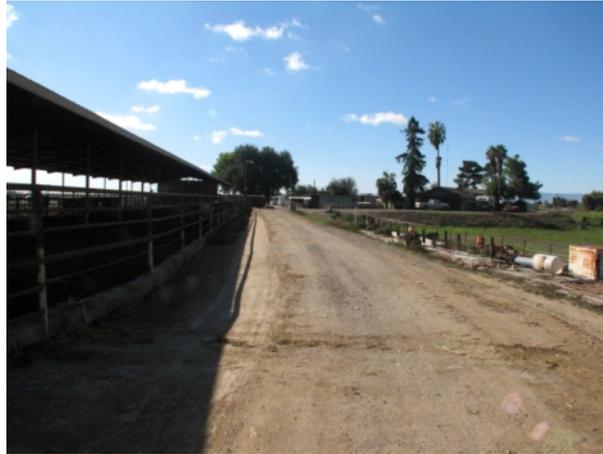
Levee Mile Report Line	7
Start Levee Mile	0.55
End Levee Mile	0.65
Location	Land Side
Category	Earthen Levee
Item	Encroachments
Photo of livestock pens and house on landside slope.	
jpaasch_20091026_62.jpg

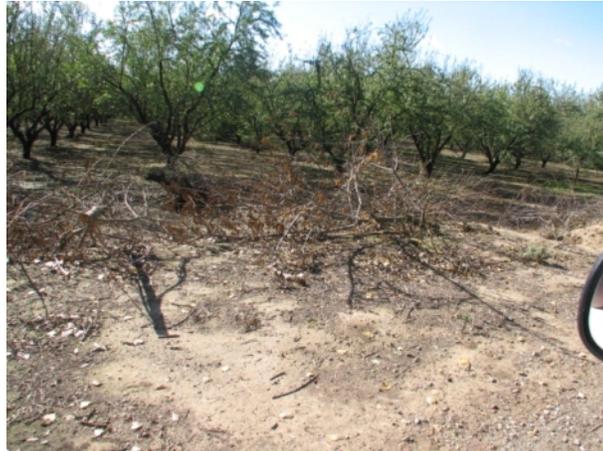
11	0.97	0.97	Earthen Levee	Encroachments	WS	M	Tree or limb	37.699536 ° -121.164667 °	37.699536 ° -121.164667 °	973
12	1.08	1.08	Earthen Levee	Encroachments	CR	M	Tree or limb	37.699060 ° -121.166553 °	37.699060 ° -121.166553 °	974
13	1.09	1.09	Earthen Levee	Encroachments	LS	M	Prunings	37.699024 ° -121.166727 °	37.699024 ° -121.166727 °	975 Y
14	1.30	1.30	Earthen Levee	Vegetation	LS	U	Remove the wild growth other than native grasses from the levee slopes.	37.699686 ° -121.170118 °	37.699686 ° -121.170118 °	976 Y

Levee Mile Report Line	13
Start Levee Mile	1.09
End Levee Mile	1.09
Location	Land Side
Category	Earthen Levee
Item	Encroachments
Prunings within 10-ft of landside toe.	
jpaasch_20091026_64.jpg

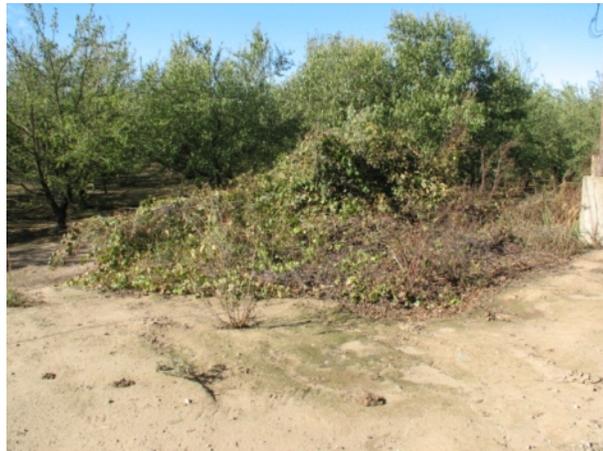
Levee Mile Report Line	14
Start Levee Mile	1.30
End Levee Mile	1.30
Location	Land Side
Category	Earthen Levee
Item	Vegetation
Dense vegetation limits visibility and access to slope.	
jpaasch_20091026_65.jpg

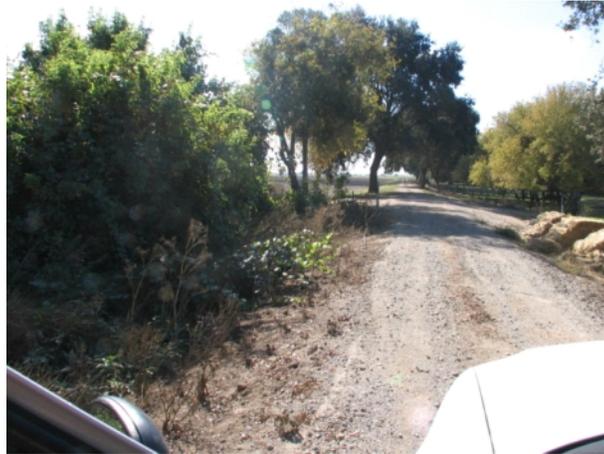
Levee Mile Report Line	17
Start Levee Mile	1.80
End Levee Mile	1.80
Location	Land Side
Category	Earthen Levee
Item	Vegetation
Dense vegetation near small feedlot limits should be removed to 10-ft beyond the landside toe.	
jpaasch_20091026_66.jpg

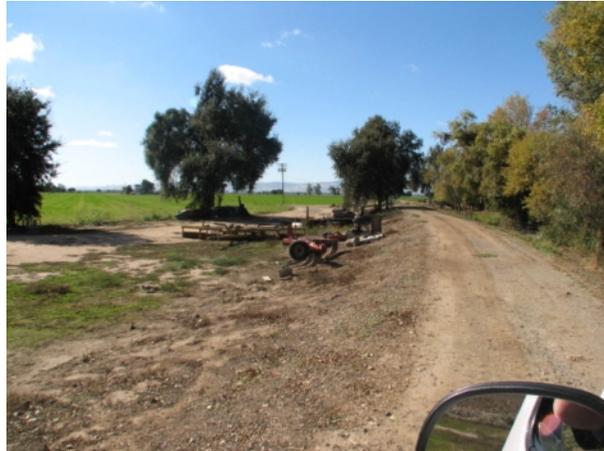
Levee Mile Report Line	18
Start Levee Mile	2.44
End Levee Mile	2.47
Location	Land Side
Category	Earthen Levee
Item	Encroachments
Photo of equipment on landside to within 10-ft of levee toe partially obstructs access and visibility.	
jpaasch_20091026_67.jpg

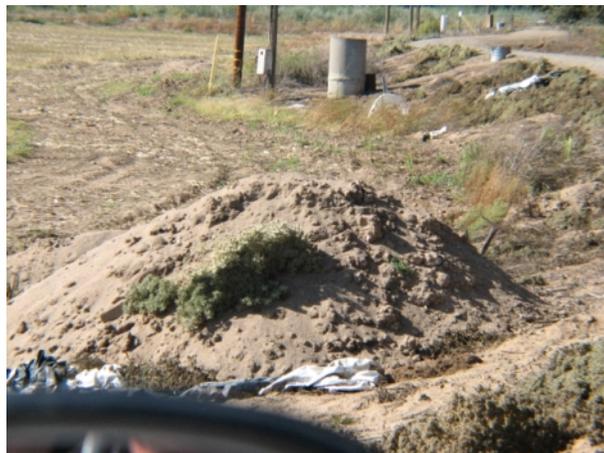
20	3.63	3.63	Earthen Levee	Encroachments	LS	M	Agricultural tilling	37.690371 ° -121.197307 °	37.690371 ° -121.197307 °	980 Y
21	3.70	3.70	Earthen Levee	Vegetation	LS	C	Elderberries are blocking visibility and flood fight capability.	37.689920 ° -121.198305 °	37.689920 ° -121.198305 °	14
22	4.60	4.80	Earthen Levee	Encroachments	LS	M	Tree or limb Inspector Comments: Wind blown Poplars	37.684474 ° -121.208447 °	37.682167 ° -121.209098 °	981
23	4.60	4.80	Earthen Levee	Encroachments	LS	PO	Landscaping Inspector Comments: Poplars	37.684474 ° -121.208447 °	37.682167 ° -121.209098 °	982
24	5.45	5.45	Earthen Levee	Encroachments	LS	CO	Landscaping Inspector Comments: Wild Rose Bushes	37.677010 ° -121.217521 °	37.677010 ° -121.217521 °	983
25	5.68	5.68	Earthen Levee	Encroachments	LS	PO	Landscaping Inspector Comments: Mostly Willow	37.673718 ° -121.217609 °	37.673718 ° -121.217609 °	984
26	5.75	5.75	Earthen Levee	Encroachments	LS	CO	Landscaping Inspector Comments: Wild Rose Bushes	37.672782 ° -121.218019 °	37.672782 ° -121.218019 °	985

Levee Mile Report Line	20
Start Levee Mile	3.63
End Levee Mile	3.63
Location	Land Side
Category	Earthen Levee
Item	Encroachments
Piles of sand presumably from nearby turnouts should be removed from the levee toe.	
jpaasch_20091026_68.jpg

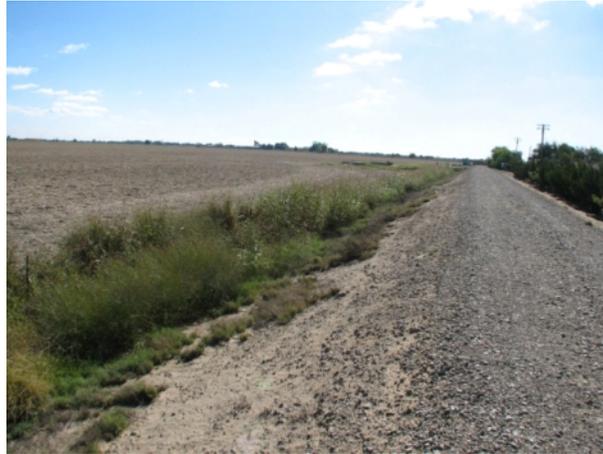
LMIR No	Levee Mile		Category	Item	Location *	Rating **	Action/Comment	GPS Latitude/Longitude		Issue No. Photo
	Start	End						Start	End	
1	0.20	0.20	Earthen Levee	Encroachments	LS	M	Tree or limb Inspector Comments: Fallen tree limb on slope.	37.659086 ° -121.234156 °	37.659086 ° -121.234156 °	964
2	1.45	1.45	Earthen Levee	Encroachments	LS	CO	Landscaping Inspector Comments: Wild Rose Bush on landside slope.	37.647708 ° -121.220873 °	37.647708 ° -121.220873 °	965
3	3.00	3.60	Earthen Levee	Trim / Thin Trees	LS	M	Trim trees to at least five feet above ground level. Inspector Comments: Trees and vegetation along highway are on the landside slope of the levee.	37.637626 ° -121.207191 °	37.638301 ° -121.196465 °	966
4	3.80	3.87	Earthen Levee	Vegetation	LS	M	Remove the wild growth other than native grasses from the levee slopes. Inspector Comments: Tall grass at toe should be removed for visibility.	37.638152 ° -121.192869 °	37.637997 ° -121.191658 °	967 Y

Levee Mile Report Line	4
Start Levee Mile	3.80
End Levee Mile	3.87
Location	Land Side
Category	Earthen Levee
Item	Vegetation
Photo of tall grass near levee toe at the rod and gun club.	
jpaasch_20091026_69.jpg
