**Flood Control Project Maintenance
Levee Inspections**

Fall 2008 Levee Maintenance Deficiency Summary Report

Reclamation District No. 2031

Levee Inspection Report By Mile - Fall 2008

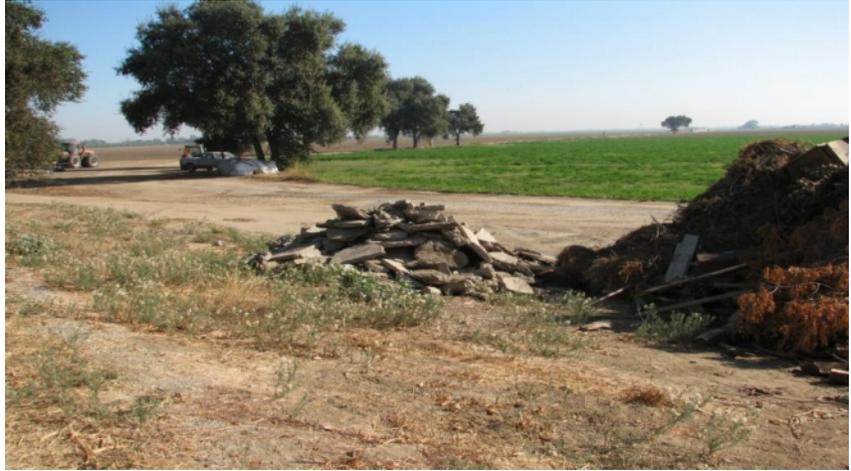
Levee Mile Report Line	7
Start Levee Mile	2.47
End Levee Mile	2.47
Location	
Category	Earthen Levee
Item	Encroachments
<p>Issue #24 RD 2031 unit 1. Debris on LS within 10' of toe must be removed. We spoke with the responsible party and were assured removal would occur soon.</p>
